# Monitoring Winter Flow Conditions on the Ivishak River, Alaska

**INE/AUTC 17.08**

# **Monitoring Winter Flow Conditions on the Ivishak River, Alaska**

## **FINAL REPORT**

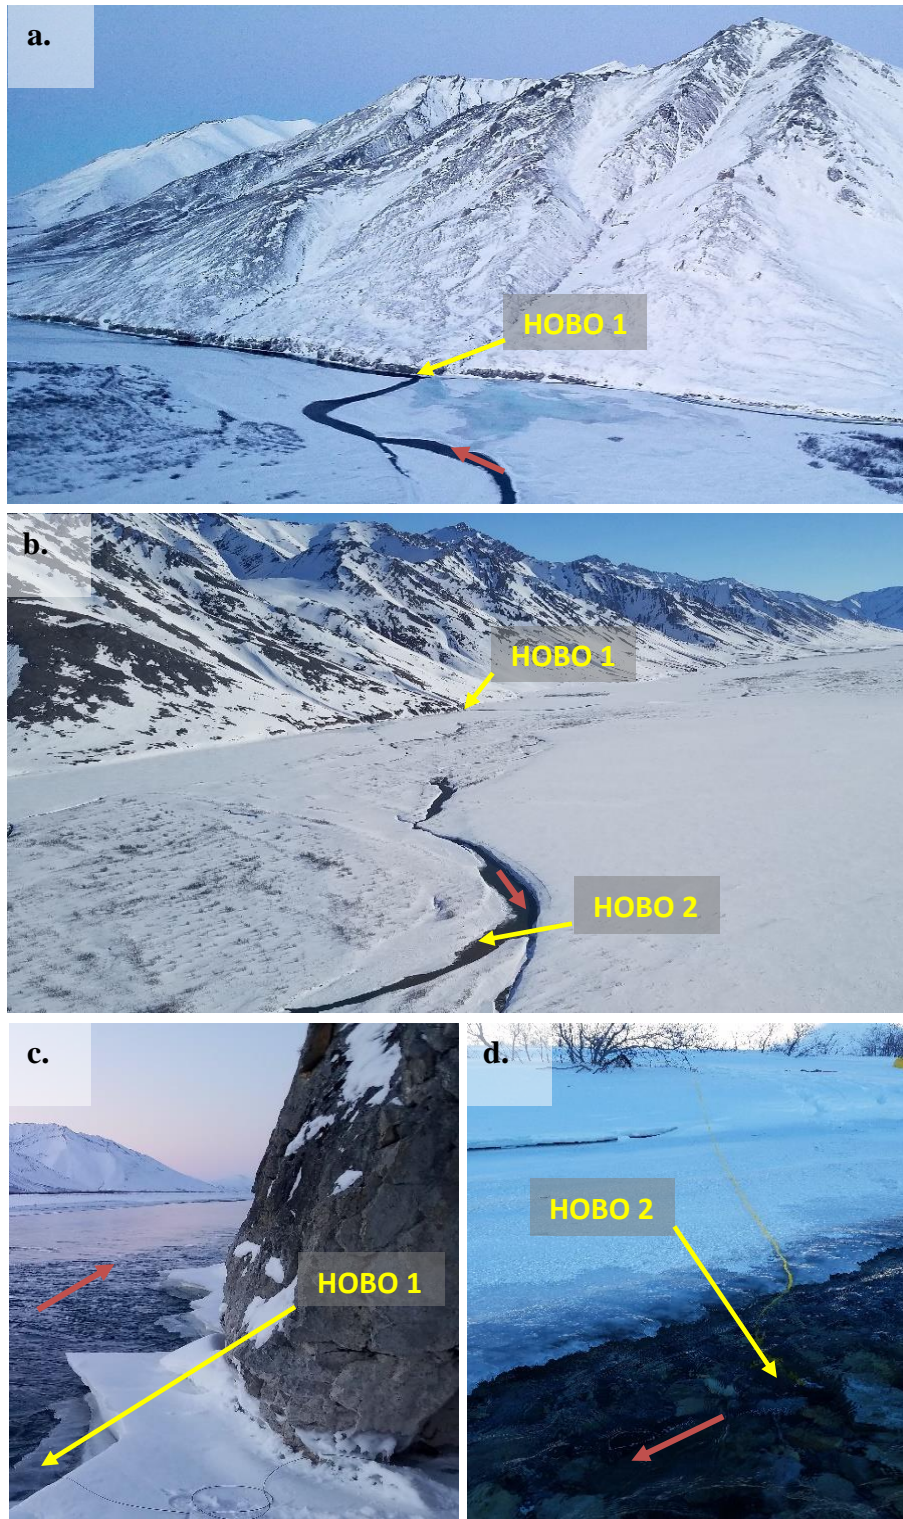
**Figure 2.1** Upper Ivishak River HOBOS sites: (a) Downstream aerial view of HOBOS 1 site on 12/7/2016; (b) upstream HOBOS 1 and 2 sites on 2/21/2017; (c) site view of HOBOS 1 on 12/7/2016; (d) site view of HOBOS 2 on 2/20/2017. Orange arrows indicate flow direction.

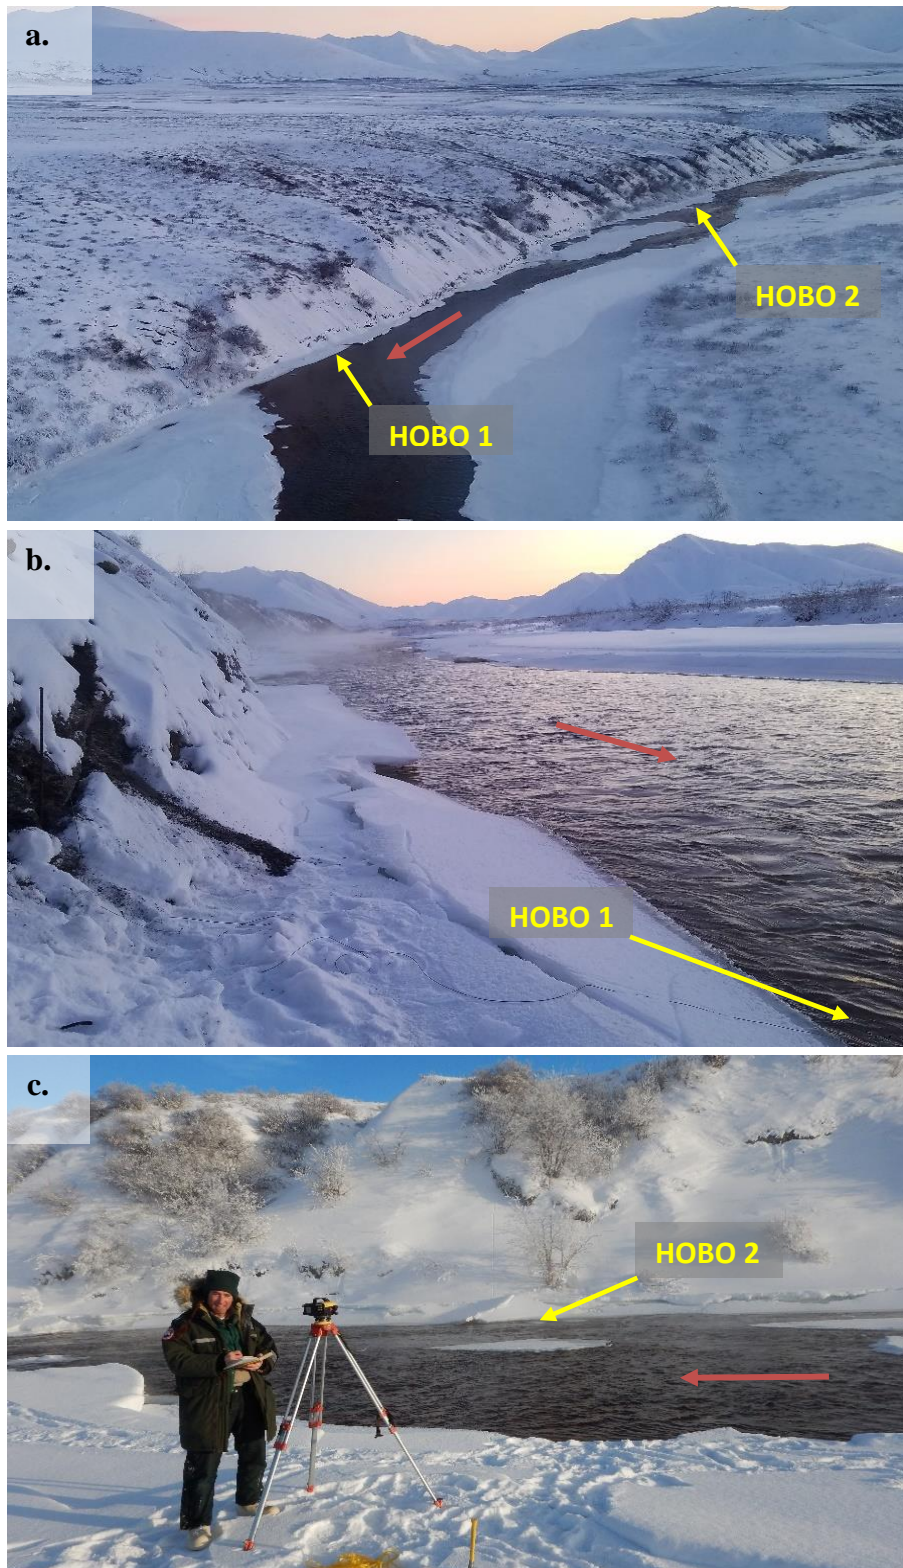
**Figure 2.2** Saviukviayak River HOB0 sites: (a) Upstream aerial view of HOB0 1 and 2 sites 12/7/2016; (b) site view of HOB0 1 on 12/7/2016; (c) site view of HOB0 2 on 2/18/2017. Orange arrows indicate flow direction.

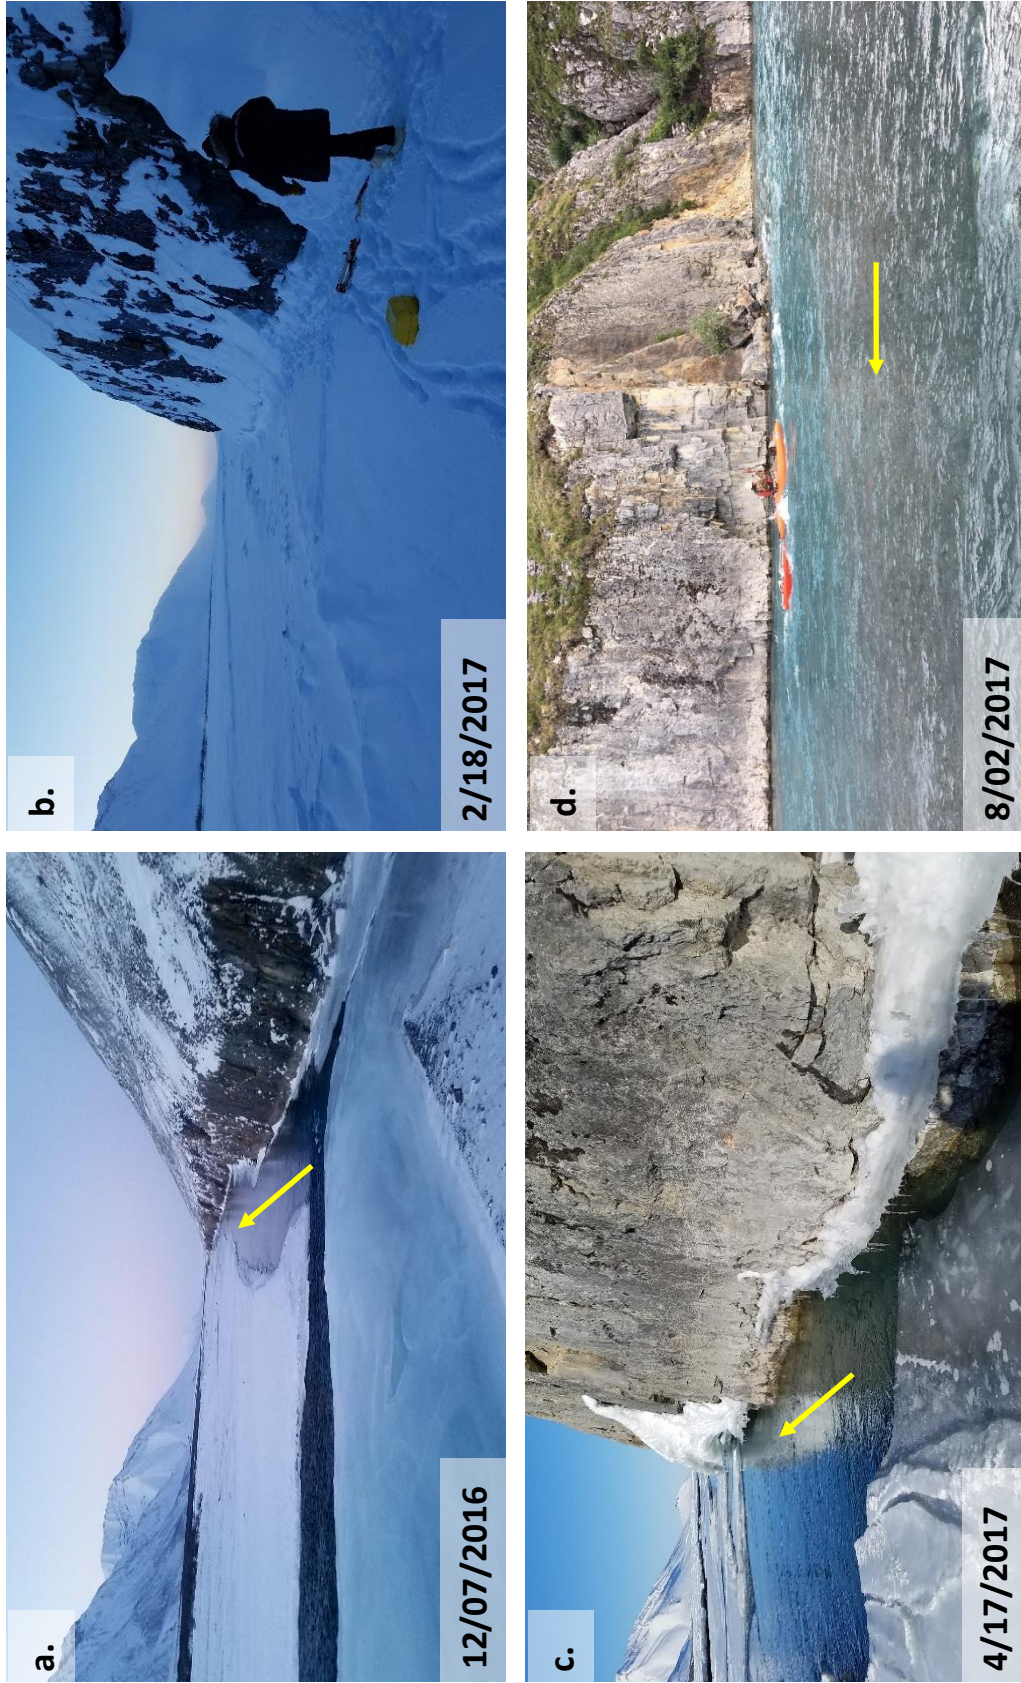
**Figure 3.1** Upper Ivishak HOB0 1 site channel ice condition (a) on 12/7/2016, (b) on 2/18/2017, and (c) on 4/17/2017; (d) discharge was measured on 8/2/2017 with a RiverPro ADCP paired with a Hemisphere S321 DGPS. Yellow arrows indicate flow direction.

A HOBO water elevation sensor was deployed at the Upper Ivishak HOBO 1 site on December 7, 2016, in an open-water section of the Upper Ivishak River (Fig. 3.1a). This channel stretch had the potential for a long-term gauging station, as all the flow was concentrated in one channel and open winter flow had been observed previously. During the February 19 site visit the channel was completely covered with ice (Fig. 3.1b), approximately 1 m thick. A second HOBO was deployed at a new site, Upper Ivishak HOBO 2, located in an open-water channel 1.5 km downstream of the Upper Ivishak HOBO 1 site. The channel at the Upper Ivishak HOBO 2 site contains only a part of the water flow from the Upper Ivishak; however, it was the only open-water channel in that area. Narrow sections of open water were observed at the Upper Ivishak HOBO 1 site during the site visit on April 17. Upon closer inspection, we noticed that the ice at this site had dropped approximately 1 m (Fig. 3.1c) and had snapped the cable holding the HOBO sensor. The water was approximately 1.5 m deep, and the sensor could not be recovered then due to unsafe ice and snow conditions. The sensor may be recoverable during low summer flows. On August 2, 2017, discharge was measured with a RiverPro ADCP paired with a Hemisphere S321 DGPS (Fig. 3.1d).

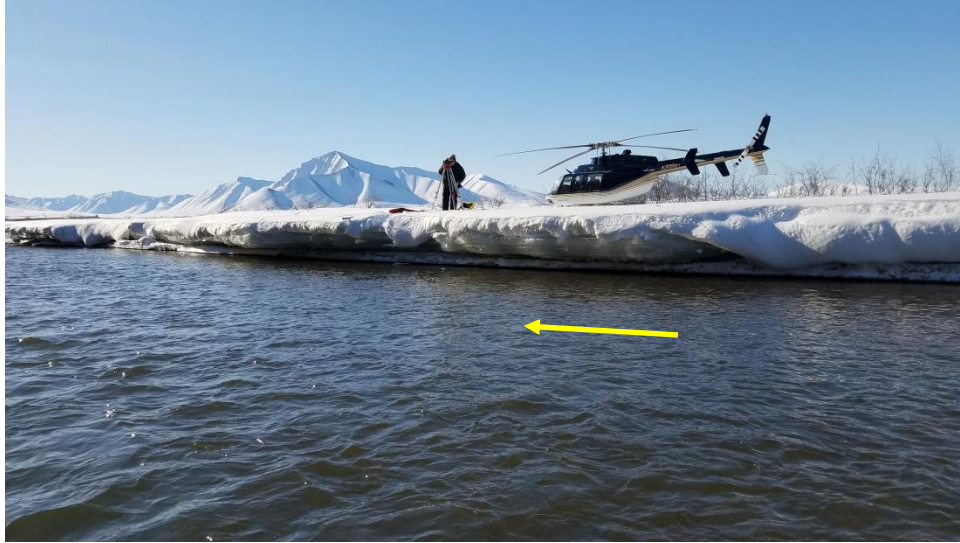
**Figure 3.4** Ice shelf formation at the Saviukviayak HOBO 1 site (photo taken 4/17/2017). Yellow arrow indicates flow direction.

This variance in water level was consistent with field observations of ice shelf formation at the Saviukviayak HOBO 1 site (Fig. 3.4). During the February 2, 2017, site visit the channel at the Saviukviayak HOBO 1 site was covered with a thin (less than 10 cm) layer of ice; however, open water was visible downstream and upstream of this site. A hole was open in the ice at the Saviukviayak HOBO 1 site, and no upward water pressure was noticed. A second HOBO sensor, Saviukviayak HOBO 2, was deployed on February 19, 2017, at a new open-water section of the channel, located approximately 100 m upstream of the first site.

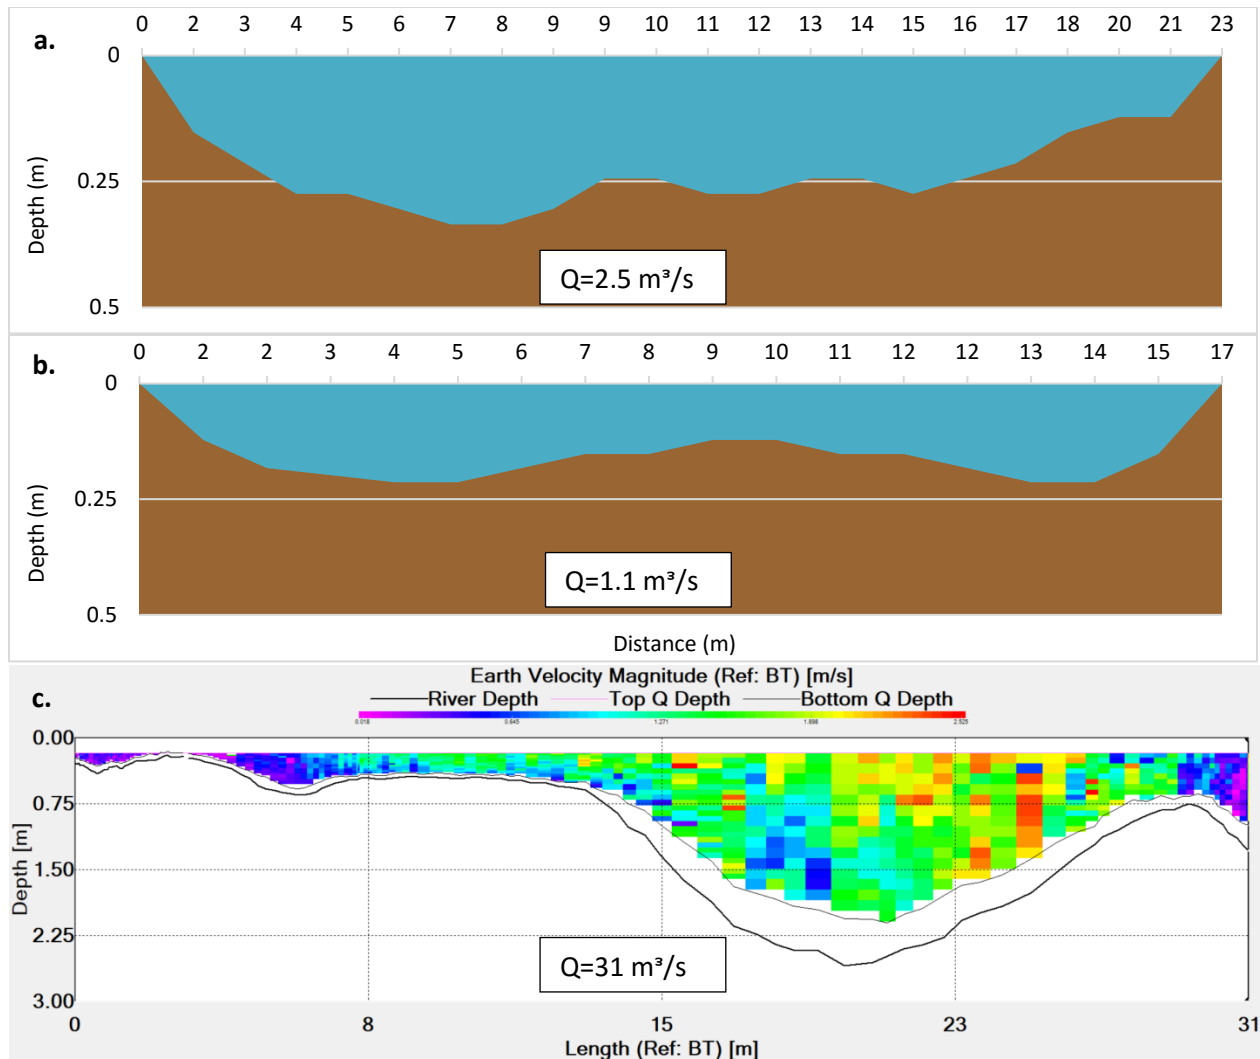
**Figure 3.5** Channel profile of (a, b) Upper Ivishak HOBO 2 site on 2/18/2017 and 4/17/2017, and (c) Upper Ivishak HOBO 1 site on 8/2/2017.

Winter discharge ( $Q$ ) measurements were conducted on the Ivishak River in February and April 2017 at the Upper Ivishak HOBO 2 site. Even though the focus of the project was winter measurements, we conducted a summer measurement in August 2017 at the Upper Ivishak HOBO 1 site as well. During the February 18 site visit, the measured discharge was  $2.5 \text{ m}^3/\text{s}$  (Fig. 3.5a) with a gauge height of 0.35 m. During the April 17 site visit, the measured discharge was  $1.1 \text{ m}^3/\text{s}$  (Fig. 3.5b) with a gauge height of 0.22 m. During the August 2 site visit, the measured discharge was  $31 \text{ m}^3/\text{s}$ , (Fig. 3.5c), with a gauge height of 387.12 m AMSL.
