Study of Internal Strains Developed in Concrete Decks at Early Ages in Steel Continuous Bridges

A thesis submitted in partial fulfillment
of the requirements for the degree of
Master of Science in Civil Engineering

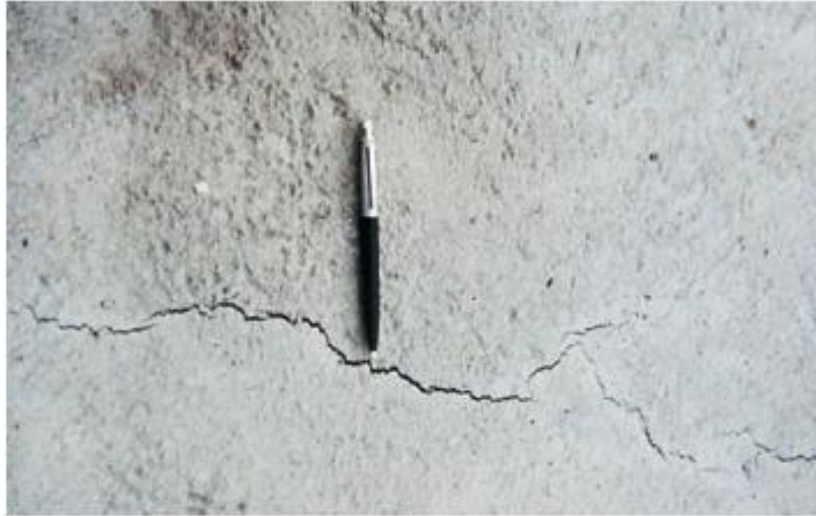
Plastic shrinkage (example shown in figure 1) refers to volume changes which occurs while the concrete is still fresh (or plastic), before hardening [15]. The resulting cracking occurs when the evaporation of water from the surface of the fresh concrete, exceeds the rate at which the bleed water within the concrete can reach the surface [4]. It is directly proportional to the rate at which water evaporates from fresh concrete meaning ambient temperature conditions will have an impact in plastic shrinkage extensiveness. Cracks will look like tears in the surface (not too deep) [15] possibly random and shallow but they are generally not a structural issue and can be minimized by minimizing evaporation from the concrete surface. Construction procedures can be implemented to reduce surface evaporation such as: fogging during placement, night

Figure 1. Plastic shrinkage in concrete [15].

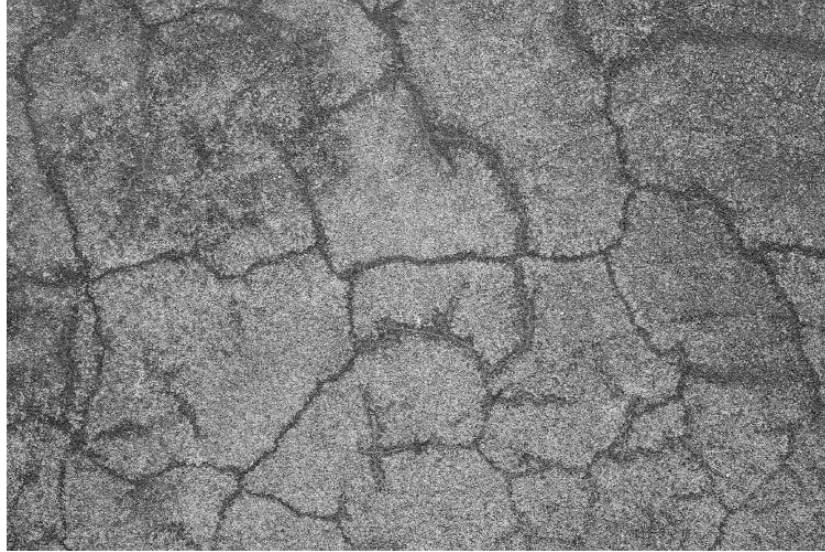
Drying shrinkage (shown in figure 3) is usually associated with transverse cracking and is considered one of the main causes of concrete bridge deck cracking [9]. As concrete hardens the internal moisture is used up in the cement reaction and is lost to the environment. This loss of moisture causes capillary pressures which result in a volume reduction known as drying shrinkage. This volume change may cause cracking if the stresses in the restrained concrete exceed the strength of the concrete. Drying shrinkage is therefore especially important at early ages. Curing techniques can be applied to the concrete after it has reached final set to mitigate drying and delay the shrinkage strains from forming before the concrete acquires enough strength to resist these stresses. Exposure conditions are a factor which influence drying. Extreme cold weather can delay concrete strength gain, whereas warm weather can accelerate the rate of moisture loss. Since these factors are uncontrollable, contractors must use efficient and effective construction methods in order to delay drying shrinkage until the concrete is mature. Examples of these curing methods include using wet burlap to maintain hydration for 7-14 days, using night pours for cooler temperatures during curing and using lower strength concrete (which tend to shrink less due to lower water demand) with proper placement and consolidation, among other techniques.

Figure 3. Drying shrinkage in concrete [18].

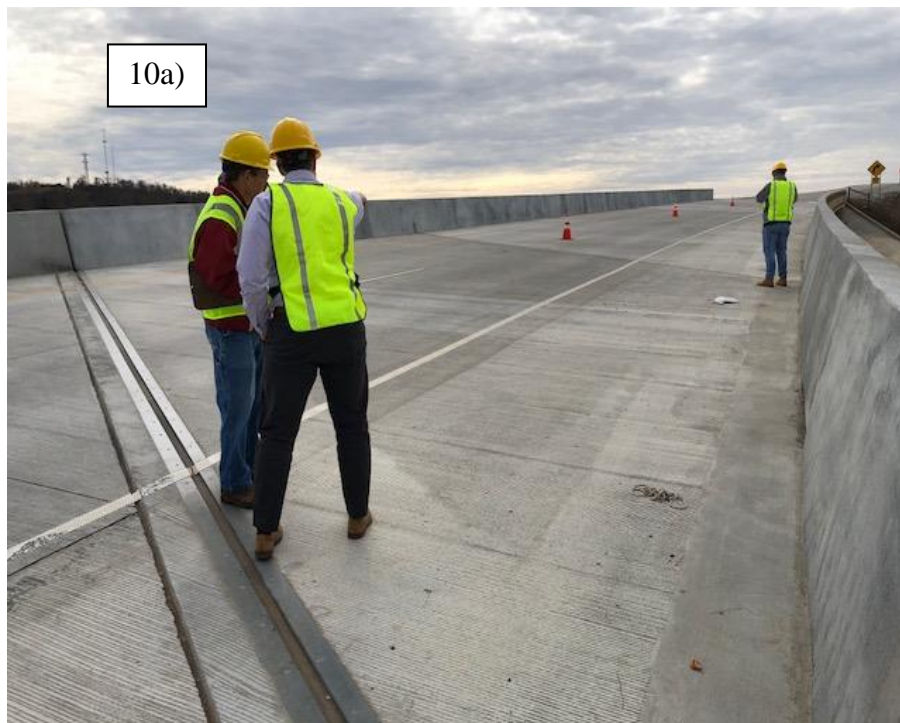
Lowell, Arkansas. Bridge 07315 is an onramp from I49 south onto 612 west. ARDOT staff mentioned it was a “new” bridge (2-3 years old) that had experienced some cracking prior to opening to traffic. Figure 10a shows the bridge from the northeast abutment looking towards the southwest. The overall bridge dimensions were roughly 42 ft wide and 230 ft long, and the bridge was skewed. Figure 10b shows a digitalized version of the observed cracks from the visit. There was a minimal degree of cracking near the northeast pier, most cracks appeared to be due to plastic shrinkage. Overall, it was in reasonably good condition so little information could be garnered from this visit to inform bridge instrumentation.

Figure 10. (a) Bridge 07315 site (photo by author) and (b) map cracking.

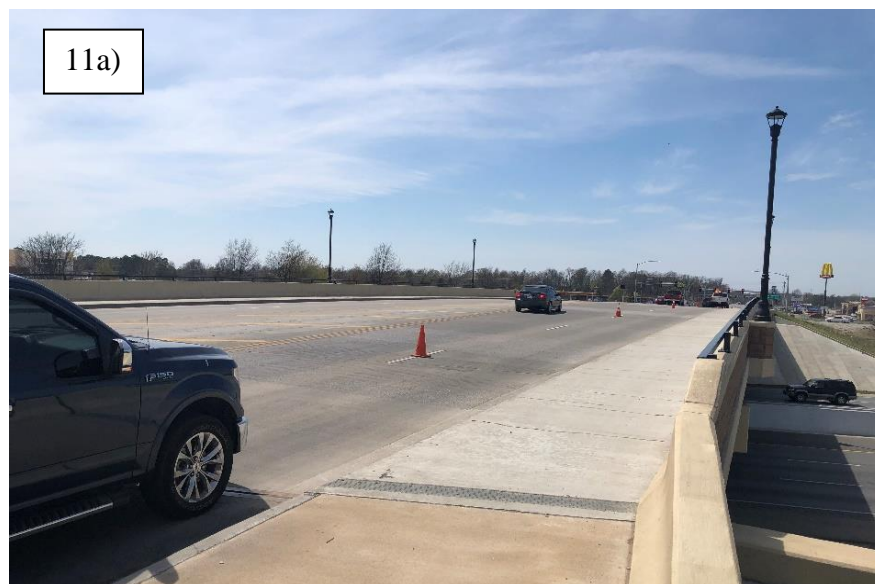
The second bridge visit was in Springdale, Arkansas (BB0413) shown in figure 11a. Bridge BB0413 carries Elm Springs Road over I49. The 3-span bridge with a skew angle of $13^{\circ}54'30''$ consisted of 7 existing beam lines reused from 1982 on the bridge deck, and 7 new ones placed during construction. The bridge deck was recommended to the research team by ARDOT engineers due to bad conditions observed on the bridge deck consisting of extensive surface cracks, as shown in figure 11b. Oddly, the positive moment regions were more severely cracked rather than the negative moment regions. The old girders were located in the central part of the deck (#6-12), the new girders were located on the outside sections of the bridge deck. Girders 1-6 were placed 6 ft between each one; girders 6-12 had 7 ft spacing. ARDOT had

Figure 12. (a) Bridge BB0413 (photo by author) site and (b) map cracking.

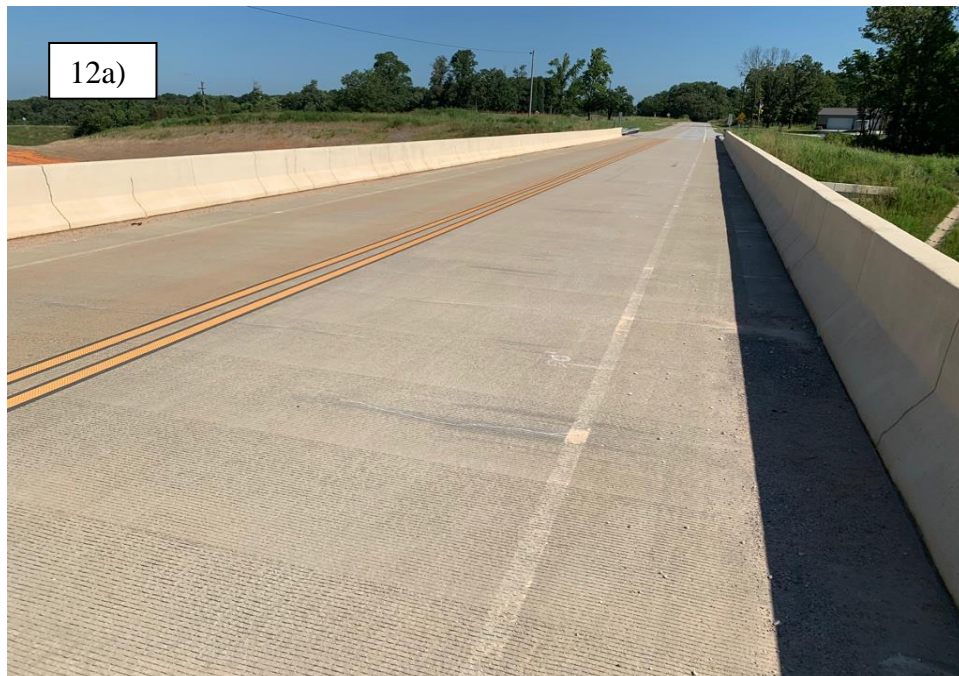
The final bridge visit was in Bella Vista, Arkansas. Bridge 07273 was a two-span continuous bridge with steel girders with a skew angle of 28° containing four steel plate girders. The bridge deck appeared to be severely cracked mostly in the negative moment region. The majority were transverse cracks, longitudinal cracks were also observed. Figure 12a-12c shows the shape and extent of cracking in this bridge. ARDOT treated the cracks on surface with epoxy filling material. Information compiled from the three bridge visits, especially bridges 2 and 3 provided the research team with a path forward for instrumentation of a new bridge. Since mostly transverse cracking was observed in the field visits, most VWSGs would be oriented to measure longitudinal strains, with emphasis in negative moment regions. All three bridges had the pouring sequence in the plans but the final method was done continuously.

Figure 14. (a) Bridge 07273 site, (b) in-situ crack shapes and (c) map cracking.

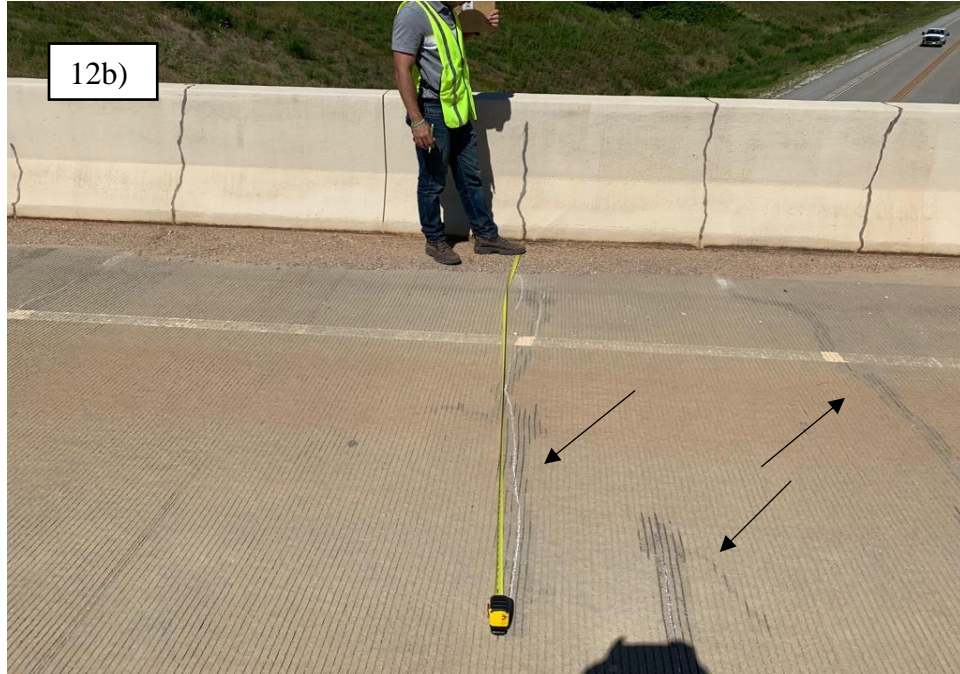
Figure 15. (a) Bridge 07273 site, (b) in-situ crack shapes and (c) map cracking.

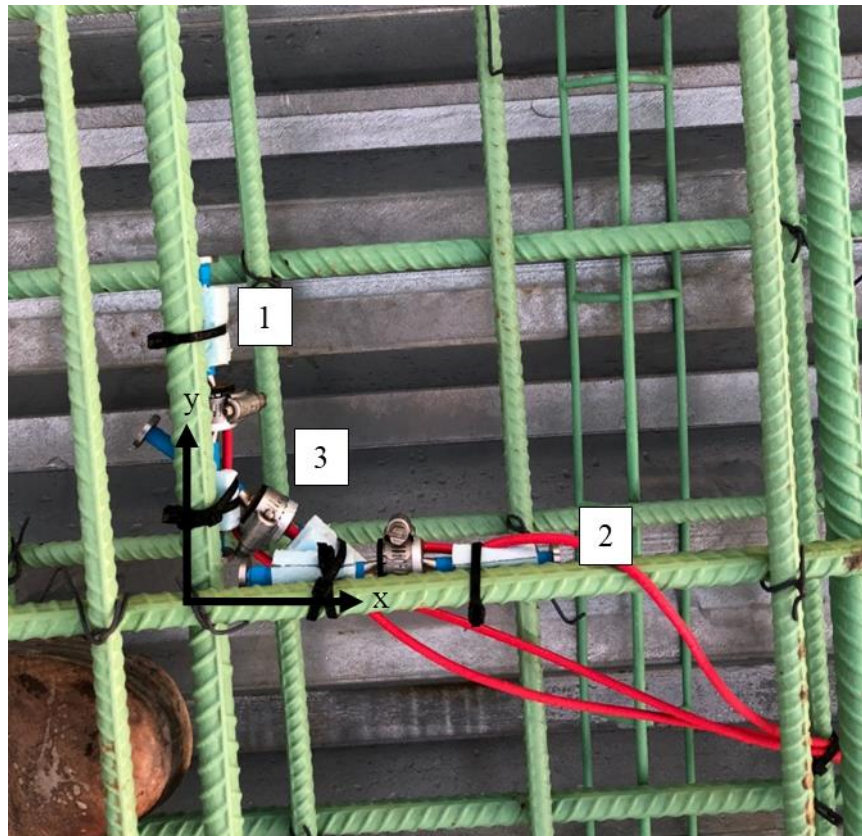
Also, we were interested in strain and stresses developed at a certain point in 3 directions: longitudinal, transverse and at angle. Figure 17 shows the “strain rosette” technique which was achieved by attaching 3 VWSG sensors together in the top rebar at a certain location in the previous mentioned directions. The VWSGs were attached to the reinforcing steel using foam pieces and plastic ties to prevent amplification of the emitted frequency by the sensor (errors could be induced if ends are touching metal material). Two 16-channel data acquisition boxes (DAQ) were installed at bent 1 and 2. Figure 18a-18b shows the actual installation in site.

Figure 20. Strain rosette display.

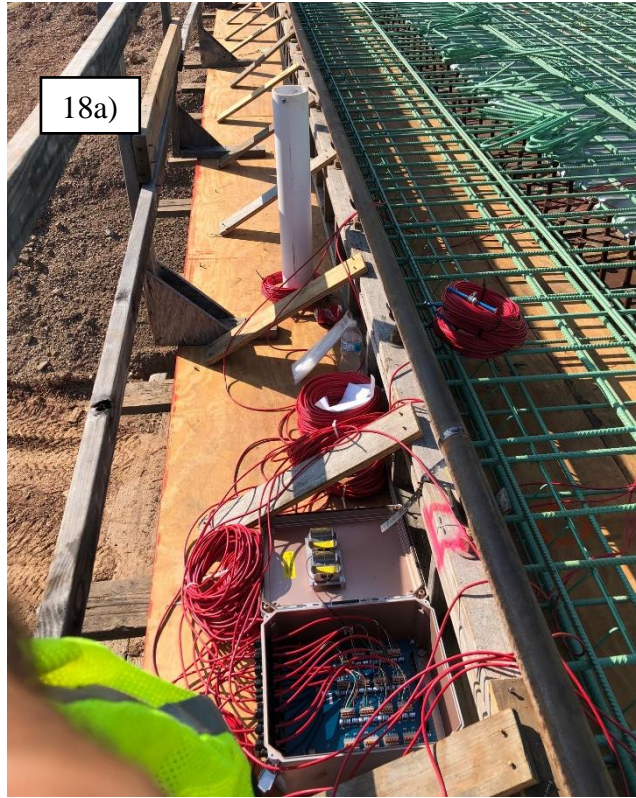
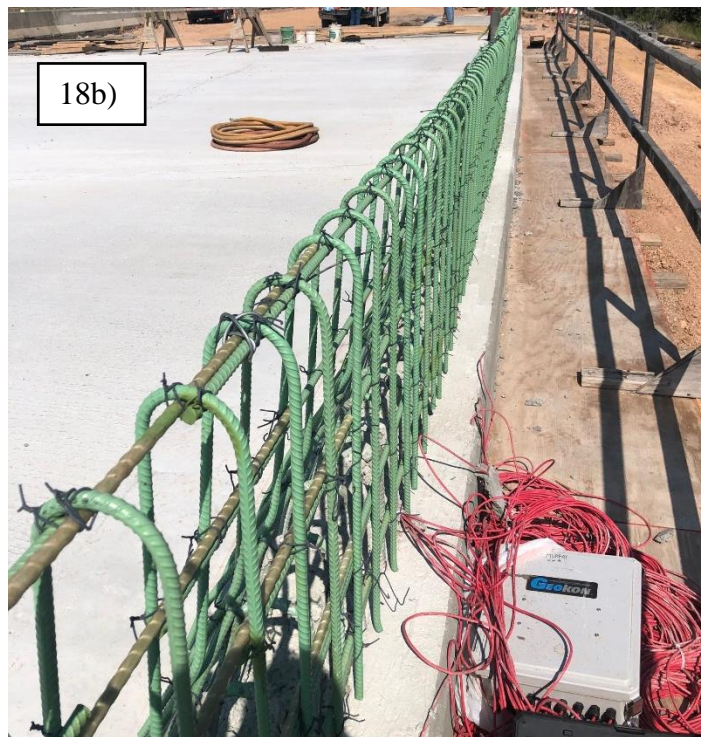
Figure 21. (a) DAQ installation before and (b) after concrete pour.

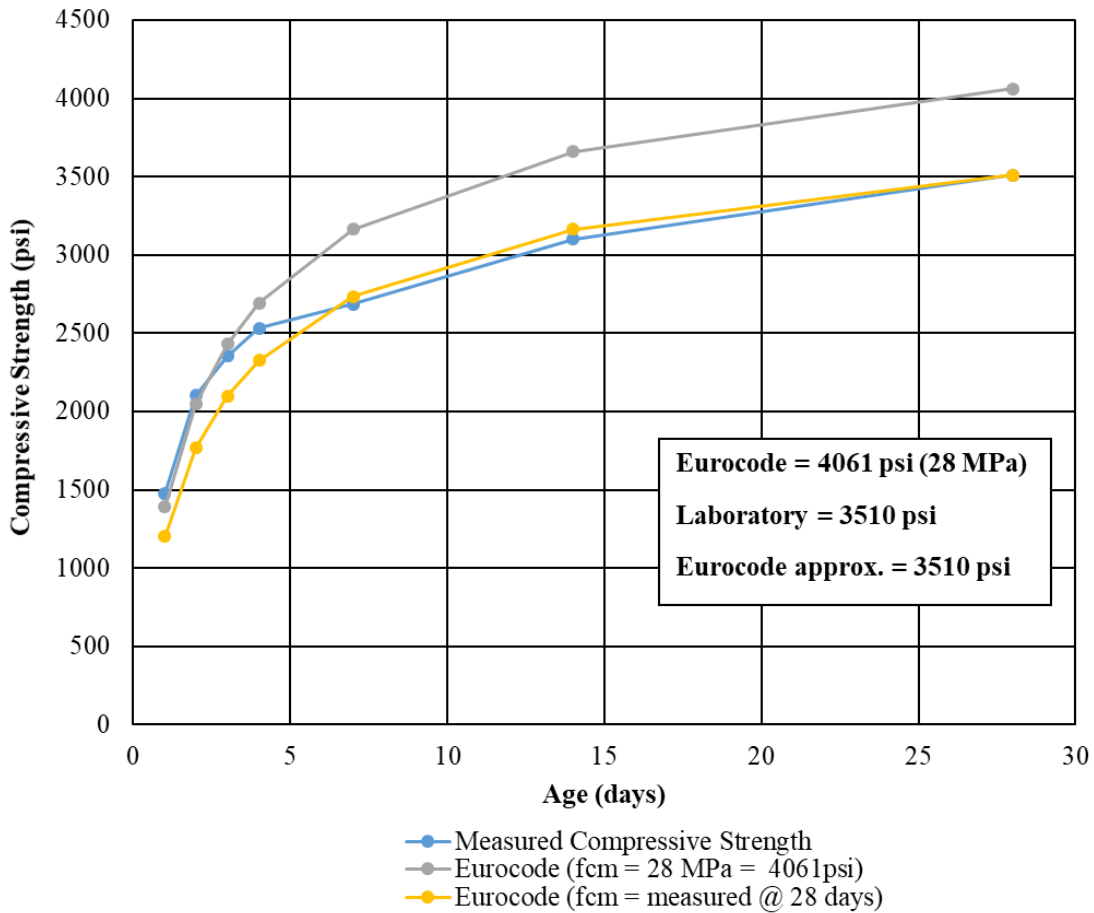
Figure 22. Compressive strength comparison between measured laboratory results and Eurocode 2 results.

From these laboratory results, it could be advised to use Eurocode approximations for early age predictions for compressive strength and modulus of elasticity. Good results can be achieved if an accurate 28-days compressive strength value is used. However, tensile strength is more difficult to estimate. The 28-days sample testing was low to what was expected. This had an effect on the Eurocode approximation since the tensile strength will depend on the compressive strength at 28 days. ACI showed to be a better approximation for this case.

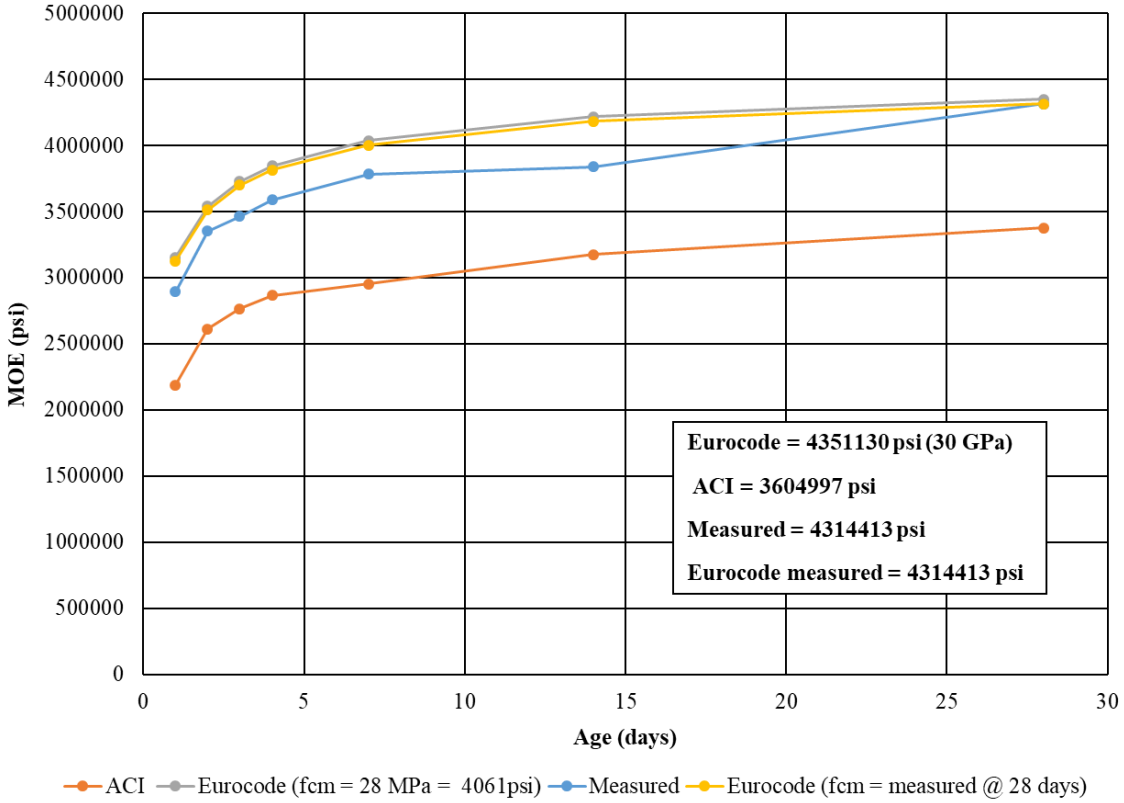
Figure 23. Modulus of Elasticity comparison between averaged measured laboratory results, ACI and Eurocode 2 values.

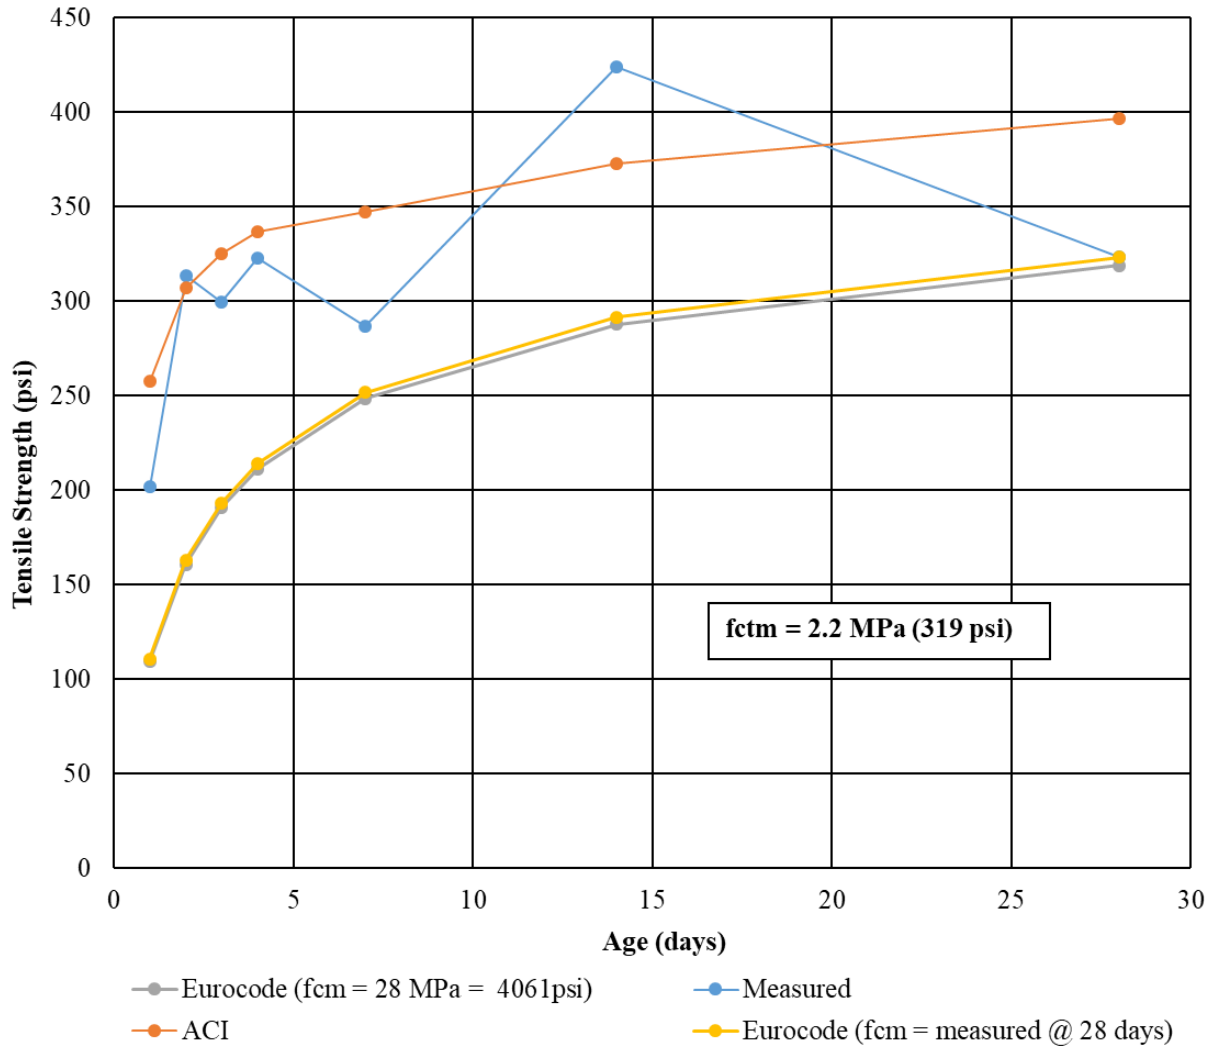
Figure 24. Tensile strength results.

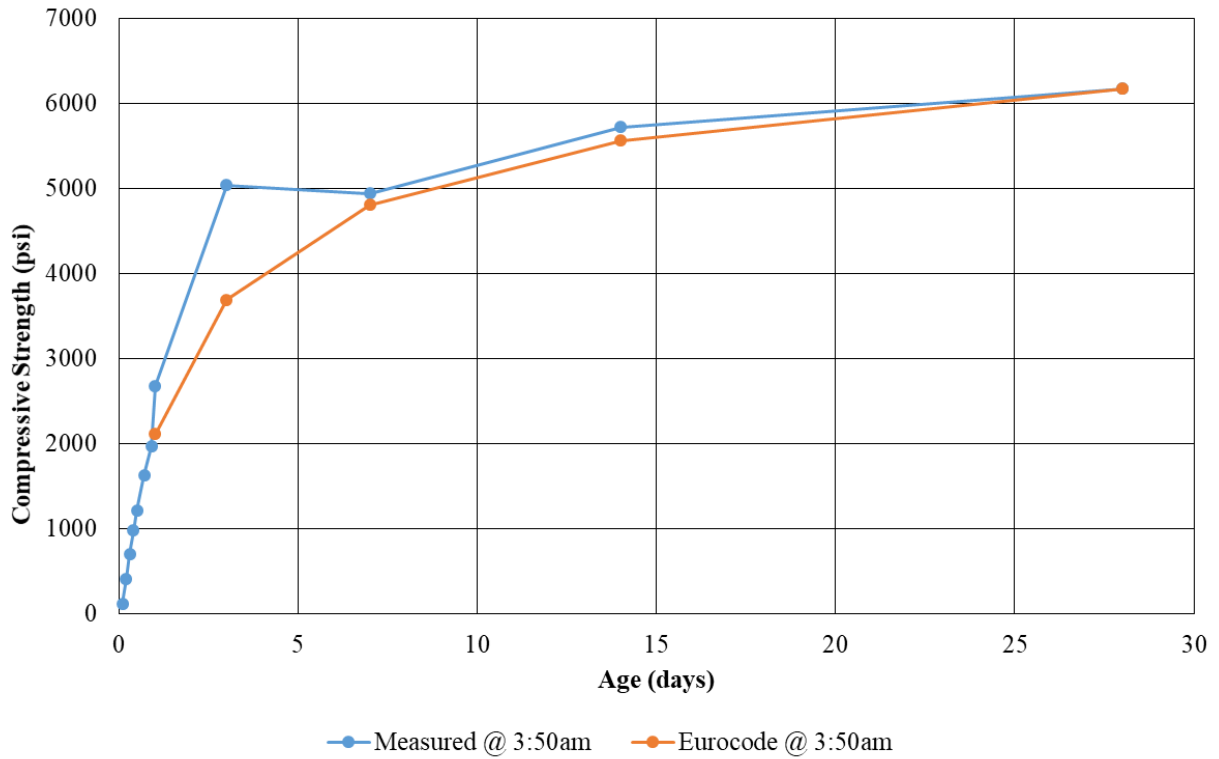
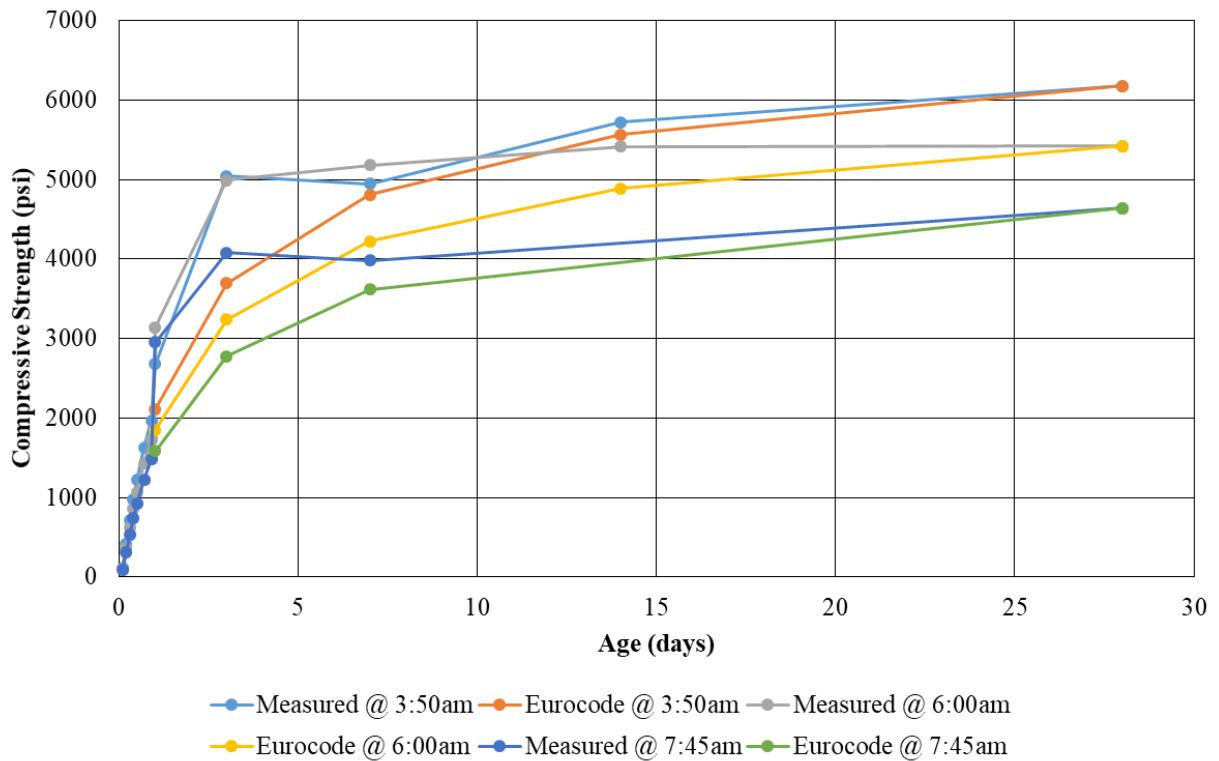
The field results at 28 days were notably higher than the minimum deck strength specified in ARDOT standards (4,000 psi). The laboratory values for compressive strength at 28 days from the 3 trucks were 6,170 psi, 5,420 psi and 4,640 psi. ARDOT's reported averaged compressive strength values at 7 and 28 days were 5,500 psi and 6,400 psi, respectively. At 3 days old, the deck already reached the 4,000 psi minimum 28 day strength through the entire length. The Eurocode 2 equation was included in the graph to estimate the early behavior and compare final results. Figure 25 shows all the behaviors and their Eurocode 2 approximations. Additional markers are shown in the early ages (prior to one day) so these strengths could be used to assist accurate modeling of the bridge deck.

Figure 25. Compressive strength results for 3:50 a.m. samples.

Figure 26. Compressive strength results for 6:00 a.m. samples.

Figure 27. Compressive strength results for 7:45 samples.

Figure 28. Compressive strength results for all collected samples.

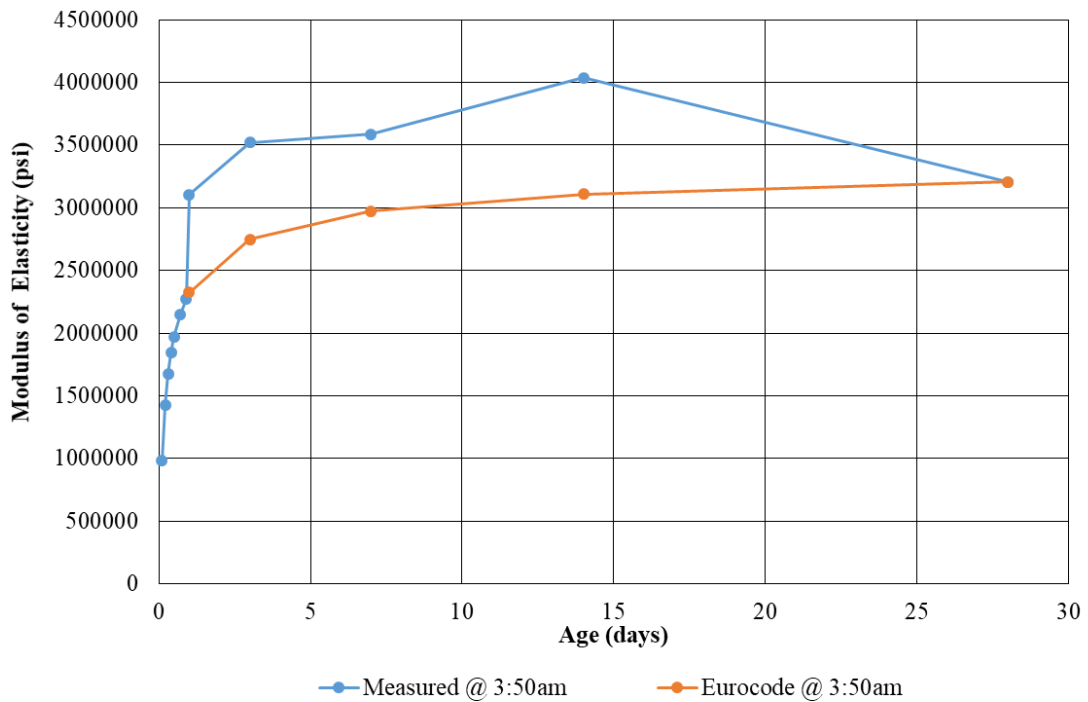
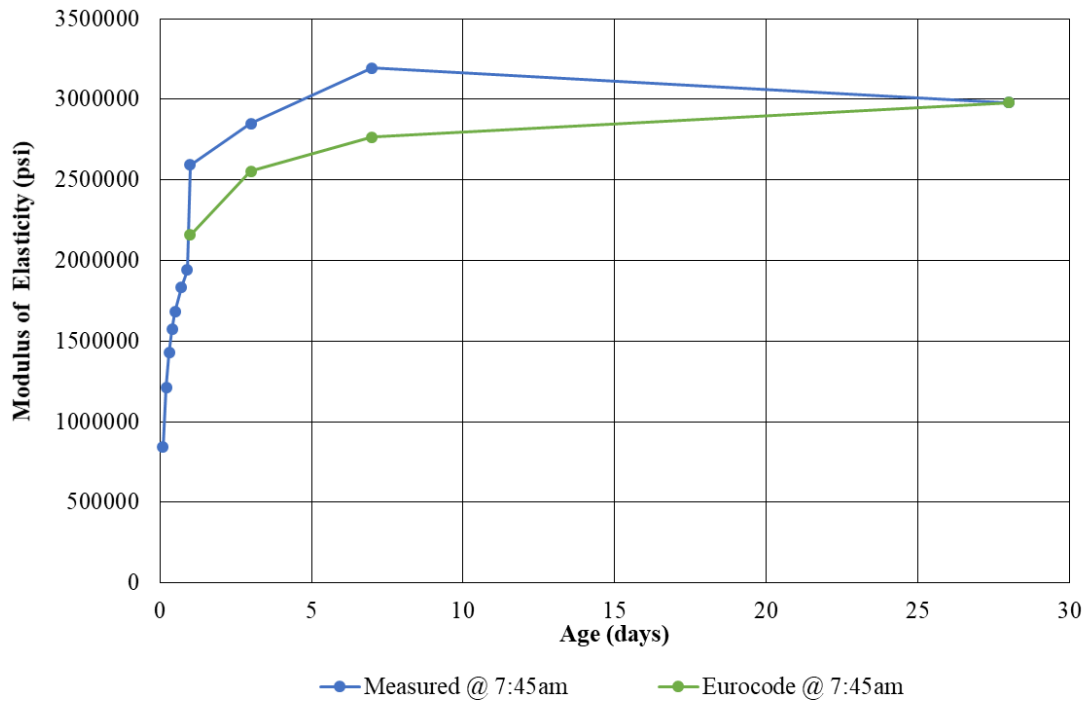
Modulus of elasticity results are illustrated in figures 26-28. At 28 days, the results of the 3:50 am, 6:00 and 7:45am specimens were 3.21×10^6 psi, 3.14×10^6 psi, 3.00×10^6 , respectively. Final 28 days results using the Eurocode 2 equation will converge to E_{cm} (equation 4 in section 5.1.1) which is the MOE value of the concrete at 28 days. For these calculations, E_{cm} was taken as the field measured value at 28 days. Figure 29 shows all the MOE measured behaviors and Eurocode 2 approximations.

Figure 29. Modulus of elasticity results for 3:50am.

Figure 30. Modulus of elasticity results for 6:00am.

Figure 31. Modulus of elasticity results for 7:45am.

Figure 32. Modulus of elasticity for all collected data.

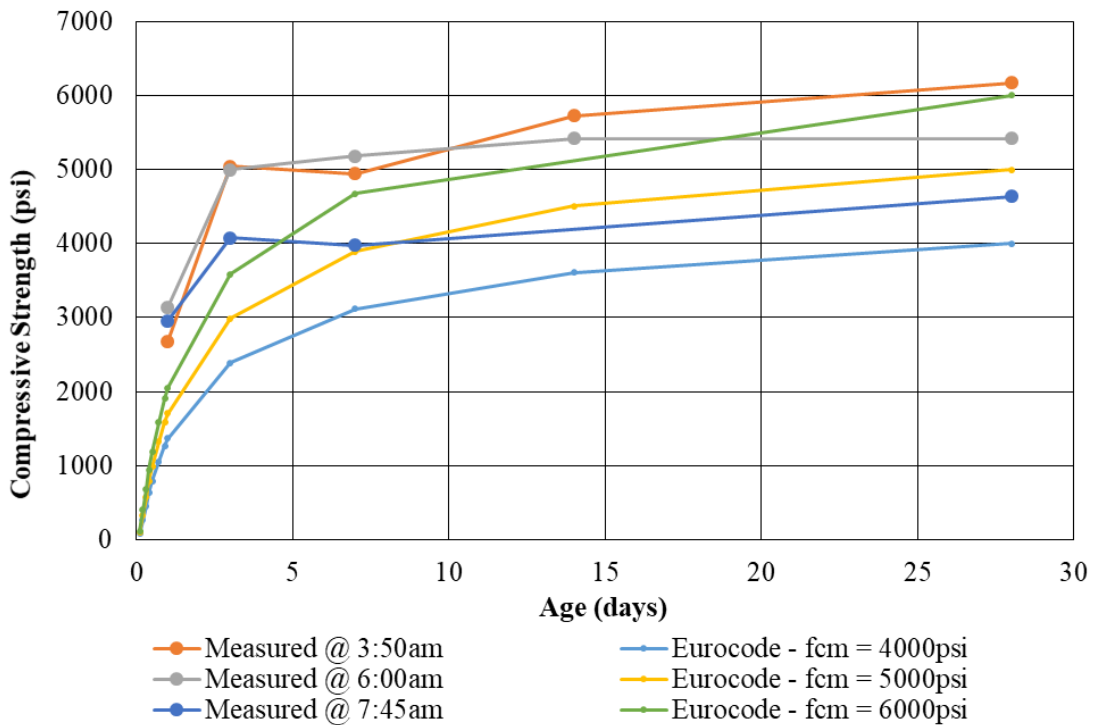
Eurocode 2 value approximations have been estimated with f_{cm} equal to the measured compressive strength at 28 days for each hour data set (3:50am, 6:00 and 7:45am). If f_{cm} is taken as 4,000 psi (minimum specified strength) the percent difference increased drastically since the equation will converge to 4,000 psi but the real 28 day compressive strength was higher, in this case approximately 6,000 psi. This presents a challenge for modeling a bridge prior to placement, since the in place strength is not known. Figure 30 shows the measured compressive strength values of the field samples and the Eurocode 2 approximation with f_{cm} equal to 4,000 psi. The Eurocode 2 equation proved inaccurate if the specified f_{cm} was used. On the other hand, if f_{cm} is taken as 5,000 or 6,000 psi the approximations showed to be better. Figure 31 shows the improved estimations compared to the measured values. Therefore, the f_{cm} value to be used is an important determinant on the estimated compressive strength behavior if the Eurocode 2 equation is going to be used as a prediction of mechanical property development over time.

Figure 33. Measured compressive strength values of the field samples and the Eurocode approximation with f_{cm} equal to 4,000 psi.

Figure 34. Compressive strength results comparison between measured values and Eurocode 2 approximations using $f_{cm} = 4000$ psi, 5000 psi and 6000 psi.

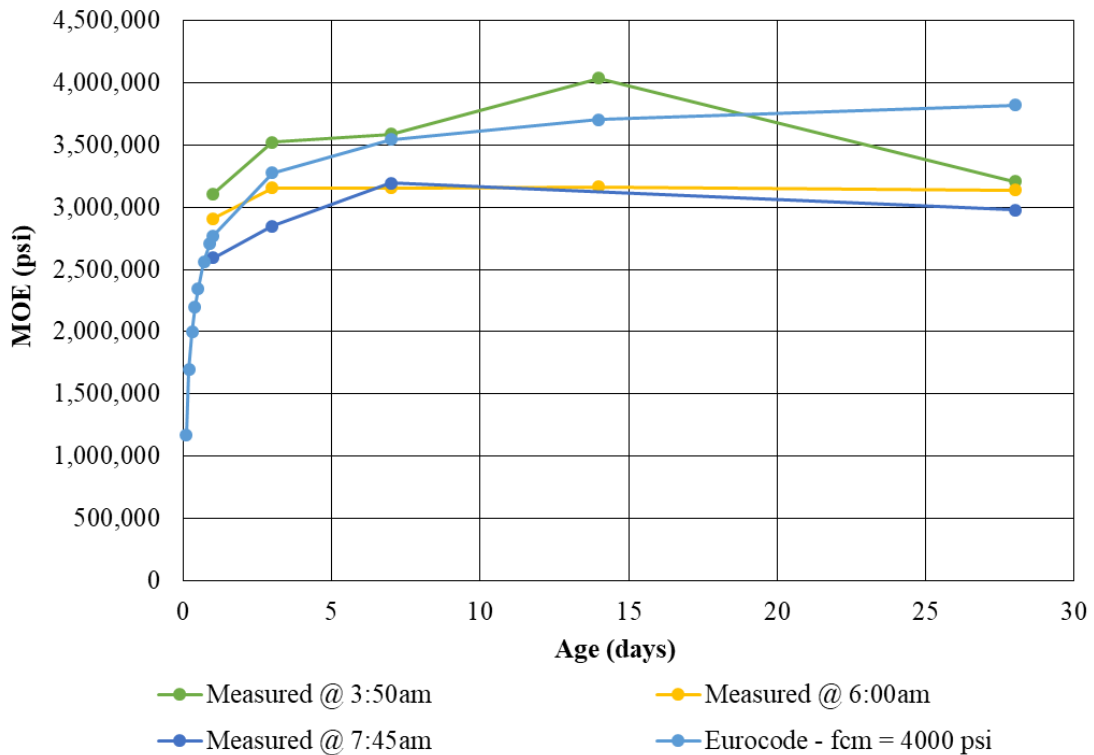
However, for the MOE results, using an f_{cm} equal to 4,000 psi provided an accurate estimate of the MOE development over time. Figure 32 illustrates the comparison between field samples and the Eurocode 2 approximation using f_{cm} equal to 4,000 psi. The final value at 28 days was higher than measured, but at early ages the behavior could be considered representative of the measured data. Figure 33 shows how the MOE is overestimated if f_{cm} is taken as 5,000 or 6,000 psi. No split tensile strength testing was performed for the bridge 030428 samples due to the limited number of specimens.

Figure 35. Elastic modulus results comparison between measured values and Eurocode 2 approximations using $f_{cm} = 4,000$ psi.

Figure 36. Elastic modulus results comparison between measured values and Eurocode approximations using $f_{cm} = 4000, 5000$ and 6000 psi.

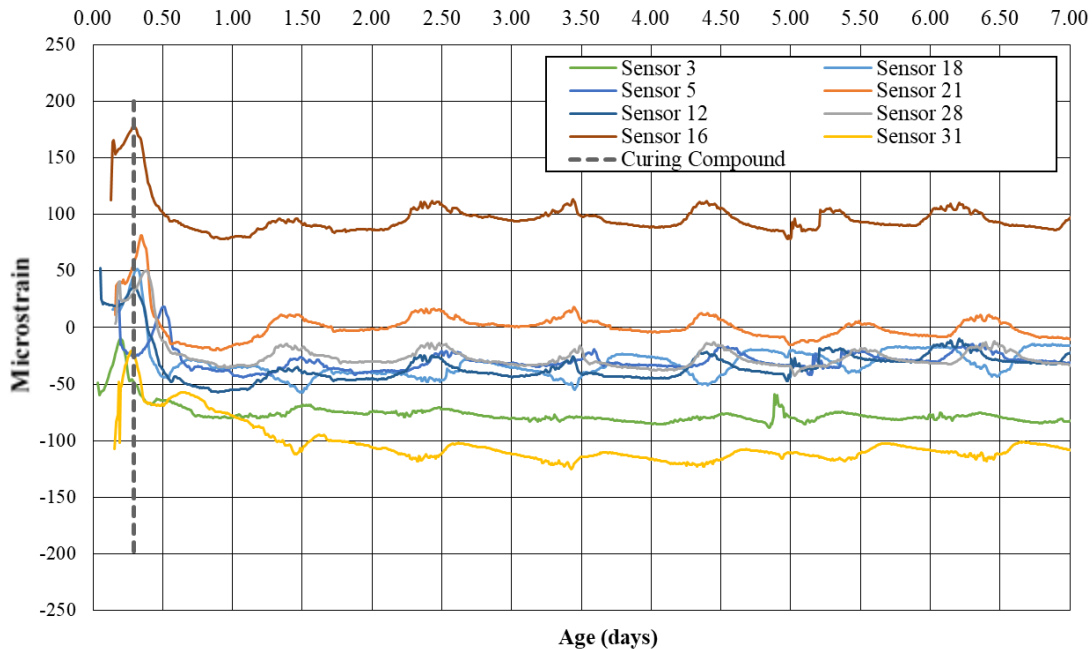
Sensors 18, 21, 28 and 31 were selected for bent 2 analysis. Figure 41 shows the strains measured at these locations. Sensor 21 recorded the highest tensile strain (81 microstrain) after approximately 6.5 hours of curing. Peaks strains occurred at different times. However, sensors 18, 21, and 31 reached their maxima fairly close in time. Now combining all these strain measurements between bent 1 and 2 (see figure 44), it can be seen which strains took place through the bridge length as a function of time. Peak tensile strains occurred between the first 3.5-12 hours after casting.

Figure 44. Recorded strains from sensors 18, 21, 28 and 31 in the first 24 hours after casting.

Figure 45. Recorded strains from sensors 18, 21, 28 and 31 in the first 7 days after cast.

Figure 46. Recorded strains from sensors at bent 1 and 2 in the first 24 hours after cast.

Figure 47. Recorded strains from sensors at bent 1 and 2 in the first 7 hours after cast.

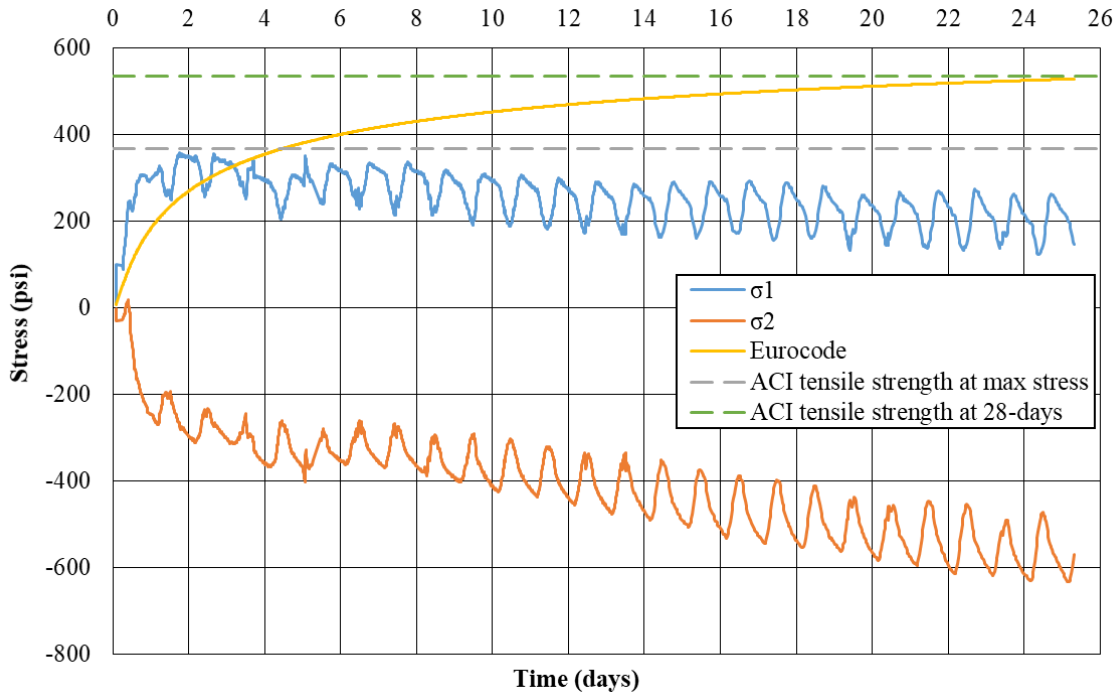
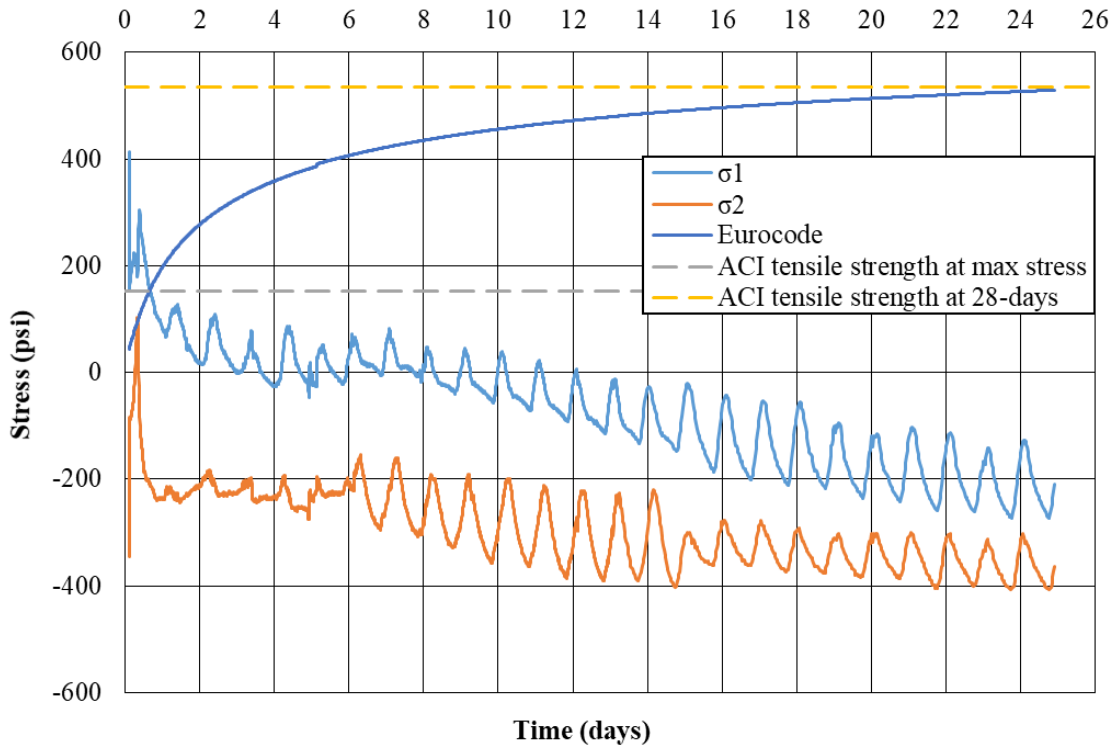
Stress recordings in the longitudinal direction were taken from the nearest VWSG sensors to the bridge centerline. These were sensors 3, 5, 12, 16, 18, 21, 28 and 31. Figure 58 demonstrates the maximum and minimum values recorded and shows that these stresses tended to be low in the longitudinal direction. Even though these occurred at different times, this graph gives an indication of the maximum and minimum strains recorded along the length of the bridge. Table 11 shows the sensor and the respective compression and tension values as well as when they occurred.

Figure 57. Principal stresses recorded in rosette 6, 7, 8 at bent 1.

Figure 58. Principal stresses recorded in rosette 9, 10, 11 at bent 1.

Figure 59. Principal stresses recorded in rosette 22, 23, 24 at bent 2.

Figure 60. Principal stresses recorded in rosette 25, 26, 27 at bent 2.
