1 Coastal defences versus coastal ecosystems: a regional appraisal

3 **Abstract**

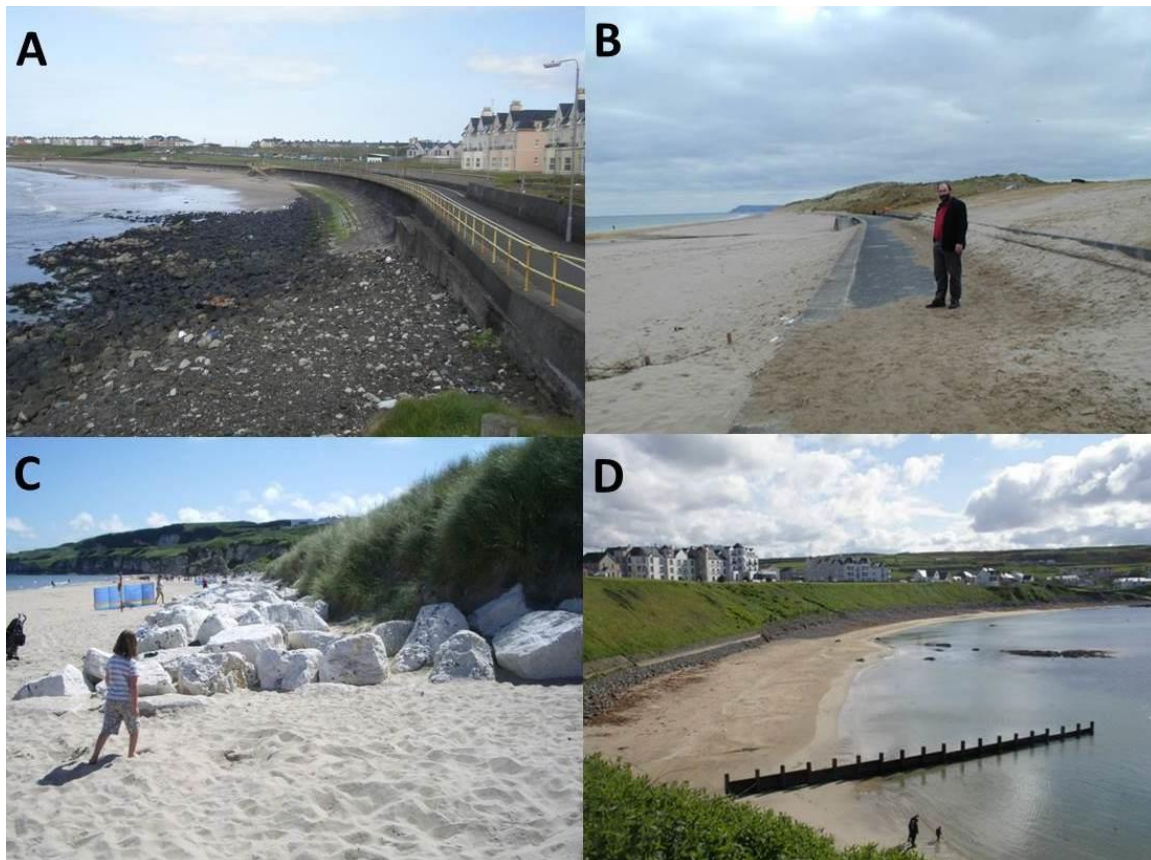
647
648 Figure 3. Sea defences on the north coast. A. Curved seawall and promenade, West
649 Strand, Portrush. B. Seawall and promenade at East Strand, Portrush. This suffers
650 regular inundation with wind-blown sand and requires regular mechanical clearing. C.
651 Rock armour to protect part of gold course. D. Portballintrae groynes ,seawall and
652 stabilized back-beach slope.

189 The sand beaches of the North Coast (Magilligan to Ballycastle) (Fig. 2) are among the
190 least developed in Northern Ireland. The high cliffs and lack of coastal roads that directly
191 impinge on beaches is the main reason. Nonetheless several do have sea defences
192 landward of the beach. These are most prominent at Portrush, the region's main seaside
193 resort. On the West Strand concave seawall and promenade are present along the rear of
194 the beach which has lowered significantly since the wall was built. On the neighbouring
195 East Strand, in contrast, a seawall and promenade suffers from regular inundation with
196 wind-blown sand. Both walls seem to have been emplaced to facilitate pedestrian access
197 on the associated promenade. Some rock armour and gabions were emplaced at
198 Whiterocks beach, Portrush at the toe of a high dune in order to protect part of a golf
199 course (Fig. 3). The sea defence situation at Portballintrae was documented by Jackson

200 (2013), who catalogued a series of interventions that led first to destruction of the beach
201 and subsequently the need to armour the glacial bluffs.

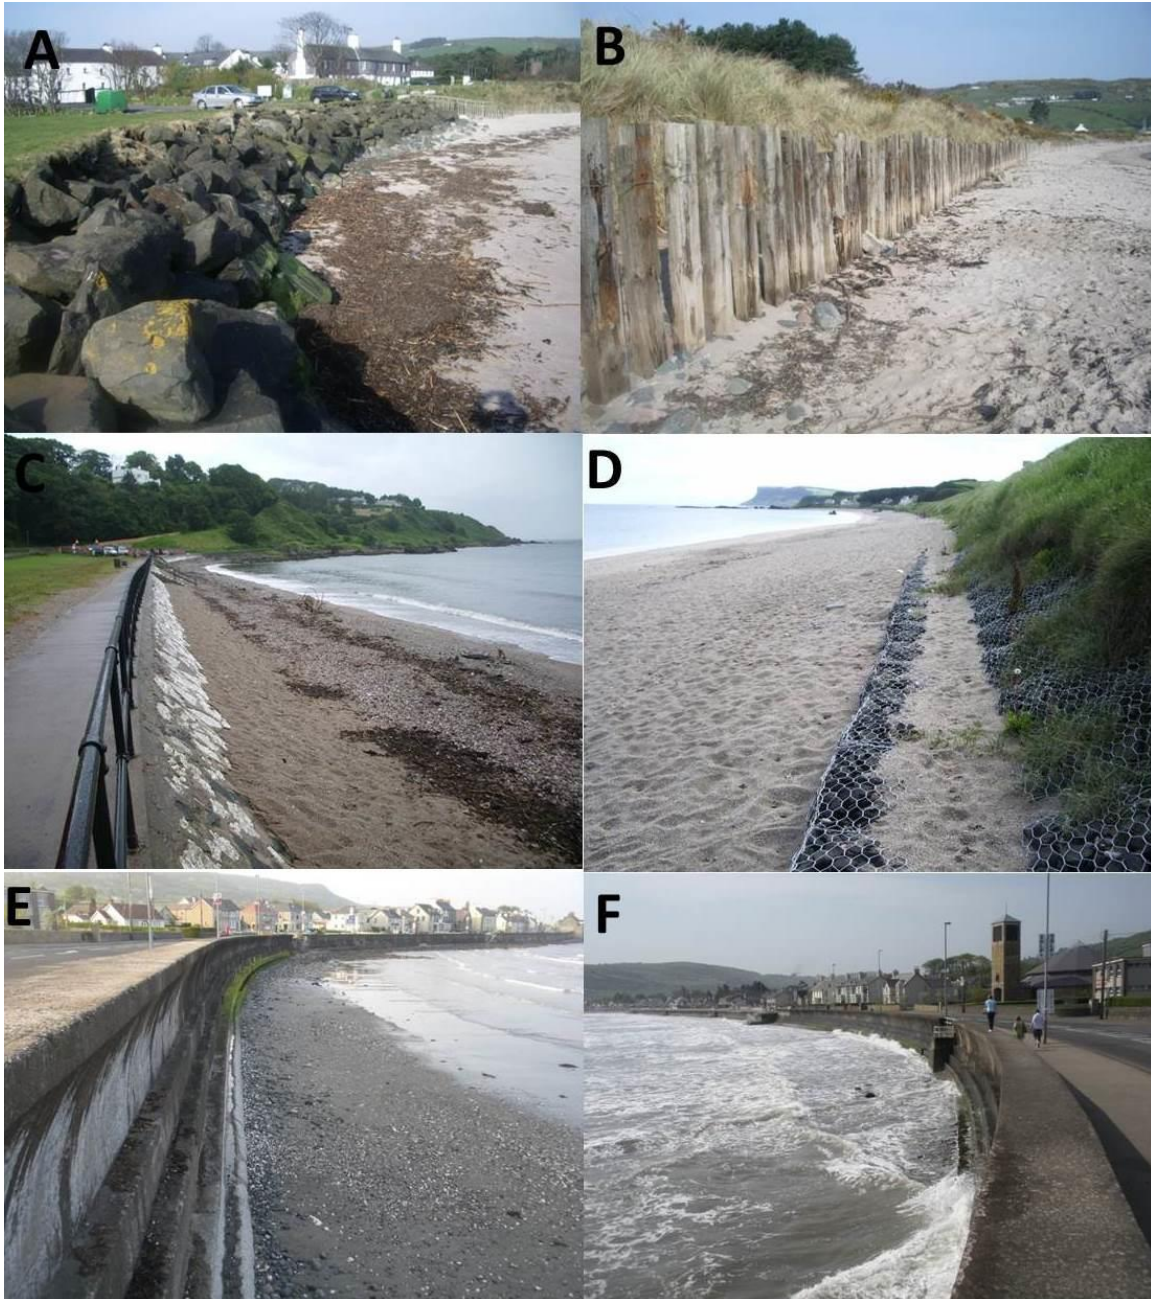
Figure 5. A. Cushendun rock armouring at a car park. B. Railway sleepers used as sea defence, Cushendun. C. Sloping stone wall, Cushendall. Gabbion baskets, Red Bay. E. and F. Near vertical, stepped seawall at Carnlough at low and high tide.

206 At Ballycastle the coastal orientation changes to run N-S (Fig. 4). Between Ballycastle
207 and Larne is a series of glaciated valleys (the Antrim Glens) with headland-embayment
208 beaches at the mouths of the valleys. The Antrim Coast Road runs semi-continuously
209 along the shoreline and a number of small settlements are present. At Cushendun
210 (Fig.5A,B), sand removal from the beach had caused beach erosion and shoreline retreat
211 (Carter, 1991). Rock armour and railway sleeper defences were built to protect adjacent
212 land. The practice of sand removal has now stopped and the walls are not being
213 maintained. At neighbouring Cushendall, a seawall and promenade was built in front of
214 a golf clubhouse. The wall collapsed during storms in 1996 and again in 2014. The
215 Antrim coast Road runs adjacent to the shoreline and where it impinges on the shore, sea
216 defences have been constructed at the rear of many beaches (Fig. 5E, F). In many cases

217 such beaches are now entirely covered at high tide and the sea defences are subject to
218 high wave energy.

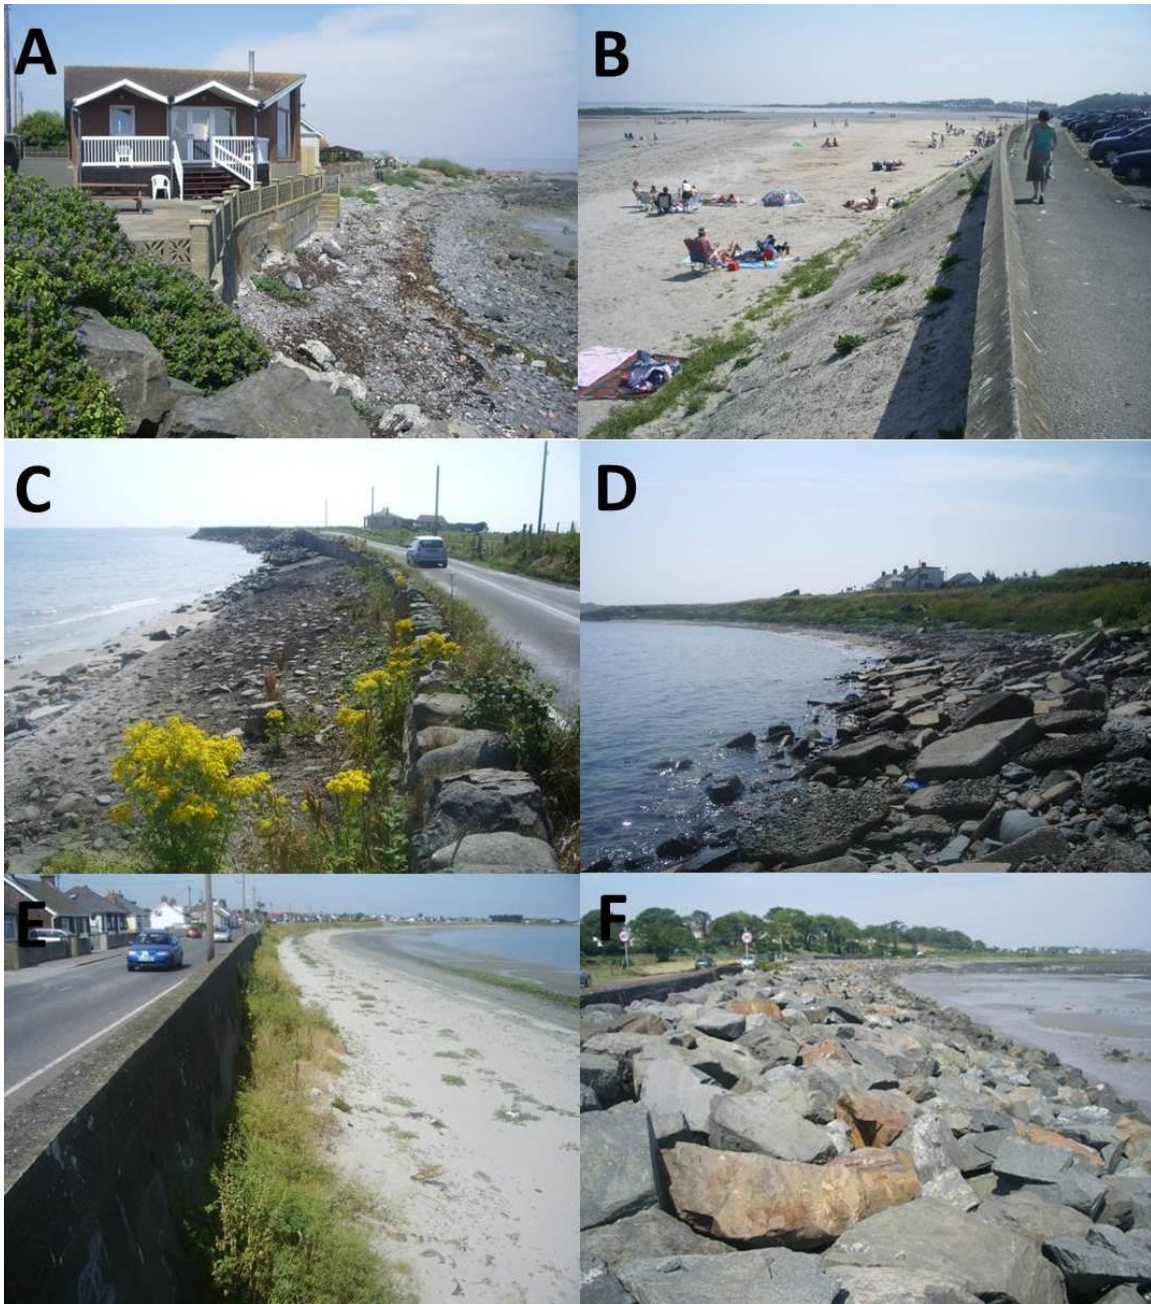
Figure 7. Sea defences on the outer Ards Peninsula. A. wall and rock armour defending house. B. concrete wall defending car park. C. Concrete wall defending road. D. Rubble dumped as sea defence. E. Vertical wall defending road. F. Massive rock armour defending road.

225 A road runs semi-continuously along the outer coast of the Ards Peninsula connecting
226 several small towns and villages (Fig. 6). Beaches are present in embayments on this
227 low-lying rocky coast and where the road impinges on the beach, sea defences have been
228 built (Fig.7). The beach margin of several caravan sites (mainly occupied by

229 holidaymakers in the summer season) are armoured with a variety of materials and most
230 of the holiday and permanent homes built seaward of the road are defended by rock
231 armour. The raised beach deposits along this stretch of coast were a source of sand
232 during storms and a future sand reservoir that would be accessed as sea level rises. This
233 has been rendered inaccessible to the beach by the sea defences. The popular seaside
234 resorts of Bangor, and Donaghadee have promenades at the rear of beaches. For
235 example, Ballyholme beach at Bangor is backed by a seawall topped by a promenade.
236 This has cut off the supply of sand from a formerly eroding bluff to landward.
237 Unsuccessful efforts to prevent the inevitable beach lowering involved construction of
238 groynes which are now in a poor state of repair.

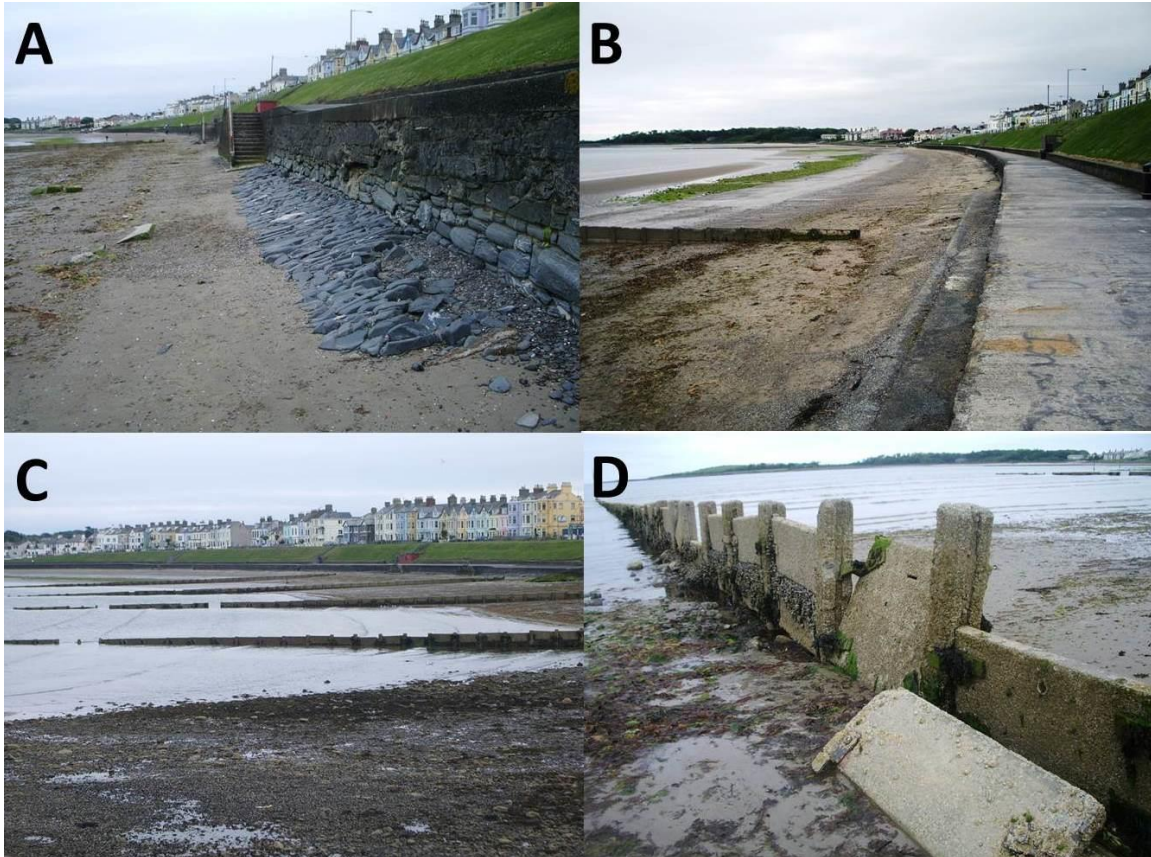
Figure 8. Ballyholme, Bangor. A. Sea wall and subsequent toe defence. B. Low promenade and seawall. C/ Groynefield/ D. Collapsing concrete groynes
