# Degradation Study of Magnesium Alloys for Development of Resorbable Bone Fixation Products

## AIM: TO STUDY THE DEGRADATION OF VARIOUS MAGNESIUM ALLOYS IN SIMULATED BODY FLUIDS FOR THE CREATION OF DEGRADABLE BONE FIXATION PRODUCTS

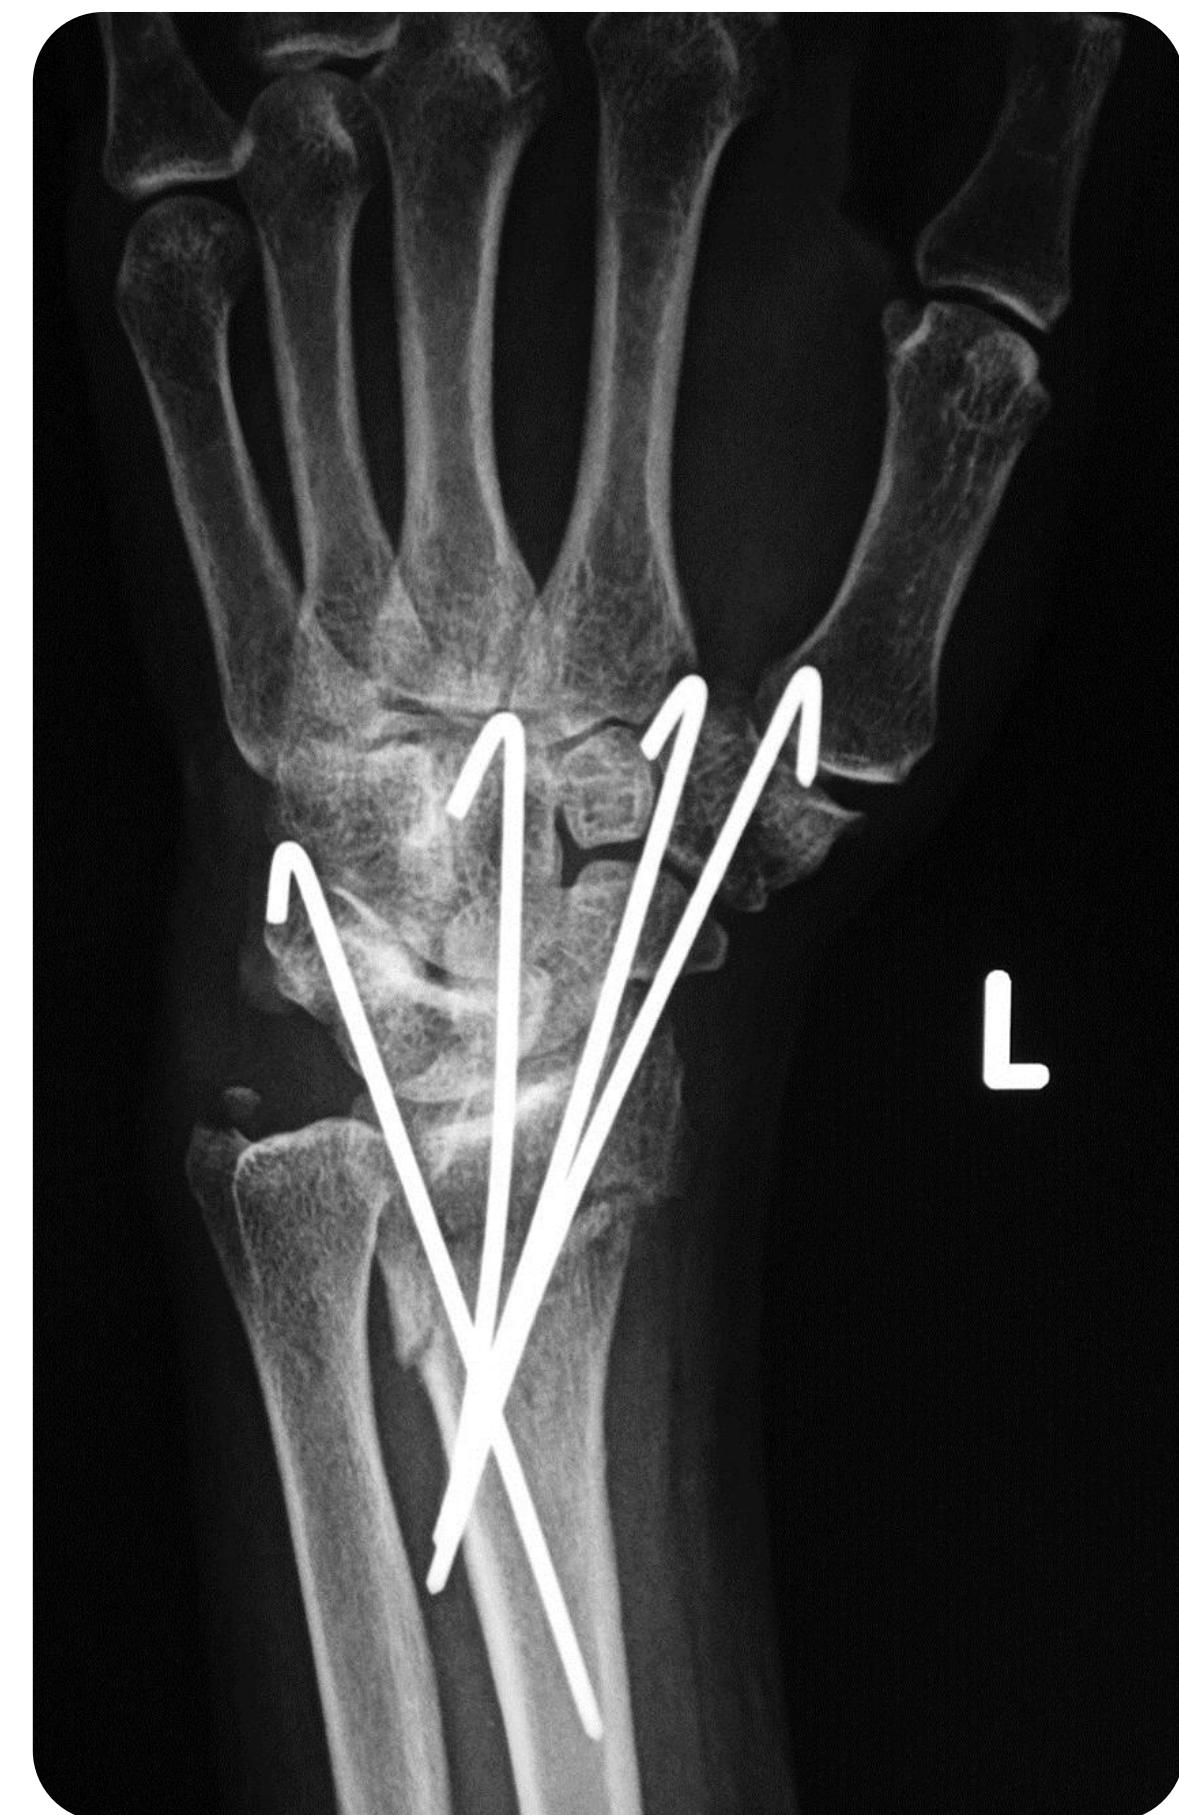
Figure 1 50 Year-old woman with distal radius immobilised by 4 K-wires<sup>[3]</sup>

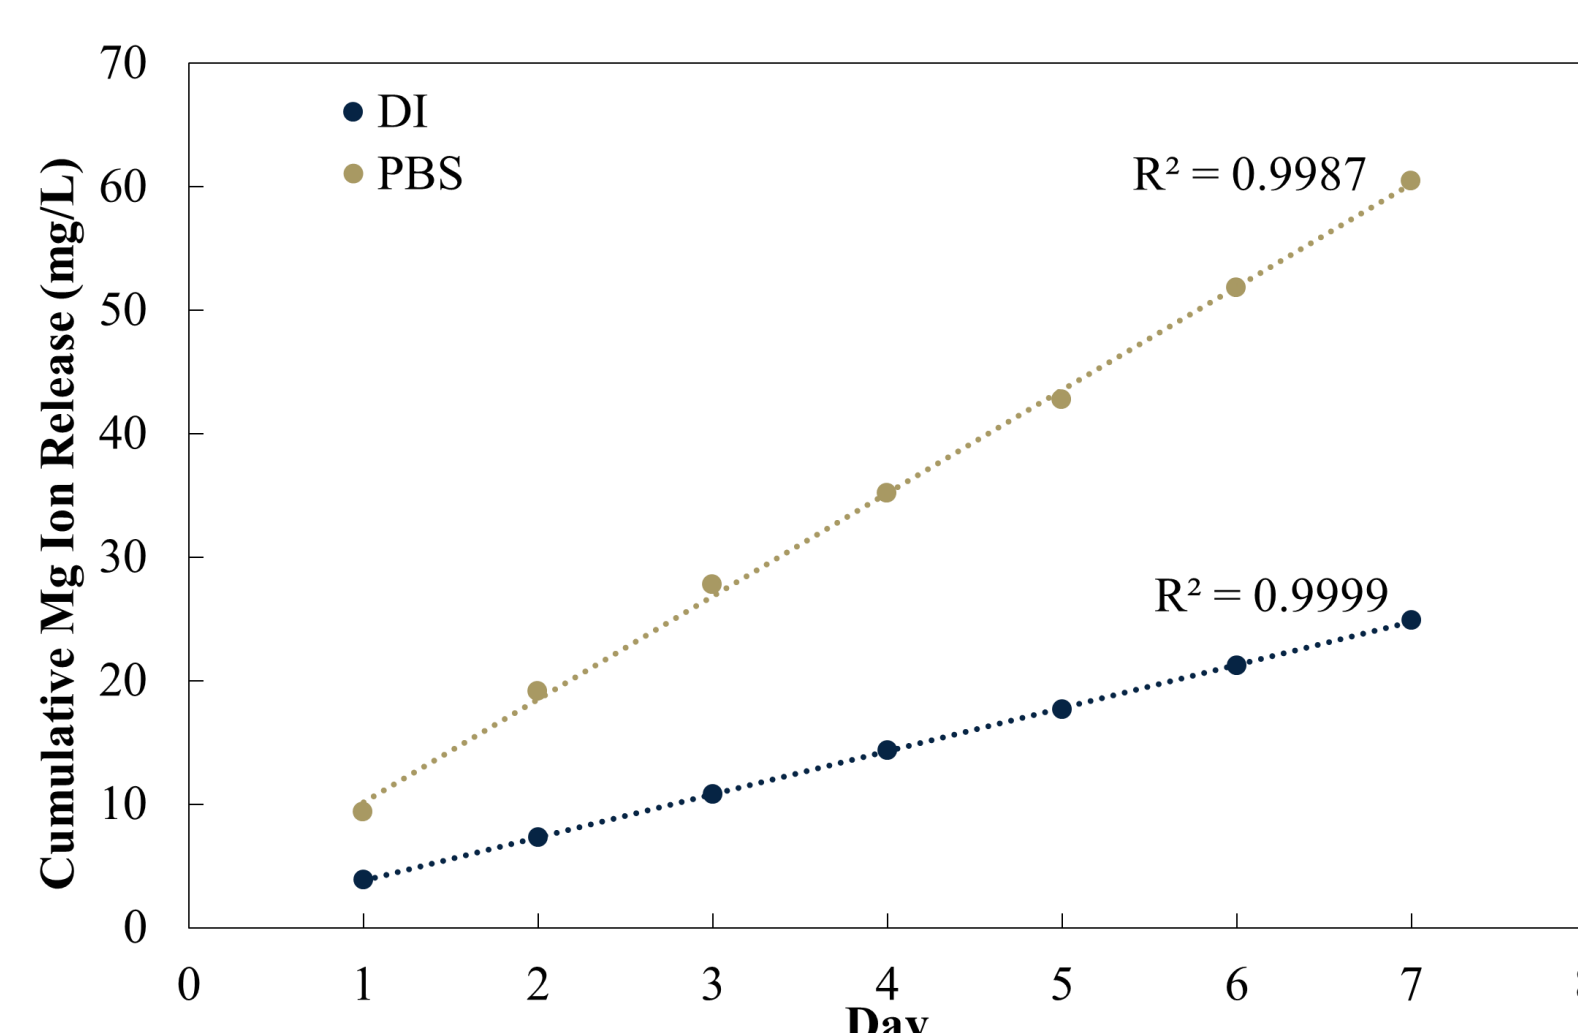
Figure 4 Mg ion release from AZ31 coupons in solutions of DI water and PBS

- AZ31 coupons degraded in all solutions with corrosion products visible on the surface of coupons in PBS and SBF solutions, Figure 3
- Coupons degrading in PBS exhibited a greater magnesium ion release than coupons degrading in DI water, Figure 4
- Coupons degrading in SBF exhibited a greater loss in magnesium volume and a greater increase in coupon surface area than coupons in DI water and PBS at 7 days, Figure 5

The results of this study show that AZ31 alloys degrade at higher rates in solutions of PBS and SBF. This is due to the passivating layer  $Mg(OH)_2$  which is created when magnesium reacts with water being readily attacked by ions of many types. Solutions with a higher ionic content also have a greater galvanic potential, increasing the amount of corrosion occurring.

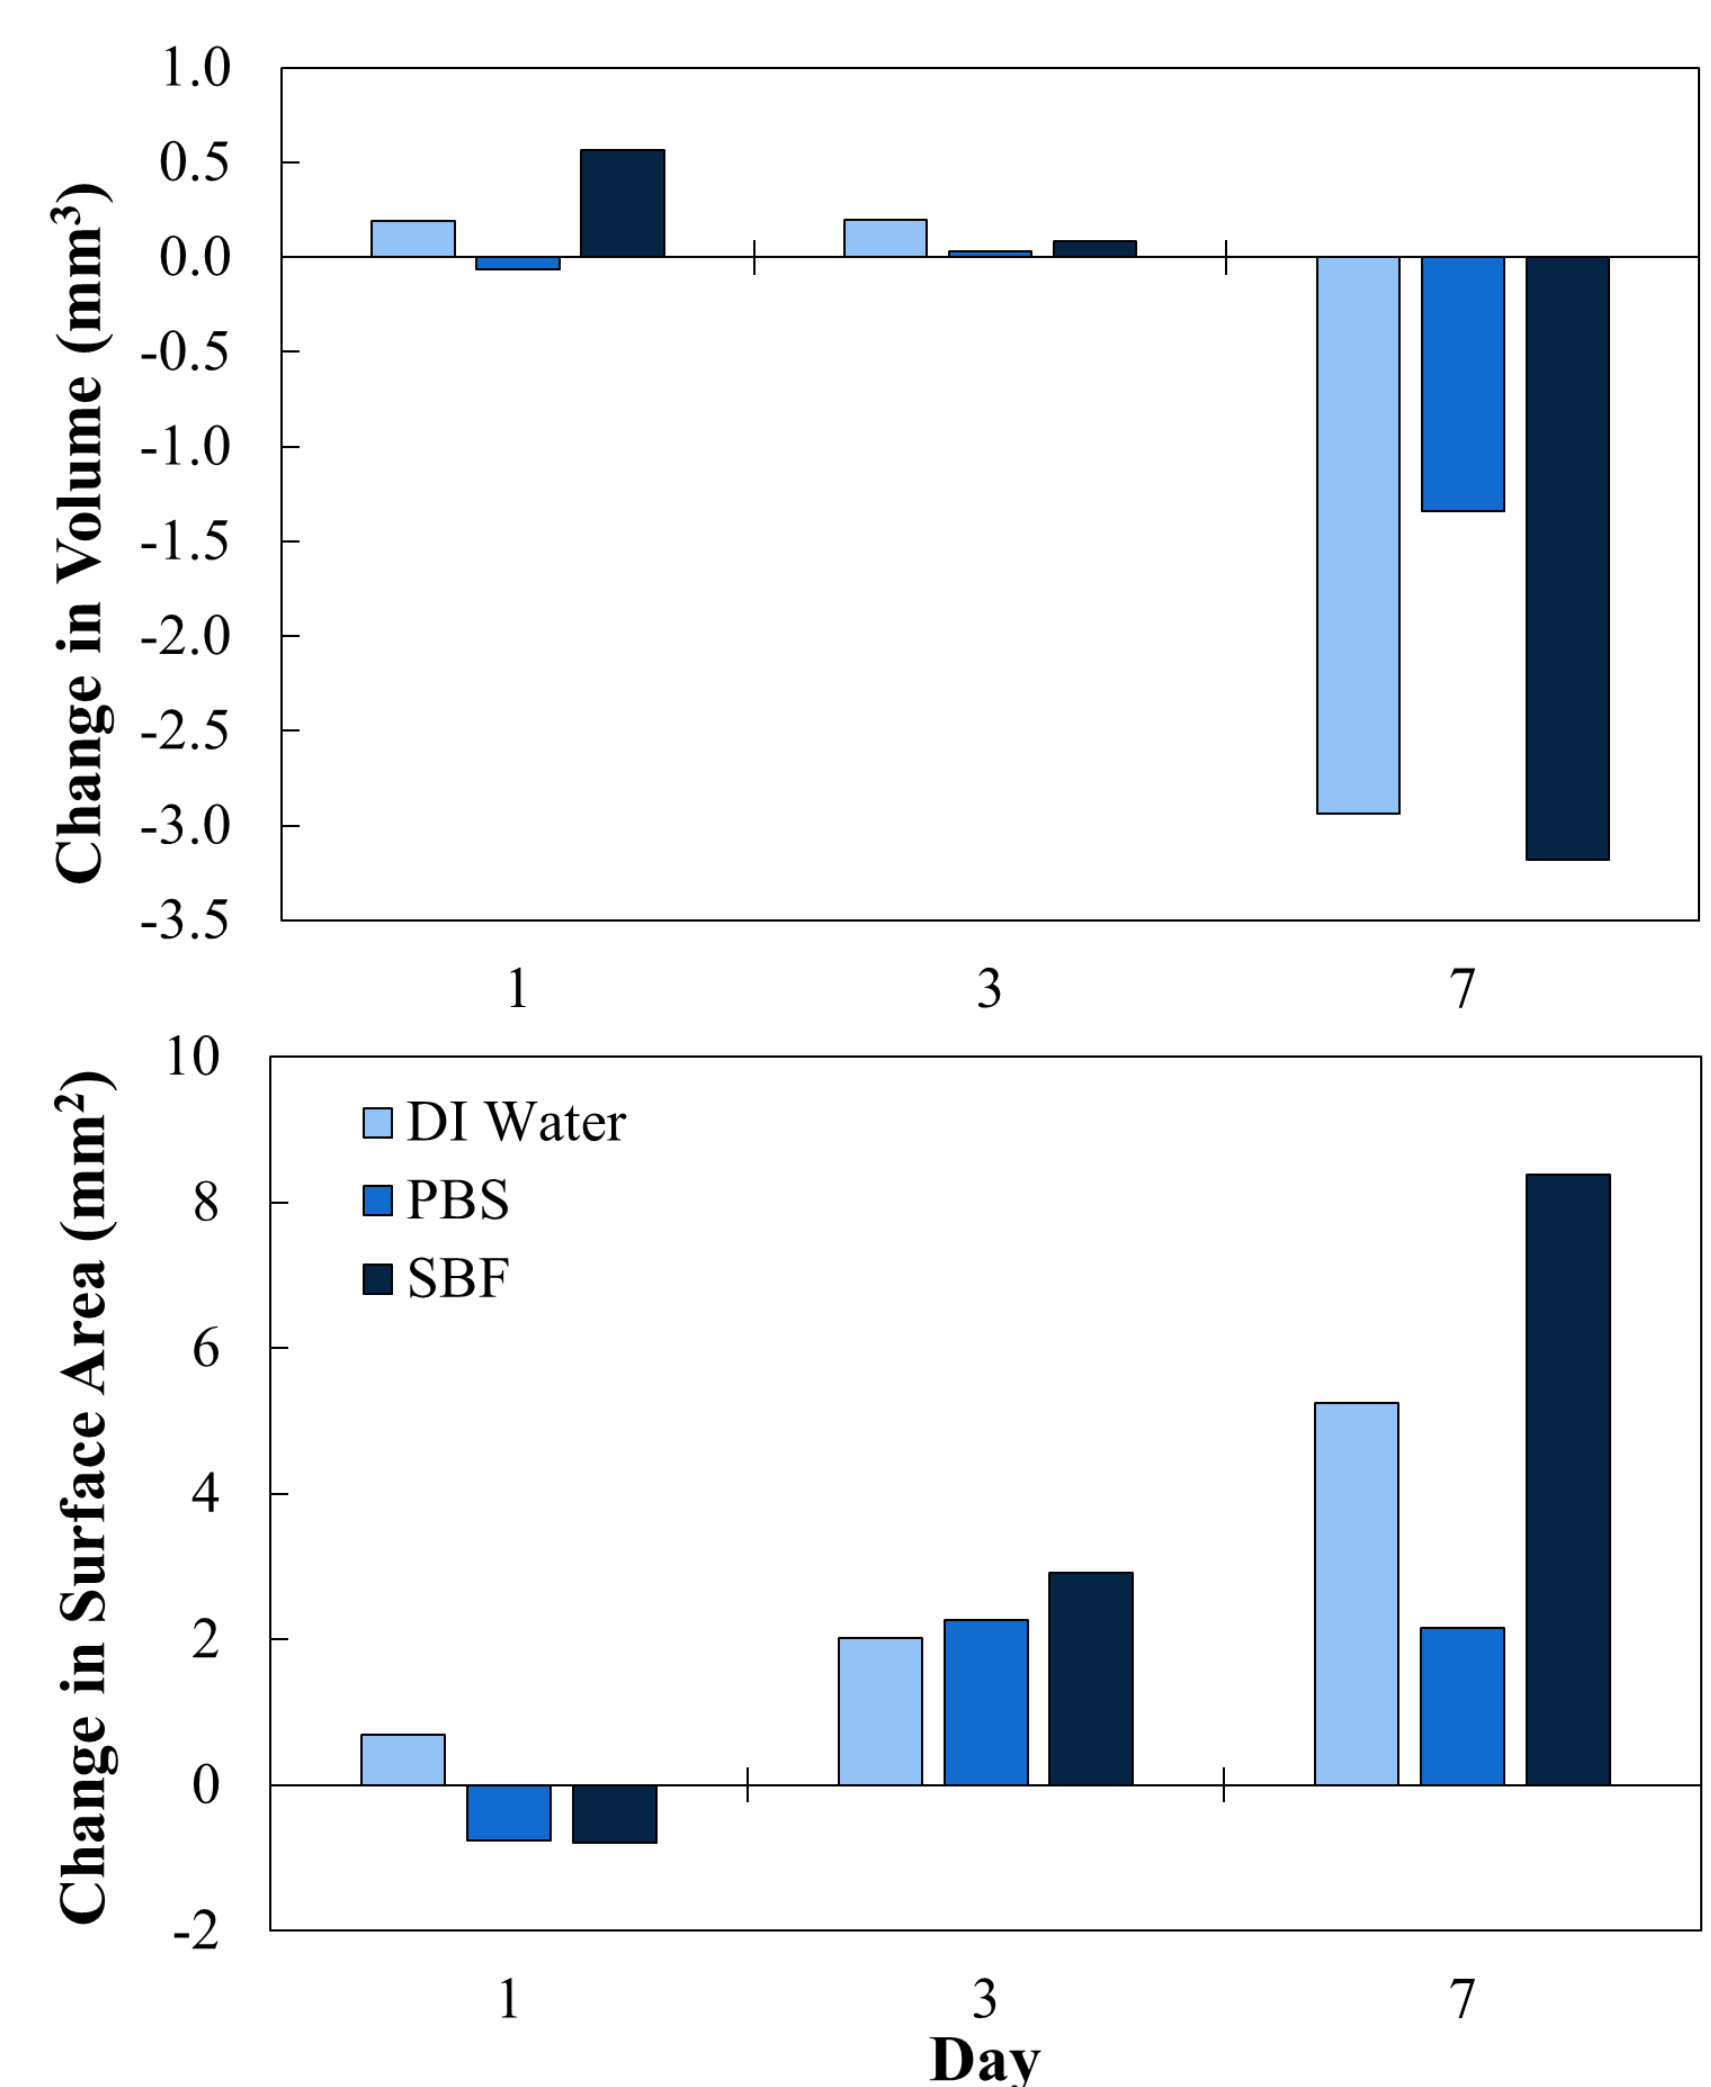
Figure 5 Change in volume and surface area of AZ31 coupons in DI water, PBS and SBF at 1, 3 and 7 days
