ANALECTA
PRAEHISTORICA
LEIDENSIA

Burning down the house: the burnt building V6 at Late Neolithic Tell Sabi Abyad, Syria

This article presents the remains of a T-shaped burnt building found in trench V6 in Operation II at Late Neolithic Tell Sabi Abyad, Syria. The burnt building closely resembles the so-called Burnt Village excavated earlier at Tell Sabi Abyad in Operation I, level 6, but is slightly older. Many objects were discovered in the ruins of the burnt building, but the most striking discovery was the burial of a young woman. In this paper we present the V6 burnt building and its remains. We argue that the building was purposely set ablaze as part of a ritual related to fire and death.

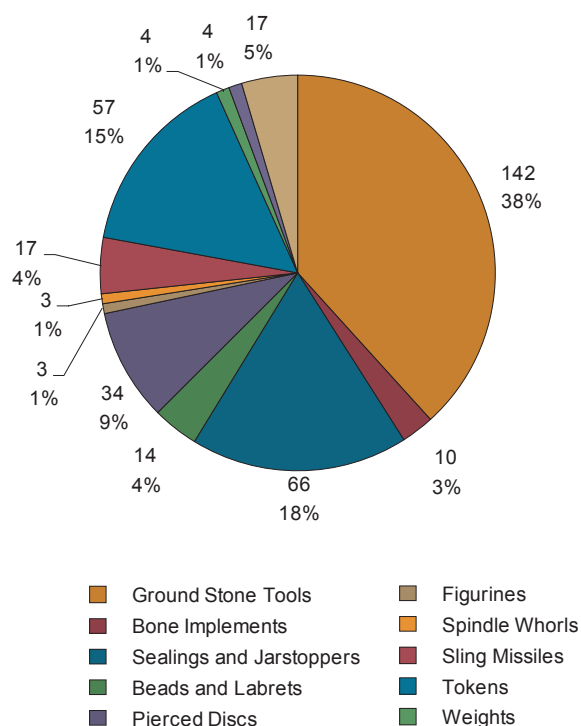
Figure 7 Tell Sabi Abyad. The composition of the small finds assemblage recovered from the burnt building V6.

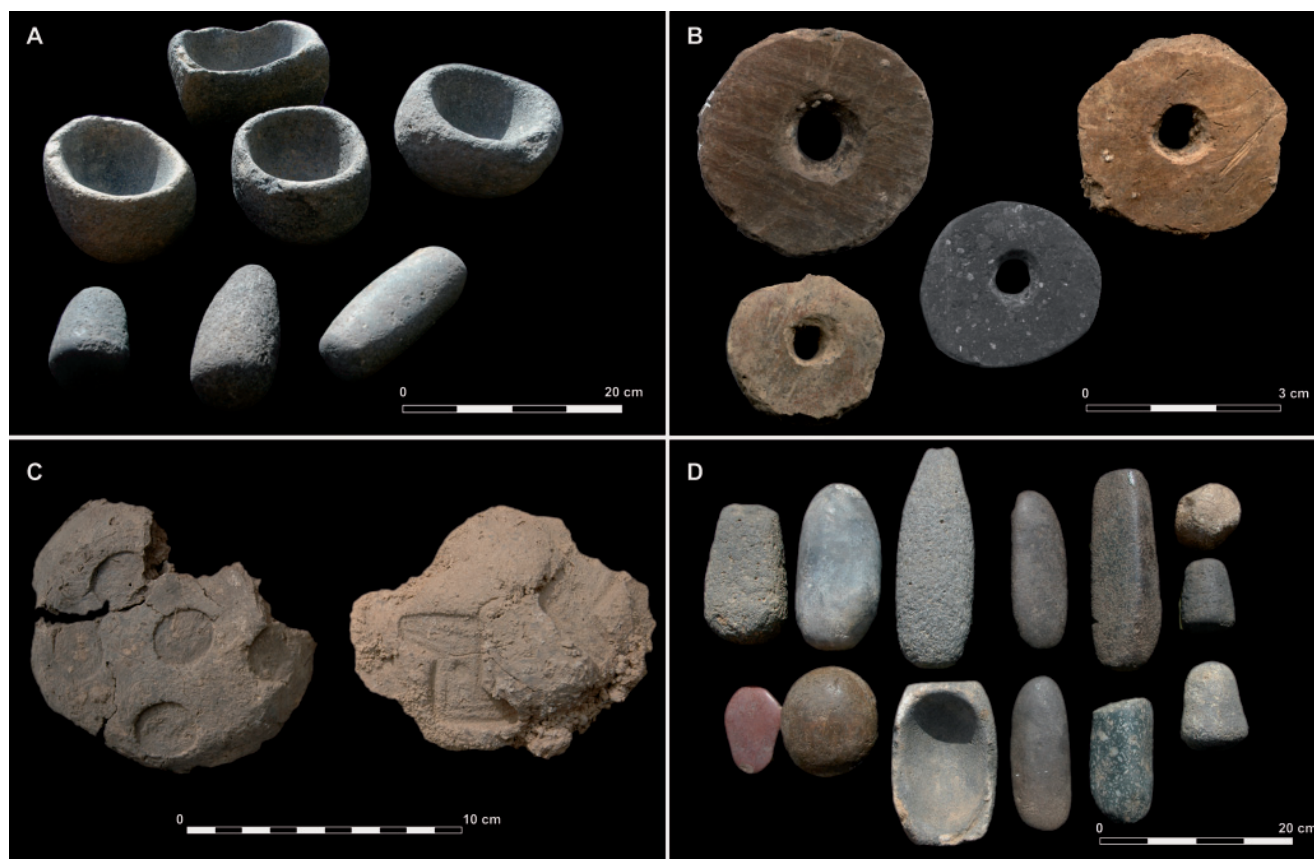
Figure 8 Tell Sabi Abyad. A selection of artefacts found in the burnt building V6. (A) Pestles and mortars. (B) Pierced discs. (C) Sealings. (D) Ground-stone tools.

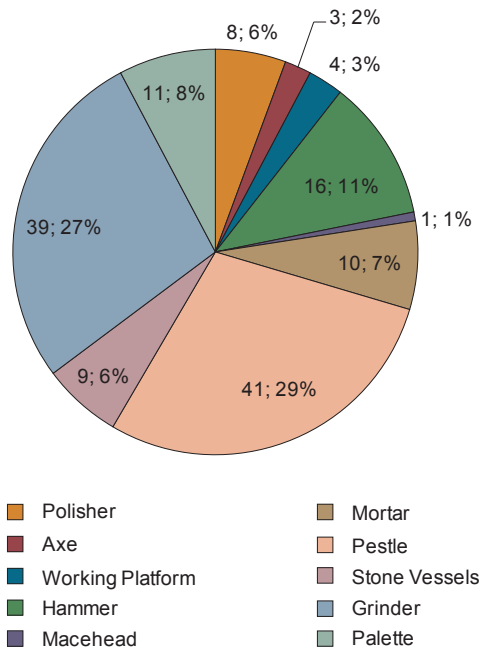
Figure 9 Tell Sabi Abyad. Composition of the ground-stone industry from the burnt building V6.

working platforms, axes, hammers, polishers and vessels (fig. 9). Two groups were predominant: pestles and grinding slabs. There were 41 pestles mainly made of basalt, of which 27 were complete. This seems to be more than one would expect in an ordinary domestic assemblage at the single household level, certainly when taking into account that only 10 mortars were found. Half of the pestles was found in room 1, the others were divided over rooms 2 (n=7), 3 (n=5) and 5 (n=15). Another group of ground-stone tools which seems overrepresented is that of the grinding slabs and hand grinders, of which 39 were found (including 5 complete or nearly complete specimens). They occurred in rooms 1 (n=13), 2 (n=2), 3 (n=19) and 5 (n=5).

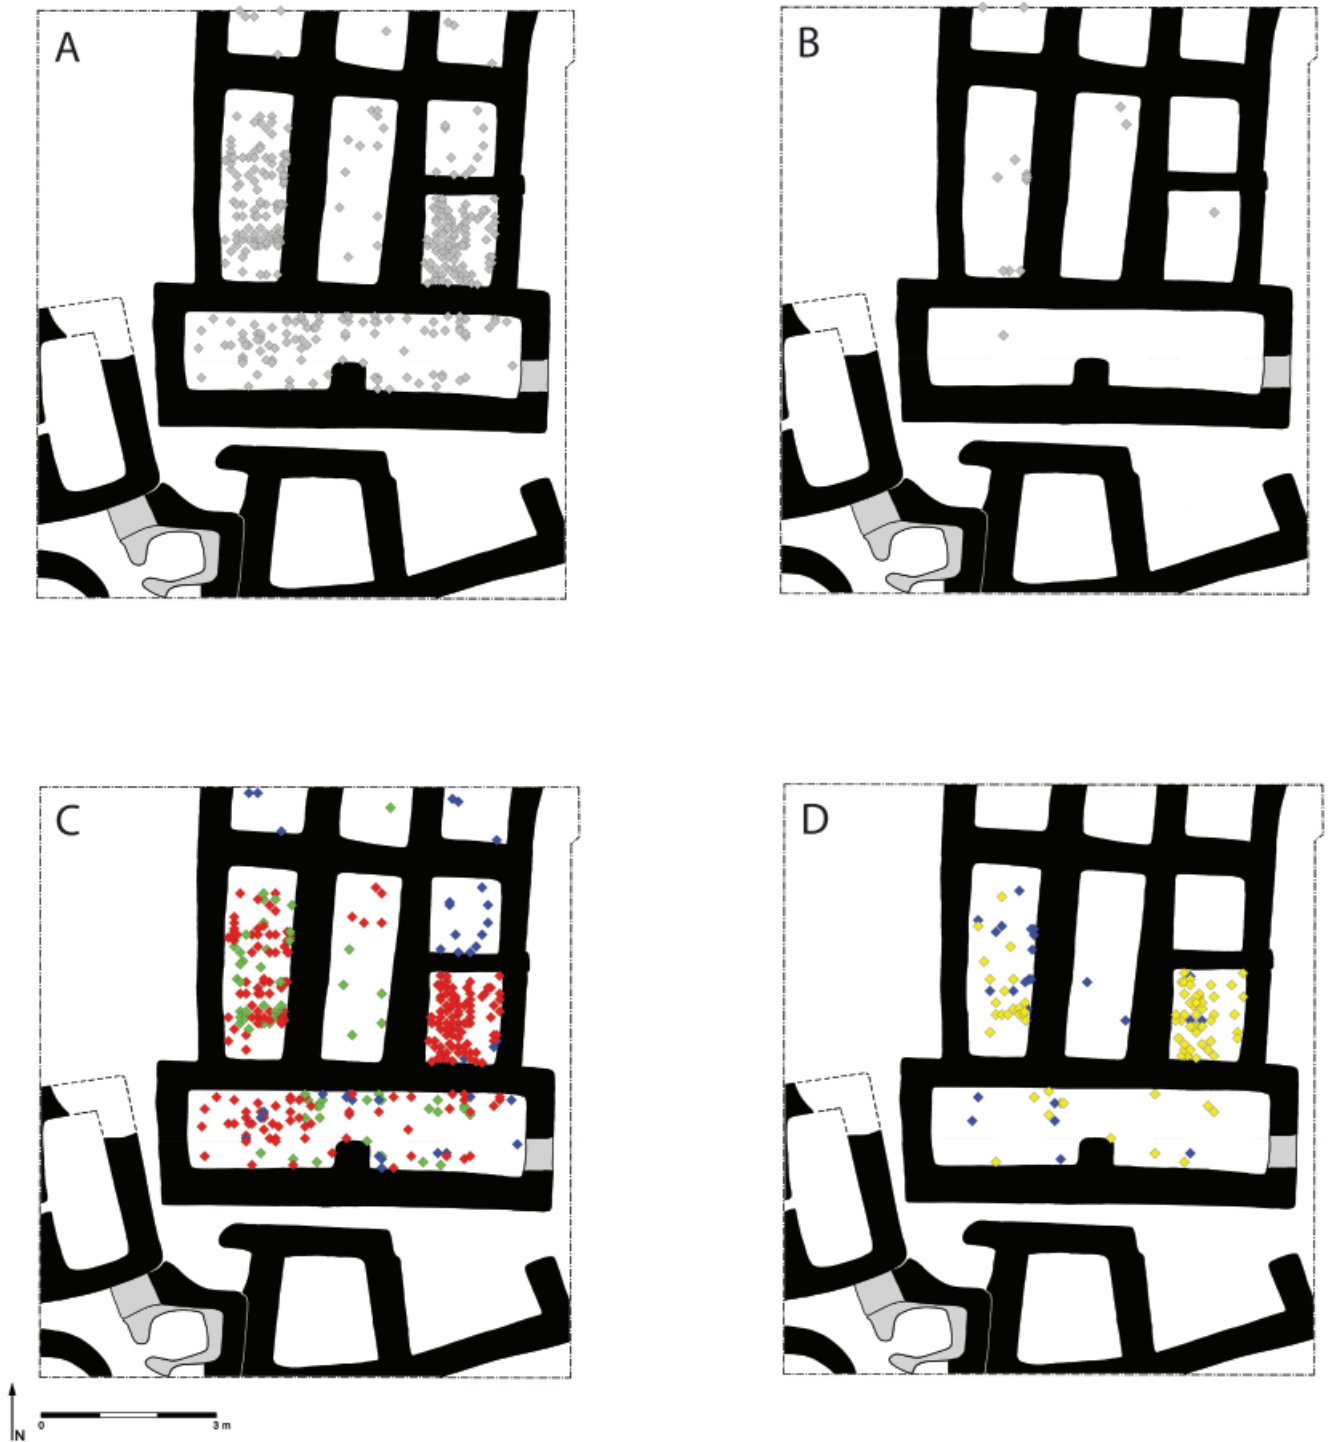
Figure 10 Tell Sabi Abyad. Distributions of objects inside the burnt building V6. (A) All objects found inside the building. (B) Objects found on the floor of the building. (C) Objects found in black ash (red), in red-burnt debris (green), and in unburnt debris (blue). (D) Distribution of pierced discs and spindle whorls (blue) and tokens and jar stoppers (yellow).

6 THE DISTRIBUTION OF FINDS INSIDE THE BUILDING
Most objects inside the building were found in the ash layers, which were most extensive in rooms 1, 3 and 5. The layer of wall and other debris shows a more even distribution, with objects found in all of the rooms (fig. 10).

Although the building yielded several hundreds of objects, only very few of these (n=14) were found on the floor of the building. Floor finds occurred only in rooms 1, 2, 3, 5 and 6 (fig. 10). In room 1 were two clusters of ground-stone tools, the first (in the southeast corner) consisting of three complete grinders and the second (further north) comprising a complete mortar, two pestles and what may have been a

Furthermore, when differentiating between various find categories found in the ashes and burnt debris layers, it appears that although most objects show a more or less random distribution, some find categories seem to cluster in specific rooms. Pierced discs and spindle whorls were mainly found in room 1, whereas tokens and jar stoppers seem to be somewhat overrepresented in room 3 (fig. 10).

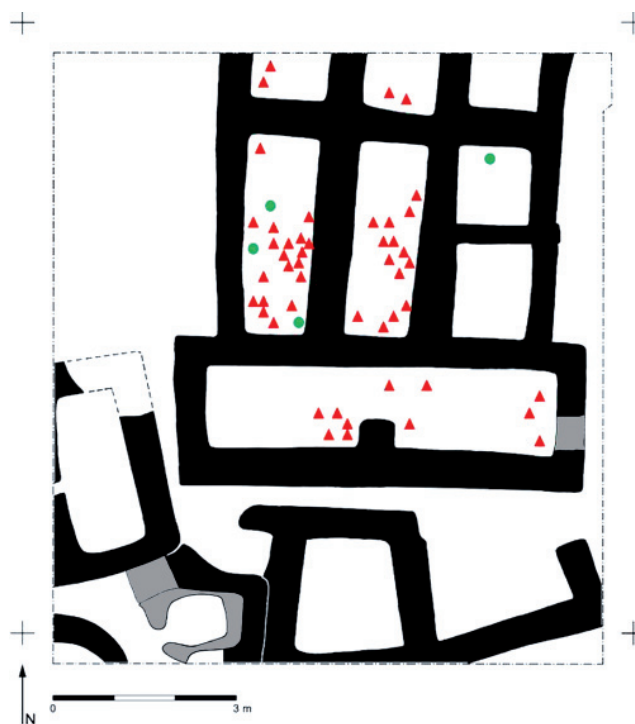
Figure 12 Tell Sabi Abyad. Distribution of roof material fragments in the burnt building V6. Clay roof fragments with reed imprints (red triangle), wood remains (green circle).

southwestern rooms 1 (n=19), 2 (n=14) and 5 (n=11), while only a few pieces were found in rooms 6 (n=2) and 7 (n=2) and none in the northeastern rooms 3, 4 and 8 (cf. fig. 12). They were widely distributed throughout the fill in these rooms, with some of them close to the floors (but never in the ashes immediately on the floors) and others higher up in

Significantly, the superstructure debris in rooms 1, 2 and 5 occurred in roughly two layers, with one layer of roof impressions at an elevation between about 80 to 120 cm above the floor and the other slightly lower at an elevation of 40-50 cm above the floor. While most imprints in room 1 were found in the upper layer, in the other rooms they were mainly in the lower layer. The occurrence of the impressions in layers suggests that the collapse of the roof in these rooms was not a single event but that it took place in a series of episodes. In the nearby room 6 the roof imprints were close to the floor, with wall debris on top of them. In the debris in the northwest corner of this room there was an ash midden; it is very likely that one part of the roof collapsed at a given moment, leaving the clay impressions, while another part kept burning, resulting in the midden. In all rooms the artefacts were found mainly in the fill below the roof imprints, while in the rooms with multiple levels of roofing material they were below and amidst both layers.
