SCOUR-INDUCED FAILURE OF MASONRY ARCH BRIDGES: CAUSES AND COUNTERMEASURES

This paper discusses how flow conditions and consequent scour of channel bed induces the failure of short-span, masonry arch bridges over small to medium sized rivers. Such bridges are common in Ireland, the U.K. and Europe. A factor frequently complicating failure is that such bridges typically are deemed historic structures and, therefore, are expensive to repair. A significant hydraulic-engineering factor is that, these bridges readily choke approaching flows, especially under large return period flooding conditions. The bridge flow area quickly decreases once flow stage reaches the crown of the arch barrel. Flume experiments, undertaken with choked flow condition, showed that three locations of masonry arch bridges are particularly prone to scour-induced erosion: piers (multi-span only), abutment corners and the channel bed immediately downstream of the bridge (in the case of a paved or protected bridge inverts). Scour can be reduced only modestly by streamlining abutments by means of wing walls, and cutwaters on piers, because of flow choking. The use of stone pitching to armour the riverbed around abut

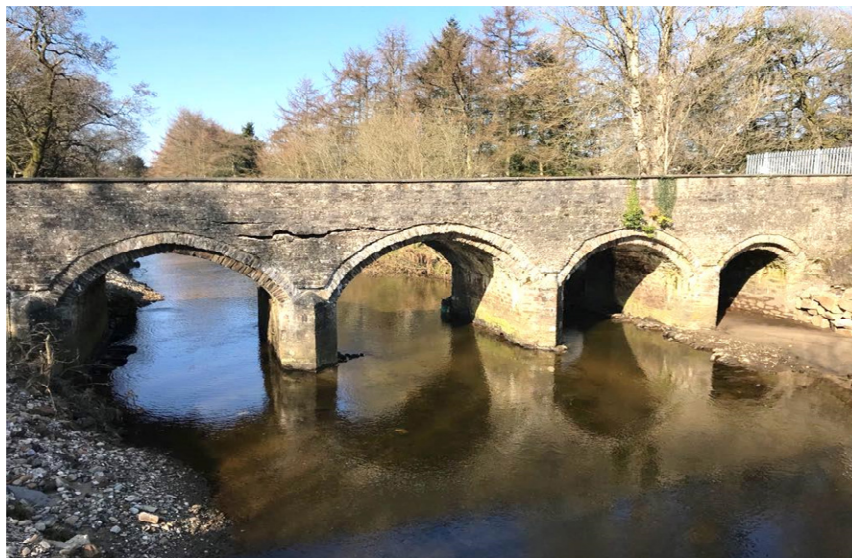
Figure 1. Scour at the front of the central pier led to scour-induced failure of failure of an arch bridge (Ballynameen Bridge) over the River Faughn near Cladys, Northern Ireland. (View looking from upstream of the bridge)

Clear-water approach-flow conditions were used in setting flow through a flow-recirculating flume, 10.0m long, 0.75m wide and 0.25m deep, set at a slope of ~0.1%; the clearwater approach conditions were representative of the failure sites observed, such as shown in Figure 1. A sediment recess 1.8m-long, 0.75m wide by 0.23m-deep, was placed downstream of the flume’s midpoint; and, was filled with uniform, fine gravel. The gravel’s median diameter was $D_{50} = 2.54\text{mm}$ with a coefficient of uniformity, D_{60}/D_{10} , of ~3 and a geometric standard deviation, $\sigma_g = (D_{84}/D_{50})$ of 1.8, close enough to negate armouring by coarser grains. This bed sediment was chosen as being representative of the coarse sediments (gravel-bed streams) typical of streams and small rivers in Northern Ireland whose median size (D_{50}) ranges from about 2mm to 256mm (Kirby et al. 2015). Thus, the sediment used in the analysis is indicative of the acceptable range of sizes found in UK alluvium stream. The Shield’s diagram indicates that the critical shear stress for entrainment of this sediment was about 1.9N/m^2 . The backwater profile of flow ensured that shear stresses on the approach bed to the arches exerted an average bed shear stress less than this magnitude.

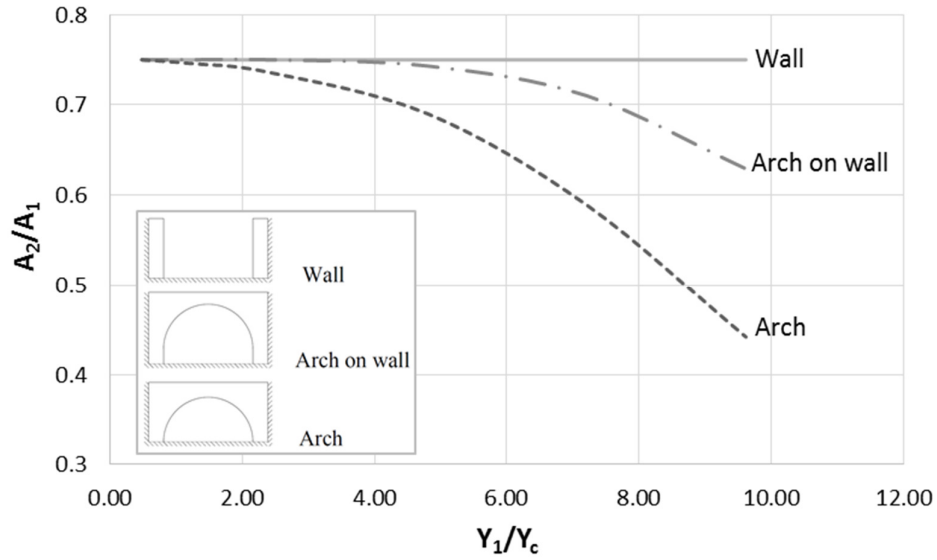
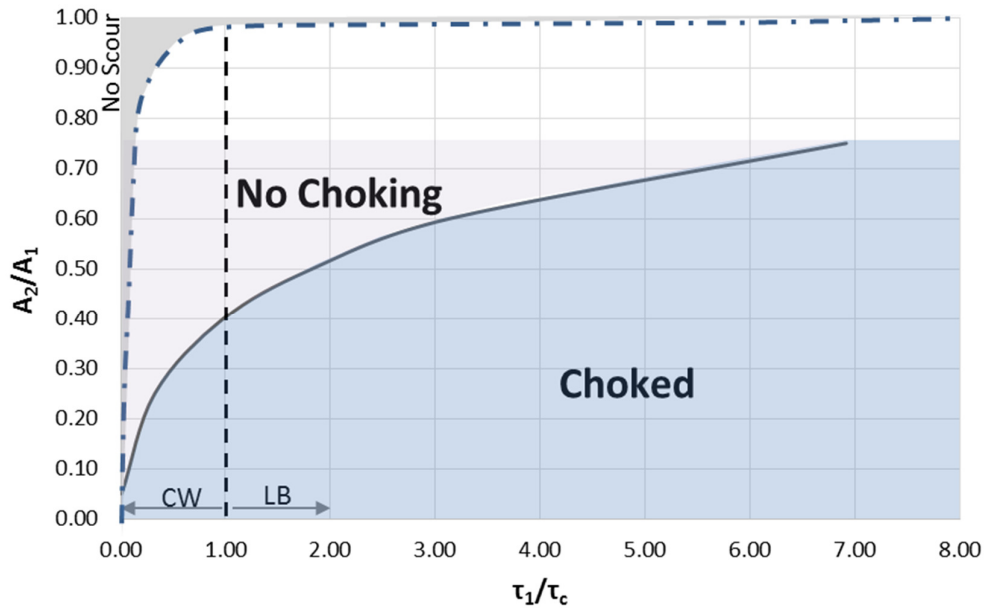
Figure 2. The condition of choked flow readily occurs at a short-span, masonry arch bridges: (a) shows how the bridge-flow area relative to approach-flow area (A_2/A_1) reduces as flow depth increases for arch bridge forms; and, (b) shows the general loci of choking versus non-choking for varying bridge shape but maximum ratio of $A_2/A_1 = 0.75$. As A_2/A_1 increases, the loci increase commensurately in extent. (Note: CW = clearwater scour; LB = livebed scour; bed slope (10^{-4}), channel aspect ratio ($B_1/Y_1 = 14$), bed sediment and τ_c are assumed constant for these figures.)

Masonry arch bridges readily choke, as Figure 2 indicates for approach flows of increasing value of the shear stress ratio expressed as $\tau_1/\tau_c = Y_1/Y_c$. Here, Y_1 = the normal depth of the approach flow, τ_1 is the bed shear stress of the approach flow ($= \gamma Y_1 S$), τ_c is the critical value of bed shear stress associated with the entrainment of a channel's bed material, and Y_c is the depth of flow producing τ_c for flow over an alluvial bed of constant slope. This ratio pertains to a channel of constant bed-sediment characteristics and slope. The flow-area ratio, A_2/A_1 has a maximum value set by the cumulative width (at low discharge conditions) of the bridge piers relative to the overall width of the approach flow. As mentioned above, this area ratio reduces when the flow enters the barrel of the arch. The resulting water-surface profile of flow through the arch bridge looks as Figure 3a shows. As a result of choking, supercritical flow occurs through the barrel of the arch and a short distance downstream of the arch, as mentioned above. Figure 3b is general for all bridge shapes in a channel of constant bed sediment.

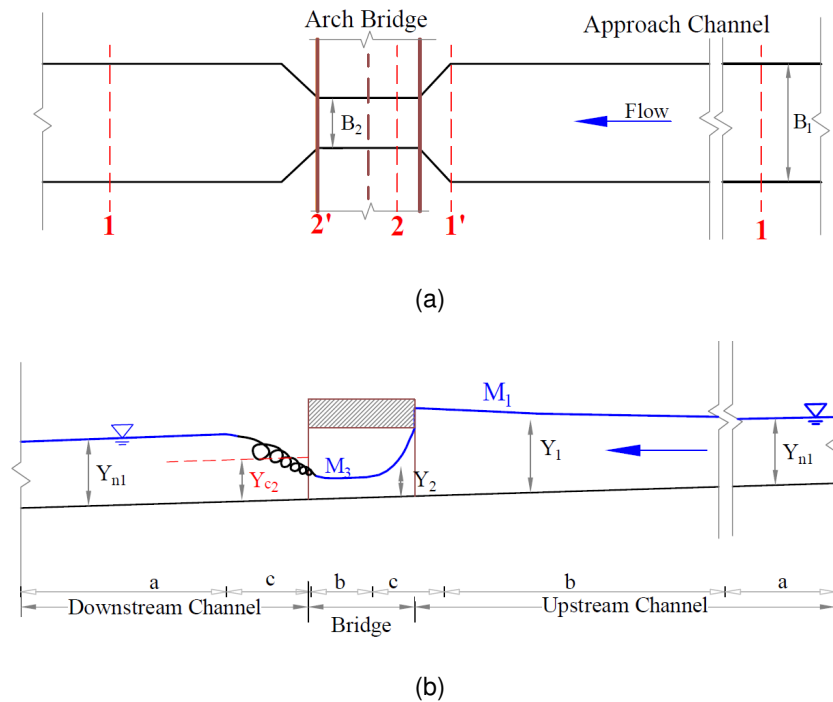
Figure 3. The water-surface profile associated with choked flow at a short-span masonry arch bridge: (a) plan view of the bridge over a channel; and, (b) water-surface profile of flow through the bridge (The zones denoted “a” are uniform flow, “b” are gradually varied flow and “c” are rapidly varied flow.)

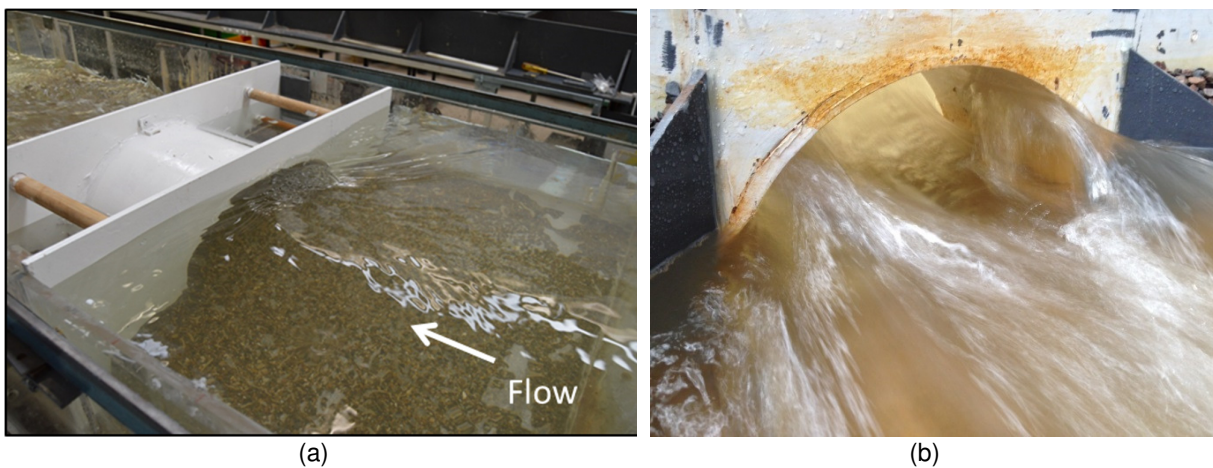
Figure 4. Two views of contracted flow at the entrance of a simulated, short-span, masonry arch bridge: (a) view from upstream; and, (b) view from downstream. In line with Figures 2 and 3, the choked-flow condition was simulated in the experiments

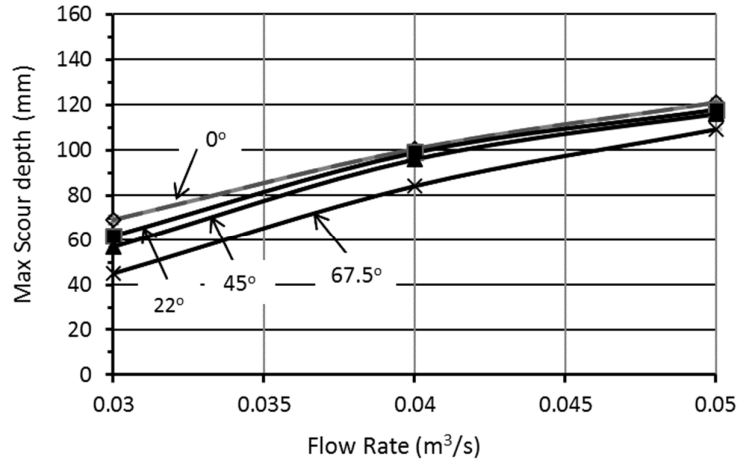
Figure 5. Maximum scour depth for a single arch with 45mm deep foundations and variable angle of wingwall

The experiments investigated hydraulic means (flow streamlining and bed armouring) to mitigate scour. The intended role of flanking wingwalls was to streamline flow approach to the barrel of an arch, thereby reducing scour depth at the arch. Figure 5 presents the data from the flume experiments. The data show clear trends that, at the lower flow rates, the maximum depth of scour reduced as wingwall angle of the single arch increased from 0° to 67.5° . This reduction in scour depth is largely attributable to the reduction in the magnitude and vorticity of the turbulence structures developed at the upstream corners of the arch. For wingwalls set at 22.5° and 45° , the scour-reduction effect was modest, with practically no effect for the two highest discharges tested. For the wingwall setting of 67.5° , wingwall mitigation of scour diminished from about 36% to 10% over the discharge range. The increased ineffectiveness of wingwalls at the higher discharges (Figure 6), for which choking increased, is due to the increased submergence of the arch crown and therefore more flow entering the arch barrel from a flow region above the wingwalls. The trends in Figures 5 and 6 concur with findings reported by Kerenyi et al., (2003), who show that entrance conditions influence scour depth at bottomless culverts for flows when the culvert crown was unsubmerged; i.e., un-choked. For un-choked approach-flow condition, Kerenyi et al., (2003) indicates, that a wingwall presence reduces scour depth to about 87 to 91% of the no wing walls condition.

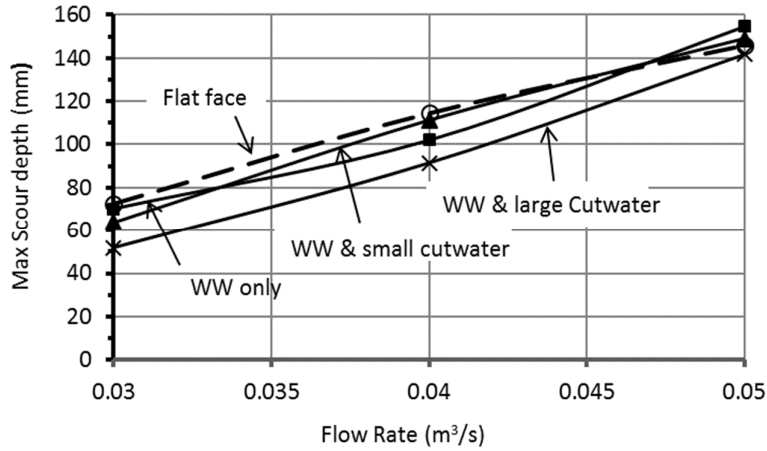
Figure 6. Variation of maximum scour depth at centre pier versus flow rate (75mm-deep footings)

Observations showed that a pier cutwater streamlined the flow around a pier linking two arches, and thereby reduced the strength of turbulence structures formed at the pier. Figure 6 indicates for a pier, that the use of the large cutwater reduced scour depth at the pier exposed to the two smaller flow rates. The maximum reduction in scour depth was about 45% for the big cutwater when the flow rate was $0.03\text{m}^3/\text{s}$. The small cutwater had essentially no effect in reducing scour depth. This lack of impact is attributed to the inability of the small cutwater to alter the intake and emerging submerged jet on the respective faces of the bridge. As water discharge increased, the effect of the large cutwater diminished. The influence of pier streamlining diminished over the range of discharges tested because the greater choking of approach flow at the higher discharges (especially at $0.05\text{m}^3/\text{s}$) further raised the water elevation at the arch entrance. For the highest discharge, $0.05\text{m}^3/\text{s}$, the large cutwater reduced scour depth by only 3%. Armour stone is sometimes placed to protect the bed through the barrel of an arch in the U.K., as stone is deemed an environmentally more friendly solution than concrete aprons. The stone-sizing relationship recommended by Lagasse et al., (2006) was used to estimate a suitable armour size, with the stone then scaled to conform to the present experimental study. Though only a small number of tests were conducted, it showed that the stone inhibited scour at the entrance corners of the double arch and inhibited scour along the barrel of each arch under low flow conditions ($0.03\text{m}^3/\text{sec}$). This finding shows that stone armouring substantially reduces scour at the entrance and within bottomless culverts. However, the present experiment also showed that flow issuing from the arches scoured a depression in the bed downstream of the double arch, as Figure 7 illustrates for the flume experiments. Recent field experience,

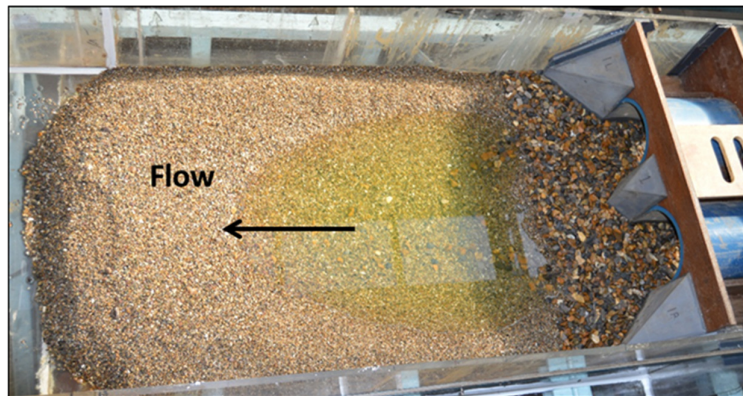
Figure 7. Armoured twin-span arch with scour developing upstream (toward bridge) with time

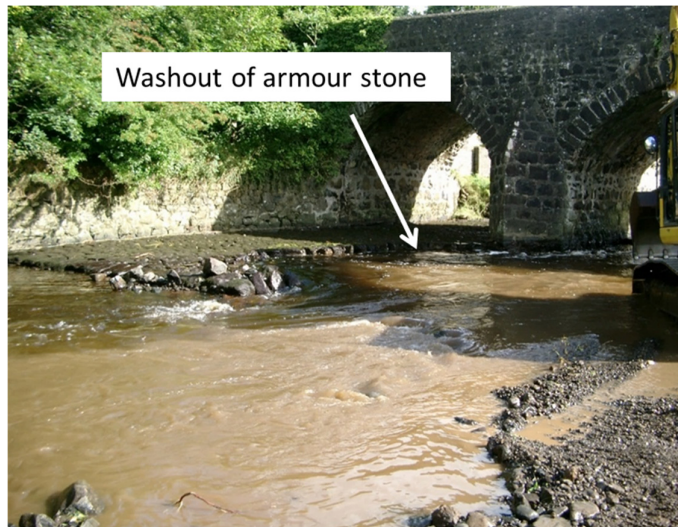
Figure 8. Supercritical flow immediately downstream of this arch bridge washed out armour stone placed there, and then (via a head-cutting mode) eroded the downstream bed; Co. Antrim, Northern Ireland

involving the failure of armour stone downstream of a masonry arch bridge (Figure 8) corroborates this finding, and shows that stone immediately downstream of the bridge had to be sufficiently large to withstand the high-exit velocity flow for unsubmerged and submerged flow conditions.
