25 years QUENCH program

Main results of the QUENCH bundle tests

J. Stuckert, M. Große, M. Steinbrück

Institute for Applied Materials; Program NUSAFE

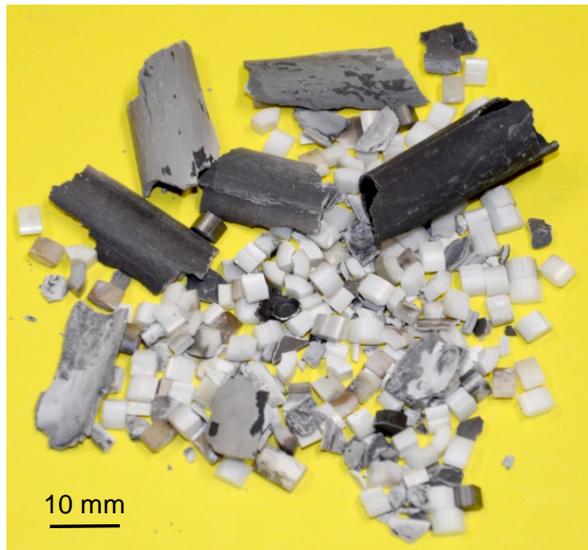
QUENCH-17: Debris formation after degradation of strongly oxidized cladding and release of pre-segmented pellet simulators

test scenario

debris: 1) separated parts of fuel pellets simulator; 2) large segments of failed Zry claddings.

X-ray tomography

cross-section at 400 mm: metallography; debris bed porosity 50%

cross-section at 400 mm: tomography; blockage 85%

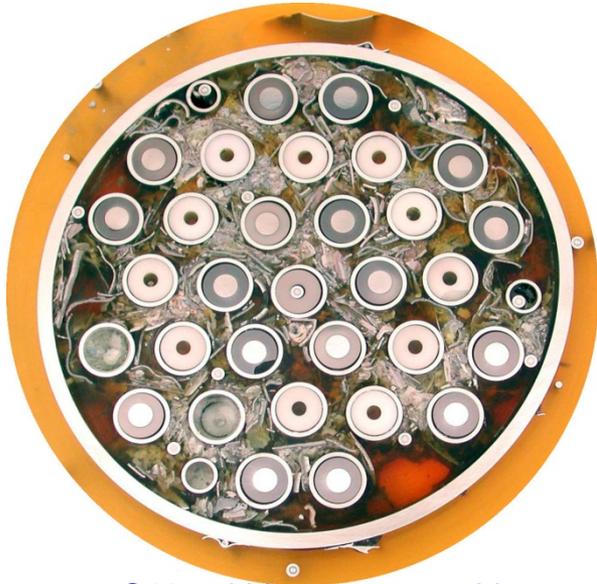
Q12: rubble on spacer grid consists of spalled cladding scales and fragments of partially oxidized cladding

Q06 cross-section

Q12 cladding: **spalling** of oxide scales due to **breakaway effect**

Q06 oxidized cladding

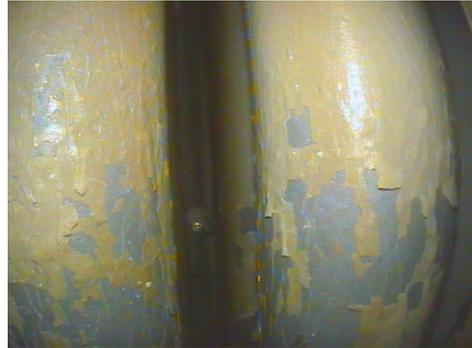
Endoscope observation at ~850 mm

prior nitrated scale →
re-oxidised during quench
and spalled

from internal ZrO₂ layer →
growing during quench

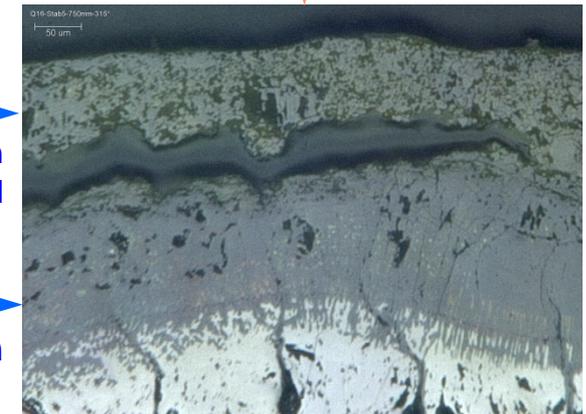
Typical layer structure of strong oxidised cladding at hottest bundle elevation of 1000 mm after reflood

outer ZrO_2
formed during pre-oxidation
and reflood

melt
formed at ~2030 K
and partially oxidised
due to dissolution of ZrO_2

inner ZrO_2
formed during reflood
(due to interaction with steam
penetrated under breached cladding;
no interaction with pellet)

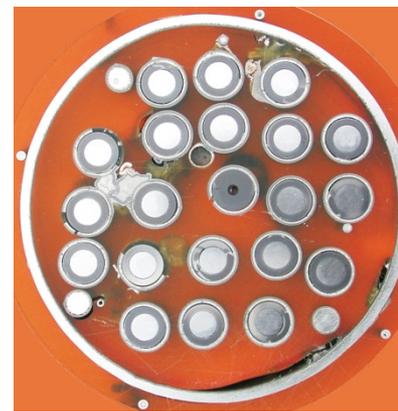
QUENCH-07: formation of significant melt amount and melt relocation

B₄C ↔ Fe eutectic at ~1150°C
Zry ↔ SS eutectic at ~1300°C

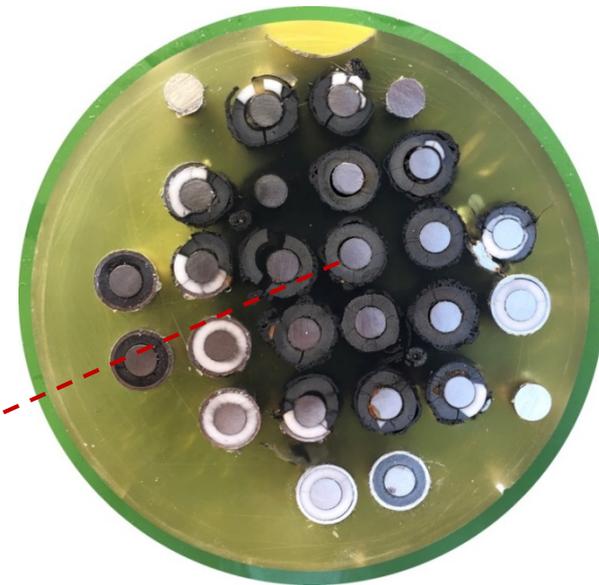
QUENCH-19, 950 mm, rod 2: molten claddings of central rods

frozen cladding melt

melt-interacting
ZrO₂ pellet

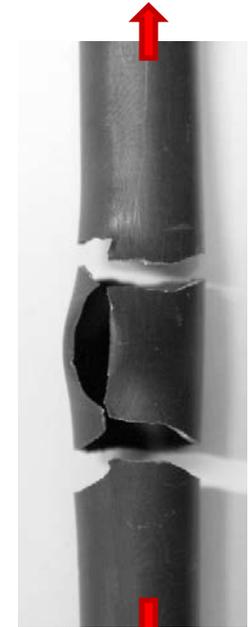
**hydrogen
bands inside
cladding
detected
with n⁰-
radiography:
>2000 wppm
hydrogen
content**

**double rupture of
cladding along
hydrogen bands
during tensile tests
for C_H>1500 wppm**
