INVESTIGATION OF THE MECHANICAL AND MICROSTRUCTURAL PROPERTIES OF WELDED API X70 PIPELINE STEEL

T. M. Ike, O. Adedipe, S. A. Lawal*, M. S. Abolarin and O. A. Olugboji

Department of Mechanical Engineering, Federal University of Technology, Minna, Nigeria

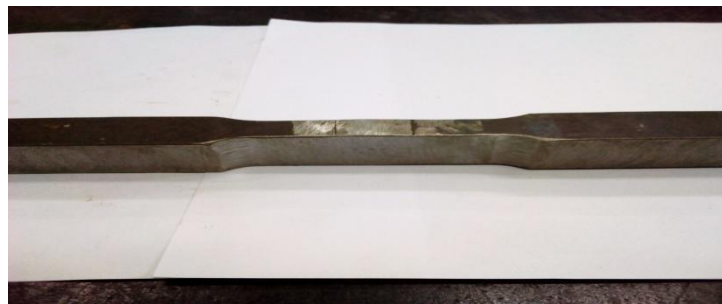
Figure 1: Tensile test specimen

facility. To ensure conformity to the American Society for Testing and Materials (ASTM) D114 on standard composition of seawater, the seawater was tested and analysed at the Chemistry lab in River Basin office, Minna, Niger State. A total of ten (10) tensile test specimens with welded joints were prepared, five of them were immersed into seawater, while the remaining five were exposed to ambient air. Ambient air refers to the normal laboratory condition. For the compressive tests using the universal testing machine located in SCC Abuja, ten (10) test specimens with welded joint were also prepared; five of the specimens were immersed into the seawater, while the other five were exposed to ambient air. Hardness test was also conducted using the Vickers hardness tester located in SCC Abuja. The tests were conducted in accordance with the specifications in API 5L standard. Hardness test was conducted on specimen containing sections of the base metal, heat affected zone (HAZ) and weld. It was ensured that the specimen was extracted in a way to encompass the weld, base material and the HAZ of the plate. In order to reveal the location of the HAZ, a slice extracted from the weld area was etched by applying 2 % Nital solution. The Toughness of the welds was investigated at SCC Abuja using the Charpy method and based on the specifications in ISO 148 standard. Ten (10) Charpy test specimens with welded joints were also prepared and likewise, five of the specimens were immersed into seawater while the rest were exposed to ambient air. The duration for the immersion into seawater for all test specimens was 12 weeks after which tensile, compressive and Charpy tests were conducted. The choice of the immersion time was based on the investigators decision bearing in mind that the phenomenon of corrosion will be revealed regardless of the soaking or immersion period. At this juncture, it should be mentioned that corrosion damage is time dependent. It should therefore be expected that in simulated corrosive environment used during experimental investigation, the effect on corrosion will be revealed regardless of soaking time. Microstructural examination and analysis of fracture surfaces of the samples were carried out using the scanning electron microscope (SEM) located at Spectral Research and Laboratory Kaduna, while spectroscopic analysis was carried out at Oshogbo machine tools. Figures 1 to 4 show the pictures of test specimens used while Figures 5-8 are the corresponding schematic representations.

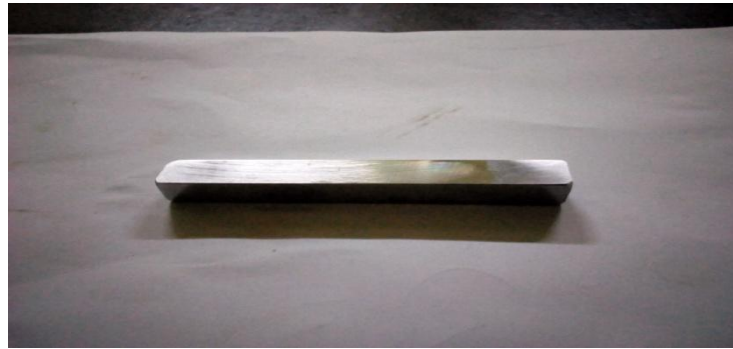
Figure 2: Compressive test specimen

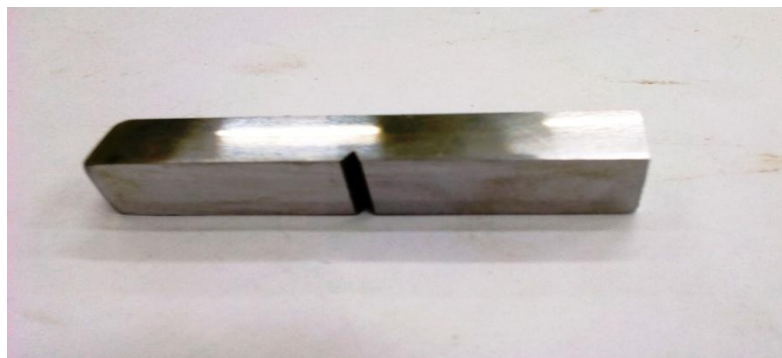
Figure 3: Charpy test specimen

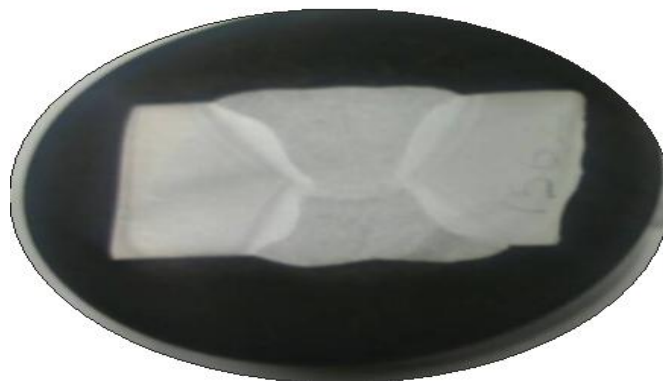
Figure 4: Hardness test specimen

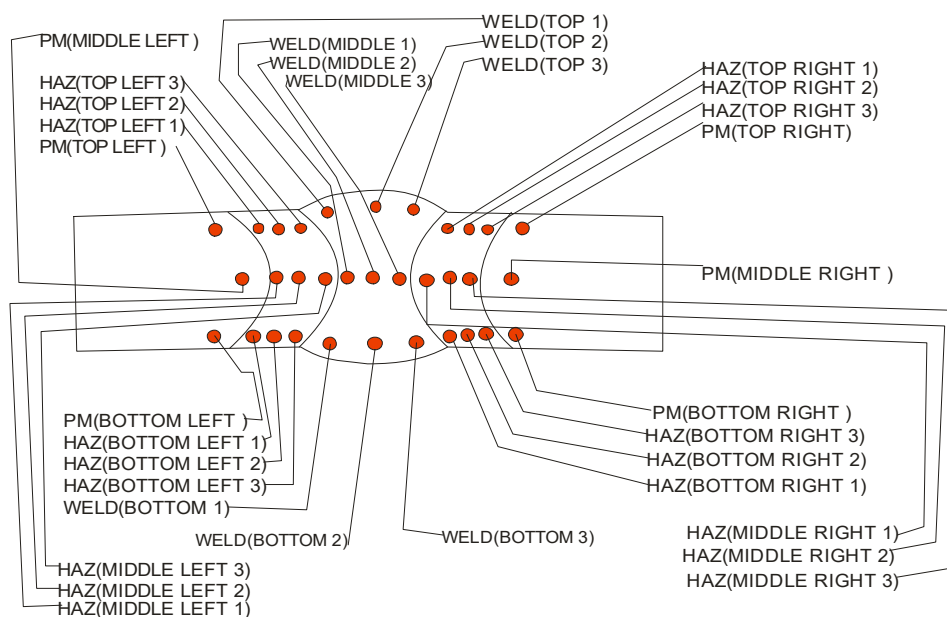
Figure 8: Schematic of hardness test specimen showing the various points of indentation

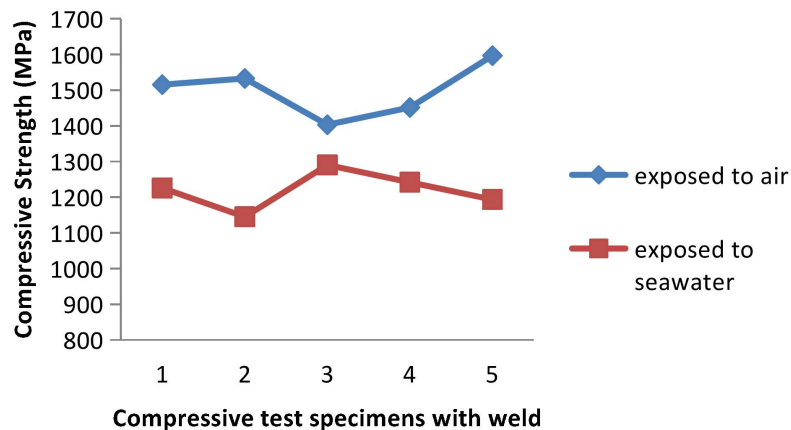
Figure 11 shows that the compressive strength of all five compressive test samples with welded joint were reduced after immersion into seawater environment for 12 weeks. The average compressive strength of the samples exposed to seawater was 1209.34 MPa, while those exposed to air was found to be 1480.68 MPa. The percentage reduction in compressive strength was determined to be 18.7%, which implies that the effect of soaking time was significant in compressive test samples than in samples used for tensile tests.

Figure 11: Compressive strength for compressive test specimens with weld joints

2. The average tensile strengths for welded joints exposed to air and seawater for 12 weeks were 680.624MPa and 609.154MPa respectively while the average compressive strengths for welded joints exposed to air and seawater for 12 weeks were 1500.02MPa and 150.75MPa respectively. At the temperature of zero degrees Celsius and same exposure period, the Charpy impact energy absorbed by welded joint exposed to air was 150.7J while that absorbed by welded joints exposed to seawater was 80.3J.

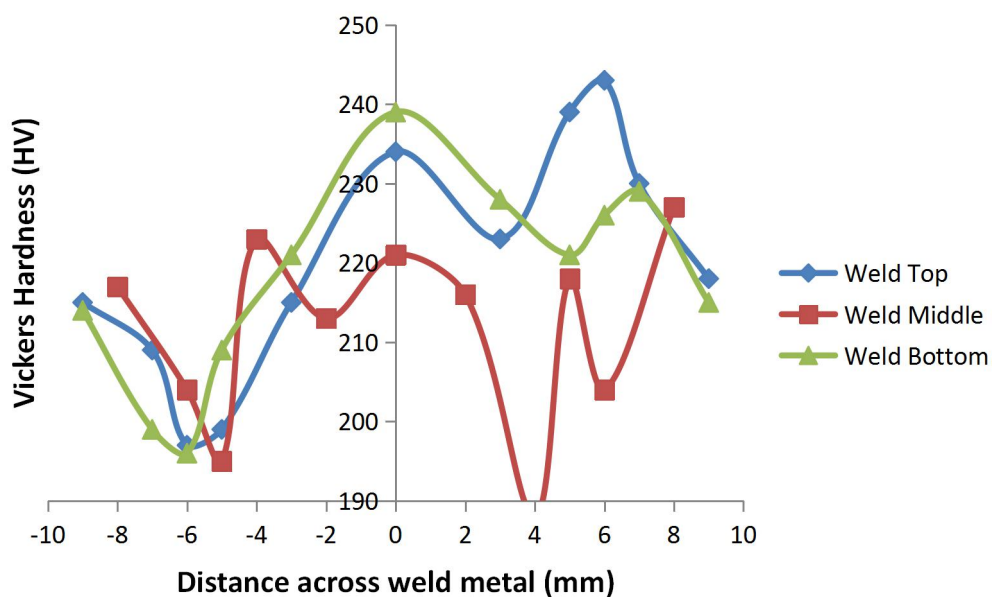
The hardness test results are shown on Table 3 while Figure 12 depicted the hardness profile across the weld top surface. From Table 3 the Weld has a higher average hardness value of 223.8 HV compare to HAZ which has an average value of 214.5 HV as well as the parent metal with an average value of 217.3 HV. These results obtained are in agreement with the work done by Omale et al. (2017). The variations in the hardness across the weld may be attributed to several factors such as residual stresses developed just after welding. From the microstructural point of view, the high hardness in the weld may be attributed to the fine grain size, and the interlocking

nature of the ferrite grains (Loureiro, 2002). One of the factors contributing to lower hardness in the HAZ is high heat input below its melting point and hence retention of heat in this region. The lower hardness in the HAZ might be explained by the intense grain growth in this region resulting from high heat input below its melting point (Kacar and KöKemli, 2005)

Figure 12: Hardness profile as a function distance from the center of weld bead

3. The hardness profile of welded joints showed variations in hardness across the base metal, HAZ and weld metal whereby the weld metal had the highest value of hardness (223.8HV) followed by the base metal (217.3HV) and the HAZ had the least (214.5HV).
4. The mechanical properties of the welds are compromised by exposure to corrosive environment such as seawater as observed in the results obtained from tensile, compressive, and Charpy test experiments. The results showed 10.5% reduction in the tensile strength, 18.7% reduction in compressive strength and at least 37% decrease in impact energy absorbed by the welds after exposure to seawater for 12 weeks.

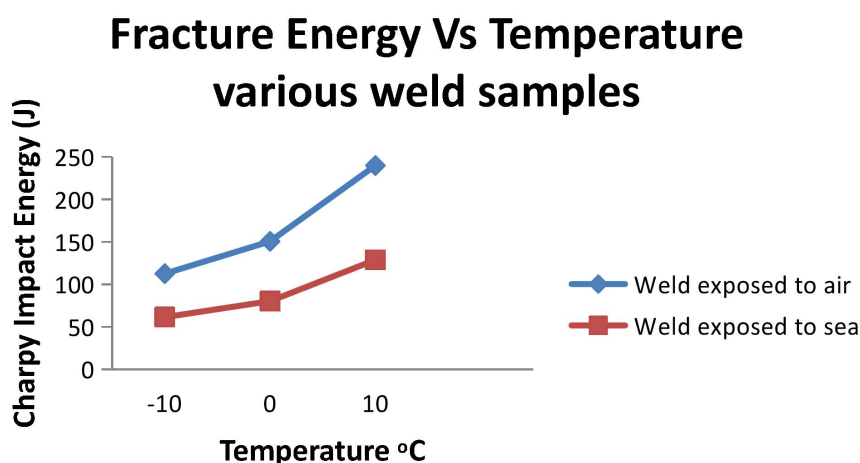
The test results are shown in Table 4 and represented in Figure 13, it can be observed that the impact energy of the weld samples exposed to air is higher than the impact energy of the weld samples exposed to sea water at all the temperatures used. The lower impact energy observed for weld samples exposed to seawater was due to the corrosive environment which affected the microstructure of the weld. The test results also confirm the work done by Nakano et al, (1993), concerning corrosion fatigue crack propagation behaviour of TMCP steels.

Figure 13: Fracture energy (J) and Temperature (°C)
