POSSIBLE RELATION BETWEEN THE SUDDEN SINKING  
OF RIVER IŠKA AND THE SEQUENCE OF WEAK EARTHQUAKES  
IN SEPTEMBER-OCTOBER 2010 NEAR IŠKA VAS  
(CENTRAL SLOVENIA)

Andrej GOSAR<sup>1,2</sup> & Mihael BRENČIČ<sup>1,3</sup>

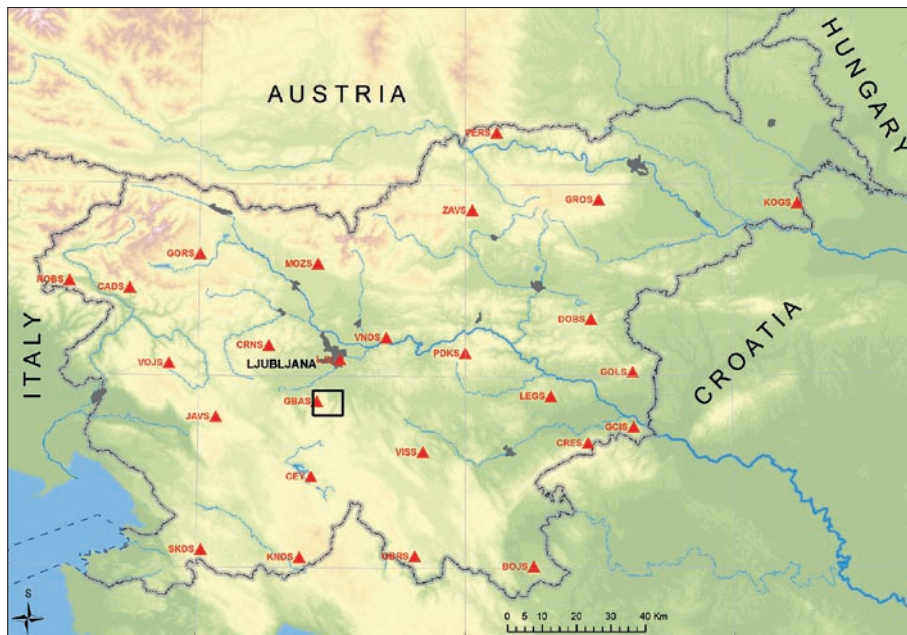
Fig. 1: Map of Slovenia with locations of stations of the Slovenian seismological network. Rectangle indicates the study area.

Iška vas is located at the southern rim of the Ljubljansko barje (Fig. 1), along the river Iška which flows in the north direction from the Krim-Mokrec mountain range built of Mesozoic carbonates into the flat surface of the Ljubljansko barje (Figs. 1 and 2). South of hamlet Iška the river flows through the narrow canyon (Iški vintgar), which is several kilometres long. Ljubljansko barje is a young sedimentary basin situated in the central Slovenia south of Ljubljana (Fig. 2). It is 23 km long and up to 12 km wide and occupies an area of 120 km<sup>2</sup>. The surface is almost flat, with an average elevation of 290 m. Several hills above this flat surface represent outcroppings of the bedrock (Fig. 2). The basin is filled with lacustrine and fluvial Quaternary sediments. The bedrock is built in the northern part of Carboniferous and Permian sandstones, conglomerates and shale, and in the central and southern part of Triassic dolomite and Jurassic limestone (Mencej 1989). The latter are extensively karstified with rugged surface and several caves and potholes.

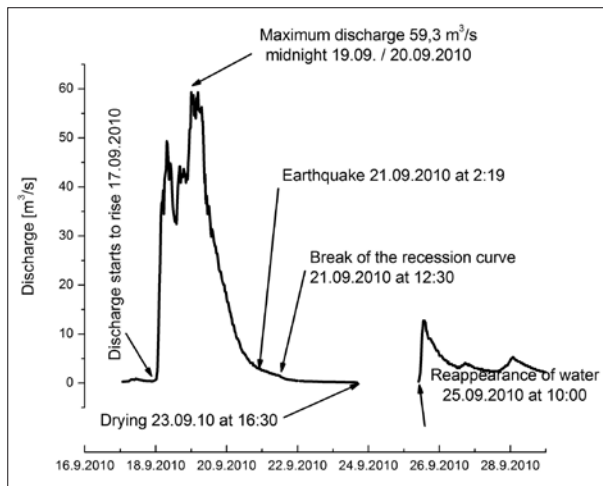
Fig. 4: Hydrograph of river Iška between September 16 and September 29, 2010 (local time = UTC+2 h).

During September 2010 heavy rain discharge of river Iška started to rise on September 17 (Fig. 4). On consecutive hours river Iška discharge reached three high peaks. The first peak with 49.3 m<sup>3</sup>/s appeared on September 18 at 7:30 local time. All the hydrological data is provided in local time (Central European time), while seismological data are provided in UTC (Universal Time Coordinated); the difference is 2 hours (local time=UTC+2h). The two following peaks that represent record values for this gauging station have discharge of 59.3 m<sup>3</sup>/s. The second one appeared exactly at midnight of September 18 and 19 and the third one on September 19 at 4:30. Hydrograph between the first and the third peak is very irregular and probably does not represent real hydrological conditions at peak discharges. It is believed that real discharges at the maximum flood were much higher and that the shape of the hydrograph in this period is a consequence of the sill collapse downstream and a consequent appearance of a hydraulic jump. Soon after the highest level was reached, water started to fall rapidly. On September 23 at 16:30 gauging profile was already completely dry. Water reappeared at the gauging station again on September 25 at 10:00.

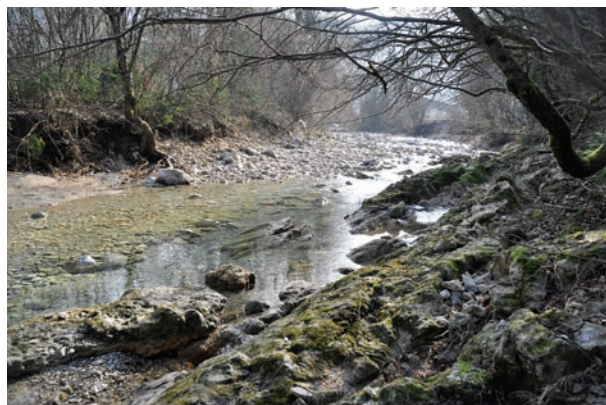
Fig. 5: Outcropping of Mesozoic limestone in the river bed.

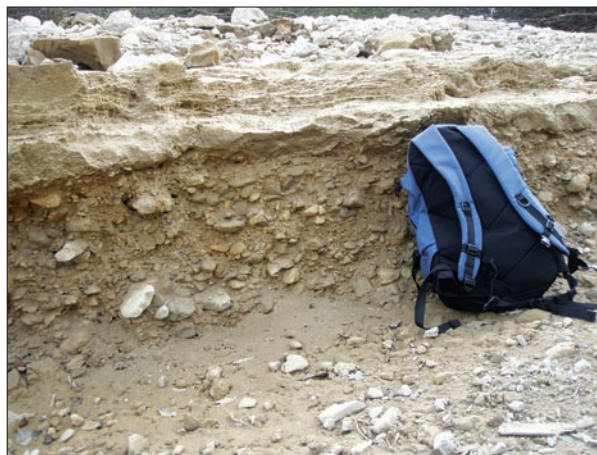
Fig. 6: Outcrop of the clogged river bed after the flood event.

tember 2010 drying of the river bed was the consequence of several events and natural conditions of the river bed. In normal situation the river bed on the Iška vas section is clogged with fine sediments composed of clay and silt. The alluvial fan of the river is represented by high permeable gravel pack and positioned on the karstified limestone where karstified fissures are present. The limestone also outcrops on the river banks (Fig. 5). During the flood event of September 2010 high waters removed up to 1.5 m of the clogged

river bed (Fig. 6). Several springs in the limestone on the left bank were also observed above the river's water table. After the end of the rainfall, springs on the banks dried and river started to sink in the cleared river bottom. Sinking appeared along the whole river bed as well as in cleared fissures in Jurassic limestone representing small sink holes. Mapping of the river bed performed after the drying event showed that before the flood, river water hang above the groundwater, due to low permeability of the river bed. With the removal of the low permeable bed and lowering of high groundwater head from the karstified limestone aquifer in the valley bottom, river water started to sink (Brenčič 2011).

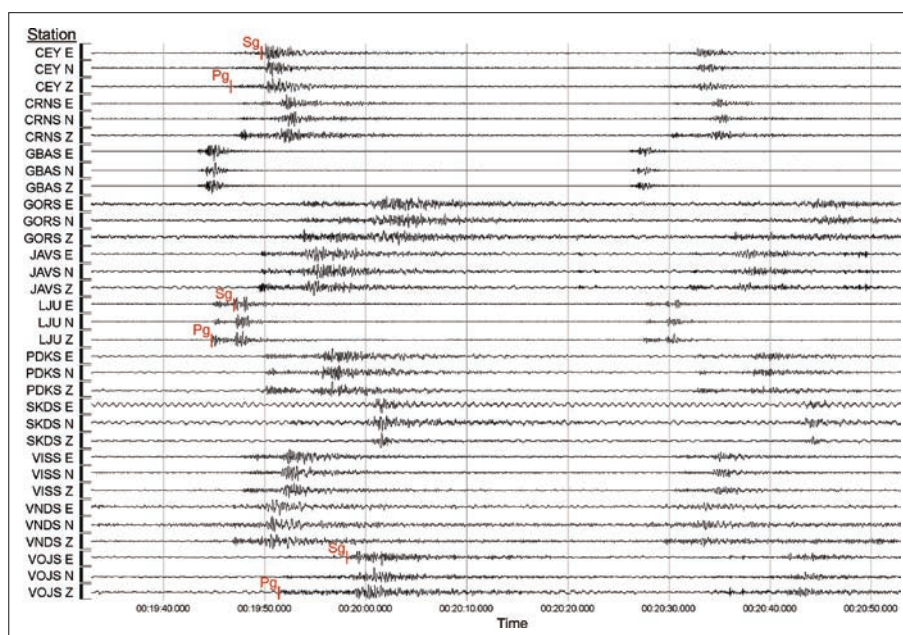
Fig. 7: Seismogram of two consecutive earthquakes ( $M_L=0.5$  and  $0.2$ ) on September 21, 2010 at 00:19 and 00:20 UTC. Locations of seismological stations are shown in Fig. 1. For each station, identified by 3 or 4 letters code, three components of ground motion (vertical Z, N-S and E-W) are shown (last letter on y axis). Some Pg and Sg phase arrivals are shown as well.

In the first hour of September 21, 2010 (00:19 UTC) two weak consecutive earthquakes ( $M_L=0.6$  and  $M_L=0.2$ ) occurred 43 seconds apart, with epicentres in Iška vas (Figs. 3 and 7). They were felt by some inhabitants who reported also a rumbling noise (brontides).

Two strongest earthquakes,  $M_L=0.5$  on September 21 (Fig. 7) and  $M_L=0.6$  on September 26 (Fig. 8), were recorded on 14 and 13 seismological stations respectively. Although the second event is slightly stronger, seismic phases could be undoubtedly determined on one station less than for the first event. This can be explained by lower ambient noise during the night time (00:19 UTC) when the first event occurred (Fig. 7) than it was during the day time (09:01 UTC) when the second one occurred (Fig. 8). This resulted in a better signal to noise ratio, which is clearly evident, if we compare both seismograms. All other weaker earthquakes ( $M_L=0.2-0.3$ ) were recorded by 6 to 11 seismological stations. For the last event seismic phases could be picked on only 6 stations, because part of the signal was masked by the preceding event, which occurred seven seconds earlier. The azimuthal gap was for all events, with exception of the last one, between  $74^\circ$  and  $88^\circ$  (Tab. 1). Since also the Root Mean Square (RMS) residual misfit of hypocenter determination does not vary considerably (range 0.3-0.4 s, only for one event it was 0.2 s) we can conclude that the accuracy of epicentre determination is comparable for all events. RMS residual misfit is computed from a set of travel times for a given hypocenter and origin time and represents a measure of the accuracy of the solution (Lienert 1994). Also the es-

Detailed analysis of seismograms of all events (Figs. 7, 8 and 9) and their comparison with earthquake seismograms recorded daily by the Slovenian seismological network has shown that they are very similar. Therefore it is very likely that the recorded events in the Iška vas area are tectonic earthquakes. Although almost no seismograms of collapse earthquakes are published in the

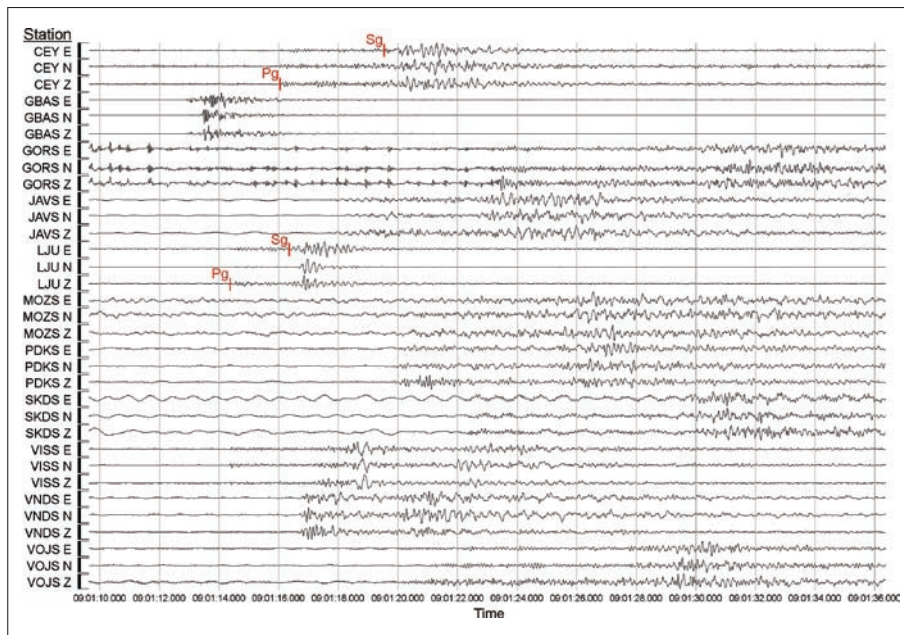
Fig. 8: Seismogram of the earthquake ( $M_L=0.6$ ) on September 26, 2010 at 09:01 UTC.

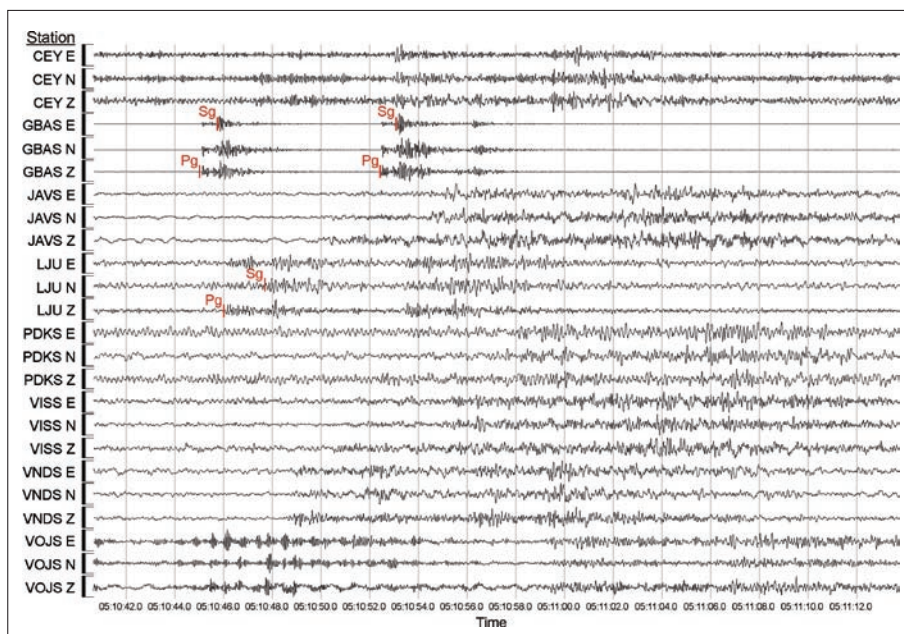
Fig. 9: Seismogram of two consecutive earthquakes ( $M_L=0.2$  and  $0.3$ ) on October 4, 2010 at 05:10 UTC.

(Fig. 8) and is located again close to Iška vas. The last two earthquakes on October 4th ( $M_L=0.2$  and  $M_L=0.3$ ) occurred only 7 seconds apart (Fig. 9). Their epicentres were close to Tomišelj, which is located downstream from Iška vas (Fig. 3).

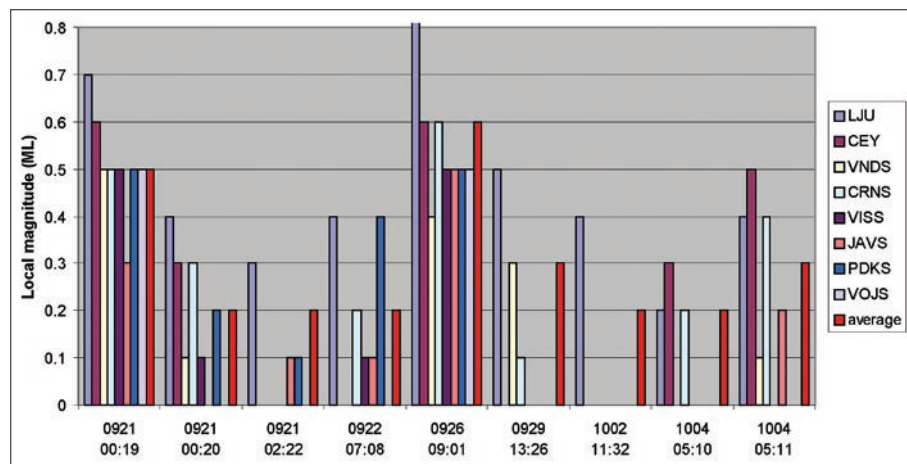
Fig. 11: Local magnitudes of earthquakes from Table 1 as determined from seismograms recorded at different seismological stations and their average.

to exaggerate the estimated magnitude and some to diminish it. From Fig. 11 it can be seen that Ljubljana (LJU) seismological station gave for almost all events the highest value and that Javornik (JAVS) and Višnje (VISS) seismological stations gave mostly the lowest values. For the two strongest events it was possible to determine magnitudes on eight seismological stations, and for all other events on two to five stations.

Magnitudes were computed from the maximum  $A/T$  ratios measured on seismograms from all seismological stations where  $P_g$  and  $S_g$  seismic phases were picked and where the signal to noise ratio in the part of the seismogram, which follows  $S_g$  arrival allowed this. Local magnitudes of all earthquakes as determined from seismograms recorded at different seismological stations are shown on Fig. 11 together with their average, which is shown also in the last column of Table 1.
