Standardized Waterproof Testing of Plastic Based Material Flooring (PBM Flooring)

Clemson University
Bishop Materials Laboratory

Research Report | December 2019

**Standardized Waterproof Testing of
Plastic Based Material Flooring
(PBM Flooring)**

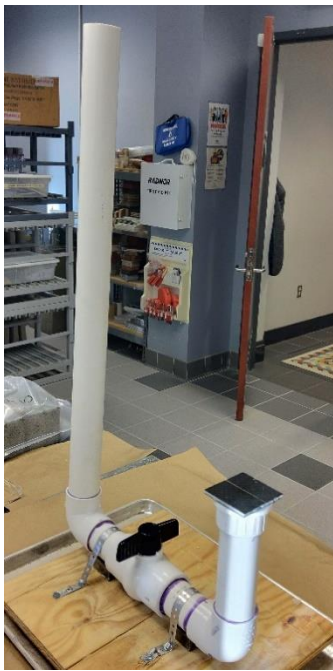
Figure 5.3.1: ASTM D4068 apparatus with specimen installed

ASTM D4068 requires that hydrostatic pressure be applied to test specimens using a PVC pipe with an inner diameter of 51 mm and a water column of 610 mm. A ball valve was installed in the apparatus to isolate the test specimens from the hydrostatic pressure (Figure 5.3.1) prior to the test commencing. The ball valve created two distinct zones, a specimen side and a hydrostatic pressure side. With the ball valve closed, water was added to the apparatus on the specimen side such that the water level was equal to the height of the specimen holder. On the hydrostatic pressure side, water was added such that the water level was 610 mm above the water level of the specimen side.

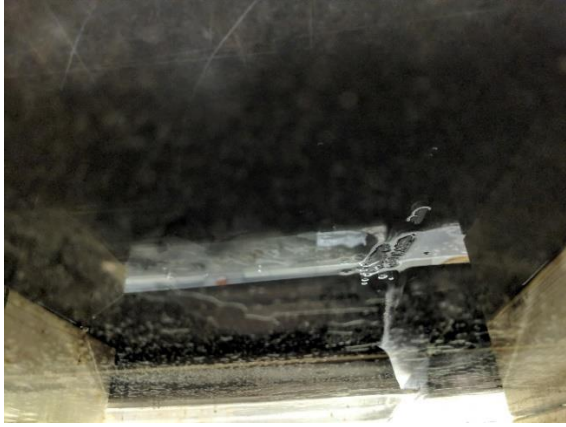
Figure 6.2.1: Water penetrating the flooring seam (seen from below the acrylic testing apparatus)

All 10 PBM floor covering products began leaking immediately upon initiating the test (well before reaching the required water level of 20 cm). As shown in Table 6.2.1, the measured rates of leakage ranged from 0.49 to 7.54 liters per hour (0.13 to 1.99 gallons per hour). For each assembly, water leakage was observed in three locations: (1) through the seams to underneath the floor covering (Figure 6.2.1); (2) into the seams and exiting at the edges of the assembly (Figure 6.2.2); and (3) into the seams and exiting atop the assembly, outside of the sealed containment box (Figure 6.2.3).

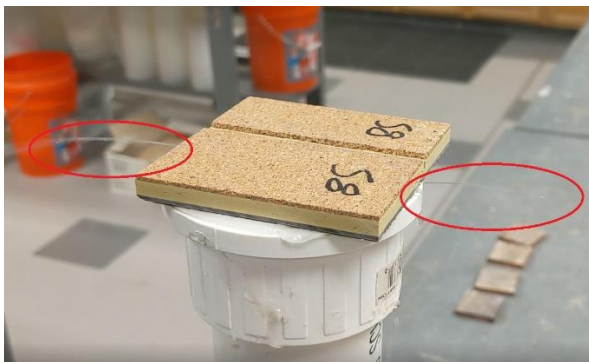
Figure 6.3.1: Water penetrating the seam and exiting from the edges

All 10 PBM floor coverings tested began leaking immediately after initiating the test. As shown in table 6.3.1, measured leakage ranged from 0.38 to 2.43 liters per hour (0.1 to 0.64 gallons per hour). All PBM floor covering products tested leaked through the seam with water exiting from the edges of the seam (figure 6.3.1). Additionally, some specimens leaked through the center seam to the back of the floor covering. (figure 6.3.2).

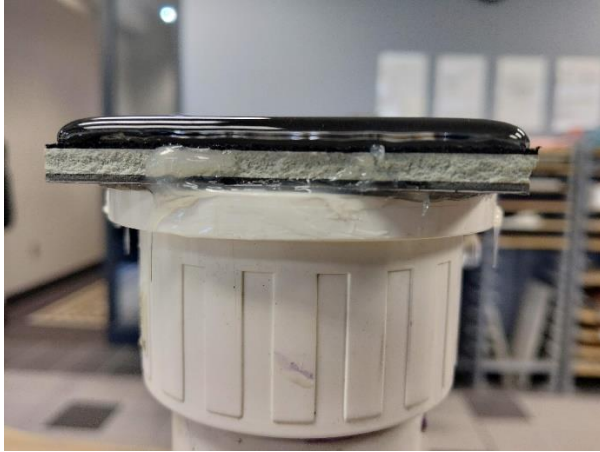
Figure 6.3.2: Water penetrating the seam and leaking to the back of the specimen
