THE MOSAIC PAVEMENT SUBSTRATES IN THE SOUTHERN ROOMS OF THE EASTERN CHURCH AT KHIRBET ET-TIREH, RAMALLAH (PALESTINE)

Salah Hussein AL-HOUDALIEH* and Hamdallah BEARAT**

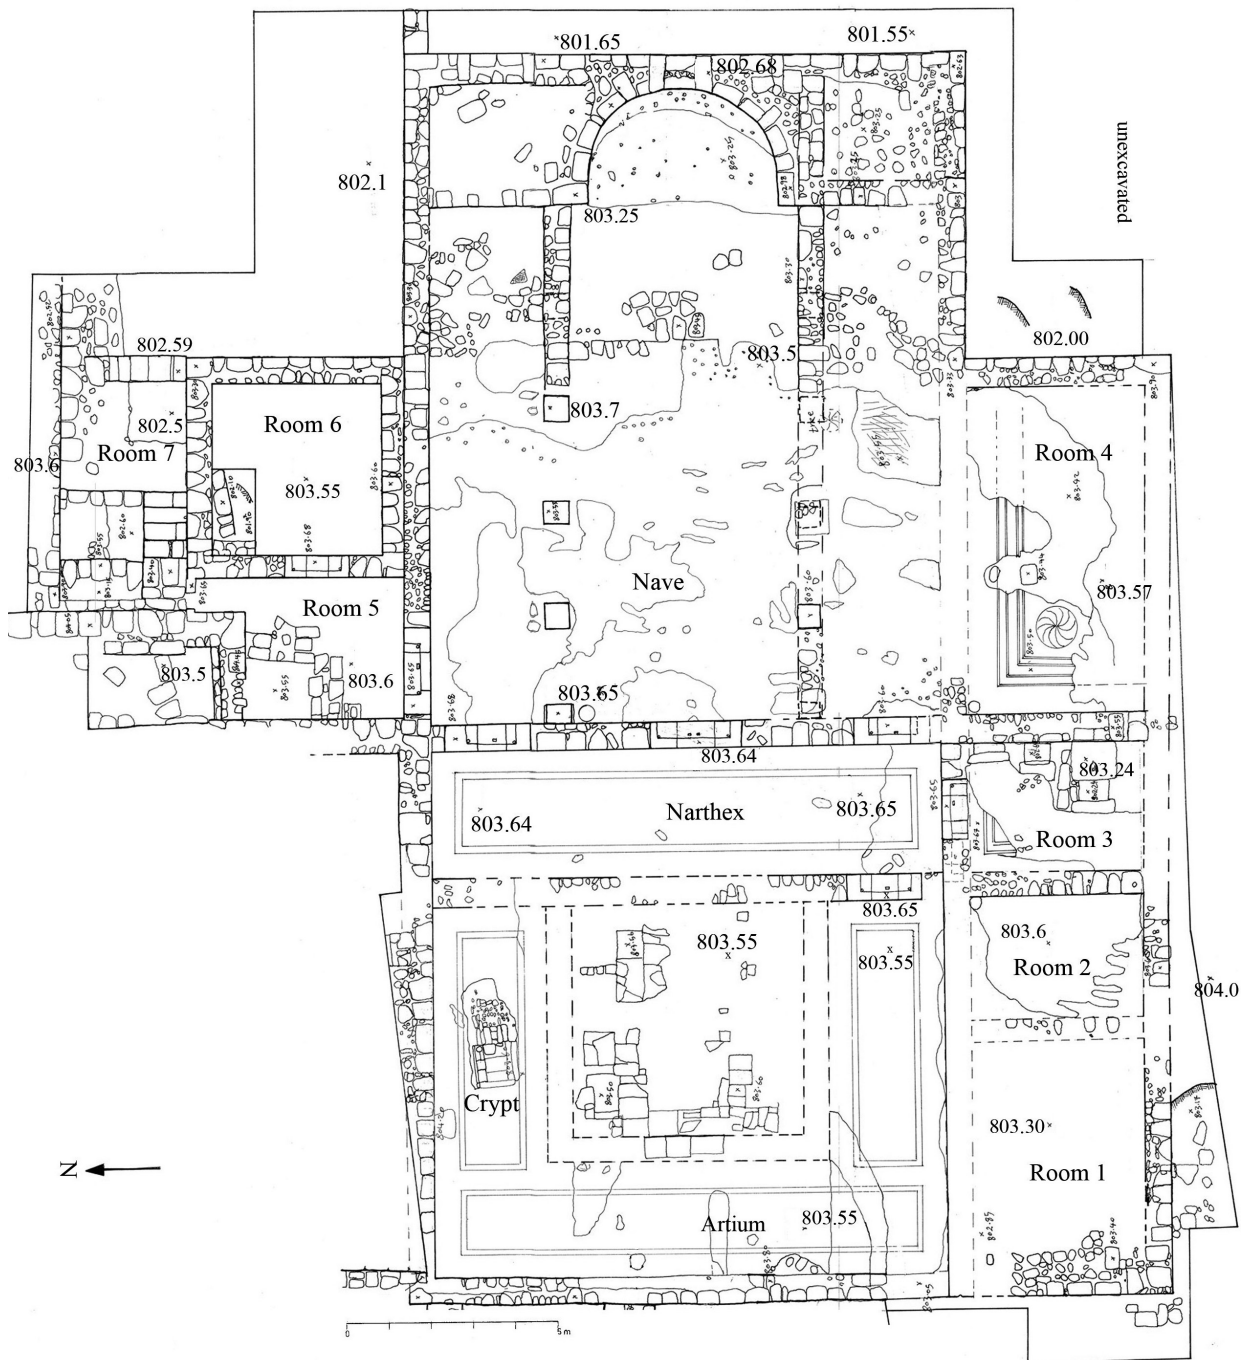
FIG. 3. Top plan of the Eastern Church of Khirbet et-Tireh (drawn by I. Iqtait).

The string of four south-side rooms adjoins externally the southern wall of the atrium, the narthex, and part of the southern aisle of the church complex (Fig. 3). The four rooms all have an internal north-south dimension of 4 m, however their east-west measurements vary: Room 1 = 5.2 m; Room 2 = 2.8 m; Room 3 = 3 m; and Room 4 = 7.7 m. The masonry of these rooms consists of large, mostly well-cut and nicely dressed ashlar approximately 0.65 m long, 0.35 m thick, and 0.34 m high on average. One section, the eastern wall of Room 4, which is an exterior wall of the complex, stands as high as 1.5 m, but still at or below floor

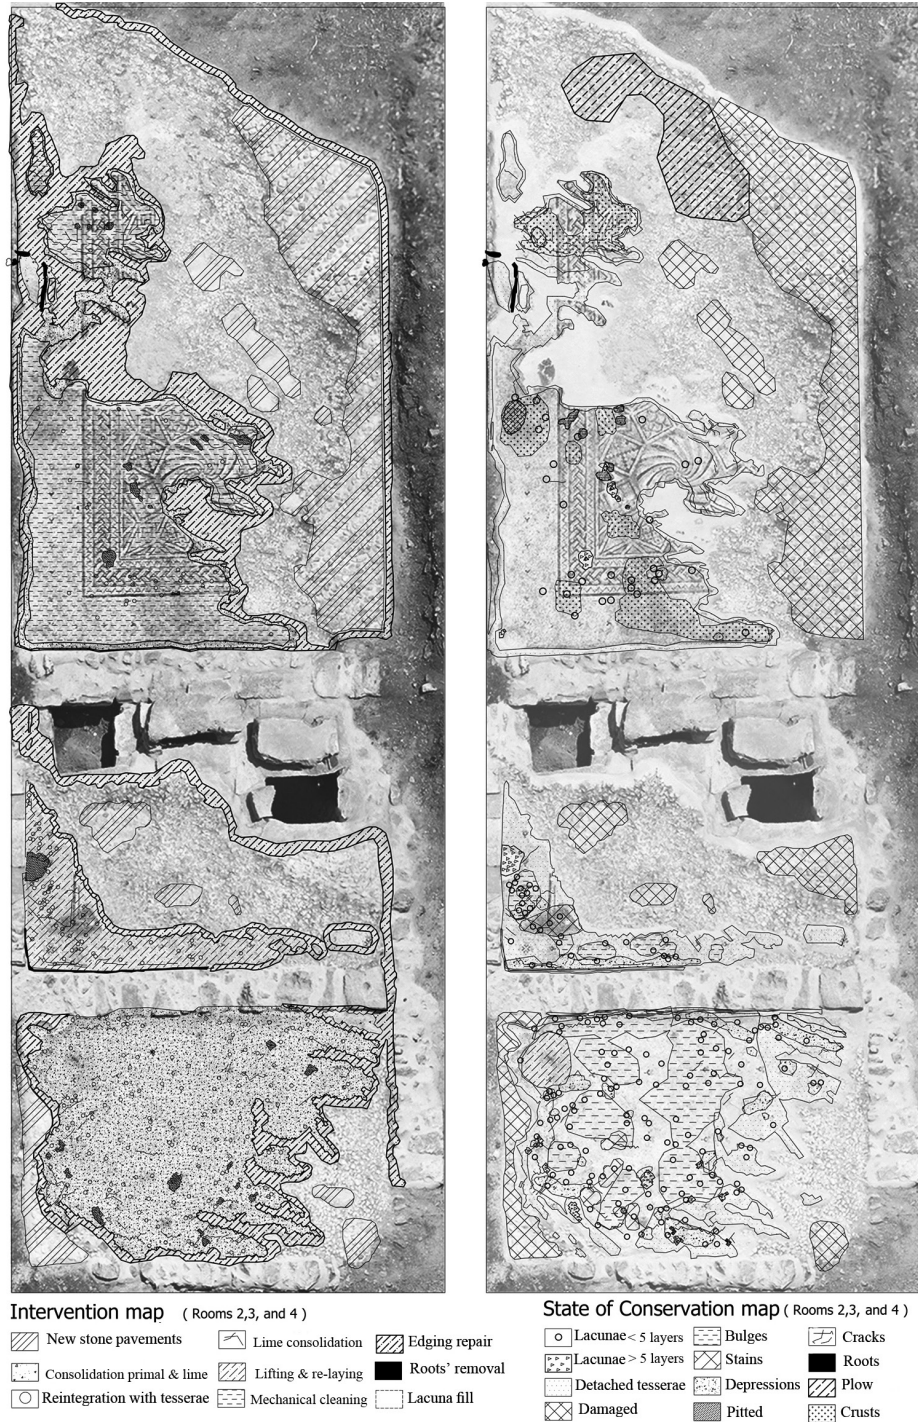
FIG. 5. *Condition assessment and intervention map (prepared by R. Khalil).*

2) Documenting the physical condition of the mosaic pavements through visual inspection and textual recording; preparing a series of thematic charts detailing the physical condition of the surveyed pavements, especially noting all visible problems (Fig. 5); compiling a written description of the problems relating to these floors; and finally, formulating a detailed action plan for intervention.

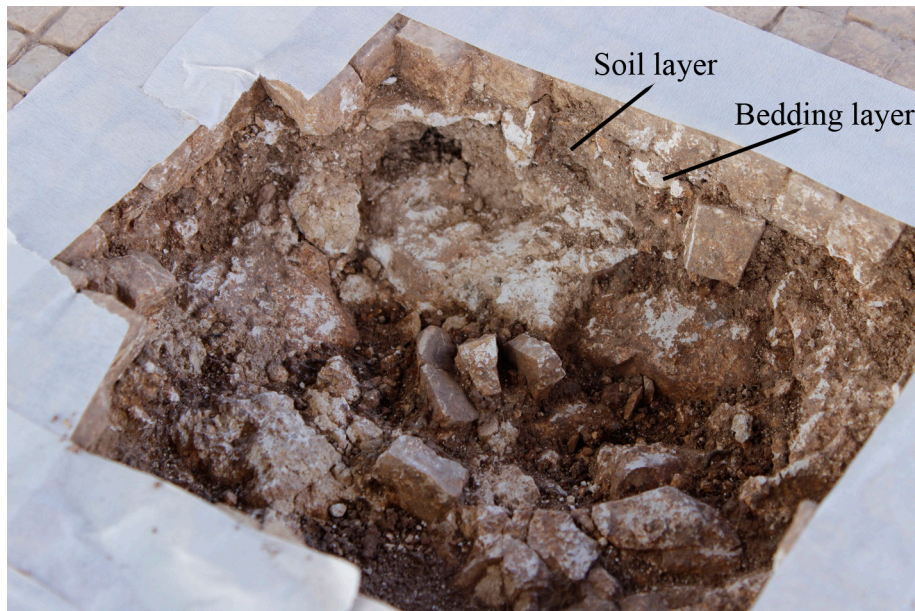
FIG. 7. The soil layer in between the bedding layer and nucleus in Room 2.

lacunae or cracks–, and the results of this work revealed the same soil layer seen elsewhere, extending beneath the intact section of this floor (Fig. 7). Furthermore, when we lifted the mosaic floor of Room 3, we again found a soil layer of the same characteristics, composition and thickness as those found in Rooms 4 and 2 (Figs. 8-9). So, we can conclude that the soil layers found in Rooms 4, 3 and 2 between the *nucleus* and bedding layers are an original part of the foundation layers of these mosaic

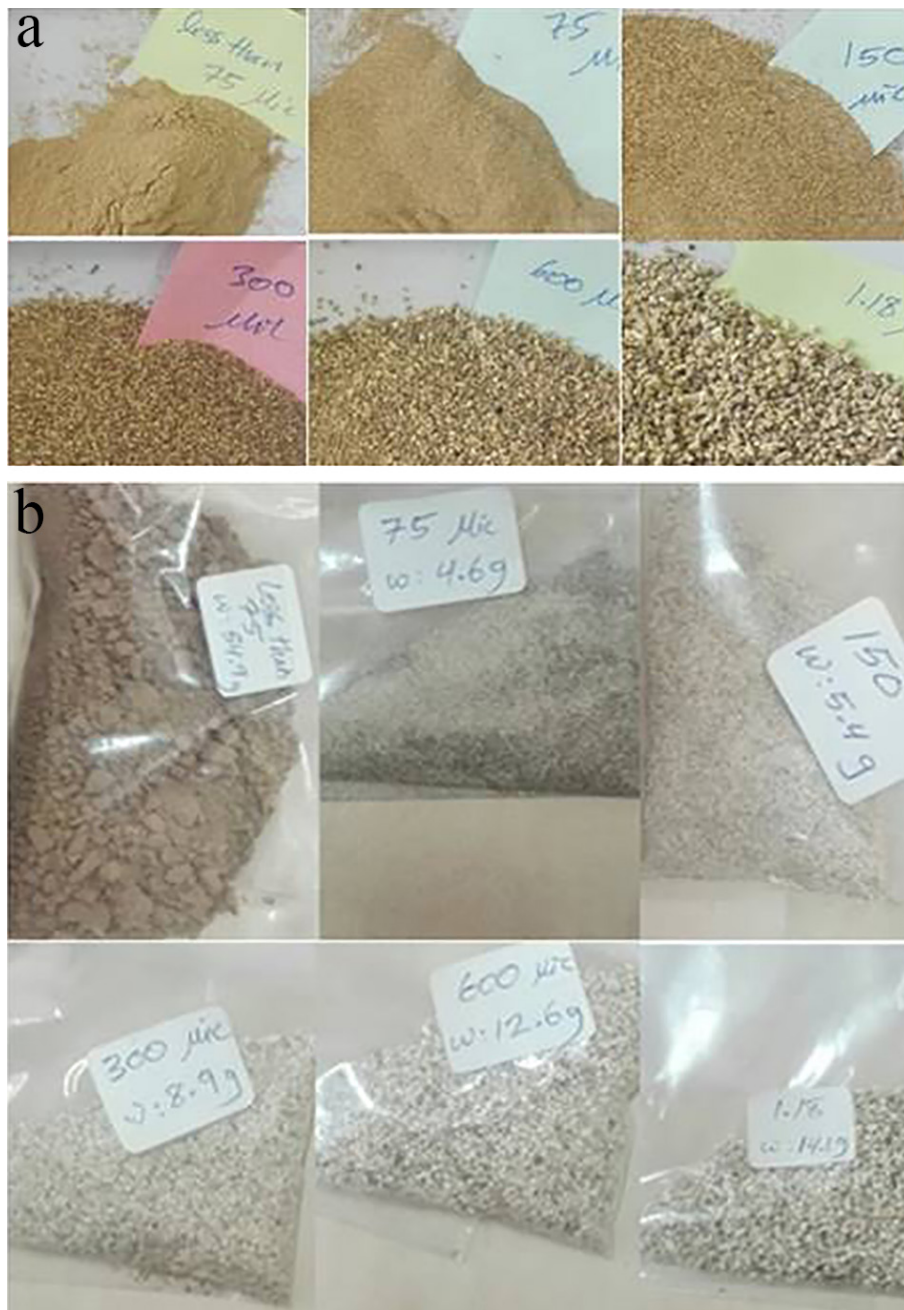
FIG. 13. Particle size distribution of the mosaic fill material: a) after screening of dry sample; b) after screening of wet sample.

Data obtained for the fill soil sample screened dry are presented in Fig. 12. The table also shows data obtained for the same sample screened suspended in water. Collected size fractions in both tests are shown in Fig. 13a and b, respectively. These data are presented by the histograms of Figs. 13a and 13b. Histograms show that granulometric analysis of dry fill soil material is misleading in representing the proportion of the fine materials which is mainly composed of clay (Fig. 14a). The fine fraction –<75 μ – is underestimated and only makes about 12% of the total mass. Otherwise, the sand fractions are overestimated due to the fact that large amount of clay is still adhering to the sand particles, making grains appear larger than they are and making each size fraction higher. On the other hand, histograms of Fig. 14b provide a realistic measure of the grain size distribution of both the sand and the clay materials. Thus, the clay component amounts now to over 50%, indicating that the two materials –clayey soil and sand– were prepared in a 1:1 ratio. Moreover, the particle size distribution of the sand component is now meaningful. The wt.% of size fractions increases as the particle size increases. There is an artificial cut in particle size at 2000 μ . It is worth noting that the sieve with 2000 micron opening did not retain any sand material. This indicates the voluntary elimination of any larger particles. One can claim that a sieve of 2000 μ (= 2 mm) size opening –us mesh 10– was employed to screen the sand material before mixing it with equal proportion of clay material.

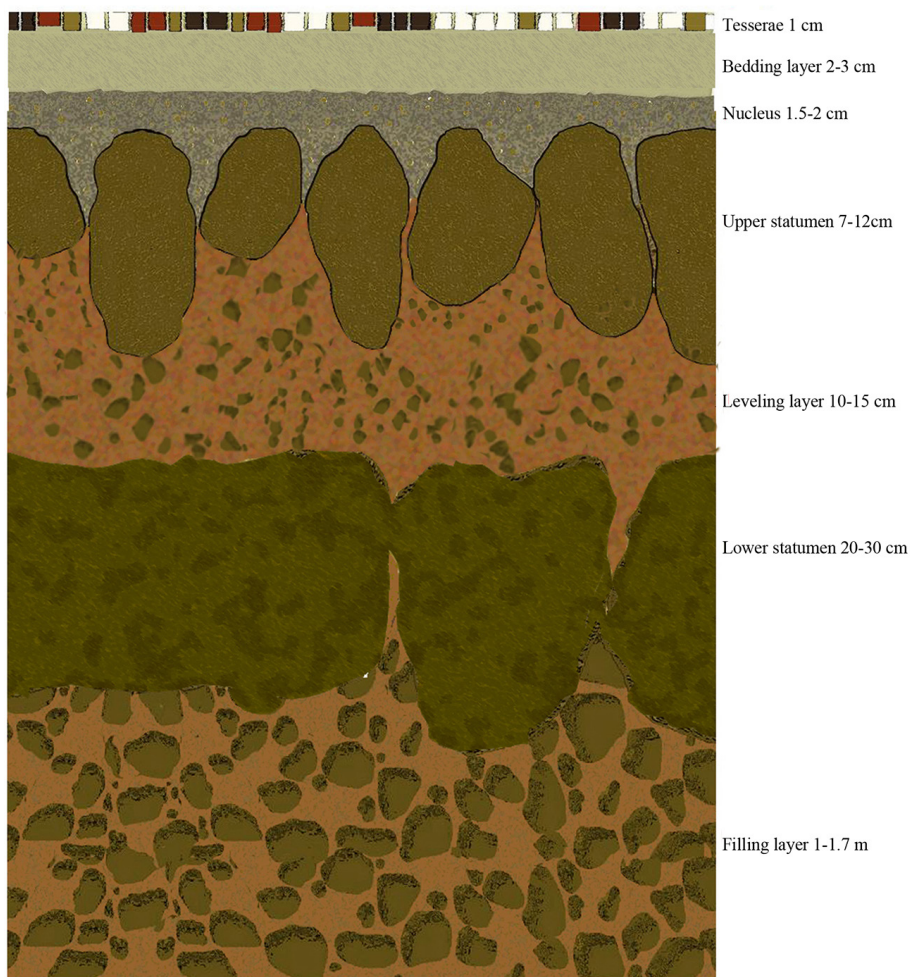
FIG. 19. *The foundation layers of the mosaic pavements of the main hall of the Eastern Church at Khirbet et-Tireh (prepared by R. Khalil).*

At Khirbet et-Tireh, the substrate of the main hall of the same Eastern Church was constructed of six distinct layers (Fig. 19): 1) A filling layer ranging from 1 m thickness over the western part of the church to 1.7 m in the eastern part, varying with the elevation of the underlying bedrock surface which, again, slopes generally downward toward the east; 2) a stone pavement – a lower *statumen*– 0.2 m to 0.3 m thick; 3) a leveling layer of additional earthen fill 10 cm to 15 cm thick; 4) another stone pavement – an upper *statumen*– 7 cm to 12 cm thick; 5) a *nucleus* layer 1.5 cm to 2 cm thick; and finally 6) the bedding mortar layer 2-3 cm thick – as stated above, along with additional analysis–.

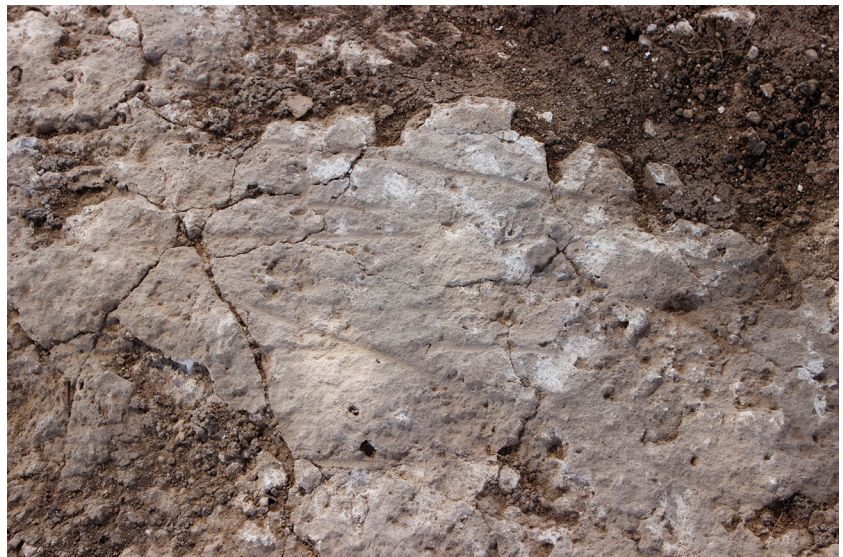
FIG. 20. *Plow marks and deep cracks on the surface of the nucleus layer in Room 4.*

The mosaics and substrates of the southern rooms, as we found them, varied in physical condition, ranging from good, through severe damage, to complete destruction. Based on the scant overlying earthen deposits –only 0.2 m to 0.4 m thick– which we excavated from the surface of the southern rooms of the Eastern Church at Khirbet et-Tireh in 2015, and also the plow marks clearly visible in the *nucleus* layer of Room 4 (Fig. 20), we

believe that the mosaics in this area of the church were dramatically damaged through agricultural activity, probably over a long period of time. The mosaics of these rooms are distinguished not only
