# Insulation historical buildings from the inside

**Abstract:** This article focuses on the problem of thermal insulation of historical buildings. This issue is very important, especially for historical buildings and those not covered by any form of preservation maintenance. In the case of thermal insulation of this type of buildings, we often have to deal with irretrievable loss of architectural values and even with stripping the buildings from their history and identity and often turning them into architectural monstrosity. The article refers to both aesthetic, legal and technical issues, which should be kept in mind before planning thermal modernisation. It indicates the most common technical and system errors and points to certain changes that can minimise the problem of uncontrolled styrofoam covering of historical buildings.

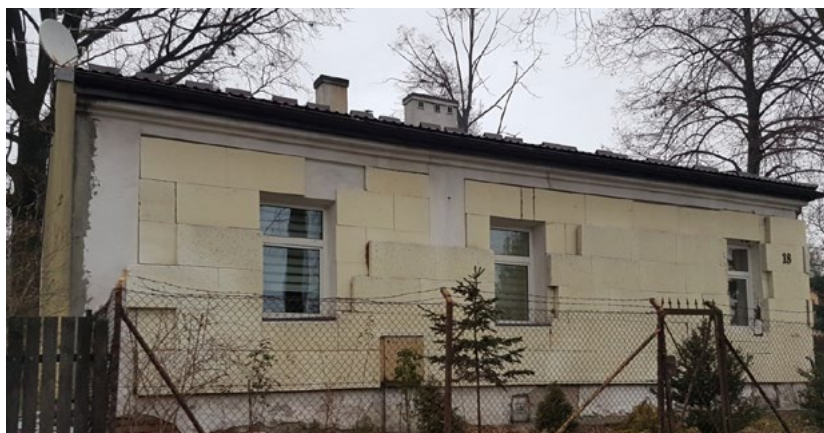
**Fig. 1.** An attempt to insulate the building from the outside, photo. K. Janus

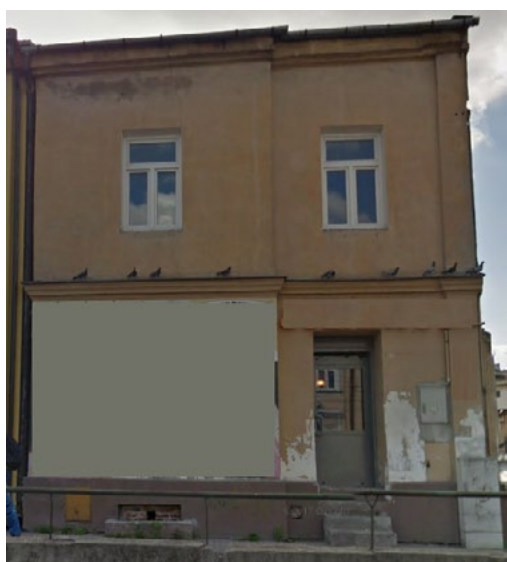
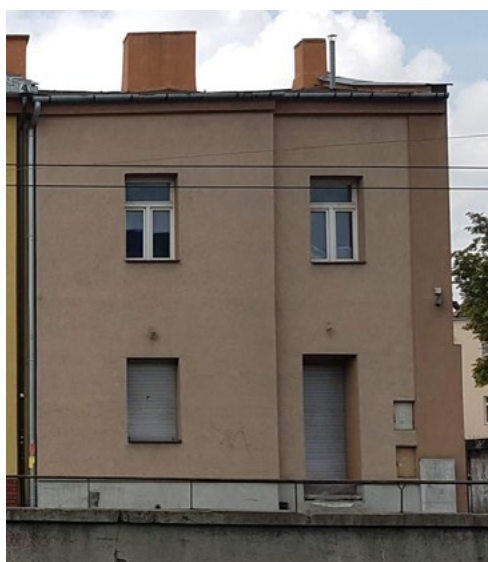
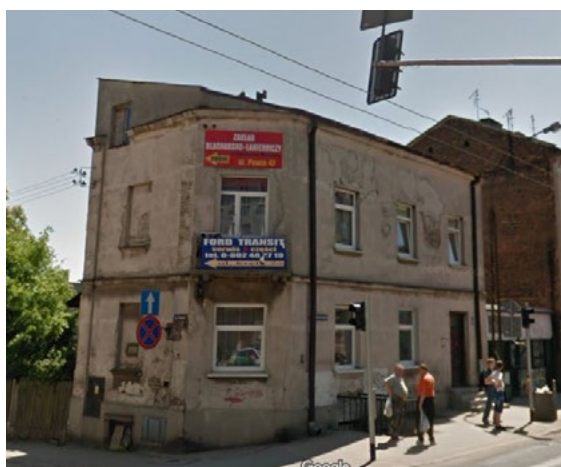
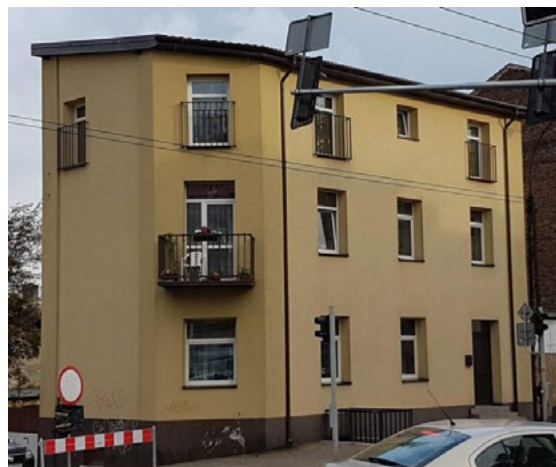
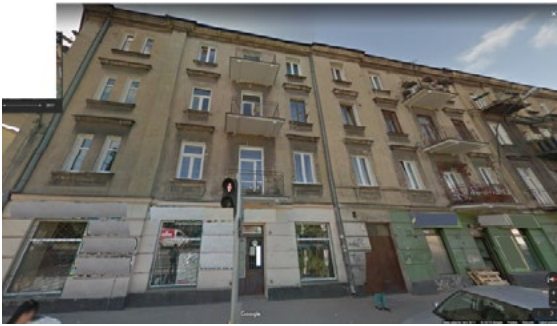
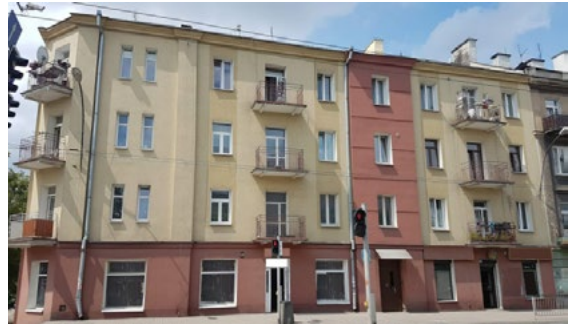
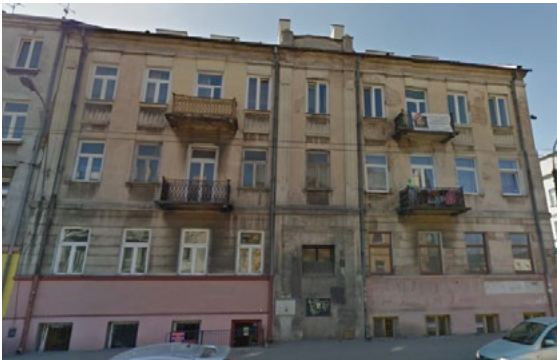
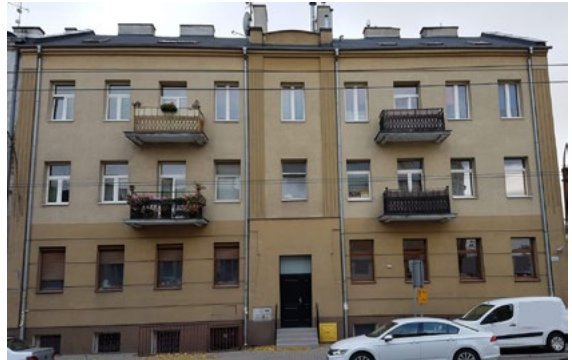
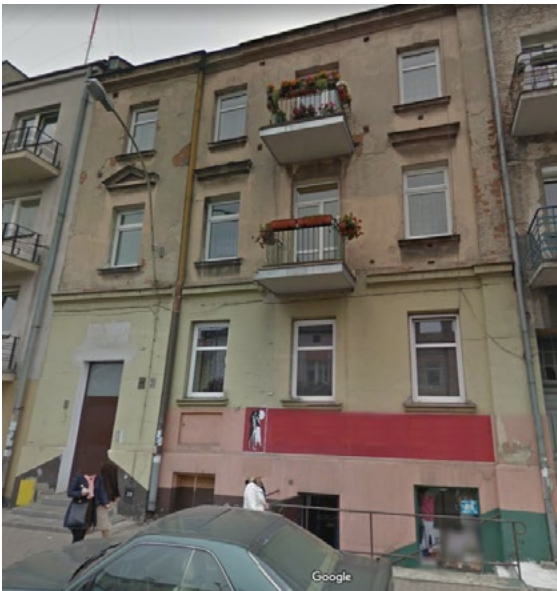
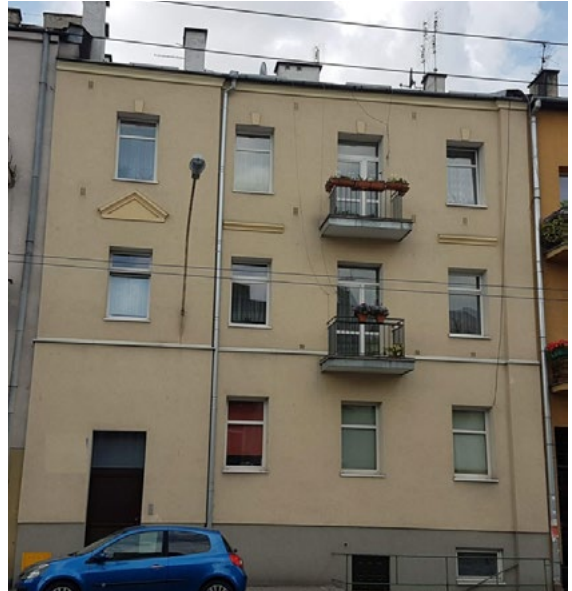
**Fig. 2.** Tenement house 1, [www.google.com/maps/ street View](http://www.google.com/maps/streetview), state of 2011, access: 15.08.2019

**Fig. 3.** Tenement house 1, current state, photo K. Janus

**Fig. 4.** Tenement house 2, [www.google.com/maps/ street View](http://www.google.com/maps/streetview), state of 2011, access: 15.08.2019

**Fig. 5.** Tenement house 2 with upward extension, current state, photo K. Janus

**Fig. 6.** Tenement house 3, [www.google.com/maps/](http://www.google.com/maps/) street View, state of 2011, access: 15.08.2019

**Fig. 7.** Tenement house 3 with upward extension, current state, photo K. Janus

**Fig. 8.** Tenement house 2, [www.google.com/maps/](http://www.google.com/maps/) street View, state of 2011, access: 15.08.2019

**Fig. 9.** Tenement house 2 with upward extension, current state, photo K. Janus

**Fig. 10.** Tenement house 4, [www.google.com/maps/](http://www.google.com/maps/) street View, state of 2011, access: 15.08.2019

**Fig. 11.** Tenement house 4 with upward extension, current state, photo K. Janus

This issue has been raised for years and yet, it has not been properly addressed by the legislator. The photographs below show the method of insulation of only a few buildings in the area of one street, one city, made in the last few years. Of course, they are not as "colourful" as many other examples, but they do represent an important aspect.

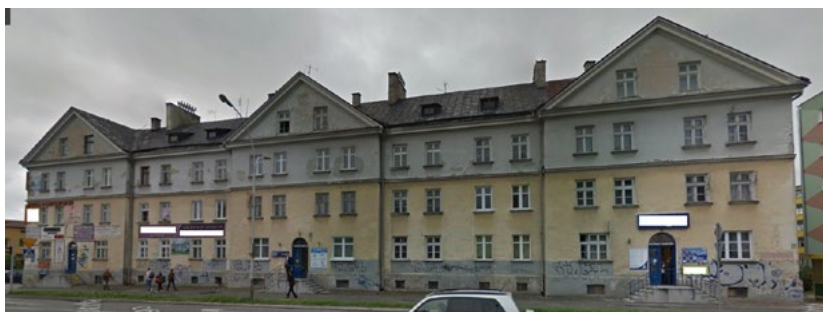
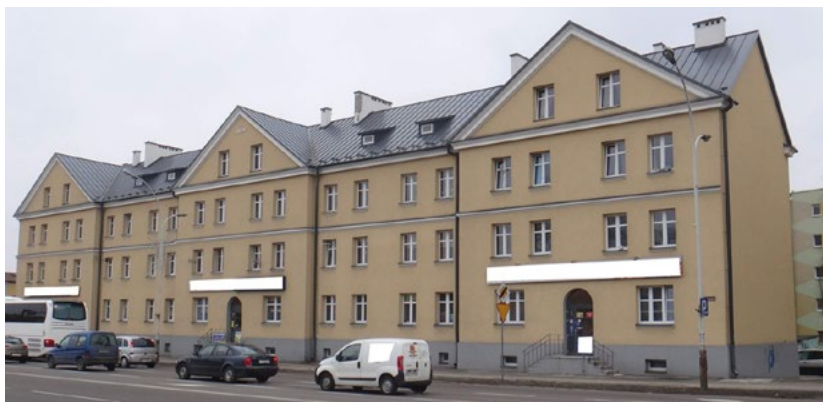
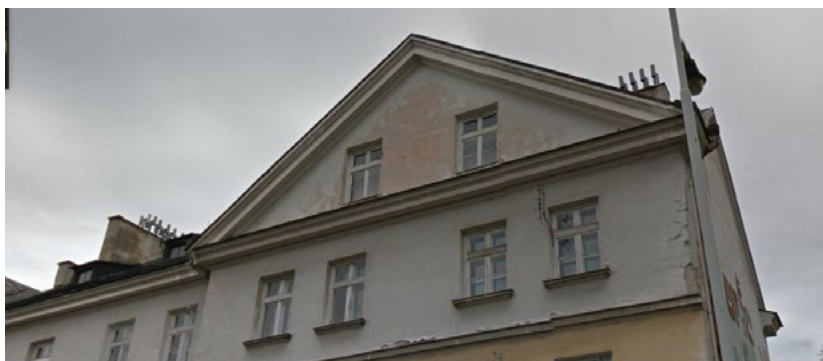
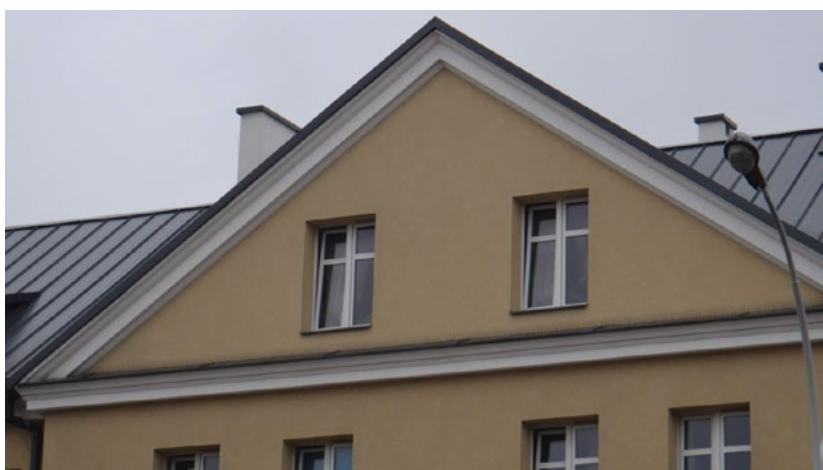
**Fig. 12.** Tenement house 6, [www.google.com/maps/ street View](http://www.google.com/maps/streetView), state of 2011, access: 15.08.2019

**Fig. 13.** Tenement house 6 with upward extension, current state, photo K. Janus

**Fig. 14.** Tenement house 4, [www.google.com/maps/ street View](http://www.google.com/maps/streetView), state of 2011, access: 15.08.2019

**Fig. 15.** Photo 8. Tenement house 6 with upward extension, current state, photo K. Janus

An interesting combination of the technology of insulating from the outside is the following example of a tenement house, where the insulation technology was applied on the outside of the building with a façade decor (modest but visible). The work included filling the space between the cornices with a layer of insulation, which partially covered the cornices, but did not significantly change the appearance and perception of the building. On the surface, windowsills were made as new elements. The façade finally obtained the “woodworm” texture, which could have been avoided, and the final finishing layer should have been the paint on the adhesive layer. In this case it was not possible to prevent thermal bridges, which (surprisingly!) are not very visible in the thermal vision or felt by the inhabitants.

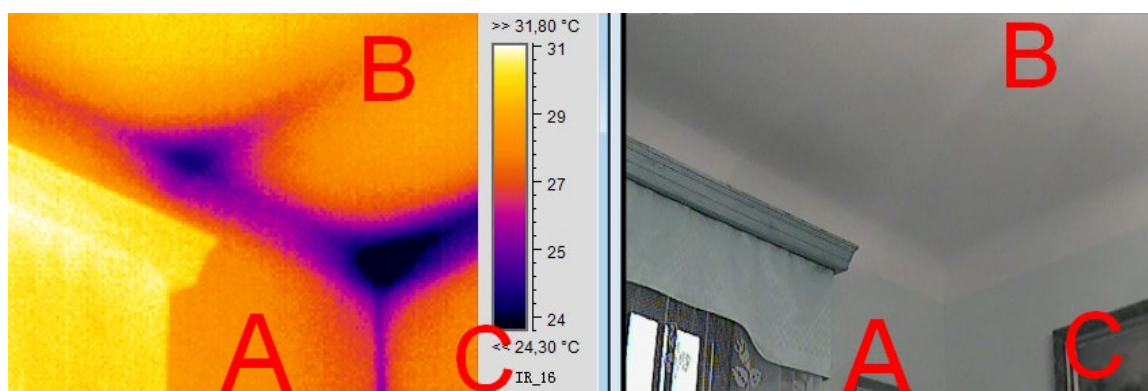
**Fig. 16.** Place of joint wall with insulation from inside with ceiling and internal division (A – wall insulated from inside, B – ceiling without insulation, C – internal wall without insulation), K. Janus

For the second group of buildings, i.e. those that can be insulated from the inside, the problem of the dew point and water condensation in the wall in unfavourable temperature conditions has not been solved (this is the biggest disadvantage of this method, which still takes place in the current state of building). It is also problematic to insulate key places such as the connection of internal partition walls or ceilings with external walls. It is possible of course to add an additional insulation layer reaching deep into the room (visible in the form of a bump on the wall or ceiling), which in part would solve the problem, but in terms of aesthetics and conservation, e.g. in palace interiors, is simply unacceptable. It is also possible to consider insulation of all walls and ceilings from the inside, which would reduce the usable area and increase costs. Window glyphs, which due to the size of the window can be insulated with a thin layer of insulation (thinner than in the case of external walls), are a crucial point. Available technologies for internal insulation enable moisture flow from the walls to the interior and its removal through the ventilation system to the exterior, and properly selected pH of materials significantly reduces the risk of development of biological corrosion at the contact of the wall with the insulation layer. The biggest problem is the place where external walls are connected with the ceiling and internal division walls, where thermal bridges occur. This problem remains unresolved and its elimination may consist in limiting the effects, i.e. introducing efficient ventilation and the use of suitable materials that will reduce the risk of biological corrosion.
