Journal of Civil Engineering and Architecture 14 (2020) 37-45
doi: 10.17265/1934-7359/2020.01.004

Influence of Local Weather Conditions on Ventilation of a Pitched Wooden Roof

Abstract: This paper investigates the influence of temperature and wind conditions on ventilation of the air cavity beneath the roofing in a full-scale pitched wooden roof construction. The potential for condensation in the air cavity is studied. The relevant roof construction is equipped with 81 thermocouples and four air velocity measurement devices. A weather station at the site records outdoor temperature and wind conditions. Five periods between 2016 and 2018 are investigated. The findings show distinct periods of below-ambient temperature and positive condensation potential in the ventilated air cavity of the roof. A relation between low wind speed and positive condensation potential is shown. Difference in size of periods with below-ambient temperature and periods with positive condensation potential implies that the materials in the roof regulate the humidity in the air cavity. Large negative peaks in the condensation potential indicate dry-out of the construction.

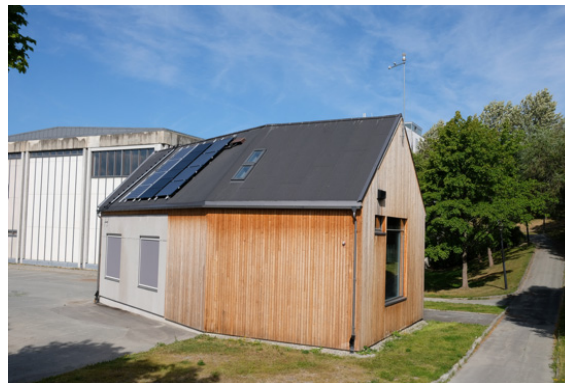
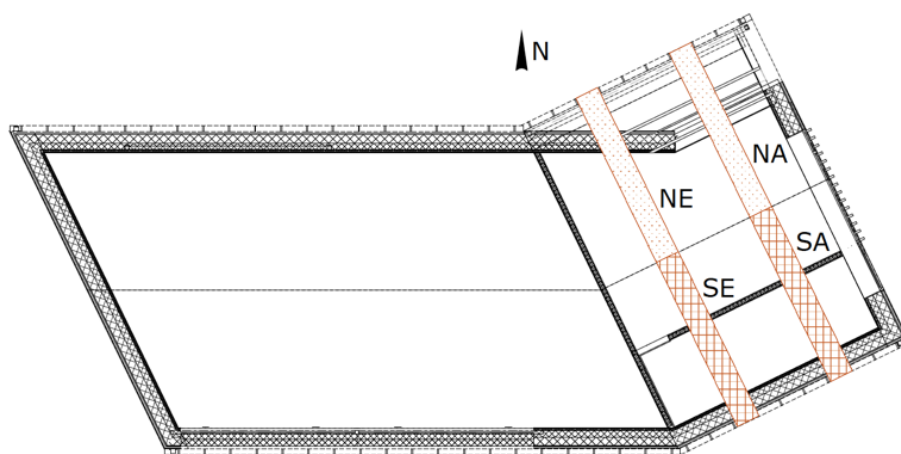
Fig. 1 (a) The ZEB Test Cell Laboratory; (b) position of the air cavities included in the study.

The study was carried out on a full-scale experimental laboratory building, ZEB Test Cell Laboratory, situated in Trondheim, Norway (see Fig. 1). The building has a wooden roof construction with a roof angle of 40° . The roof has eaves-to-eaves ventilated air cavities below the roofing, with 48 mm wide inlets and outlets along the eaves. The air cavities are 10.8 m long, 552 mm wide and 48 mm high. The lower surface of the cavities consists of a flexible roof underlay mounted on an oriented strand board (OSB). The upper surface is an OSB covered by a bitumen-based roofing membrane on the weather exposed side (see Fig. 2).

Four of the cavities on the roof were studied, described in the plan drawing in Fig. 1, showing the building from above. Two cavities on the southern side of the roof, denoted as SA and SE, and two cavities on the northern side of the roof, denoted as NA and NE, were included in the study.

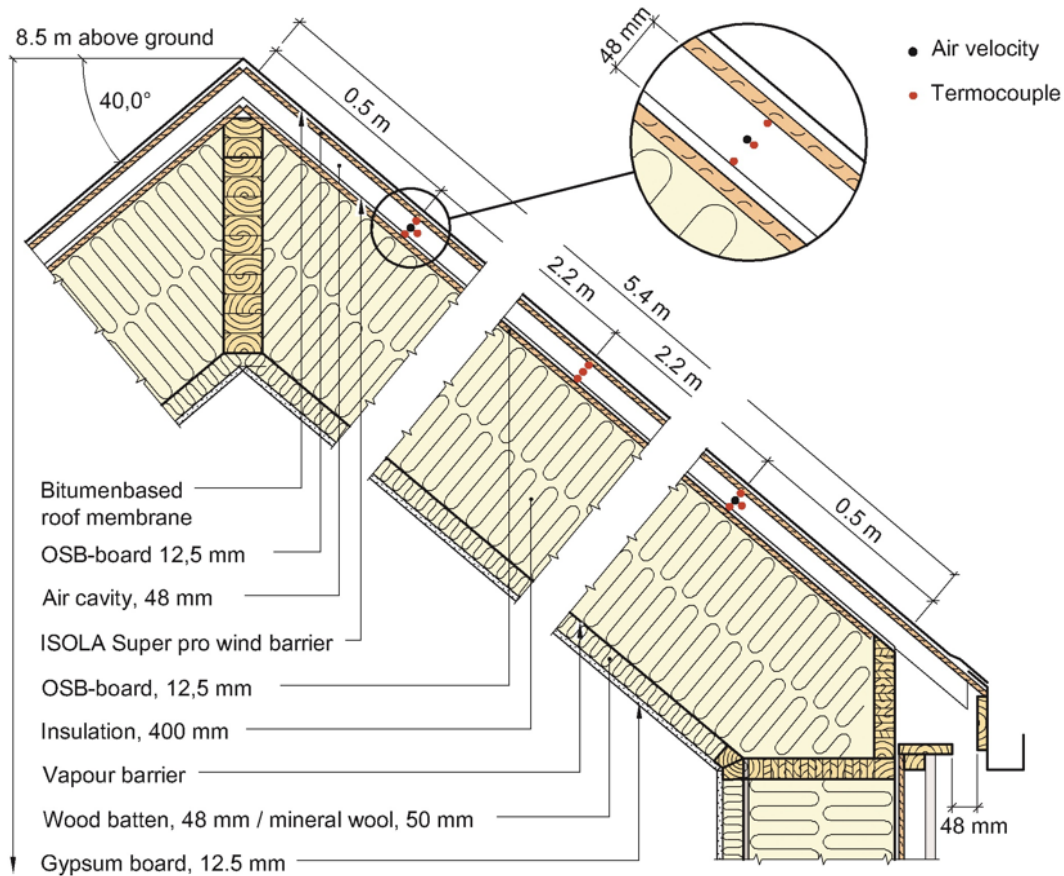
Fig. 2 ZEB Test Cell Laboratory roof structure.

The air cavities of the roof are equipped with instrumentation for temperature and air velocity measurements (Fig. 2). Eighty-one (81) thermocouples are shared evenly on nine parallel cavities. In each cavity, three thermocouples are located 0.5 m above the eaves, three are found between the eaves and ridge, and three are located 0.5 m below the ridge. In each triplet, one sensor is installed on the roof underlay, one is installed in the middle of the air cavity, and one is mounted on the rear surface of the roofing. In two of the air cavities, two air velocity measurement probes are installed. The accuracy and range of the sensors are $\pm 0.10^\circ\text{C}$ and -20°C - 60°C for the thermocouples, and 0.05 m/s and 0.05-5 m/s for the air velocity probes.

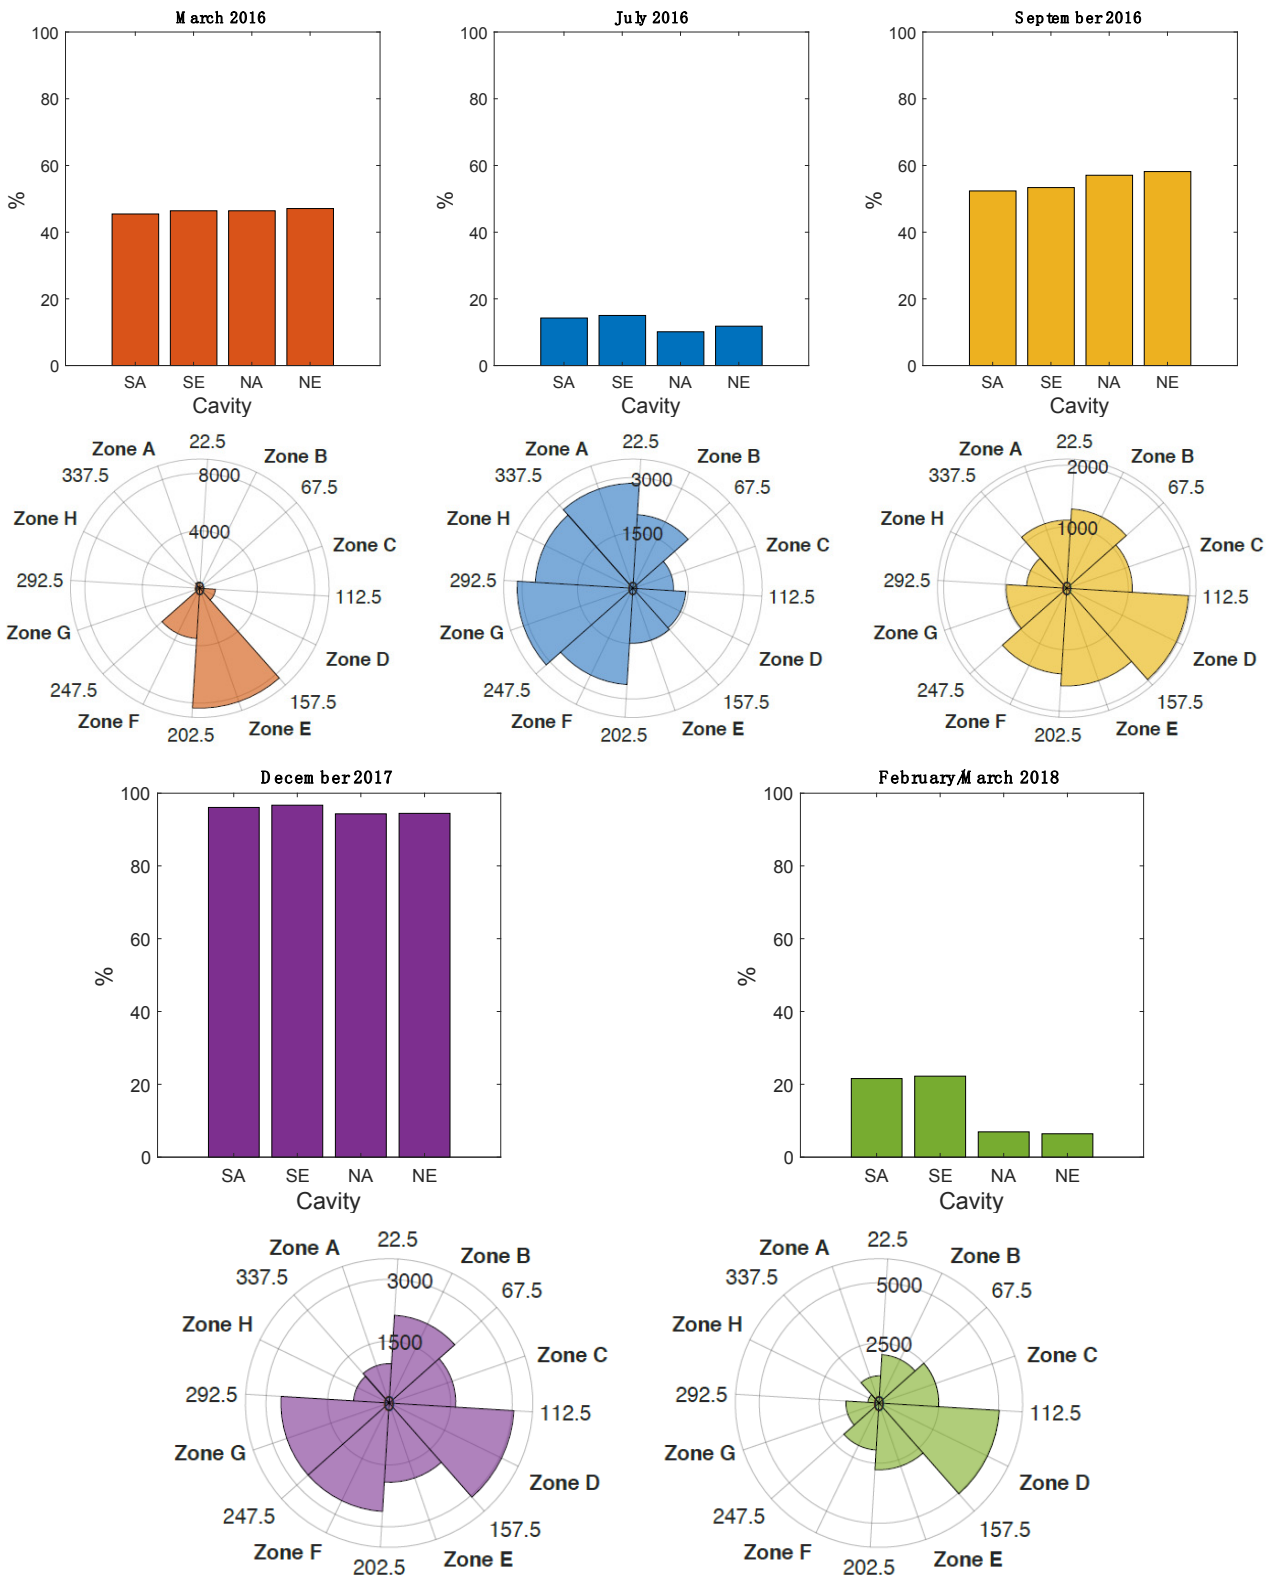
Fig. 3 The bar charts present the percentage of each period with lower temperature on the rear side of the roofing than in the outdoor air. The polar charts show the occurrence of wind from different directions towards the house. The radial axes in the polar charts represent the number of measurements within a zone. Note that the scale of the radial axes varies between the different periods.

In this paper, the temperature and condensation conditions in the ventilated air cavity of a full-scale pitched wooden roof have been investigated. Five periods between 2016 and 2018 were included in the study. How the temperature in the air cavity depends on the outdoor temperature and wind is presented in Fig. 3. The subsequent CP_i in periods with below-ambient temperature in the air cavity is examined in Figs. 4 and 5.

The measurements from the roof at ZEB Test Cell Laboratory demonstrated long periods of below-ambient temperature in the ventilated air cavity beneath the roofing. During the spring and autumn periods, the measurements at the rear side of the roofing showed temperatures below the ambient temperature for approximately 50% of the time. This is in line with the results found by Gullbrekken et al. [10]. In the December period, below-ambient temperature was measured close to 100% of the time. There was no snow on the roof in this period. Low outdoor temperatures and periods with clear sky may have contributed to large cooling of the roof and the subsequent low temperatures at the rear side of the roofing. During the second winter period, in February/March 2018, comparatively small intervals with below-ambient temperature were measured. Snow,

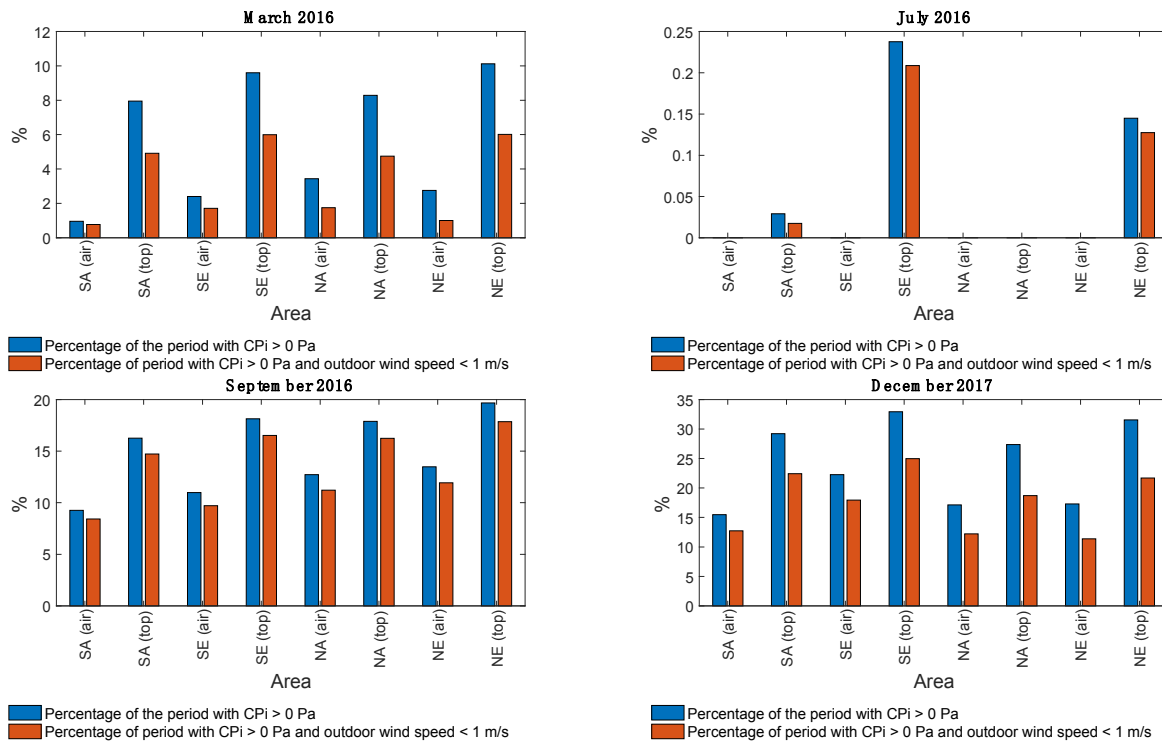
Fig. 5 Percentage of each period with positive CP_i , and percentage of each period with positive CP_i at the same time as the wind speed is < 1 m/s. Note different axes scales.

180°, 225°, 270°, 315° ± 22.5°. The angle of 0° corresponds to wind approaching perpendicular to the wall on the northern side of the building (zone A). Fig. 4 shows CP_i in the air cavity and wind speed as a function of time. Fig. 5 compares the risk of condensation in the different periods. In Fig. 5 results are not given for February/March 2018, as no positive CP_i was found in this period.
