Building Conservation Journal

Think ahead, but look back

Time for a revival

Needle points

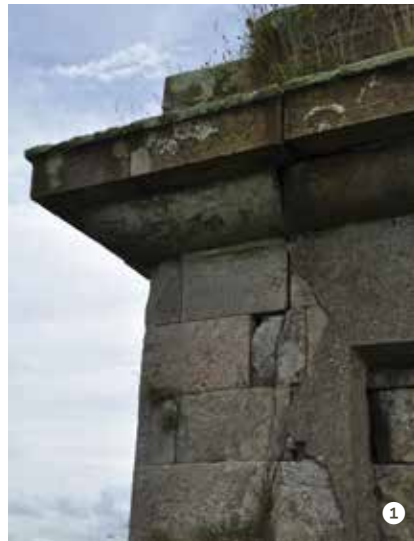
The initial assessment also concluded that there was a slight stoop to the top third of the needle and localised disturbance of the higher stone sections. There was also evidence of structural cracking where vegetation was taking hold in joints in the stone

that had significantly eroded, principally associated with increased frost damage and salt crystallisation. The degree of exposure and the severity of wind-driven rain was a conducive environment for extended periods of fabric saturation.

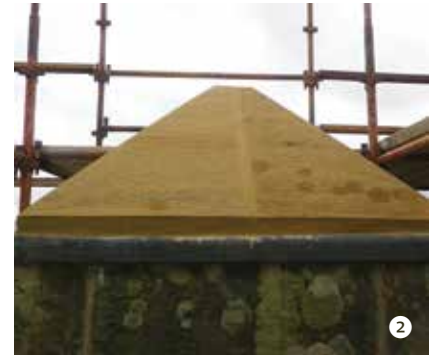
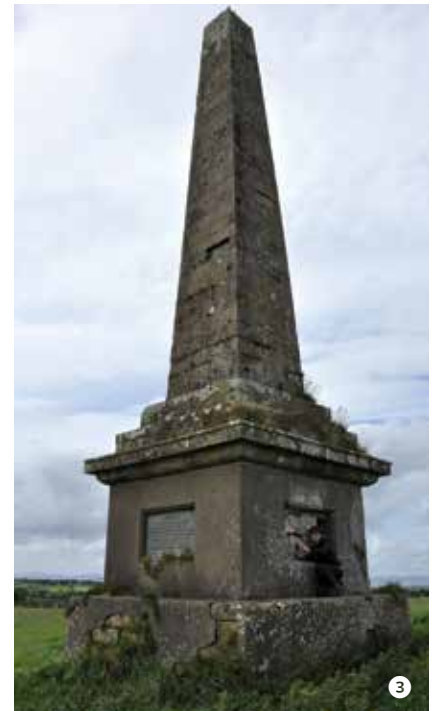
A number of stones were dislodged and the cement-based render was failing, characteristically pulling the face off the stone below. Finally, much of the original

moulded stone had mechanical damage where it had been keyed to allow the application of cement render. Enough moulding remained to allow the original profiles to be determined.

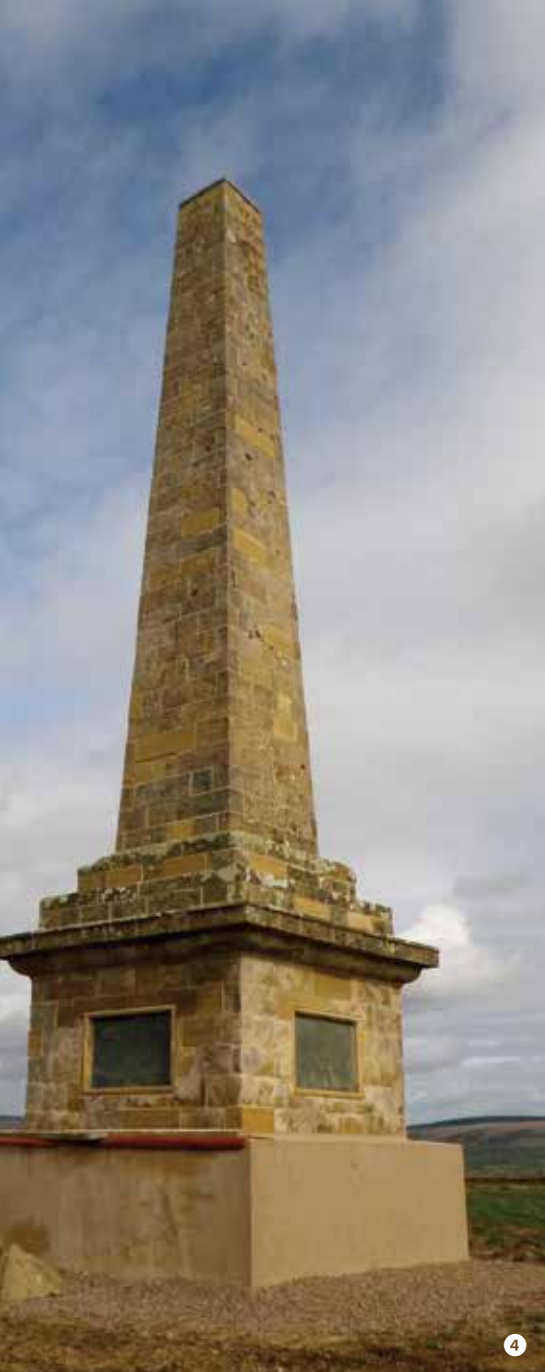
- 1 Second tier of obelisk with original ashlar covered in cement render; the latter had failed, resulting in failure of masonry as well
- 2 Replacement of obelisk's apex stone.
- 3 The obelisk as conservation work starts and 4 once complete with the former apex stone placed at the base of the steps

The apex stone was replaced due to its very poor condition, but has been retained at the base of the structure to allow visitors to see the original mason's mark found on its underside. The two missing slate plaques were remade using fragments of the original to create a template for the lettering style.
