**Enhancing the out-of-plane performance of masonry walls using
engineered cementitious composite**

S. Pourfalah*,
B. Suryanto,
D. Cotsovos

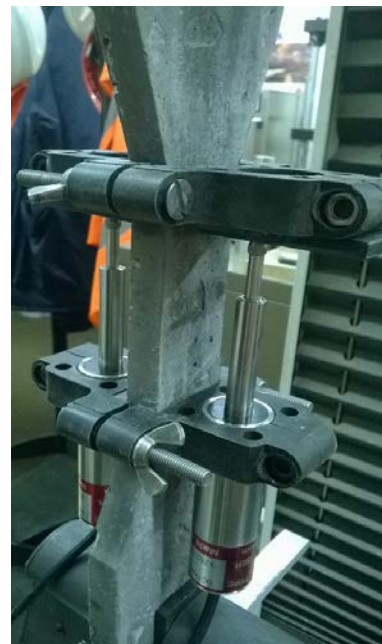
211 **Uniaxial tensile testing of ECC dog-bone specimens:** Ten dog-bone shaped specimens with
 212 dimensions in accordance to JSCE (2008) [34] (see Figure 4a) were prepared to study the
 213 ECC material behaviour under uniaxial tensile loading. The ECC binder comprised of CEM I
 214 52.5N Portland cement in accordance with BS EN197-1 [29] and fine fly-ash (Superpozz
 215 SV80, Scotash). These two components were mixed at fly-ash-to-cement ratio of 1.8 (by
 216 mass) and at water-to-binder ratio of 0.28. Fine silica sand with an average particle size of
 217 120 μm was used as the filler at a sand-to-cement ratio of 0.6 (by mass), together with a
 218 polycarboxylate high-range water-reducing admixture (at a dosage rate of 1% by the cement

219 weight) and 12mm long polyvinyl alcohol (PVA) fibres (at a dosage of 2% by volume). The
 220 PVA fibres had an average diameter of 39 μ m and a tensile strength of 1600MPa. They came
 221 with a proprietary oiling agent coating to reduce the fiber/matrix chemical bond strength,
 222 thereby enabling the ECC to achieve its desired properties. After fabrication, the specimens
 223 were cured in water for 28 days. Direct tensile testing was performed using a 100kN Instron
 224 testing machine, with each dog-bone specimen initially clamped on both ends. It was then
 225 subjected to uniaxial tensile loading to failure; five specimens were tested at a loading rate of
 226 1 mm/min (ST series) whereas five others at a rate of 400mm/min (ET series). LVDTs were
 227 mounted on each side of the dog-bone specimen to measure the elongation of the centre
 228 region throughout the loading process (see Figure 4(b)).

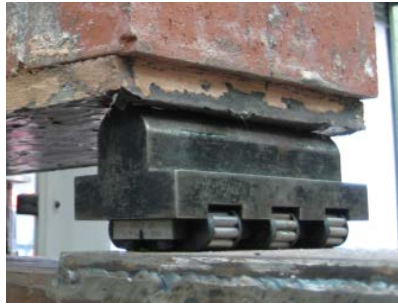
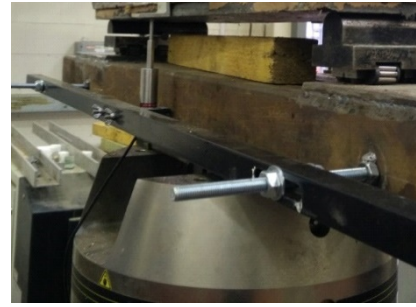
307 Figure 7. Four-point bending test setup a) Instron machine, b) Loading rig, supports and LVDT positions, c)
308 loading rig d) support e) LVDT holder

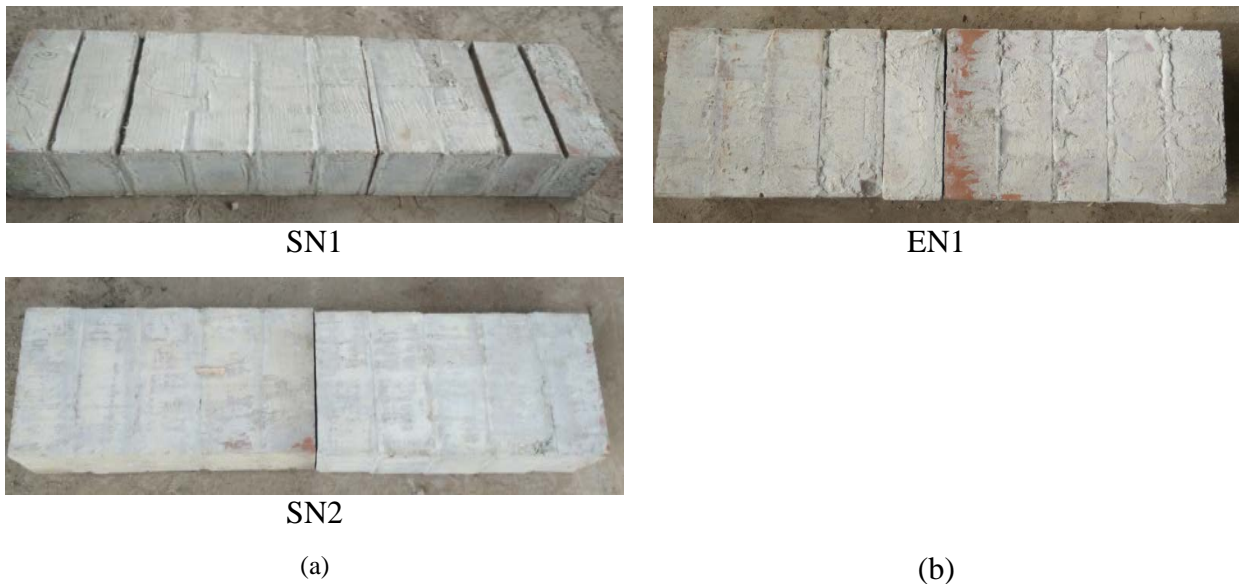
396 Figure 14. Crack patterns at failure exhibited by the un-strengthened specimens when subjected to loading rates
 397 of a) 1 mm/min and (b) 200 mm/min.

388 sudden (brittle) failure, resulting in a sudden loss of load-carrying capacity, with failure
 389 occurring shortly after the development of cracking along one of the brick/mortar interfaces
 390 at the central span of the specimen (i.e. between the two locations at which the external load
 391 was applied). The results highlight the vulnerability of the masonry beams when subjected to
 392 out-of-plane forces. The **state of the** specimens after failure is presented in Figure 14.

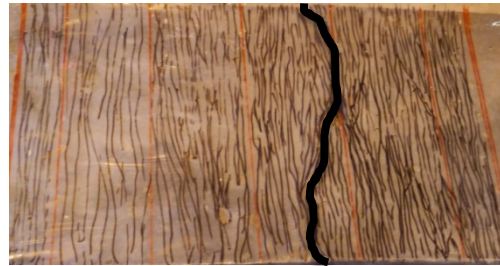
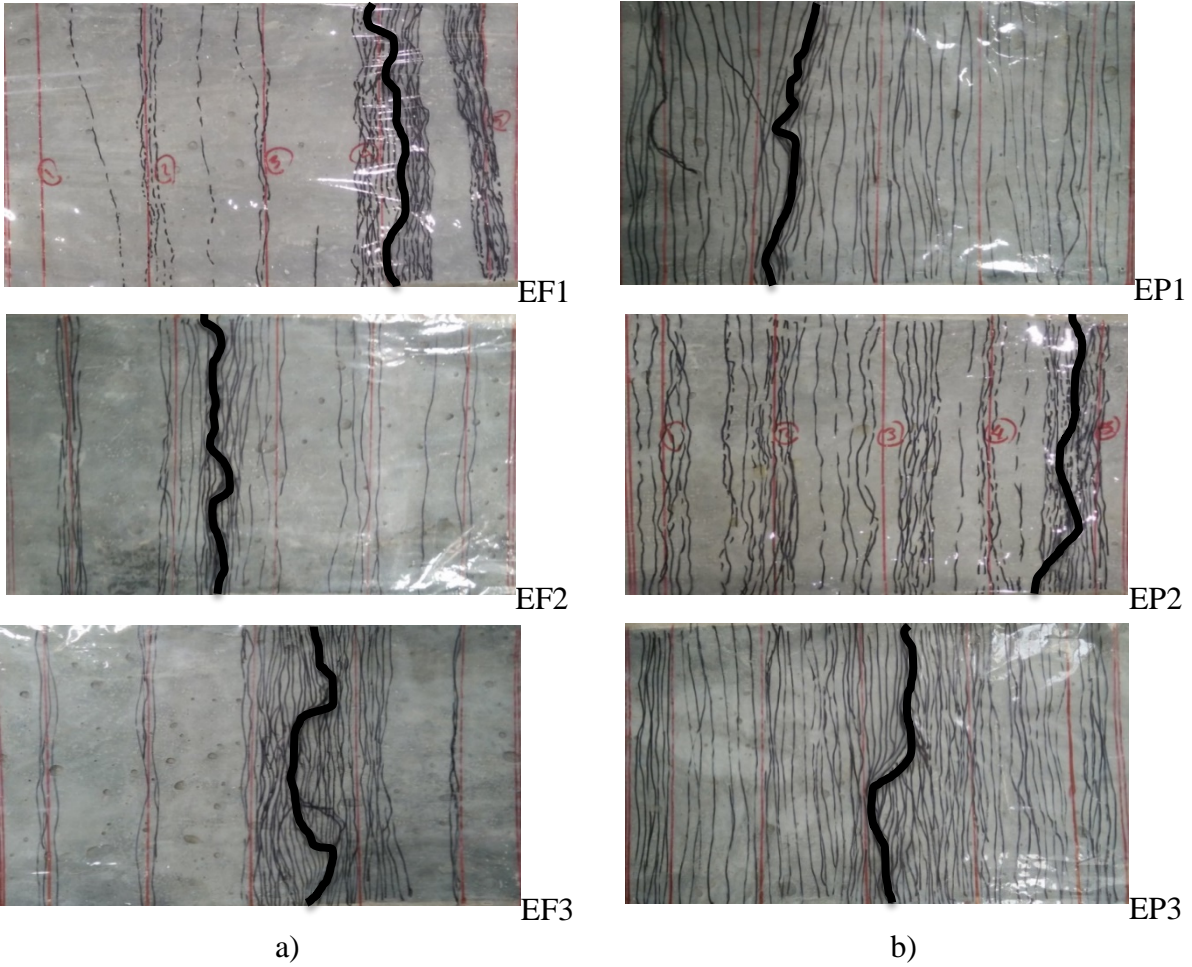
Figure 16: Failure crack pattern observed on the retrofitted ECC layer from the specimens: fully bonded series (SF and EF series), b) partially bonded series (SP, and EP series).

424 crack-initiation 23% higher than that of their counterparts (EP series). These trends are
425 similar to that observed in a lower rate of loading. With regards to the out-of-plane ductility,
426 the ductility of EF and EP series specimens was approximately 13 times and 37 times higher
427 than that of the un-strengthened specimens (EN series), with EP series specimens exhibiting
428 a mid-span deflection at failure 183% higher than that of EF series specimens (full bond).
429 The higher ductility exhibited by the EP specimens can be attributed to the formation of more
430 cracks along the central (un-bonded) span (see Figure 16).

436 Figures 16 presents the crack patterns observed from the soffit of all ECC-retrofitted
437 specimens after failure. In this figure, the black lines represent individual fine cracks while
438 the red lines represent the location of the brick/mortar interfaces. All specimens reinforced
439 with full-bond ECC layer (SF and EF series) exhibit microcracks forming locally around the
440 joints between the bricks, regardless of the rate of loading. It is seen that these microcracks
441 merge together, forming a larger crack that ultimately causes the ECC layer to fail, thereby
442 resulting in the collapse of the beam specimens. From the SP and EP series specimens (partial
443 bond), a more uniform crack formation can be seen from the central (unbonded) region
444 regardless of the position of the brick/mortar interface, with more crack numbers seen from
445 SP series specimens subjected to lower rate of loading. By comparing the crack patterns of

500 With reference to Figure 16, it is evident that the crack number is affected by the rate of
501 loading, with both SF and SP series specimens consistently showing less number of cracks to
502 those tested under higher rate of loading (EF and EP series). This can also be associated with
503 the strain rate dependent characteristics of the ECC as was observed earlier in the dog-bone
504 ECC specimens when subjected to different rates of loading. The development of fewer
505 cracks along the ECC layers of the strengthened specimens under increasing loading rates
506 provides the evidence to as why EF and EP specimens exhibited less ductility.

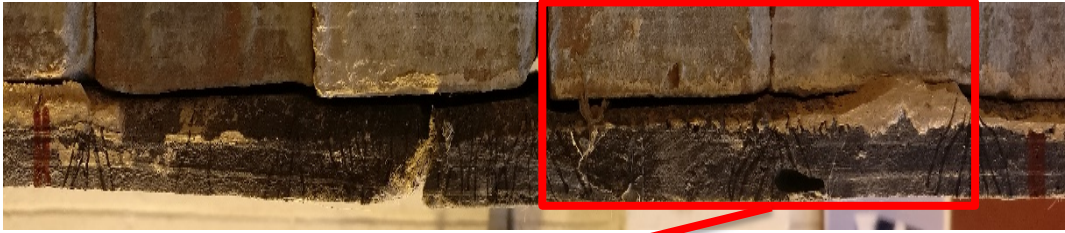
472 Figure 17 Comparison of the crack pattern distributed in the front face of ECC layer within the central span a)
 473 fully bonded b) partially bonded specimens.

450 With regards to the crack pattern across the thickness of the ECC layer, the cracks in both SF
451 and EF series specimens (full bond) tend to originate from the cracks initiated at the
452 brick/mortar interface, which was found to extend into the ECC layer, thereby resulting in the
453 development of radial cracking as shown in Figure 17(a). Considering that the thickness of
454 the ECC layer was approximately 15 mm and the maximum angle of the cracks was
455 approximately $\pm 45^\circ$ to the vertical, this gives 30 mm which is similar to the width of the
456 cracked region on the ECC layer below each brick/mortar cracked interface. On the other
457 hand, the cracks in SP and EP series specimens (partial bond), the cracks were more and less
458 vertical and perpendicular to the tensile stresses acting in the ECC layer (see Figure 17(b)).
459 The difference observed in the directionality of the cracks forming in the fully and partially

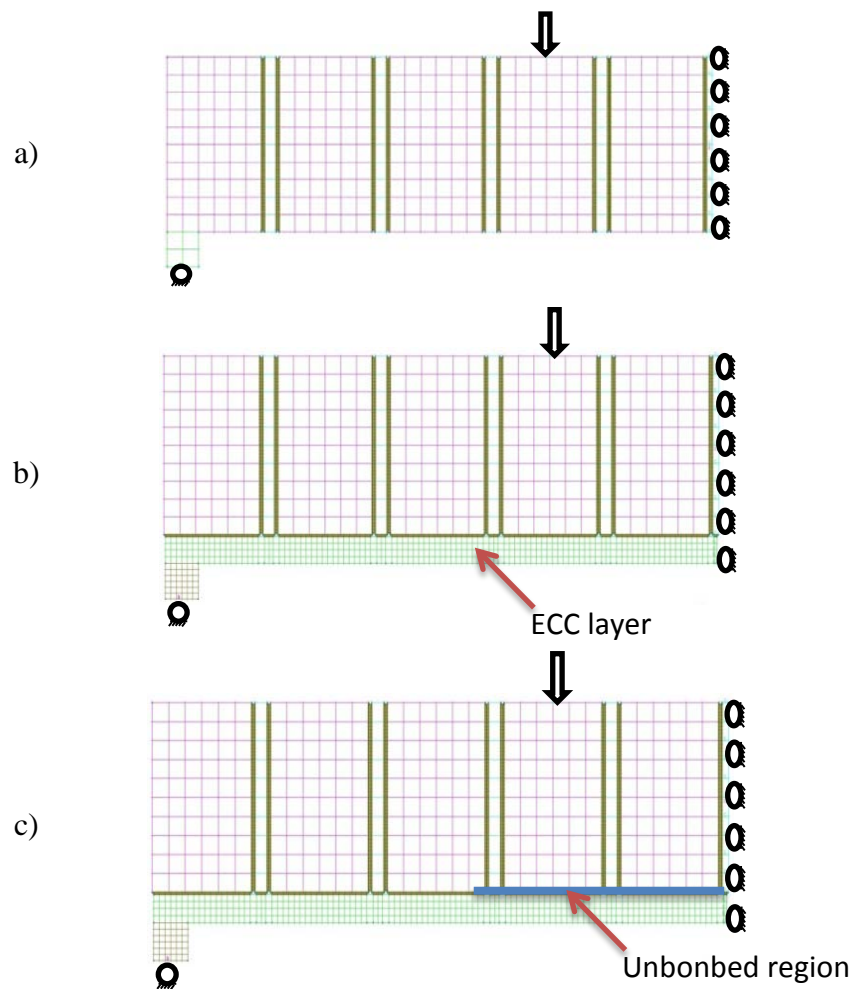
554 Figure 18 a) FE model developed for the a) SN specimens, b) FE model developed for the SF specimens
555 c) FE model developed for the SP specimens

533 Figure 18a presents the finite element (FE) model adopted for representing the non-retrofitted
534 masonry specimen (SN series). Due to the symmetry characterising the problem at hand only
535 half of the specimen was simulated. The FE model comprises of five bricks and five mortar
536 layers between the bricks. The size of the bricks was 102mm x 65mm. Each brick was
537 modelled by a 6 x 10 FE mesh. The thickness of mortar layer (joint) was 10mm except in the
538 case of the layer at the mid-span of the specimen which had a thickness of 5mm (due to the
539 symmetry conditions of specimen only half of the thickness of the middle mortar joint was
540 modelled). All mortar layers were modelled by a 1x10 FE mesh. Cohesive elements were
541 defined at the interface between the brick and the mortar layer based on the results presented
542 in Table 6. All nodes located on the face of the model at its right end (essentially representing

543 the mid-span region of the specimen) were restricted from moving axially. The specimen was
544 supported on a steel plate which was allowed to move axially and rotate along its mid-span
545 (forming a roller). A concentrated load (see figure 18a) was applied monotonically to failure
546 in the form of displacement increments.

547 The same model was used to investigate the behaviour of the strengthened specimens (see
548 Figure 18.b and c). A 15mm thick ECC layer was added to the lower face of the masonry
549 beam and was modelled using a 4x100 mesh of 4-noded 2D plain-strain elements. The ECC
550 layer was either considered fully bonded to the masonry surface or was assumed un-bonded
551 in the middle third span of the specimen (see the blue line in Figure 18c) by introducing a
552 contact surface between the ECC layer and the masonry specimen.

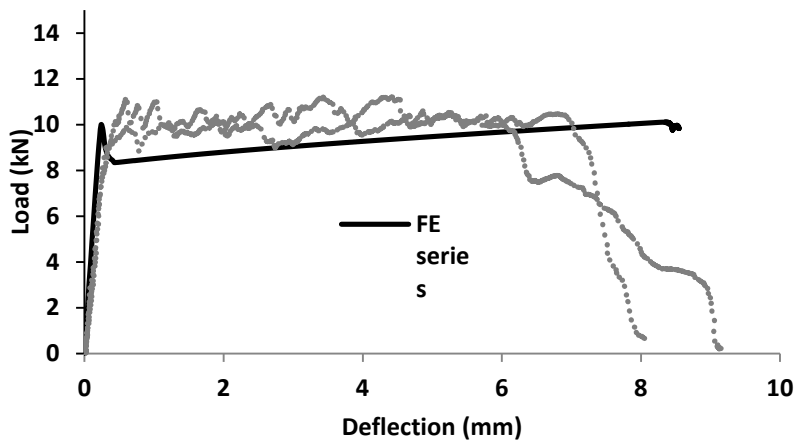
606 Figure 19. Comparison of numerically and experimentally established load-deflection curves describing the
 607 behaviour of a) the un-strengthened specimens (SN-series), b) the specimens strengthened with a
 608 fully bonded EEC layer (SF-series) and c) the specimens strengthened with a partially-bonded
 609 EEC layer (SP-series)

560 The predictions obtained from the un-strengthened specimens (SN-series) concerning the
561 load–deflection curves (see Figure 19.a) as well as the mode of failure (see Figure 20a) exhibit
562 similar trends with their experimentally established counterparts. However, the numerically
563 predicted load-bearing capacity is higher than that established experimentally. This difference
564 can be attributed to the variation of the material properties that often characterise masonry or
565 to the effect of imperfections associated with the manufacturing process of the subject
566 specimen that can have a significant effect on the behaviour of specimens characterised by
567 low load-carrying capacities and exhibiting brittle modes of failure as is the case for the un-
568 strengthened specimens presently considered. The mode of failure predicted numerically was
569 associated with failure along the cohesive interface (defined between the mortar and the

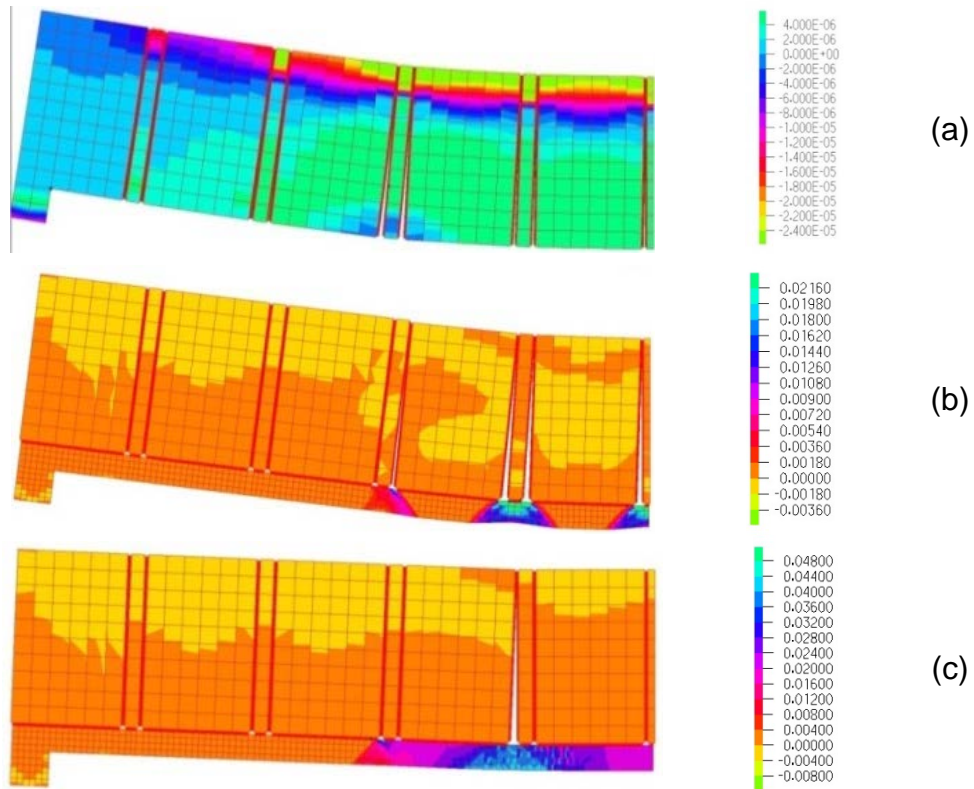
612 Figure 20. Predicted strain distribution at failure for the case of a) the un-strengthened specimens (SN-series),
 613 b) the specimens strengthened with a fully bonded ECC layer (SF-series) and c) the specimens
 614 strengthened with a partially-bonded ECC layer (SP-series)

570 brick) which was in line with what was observed experimentally (Figure 20a).

604 ECC layer and the collapse of the specimen (see Figure 20c). This is in line with the cracking
605 process observed during the test.
