CARDIOVASCULAR FLASHLIGHT

Transcatheter tricuspid valve-in-ring placement: complex valve obstruction by hypo-attenuating leaflet thickening, hypo-attenuation affecting motion, and native tricuspid valve remnant

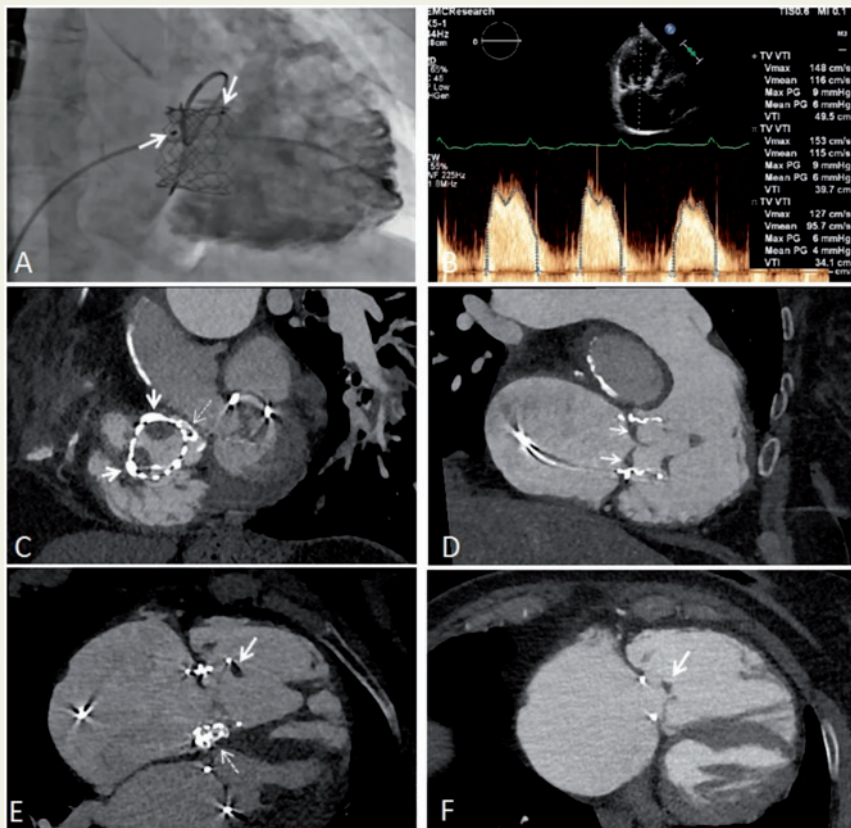
(Panel A) Fluoroscopic appearance of the SAPIEN valve during placement, while injecting the right ventricle with contrast. Note the markers of the AVP3 plug next to the valve (arrows). (Panel B) Transthoracic echocardiography showing elevated pressure gradient. (Panel C) Short-axis CT image of the SAPIEN valve in tricuspid position and the plug next to it showing HALT of two of the valve leaflets (arrows). The AVP3 plug is also depicted (dotted arrow). (Panel D) Long-axis CT image of the SAPIEN valve showing HALT of two of the leaflets (arrows). Also note the pacemaker lead, placed to treat total AV block, developed recently after the procedure. (Panel E) Four-chamber CT view showing the additional hypodense structure at the ventricular side of the stent, which is a remnant of the native tricuspid valve (arrow). The plug is also demonstrated (dotted arrow). (Panel F) Pre-operative axial CT showing the tricuspid ring with native tricuspid leaflet in the same position and with the same geometry as the additional hypodense structure (arrow).

She presented now with progressive dyspnoea, right ventricular failure, and severe tricuspid insufficiency. Because of the complex medical history, age, and poor clinical condition, a percutaneous procedure was preferred. After implantation of a SAPIEN valve, there was a moderate residual paravalvular leakage which was closed with an amplatzer vascular plug (AVP)3 plug (Panel A). Transthoracic echography, performed 2 days after surgery, showed an elevated pressure gradient (mean gradient 6 mmHg) across the tricuspid valve, indicating significant stenosis (Panel B). This was confirmed 6 months later (mean gradient 7 mmHg), followed by a cardiac computed tomography (CT) scan to determine the cause of the elevated gradient, using a dedicated dynamic heart valve protocol with reconstructions in 15 phases of the cardiac cycle. CT showed the SAPIEN valve in tricuspid position with the plug next to it (Panel C). There is thickening of two of the three valve leaflets with reduced leaflet mobility, suggesting hypo-attenuating leaflet thickening (HALT) with hypo-attenuation affecting motion (Panels C and D, [Supplementary material online, Video S1](#)). Furthermore, a remnant of the native tricuspid valve is identified as a hypodense structure at the ventricular side of the stent, also partially obstructing the stent outflow (Panels E and F, [Supplementary material online, Video S2](#)). After 6 weeks of intense oral anticoagulation therapy aiming for an international normalized ratio (INR) of 3, mean gradient across the SAPIEN valve dropped to 3 mmHg, suggesting leaflet thrombosis as the most probable cause of the leaflet thickening.
