Article

A New Procedure for an Effective Management of Geo-Hydrological Risks across the “Sentiero Verde-Azzurro” Trail, Cinque Terre National Park, Liguria (North-Western Italy)

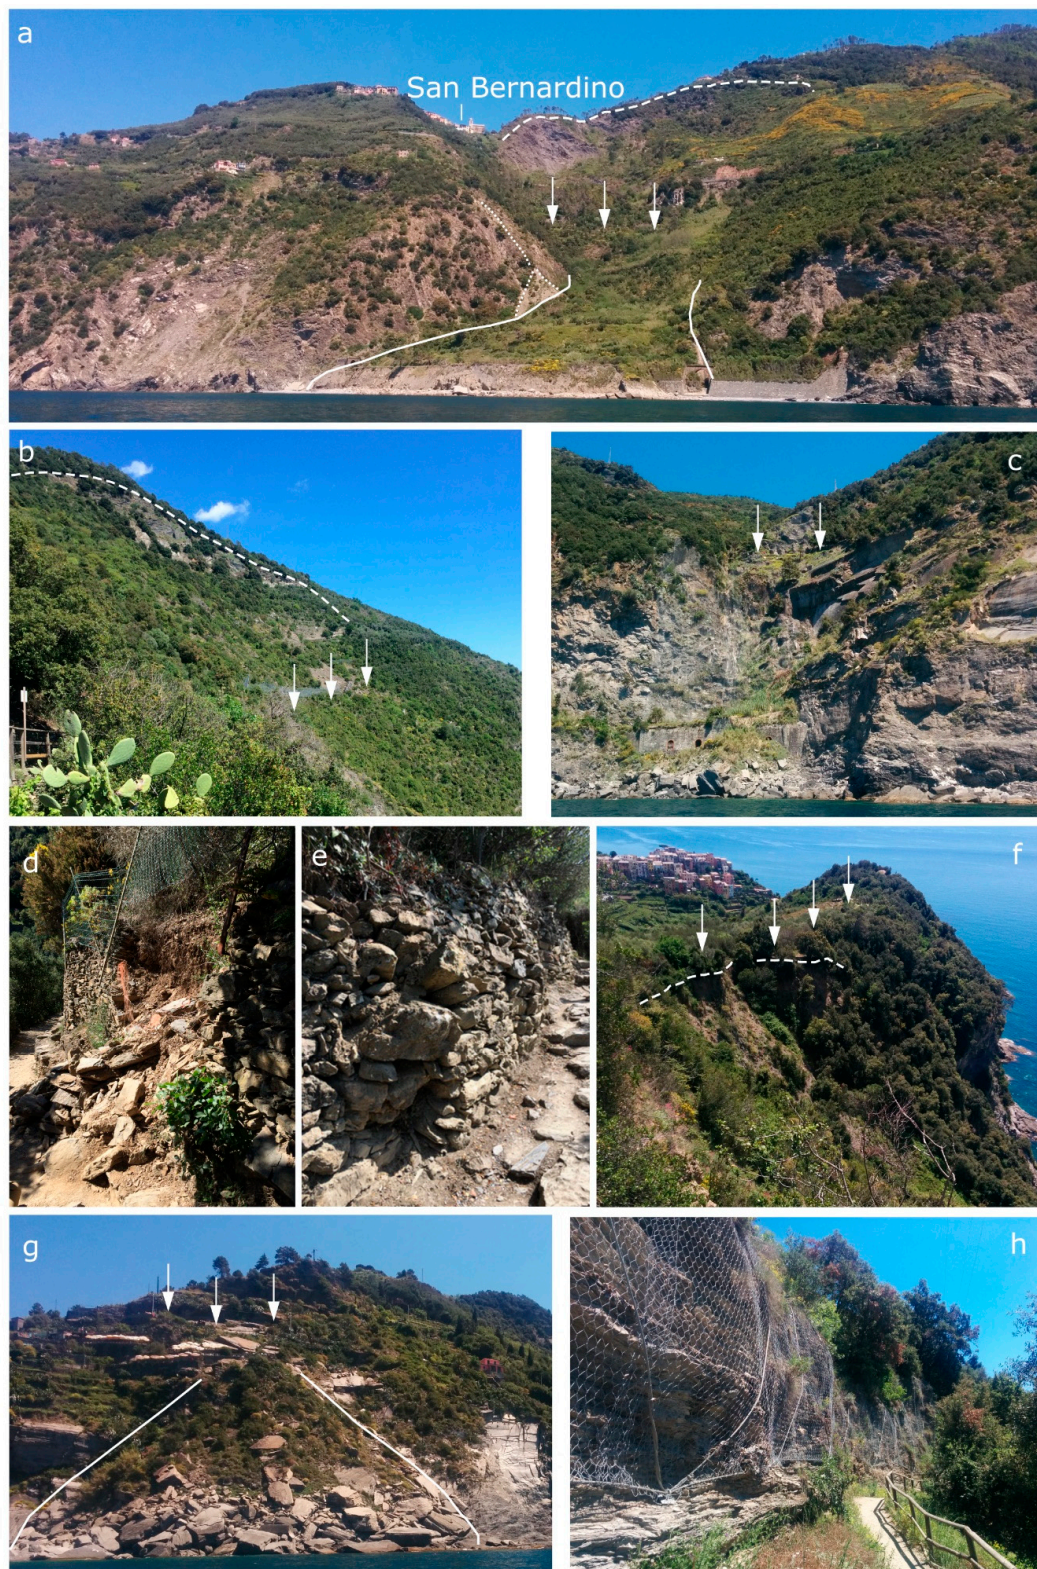
Figure 4. Main landslides and critical issues recognized along the “Sentiero Verde-Azzurro” trail: (a) Guvano landslide; (b) Macereto area; (c) rock sea cliff equipped with falling rock protections, Crovarla Valley; (d) local dry-stone wall collapse along the path; (e) visible dry-stone wall deformation along the SVA trail between Vernazza and Corniglia; (f) degradation scarp in correspondence of the Guvano beach, close to Corniglia; (g) rockslide close to Vernazza; and (h) local rock falls corresponding to the bedrock outcropping along the “Sentiero Verde-Azzurro” trail. White arrows indicate the path location.

Based on the historical data collection and field survey observations along the analysed SVA trail, eleven Operative Monographies have been compiled. These documents focus on the diverse critical issues recognized along the path related to geo-hydrological instabilities and their impact on the SVA trail (Table 1). Moreover, to obtain a comprehensive view of this peculiar landscape, all potential punctual criticalities along the track have also been considered. Therefore, local dry-stone wall collapses threatening path safety were also included (Figure 4d).

Moving on from Corniglia to Vernazza, the main landslides that intersect the SVA trail are: (i) the Guvano landslide, (ii) the Macereto area, and (iii) the Vernazza rockslide. The Guvano landslide is a complex landslide extending from San Bernardino hamlet (approximately 350 m a.s.l.) to the seaside (Figure 4a). The source area evolves into rock falls and topples, threatening the main road positioned just above the SVA track. This complex landslide then evolved into an earth flow, generating a large accumulation whose toe is exposed to the erosional activity of the sea waves and that in the past was stabilized by different protection measures. This landslide is monitored by a permanent network of GNSS stations and instrumented with five inclinometers derived from a past geotechnical investigation performed in 2003–2004 [32,41].

The Macereto area corresponds to a wide slope sector with widespread rock falls and other geo-hydrological instabilities, mainly due to drainage network failure (Figure 4b). Almost the entire area is equipped with massive rock fall defences and barriers along the path. In the western portion, defined as the “Gerai area”, an important engraved channel threatens the dry-stone wall built upstream of the trail to protect it (Figure 4e). The Vernazza rockslide took place in the upstream portion of the trail, actually equipped by rivets, while the landslide body, made up of large rock blocks, extends up to the shoreline (Figure 4g). Numerous rock falls, degradation scarps and engraved channels associated with debris cones are observed along the entire path, both in the upstream and downstream sectors (Figure 4c,h). The impressive degradation scarps, which are mainly located just downstream of the trail and threaten the road, correspond to the “Prevo area”, a small hamlet between Corniglia and Vernazza, defined as the “Massolina area” on the right side of the Guvano landslide, as well as in correspondence of the Guvano beach area (Figure 4f).

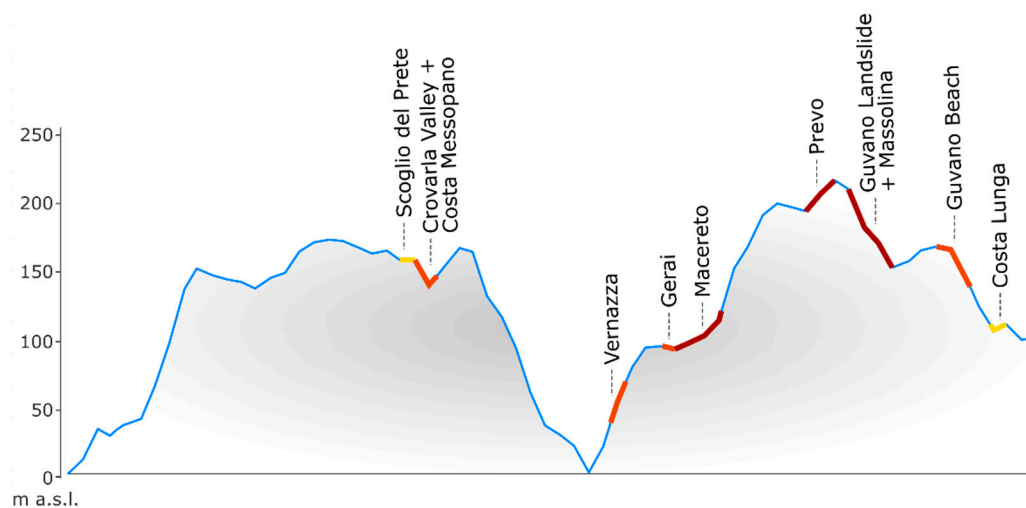
Figure 5. Sketch of the “Sentiero Verde-Azzurro” trail profile characterized on the basis of the degree of hazard with respect to the recognized geo-hydrological instabilities described in the OMs: high interference in red, medium degree in orange, and low degree in yellow.

For each document, a brief form has been reported to identify a distinct phenomenon or critical issue, indicating the general information about the geographic location, type of phenomenon, and state of activity. Then, an analysis of previous data, including scientific papers, technical reports and eventual map annexes, has been carried out, dividing the collected information into three sub-sections: i. photographic evidence, ii. geological and geomorphological settings and iii. available data analysis. Significant importance has been given to the degree of interference between the recognized geo-hydrological instabilities and the SVA trail. By reference to the eleven critical issues recognized and analysed in the OMs, the SVA trail has been divided on the basis of the degree of potential risk, considering high, medium and low interferences between the geo-hydrological instability and the path (Figure 5).

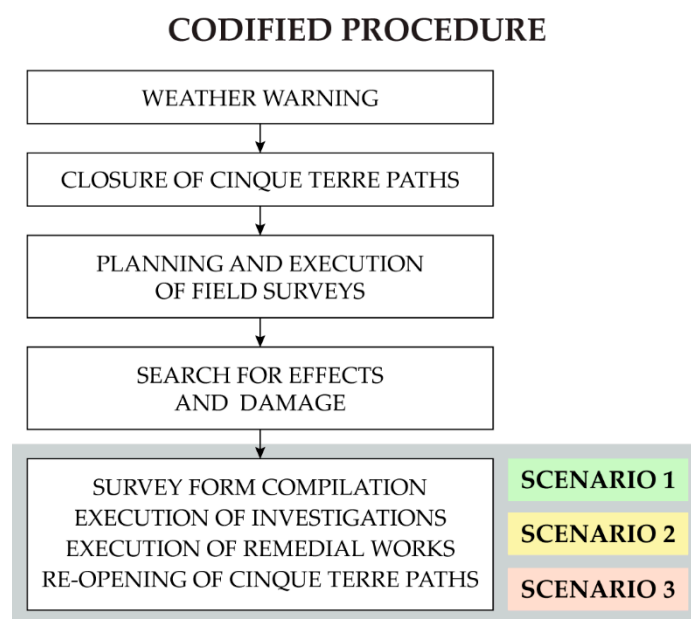
Figure 7. Codified procedure proposed for the Cinque Terre National Park administration after a weather warning occurrence.

Figure 7 shows the structure of the proposed codified procedure. The weather alert follows the meteorological and hydrological forecasting and warning procedures adopted by the Liguria Region [49], based on the 27 February 2004 Directive of the Italian President of the Council of Ministers of “Guidelines for the organizational and functional management of national and regional warning system for hydraulic and geo-hydrological risks for Civil Protection purposes”. At the regional scale, five alert zones defined on the basis of physiographic aspects, both topological (i.e., catchment extent) and meteorological criteria were established by the Italian National Civil Protection Department with respect to the level of hazard in terms of floods and landslides. A total of four alert levels have been defined, following a “traffic-light” code. In a meteorological and hydrological “state of alert” when “orange” or “red” alert levels are being issued, the SVA path closure is planned.

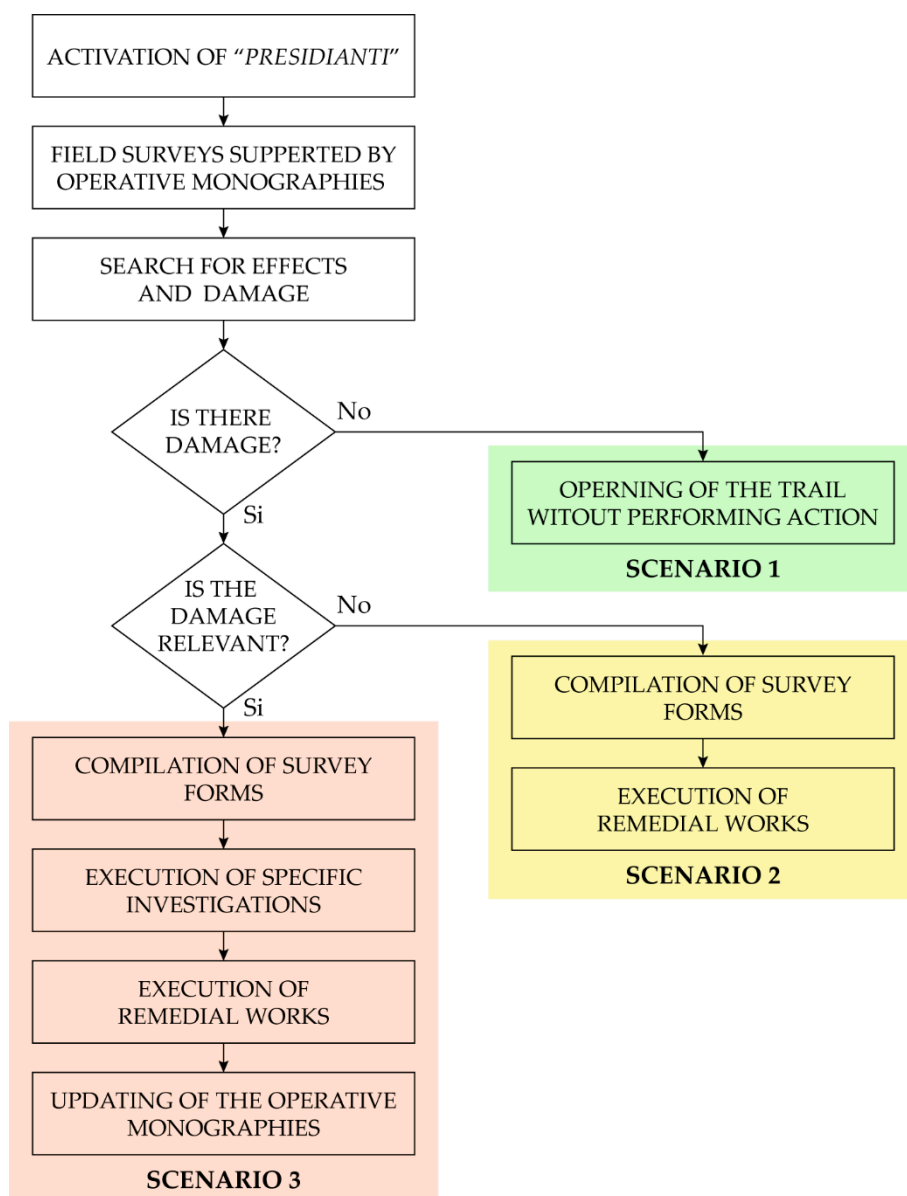
Figure 8. Structure of the codified procedure for different Scenarios.

Starting from the path closure up to the SF compilation and transmission to the Park authority, three possible scenarios may occur, on the basis of the level of damage and effects that occurred after the weather alert. Figure 7 shows the first scenario, which arises when no damage or effects occur. After the “Presidianti” involvement by the Park authority, the field survey supported by the OMs is planned. Scenario 1 (Figure 8) is applied when no difference with respect to the previous setting takes place, and any new or reactivated geo-hydrological instabilities occur. In this scenario, the “Presidianti” state the absence of critical issues to the Cinque Terre Park administrators, hence the absence of SF drafting, by concluding their survey.

Scenario 2 (Figure 8) is planned in cases of limited damage, and effects are observed during field surveys. For instance, a minor damage condition can be represented, for example, by trees falling down or by small stones located along the path (Figure 9a–c). In those cases, an SF is filled in for each critical issue observed. Subsequently, all the compiled SFs are transferred to the Cinque Terre Park authority and commensurate remedial works are planned and executed before the reopening of the trail.

Scenario 3 (Figure 8) considers the possibility that the meteorological event could cause relevant damage. Rainfall-induced landslides, runoff and erosion processes are the most common effects that could occur. In this case, the “Presidiante” fills in an SF for each geo-hydrological instability identified, considering both first activated or re-activated instabilities, that partially or totally involve the surface path. A focus has also been dedicated to local damage to the dry-stone walls that could collapse involving the path surface (Figure 9d). Even in this case, the first identification of the critical condition is based on the completion of the SFs and a consequent report to the Cinque Terre Park authority that will activate the procedure for the implementation of remedial works. It should be noted that if the geo-hydrological phenomenon, already described in the OM in this area, is reactivated during the most recent meteorological event, at the end of the procedure, the update of the dedicated OM is mandatory to guarantee a correct description of known geo-hydrological instabilities. Moreover, if a new and relevant geo-hydrological phenomenon has been identified during the dedicated field survey, a new OM can be drafted to constantly update a standardized document and the overall state-of-the-art of the study area.

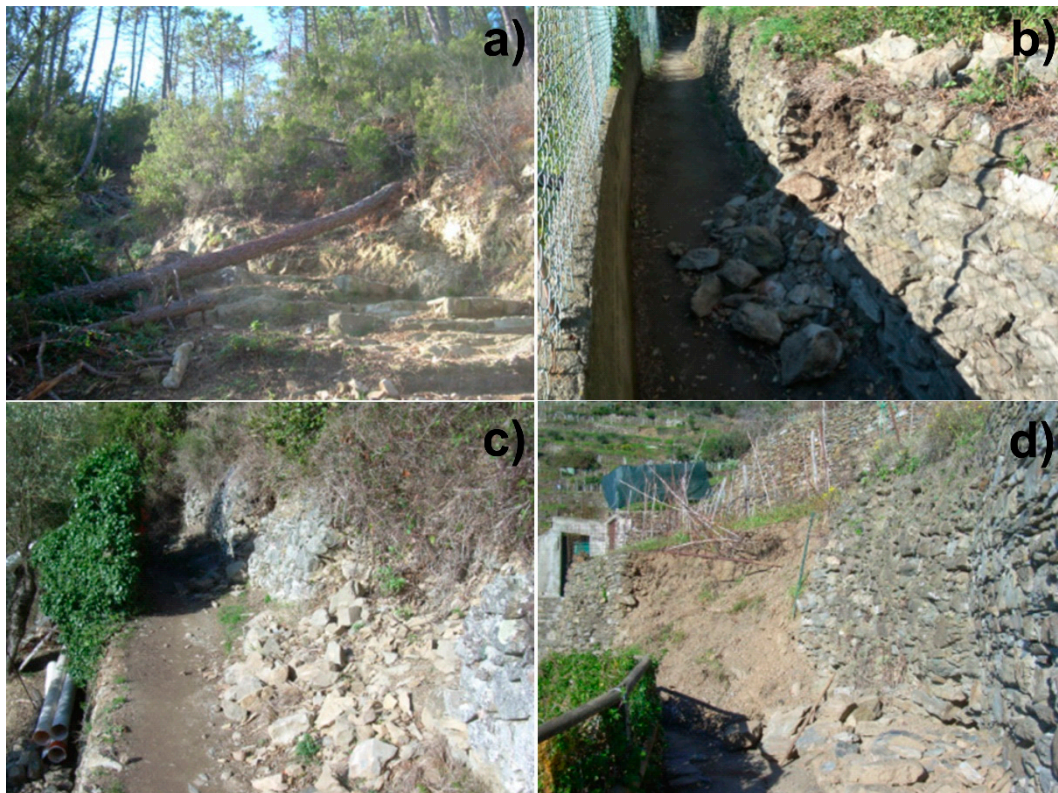
Figure 9. Examples of damage and/or rainfall-induced effects recorded using survey forms after a weather alert: (a) trees fall down; (b,c) small dry-stone wall collapses; and (d) dry-stone wall failure causing a local path interruption.
