## The Investigation Of Okhissa Dam Using A Real-Time Monitoring System

THE INVESTIGATION OF OKHISSA DAM USING A REAL-TIME MONITORING  
SYSTEM

A Thesis  
Presented in partial fulfillment of requirements  
For the degree of Master of Science  
In the Department of Civil Engineering  
The University of Mississippi

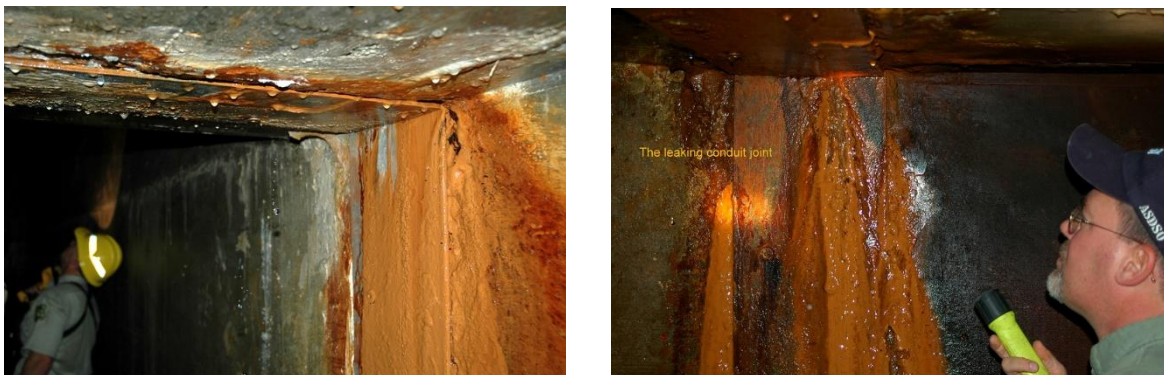
**Figure 2.5:** Box conduit inspection (Bingham, 2014).

The Okhissa Dam project sat unattended, empty and overgrown with weeds for nearly five years until the project was rebid with the intent to complete. Inspections were performed before construction resumed on the Okhissa Project. The inspections detected joint separation within the inlet box and based on the dams' review, the stability of the dam was in question. The recommendations to rectify the inlet box included additional soil borings to check the stability of the foundation and embankment and develop a suitable monitoring plan to include instrumentation. (Millete, 2003). The NRCS conducted an extensive evaluation and inspection, revealing hairline cracks and differential displacement between the joints as shown in Figure 2.5. Upon inspection it was determined the box sections were structurally designed to carry all applied soil and water loads, and there was no concern for structural failure.

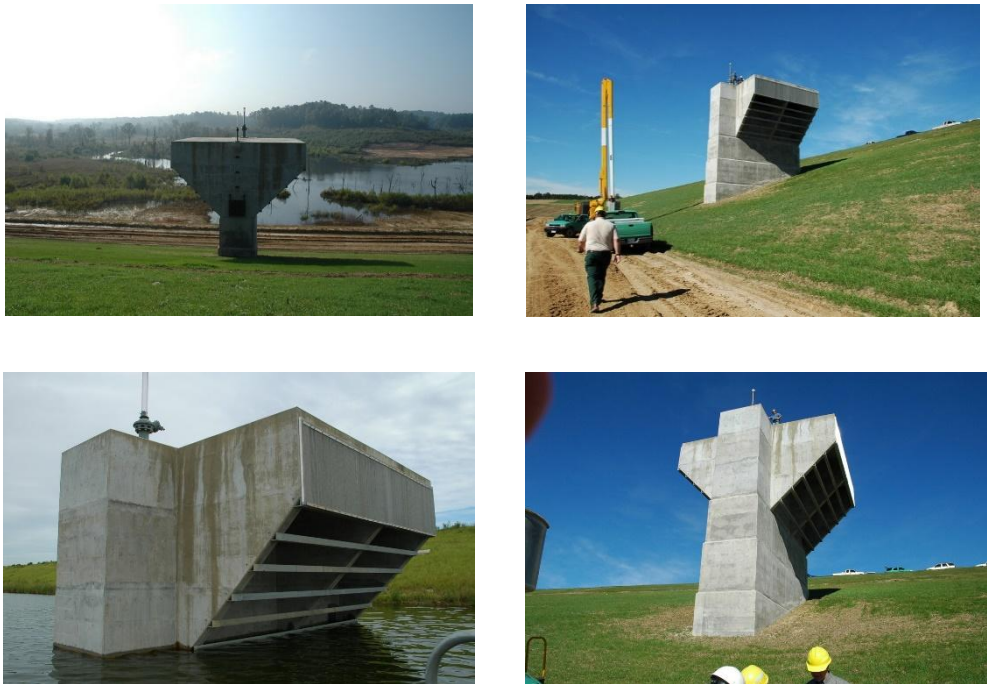
**Figure 2.6:** Final concrete box conduit (Bingham, 2014).

The completed principle spillway inlet conduit is shown in Figure 2.6. Okhissa Dam's cost for the Okhissa Lake recreation project was estimated to be \$34 million. Okhissa Lake opened to the public on November 7, 2007 and was deemed a Bill Dance Signature Lake (Picayune Item, 2007). Unfortunately, the promise of cabins and a resort has not come to fruition for Okhissa Lake. The fishing for Okhissa Lake has continued to be promising, but the hope for this location to be a vacation destination to aid economic growth in this area has not occurred. A timeline of significant occurrences is provided in Figure 2.7.

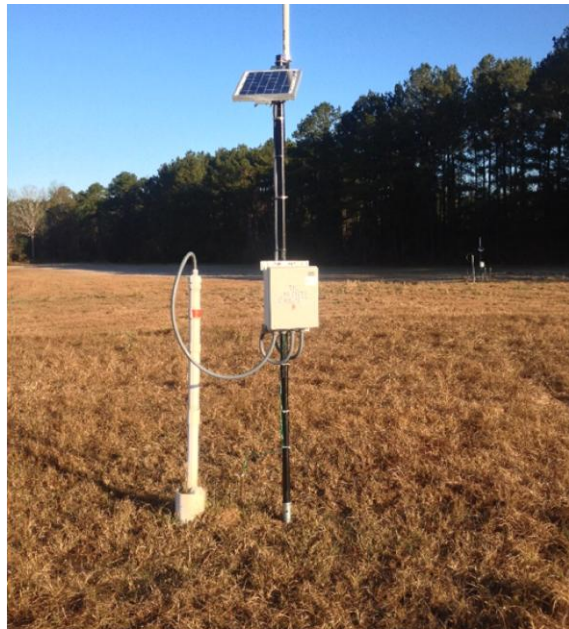
**Figure 3.3:** Well instrumentation at Okhissa Lake.

The vented vibrating wire piezometers are installed in the existing two inch Casagrande standpipe piezometers at Okhissa Dam. The vibrating wire piezometers are not grouted or sealed within the standpipe piezometers, as they are property of the NRCS. Sealing the vibrating wire piezometers would make the Okhissa Dam monitoring system a permanent installation, and the goal of the project is to establish a wireless portable system. The vibrating wire piezometer porous filter tip is removed and filled with water to saturate the instrument prior to placing the sensor down the standpipe well. The “used” sensor cable is measured in order to subtract that length from the standpipe riser elevation to obtain a piezometric water elevation with respect to MSL. Before the sensors are lowered, a zero reading is first established by calibrating the sensor at zero pressure to obtain an initial digits and temperature reading. The vented vibrating wire piezometers include a desiccant chamber that has a screw type seal that is removed before the sensor is put into service (Geokon, 2011). The sensors are lowered to an elevation approximately two feet above the screen of the standpipe piezometer to prevent any influence of organics and soil that may affect the accuracy of sensor measurements. The remaining cable that connects to the data acquisition box at each well is run through PVC conduit to protect the sensor signal cable. Figure 3.2 shows a cross-section of the vibrating wire piezometer standpipe installation. A photograph of an instrumented well at the Okhissa Lake site is seen in Figure 3.3.

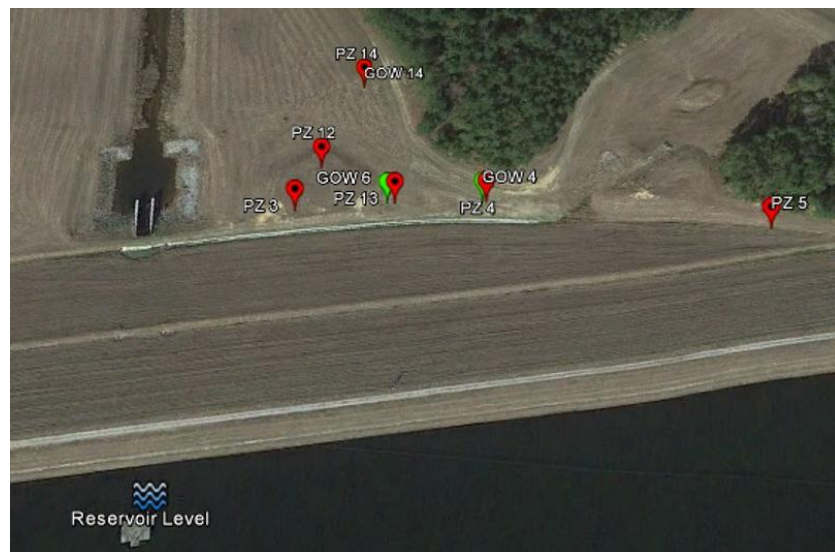
**Figure 3.4:** Sensor node locations at Okhissa Lake (Google Earth, 2012®)

The vibrating wire piezometers' filter tip is removed and filled with water, and the “used” sensor cable is measured to obtain a water level value as it relates to MSL. A zero reading is established for the reservoir vibrating wire piezometer and it was lowered down the PVC casing. Next, the installed vibrating wire piezometers are connected to the spectrum analyzers to be read on programmed intervals, continuously monitoring piezometer levels. Figure 3.4 shows an image of the sensor locations at Okhissa Lake.

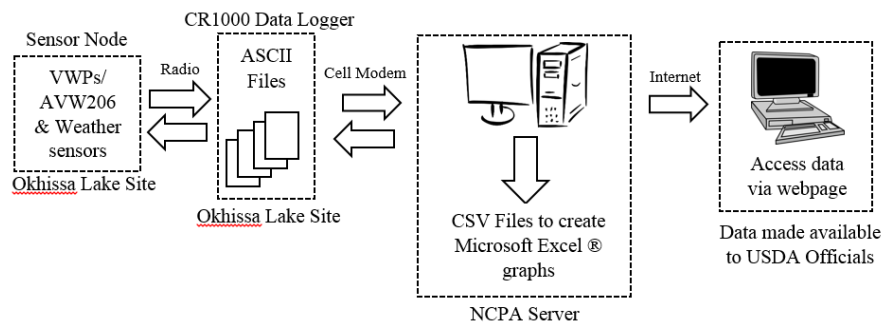
**Figure 3.7:** Communication and the flow of data collection.

The collected monitoring data from Okhissa Dam is immediately available on its designated webpage, <http://ncpa.olemiss.edu/okhissa-lake-dam-monitoring-system/>. The data files containing the raw and processed data are made available to the USDA officials at their request. The data files are stored in a .csv format to create time history and correlation plots using Microsoft Excel®. A summary of the data and communication flow from the Okhissa Dam site to the webpage is provided in Figure 3.7.

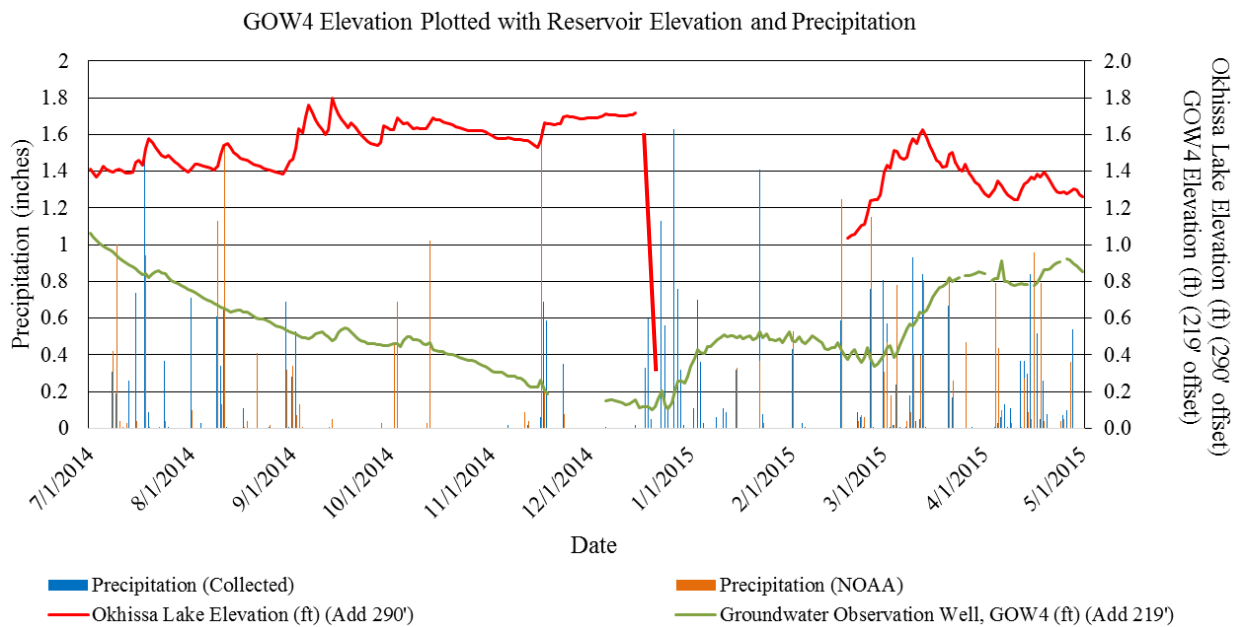
**Figure 4.8:** Reservoir and piezometer (GOW4) water levels with daily precipitation.

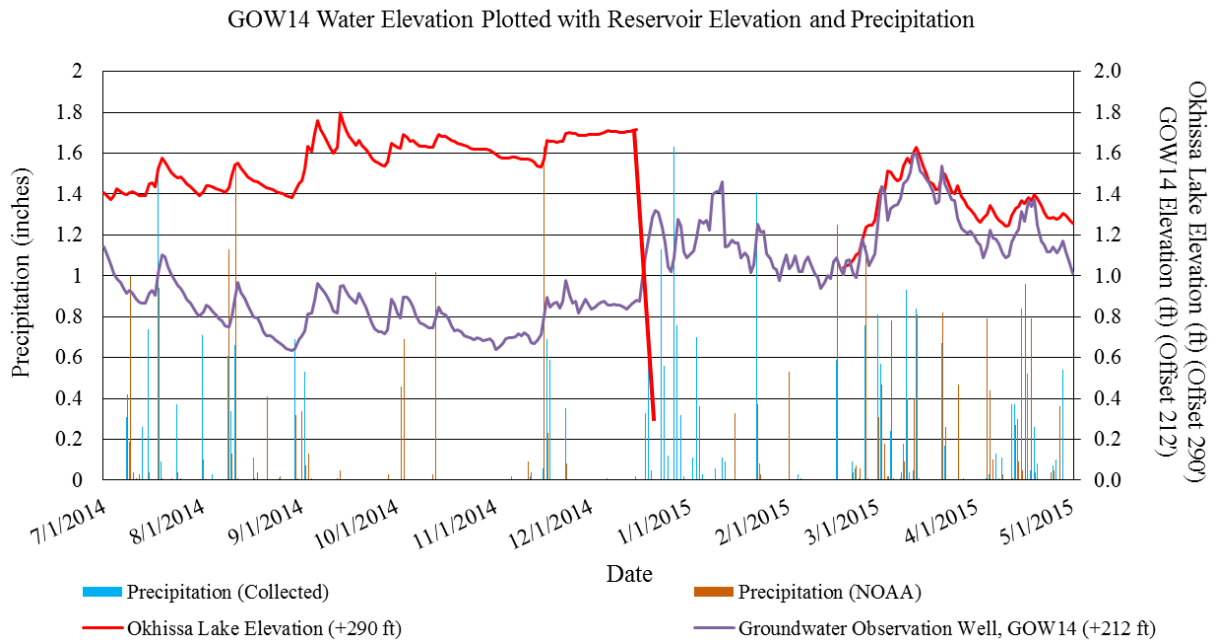
**Figure 4.9:** Reservoir and piezometer (GOW14) water levels with daily precipitation.

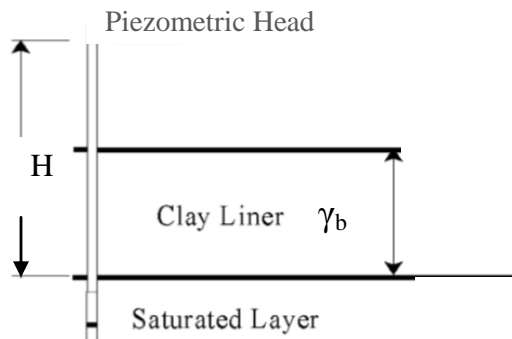
**Figure 4.30:** Piezometric cross section with input labels.

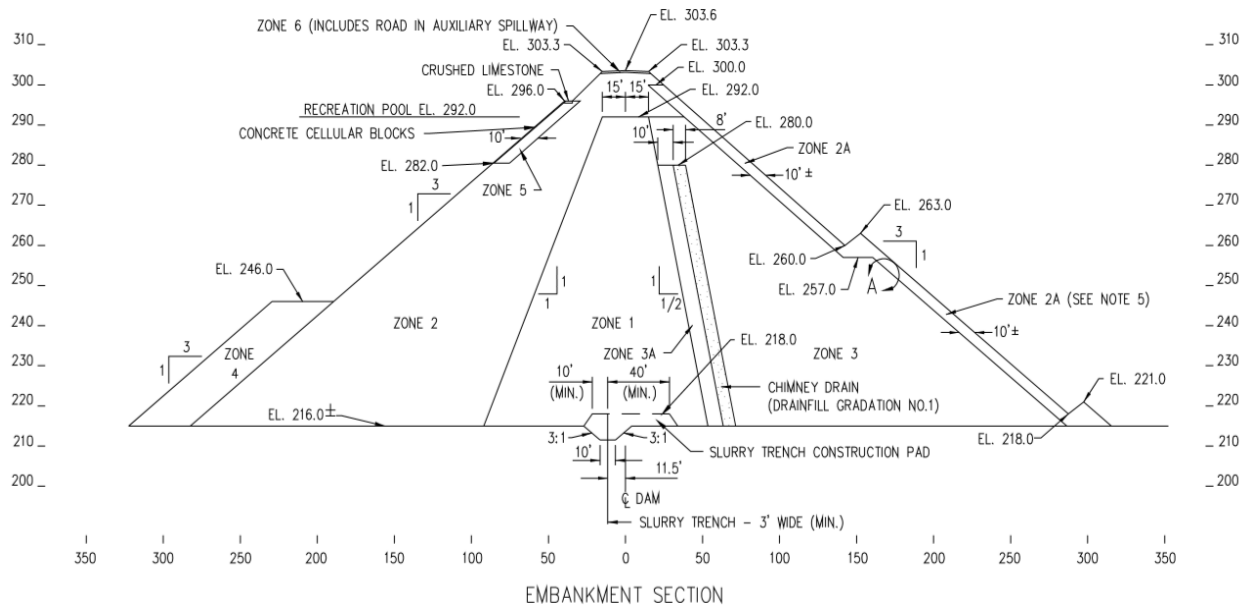
**Figure 4.32:** Okhissa Dam cross-section design drawing (Spencer Engineers, 1999)

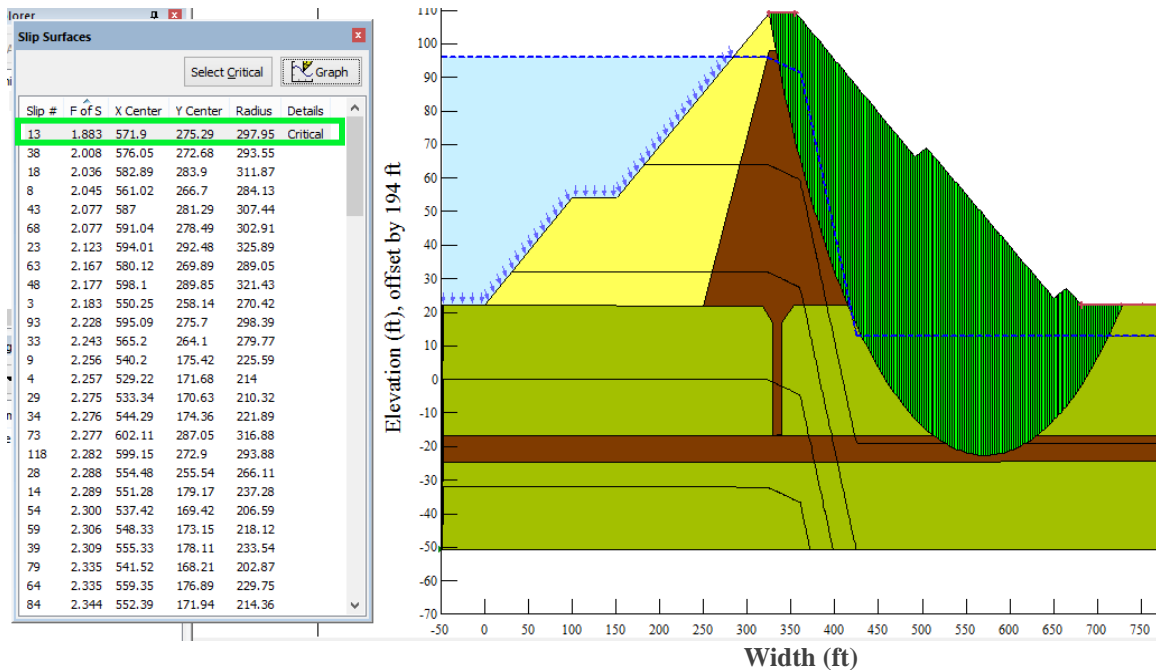
**Figure 4.35:** Downstream slope stability analysis (GeoStudio, Slope/W®).

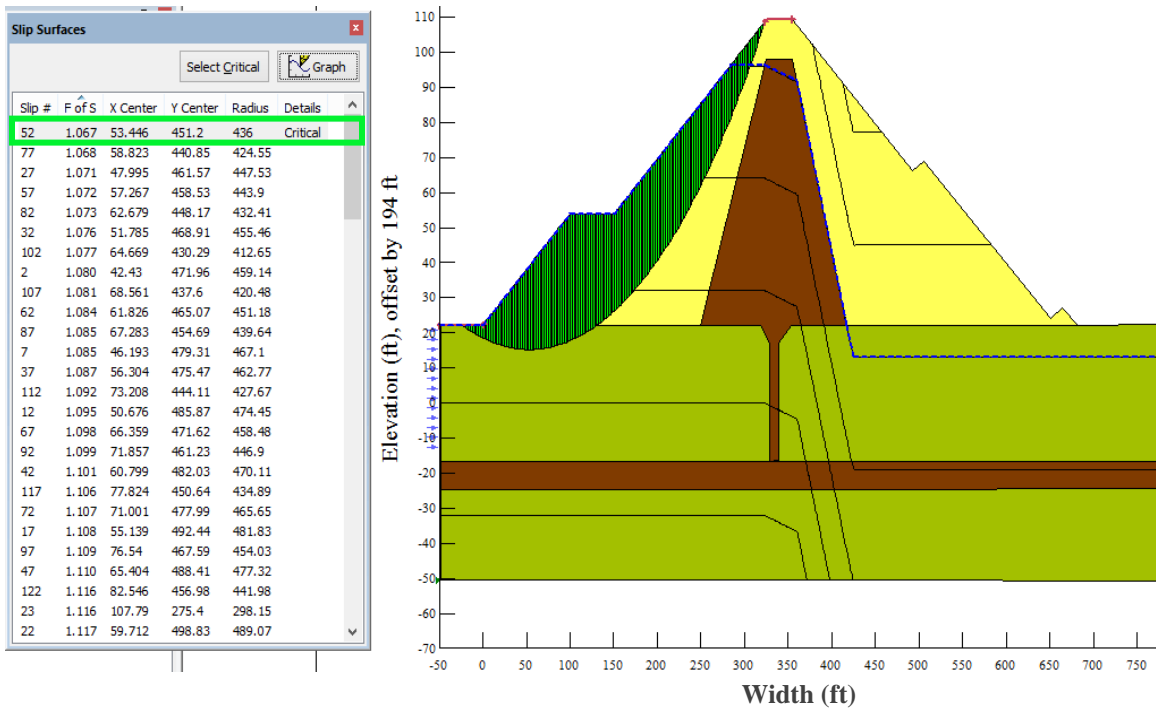
**Figure 4.37:** Upstream slope stability analysis (GeoStudio 2012, Slope/W®).
