Oxidation and degradation of polyethylene cups in hip joint prostheses

Summary — The properties of polyethylene cups of hip prostheses produced by Johnson & Johnson Orthopaedics, De Puy International Ltd. (Great Britain) and Aesculap AG & Co. KG (Tuttlingen, Germany), removed after various times of implantation due to their premature wearing out, were compared by means of the analysis of FT-IR spectra and determination of the hardness and viability of macrophages and osteoblasts. The oxidation of polyethylene was found to be a main reason of Aesculap cups' damages.

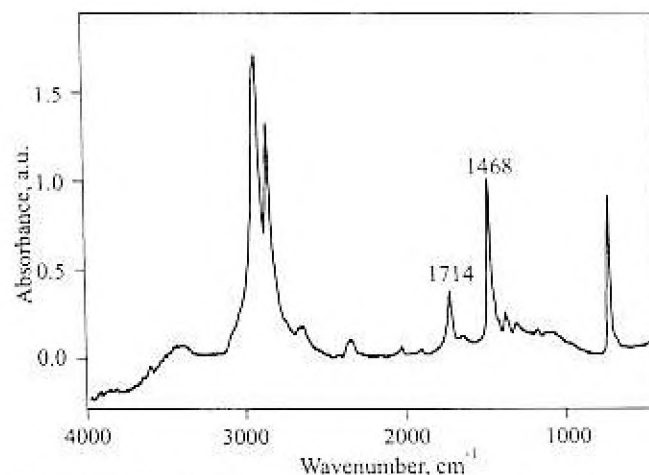
The analysis of FT-IR spectra of PE samples shows that the material taken from the new, unused *C_{AE}* cup does not show any oxidation, but all this type samples originating from the exploited cups (the time of implantation ranging from 4 months to 12 years) are highly oxidized (Fig. 1).

Fig. 1. FT-IR spectrum of *C_{AE}* sample exploited 4 months

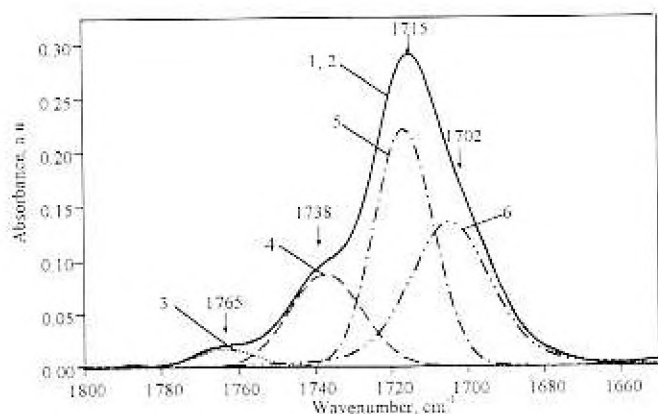
Figure 2 shows the absorption of the carbonyl band — experimental as well as 4 Gaussian-Lorentzian sub-bands. The carbonyl band is complex thus it seemed reasonable to resolve it into sub-bands, taking into account

Fig. 2. FT-IR spectra of C_{AE} sample exploited 4 months (see Fig. 1b): 1 — experimental spectrum, 2 — calculated spectrum, 3 — ester band, 4 — aldehyde band, 5 — ketone band, 6 — acidic band. Experimental data and spectrum calculated as a superposition of 4 sub-bands

the literature data referring to the frequencies of C=O groups in oxidized polyethylene: carboxylic ($1692\text{--}1702\text{ cm}^{-1}$), ketonic ($1715\text{--}1718\text{ cm}^{-1}$), aldehydic ($1735\text{--}1741\text{ cm}^{-1}$) and esteric ($1760\text{--}1767\text{ cm}^{-1}$) [12]. The sub-bands were integrated and then summed up which allowed to obtain the calculated absorption profile, almost identical with the experimental spectrum (spectra 1 and 2).

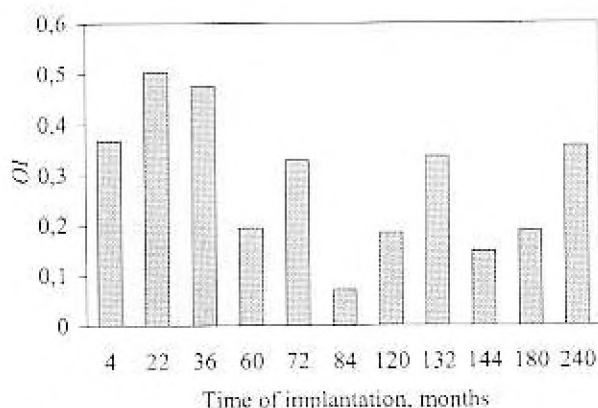
The oxidation index (OI) was defined as the ratio of the integral intensity of C=O band and the integral intensity of the reference band with the maximum at 1468 cm^{-1} (attributed to scissors vibrations of CH_2 group). The values of OI of the cups exploited during various periods of time are shown in Fig. 3. There is no time correlation of OI which can be understood if one takes into

Fig. 3. Oxidation index (OI) of PE samples extracted from C_{AE} samples exploited various periods of time

account the fact that the deterioration of cups certainly depends on many factors including individual features of a patient, e.g. age, weight, physical mobility.

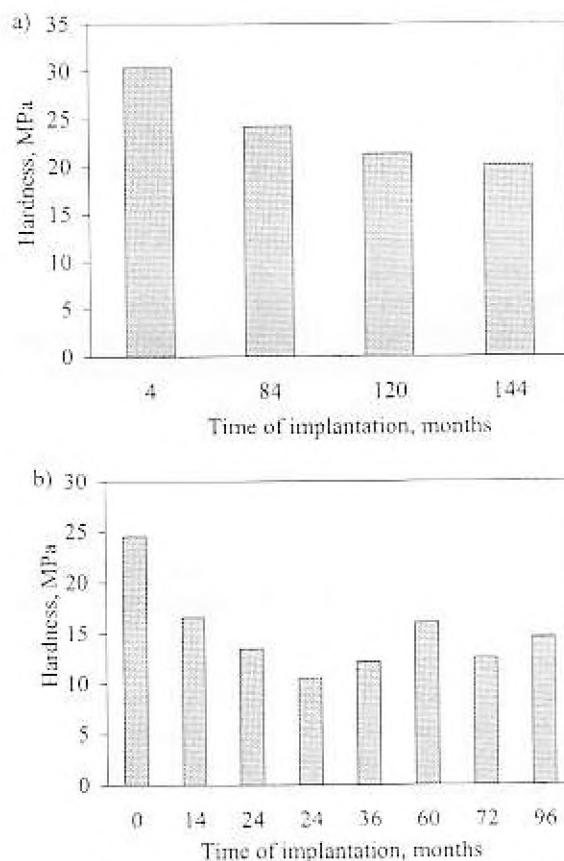
Hardness tests of the cups performed for both types of prostheses showed the decrease in hardness with the increasing exploitation time (see Fig. 4).

Fig. 4. The dependence of hardness on the time of implantation PE samples: a) C_{AE} , b) C_{II}
