Exploring the influence of vegetation cover, sediment storage capacity and channel dimensions on stone check dam conditions and effectiveness in a large regulated river in México

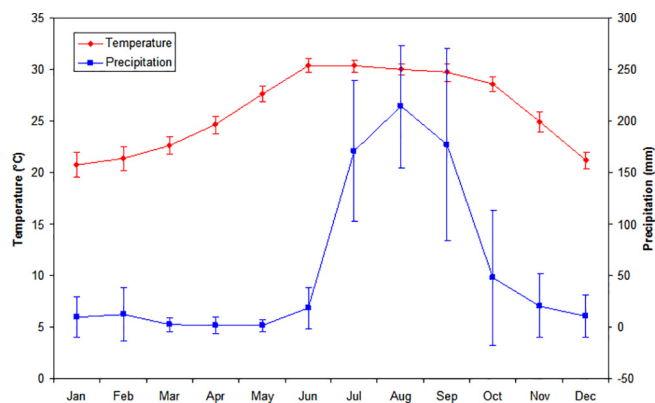
Fig. 2. Annual trends (mean \pm std. dev.) of precipitation and mean temperature measured at the meteorological station of Culiacán in the period 1995–2015.

This study was conducted in the Culiacán watershed in the state of Sinaloa, north-western Mexico (latitude 24.867346°N, longitude -107.181013°W) (Fig. 1). The watershed, which covers 10,368 km², drains into the Sinaloa reservoir at an elevation of 128 m after running 25.3 km from the headwater. Topography ranges from mountains to lower lying hilly areas and plains. Average annual precipitation is 860 mm, mostly occurring, together with the resulting surface runoff, during July, August and September; winters are generally milder and in this season rainfall is less intense. Mean annual temperatures are in the range 24–26 °C. Fig. 2 reports the annual trends of precipitation and mean temperature measured at the Culiacán meteorological station during the period 1995–2015.

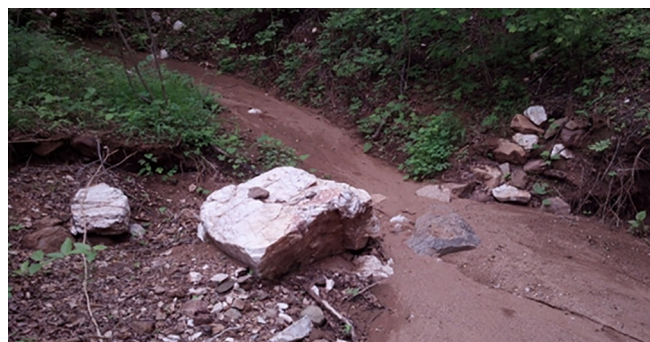
Fig. 3. Stone check dam failure (broken) in the Culiacán watershed (Mexico).

In this watershed, small, temporary, stone check dams were constructed across swales and drainage ditches (Figs. 3 and 4). These structures were built to reduce flow velocity and thereby potentially

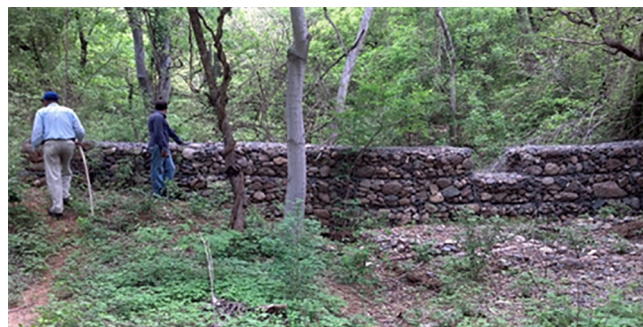
Fig. 4. A working gabion check dam in the Culiacán watershed (Mexico).

control the channel grade and mitigate channel erosion. The maximum height of the stone check dams is 3 m; to increase their stability, the base of each check dam is embedded into the soil approximately at 1-meter depth. The check dams were constructed to achieve complete cover of the channel and to assure that the middle of the dam is lower than the edges. No large magnitude, low frequency floods were recorded during the period of study (2011–2015). Fig. 5 shows a general map and the original/regulated longitudinal profile of four reaches containing the staggered check dams, allowing the identification of the channel gradient changes following the structure installation.

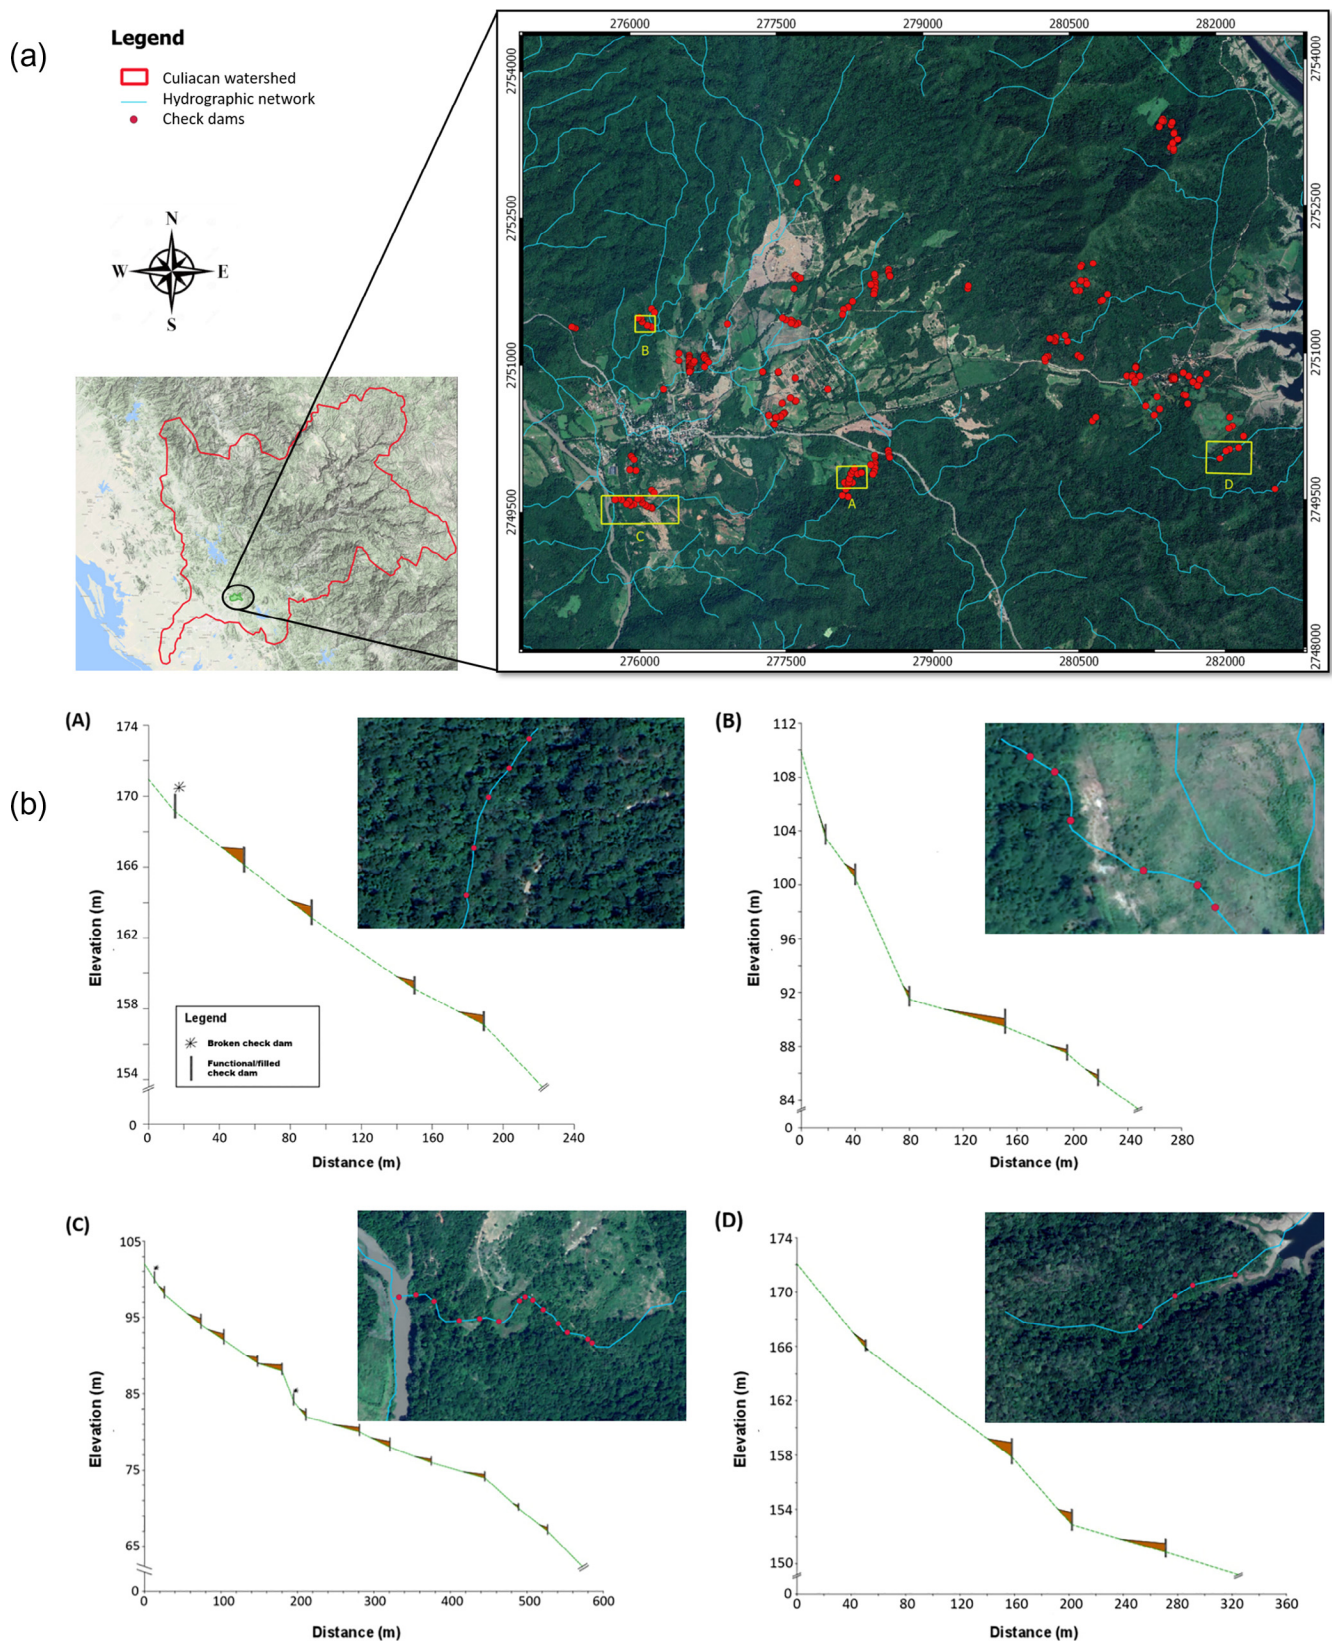
Fig. 5. Map (a) as well as longitudinal original and regulated profiles (b) of four check dam staggered series in the Culiacan watershed (Mexico).

and estimating the local slope behind each check dam (Figs. 5 and 6). From the current (regulated) and the original longitudinal profiles close to the check dams as well as from check dam dimensions, the potential storage capacity and actual sediment storage were estimated
