NEW FINDINGS IN FIRE PREVENTION AND FIRE FIGHTING OF PV INSTALLATIONS

Prof. Urs Muntwyler

Berne University of Applied Sciences (BFH), Engineering and Information Technology
Photovoltaic Laboratory (PV-Lab), Jlcoweg 1, CH-3400 Burgdorf, Switzerland
phone: +41 (0)34 426 68 37, fax: +41 (0)34 426 68 63, urs.muntwyler@bfh.ch

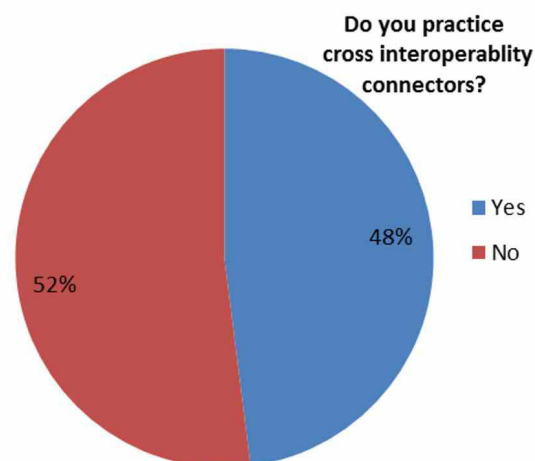
Figure 1: 48% of PV installers in Switzerland practices cross connectors

47% of all installers had problems with connectors. 14% had damaged cross connections. They reported 75% of the problems in the first year of the installation. This is not amazing as the Swiss PV market grows quick in the years 2010-2013 from 40 MWp to over 300 MWp⁷.

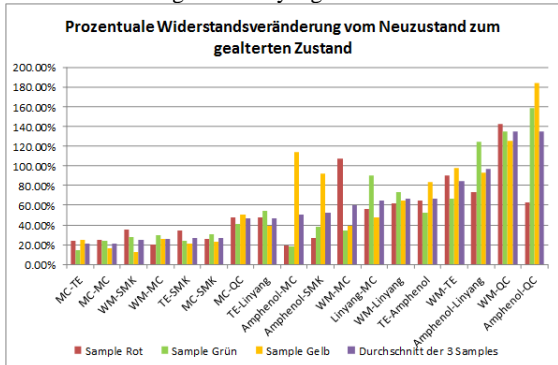
The resistance went up to more than 180%. Many of the cross connections are over the allowed value of 50%. Some of the changes are very significant.

Figure 7: Contact resistance after the artificial aging [mΩ]
