Venkatesan, Senthil velan and Lim, Chan and Holdcroft, Steven and Kjeang, Erik (2016) Progression in the Morphology of Fuel Cell Membranes upon Conjoint Chemical and Mechanical Degradation. *Journal of The Electrochemical Society*, 163 (7). F637-F643. ISSN 0013-4651

Progression in the Morphology of Fuel Cell Membranes upon Conjoint Chemical and Mechanical Degradation

Ionomer membranes used to separate the electrodes in polymer electrolyte fuel cells are known to degrade both chemically and mechanically during regular fuel cell operation and may ultimately result in lifetime-limiting failure. The objective of the present work is to understand the effects of combined chemical and mechanical stresses on the mesoscale morphology of the membrane and its role in the overall degradation process. The mesoscale effects of sulfonic acid group loss and fluoride release on the phase segregated morphology of the membrane are analyzed using contrast-enhanced transmission electron microscopy and energy dispersive X-ray spectroscopy. The end-of-life ionic domain size of the ionomer is shown to be substantially enlarged compared to the pristine membrane state. Elemental mapping overlaid with the

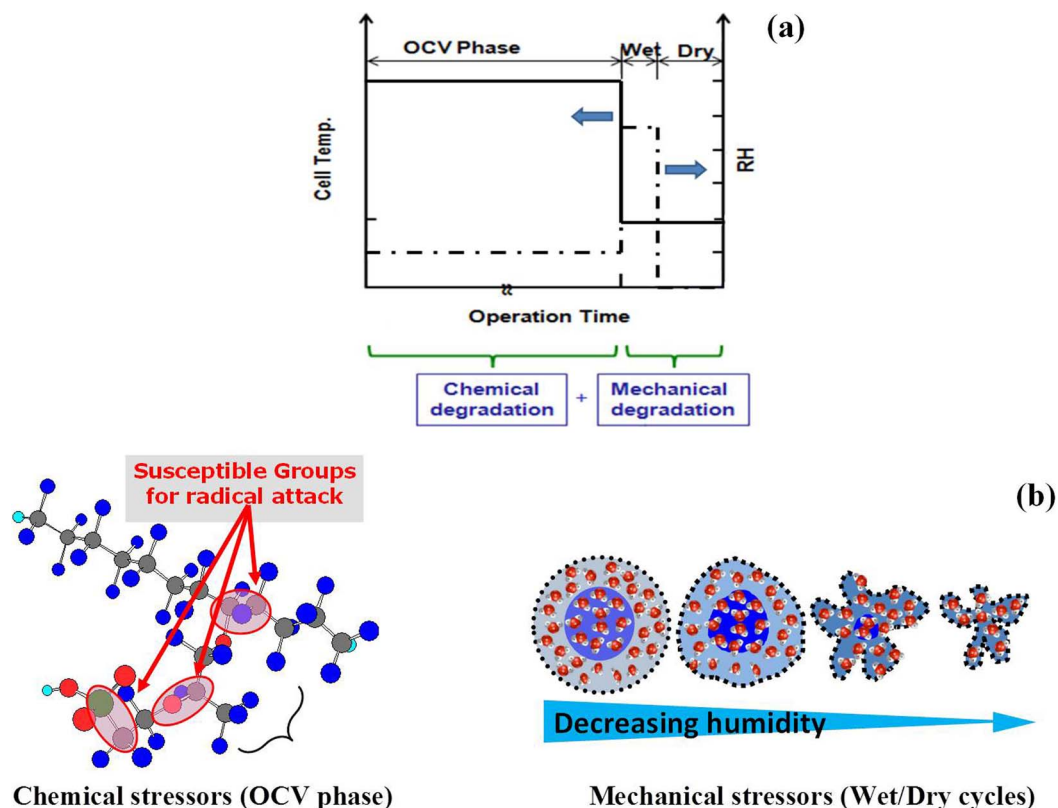
Figure 1. Graphical illustration of (a) the cyclic open circuit voltage accelerated stress test (COCV AST) and (b) its induced chemical and mechanical stressors on the membrane.

In situ degradation protocol.—A commercial non-reinforced PFSA ionomer membrane in the protonic form was used in this work. Research-scale fuel cell stacks with membrane electrode assemblies (MEAs) fabricated from the same PFSA membrane with catalyzed gas diffusion electrodes (GDEs) were prepared. In order to evaluate the effects of combined chemical/mechanical stressors on the durability of the membrane, an in situ cyclic open circuit voltage accelerated stress test (COCV AST) was applied. The COCV AST exposed the membrane/MEA to periodic chemical and mechanical stresses through open circuit voltage hold at high temperature, elevated oxygen concentration, and low relative humidity and alternating wet/dry cycles, respectively (Figure 1), until membrane failure occurred. The fuel cell stacks were operated on an automated test station, consisting of fully computer-controlled mass flow controllers, back pressure regulators, preheated water circulating coolant loops, and electronic load. In the wet period, the inlet gases were oversaturated by injecting water into the evaporator type humidifier in an amount excess than that required attaining the saturated vapor pressure. In the dry period, the inlet gases were kept in a relatively dry state by closing the water supply pumps of the humidifiers. The stack was subjected to a beginning-of-life (BOL) conditioning procedure for initial electrochemical activation of the MEAs by applying a medium current density in pure hydrogen at the anode and air at the cathode. Further information on the fabrication and assembly as well as a set of in situ and ex situ diagnostics can be found in our previously published article by Lim et al.¹⁷ which utilized the same methodology. Partially degraded MEA samples were extracted from the AST stack after the 2nd, 5th, 8th, and 10th cycles for further analysis. A hydrogen leak rate indicative of stack failure represented the end-of-life (EOL) of the MEAs which occurred after ten cycles. The MEA samples were taken from the inlet region, which experienced the most aggressive conditions for degradation.

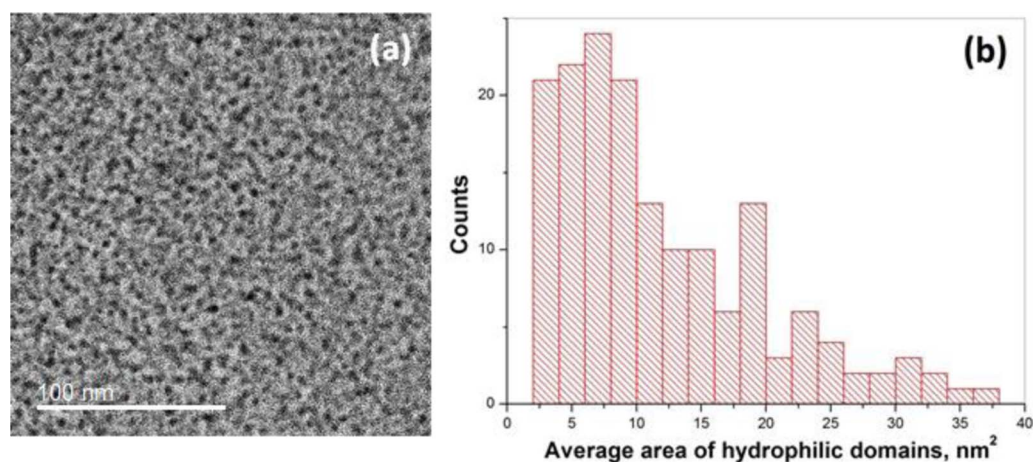
Micrographs of pristine and degraded membranes.—Figure 2a shows a representative bright field TEM micrograph obtained for the pristine PFSA ionomer membrane which features micro phase separated morphology of uniformly distributed ionic and non-ionic domains. Since the protonic sites in the membrane were exchanged with Pb²⁺ ions, the dark regions indicate ion-rich hydrophilic domains and the bright regions indicate non-ionic, hydrophobic fluorocarbon main chain domains. The ion-rich domains are randomly distributed in small pockets defined by the surrounding structural matrix of the fluorocarbon backbone phase. The statistical treatment of the image through the domain area distribution plot is presented in Figure 2b. Binary phase segmentation and domain area calculations were performed using ImageJ (with details provided in the Appendix) and the average hydrophilic domain area was found to be approximately 7.5 nm². The images obtained are in close agreement with previously reported images of similar membrane materials.^{7,23,24} Furthermore, the obtained absolute morphology result was reproducible on different pristine samples on different days using the same sample preparation and imaging techniques. It is thus expected that major alterations in morphology arising from degradation can be captured by this approach.

Figure 2. (a) TEM micrograph of a pristine PFSA membrane showing random distribution of dark ion-rich regions and bright tetrafluoroethylene regions and (b) statistical distribution of average hydrophilic (dark) domain area.

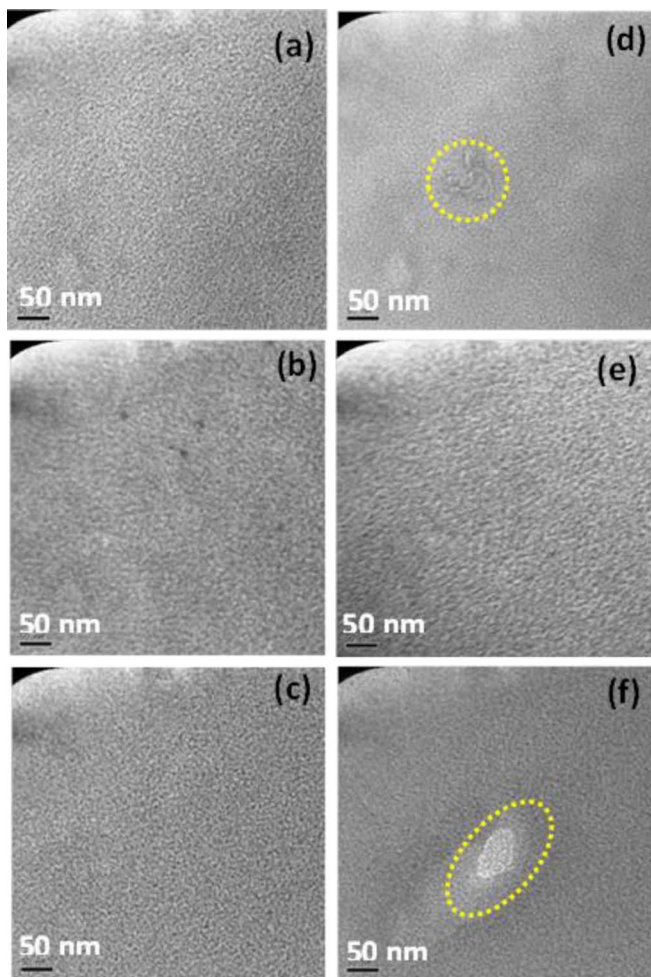
Figure 3 provides a collection of bright field TEM images observed for two typical regions of the partially degraded membranes from conjoint chemical and mechanical degradation using the COCV-AST protocol. Three different stages of degradation are shown (from top to bottom): two, five, and eight AST cycles. For reference, end-of-life (EOL) failure was reached after ten AST cycles. The same sample preparation and imaging procedures, including Pb staining, were applied in all cases; hence, any change in the morphology compared to the pristine membrane (Figure 2) was due to the degradation

stressors rather than imaging artifacts. The two typical regions identified in Figure 3 represent regular morphology (a-c) present in the membranes after two, five, and eight AST cycles and special features related to local membrane degradation (d-f) after the same numbers of cycles. Notably, considerable variation in local morphology can be observed by comparing the images of the two regions. Though the regions exhibiting regular morphology were exposed to severe degradation stressors, the morphology of these regions were found to resemble the regular morphology of the pristine membrane, representing the bulk (overall) characteristics of the ionomer, whereas the regions exhibiting local degradation features were observed to deviate from the original membrane morphology, even at the early

degradation stages. The extent of structural degradation as a result of radical attack and hydrothermal stress is expected to have perturbed the local morphology at the degraded sites. Apart from these special features observed due to local degradation, the images obtained after two and five AST cycles did not exhibit major morphological differences in other areas when compared to the pristine morphology. The relatively minor local degradation feature identified after two AST cycles shows a sudden disruption (encircled) in the phase-separated morphology that may have been initiated by locally elevated radical attack and resulting loss of functional groups associated with a local defect or contamination in the membrane or adjacent electrodes (Figure 3d). At this stage, however, the membrane largely appears

Figure 3. TEM micrographs of partially degraded membranes subjected to (a,d) two, (b,e) five, and (c,f) eight COCV AST cycles. (a-c) represent regions exhibiting regular ionomer morphology while (d-f) show specific features related to local degradation.

to withstand the effect of initial degradation. After five AST cycles, though most of the membrane area still exhibited regular morphology, a qualitative feature observed in some locations exhibits an increase in the ordering and long range formation of ion-rich domains, which differs from the pristine morphology. The long range ordering of ionic domains may be due to the permanent deformation and creep resulting from the induced mechanical stresses acting on chemically weakened ionomer domains (Figure 3e). Similar effects of polymer chain alignment along the direction of applied tensile force are a commonly observed phenomenon in the literature,²⁵ although it has not been previously shown for fuel cell membranes. At this stage of degradation, the membrane has already lost a substantial amount of fluoride from chemical degradation initiated from the side chains of the ionomer¹⁷ and hence affecting the functional groups, the loss of which is associated with decay in mechanical strength.¹² After a significant effect of degradation exerted upon the membrane through subsequent AST cycles, the radical attacked regions are believed to have lost a large portion of the sulfonic acid end groups, which can influence the local phase-separated ionomer structure. Interestingly, the membrane subjected to eight AST cycles revealed a relatively large non-ionic feature in the severely degraded region that resembles the presence of a hollow, void space in the membrane slice (Figure 3f). This is believed to be a result of more mature local degradation under the auspices of combined chemical and mechanical degradation,¹⁷ where the chemical degradation is expected to have propagated from the side chain onto the main chain of the ionomer (i.e., also affecting the hy-

drophobic backbone domain), hence enabling a longer range of local morphological changes in the ionomer structure. Such regions may ultimately lead to the formation of pinholes, which were previously observed to be $\sim 100 \mu\text{m}$ in diameter and occur at the frequency of five holes per 3 cm^2 survey area at the EOL state.¹⁷ However, the fine resolution of the present imaging technique is unable to resolve such ‘large’ scale features.

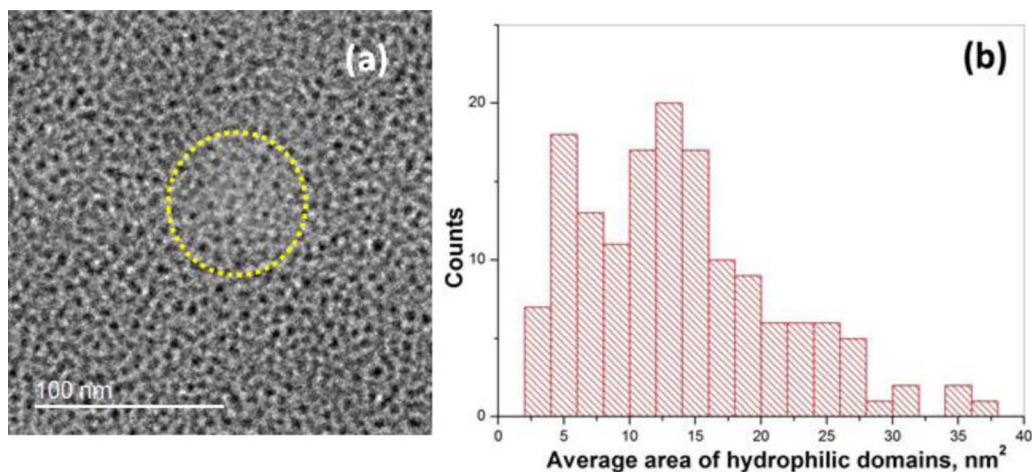
Figure 4a shows a bright field TEM micrograph of a typical membrane region at the EOL state. This image features regular ionomer morphology and a specific region (encircled) having reduced concentration of ion-rich domains essentially due to locally elevated chemical degradation. The morphology of the pristine membrane exhibited irregularly shaped ionic domains with low connectivity (Figure 2), whereas the morphology of the EOL membrane was found to have more spherical and highly networked ionic domains (Figure 4) which is believed to be an effect of bulk membrane degradation. These scenarios were observed irrespective of the imaging position across the membrane and are prevalent at the EOL stage. Statistical treatment was applied to the overall membrane structure, excluding the locally degraded zone in order to capture globally relevant effects. Figure 4b presents the obtained hydrophilic domain area distribution at end-of-life. It was inferred from these data that the average size of the hydrophilic domain areas in the selected region had undergone an increment of $\sim 16\%$ compared to the pristine membrane. The calculated domain area distribution becomes bimodal at the EOL stage and a substantial increase in the number of domains in the range of $10\text{--}25 \text{ nm}^2$ was observed, in contrast to the smaller domain areas in the pristine ionomer. This was accompanied by a net increase in the hydrophilic domain fraction observed in the image from roughly 15% at BOL to 20% at EOL. These results suggest that the advanced stage of chemical degradation affecting both main and side chains of the ionomer (as evidenced by high fluoride release and membrane thinning) may have reduced the hydrophobic domain size, while the loss of sulfonic acid functional groups could lead to weaker local ionic interactions and hence an increased hydrophilic domain size. Thus, the overall collection of hydrophilic domains in the image appears larger compared to the pristine morphology. These results demonstrate the influence of global chemical degradation on the bulk membrane structure, in addition to the locally elevated degradation exhibited by the regions with special features. The findings are in agreement with previously reported ionomer mass normalized water uptake data, which indicated a sharp increase from eight AST cycles to EOL.²⁰ It is hence expected that the enlarged hydrophilic domains are filled with water during humidified conditions such as those prevalent during fuel cell operation.

Figure 4. (a) TEM micrograph of the end-of-life membrane subjected to conjoint chemical and mechanical degradation. The encircled area indicates locally elevated chemical degradation. (b) Statistical distribution of the average hydrophilic (dark) domain area.

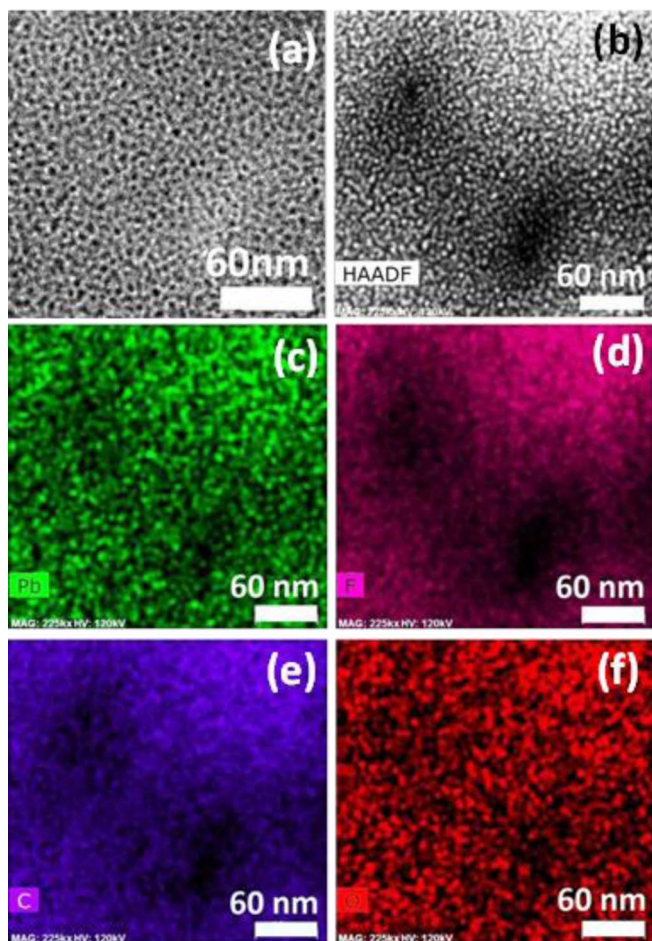
Local degradation effects observed by elemental mapping.—Elemental mapping was performed on the degraded zones in order to determine the chemical state of the previously observed local degradation features. In this technique, the electron beam was focused on the area of interest and scanned across the material to generate characteristic X-rays of each element. Figure 5 shows (a) the micrograph of a representative, severely degraded zone at the EOL state, along with its (b) high-angle annular dark field (HAADF) image and corresponding elemental maps of (c) Pb, (d) F, (e) C, and (f) O. The HAADF mode is sensitive to the average atomic number of the electron scatterer and can therefore illustrate the effects of chemical degradation with improved Z-contrast and without diffraction effects. In the dark field image, the regions of the specimen which transmit electrons appear dark while those that scatter appear bright. In the present case, the dark region represents significant loss of ionomer material in the two hollow, dark areas in Figure 5b. This is expected to be associated with regions depleted of side chains carrying the sulfonic acid groups. Hence, the elemental map of Pb is presented in Figure 5c which was used to exchange protons with heavy Pb^{2+} ions at the sulfonic acid group sites. It shows a reduced concentration of Pb at the two locally degraded areas which indirectly reveals missing sulfonic acid groups due to side chain scission by radical attack. Since the PFSA ionomer is predominantly comprised of fluorine, carbon, and oxygen in the

main and side chains, chemical maps of these elements at the severely degraded site are also presented. Figure 5d indicates the absence of fluorine element due to severe fluoride release at the two hollow areas. The carbon map (Figure 5e) further reveals the loss of carbon to a similar extent in these two areas.¹⁷ The elemental map of oxygen presented in Figure 5f shows a similar trend of oxygen loss, albeit with

a lower contrast compared to carbon and fluorine in the local areas. The similarity of the oxygen and Pb patterns suggests a presence of residual water in the remaining hydrophilic domains, mainly located in the mildly degraded regions rather than at the hollow, severely degraded areas. The oxygen map could also potentially indicate the presence of terminal carboxylic acid groups appearing due to side chain degradation induced main chain cleavage at advanced stages of chemical degradation.^{10,11} Overall, the two hollow areas identified in these images are likely to have experienced an advanced stage of chemical degradation, involving both side chain and main chain decomposition, thus creating small essentially void features that may potentially grow further into macroscopic damage features such as micro-cracks and pinholes normally observed by SEM based failure analysis of EOL membranes.

Figure 5. Analytical imaging of a locally degraded region in the end-of-life membrane: (a) regular TEM micrograph; (b) HAADF image; and (c-f) elemental maps of (c) lead, (d) fluorine, (e) carbon, and (f) oxygen.

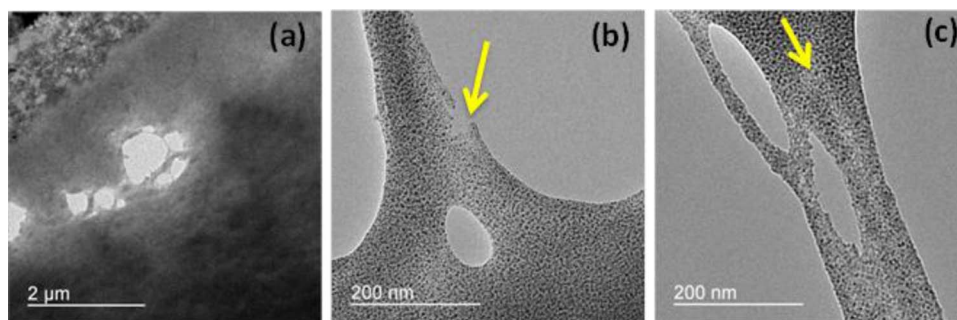
Though concurrent effects of chemical and mechanical stresses are difficult to distinguish, physical damage such as cracks and pinholes are considered to be induced due to mechanical stress acting on weakened membrane regions due to chemical degradation.^{12,17,26} Apart from the formation of chemically degraded locations in the membrane discussed in the previous section, other regions were found to undergo long range ordering of ion-rich domains until end-of-life. This could be perceived as mechanical stress induced morphological change²⁸ which is acting throughout the area of the membrane during the wet/dry cycles of the COCV-AST. Meanwhile, radical attack on the bulk membrane takes place throughout its area during the OCV phase, which was evident from the TEM images at EOL as well as from the global membrane thinning reported previously.¹⁷ Notably however, as new carboxylate end groups are formed during advanced stages of chemical degradation, the fraction of end group mediated

Figure 6. TEM micrograph of the end-of-life membrane showing (a) a local void site in the membrane, (b) a micro-crack initiation site in an ionomer fibril, and (c) local crack propagation along the low ion concentration direction (as indicated by the arrows).

radical attack at main chain sites is likely to increase over time. The gross loss of ionomer in the observed void areas is consistent with main chain, carboxylate-mediated degradation. Due to the ‘hollow’ nature of these chemically degraded areas, the local mechanical stress may be exacerbated around the perimeter of the site, thus further expanding the damage. Furthermore, chemical membrane degradation was previously found to increase the brittleness of the membrane during *ex situ* tensile testing,¹² which indicates that the chemically degraded structure is more susceptible to damage propagation under mechanical stress. It is noteworthy however that the macroscopic hydrogen leak carrying holes observed by SEM are essentially three orders of magnitude larger in scale than the hollow areas observed in the previous section, which warrants further analysis on damage propagation. Indeed, the present TEM analysis of the EOL membrane revealed a larger damage feature than those previously discussed, as shown in Figure 6a. This void feature is on the order of 1 μm in size, and is surrounded by several smaller hollow voids, which is indicative of local crazing around the edges. A magnified image captured from the edge of the void (Figure 6b) revealed a fibrillary ionomer structure which is most likely a result of mechanical stress applied to a chemically degraded area that stretches out the remaining ionomer strands during the process of damage growth. Another interesting observation from this image is the small micro-crack being initiated at the edge of the ionomer fibril at a specific site of low concentration of ionic clusters, which indicates that small cracks may propagate preferentially from chemically degraded regions (Figure 6b). The direction of crack propagation is also found to be along the direction of low concentration of ionic clusters, which is more distinctly shown in the supporting image in Figure 6c. These regions are likely to possess weak interaction between the constituent polar and non-polar phases due to chemical degradation and could favor mechanical fracture along this direction. In general, it is inferred that the mechanically yielding ionomer fibrils exhibit low concentration of hydrophilic domains. The severe side chain loss that caused a low concentration of ion-rich domains is likely to initiate the crack formation which is evident from the micrograph as shown by the arrows in Figure 6.

Overall, the observations in these images suggest that the conjoint chemical and mechanical degradation mechanism proceeds with the formation and coalescence of mesoscopic voids to form a fracture. Such fractures could eventually propagate under mechanical stress into membrane-spanning cracks and pinholes observed macroscopically.^{17,26} Imaging of macroscopic damage evolution would however require alternate techniques with higher field of coverage than TEM, which is subject to future work.

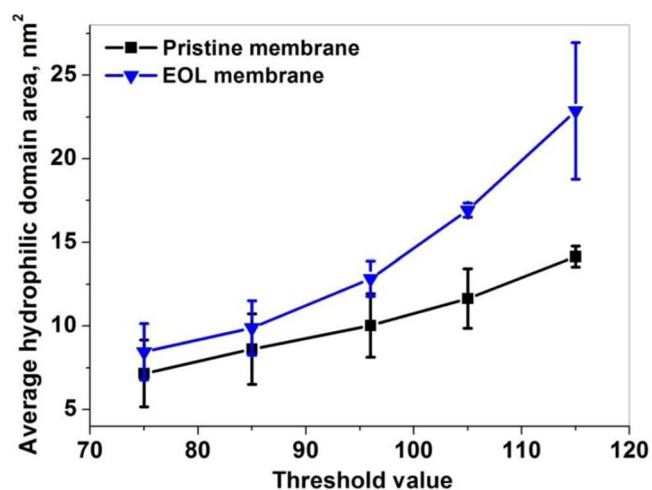
Figure A1. Sensitivity analysis carried out on the BOL and EOL membrane images for various threshold values.

interfaces. The BOL and EOL images were analyzed using ImageJ software for the average area of hydrophilic domains. The average domain area was calculated from the binary hydrophobic/hydrophilic images by assuming a threshold value for segmentation of the TEM images obtained at the BOL and EOL stages. From the sensitivity analysis, it was found that the threshold value is a sensitive parameter in calculating the average domain area. For any threshold value selected, the average domain area for the EOL membrane was always higher than at BOL, as shown in Figure A1. The threshold value set at 96 was empirically found to completely cover the hydrophilic area in the BOL membrane, and hence the same was selected for EOL membrane image analysis as well (Table A1). Two different regions of the same image were selected to carry out the domain area analysis.

Domain areas from 3 nm² to 40 nm² were considered. This is based on previous reports on the size of hydrophilic domains considering circular cross sectional area.⁷ Hence, any domains less than 3 nm² could be due to image noise and domains above 40 nm² could be an artifact due to the application of thresholding, and the corresponding hydrophilic cluster diameter tends to be impractical.⁷
