MECHANISMS FOR PREVENTING RISING DAMP IN NEW BUILDING INFRASTRUCTURE

Paper type: Research paper

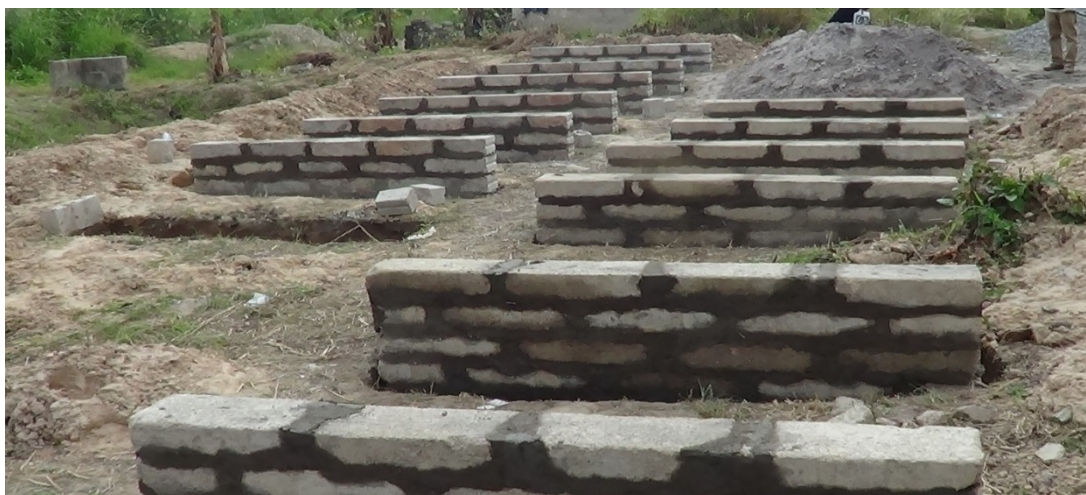
235 Fig 1 Photograph of test walls (extreme left are those constructed with SBs and extreme right are
236 those constructed with CBs) (Source: Agyekum *et al.*, 2016)

205 Fourteen masonry test walls of dimensions 2.1 m high by 2.0 m long were constructed at the
206 location. The walls were not erected under sheds in order to ensure their complete exposure to the
207 inclement weather. The construction of the fourteen test walls began on 1st July 2014 and ended
208 on 24th July 2014.

209 The first set of walls, which consisted of seven free standing walls were constructed of the
210 SBs, whilst the second set of walls, also made up of seven free standing walls were constructed of
211 the CBs. The CB construction was used to replicate to an extent the kind of blockwork construction
212 commonly adopted during the construction of residential buildings in Ghana (Agyekum *et al.*,
213 2016).

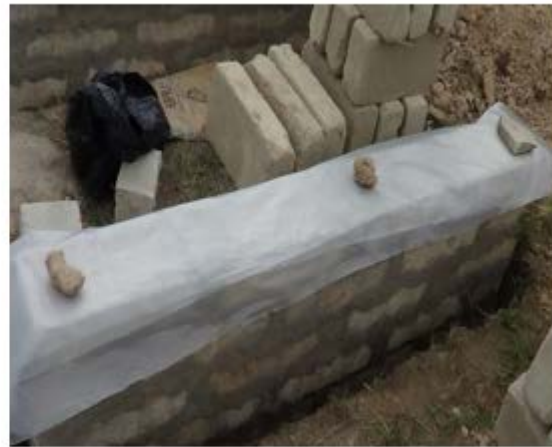
249 Fig 2 (a) Schematic diagram of the position of the dpc (b) Photograph showing how the dpc was
250 laid (Source: Agyekum et al., 2016)

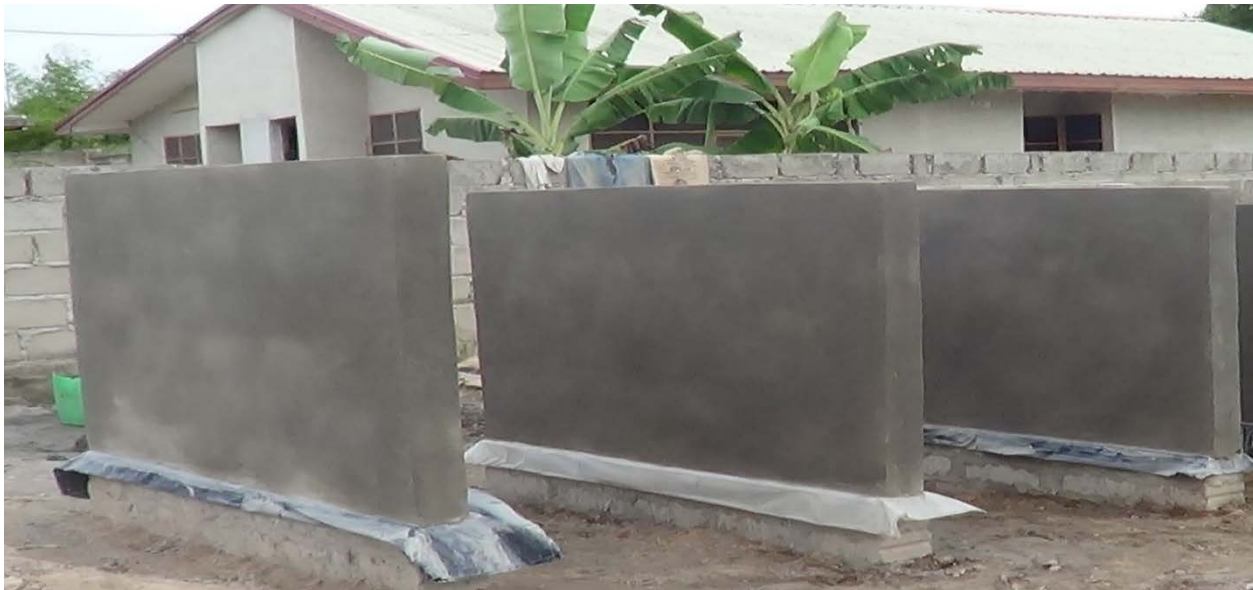
251
252 Fig 3 Photograph of test walls after the dpcs were laid

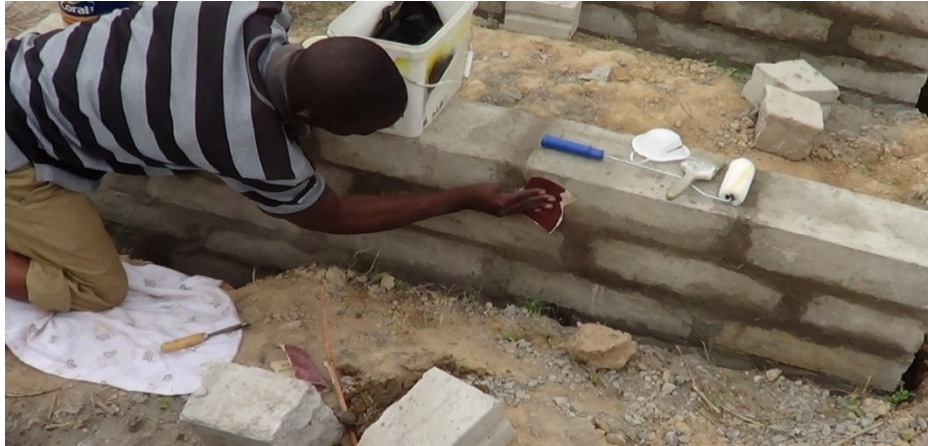
Fig 4 Photograph showing the preparation of the wall surfaces

253
254 The damp proof coatings were also applied to the fourth sets of test walls. During the application
255 of damp proof coating 'A', the wall surfaces were thoroughly cleaned and dried (Figure 4). The
256 soil of the adjoining walls was excavated about 3 feet (900 mm) deep. A catalyzer was mixed with
257 the epoxy paint, stirred and left to stand for 30 minutes. The catalyzer was part of the product as

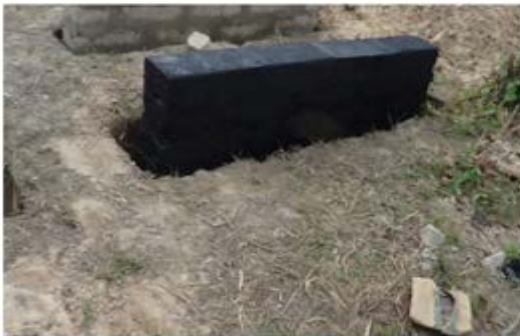
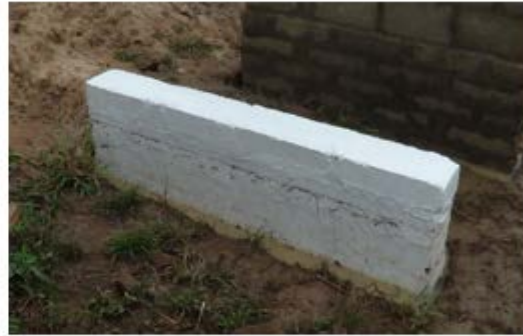
282 Fig 5 Photographs of the walls after the damp proof coatings 'A' (left) and 'B' (right) were
283 applied

260 Similar preparations as done for the application of damp proof coating 'A' was done for the
261 damp proof coating 'B'. Before its application the product was thinned with water in the rate of
262 40% and applied to the walls. After drying first coat, the second and third coats were applied
263 without dilution and allowed to stand for 48 hours after which the walls became completely dried
264 (Agyekum *et al.*, 2016). Figures 5 and 6 show the test walls after the applications of the damp
265 proof coatings.

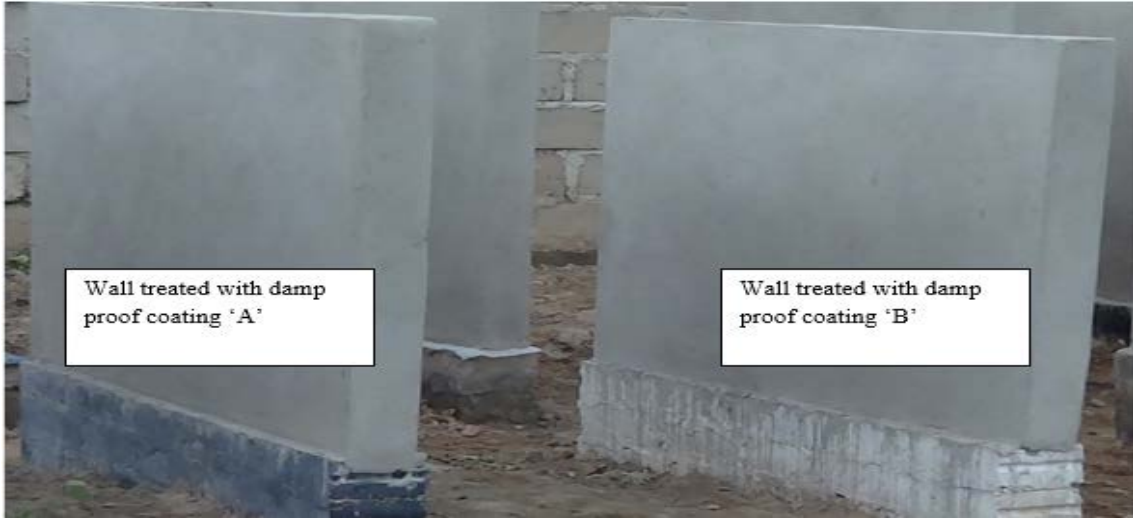
297 Fig 6 Photograph of test walls after they were treated with the damp proof coatings

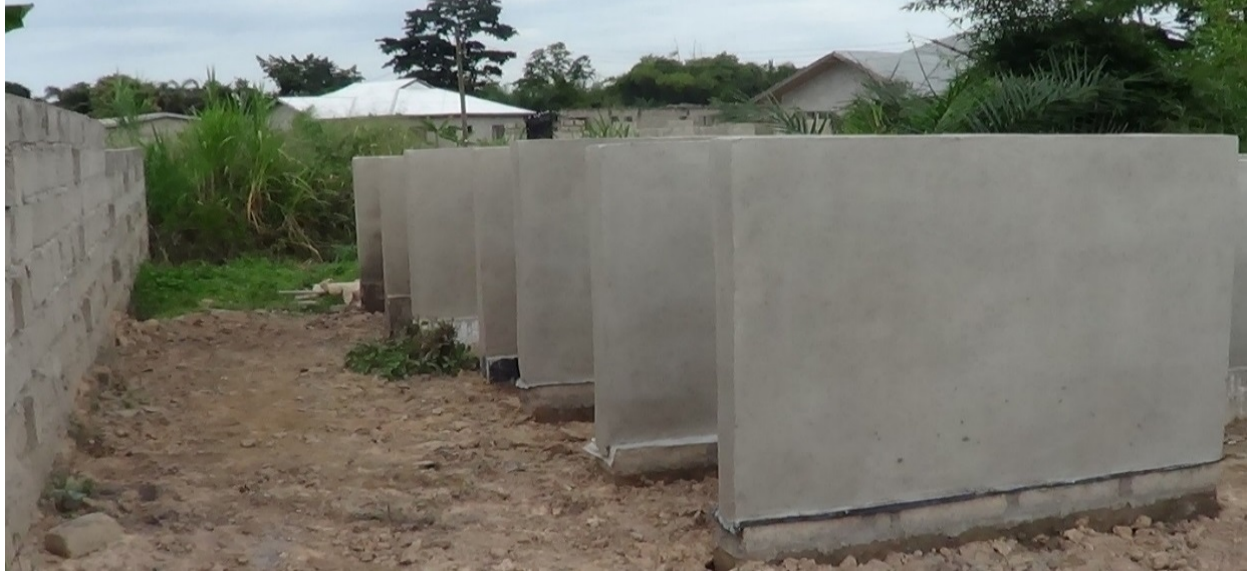
378 Fig 10a Photograph showing the damp front achieved by moisture in the walls constructed

367 One month after erecting the walls, a slowly progressing rising water front was visually observed.
 368 By the fifth month, the front had reached close to a third of the first course from ground level for
 369 the walls constructed with SB, and more than two thirds for that constructed with the CB. These
 370 initial observations were closely associated with the quality of the sandcrete blocks manufactured
 371 in the two cases. For instance, preliminary sorptivity test conducted on the two sets of sandcrete
 372 block samples (SB and CB) indicated that the those manufactured with the CB were more

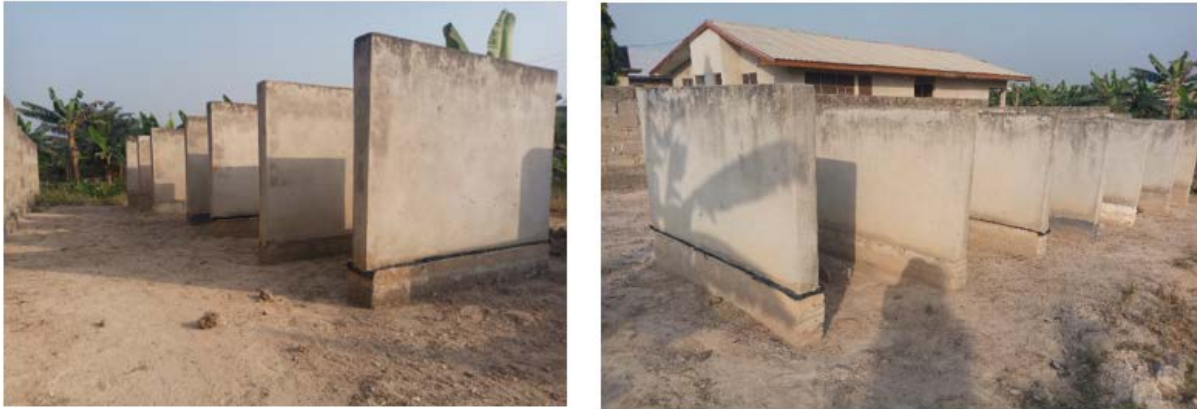
406 Fig 10b Photographs showing the conditions of the walls in the dry season

398 Riley and Cotgrave (2005) further stated that if the ground is not saturated, the soil exerts a
399 suction that opposes the upward pull of the water in the wall. As a result, when the water table
400 falls, the height of the moisture in the walls will drop to a new level provided there is sufficient
401 time for equilibrium to be achieved. This further shows why in the dry season, the water levels
402 recorded in the walls were lower (Figure 10b). Each period of heavy rain on the ground at the base
403 of the wall produces a temporary condition of saturation following which the water level in the
404 wall rises again.

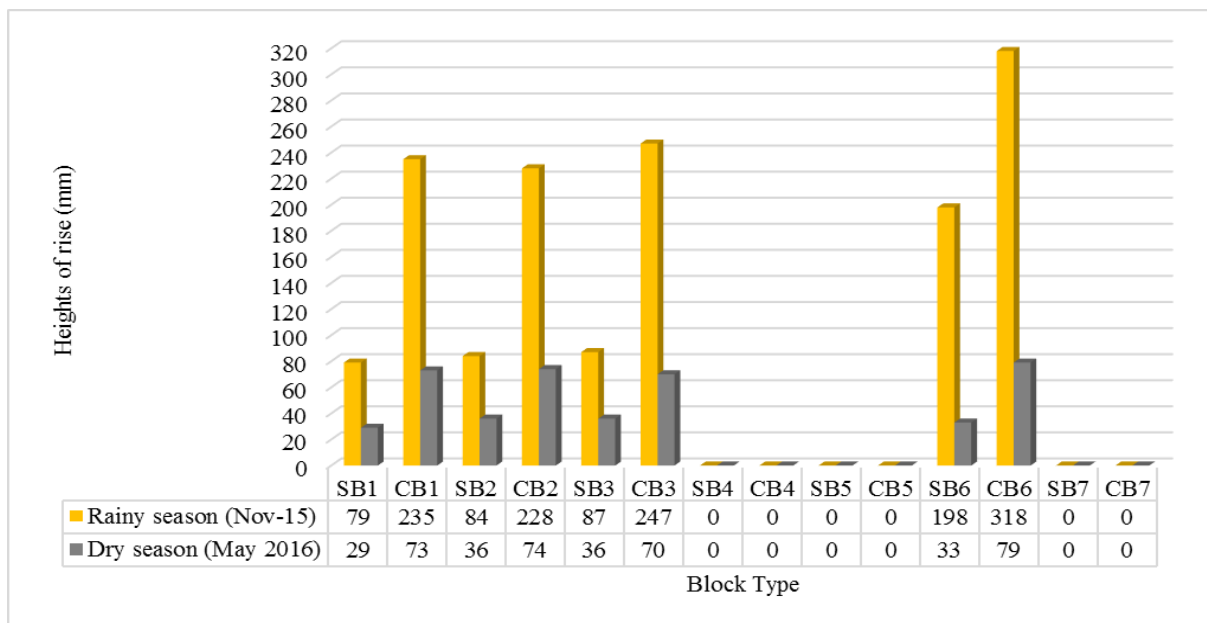
421
422 Fig 11b Capillary rise of water visually recorded at the peak of the seasons for 2015-2016

412 Figures 11a, 11b and 11c show the capillary rise of water recorded at various heights at the
413 bases of the different walls. Only the values measured at the peak seasons (i.e. November for the
414 rainy seasons and May for the dry seasons) have been presented in the figures. The peak seasons
415 were chosen because it was found that during the peak of the rainy season, the water table rose,
416 thereby increasing the amount of water in the ground and subsequently the increase in water in the
417 walls (Figures 11a, 11b and 11c). During the peak of the dry seasons however the opposite
418 happened (Figures 11a, 11b and 11c). All the other readings taken for the individual months are
419 shown in Tables 2a, 2b and 2c attached as an Appendix.

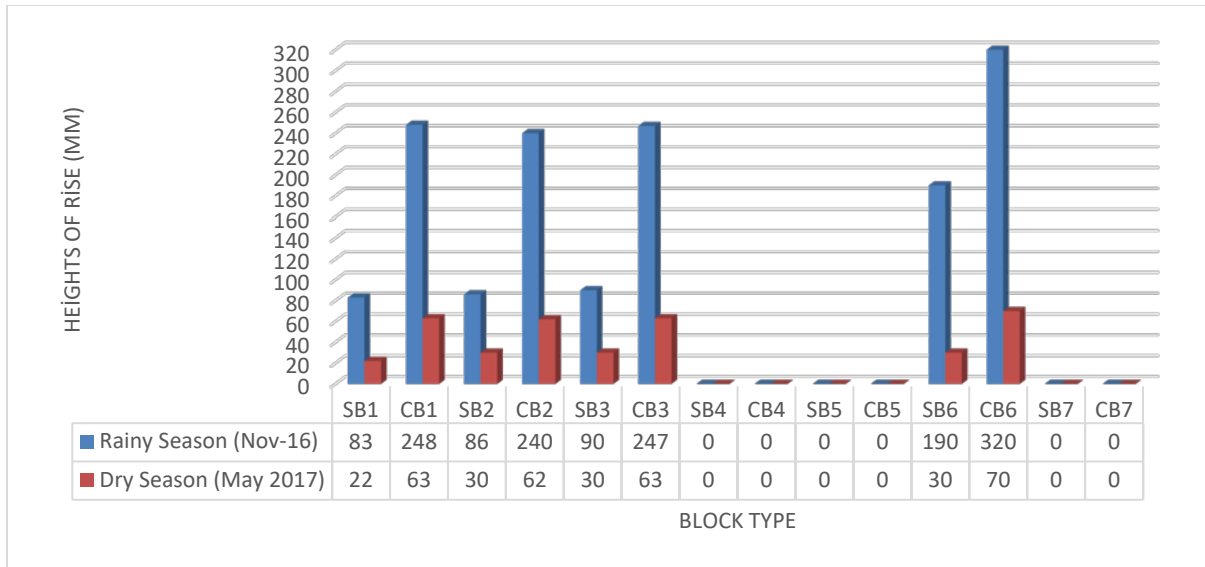
425 Fig 11c Capillary rise of water visually recorded at the peak of the seasons for 2016-2017

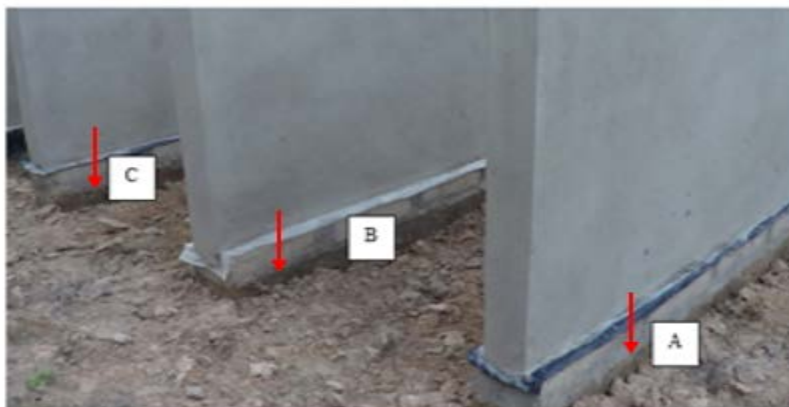
431 Though at the peak of the rainy seasons (Figure 12) the water levels rose higher, especially in the
 432 block walls manufactured with the CBs, the water could not go beyond the dpcs.

441 This indicates that the dpcs acted as barriers that prevented the water from rising higher.
442 Comparing this scenario to that in SB 6 and CB 6 (Figure 14), there is the likelihood that water
443 would have risen higher in the walls had the dpcs not been in place. From Figure 12 it is clearly
444 evident that the bases that had not been treated had been soaked with water. The ability of the
445 water to rise in the walls depended on factors such as ground and soil conditions, environmental
446 factors, climatic factors, etc of the area.

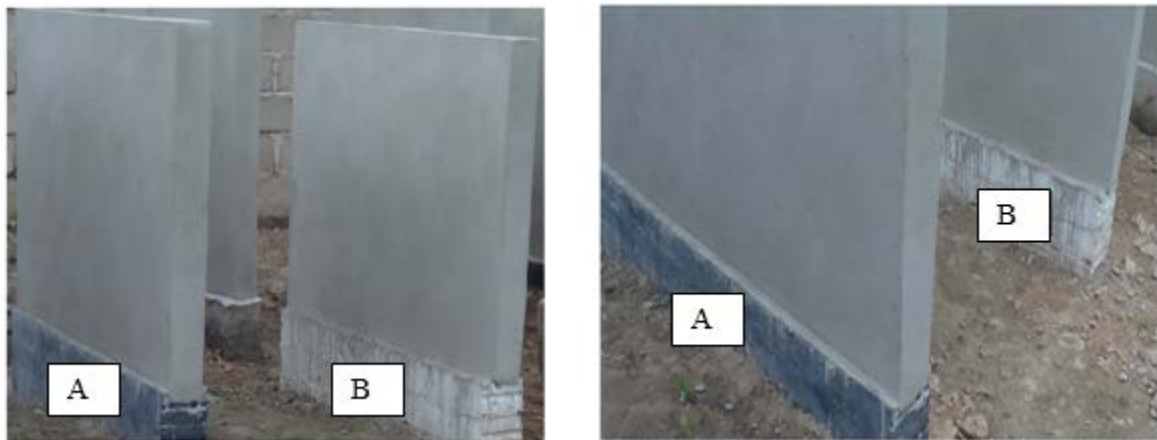
459 Fig 13a Photographs showing the conditions of the treated walls in the rainy season

448
449 Figures 13a and 13b show the conditions of the two sets of walls (SB 4, CB 4; SB 5, CB 5) treated
450 with the damp proof coatings during the rainy and dry seasons. The monitoring revealed that 4
451 years into the treatment of the walls, the damp proof coatings 'A' and 'B' are working perfectly.
452 Moisture content measurements with the PCE MMK1 moisture meter with deep probes showed
453 no traces of water at the bases of the walls, and the inner parts were considerably dry. This is
454 because the entire perimeters of the wall bases were completely covered with the coatings, which
455 filled the pore spaces within the sandcrete blocks, making it difficult for water to rise and penetrate.

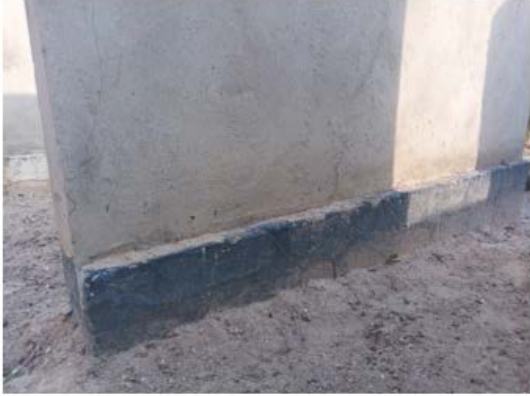
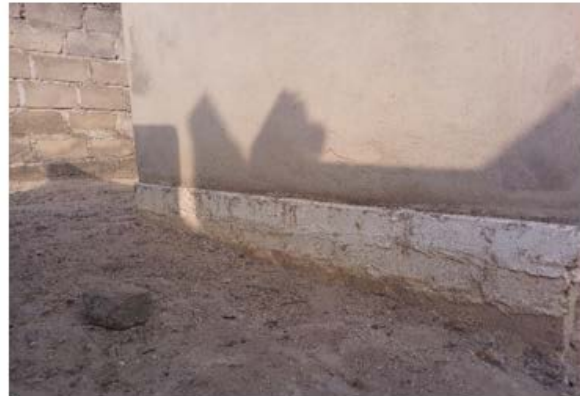
463 Fig 13b Photographs showing the conditions of the treated walls in the dry season

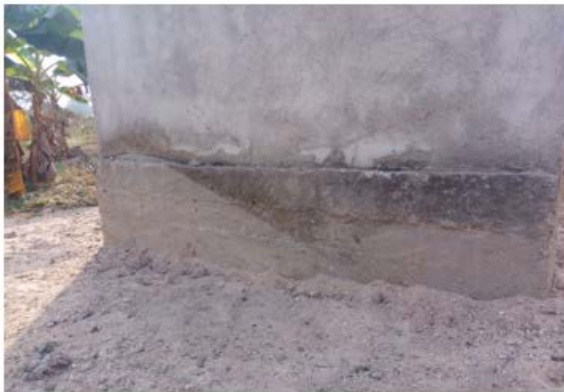
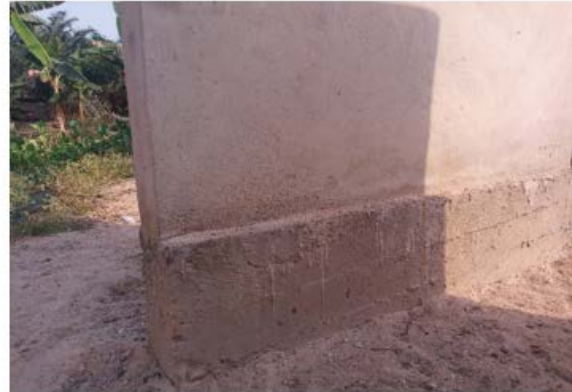
473 Fig 14 Photographs showing the conditions of the test walls with concrete bases

467 Test wall 7 for the two sets of sandcrete blocks were constructed with dense concrete bases. After
468 four years of monitoring the walls against the capillary rise of moisture, the findings revealed that
469 the bases of the walls showed no traces of moisture rise or penetration. The concrete bases were
470 very dense and did not permit the ingress of water by capillary action. Figure 14 is a photograph
471 that shows the conditions of the walls for the two different constructions.
