LONG TERM FIELD STUDY INTO THE DURABILITY OF SILICA FUME CONCRETE IN A MARINE TIDAL ZONE

B Sealey, O Skjølsvold, C Goodier, H Justnes

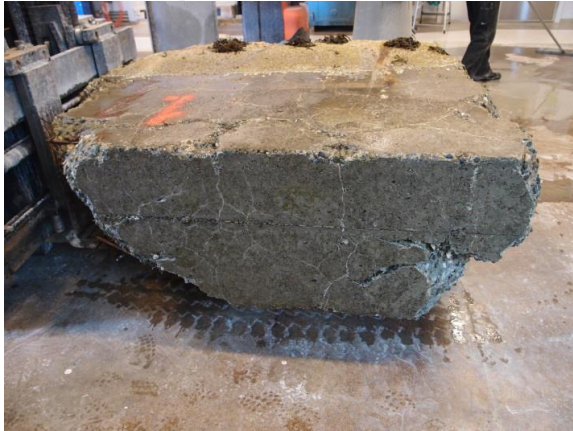
Figure 1 - Sample block, Mix 1

Control	Reduced cement + Silica fume		Increased cement + Silica fume	
Mix 1	Mix 2	Mix 3	Mix 4	Mix 5
Severe spalling on upper parts of the blocks, especially corners	Moderate spalling at upper corners	Moderate spalling at upper corners	Insignificant spalling at corners	Insignificant spalling at corners
Severe surface cracking due to freeze/thaw and/or alkali silica reactions	Some exposed aggregates at the surface, i.e. the surface paste layer is removed	Some exposed aggregates at the surface	Some exposed aggregates at the surface	Some exposed aggregates at the surface
Generally in poor condition

On visual inspection, Mix 1 (control mix; non-silica fume) was found to be in a generally poor condition (Table 3; Figure 1). Severe spalling and severe surface cracking was apparent; it is likely this is due to alkali silica reactions and possibly also freeze-thaw. This is in contrast to the good condition of Mixes 4 and 5 (silica fume added; reduced water/binder ratio) – Mix 4 can be seen in Figure 2. Note that a structural analysis (including thin section analysis) of samples from the five blocks has been undertaken and the results are to be published subsequently.

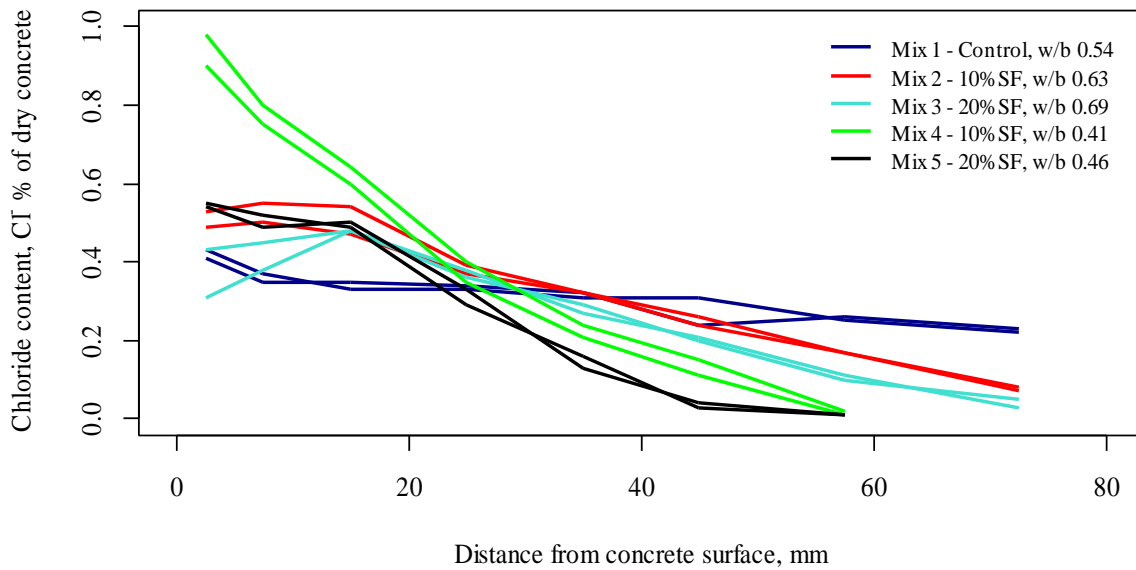
Figure 3 - Chloride ingress profiles

The chloride ingress profile was determined for specimens from drilled cores. Thin layers (5 to 15 mm) were ground from the surface and the chloride content for each layer determined. Table 4 and Figure 3 show the results.

Chloride content results for the samples after 31 years of exposure (Table 4; Figure 3) show that the addition of silica fume has reduced chloride content significantly at typical reinforcement depths. Figure 4 highlights chloride content at 50mm to 65mm depth – Mixes 4 & 5 both have chloride content below what would normally be expected to cause corrosion. It is also interesting to note that Mixes 2 & 3 (both with silica fume) show reduced chloride ingress compared to the non-silica fume Mix 1, despite Mix 1 having a lower water/binder ratio. The results are a consequence of an improved, more homogeneous, pore system in silica fume concrete, giving reduced permeability. It is likely that cracks occurring in the concrete will also have influenced the chloride profiles.
