# Development of an Acoustic Emission Waveguide-based System for Monitoring of Rock Slope Deformation Mechanisms

A Doctoral Thesis

September 2017

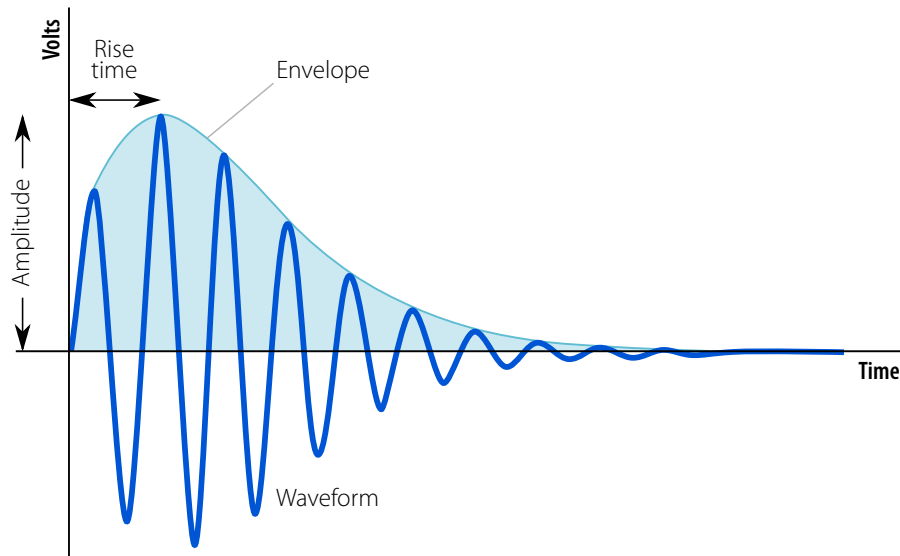
**Figure 2.4:** Characteristic AE event waveform with main parameters indicated

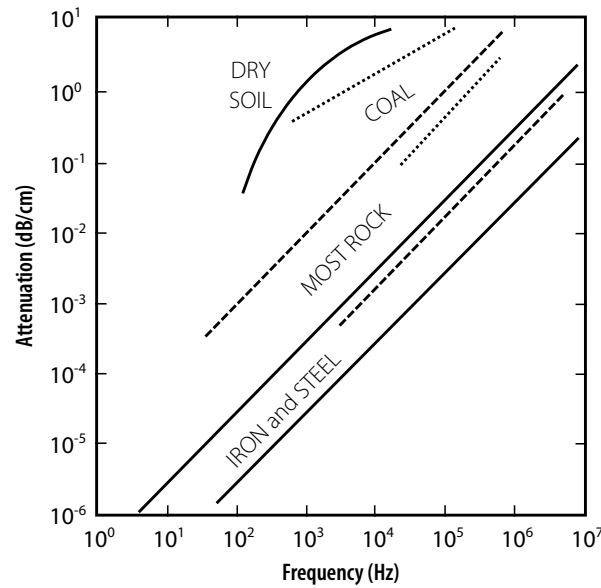
**Figure 2.5:** Attenuation versus frequency by material group. Intact rock attenuates more than iron and steel but much less than soils. It is also evident how attenuation is highly frequency-related. After Koerner et al. (1981)

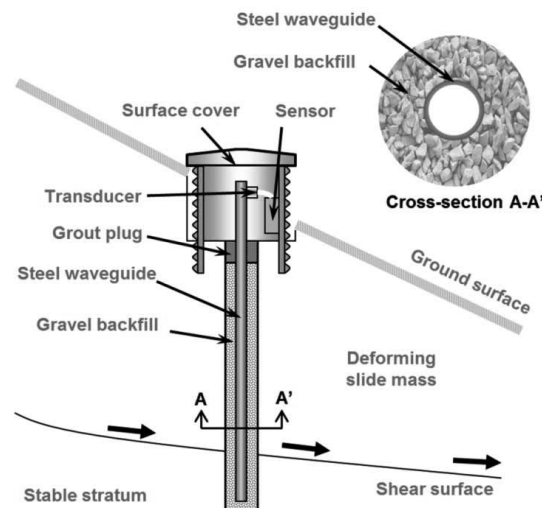
**Figure 2.10:** The concept of active waveguide in soil slopes: a hollow tube surrounded by a wave-generator backfill (i.e. gravel) is installed in a borehole which crosses any shear surfaces. After Dixon et al. (2014)

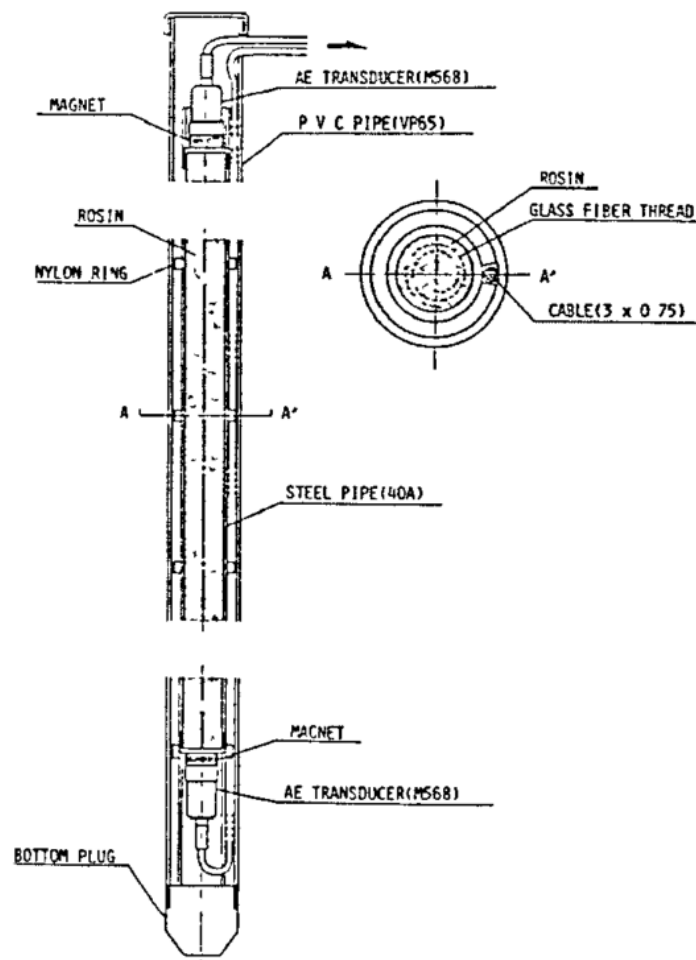
**Figure 2.11:** The active waveguide proposed by Nakajima et al. (1995). A fibreglass-reinforced resin wave-generator is placed within a steel pipe

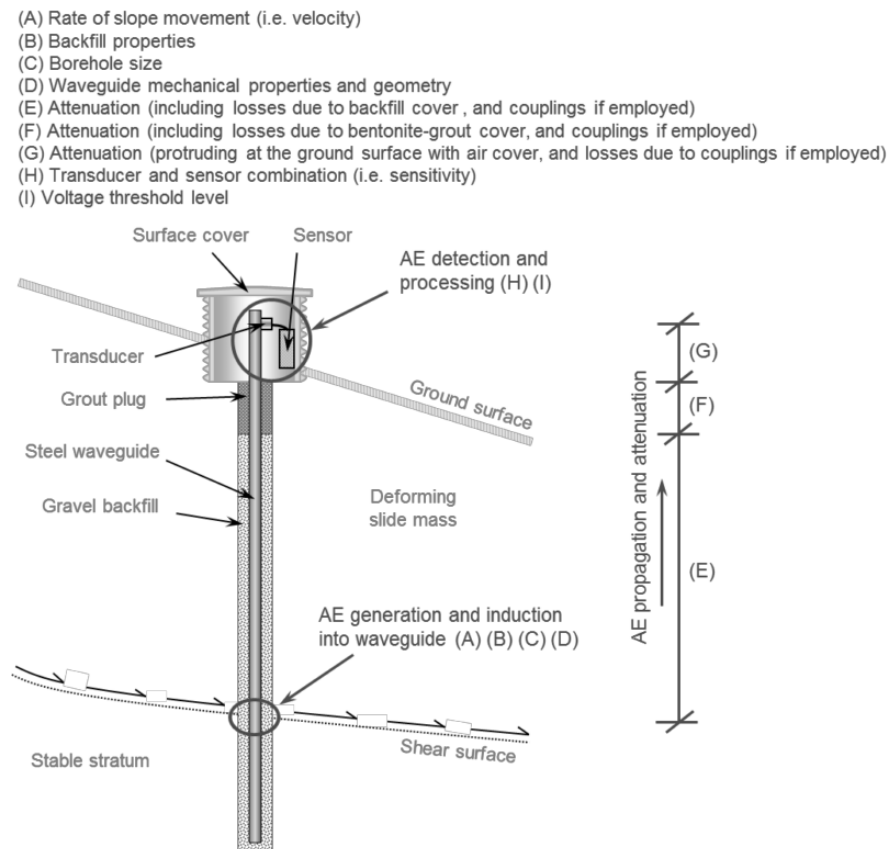
**Figure 2.19:** Parameters that have an influence on the acoustic emission detected by the Slope ALARMS system. The schematic considers the use of an active waveguide installed in a fine-grained soil and placed across one (or more) shear surface(s). After Smith (2015)

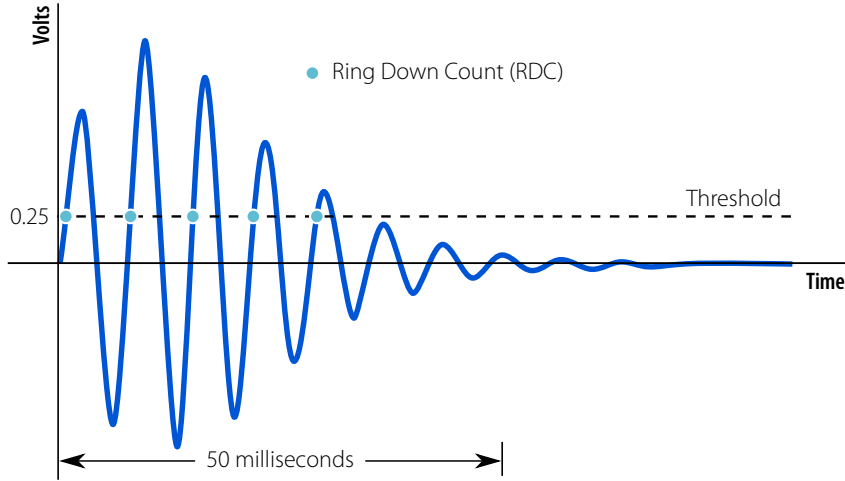
**Figure 3.3:** Generalised concept of Ring Down Count. RDC is computed counting the number of times the signal exceeds a voltage threshold (e.g. 0.25 V) in a set period of time (e.g. 15 min). In the figure an example rate equal to 5 RDC/50 milliseconds is given

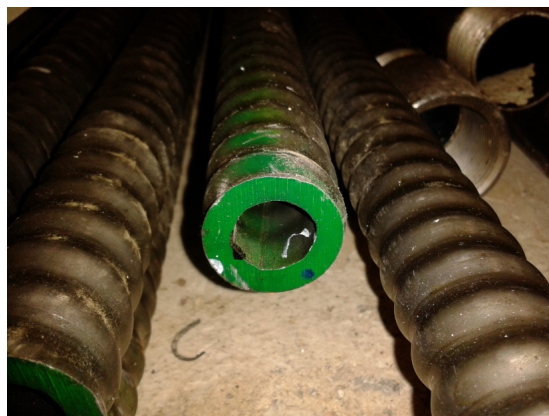
**Figure 3.4:** 32 mm outer diameter self-drilling threaded pipes

To install the self-drilling (hollow) bars a drill bit is attached on the first bar

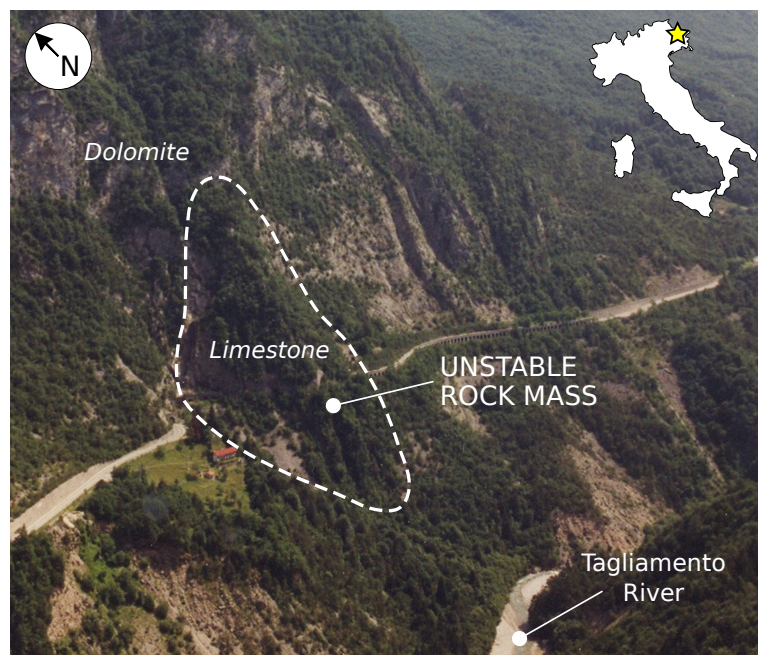
**Figure 3.5:** Photograph of Passo della Morte (Italy) taken towards north-east, along the Tagliamento River valley. Modified after Codeglia et al., 2017

This site located on the flank of the narrow Tagliamento River valley in the Italian Alps consists of a limestone layered rock mass (Figure 3.5) which is considered to be unstable for its structural layout with thin layers steeply laying parallel to the slope. The dip direction of the layers coincides with the slope, with layers inclined at  $73^\circ$  towards the valley. The rock mass has the potential to mobilise approximately  $650,000 \text{ m}^3$  of material in case of collapse of the whole unit (Codeglia et al., 2017). The site threatens the downstream villages for the potential of valley damming and consequent sudden discharge of the water accumulated at its back by the river, if dam outburst occurs (Codeglia, 2013).

The failure mechanism expected for this site is of the translational sliding type (Table 2.1). The sliding is expected to occur along the major joint system (bedding) subsequent to the formation of a shear zone transverse to the bedding system at the base of the slope. This condition is needed because the bedding is parallel to the

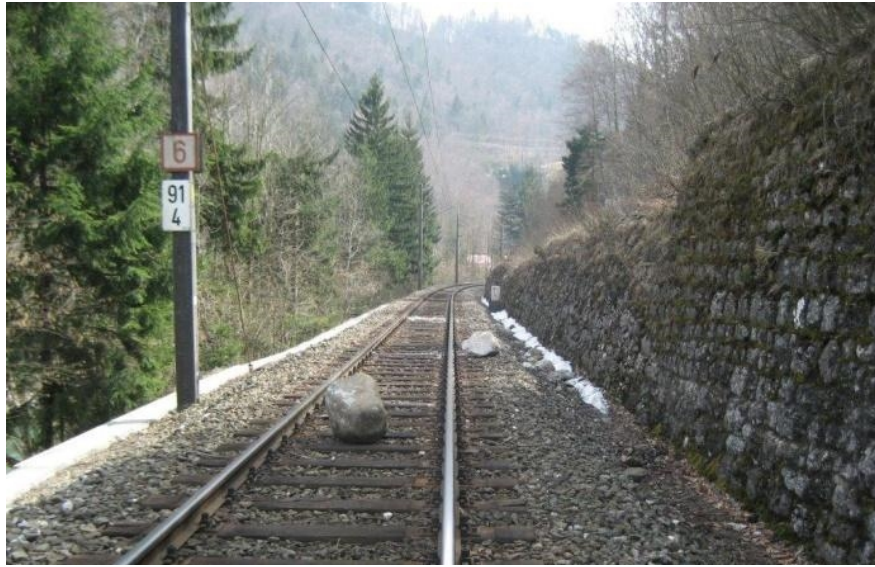
**Figure 3.8:** April 2013. Rockfall occurred at the Grossreifling site landing on the rail track. The boulder of about  $0.8 \text{ m}^3$  is broken in two pieces

At the toe of the slope, the railway track is protected by a dynamic 4 m high 1000 kJ rockfall barrier, identified as *Protection fence* in Figure 6.2, installed by OeBB after the occurrence of a 1 m<sup>3</sup> rockfall in April 2013 (a photography of the rockfall is provided in Figure 3.8).

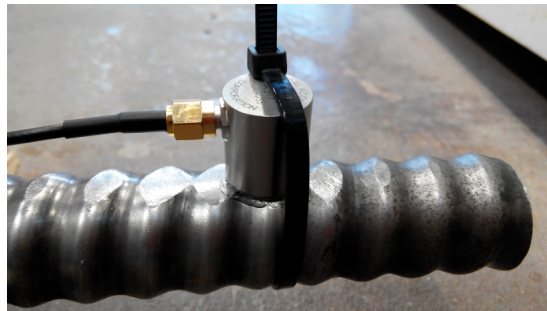
**Figure 3.12:** Transducer mounting on flattened threads obtained by filing (B5)

The first test was conducted on a smooth waveguide for reference, the position of the transducer was upright on the tube (B0). The subsequent tests were conducted on a threaded waveguide; five different transducer mounting configurations were considered: upright on a thread (B1), at an angle to the side of a thread (B2), upright over two threads with additional silicone gel filling the gap in between the two threads (B3), horizontal at the end of the pipe (B4) and upright on a flat area formed by filing consecutive threads (B5) as can be seen in Figure 3.12. The configurations are depicted in Figure 3.11. The transducer was secured to the waveguide using a cable tie, except B4 where the transducer was held in place by pinching it between the pipe and a heavy plastic box. Each test comprised of 10 x 1 second bursts and 10 x 10 seconds bursts of vibration from the AE generator. The results were compared to those obtained from the test conducted on a standard smooth steel pipe (B0).

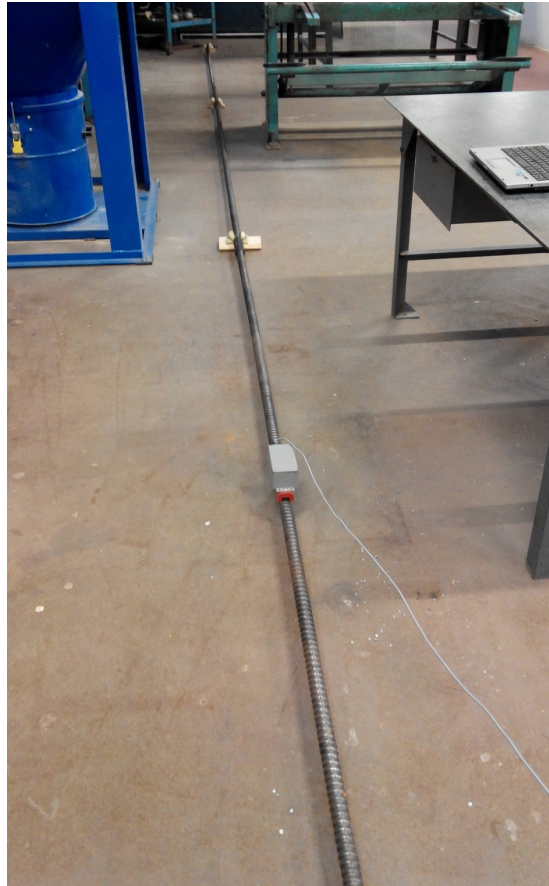
**Figure 3.15:** The 12 m waveguide employed in Test C

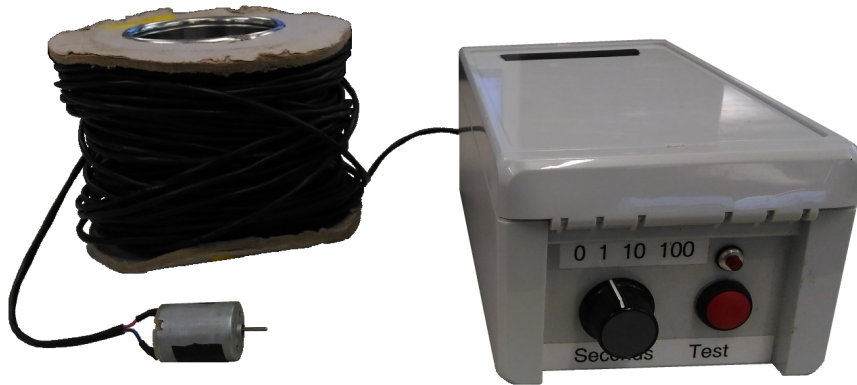
**Figure 3.16:** 10,000 RPM DC motor connected to the control box through a 50 m cable

This experiment was carried out at PdM as waveguides at this site are hollow and thus a wave-generator can be inserted within them (waveguides installed at SART are completely grouted). A small artificial source was used to generate AE in the range of interest. The AE generator was a 10,000 RPM motor (equivalent to a rotational frequency of 167 Hz) with a power input of 6 V (this is different from the motor in the AE generator described in 3.4.1). The 10,000 RPM motor was chosen for the small body diameter ( $\varnothing$  28 mm), required to fit it into the inner  $\varnothing$  35 mm diameter of the waveguide, and the relatively high rotational frequency. The restricted space available between the motor and the tube did not make possible to encase the motor in a water-tight protective shell, however the holes in the motor body were filled with grease for protection from moisture ingress. The motor was attached to a 50 m power cable to be able to test the whole length of the waveguides. The control box used for this experiment was the same as for the wave-generator used in the lab (see Section 3.4.1). The control box allows regular sets of 1, 10 or 100 seconds of continuous vibration to be induced. The equipment is shown in Figure 3.16. The AE generator was secured to a  $\varnothing$  4 mm galvanised steel wire rope to aid insertion into the tube Figure 3.17. The equipment was tested in the lab and this configuration was found to give repeatable and consistent RDC

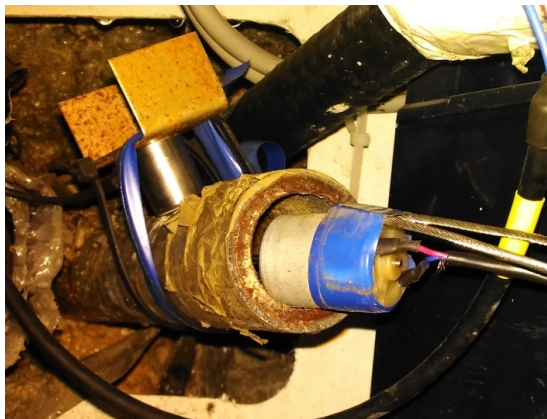
**Figure 3.17:** Test D. The small AE wave-generator being inserted in one of the waveguides at Passo della Morte

The small AE generator was inserted in each waveguide at PdM site (see Figure 3.17) and placed at various lengths. The schematic in Figure 3.18 shows the positions where the source was triggered and the position of the transducer for each waveguide (AEWG1, AEWG2 and AEWG3). For every position 10 x 1 s bursts of vibration were induced. The AE transported along the waveguide was measured with the equipment already in place at Passo della Morte (see Series 2 in Table 3.4).

into the hollow smooth waveguides at different lengths (see Figure 3.18) and 10 x 1 s bursts of vibration where induced per each position. This experiment was designed to run for the whole length of the three waveguides (50, 30 and 10 m respectively for AEWG1, AEWG2 and AEWG3) at intervals of 0.5 m. The AE generator used in this test is detailed in Test D design description in Section 3.4.3.1. The AE transmitted along the waveguide was measured with the equipment already in place at the PdM site (Section 3.3.1).

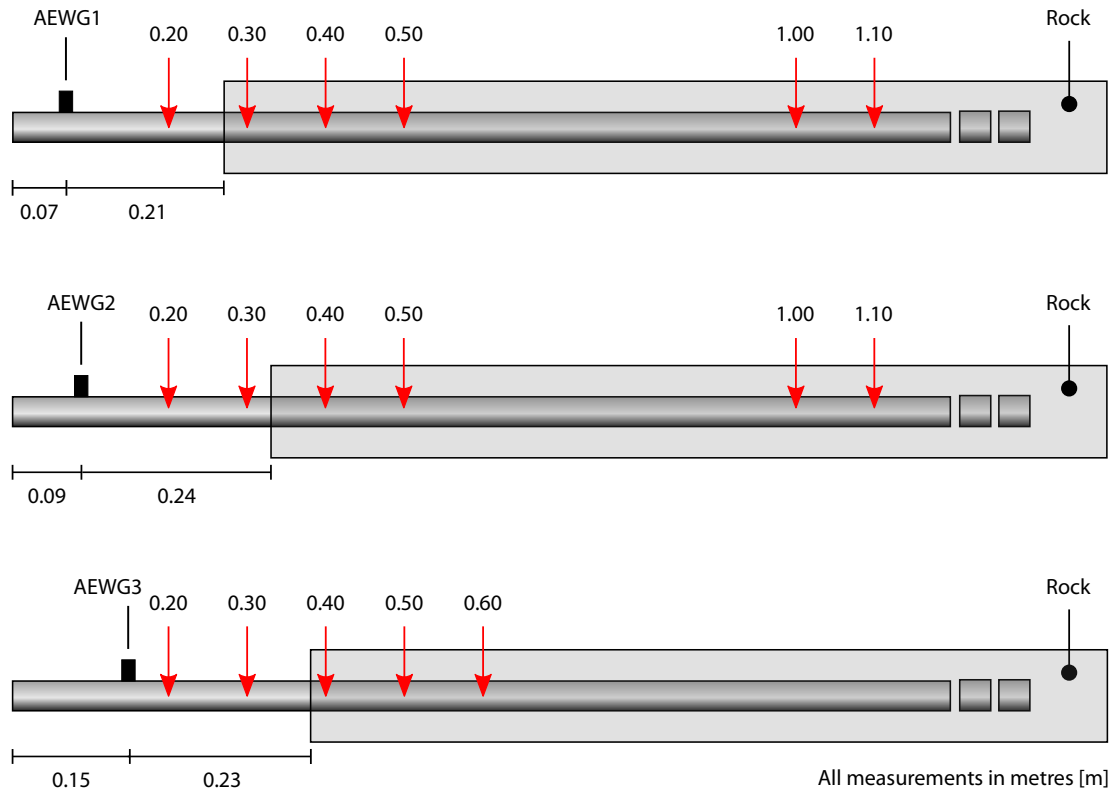
**Figure 3.18:** Schematic of Test D. For each waveguide (AEWG1, AEWG2, AEWG3) the positions where the wave-generator was triggered are detailed. The schematic also shows at which distance from the end the waveguide enters the rock mass

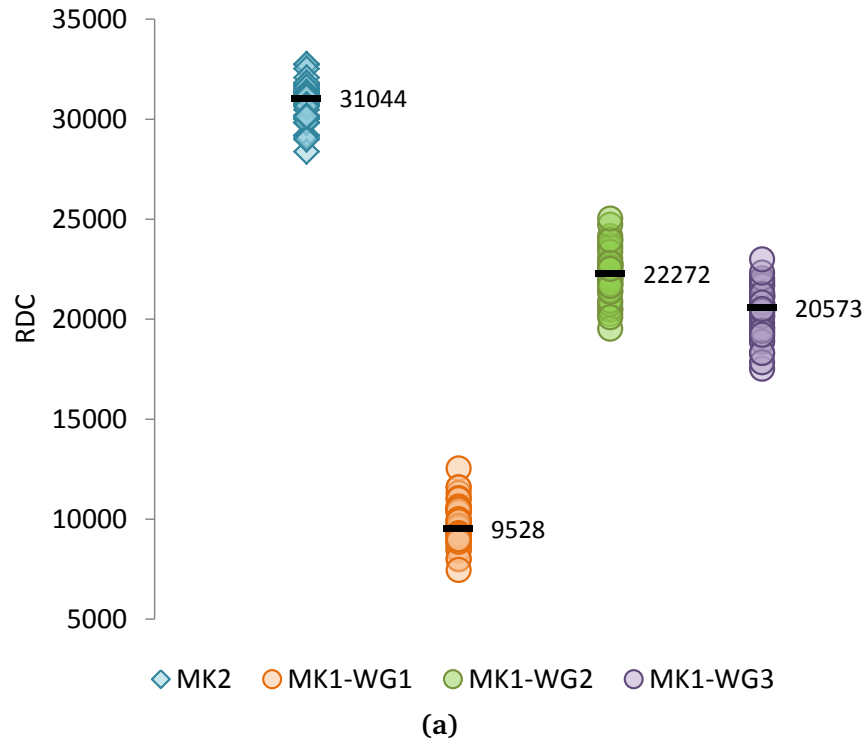
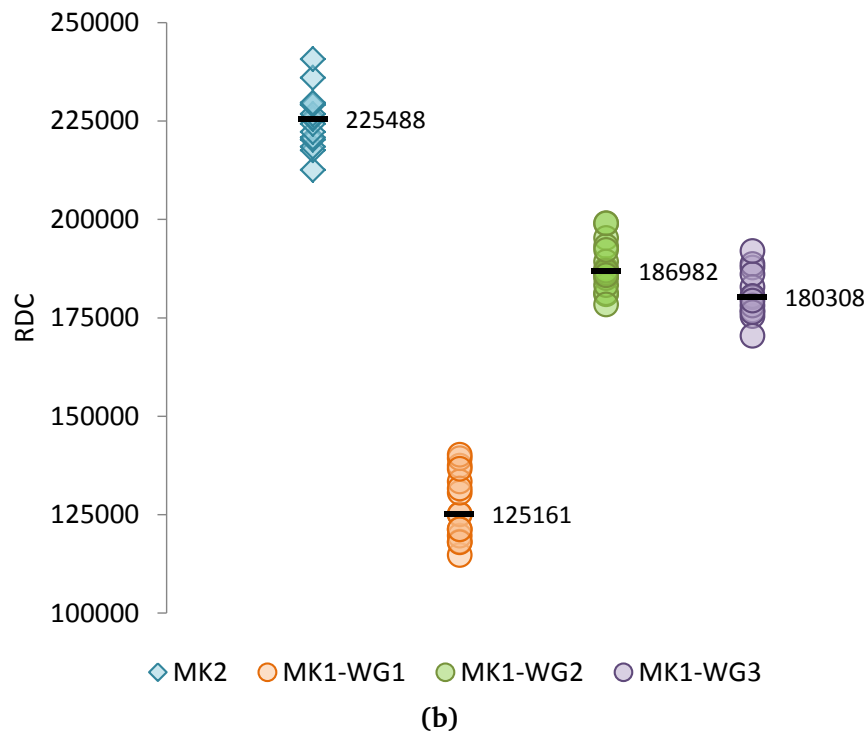
**Figure 4.1:** Results of Test A. Comparison of RDC responses given by the Slope ALARMS MK1 and MK2; **(a)** Test A1, 1 second burst of vibration; **(b)** Test A2, 10 seconds burst of vibration

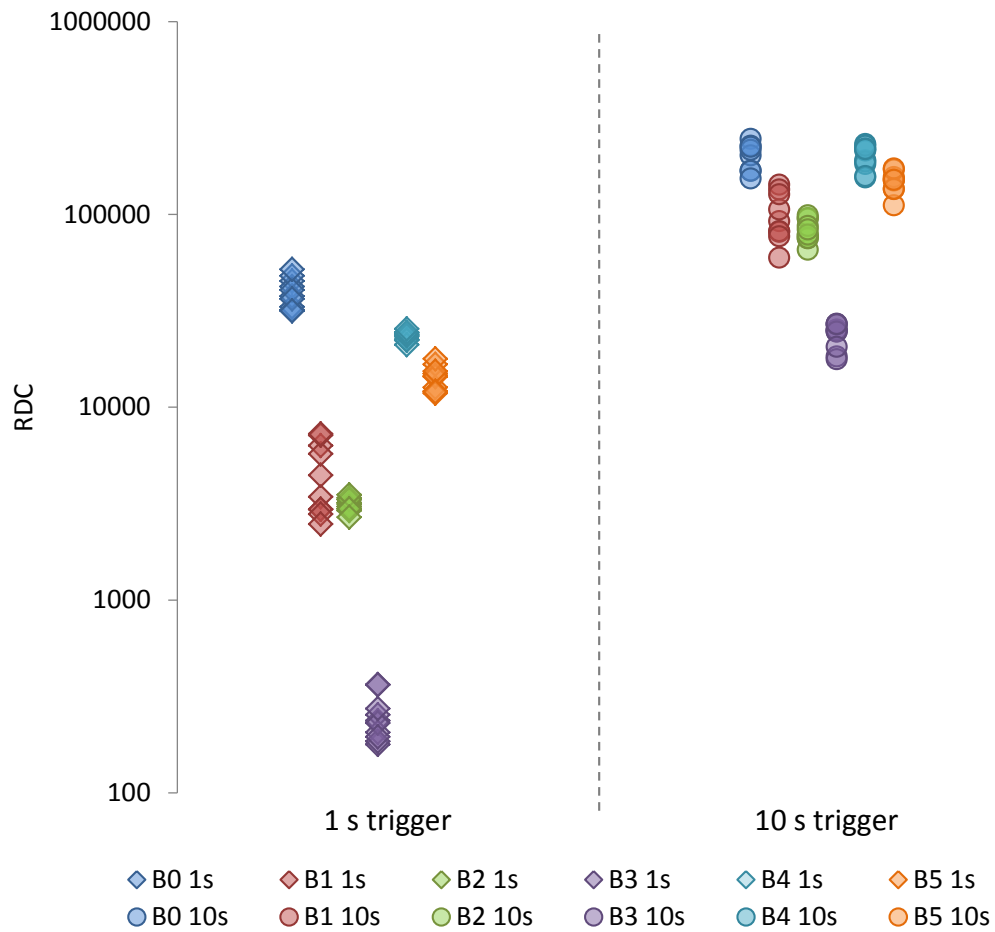
**Figure 4.2:** Results of Test B. RDC responses of five different mounting configurations (B1 to B5) compared to the response of a standard steel pipe (B0). 1 second burst of vibration to the left and 10 seconds to the right

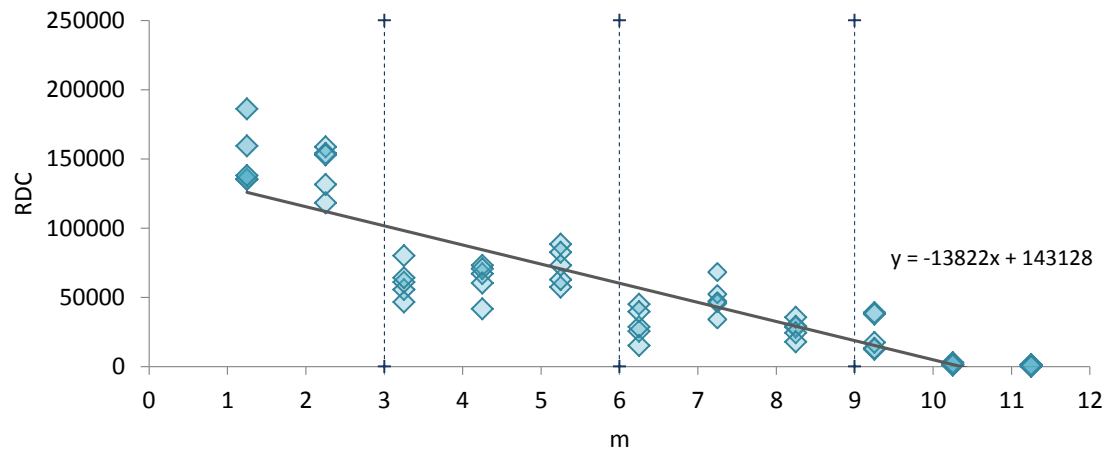
**Figure 4.3:** Results of Test C. The trendline is calculated on the average of the RDC results for each wave-generator position. Each 3 m rod length is identified by a dashed line

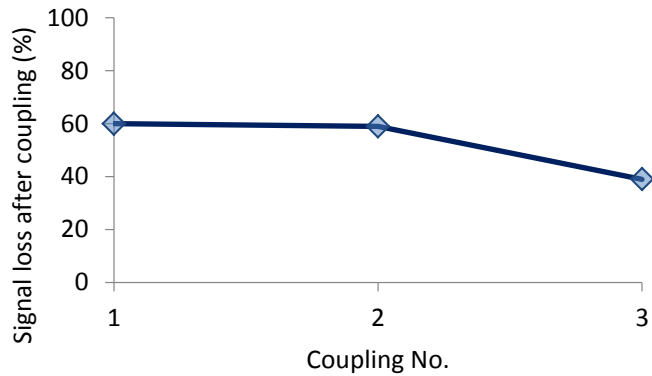
Figure 4.5: Percentage of signal loss after couplings: (a) for Test C; (b)

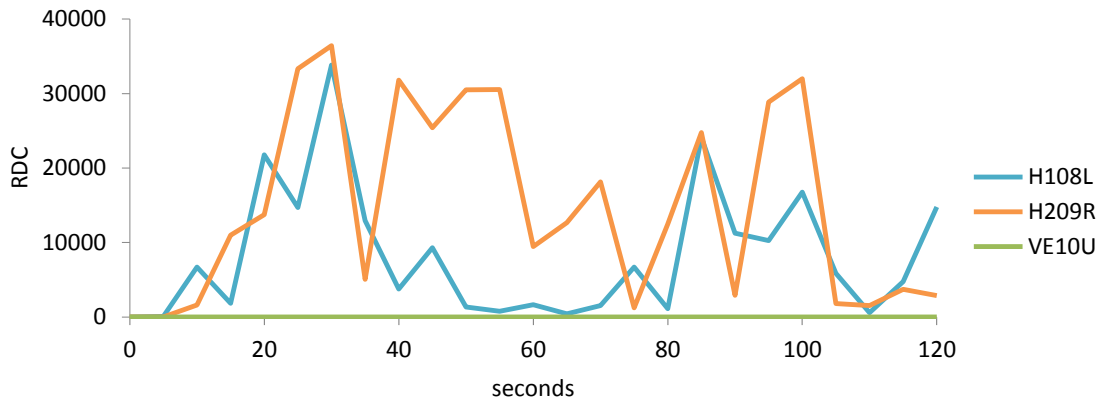
**Figure 4.9:** Results of Test F1. The test consisted in pouring water from a watering can onto sensors covers at SART site

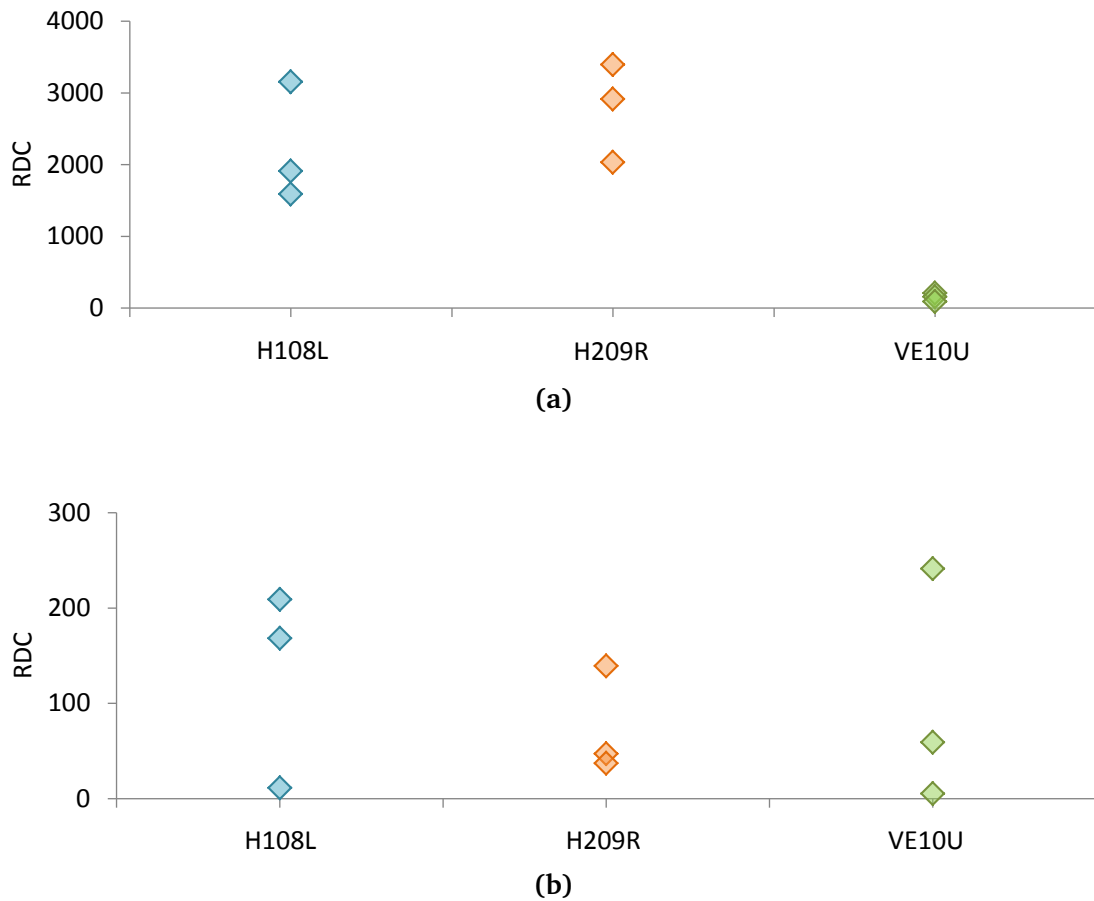
**Figure 4.10:** Results of Test F2. (a) drumming onto sensors covers for 5 seconds (3 repetitions); (b) hitting the cover with the shank of a screwdriver (3 repetitions)

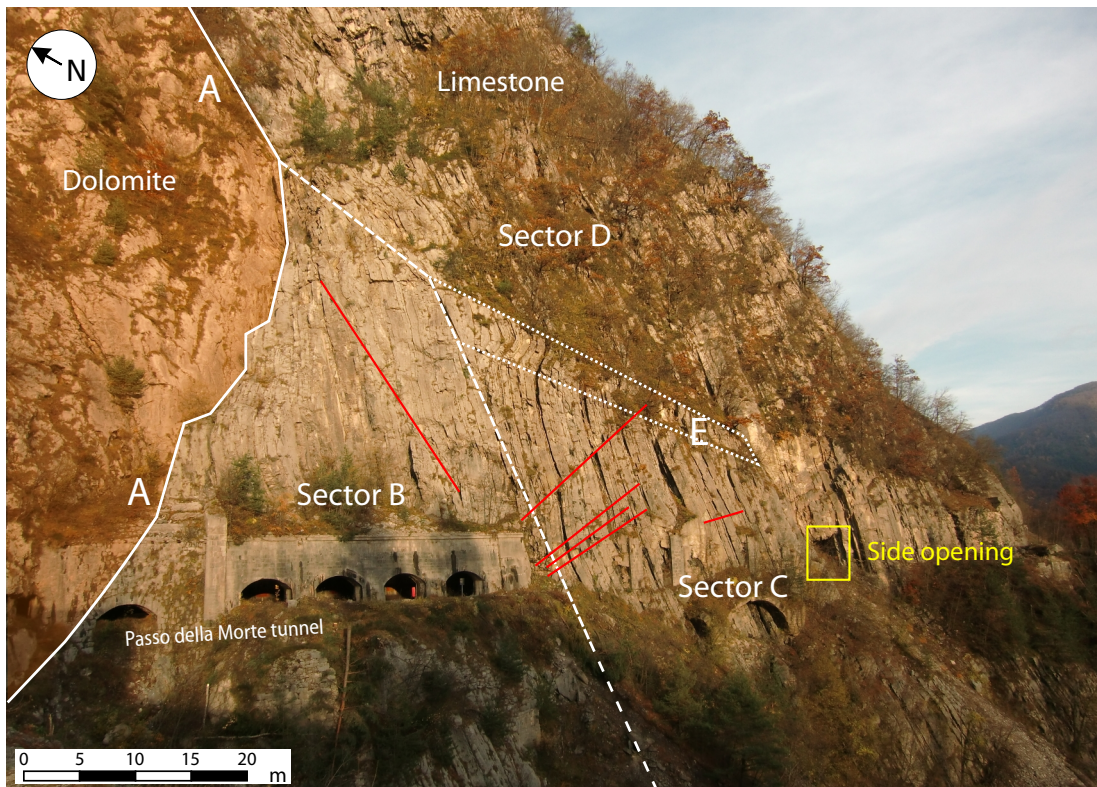
**Figure 5.4:** The limestone rock mass face photographed from the west. The structural elements described in the text are outlined: A is the contact between dolomite and limestone; B the sector characterised by tight bedding; C the sector with open bedding and marl infill; D the sector with shallower dip angle and E are small folds. The dolomite bedrock is coloured in light orange and the small faults are marked in red. The Rio Scuses flows along A during rainfall events. Some openings in the Passo della Morte tunnel are visible

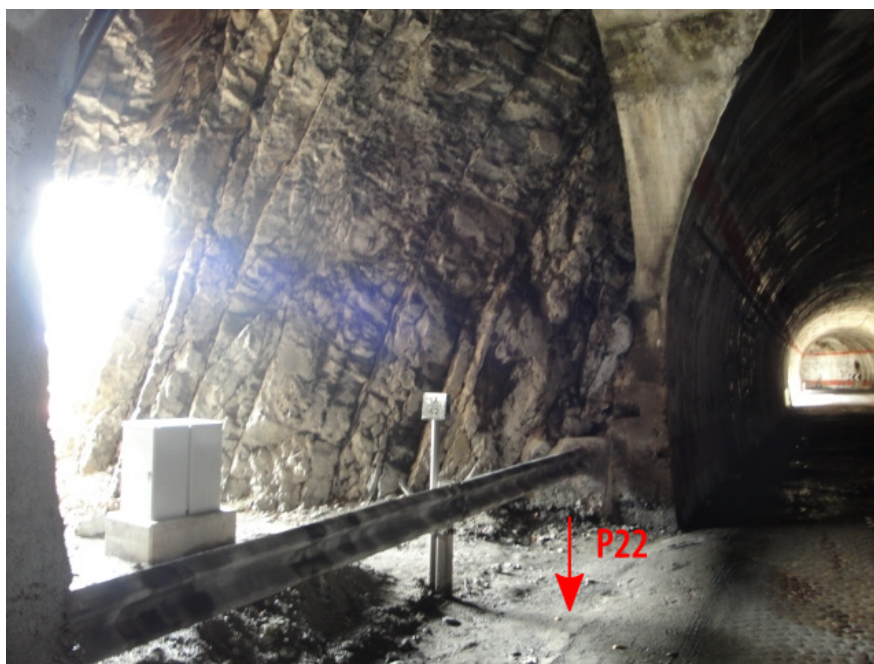
**Figure 5.5:** Side tunnel, also referred to as opening on the side of Passo della Morte tunnel. The red arrow indicate the location of piezometer P22 (in this photo it was not yet installed)

The piezometer available on site (see Section 5.2), located within the road tunnel just meters away from the slope (about 5 m from well head at tunnel level, as Figure 5.5 shows), continuously measures the groundwater level by means of a piezometric transducer. Figure 5.6 shows the comparison between the groundwater level measured by P22 and the precipitation. The rise in groundwater level follows the start of rainfall events after few hours, generally in the order of 12–15 hours. The base level is around  $-39$  m from tunnel level, which corresponds to an elevation of about 678 m a.s.l., as can be seen in the example graph reported in Figure 5.6.

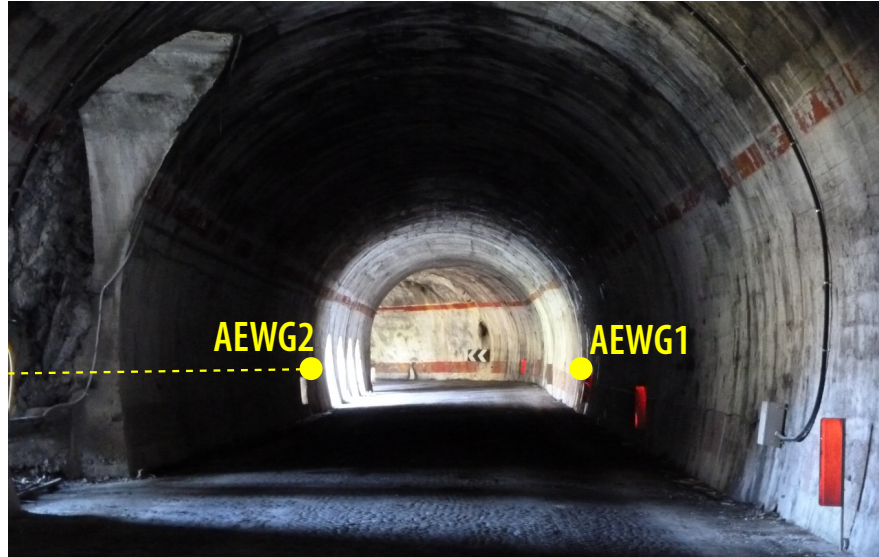
**Figure 5.7:** Location of sensors AEWG1 and AEWG2 within the PdM tunnel (yellow circles). The dashed line represents the projection of waveguide AEWG2; waveguide AEWG1 enters the rock mass approximately perpendicular to the photograph, which makes not possible to indicate the waveguide

At this site three horizontal waveguides, named AEWG1, AEWG2, and AEWG3, were installed in boreholes drilled through the steep limestone layers from within the road tunnel (Figure 5.7). The type of waveguides installed, sensors and parameter settings were previously discussed in Section 3.3.1 and summarised in Table 3.5. It is important to remind that data from this site are subdivided into Series 1 and Series 2 as two versions of the Slope ALARM system, version MK1 and MK2 respectively, were installed at this site at different times.

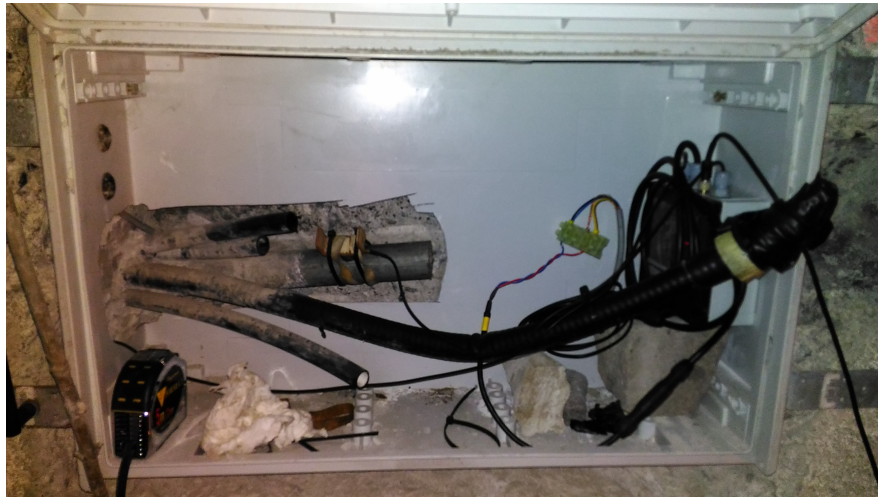
**Figure 5.8:** Plastic enclosure protecting AE equipment at Passo della Morte site placed in a niche formed within the road tunnel lining

Each Slope Alarm sensor is housed in a niche created in the tunnel lining around the waveguide end and protected by a plastic enclosure, see an example from the site in Figure 5.8.

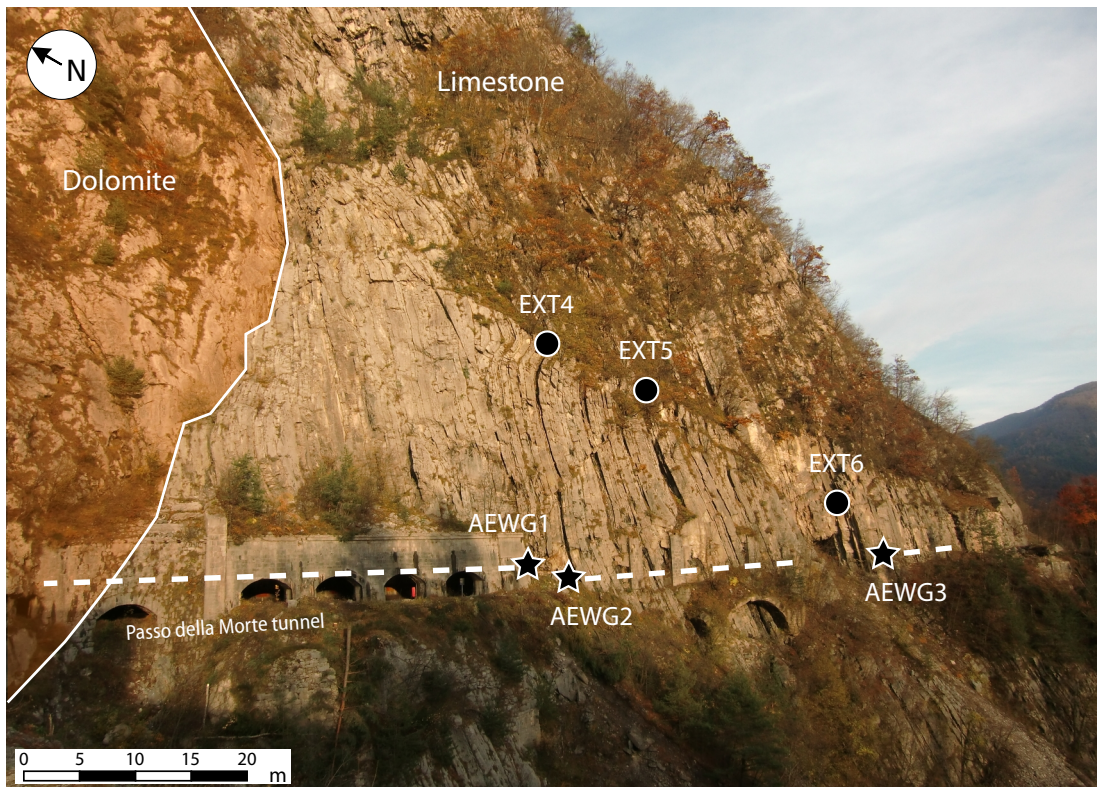
**Figure 5.9:** West rock mass face with projection of waveguides (dashed lines) and position of the Slope ALARMS sensors (stars, AEWG1,2,3) and locations of crackmeters (EXT4,5,6)

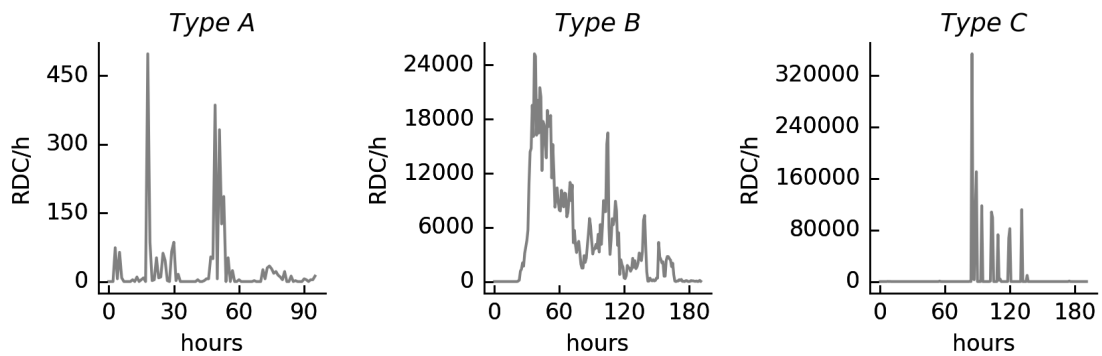
**Figure 5.15:** Type A, Type B and Type C acoustic emission patterns at Passo della Morte. Generally, Type A is in the order of hundreds RDC/h, Type B in the order of tens of thousands RDC/h and Type C in the order of hundreds of thousands RDC/h

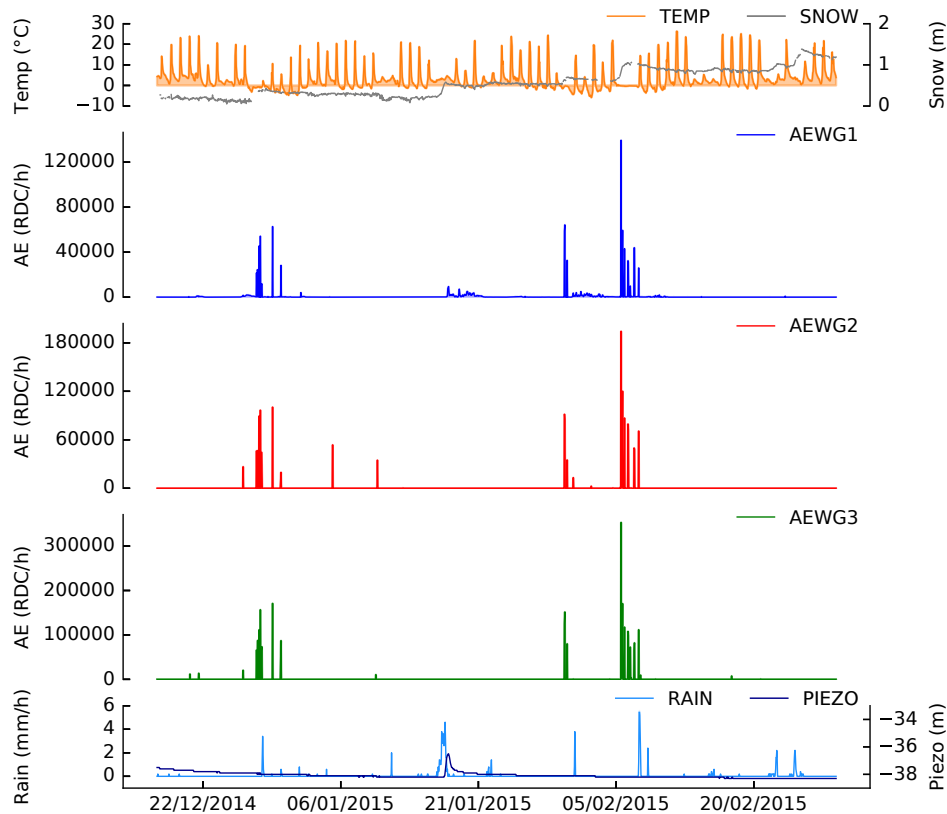
**Figure 5.20:** Examples of AE rates (RDC/h) in response to snow load. The high count events last for short time. They are clustered around the times when the snowfall occurs and are clearly not correlated with piezometric level changes or rainfall events

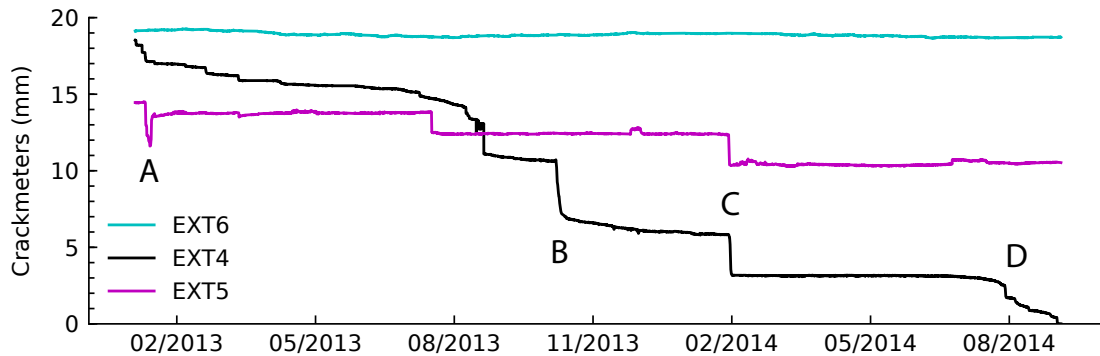
**Figure 5.21:** Crackmeters measurements. A, B C, D correspond to the events analysed in this Section

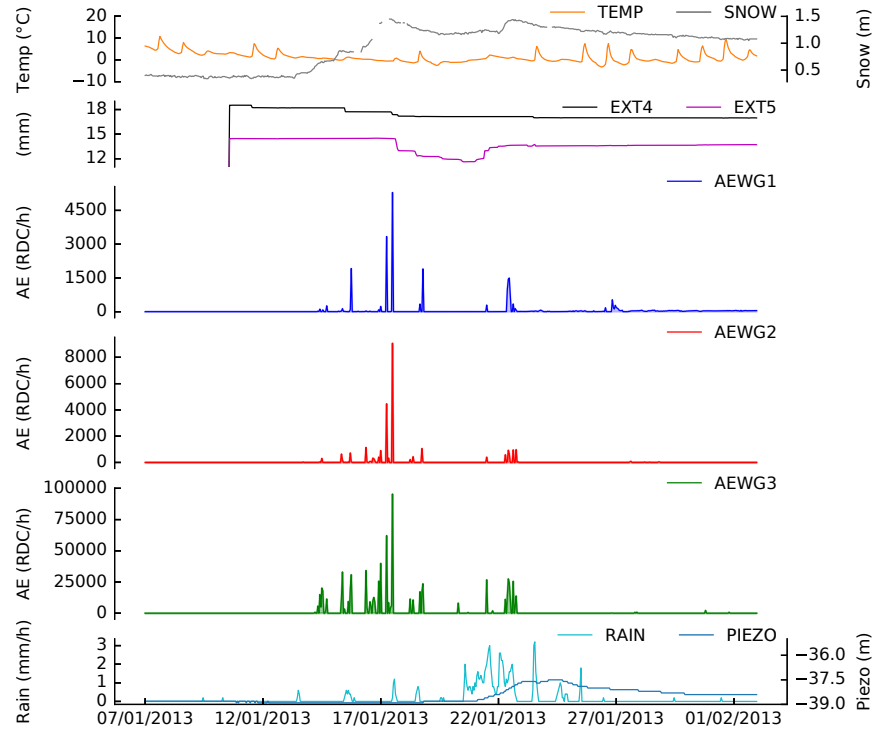
**Figure 5.22:** Event A – EXT4 cumulative displacement 1 mm; EXT5 cumulative displacement 1.5 mm

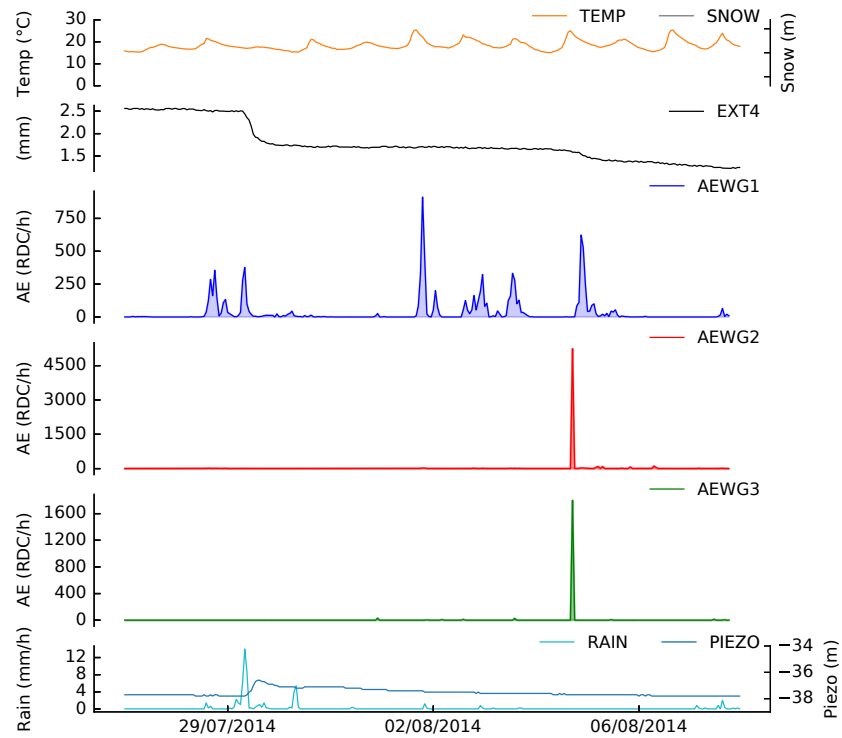
**Figure 5.25:** Event D – EXT4 displacement 0.8 mm main event; 0.2 mm minor event

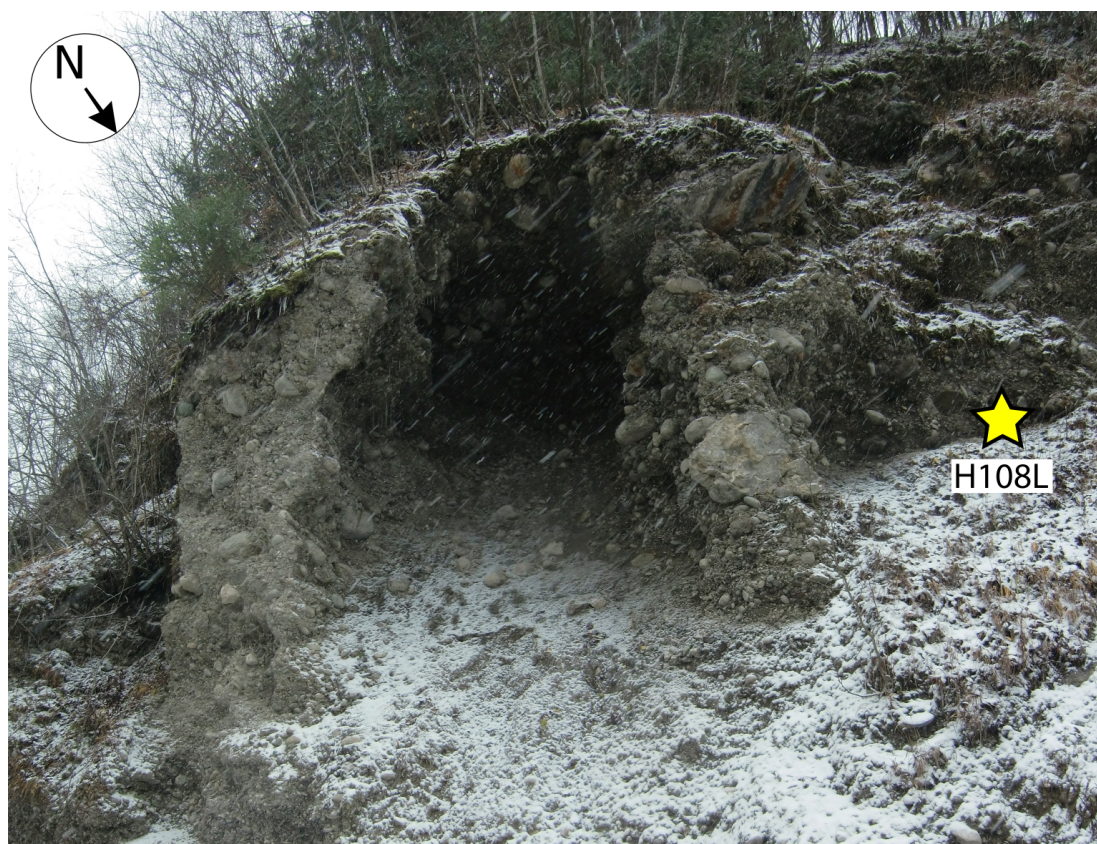
**Figure 6.4:** The small cave formed by localised washout of conglomerate material; sensor H108L is indicated with a yellow star

The waveguides are installed in the area where the April 2013 rockfall detached. From visual inspection this area seemed particularly prone to collapse due to vicinity of a overhanging section of the conglomerate sustained by two conglomerate pillars, forming a sort of small cave which can be observed in Figure 6.4. Wearing at the base of the two pillars by detachment of elements forming the conglomerate is foreseeable in the near future, thus enabling for a bigger-size collapse of the structure. An evidence of this is the rockfall occurred in April 2013, which detached from this area. The three waveguides are installed just to the right of the cave.

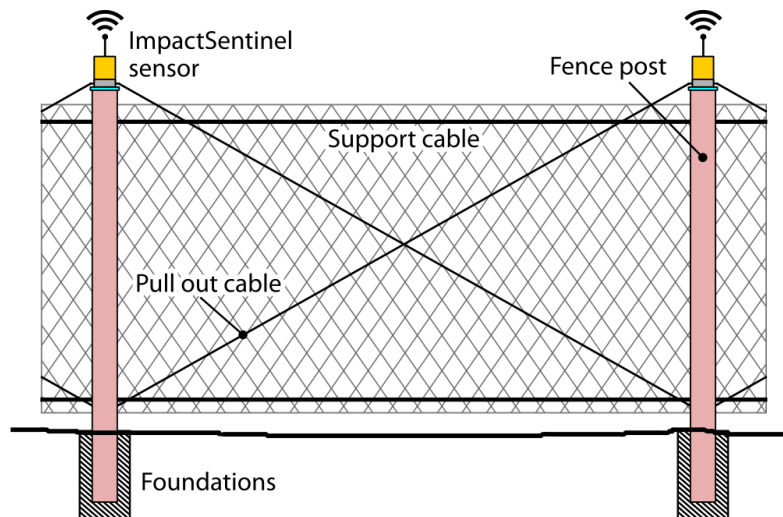
**Figure 6.6:** Schematic of the Detection Fence design. Modified after Hendricks et al. (2014)

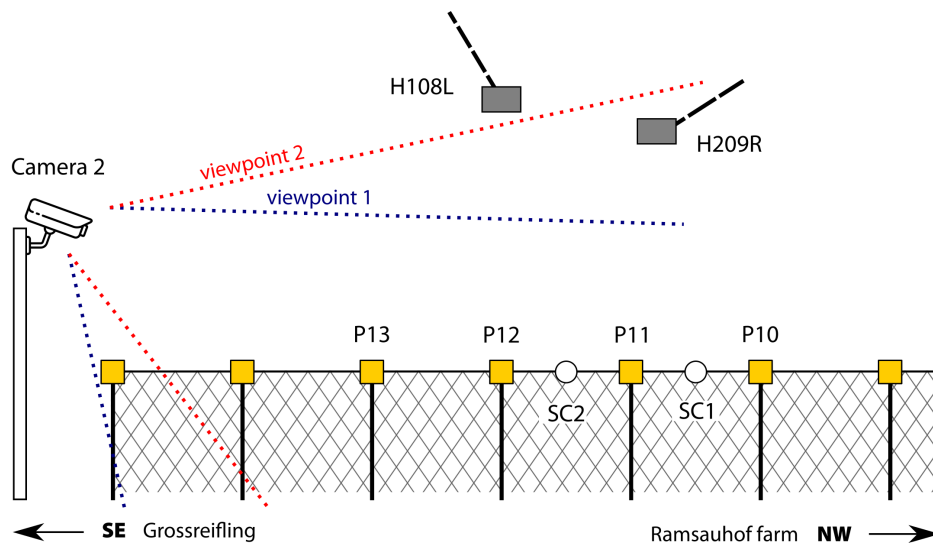
**Figure 6.7:** Schematic of the southernmost part of the detection fence below acoustic sensors H108L and H209R. The schematic includes the movement sensors locations, (P) = post, (SC) = support cable

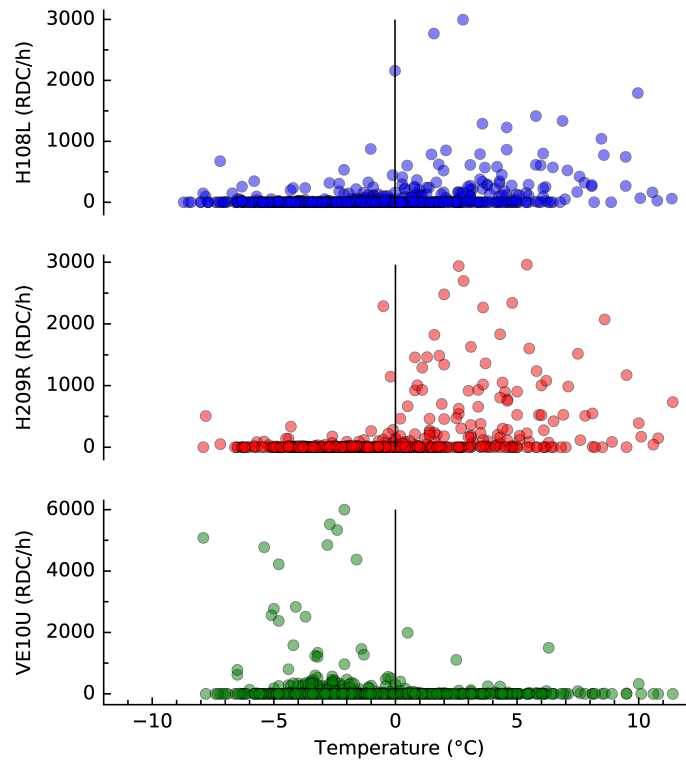
**Figure 6.15:** Acoustic emission (RDC/h) versus Temperature (°C) graphs for the three sensors H108L, H209R and VE10U. Data represented are same as Figure 6.14. H108L and H209R higher acoustic rates are concentrated at temperatures greater than 0 °C whereas VE10U shows higher rates at temperatures lower than 0 °C. The red line represents the 0 °C
