# Development of an Acoustic Emission Waveguide-based System for Monitoring of Rock Slope Deformation Mechanisms

A Doctoral Thesis

September 2017

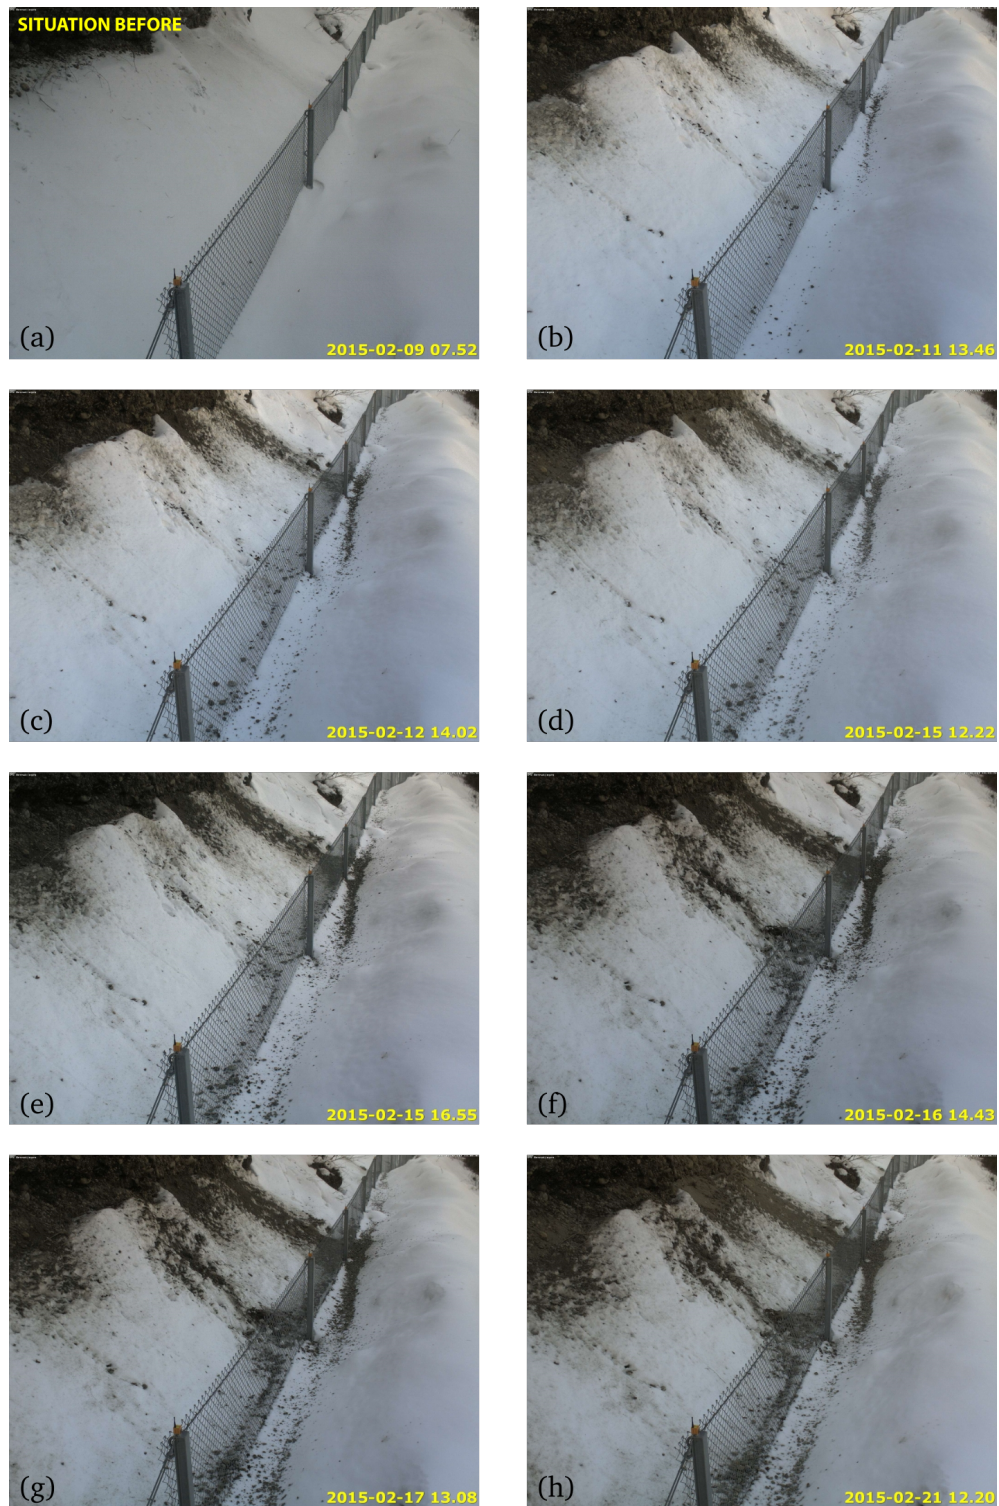
**Figure 6.17:** Material detached as consequence of freeze-thaw weathering. Samples of photos taken by Camera 2 (viewpoint 1) in the period 10–21/02/2015. For camera location reference to Figure 6.7

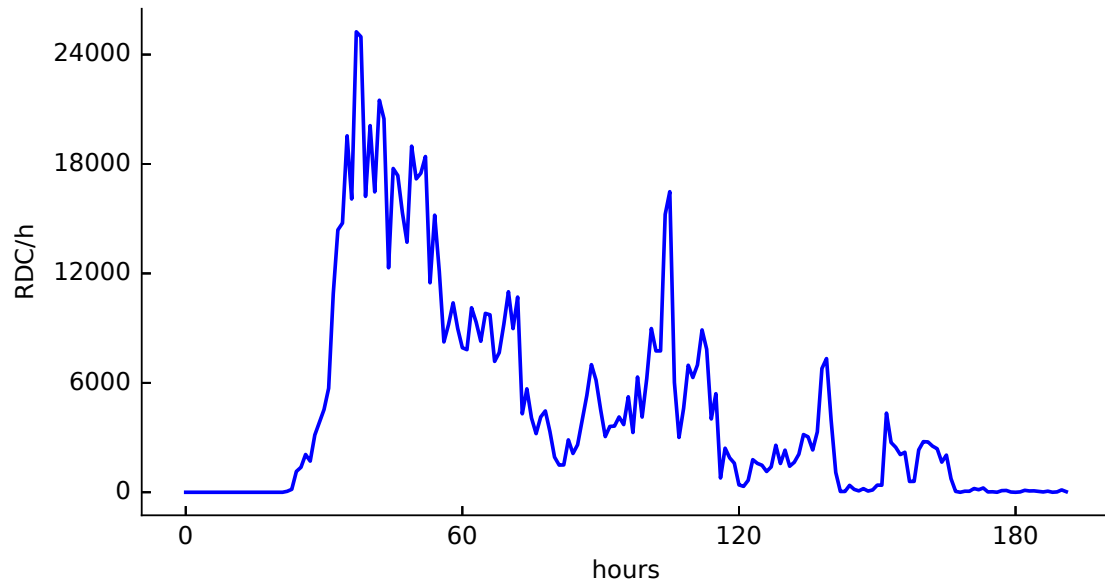
**Figure 7.1:** Typical AE trend due to variation of water pressure conditions (sharp increase and slow decrease)

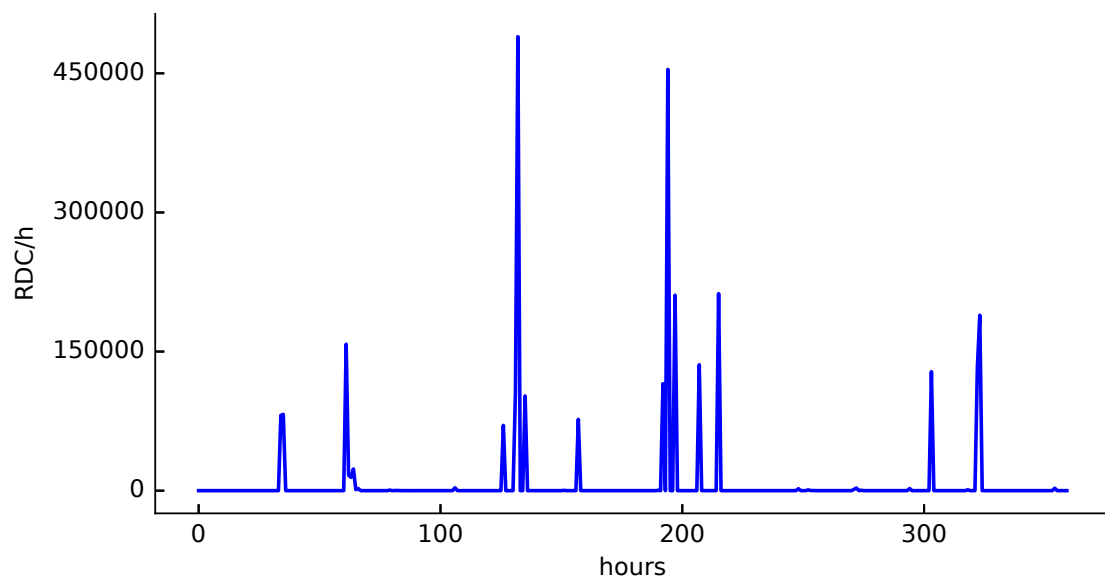
**Figure 7.2:** Typical AE trends due to snow load (sharp spikes)

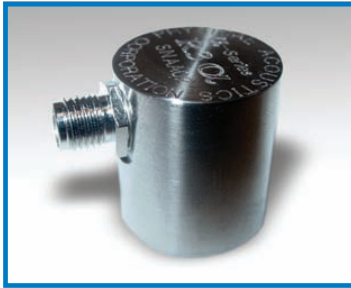
# R3α Sensor

## General Purpose, 30 kHz Resonant Frequency Acoustic Emission Sensor

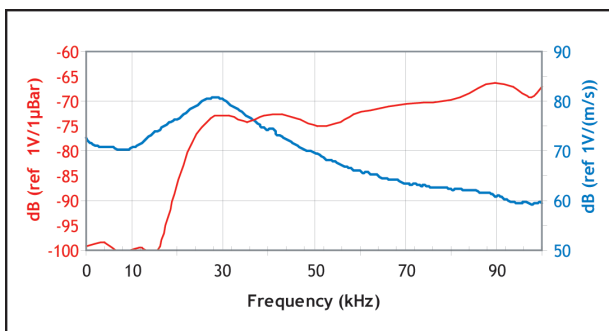
Frequency response of the R3α. Calibration based on ASTM E1106; Calibration based on ASTM E976.

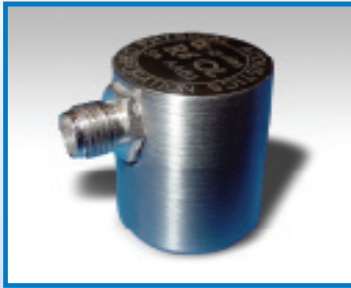
# R6α Sensor

## General Purpose, 60 kHz Resonant Frequency Acoustic Emission Sensor
