38th WEDC International Conference, Loughborough University, UK, 2015

**Septage treatment in Indonesia: lessons from field
investigations in seven cities**

BRIEFING PAPER 2114

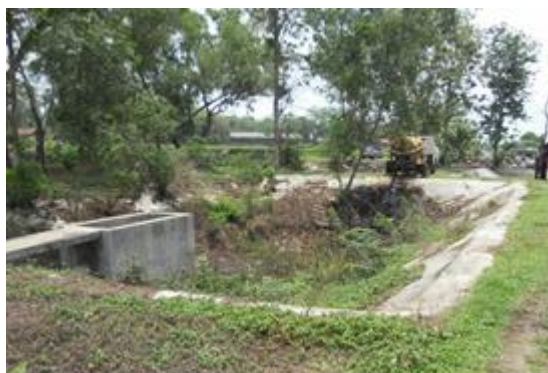
Photograph 1. Underloaded Metro anaerobic pond

The consequences of designing only for the assumed loading at the design horizon are evident at several of the treatment plants investigated. At worst, the volume of septage discharged is insufficient to fill treatment units. Photograph 1 shows the first anaerobic pond at Metro, where the low hydraulic loading, combined with leakage from the bottom of the pond, means that the pond is almost empty during dry weather.. All subsequent ponds receive no flow and are overgrown. In Palu, water does pass through the ponds but the ‘anaerobic’ ponds are light green in colour, indicating that they are performing in facultative or even maturation pond mode.

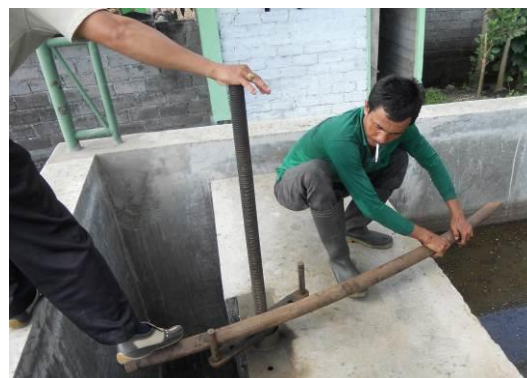
Photograph 2. Operators struggling to move SSC outlet penstock

It should be possible to follow this cycle for the first and third SSCs simultaneously and then switch to the second and fourth SSCs. In fact, only two of the SSCs were in use at the time of the visit but the principle remains the same. When requested to lower the outlet penstock, operators had to use considerable force to move the penstock, even after applying grease. (See Photograph 2). The light green colour of the ‘anaerobic’ pond receiving the liquid fraction from the SSC indicated that it was very lightly loaded. The likely explanation for these observations an SSC does not fill over the prescribed four day filling period at the current hydraulic loading rate. There is thus little or no flow over the penstock. After the prescribed three days settling period, the operators pump a mixture of sludge and supernatant water to the drying area without lowering the penstock. The flow to the first pond thus consists mainly of the small volume of that drains through the porous base of the SSC, perhaps supplemented by a small amount of overflowing supernatant water: hence the light colour, which is indicative that the pond is lightly loaded. In view of this, there is reason to doubt whether the filter bed detail shown in Figure 1 fulfills any useful purpose. Operational performance would be improved by loading each SSC for longer than the prescribed four-day loading period and allowing supernatant water to follow over the penstock to the first anaerobic pond. This would make better use of the capacities of both the SSC and the anaerobic pond.

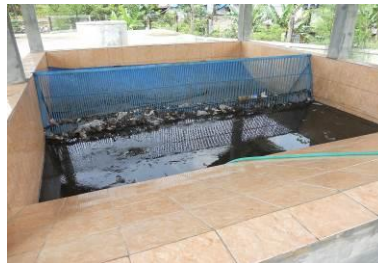
Photograph 3. Vertical screen with no operator access

Screens Photograph 3 illustrates two common design weaknesses. First, the use of a vertical screen rather than inclined screen, which makes raking the screen difficult and second, the failure to think about how the operator can access the screen to rake it. The result is that solids block the screen and cause the water level to build up until an operator enters the chamber to remove the objects caught on the screen by hand. This is clearly an unhygienic and unpleasant practice. Figure 2 shows the recommended layout for a hand-raked screen, with bars sloped at an angle of about 60 degrees to the horizontal and bent over at the top to allow screenings to be raked into a trough, from which they can easily be removed. A platform is provided behind the screen to allow operator access for raking.
