38th WEDC International Conference, Loughborough University, UK, 2015**WATER, SANITATION AND HYGIENE SERVICES BEYOND 2015:
IMPROVING ACCESS AND SUSTAINABILITY****A hidden crisis: strengthening the evidence base on the
current failures of rural groundwater supplies**

BRIEFING PAPER 2181

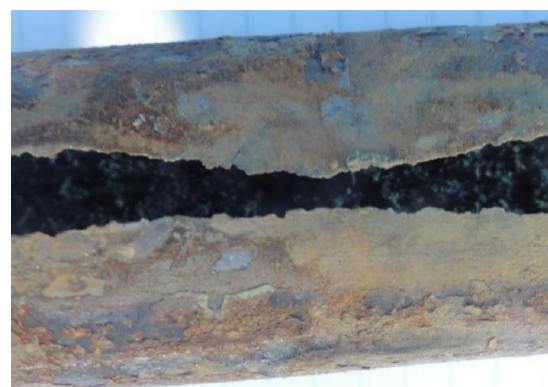
Photograph 2. Perforation of a rising main from corrosion

Corrosion of GI handpump components is clearly shown to be a significant causal factor to many of water point failures in the study, with corrosion having led to, or contributed, to mechanical and/or water quality failure symptoms in almost all of the water points examined. Photograph 2 shows an example of corrosion having led to complete perforation of a 0.5 m long section of hand-pump rising main pipe.

In the absence of a robust evidence base the MWE have been unable to assess the main causes of water point failure in the Amuria and Katawki districts to inform better practice. The results of the pilot study begin to provide this robust evidence base, and the MWE are now working to enforce tighter regulation of hand-pump material quality with the Uganda Bureau of Standards. This should move to find more appropriate hand-pump materials in the region, in which GI material have been advised against for reasons of corrosion in Eastern Uganda since the 1990s.
