20th WEDC Conference

Colombo, Sri Lanka, 1994

**Wastewater disposal and problem soils in Lanzhou, China***Tom Dijkstra, WEDC, UK.*

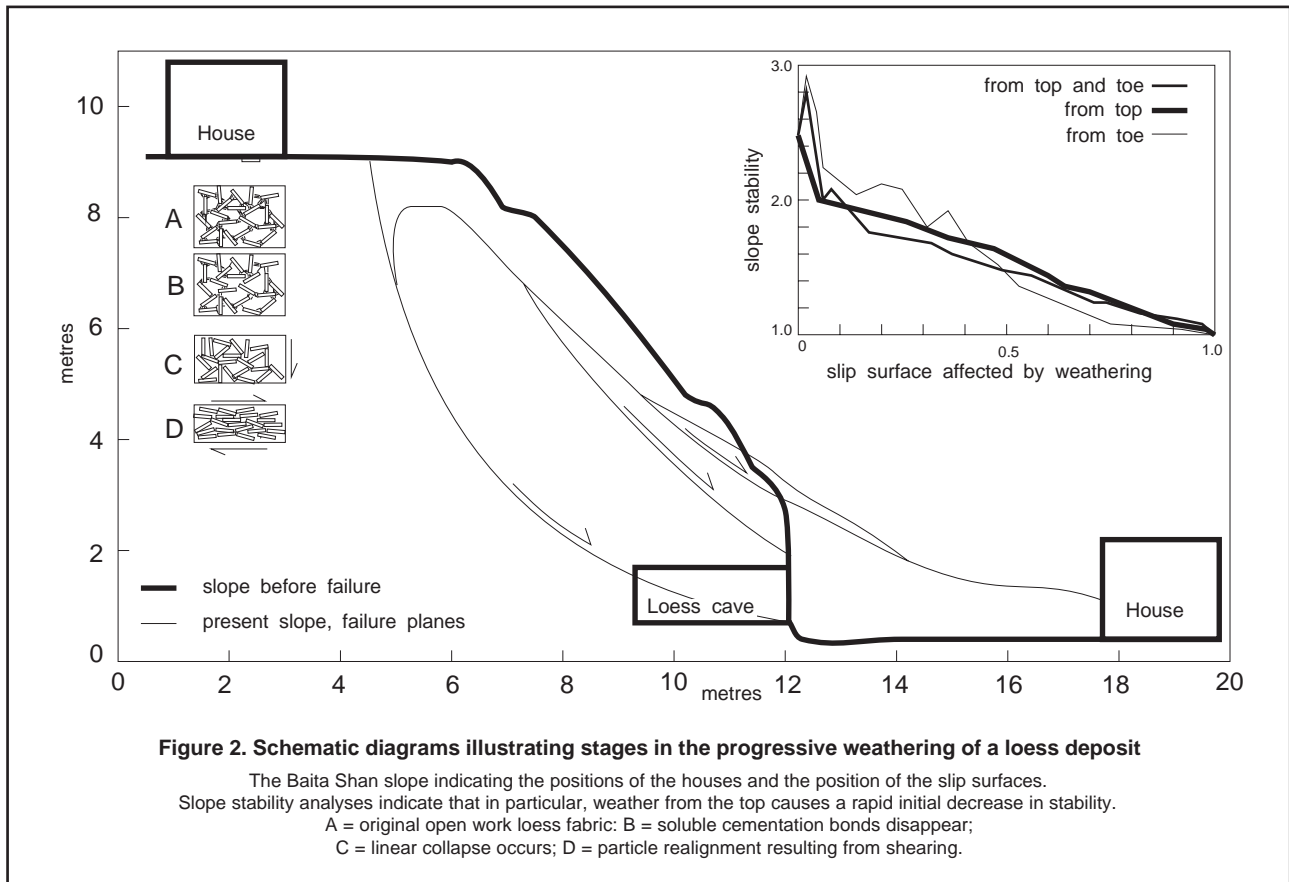
The results of the analyses are shown in Figure 2. With the weathering from the top of the slope a strong initial decrease of slope stability occurs, which is explained by the considerable drop in effective cohesion values when the loess changes from an undisturbed into a weathered ('remoulded') state and the relatively small effective normal stress acting on the failure plane at this point. This effect gradually becomes less important with the increase in the effective internal friction angle taking effect at greater depths after further progression of the internal weathering of the slope. Slope stability analyses carried out while adding weathered slices from the toe of the slope indicate an initial increase in factor of safety due to the higher internal friction angles of the weathered slices causing the lowest slices to act as buttresses against movement of the upper parts of the slopes. After adding the third slice this effect is diminished by the changes in the effective apparent cohesion values, leading to a sudden drop in the safety factor. This curve does not follow the relatively smooth progression of weathering from the top, but for certain additional slices the factor of safety increases above the previous value. The reasons for this are thought to be a combination of the complexity of strength parameter variation (c' falls, rises and then falls again while $\tan \phi'$ rises then falls), the irregular pre-failure surface profile and the considerable influence of effective normal stress up to at least 50% weathering, and the rapid inclination of the failure plane.

During the simulation of the combined effects of weathering of the top and the toe of the slope an initial increase in factor of safety is observed, which is immediately followed by a rapid decrease and a subsequent small increase. Both increases are caused by the higher values of the effective internal friction angle of the remoulded loess. These higher values are particularly effective in the lower part of the slide, where the effective internal friction angles are significantly higher than the local slip surface angle measured at the base of each slice and the effective normal stress is greatest. The effect will be even more pronounced for larger mass movements where the changes in effective internal friction become relatively more important than the changes in effective

cohesion. Figure 2 indicates that slopes which, in an unweathered state, have safety factors close to unity might fail after only a short period of progressive weathering. This process will take considerably longer for the initially more stable slopes. Within the urban environment the man-made cut slopes are frequently close to equilibrium and therefore moderate amounts of weathering affected by *e.g.* the uncontrolled disposal of waste water may bear great risks for these sites.
