**35th WEDC International Conference, Loughborough, UK, 2011****THE FUTURE OF WATER, SANITATION AND HYGIENE:  
INNOVATION, ADAPTATION AND ENGAGEMENT IN A CHANGING WORLD****The impacts of on-site septic tank  
wastewater disposal in Kampala city***S. Kagwisagye & L. Gill, Uganda***REFEREED PAPER 1107**

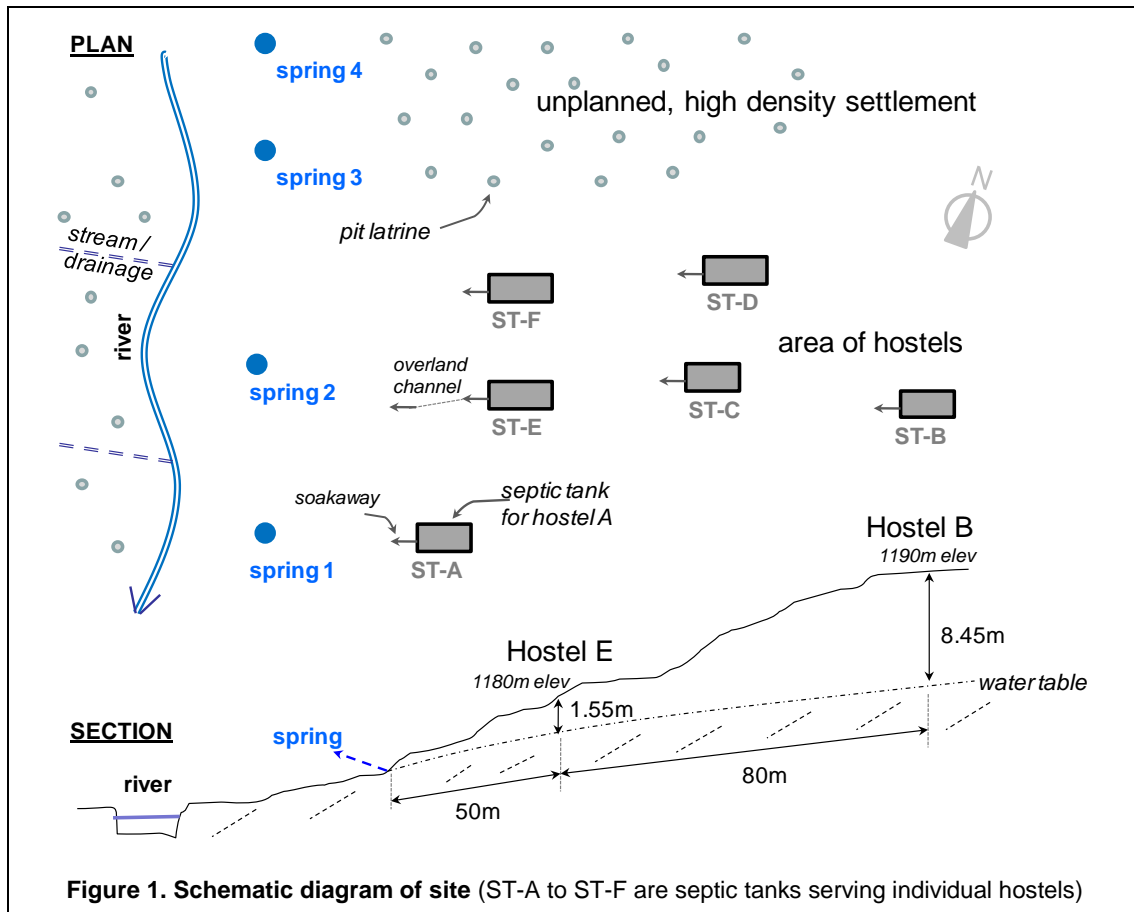
students of Makerere University (see Figure 1 and Photograph 1). This area has been relatively well-planned and each hostel was serviced by piped water and a septic tank for wastewater treatment prior to discharge into the subsoil. Several of the hostels also had their own additional source of groundwater collected from shallow wells in the basements of the buildings. This groundwater was pumped up to the header tank on the roof to avoid paying high prices for the metered piped water supply. To the east and further down into the valley bottom of this study area was an un-planned peri-urban area, shown schematically on Figure 1, which predominantly relies on the local springs and pit latrines for their water and sanitation needs. Some of the springs used were in close proximity to the effluent discharge points from the hostels as detailed in Table 1.

The trial holes dug just downstream of Hostels E and F, in addition to a deep construction site excavation near to Hostel B, enabled the depth the water table profile down the hill to be plotted, as shown on the section in Figure 1. This revealed a reducing depth of unsaturated subsoil with distance down the slope to the point where the springs emerge. Hence, the springs were more at risk of contamination from the septic tank effluent from the hostels which are furthest down the slope due to proximity (as expected) but also the
