The energy and thermal performance of
UK modular residential buildings

Doctoral Thesis

Abstract

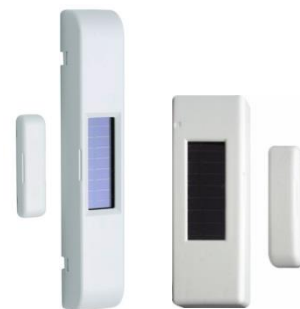
Contacts were purchased from two manufacturers, (Figure 3.5), Eltako contacts were used in the Loughborough study, and Peha contacts in the London study. The technical specifications are identical, the only difference is the sensor housing and dimensions, (Table 3.6). The contacts sensors have two parts, the sensor and the magnet. One part is fixed to the frame and the other to the window or door. When the two parts are brought together or separated the sensor is triggered and a wireless telegram is transmitted.

Figure 3.5: Peha contact left and Eltako contact right [EnOcean Alliance, 2014]

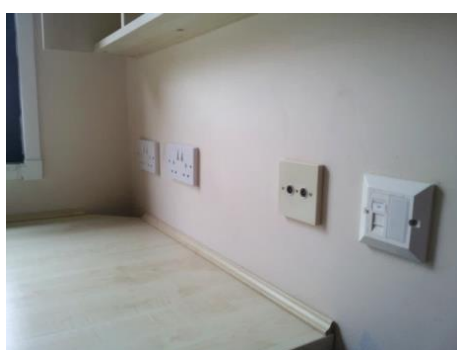
Within the modules strong air leaks were found coming through the various sockets (Figures 7.4 and 7.5). No other leaks were detected, including around the windows or at the junctions between walls, floors and ceilings.

Figure 7.4 (left): Air leakage path through sockets in modules: Loughborough case study

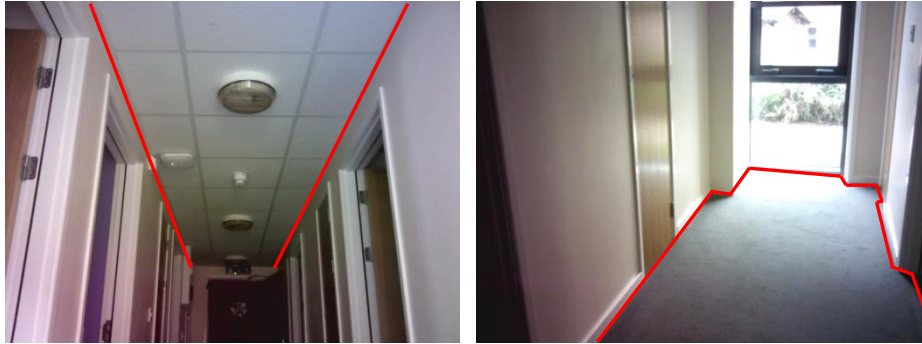
Air leaks were also detected along the full length of the corridor at floor and ceiling level where the corridor and modules interface (Figures 7.6 and 7.7).

Figure 7.6 (left): Air leakage paths along corridor ceiling indicated in red

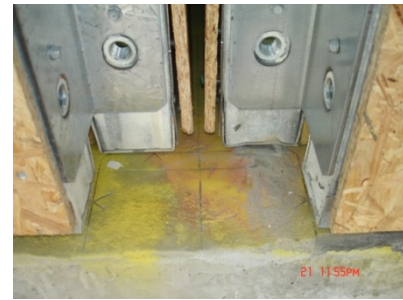
25mm air gap at the party wall junction between modules; at each end of these junctions are voids measuring 100mm by 175mm (Figures 7.14 and 7.15). The externally facing voids are filled with rock wool insulation before being covered with rigid insulation and cladding. The internally facing voids are simply covered with two layers of plasterboard, which form the corridor walls. No evidence was found of any further measures taken to seal the party walls junction between modules.

Figure 7.14: Air gap at party wall junction between modules
[REDACTED] 2012]

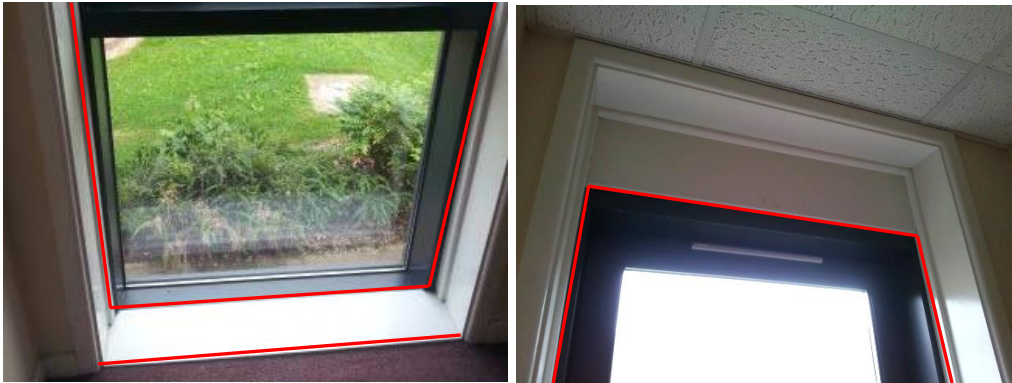
During depressurisation with the blower door kit large quantities of air were found leaking through the interface between the curtain walling and the corridor, both horizontally and vertically (Figures 7.20 and 7.21).

Figure 7.20 (left): Air leakage paths shown in red around bottom of curtain walling

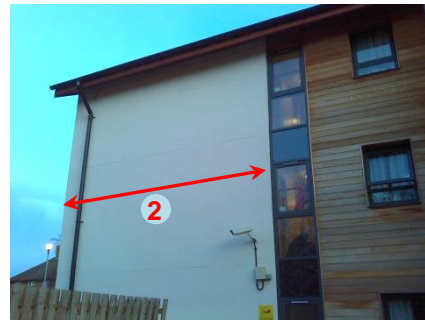
Figure 7.51 (left): Plan of Loughborough south building – walls indicated for heat loss calculations
[Architect 2, 2006]

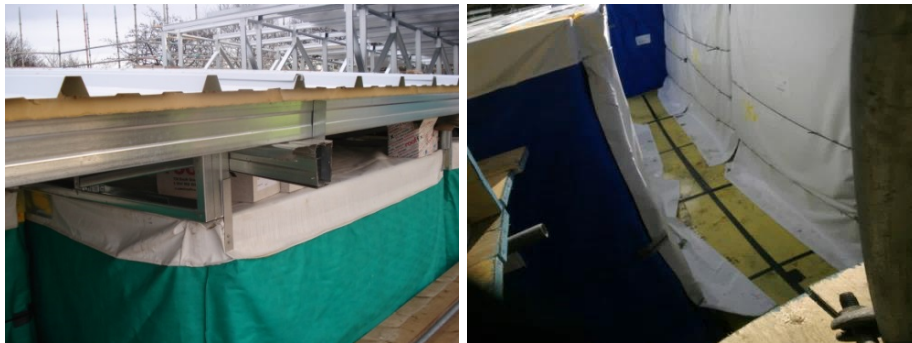
Figure 7.61 (left): Loose fitting breather membrane [REDACTED] 2012]

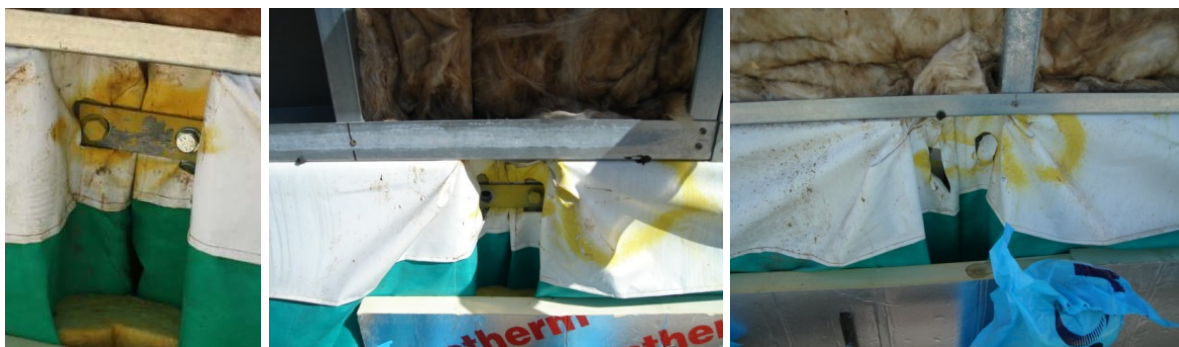
The insulation that is fitted into the void at the party wall junctions between modules was of insufficient length in all photographs (Figures 7.65 to 7.68). The thermal bypasses this creates have already been discussed in section 7.2 Airtightness. [REDACTED] the loose fitting breather membrane appears to make it impossible to correctly fit the rigid insulation to the external walls of the modules, because the membrane bunches up and the rigid insulation cannot be fitted flat against the module (Figures 7.66 to 7.68). [REDACTED] many of the rigid insulation boards are not taped at their joints (Figures 7.68 to 7.70).

Figure 7.65 (left): Insulation of insufficient length revealing party wall junction behind [REDACTED] 2012]

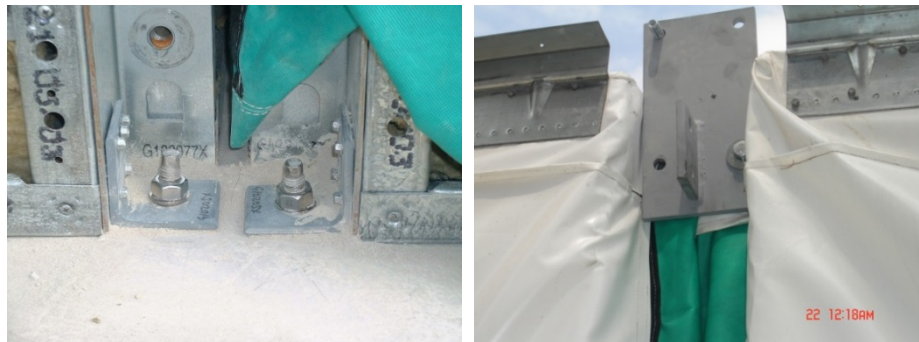
Figure F.1 (left): Two adjacent modules fitted to the foundations [REDACTED] 2012]

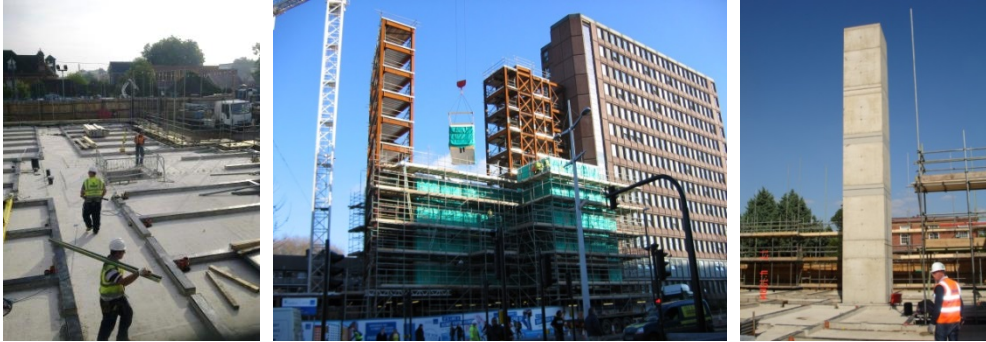
Figure I.1 (left): Site photo: Foundation being prepared on site for module installation [REDACTED] 2012]
