# Acoustic emission monitoring of coastal slopes in north-east England, United Kingdom

**Abstract:** Acoustic emission (AE) monitoring of active waveguides (a steel tube with a granular backfill surround) installed through a slope can provide real-time warning of slope instability by quantifying increasing rates of movement (i.e. accelerations) in response to slope destabilising effects. The technique can also quantify decelerations in movement in response to stabilising effects (e.g. remediation or pore-water pressure dissipation). This paper details the AE monitoring approach and presents results from a field trial that compares AE measurements with continuous subsurface deformation measurements. The results demonstrate that AE monitoring provides continuous information on slope displacement rates with high temporal resolution. Case studies are presented where the AE technique is being used to monitor coastal slopes at Filey and Scarborough in North Yorkshire, UK, to inform on-going risk assessments for these slopes. The results demonstrate that the AE approach can successfully be used to monitor slopes with relatively deep shear surfaces (> 14 m); however, they also show that p

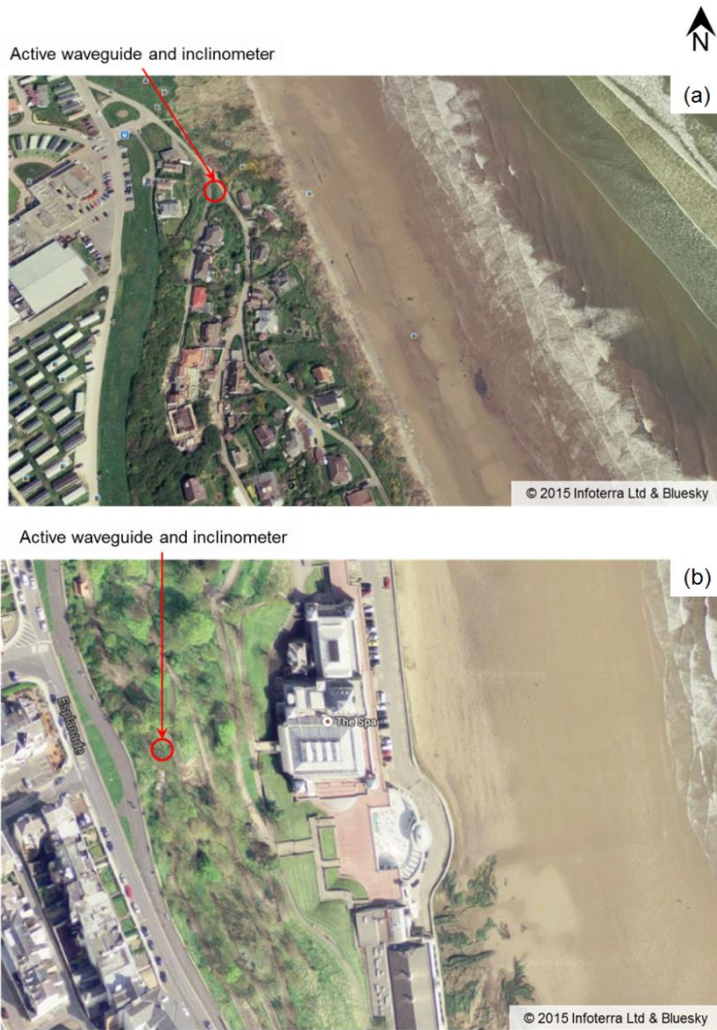
Figure 5. Instrumentation locations: a) Flat Cliffs, Filey; b) Scarborough Spa (© 2015 Infoterra Ltd & Bluesky)

Cliff instability along the Filey and Scarborough coastlines (Figure 4) has necessitated Scarborough Borough Council to commission ground investigations, which have been interpreted by Halcrow (now CH2M) to facilitate stability assessments and inform on-going risk assessments and site management. As part of a monitoring programme an array of instruments were installed across the cliffs, and active waveguides were installed at both Filey (in September 2011) and Scarborough (in November 2012). Their locations are shown in Figure 5.

An active waveguide (location in Figure 5) was installed in a 130 mm diameter borehole to a depth of 25 m below ground level, with the annulus around the steel tubing backfilled with compacted angular 5 to 10 mm gravel. The steel tube (50 mm diameter 3 mm thick) extends 0.3 m above ground level and is encased in a secure protective chamber (Figure 6). The adjacent inclinometer casing was installed to a depth of 24.5 m below ground level. The battery powered AE sensor is located inside the protective cover with the piezoelectric transducer coupled to the waveguide, and monitoring is continuous at 30-minute intervals.

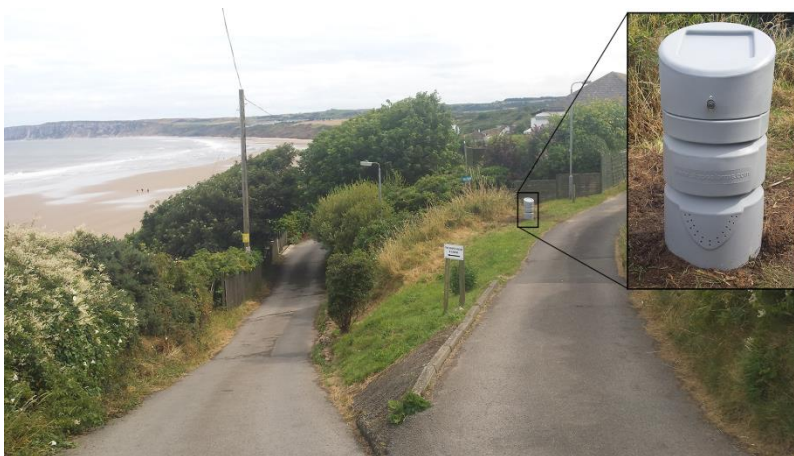
Figure 6. Photograph of the coastal slope at Flat Cliffs, Filey, showing the instrumentation location

The slope at Flat Cliffs, Filey, is a reactivated landslide that threatens a settlement of houses, access roads and utilities, and moves along a relatively deep shear surface (14 m) in response to excess pore-water pressures, and due to toe erosion by the sea. Instability is indicated at the ground surface by repeat deformation of an access road.

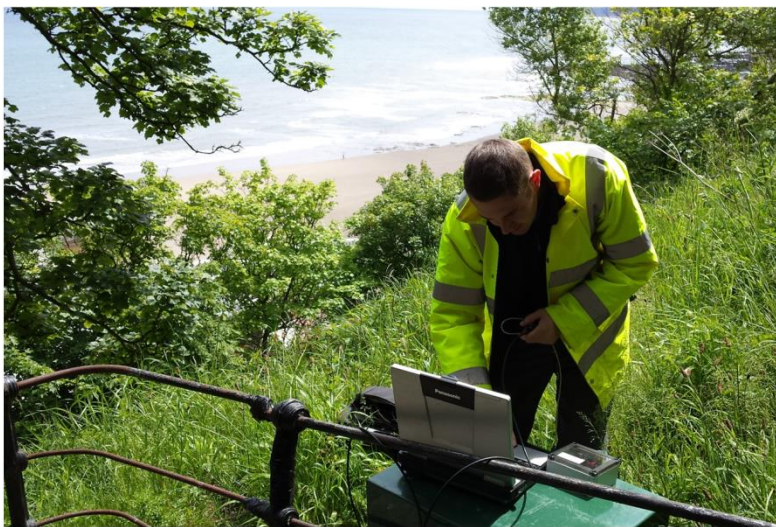
Figure 7. Photograph of the coastal slope at Scarborough

The published geological maps for the Scarborough site show Glacial Till overlying mudstone and limestone of the Scarborough Formation of Jurassic age. Logs from the borehole in which the active waveguide was installed show the predominant material down to the bottom of the hole was glacial sediment (boulder clay), with bands of sand and gravel from 15 to 18 m below ground level. Figure 7 shows a photograph of the slope.
