An acoustic emission slope displacement rate sensor — case studies

Abstract

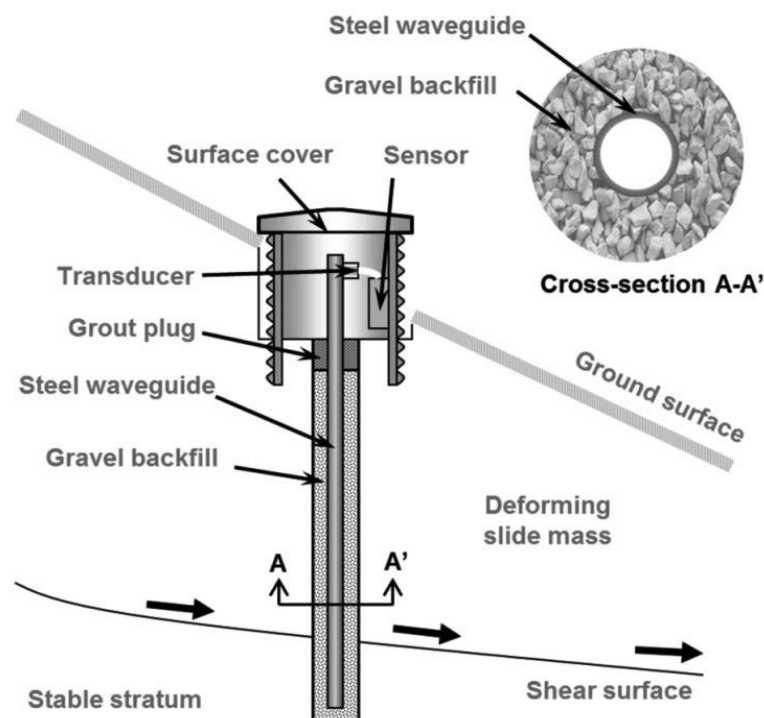
Figure 1 Schematic of an active waveguide installed through a soil slope deforming on a shear plane, with a sensor connected at the ground surface and protected by a cover (after Dixon et al. 2012a; Smith et al. 2014a)

In order to apply the AE monitoring approach to soil slopes, Dixon et al. (2003) conceived the active waveguide (Figure 1). This is installed in a borehole through existing or anticipated shear zones. Deformation of the slope strains the waveguide generating detectable AE. The use of a reproducible 'active' waveguide allows standard interpretations from the system to be developed. Additionally, the granular backfill soil generates measurable AE and overcomes the small magnitude AE generated by slopes formed of 'quiet' fine-grained soils. AE monitoring using active waveguides has become an established approach to monitor the stability of soil slopes; however, the challenge has been to develop strategies to quantify deformation behaviour from the measured AE. Physical modelling (e.g. Dixon & Spriggs 2007; Smith & Dixon 2014) and field trials (e.g. Dixon et al. 2003; Dixon et al. 2014; Smith et al. 2014a; Dixon et al. 2015) have demonstrated that active waveguide-generated AE is proportional to the rate of deformation, and this relationship can be quantified to allow slope displacement rates to be derived from measured AE.

The active waveguide (Figure 1) is installed in a borehole that penetrates stable stratum below any shear surface or potential shear surface that may form beneath a slope. It comprises a metal waveguide with a granular backfill soil surround. When the host slope deforms, the column of granular soil also deforms generating AE that can propagate along the waveguide. A transducer coupled to the waveguide at the ground surface converts the AE to an electrical signal, which is sequentially processed by the AE sensor. The AE sensor amplifies the signal and removes frequencies outside of the 20 to 30 kHz range. This is an important step in removing low frequency (<20 kHz) background noise such as traffic and construction activity. The sensor then logs the number of times the waveform crosses a pre-programmed voltage threshold level within pre-set time intervals; ring-down counts (RDC) per unit time (AE rates). The AE monitoring system that has been developed is called Slope ALARMS (Assessment of Landslides using Acoustic Real-time Monitoring Systems). Figure 2 shows an annotated photograph of the system taken from inside a surface cover.

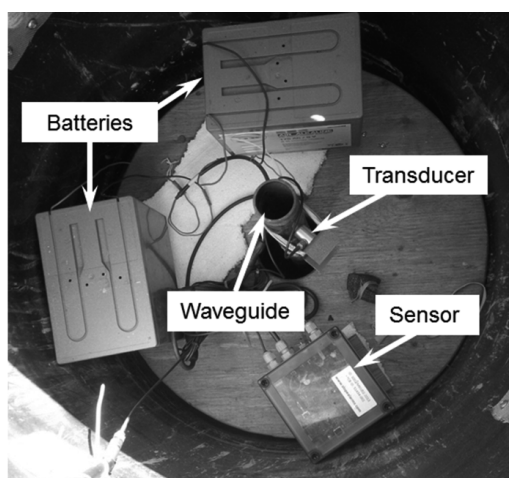
Figure 2 Photograph of the Slope ALARMS AE measurement system from inside the protective surface cover (after Smith et al. 2014b)

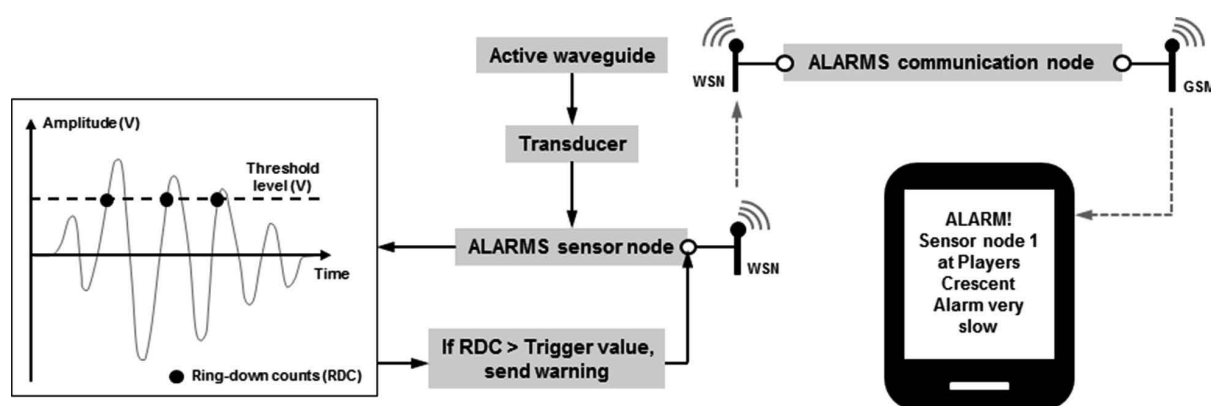
Figure 3 Schematic of operation of the AE monitoring for soil slopes and communication system (after Smith et al. 2014c and Dixon et al. 2015). In rock slopes the active waveguide is replaced by a passive waveguide

AE rates recorded by the measurement system in each monitoring interval are compared to a series of threshold levels, which are derived from the order of magnitude slope displacement rate classifications (e.g. Cruden & Varnes 1996): ‘slow’ (e.g. 1 mm/hour), ‘moderate’ (e.g. 100 mm/hour) and ‘rapid’ (e.g. 10,000 mm/hour). If a Slope ALARMS sensor detects RDC within a set time period that exceeds a trigger warning level then the sensor transfers this to the communication system through a wireless network link. The communication system subsequently sends an SMS message to responsible persons so that relevant action can be taken (e.g. send an engineer to inspect the slope or immediately stop traffic). The absence of generated SMS messages means that slope displacement rates are lower than the minimum threshold set. Automatically generated daily health SMS messages provide information on the status of the system, demonstrating it is operational. The system therefore provides continuous near real-time information on slope displacement rates with high temporal resolution (i.e. monitoring periods are typically 15 or 30 minutes) (Dixon et al. 2015). Figure 3 shows an operation schematic of the AE early warning system.

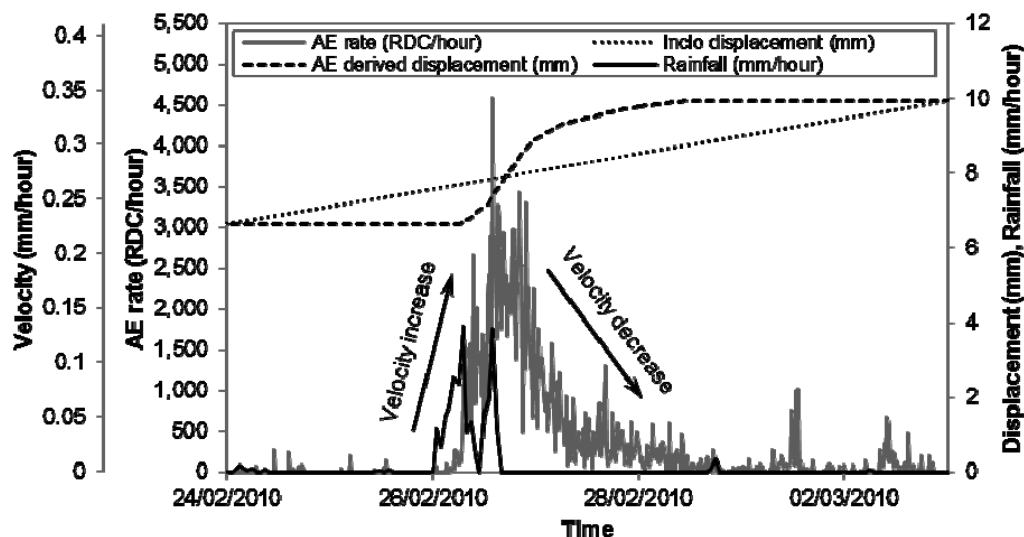
Figure 4 AE rate-, AE derived velocity-, inclinometer measured displacement-, AE derived displacement- and rainfall-time series for a reactivated slope deformation event at Hollin Hill after Dixon et al. (2014)

Figure 4 shows the typical AE response to a reactivated slope movement event at Hollin Hill. Note that the inclinometer measurements (produced from manual surveys of the casing) are separated by an interval of seven days and therefore have low temporal resolution. During the reactivation event both the velocity of

the sliding mass and the AE rates generated increase exponentially until they reach a peak, at which point they subsequently decay exponentially as pore-water pressures dissipate, shear resistance is mobilised within the slide mass and through remoulding of the landslide toe. The shape of this curve is analogous to the conceptual velocity–time relationship for reactivation events described by Leroueil (2001). This produces the ‘S’-shaped displacement-time curve that was derived from the AE rate data (through determination of the rate of change with respect to time and equating the area under the curve to the magnitude of displacement measured by the inclinometer; a method developed in Dixon et al. 2014) and provides increased temporal resolution for the deformation event.

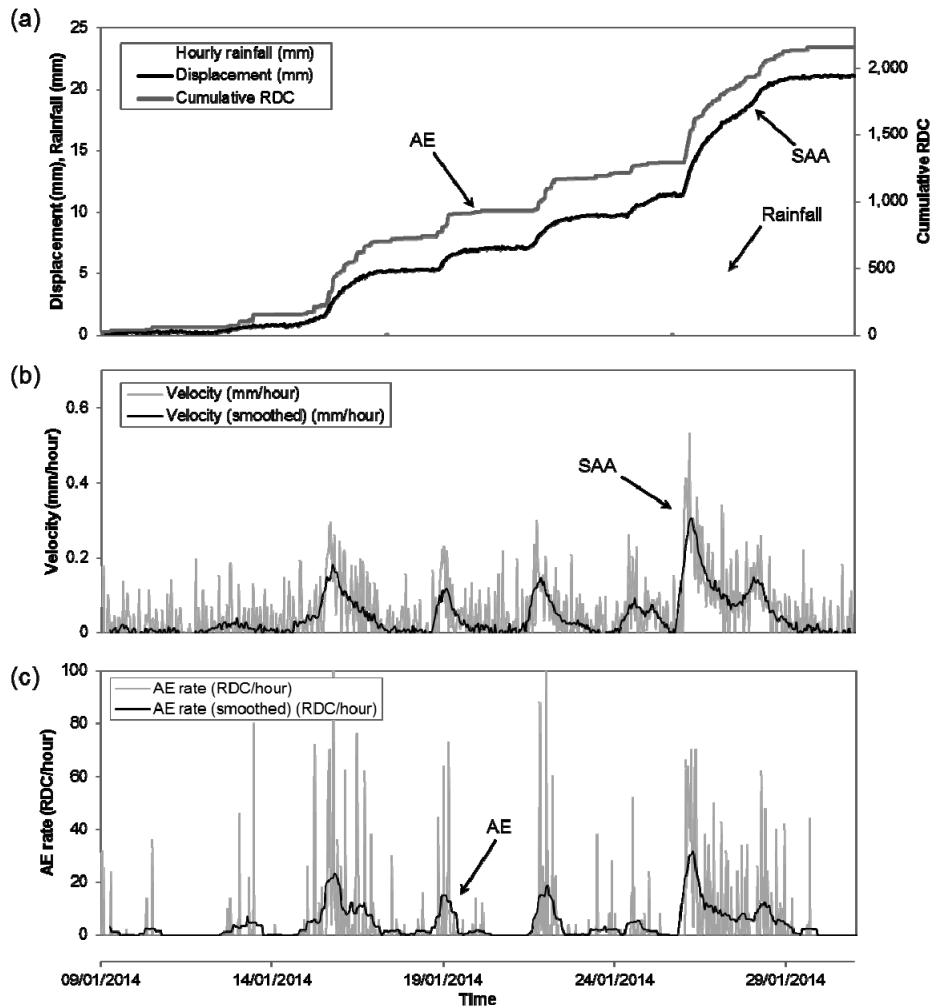
Figure 5 Time series for reactivated movements at Hollin Hill: (a) Rainfall, cumulative AE and cumulative SAA displacement; (b) SAA velocity; and (c) AE rate (after Smith et al. 2014a)

SAA's installed at Hollin Hill have allowed the comparison of continuous AE with continuous subsurface deformation measurements. A series of reactivated slope movements (i.e. small magnitude displacements with low velocities as the shear surface is already at or near residual strength (Hutchinson 1988; Leroueil 2001) occurred in response to periods of rainfall that produced transient elevations in porewater pressure along the shallow shear surface in January 2014 (Figure 5). Note that the smoothed curves were calculated using 10-hour moving average values. These comparisons confirm that: AE rates generated by the system are directly proportional to the rate of deformation; AE monitoring of active waveguides can provide continuous information on slope displacements and displacement rates; and the technique is sensitive to small displacements, displacement rates (i.e. less than 1 mm per hour) and changes in displacement rates (i.e. accelerations and decelerations).

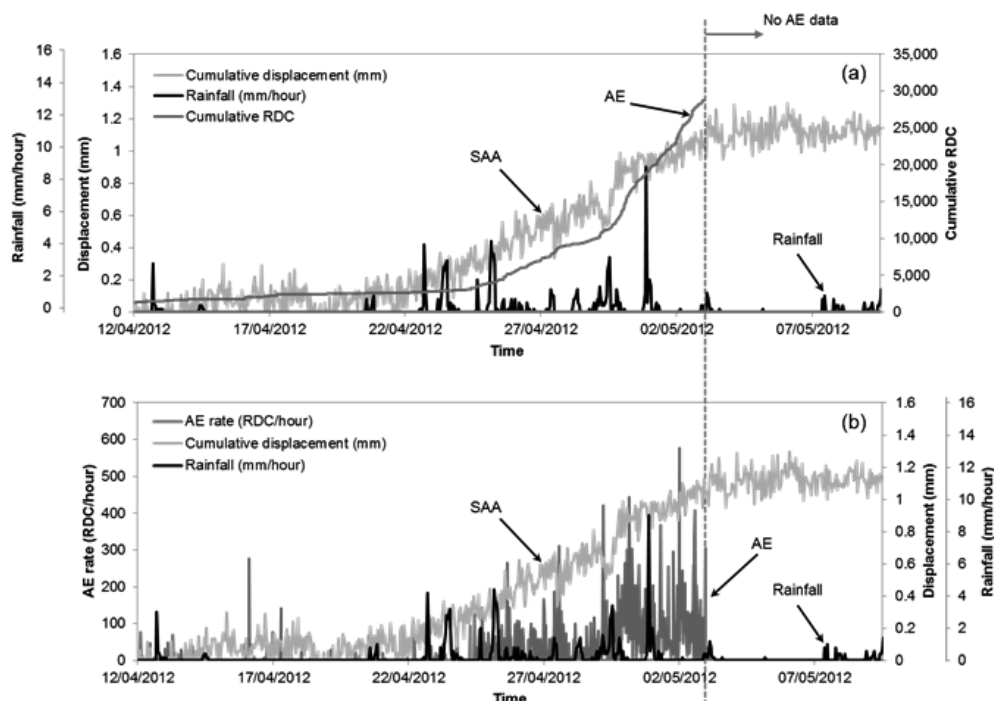
Figure 6 (a) Cumulative RDC, displacement and hourly rainfall versus time for a small magnitude low velocity reactivated deformation event, and (b) AE rate (RDC/hour), displacement and hourly rainfall versus time (data from the SAA and AEWG near the toe of the slope) (after Dixon et al. 2015)

Figure 6(a) shows cumulative RDC, deformation and hourly rainfall with time for a period of slope movement that occurred between 19 April and 5 May 2012 at Players Crescent. The continuous deformation information was recorded by an SAA installed down-slope (i.e. near the toe, adjacent to an AE monitoring system). Figure 6(b) shows the AE rate (RDC/hour) time series superimposed on top of the same deformation event. Approximately 1.2 mm of shear surface deformation occurred during this 16-day period. The gradient of the SAA deformation-time series during the event was relatively constant and therefore the velocity of movement was relatively constant. The velocity can therefore be determined using the displacement/time relation and this generates values of 0.075 mm/day or 0.003 mm/hour; these rates of movement would be classified as 'very slow' according to Cruden and Varnes (1996). The active waveguide and AE sensor node also detected this small, low velocity slope movement event. Of particular interest is the dramatic continual increase in AE rates as slope movement initiates and this continues throughout the 'very slow' deformation event.

The AE system produced continuous information with high temporal resolution, which demonstrates the potential of the system to provide alternative deformation rate information to detect and provide an early warning of slope movements. The ability of the AE system to detect such small low velocity slope movements highlights its potential for use as an early warning system. Unfortunately, the AE data ended on

3 May 2012 due to reaching storage capacity on the datalogger, so the final two days of the deformation event were not monitored. However, based on monitoring trends from similar events at other sites, it is expected that the AE rates generated by the active waveguide would have reduced as the rate of slope movement reduced. Additionally, the gradient of the cumulative RDC curve would gradually decrease and become horizontal as deformation ceased, and the column of gravel backfill would approach equilibrium (as in the slope movement events shown in Figure 5).

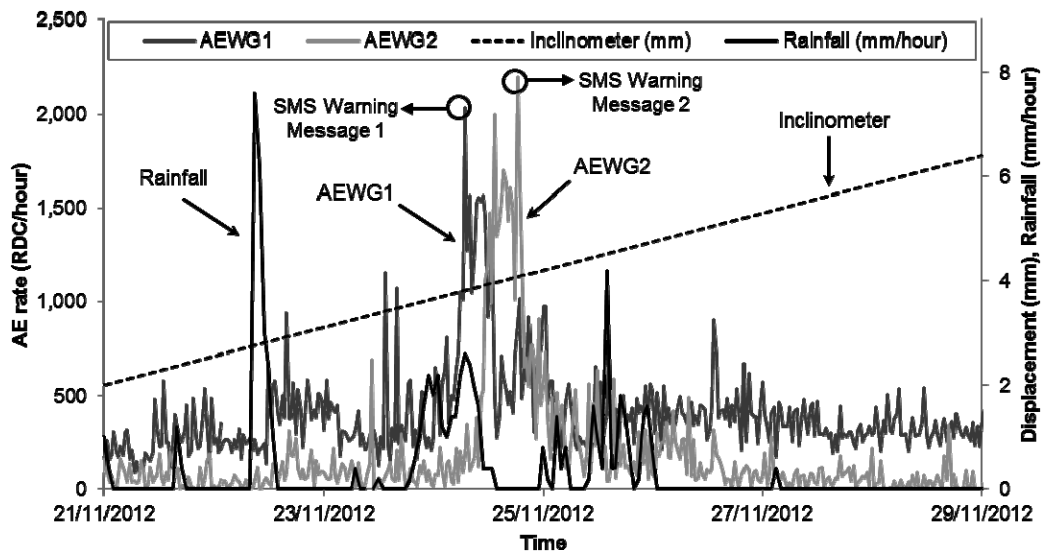
Figure 7 AE rate (RDC/hour), inclinometer measured displacement and hourly rainfall versus time for a period of slope movement in response to intensive rainfall (data from AEWG1 (near the toe), AEWG2 (near the head) and the inclinometer), the timing of the SMS warning messages are also shown (after Dixon et al. 2015)

Pre-defined trigger levels were set on the sensors at Players Crescent related to displacement rates. If the measured RDC in any given monitoring period exceeded one of the trigger levels, a SMS message was generated. The communication system sent a SMS alarm status on 24 November 2012 at 0700 h, which stated that AEWG1 (near the toe) had detected 'very slow' movement as the AE rate exceeded 2,000 RDC/hour (Figure 7).

Another SMS was sent on 25 November 2012 at 0630 h, which stated that AEWG2 (near the head) had also detected 'very slow' movement (both of these were received by the author's mobile phones, one of which was in Peru at the time). Only one text message was generated at each of the two instrument locations during this period of movement because the AE rates subsequently decreased beneath the lowest trigger threshold in the successive measurement intervals. These warnings were generated by the peaks in the bell-shaped AE rate-time curves shown in Figure 7, which are characteristic of deformation events.

Figure 7 shows the AE rate, inclinometer displacement and hourly rainfall versus time series for the period in which the deformation events and alarm SMS messages were triggered. The 11.5 hours which separated the warning messages indicated that movement had been detected in the lower part of the slope prior to being detected in the upper section of the slope. Subsequent interrogation of the data shown in Figure 7 confirmed that the toe of the slope indeed moved before the head (i.e. AEWG1 generated a bell-shaped AE rate curve prior to AEWG2).

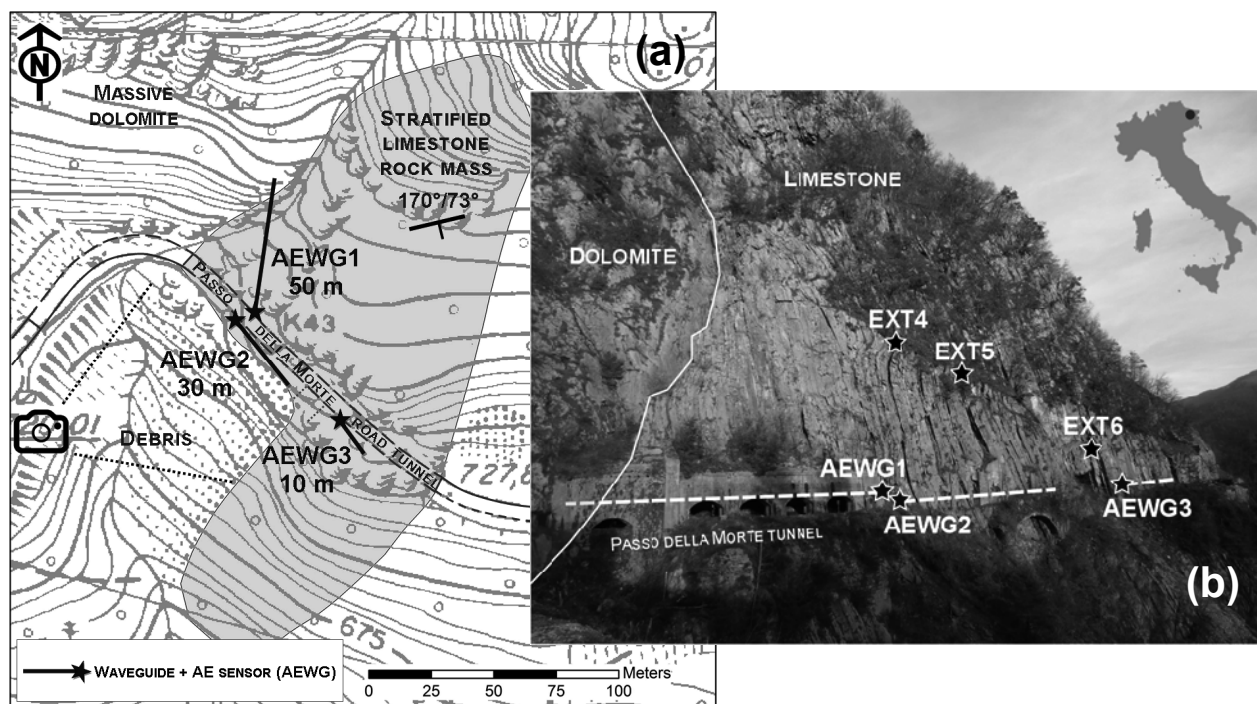
Figure 8 Passo della Morte (Forni di Sotto, Italy) trial site: (a) schematic of the unstable limestone rock mass and position of the three waveguides (AEWG1, AEWG2, AEWG3); and (b) photo of the west rock mass face with projection of the waveguides position and location of crackmeters (EXT4, EXT5, EXT6)

Application of the AE monitoring approach to rock slopes using grouted waveguides is recent (Dixon et al. 2012b). The Passo della Morte trial site in the Italian Alps (Figure 8) was set up four years ago and data have been collected continuously. This long data set has been cleaned to remove environmentally generated AE (e.g. from sensor maintenance and construction activity) and systematically analysis has commenced. A preliminary overview of the most recurring types of AE events is presented in the following sections. It should be noted that there is still not enough experience to determine which processes are generating the measured AE behaviour. A key part of the work to identify the link between rock deformation mechanisms and generated AE is on-going evaluation of data from a wide range of classical geotechnical monitoring instruments, such as extensometers, crackmeters, TDR cables and an inclinometer. Three AE waveguides are located through the steeply dipping limestone layers that form the rock mass being monitored due to concerns over slope stability. They were all installed from a road tunnel located in the limestone with only shallow (tens of metres) of cover. AEWG1 is 50 metres in length and penetrates into the rock mass away from the slope and AEWG2 (30 metres in length) and AEWG3 (10 metres in length) penetrate the limestone layers between the tunnel and the slope surface. The AE sensors are located in the tunnel within 50 metres of each other. As for the soil monitoring system, the sensors record RDC for set monitoring periods, typically set at 15 minutes. The RDC recorded are a function of the sensitivity of the sensor, the magnitude of AE events generated by deformation of the rock mass and the attenuation that occurs as the AE signals propagate through the rock to the waveguide and along the waveguide to the sensor. Therefore, relative magnitude of AE rates, trends of AE behaviour with time and comparisons between waveguides are being used to provide information on deformation mechanisms rather than absolute values.

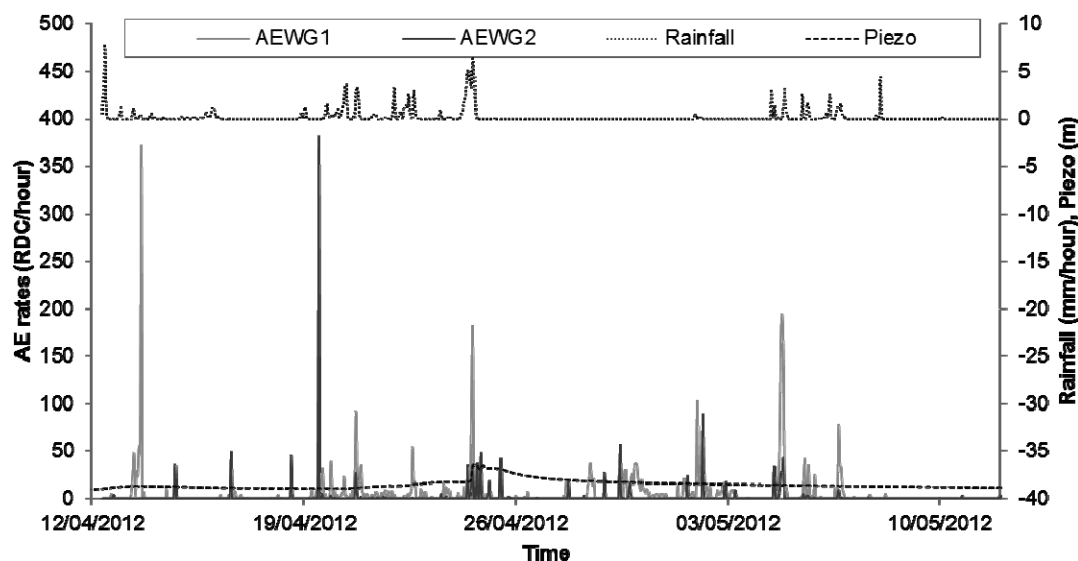
Figure 9 AE rate (RDC/hour), rainfall (mm/hour) and piezometric level (m) versus time for low AE rate events (<1,000 RDC/hour). AEWG3 was not installed in early 2012

Low AE rate events are rather common throughout the data series. As can be seen in Figure 9, they occur both during rainfall events and during dry periods and their duration is from hours to a few days, with occasional spikes of AE that are several times higher than the average. These events are often recorded by all the three sensors (AEWG1, AEWG2 and AEWG3).

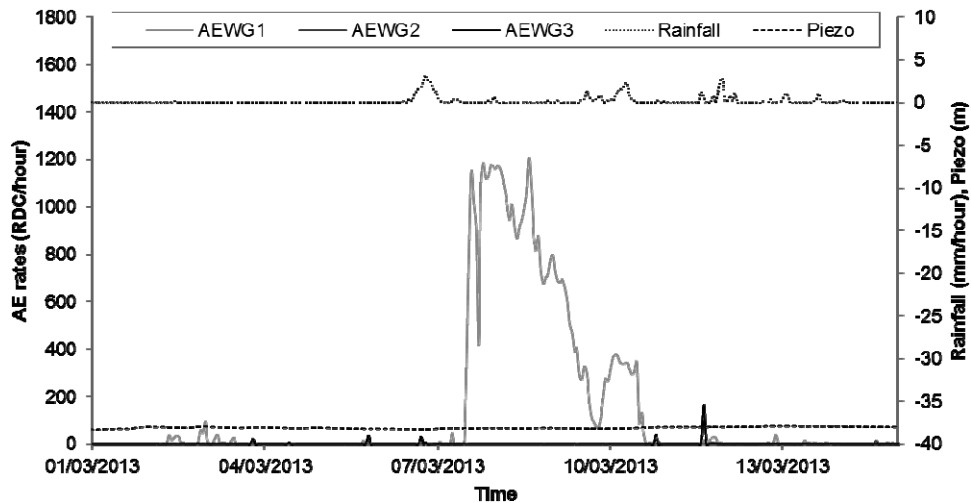
Figure 10 AE rate (RDC/h), rainfall (mm/hour) and piezometric level (m) versus time for medium AE rate events (1,000-10,000 RDC/h)

Medium AE rate events usually last for a few days and are recorded in particular from one sensor while the other two are silent or show lower activity levels. As in the example in Figure 10, they do not seem to be associated with particular rainfall events and the piezometric level does not change. These types of events can show a sharp increase at the beginning, as shown in Figure 10, or they can gently rise to a peak AE rate, but in both cases, the rates usually decrease gradually.

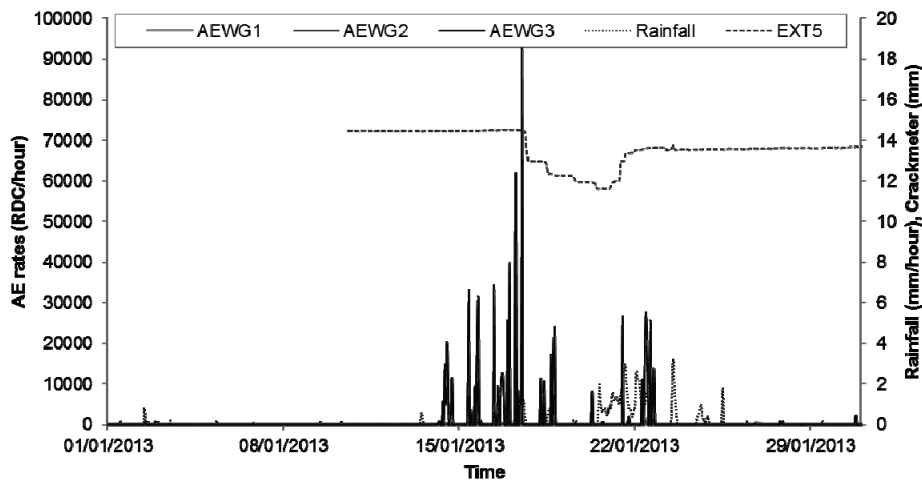
Figure 11 AE rate (RDC/h), rainfall (mm/hour), piezometric level (m) and crackmeter displacement (mm) versus time for high AE rate events (10,000-100,000 RDC/h)

High AE rate events are usually sharp singular spikes, which last for one monitoring period (i.e. 1 hour in the example), and certainly for not more than two or three consecutive monitoring periods. Spikes in AE can be grouped in clusters within a few days (Figure 11) or be isolated. Rainfall does not seem to be critical for their occurrence.

These types of events are recorded simultaneously by all three sensors, although AEWG3 consistently records RDC rates higher by about one order of magnitude compared with AEWG1 and AEWG2. It is interesting to observe that the first part of the cluster in Figure 11 precedes the displacement recorded by a crackmeter (EXT5), which monitors one of the key discontinuities where it daylight on the slope, and the cluster ends when the crackmeter stabilises.

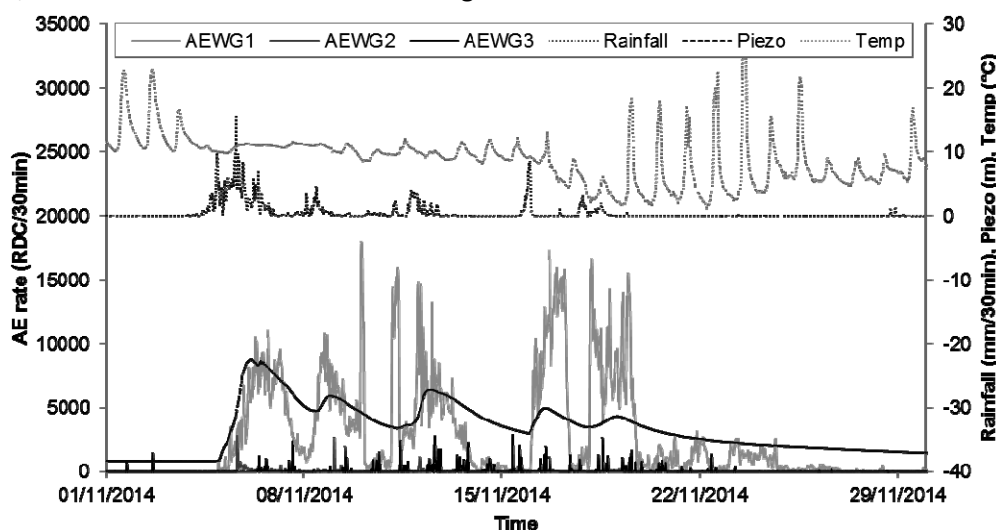
Figure 12 AE rate (RDC/30 min), piezometric level (m), rainfall (mm/30 min) and temperature versus time showing AE rate trends due to changes in piezometric level. Data are plotted for 30-minute periods

Figure 12 shows a series of AE events that occurred in November 2014 and which lasted for several days. These events can be attributed to changes in water pressure within the rock mass due to variations in the piezometric level. It can be observed that there is a delay of some hours between rainfall events and the rise in the water level, but AE are recorded by waveguide AEWG1 simultaneously with changes in the water level. AE rates tend to accelerate when the water table rises and to decrease, more or less sharply, when it drops. Hence, the AE trend follows the stress changes within the rock structure.
