Site performance of galvanic anodes in concrete repairs

ABSTRACT: Galvanic anodes can be used to limit the extent of concrete replacement and extend the service life of patch repairs to reinforced concrete (RC) structures. They respond to changes in environmental conditions and this attribute has been employed to extend their use.

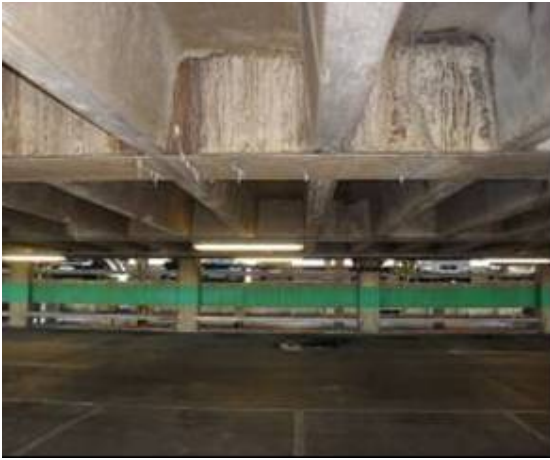
Figure 1. General condition of the MSCP's soffit indicating leaching, dynamic cracking and deterioration of the concrete elements.

A multi-storey car park (MSCP) in the UK suffering from chloride-induced corrosion was selected for this work (Figure 1). The structure was built in the early 1970s with one-way spanning concrete ribbed type deck arrangement.

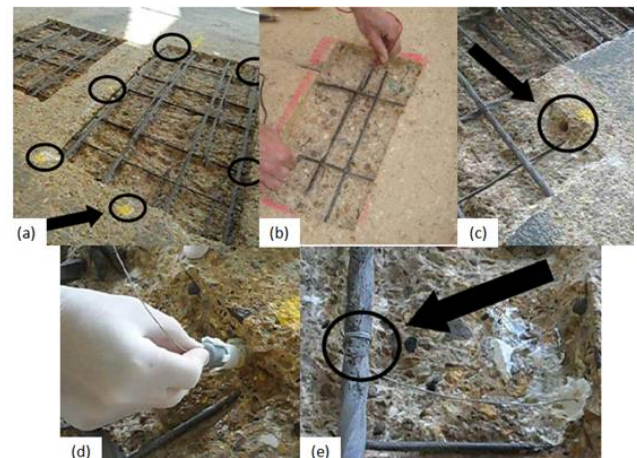
Figure 2. Galvanic anode type A installation procedure, (a) repair area following breakout and with location of anode installation marked out, (b) testing for reinforcement continuity, (c) pre-drilled holes for anode installation, (d) installation of galvanic anode and (e) connection of galvanic anode to the steel reinforcement and anode hole following filling with the proprietary backfill (Christodoulou et al. 2014)

Anodes type A, were installed in pre-drilled holes of 25 mm diameter and 45 mm long in the parent concrete, as close as practically possible to the edge of the patch and then filled with proprietary backfill (Figure 2). A titanium wire integrated with the galvanic anodes made a connection to the steel reinforcement within the repair area. Their installation spacing was 250mm centres.

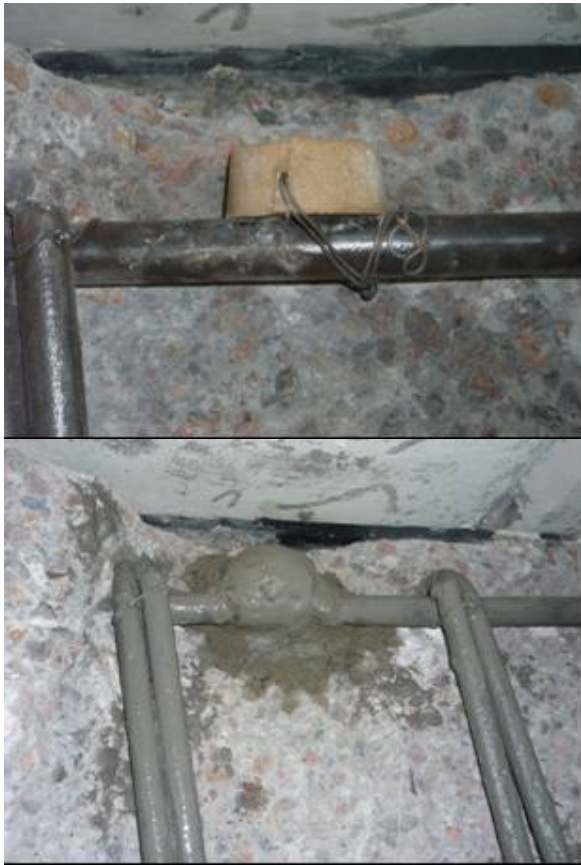
Figure 3. Galvanic anode type B installation procedure, (left) anode tied to the reinforcement as close as practically possible to the edge of the repair and (right) galvanic anode encapsulated in proprietary embedment mortar.

Anodes type B were installed within the patch repair on the side of the exposed reinforcement, as closely as possible to the edge of the repair. A steel wire integrated with the galvanic anodes made a connection to the steel reinforcement. The anodes were also encapsulated in a proprietary embedment mortar to provide a conductive path to the substrate (Figure 3). Their installation spacing was 250mm centres.

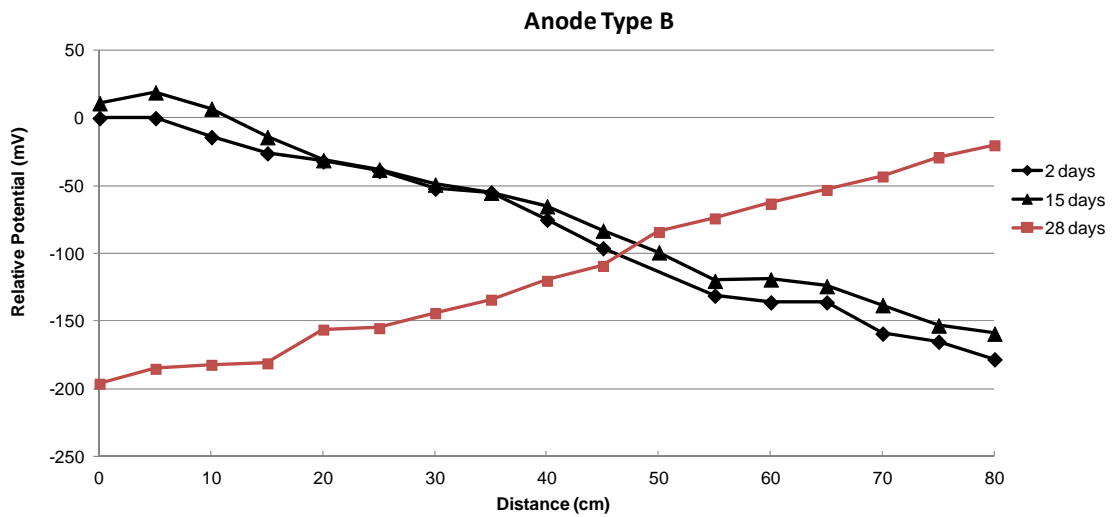
Figure 6. Polarisation effect afforded by anodes type B at a distance from the edge of a patch repair over a period of 28 days.

The typical polarisation effect afforded by anodes type B at a distance away from the edge of the patch repair over a period of 28 days following installation is shown in Figure 6. It can be observed that there was a polarisation effect almost over the entire measurement length of 800mm over the first 15 days. However, at 28 days it was observed that the effect was entirely lost and no polarisation was afforded to the steel in the parent concrete adjacent to the repair.
