# Listening for Landslides: Method, Measurements and the Peace River Case Study

Alister Smith & Neil Dixon

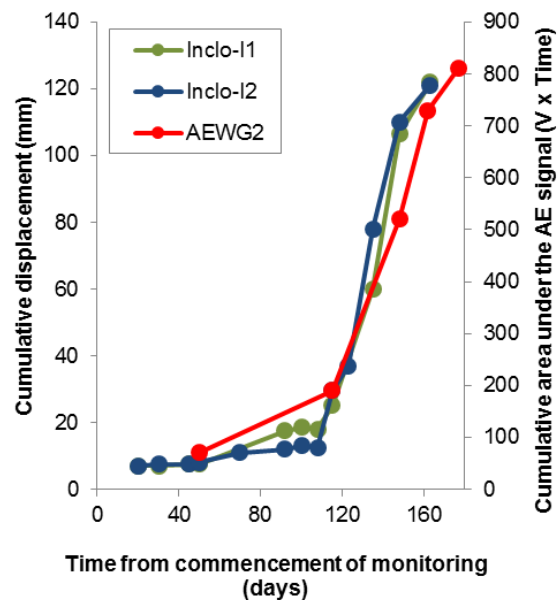
Figure 3. Cumulative displacement- and AE energy- time series from the Cowden monitoring experiment after Dixon et al. (2003)

Dixon et al. (2003) describe the AE monitoring case study of a coastal slope at Cowden, north-east England. The slope was formed of 20 m high cliffs of stiff glacial till and was experiencing rotational sliding due to erosion of the toe. The project comprised the installation of a variety of waveguides and inclinometers, both of which were read at intervals. Each reading from the active waveguide took the form of sampling the AE signal envelope for a 3 minute period, from which the area under the signal was determined (i.e. a measure of AE energy). Figure 3 shows the time series of measurements; the active waveguide comprised a steel tube with gravel backfill. Note that the onset of movement occurred prior to the first readings being taken, however; the displacement- and AE energy-time series show similar behaviour and demonstrates the potential for the AE technique to detect changes in displacement rate during first-time failure.

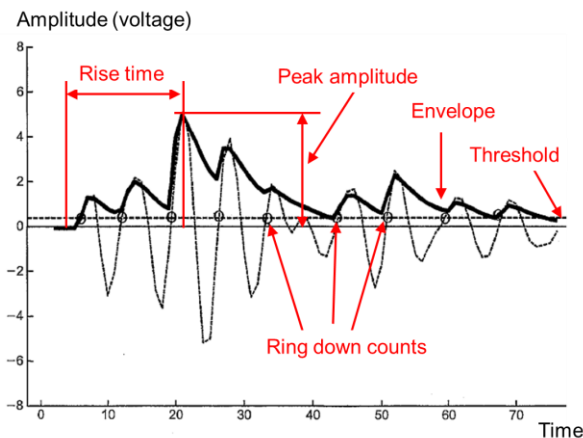
Figure 4. Example AE event waveform with typical parameters defined after Dixon et al. (2003)

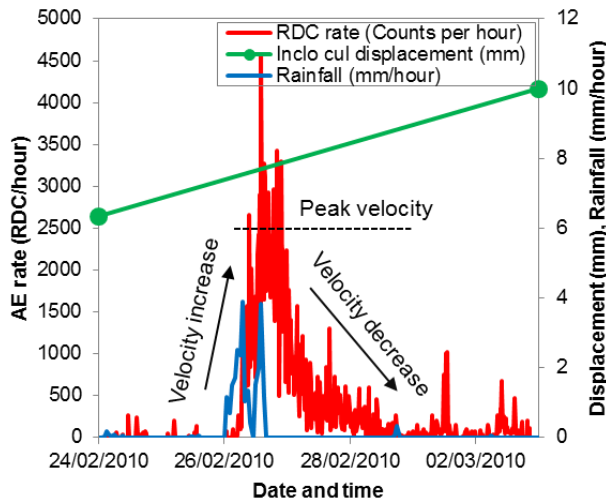
Figure 6. Reactivated landslide deformation event AE signature after Dixon et al. (2012)

A deformation event that occurred at the reactivated landslide at Hollin Hill is shown in Figure 6. The plot in Figure 6 shows two inclinometer readings with roughly 3mm of shear surface displacement occurring between them. The triggering rainfall event can be seen prior to the sudden increase in AE rates, which is interpreted to indicate the onset of movement. The AE rate (RDC/hour) rapidly increases towards a peak value and then slowly decreases, giving a bell shaped log-normal curve. This signature shape of the AE rate-time curve is characteristic of reactivated slope deformations that have occurred at Hollin Hill and at other sites. Such reactivated slope kinematics are explained by an initial acceleration of the slide mass due to increasing pore water pressures on the shear plane, and hence reducing shear strength and stability, and a peak velocity is approached. This is followed by a deceleration of movements as pore water pressures dissipate and due to mobilisation of shear resistance internally in the slide mass and through remoulding at the landslide toe. The shape of the AE rate-time curve for the deformation event is analogous to a velocity profile. Leroueil (2001) presented a conceptual

velocity-time profile for the 'reactivation stage' of slope movements that possessed the shape of a normal distribution (shown in Figure 1). The event shown in Figure 6 is analogous to such behaviour.

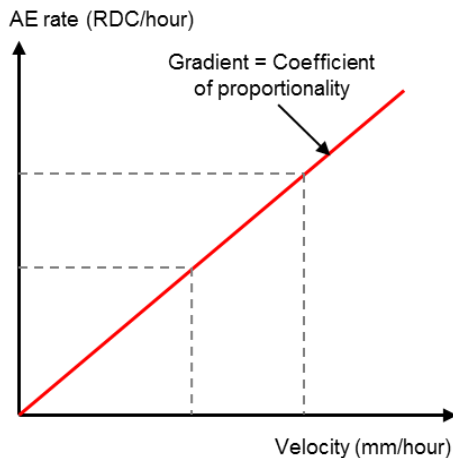
Figure 7. Calibration AE rate-Velocity relationship for active waveguide and Slope ALARMS system after Dixon et al. (2014a)

The rate of landslide displacement governs the rate of straining of the active waveguide, and therefore the AE rates (RDC/hour) that are generated. Analysis of the AE time series is based on the premise that output AE rates are proportional to the velocity of landslide movement. An example calibration relationship can be seen in Figure 7 and written as a function in Equation 1; such a relationship allows the velocity of movement to be determined through monitoring AE rates.

Dixon et al. (2014a) and Dixon et al. (2014b) both detail and use the AE rate-velocity relationship that has been described above. The relationship shown in Figure 7 and Equation 1 can be determined subsequent to a deformation event by equating the area under the AE event log-normal bell shaped curve to the magnitude of displacement that was measured by adjacent deformation monitoring instrumentation for the same period. The total event displacement can be distributed proportionately to each trapezoidal integrand under the curve. This will allow the velocity over each trapezoid under the curve to be determined from the displacement/time relation. This enables a velocity-time curve that is proportional to the AE rate-time curve to be produced for the displacement event; an example taken from Dixon et al. (2014a) can be seen in Figure 8.

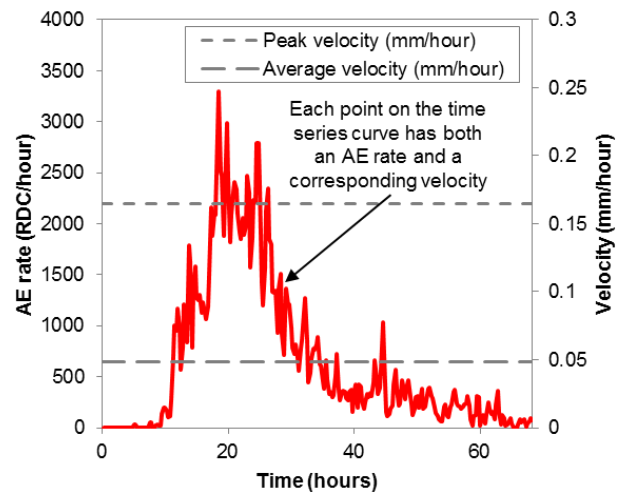
Figure 8. AE rate- and derived velocity- time relationship for reactivation event at Hollin Hill after Dixon et al. (2014a)

The sporadic nature of the AE rate data is due to slip-stick deformations taking place between the gravel particles within the backfill as interlock is overcome and regained. Indeed it would be assumed that the velocity-time profile of the slope movement would be a smoother curve of moving averaged values. Interrogation of the velocity profile for the event in Figure 8 yields an event

duration of roughly 60 hours, with a peak velocity of 0.16mm/hour and an average velocity of 0.05mm/hour. This event would be classified as 'very slow' according to Transportation Research Board (1978). The systems apparent sensitivity at relatively small displacement rates indicates that the technique is suitable for detection of changes in relative slope stability in response to destabilising (e.g. climate related) and stabilising (e.g. remediation) events, and as an early warning system.

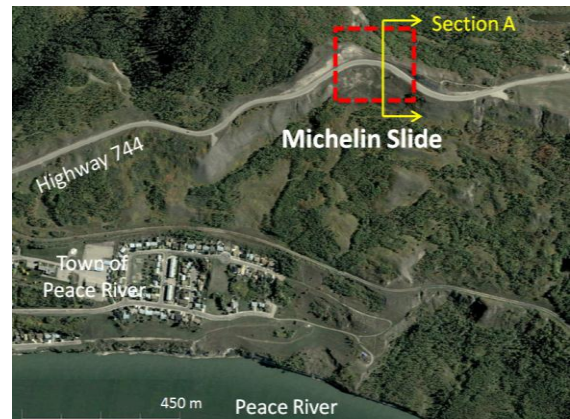
Figure 11. Location of Michelin landslide along Highway 744, the placement of the cross section in Figure 10 is shown as Section A

Michelin is one of six sites located along Highway 744 which are currently being monitored for slope instability by Thurber Engineering Ltd. on behalf of Alberta Transportation. The Michelin site covers 200 m of highway between chainage 57.7 km and 57.9 km. Currently there are a series of 1 m to 4 m high scarps and several small slides on the site. These slides are located down slope of a concrete pile wall which was constructed in 1997 as part of a stabilisation attempt (Thurber 2009). The location of the Michelin landslide site along Highway 744 can be seen in Figure 11.

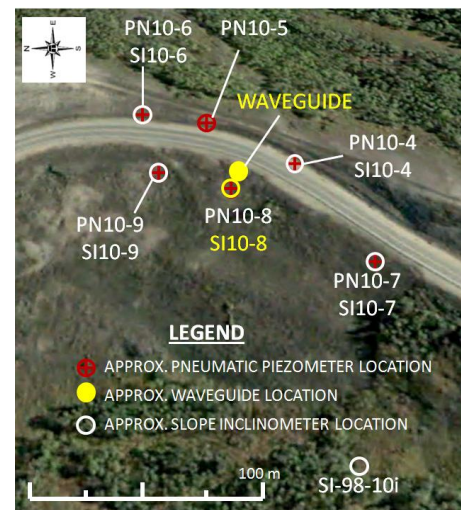
Figure 12. Instrumentation location plan at the Michelin slide, the location of the Slope ALARMS waveguide and the closest inclinometer (SI10-8) are shown in yellow

Currently there are seven slope inclinometers and six piezometers installed at the Michelin landslide site. The instrumentation location plan can be seen in Figure 12. The location of the Slope ALARMS waveguide and the closest inclinometer (SI10-8) are highlighted. Readings from the inclinometers and piezometers are taken twice a year unless large displacements are measured; necessitating more frequent readings.

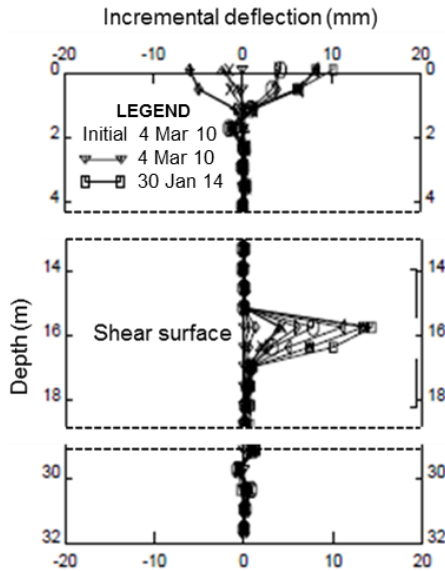
Figure 13. Inclinometer (S110-8) report showing the depth of the shear surface

An active waveguide was installed in a 150 mm diameter borehole that penetrated to a depth of 21 m below ground level. The waveguide was installed in the centre of the borehole and comprised 3 m lengths of 38 mm diameter steel pipe connected with screw threaded couplings. The annulus around the steel tube was backfilled with 10 mm subrounded washed pea gravel. The pea gravel backfill filled the annulus from the base of the borehole to 11.9 m below ground level and hydrated bentonite grout chips filled the annulus up to 8.8 m below ground level. The depth of the shear surface was determined to be at roughly 16 m from an already installed inclinometer casing adjacent to the active waveguide (Figure 13).

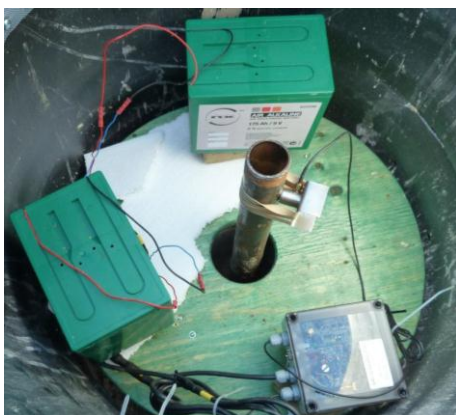
Figure 14. Waveguide with piezoelectric transducer attached, AE sensor, and batteries inside surface cover

As the AE is predominantly generated in the zone of shearing, the ‘active’ section (gravel backfill) of the waveguide only needed to cover a zone at the slip surface to function successfully. The bentonite grout plug was used to seal against the ingress of surface water that can potentially generate AE unrelated to slope movements and therefore contaminate the data set. Borehole spoil was used to fill the remaining annulus around the waveguide to the ground surface. The tube extends 0.3 m above ground level and is encased in a secure protective chamber. A unitary AE sensor is located inside the protective cover. A piezoelectric transducer is coupled to

the waveguide and linked to the sensor via a cable. The AE sensor is powered by air alkaline batteries (Figure 14).

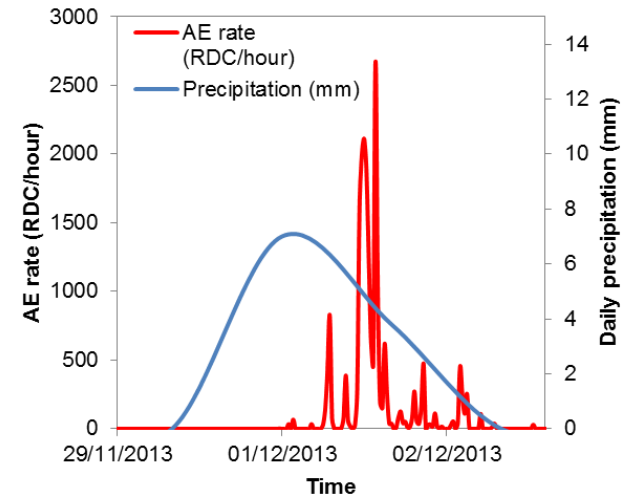
Figure 16. AE rate- and precipitation- time for Event A

It can be seen that the AE generation is triggered by preceding precipitation. The AE rate (RDC/hour) rapidly increases towards a peak and then decreases, and the curve exhibits a similar shape to the deformation events

described in section 3.2. The increased AE rates in Event A were sustained for 1.5 days indicating they were generated in response to a period of slope movement. However, as continuous measurements of slope deformation were not available it is an assumption at this time that Event A was generated by sub-surface straining of the active waveguide in response to slope movement. Another hypothesis is that seepage effects are superimposed on the AE time series, and the elevated levels of AE activity in Event A could be in response to seepage through the active waveguide gravel column; either via groundwater flow through relatively permeable stratum, or infiltration from the ground surface.

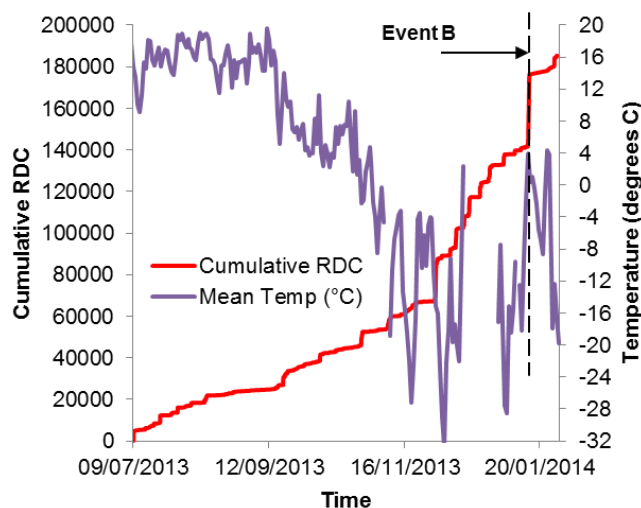
Figure 17. Cumulative RDC- and temperature- time, with Event B highlighted

Figure 17 shows cumulative RDC and daily mean temperature for the initial monitoring period. It was important to investigate the influence of the sustained low temperatures on the performance of the AE system. A sample event (Event B) which occurred during a period of changing temperature (a change of several degrees C, above and below zero) has been selected and is shown in Figure 18 at a larger scale.

The increased levels of AE activity in Event B are hypothesised to be caused by temperature changes, causing for example; physical expansion and contraction of the surface cover and/or near surface soil inducing AE within the frequency range that the sensor monitors. There is a strong possibility that many of the AE events detected after the temperature dropped below freezing could be caused by the cycles of extreme temperature changes.

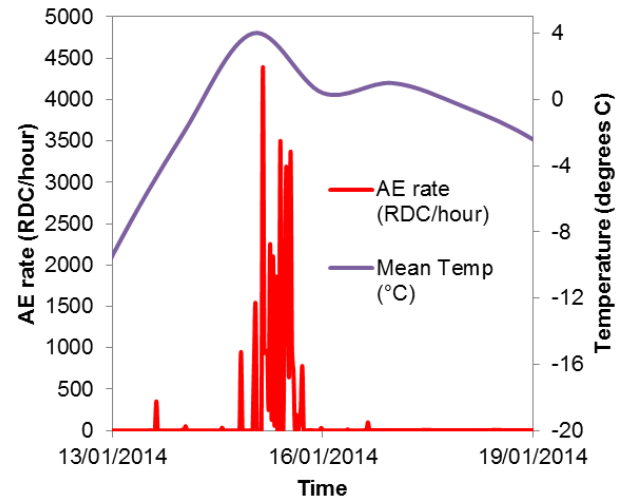
Figure 18. AE rate- and temperature- time for Event B
