Repair and Corrosion Management of Reinforced Concrete Structures

REPAIR AND CORROSION MANAGEMENT OF REINFORCED CONCRETE STRUCTURES

A dissertation thesis submitted in partial fulfilment of the requirements for the award of the degree Doctor of Engineering (EngD), at Loughborough University

November 2013

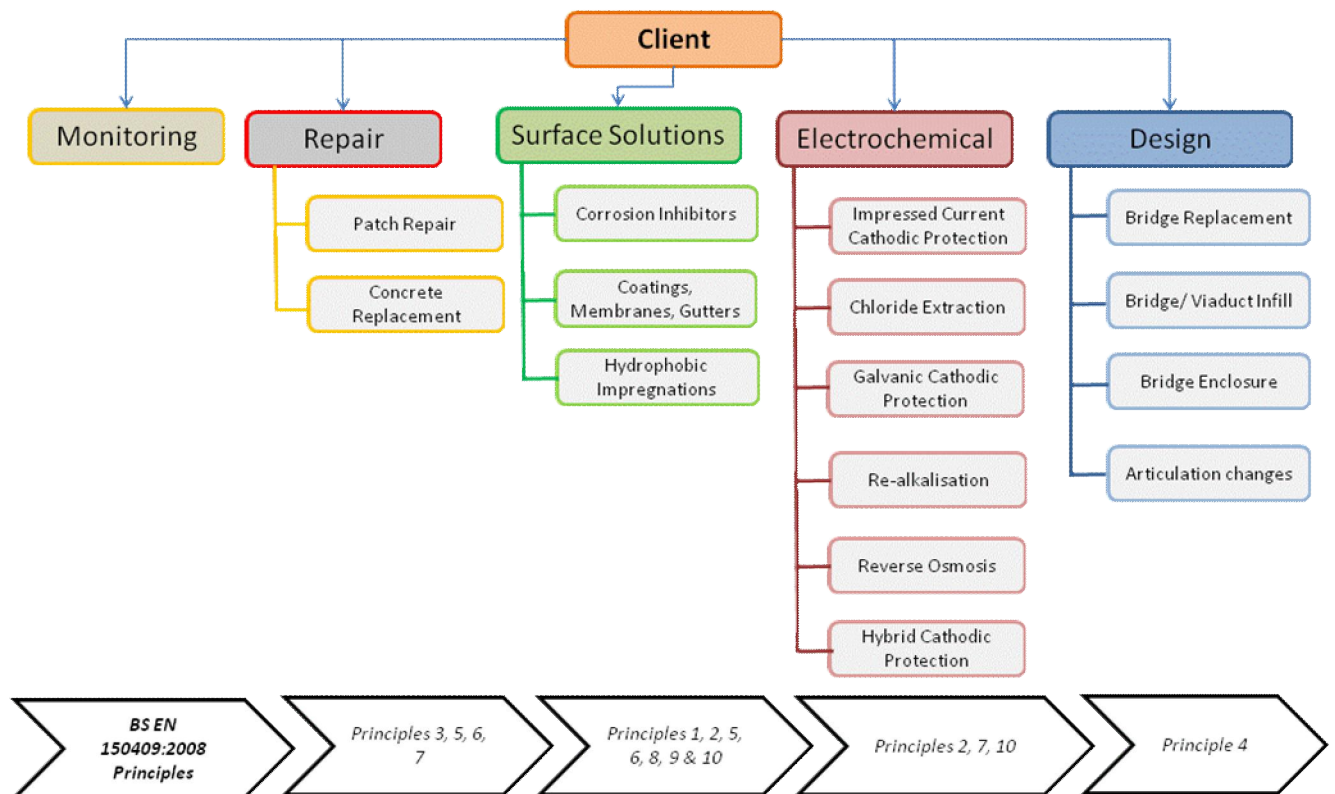
Figure 1.1 Categorisation of corrosion management techniques based on the nature of the works

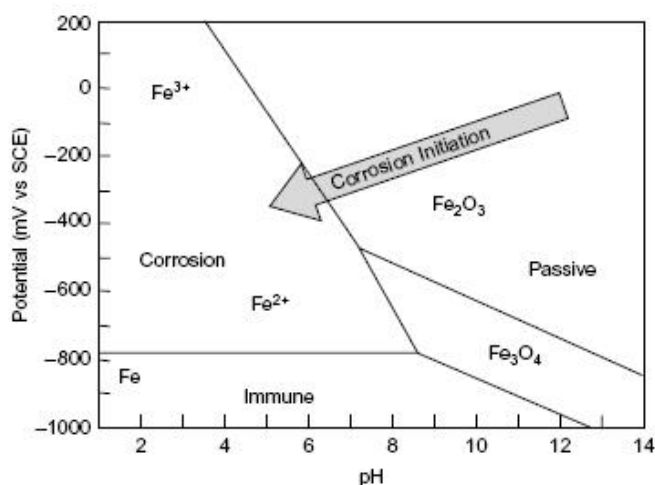
Concrete under normal circumstances provides a non-aggressive and highly alkaline environment with a pH above 13. As can be observed from Figure 1.2, under these conditions the steel remains passive and develops an oxide film which covers its surface and presents a barrier to further metal dissolution (Page and Treadaway 1982, Glass and Buenfeld 1996).

Figure 1.2 Interpreted Pourbaix diagram, illustrating the thermodynamic stability of iron oxides in varying conditions. (Glass et al. 2007)

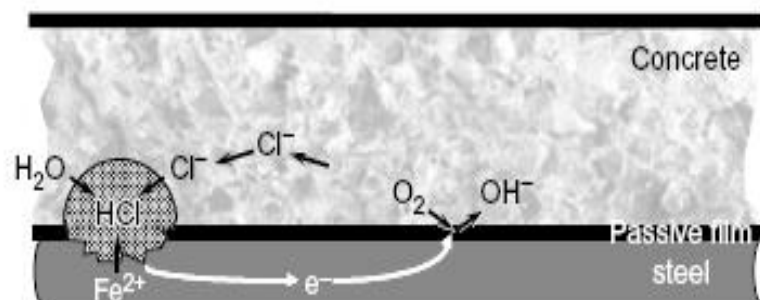
The positively charged hydrogen ions are balanced at the anode by the presence of negative charged chloride ions, combined to produce hydrochloric acid (Figure 1.3). The amount of oxygen supply is critical at the cathode for sustaining the reaction. For submerged RC structures, corrosion will not easily initiate as the supply of oxygen is limited. However, oxygen deficient reactions may be serious as they tend to develop for a considerable time before any visible evidence. In such cases, the rust may be green which is believed to be a complex chemical composition based on chlorides or black as a product of magnetite (Fe₃O₄).

Figure 1.3 Process of corrosion on steel in concrete (Glass et al. 2006)

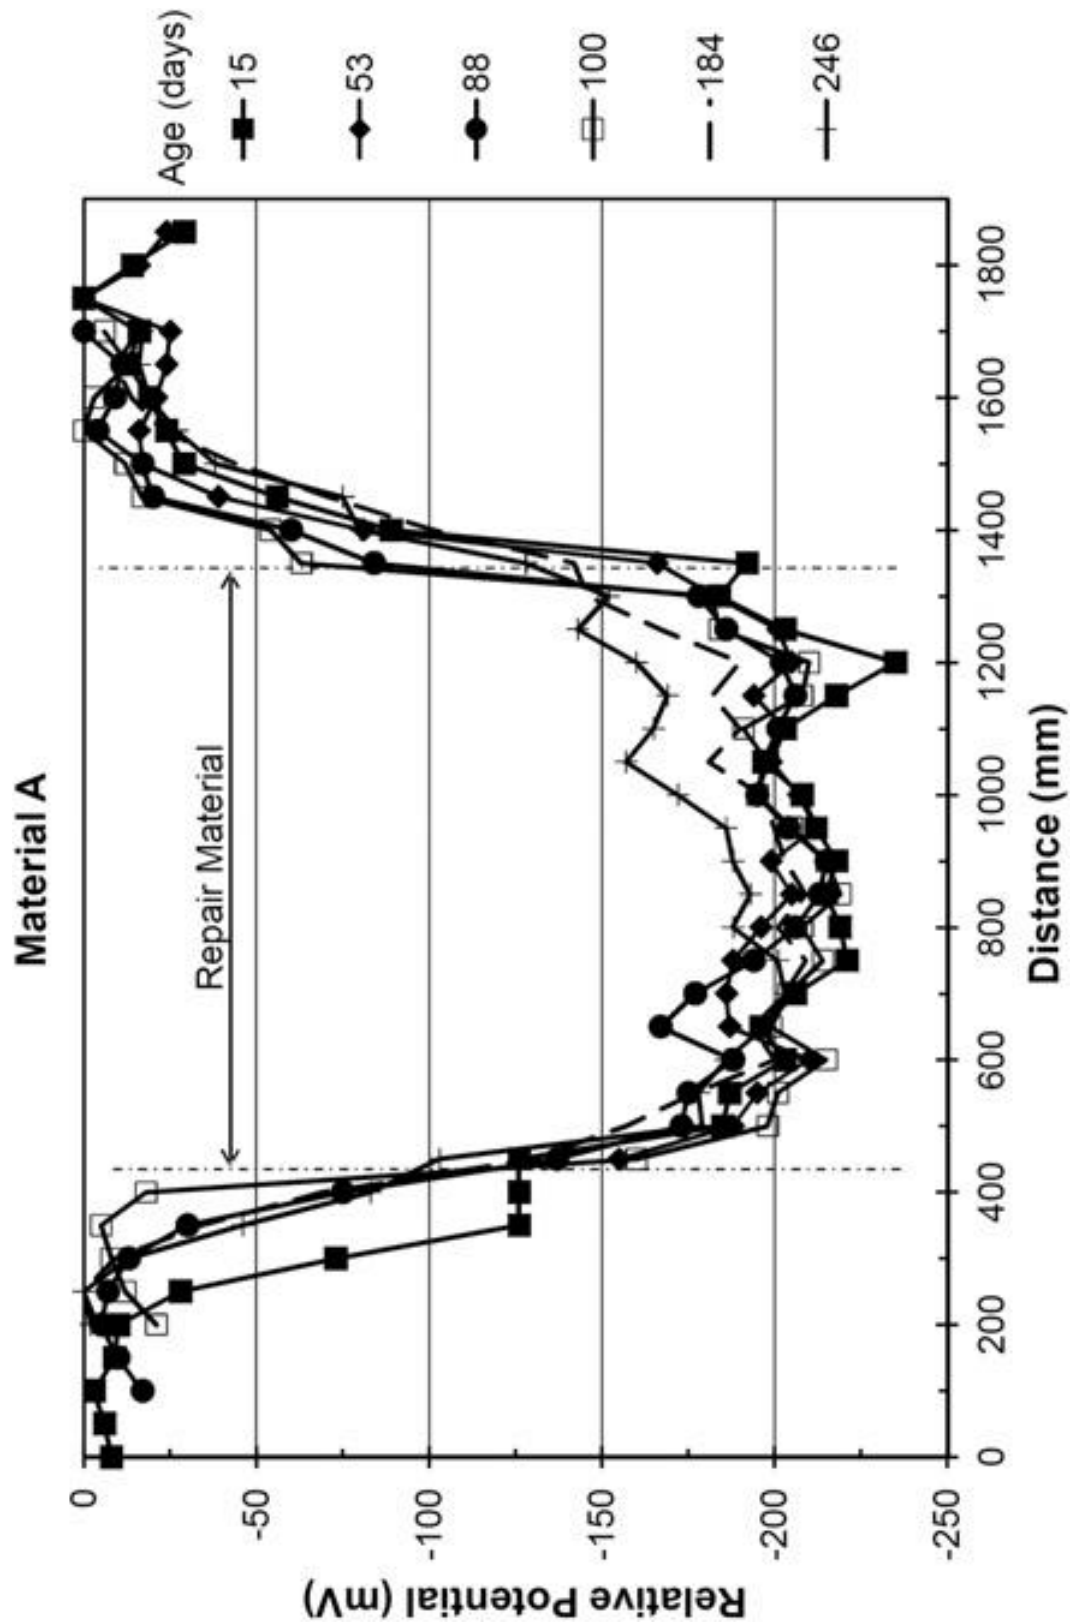
Figure 4.1 shows the change in the potential difference between an area repaired with material A (from the MSCP) and the adjacent parent concrete over a period of up to 246 days. The early age results (15 days) show that the potentials within the patch repair were about 200 mV more negative than the potentials in the parent concrete. This difference reduced with time but the changes were relatively small. After 246 days the potential difference was between 150 and 200 mV. The potentials were measured in a variety of naturally occurring conditions including a very wet day on day 88.

Figure 4.1 Effect of a repair (material A, MSCP) on the relative potential determined at the concrete surface after curing over varying periods of time (Christodoulou et al. 2013).

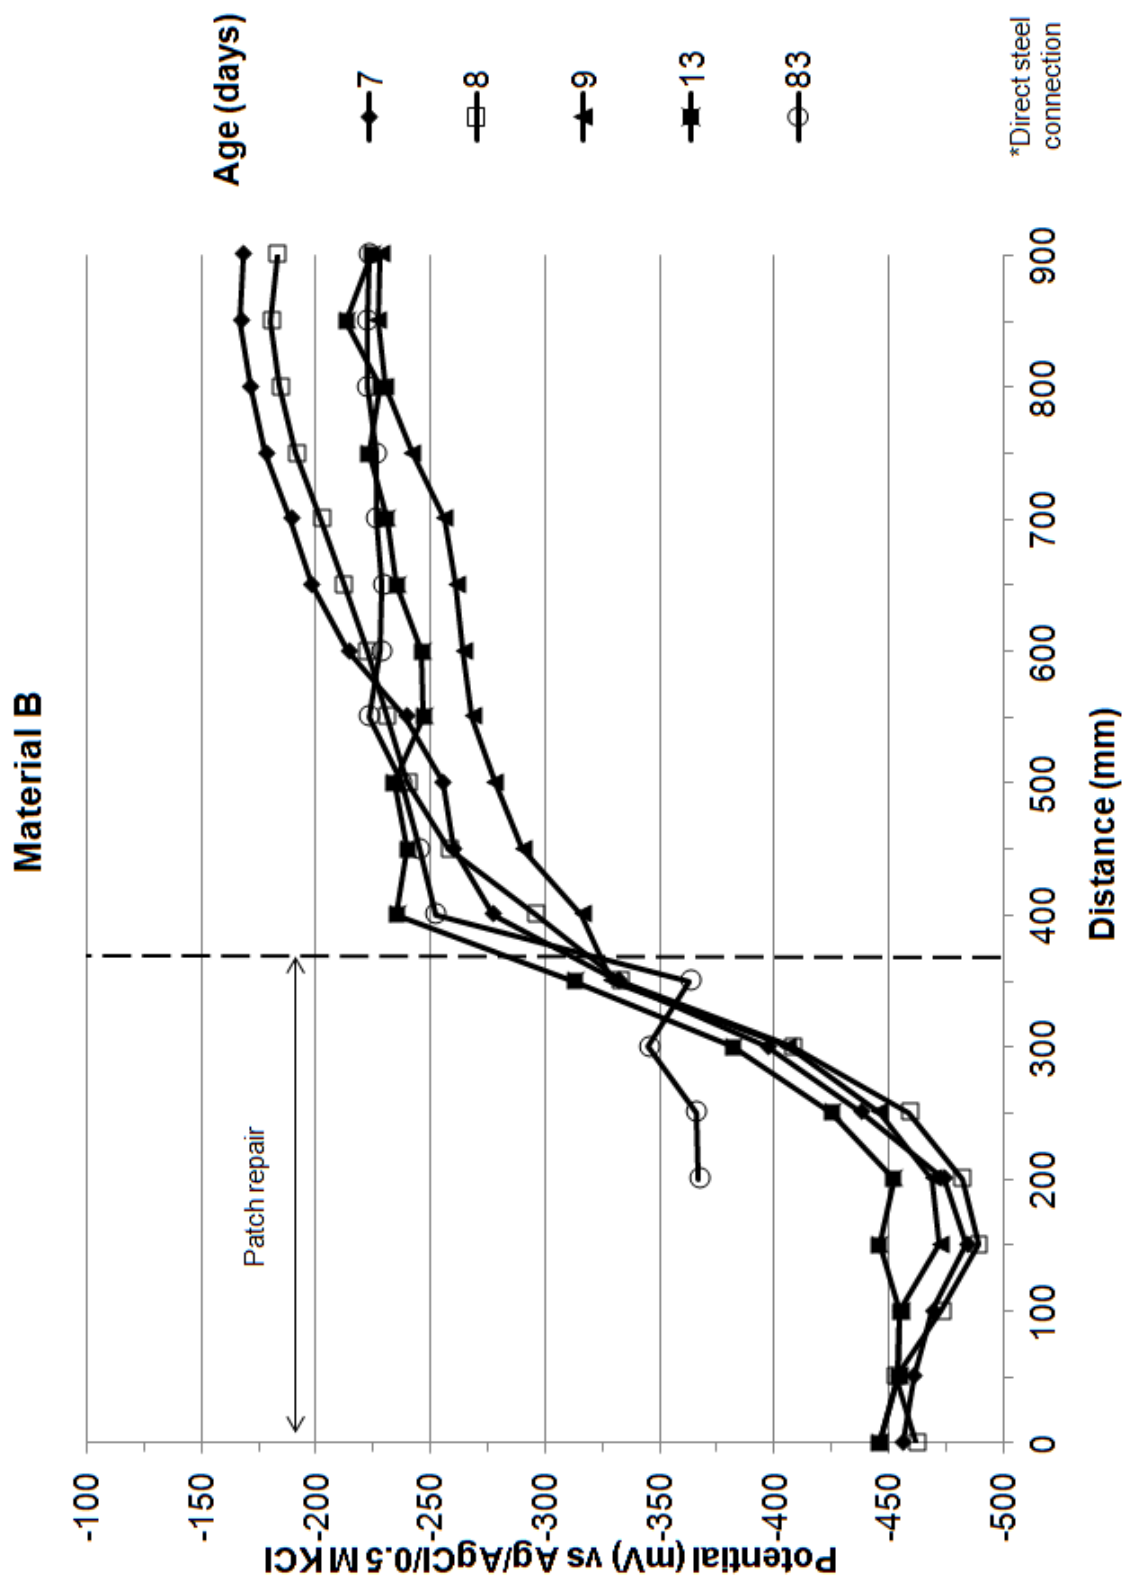
Data obtained from the patch repairs of the bridge structure illustrated similar behaviour to that obtained from the MSCP. Figure 4.2 shows data obtained at an area repaired with material B. The potentials of the steel within the repair material were about 200 mV more negative than the potentials of the steel in the adjacent parent concrete at the start. After 83 days the change was still greater than 100 mV. In a similar manner, data within the repair area measured before and after repair with material C (Figure 4.3) demonstrated that the potential of the steel within the repair area may be depressed to values that are more negative than the values observed in the parent concrete. The above, were typical and re-occurring findings of the effect of the repair materials on the steel potentials in all cases examined.

Figure 4.2 Effect of a repair (material B, Bridge) on the steel potentials determined at the concrete surface after curing over varying periods of time (Christodoulou et al. 2013).

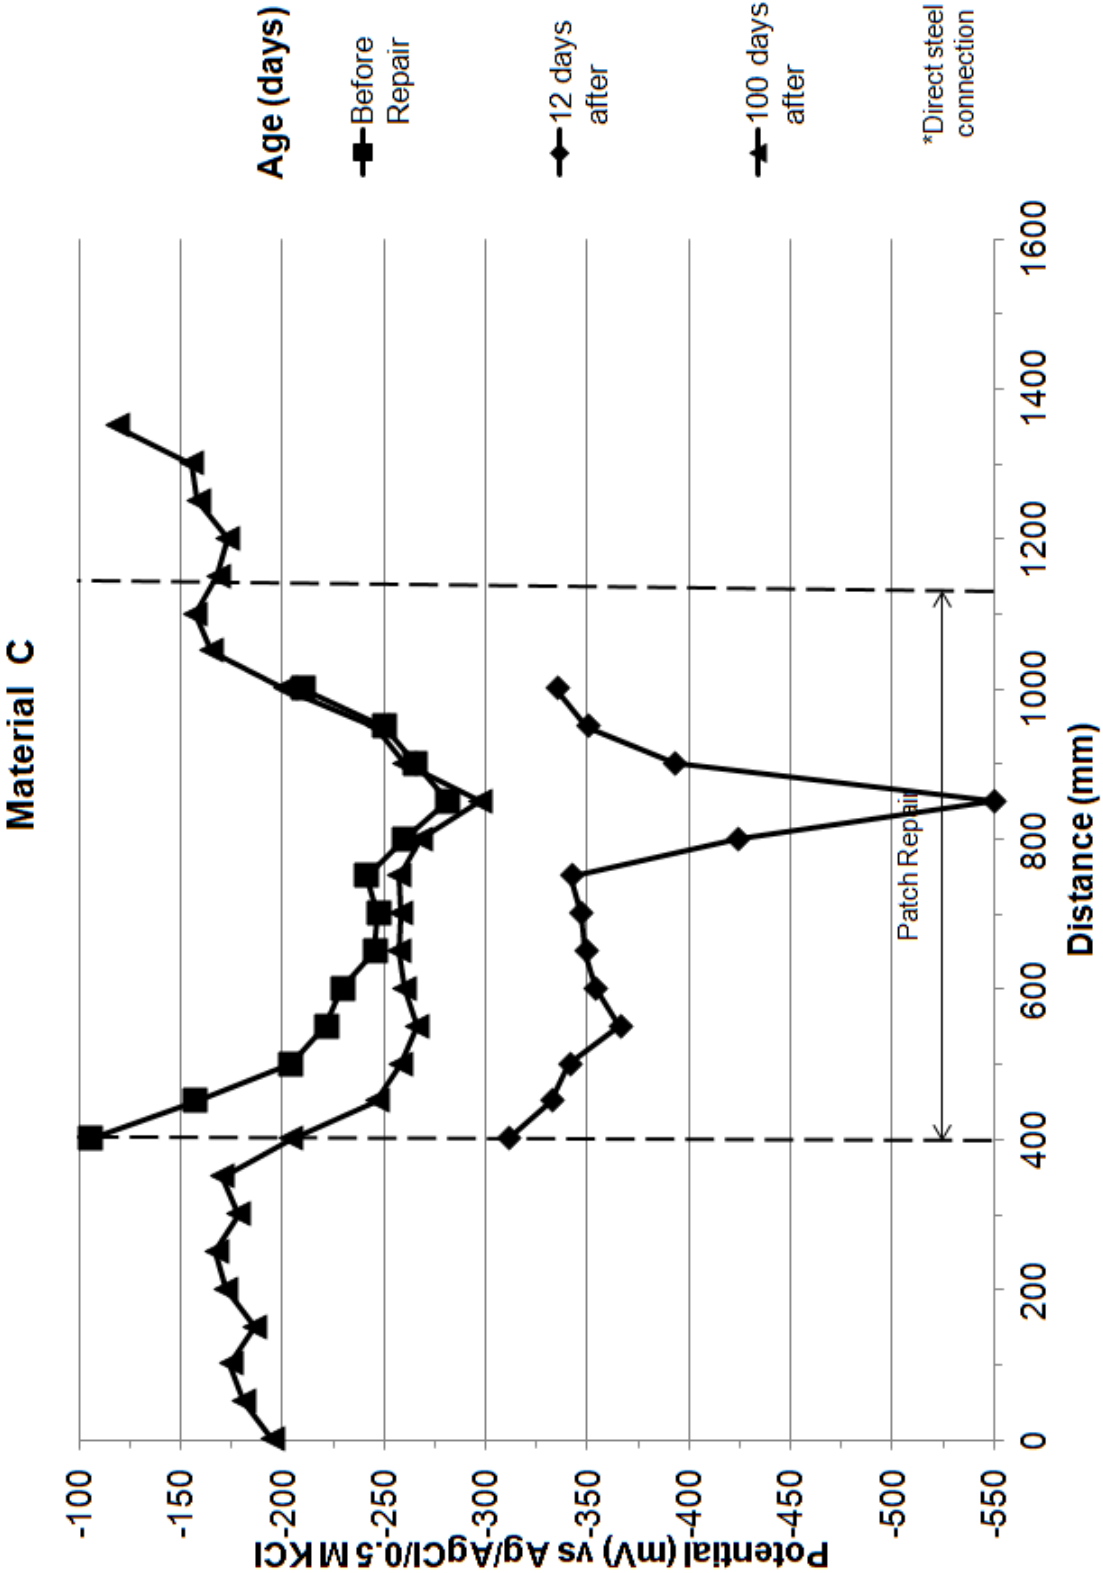
Figure 4.3 Effect of a repair (material C, Bridge) on the steel potentials determined at the concrete surface after curing over varying periods of time (Christodoulou et al. 2013).

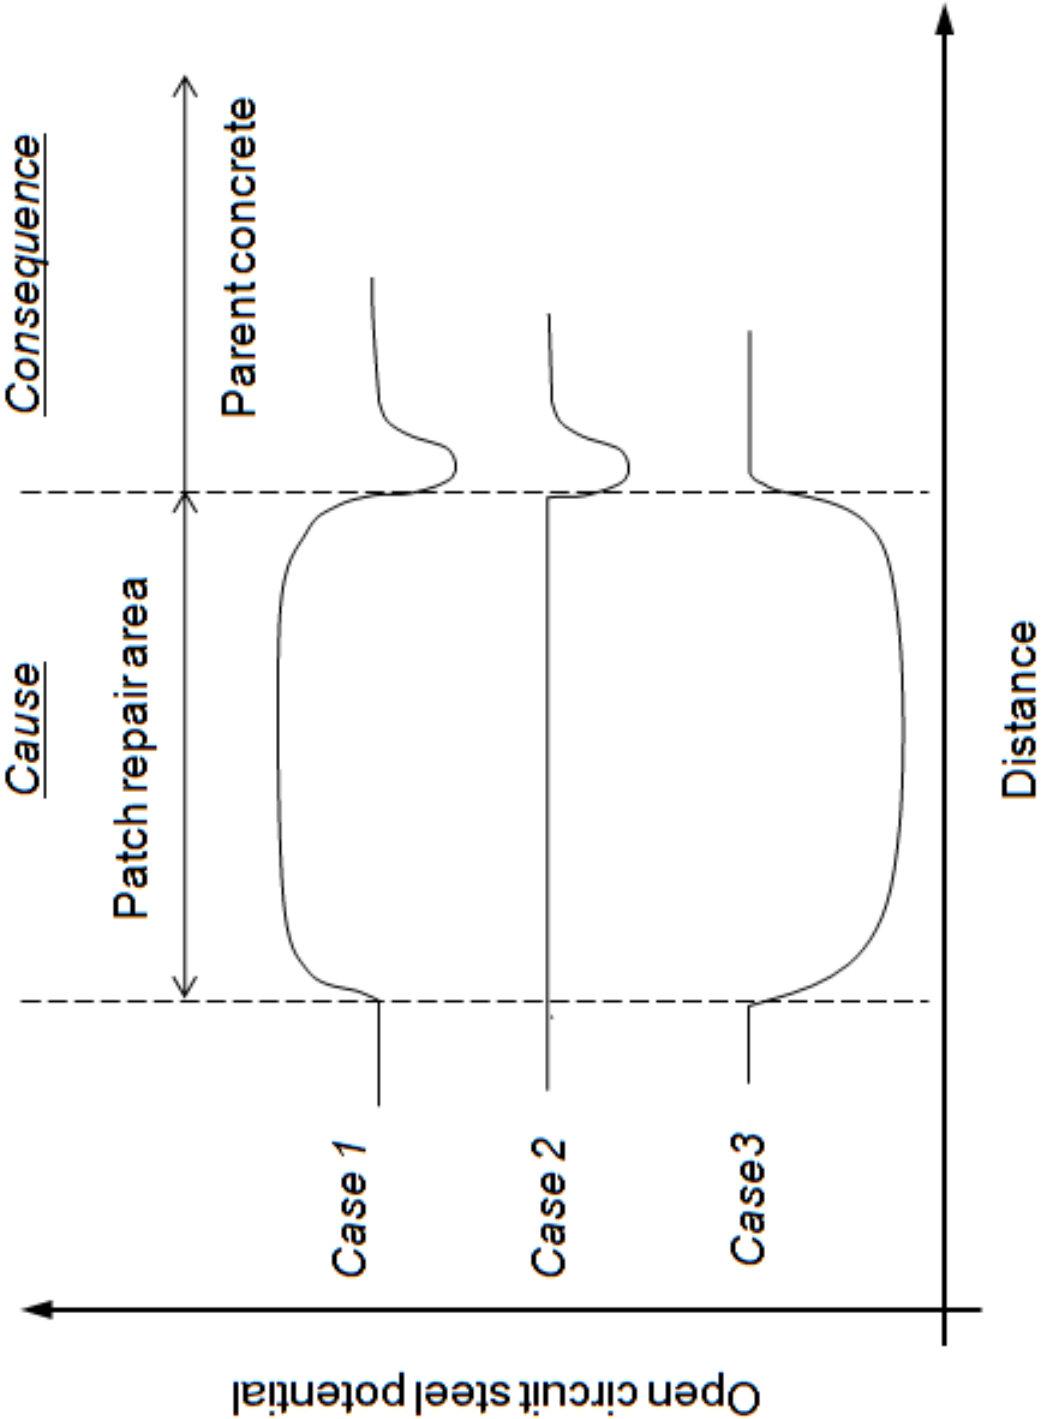
Case 2, represents previously published laboratory data by Page and Sergi (2000) where the repair results in the removal of the corrosion site that used to be an anode. The results are based on testing of a concrete slab cast and repaired under laboratory conditions. The parent concrete was not aged in the same way that concrete on full-scale structures is aged and did not use a proprietary repair material conforming to existing standards for the repair. However, the data presented by Page and Sergi (2000) suggests that although the anodic area was cut out and repaired, the parent concrete still had a residual chloride content which was sufficient on its own to cause corrosion on at least one of the identified areas of incipient anode formation.

Figure 4.4 Three schematic cases showing potential changes between parent and repair concrete (Christodoulou et al. 2013).

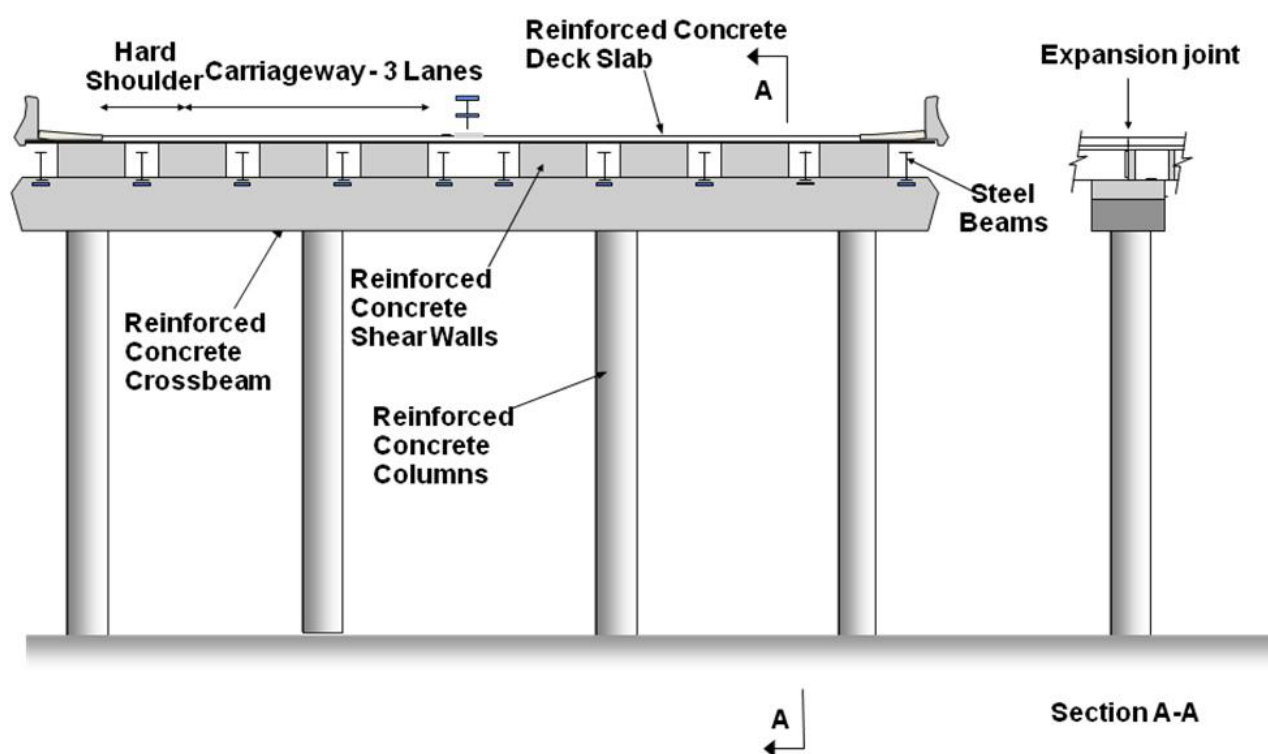
Figure 4.5 Typical sub-structure arrangement of the MLMV

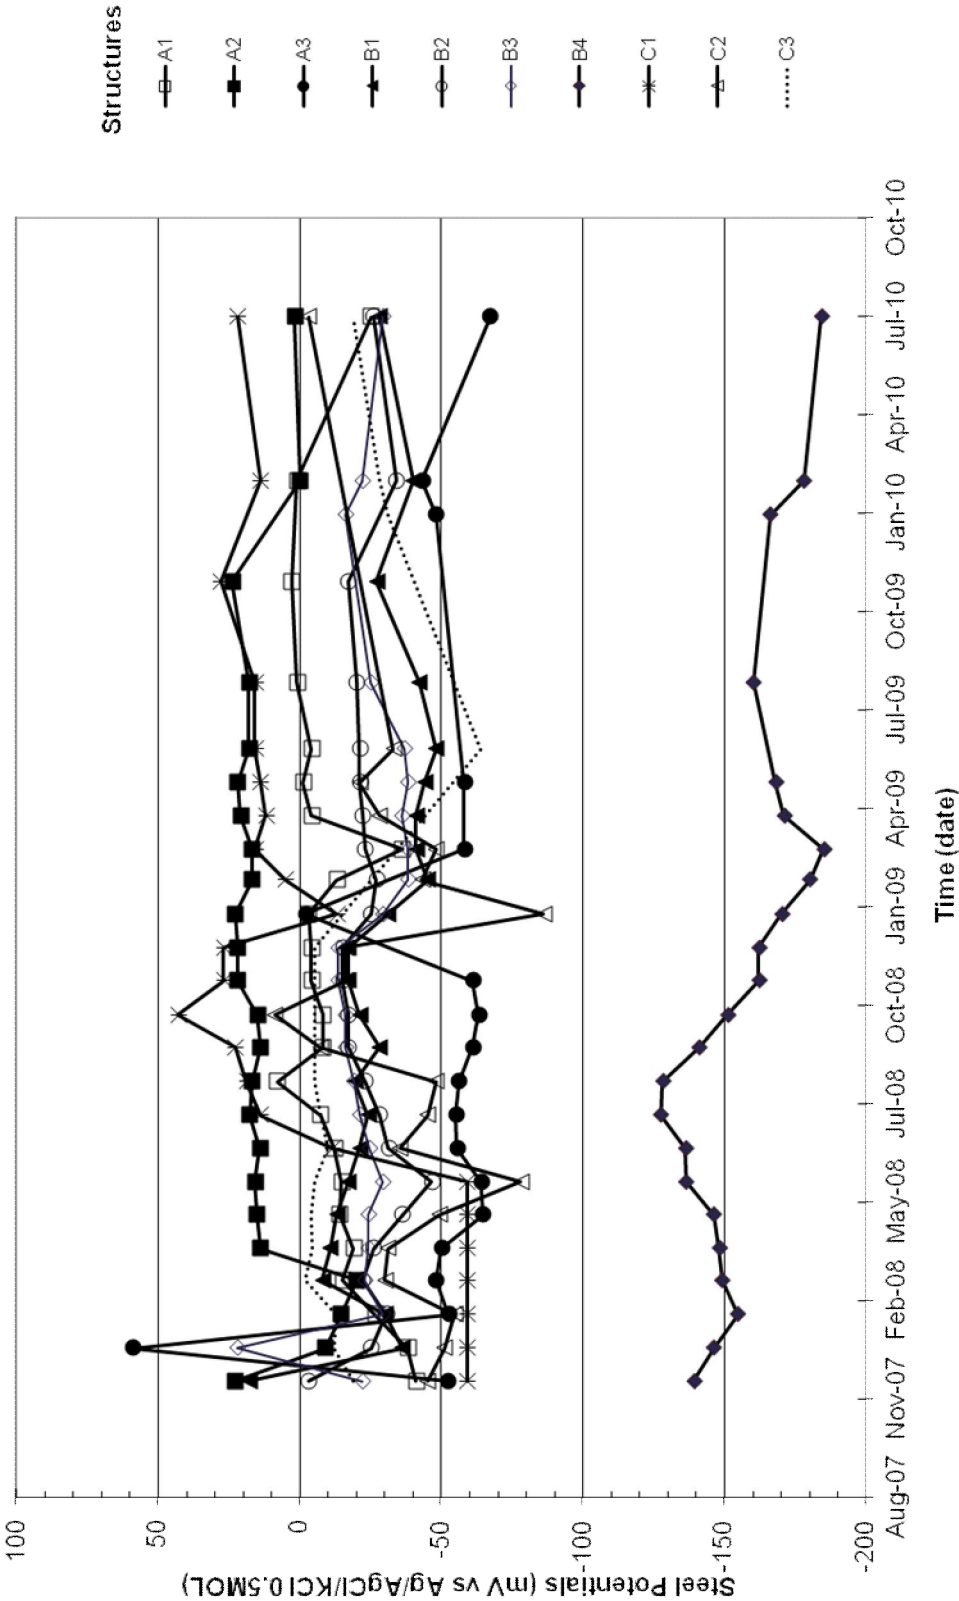
Structure B4 exhibited a different response than the other structures, which could have suggested that corrosion was occurring. However, corrosion rates both from polarisation resistance and transient response analysis indicated that the steel was passive. This reinforced the view that open circuit steel potentials should be used only for guidance on overall corrosion risk and not to interpret absolute values which are subject to a great degree of variation.

Figure 4.6 Steel potentials of the 10 structures monitored over a period of 33 months (Christodoulou et al. 2010).

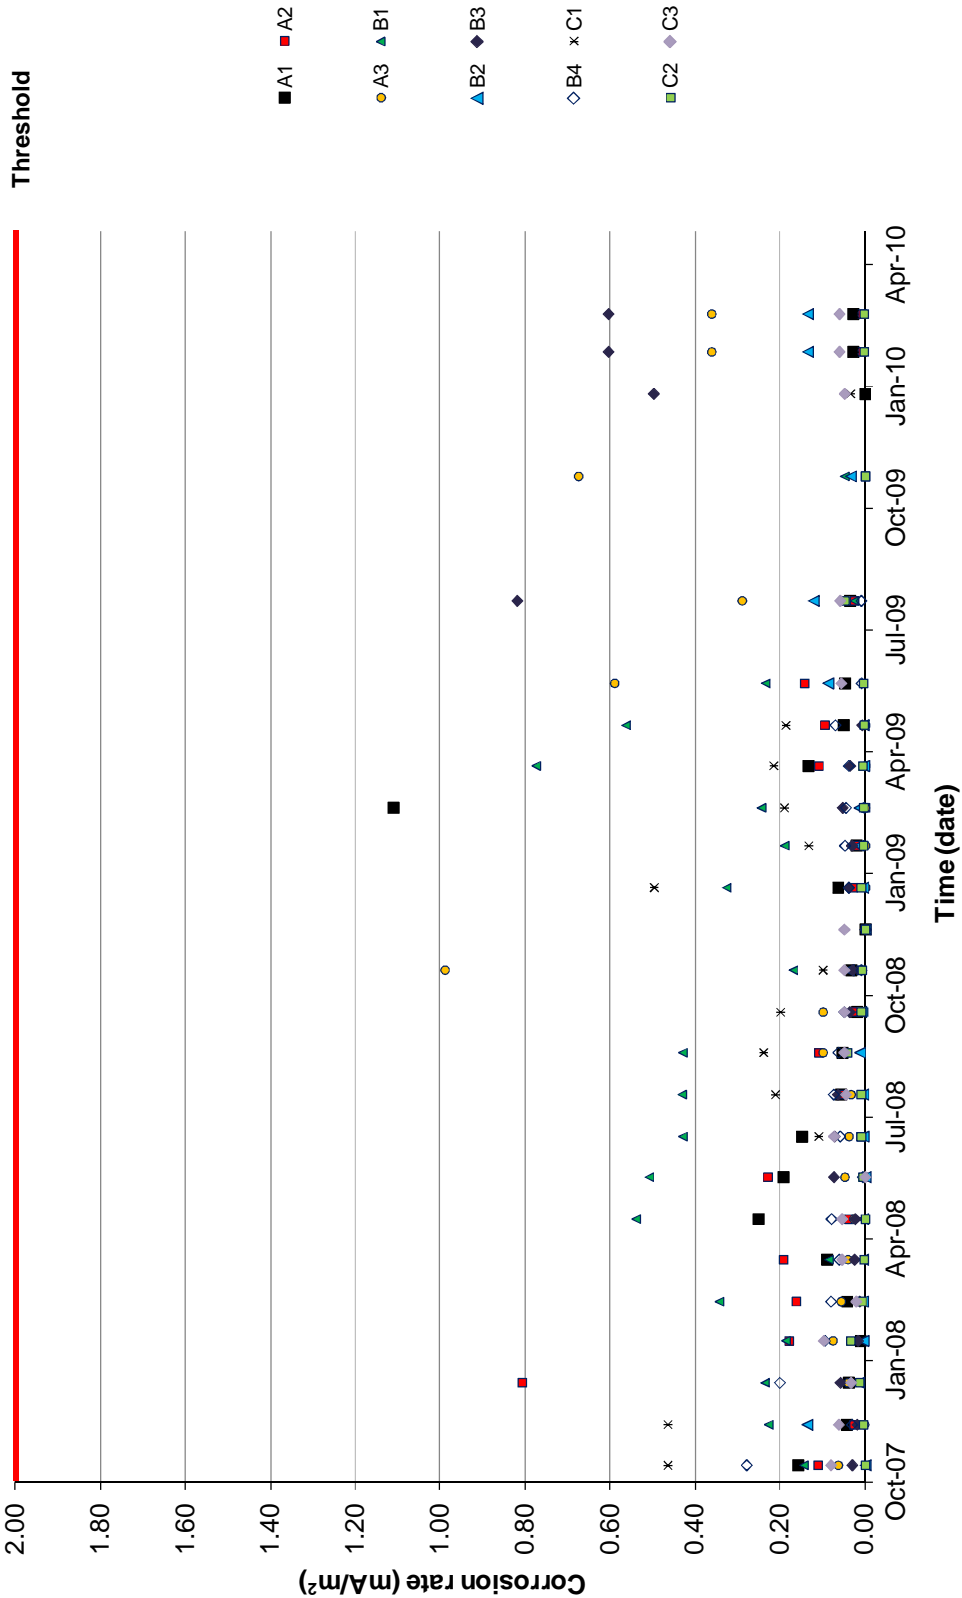
Corrosion rate measurements based on polarisation resistance testing over a period of 33 months are shown in Figure 4.7. It can be observed that in all cases the corrosion rates were well below the threshold level of 2 mA/m^2 (Concrete Society 2004b), reinforcing the view that ICCP may have persistent long-term beneficial effects. Occasionally, peaks of higher corrosion activity can be observed. These are primarily associated with galvanic currents during wet weather conditions when parts of the structures are wet whereas others remained dry. Overall, there was no trend of increasing corrosion rates after 33 months of no protection.

Figure 4.7 Corrosion rates summary from polarisation resistance testing over a period of 33 months (Christodoulou et al. 2010).

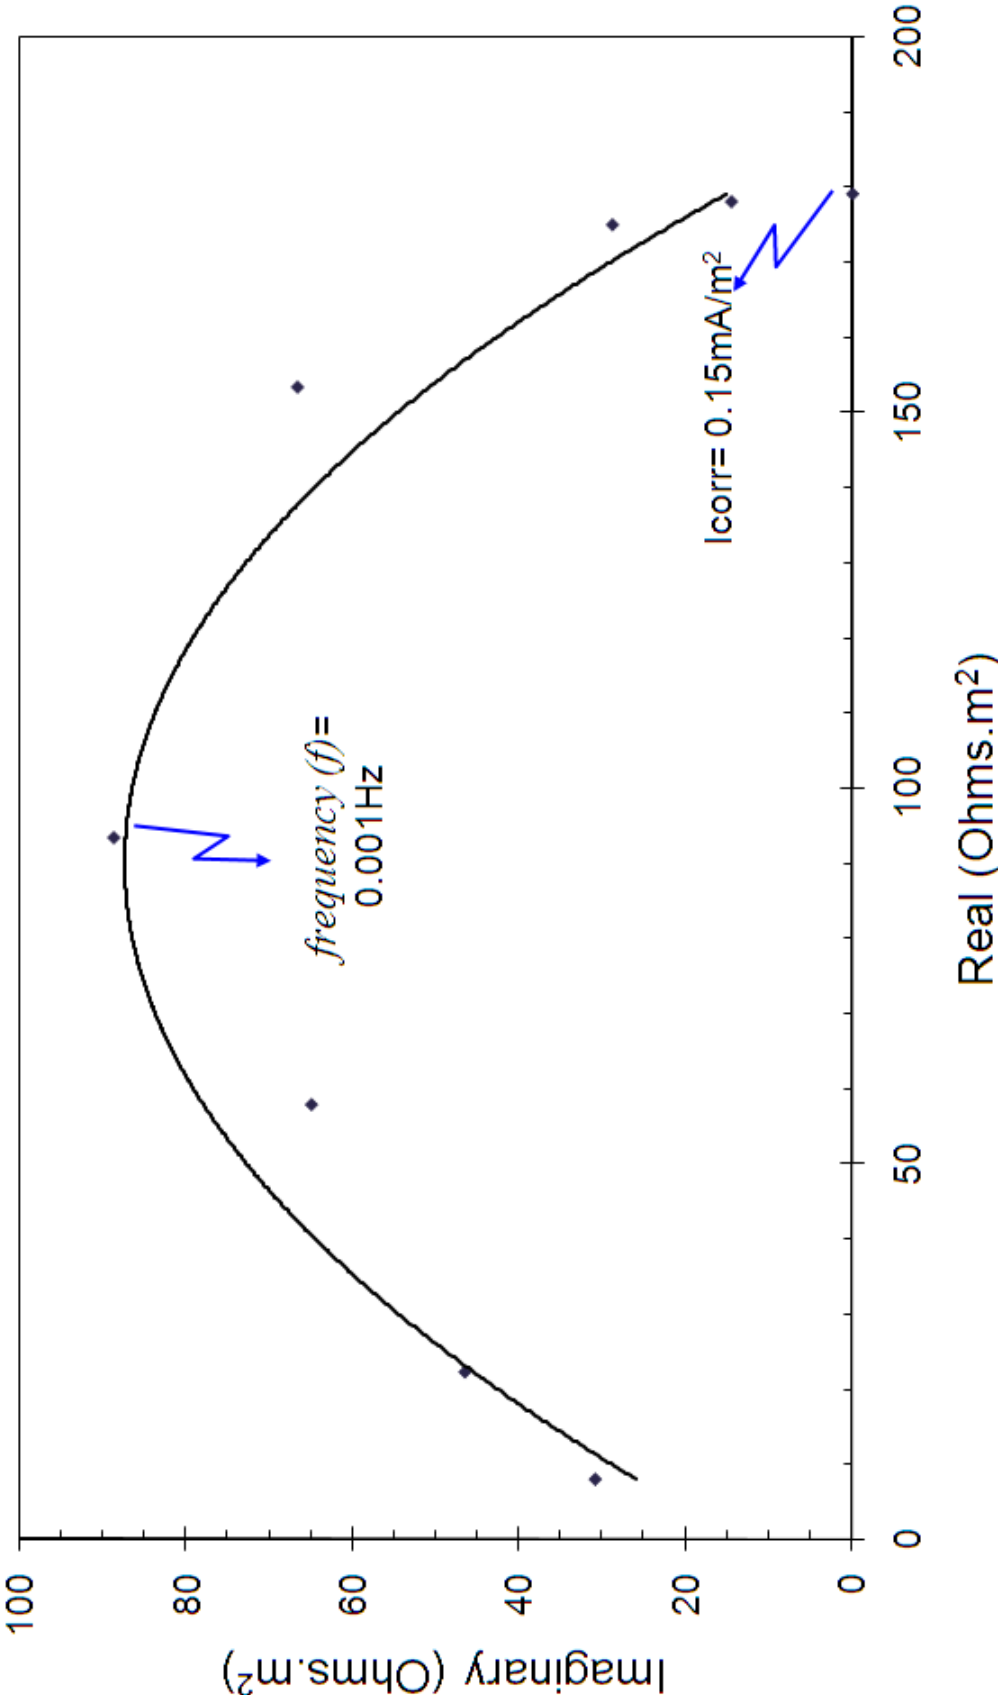
When comparing the data of Figure 4.8 with published laboratory data for active and passive steel (Glass et al. 1997, Glass et al. 1998) it can be determined that the site data corresponds closely to data obtained from passive steel specimens. This is indicated by both the x-axis range and the characteristic frequency.

Figure 4.8 Typical impedance plot arising following analysis of transient data (Christodoulou et al. 2010).

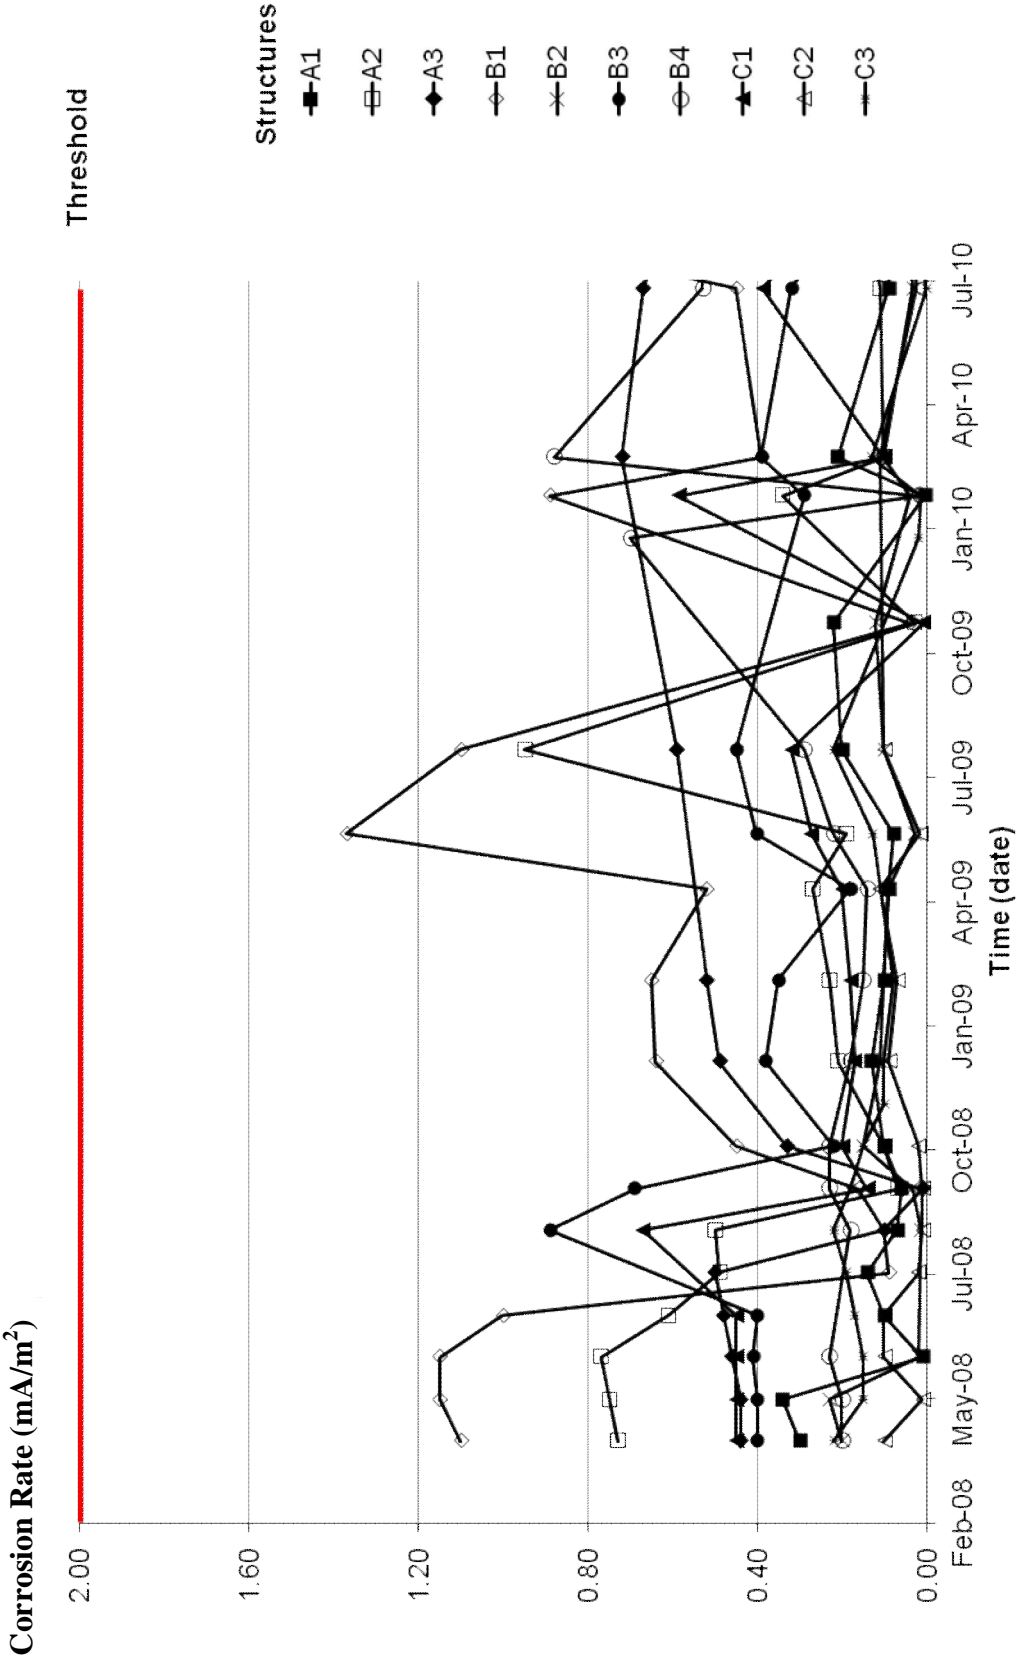
From the raw data, an equivalent corrosion rate can also be derived which can be used for comparison with corrosion rates derived from polarisation resistance testing. Figure 4.9 provides a summary of corrosion rates based on transient analysis over a period of 33 months without corrosion protection. It can be observed that in all cases examined the corrosion rates were well below the threshold level of 2 mA/m^2 (Concrete Society 2004b). The occasional peaks of higher corrosion activity can be associated with galvanic currents during wet weather conditions when parts of the structures are wet whereas others remain dry. Overall, there was no trend of increasing corrosion rates after 33 months of no protection.

Figure 4.9 Corrosion rates summary from transient analysis testing over a period of 33 months (Christodoulou et al. 2010).

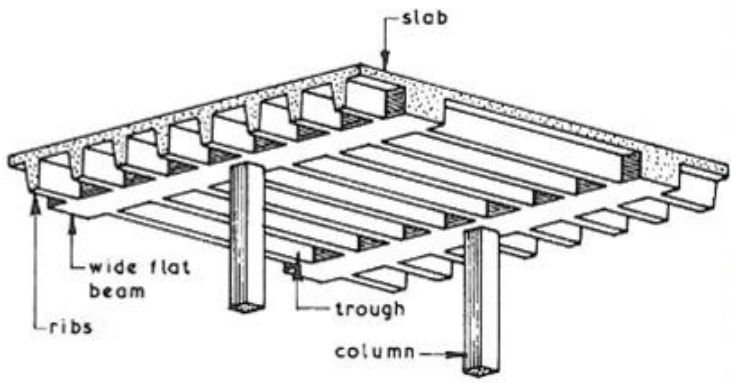
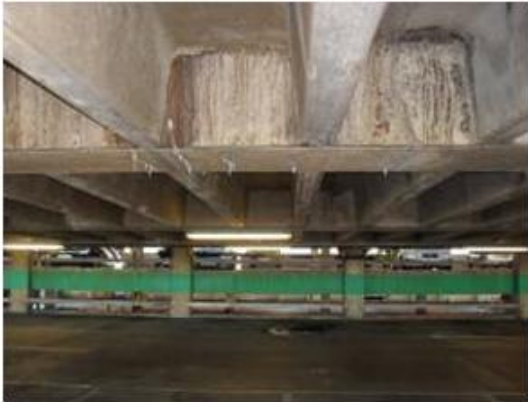
This work tested a new arrangement for the installation of galvanic anodes on a MSCP and a bridge structure (refer to Figures 4.10 and 4.11). Both structures suffered from extensive chloride-induced deterioration. Their refurbishment incorporated concrete repairs together with the installation of discrete galvanic anodes.

Figure 4.10 MSCP structural arrangement

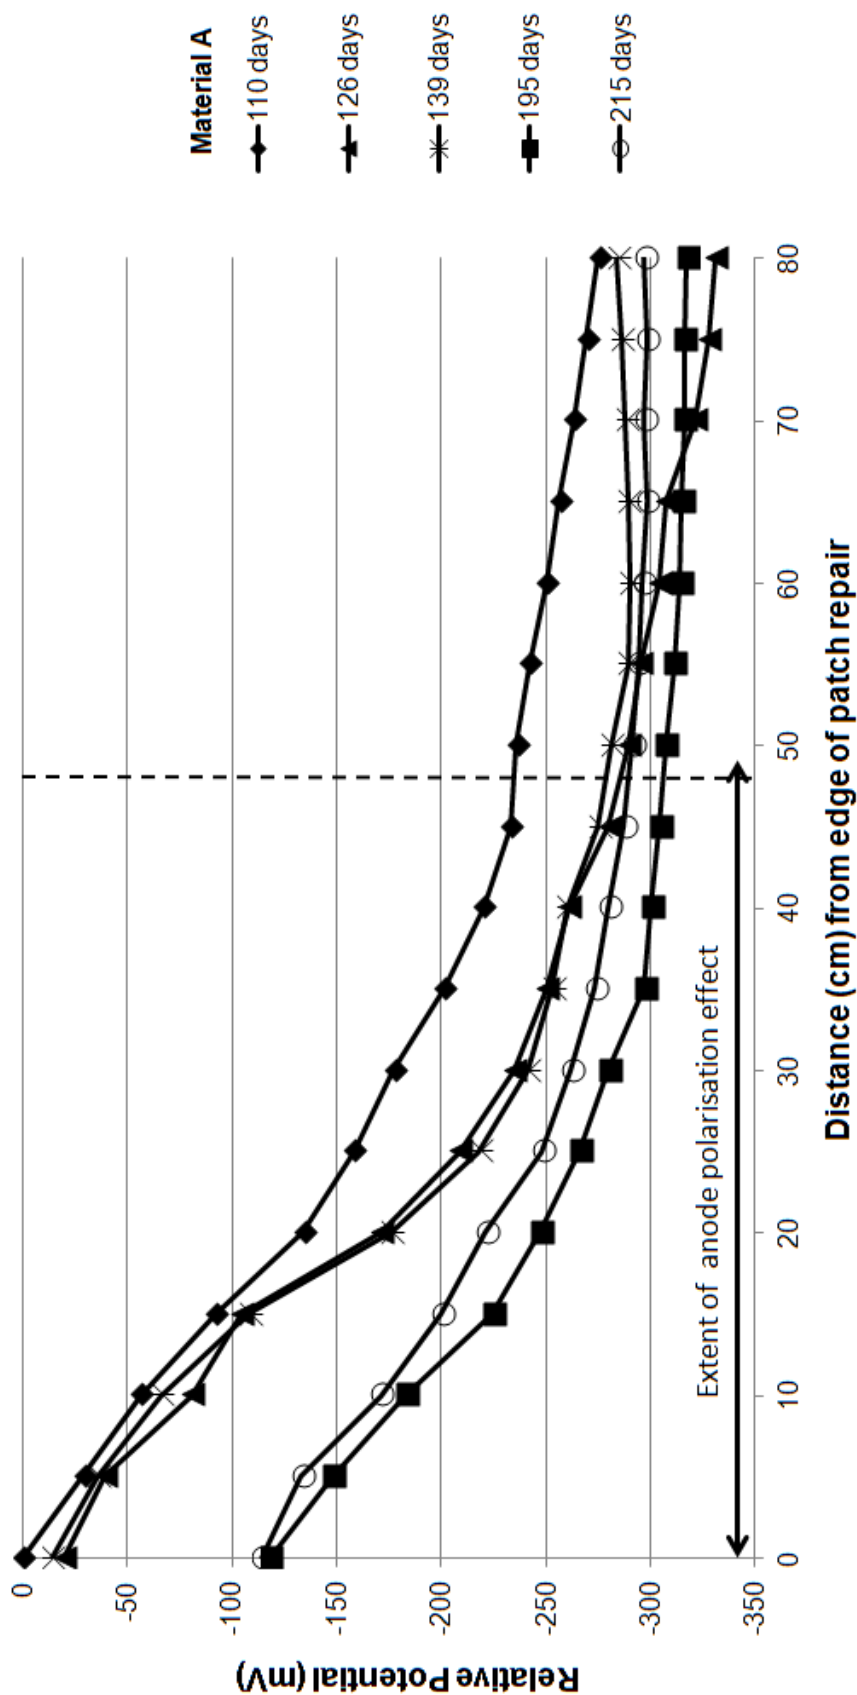
MSCP with material type A. The exact polarisation distance varied between 500 mm and 600 mm depending on the age of the anodes and the prevailing environmental conditions at the time of testing. No readings could be obtained for longer than 215 days as thereafter the slabs of the MSCP received a surface applied waterproofing.

Figure 4.12 Polarisation effect of the anodes at a distance from the edge of a patch repair in the MSCP with material type A over a period of 215 days following installation.

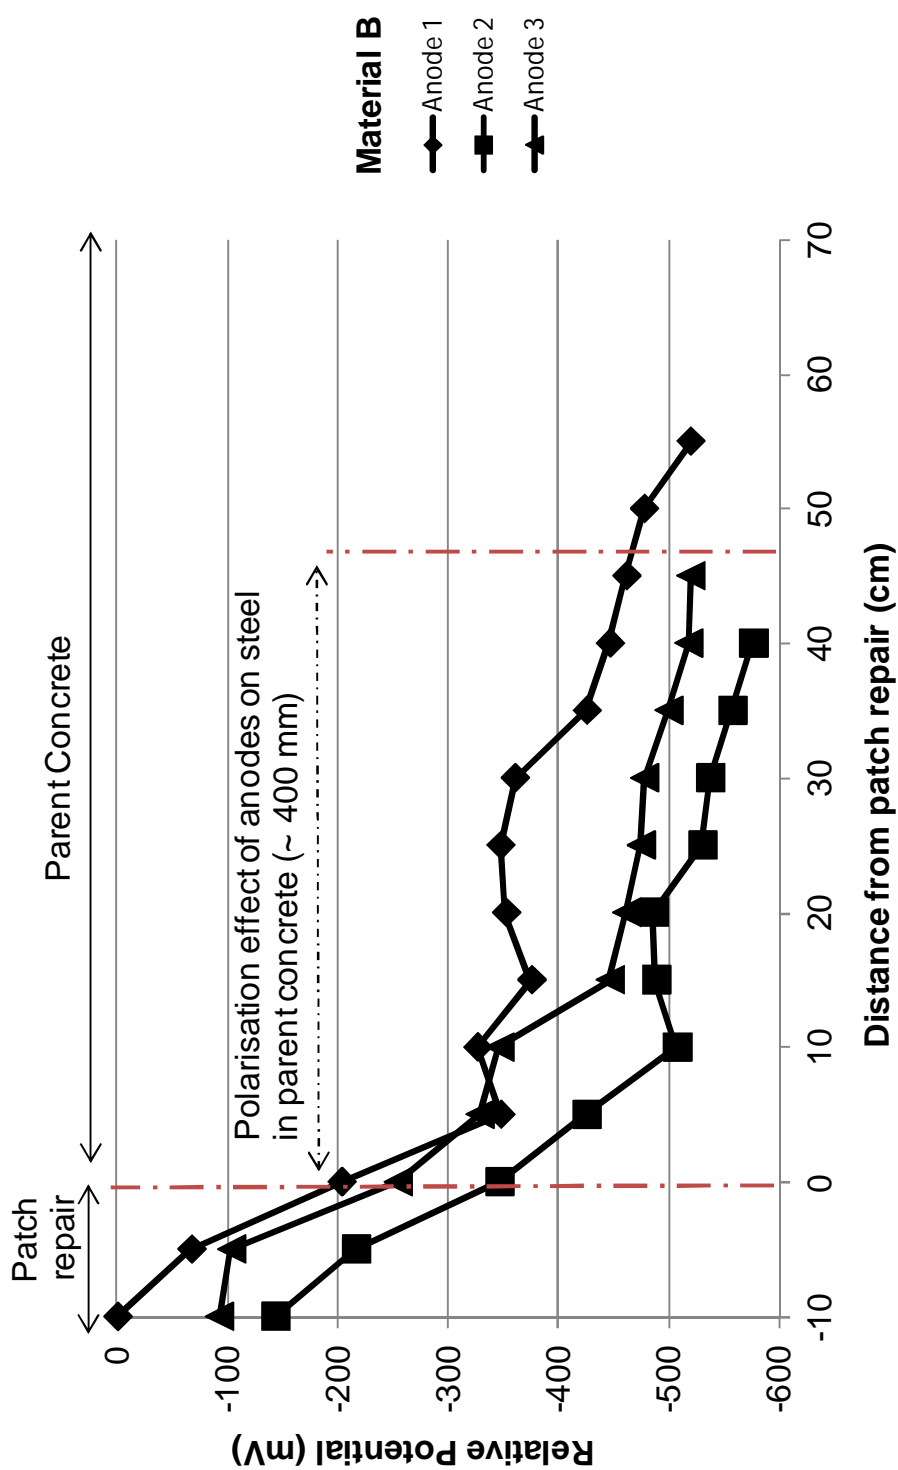
These are typical and re-occurring findings on the polarisation effect afforded by the anodes to steel in parent concrete at a distance from the edge of a patch repair with material type B, in the case of the bridge structure. The typical polarisation distance afforded by the anodes was 400 mm. Readings longer than 45 days after installation were not possible due to access restrictions on the bridge.

Figure 4.13 Polarisation effect of anodes at a distance from the edge of a patch repair from the bridge structure, with material type B, 30 days following installation.

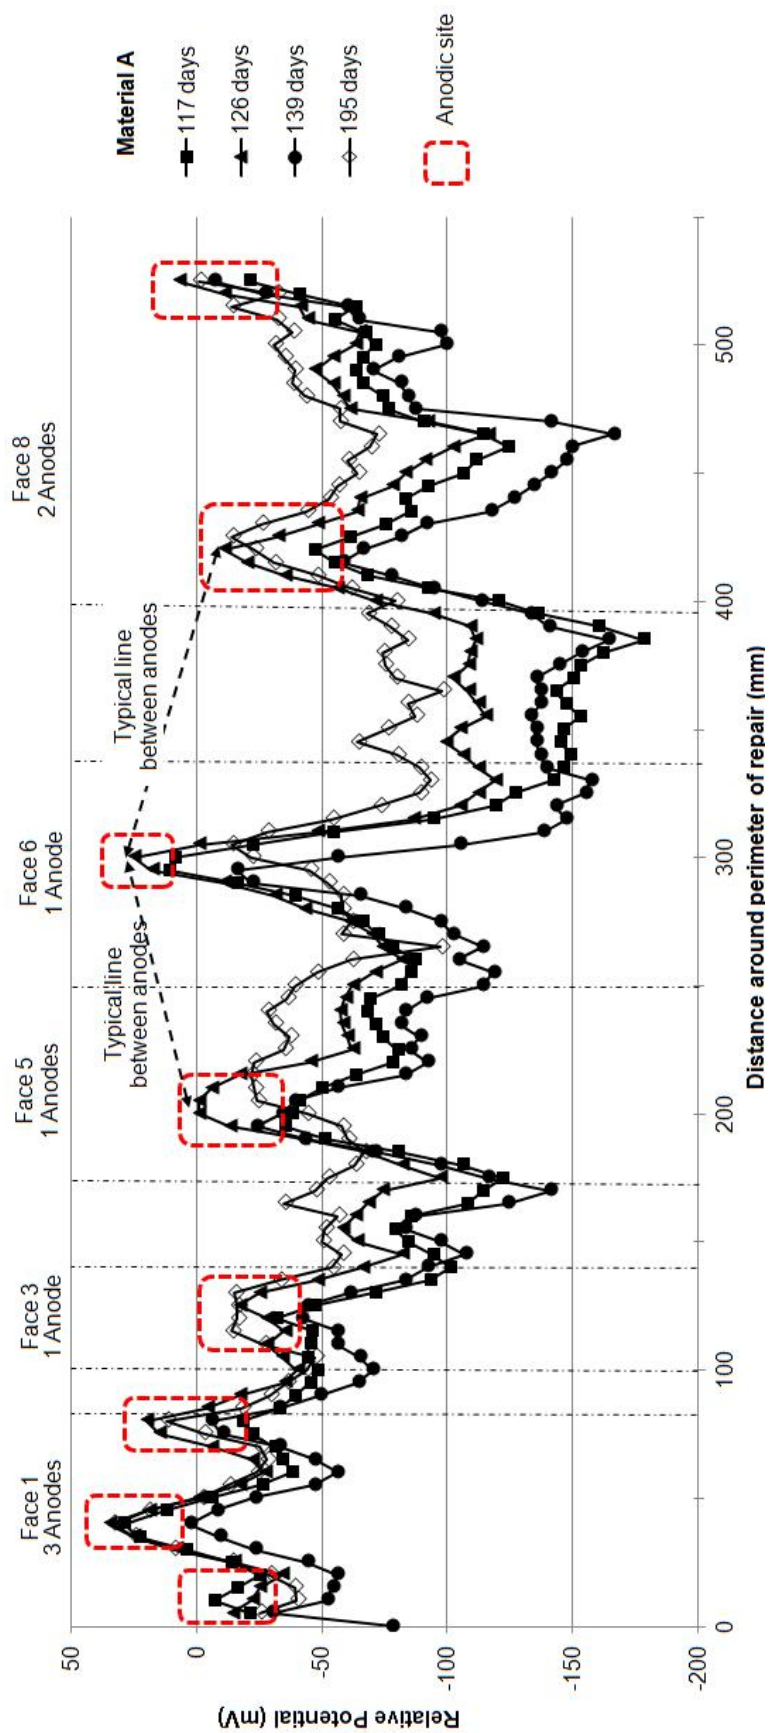
Figure 4.14 Potential mapping around a repair location with Material A up to 195 days following installation of the galvanic anodes.
