Repair and Corrosion Management of Reinforced Concrete Structures

REPAIR AND CORROSION MANAGEMENT OF REINFORCED CONCRETE STRUCTURES

A dissertation thesis submitted in partial fulfilment of the requirements for the award of the degree Doctor of Engineering (EngD), at Loughborough University

November 2013

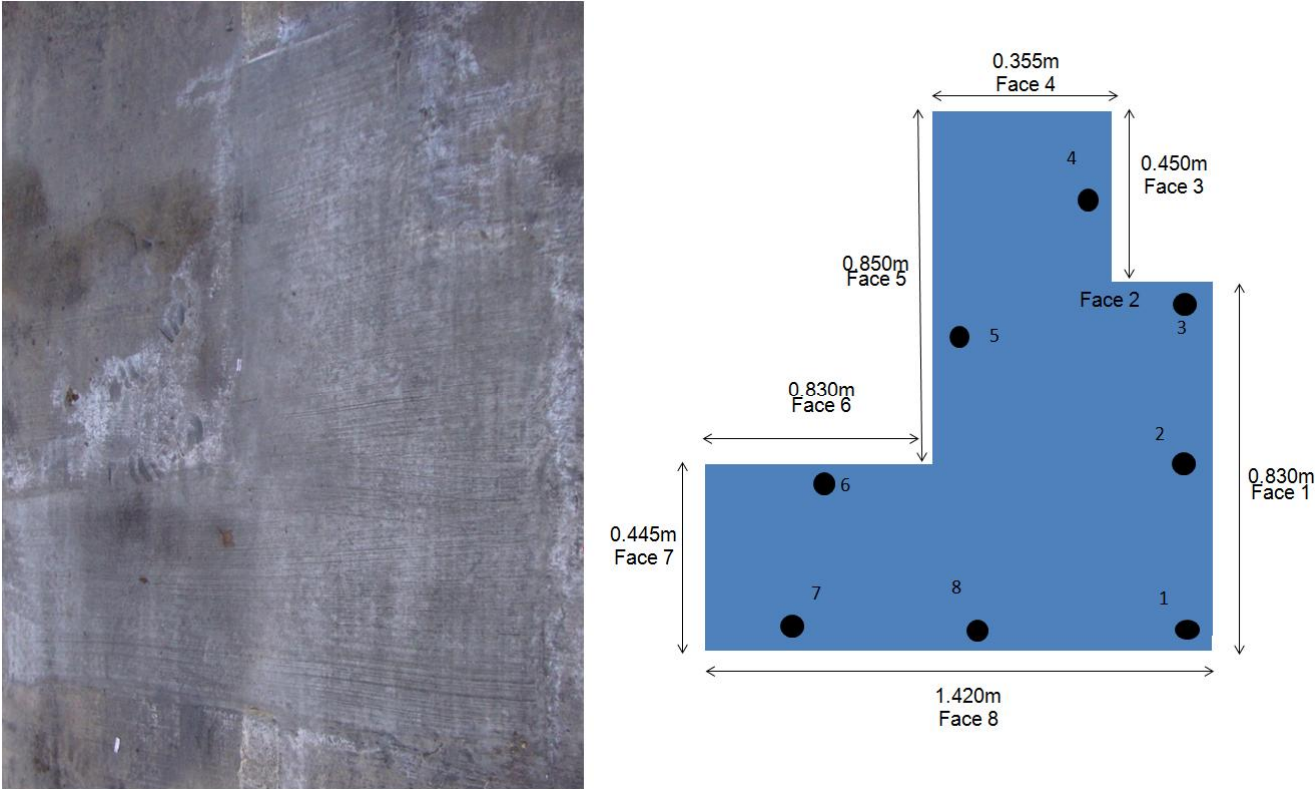
Figure 4.15 Diagrammatic outline of the patch repair and the location of anodes.

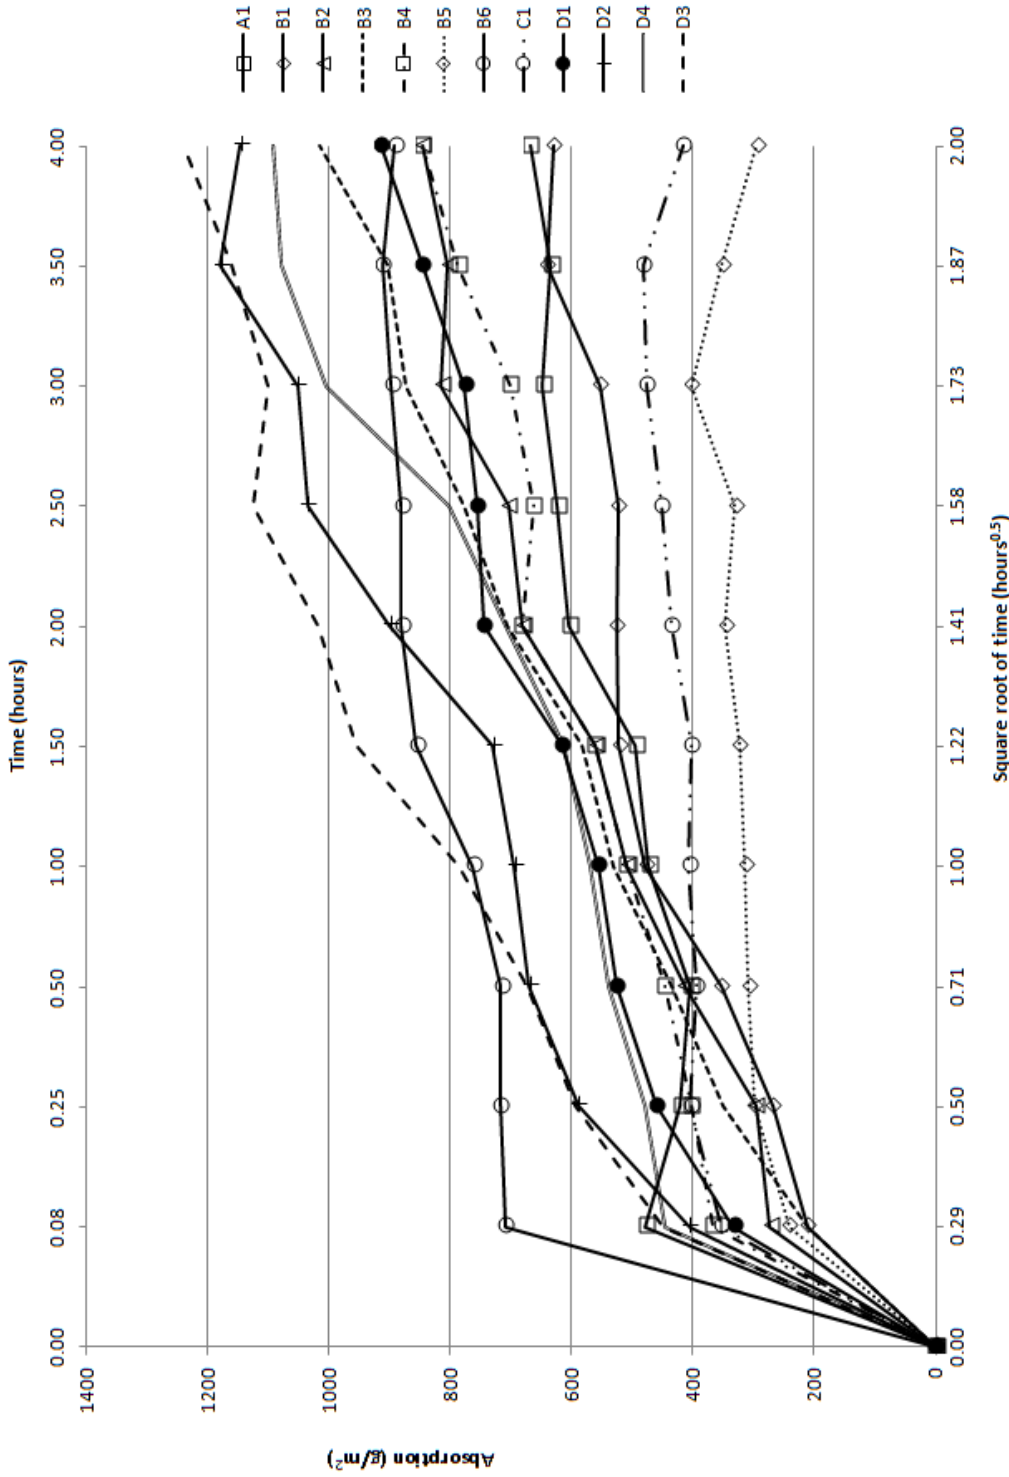
Figure 4.18 Average cumulative absorption for each structure’s group of specimens over 4 hours of capillary absorption testing.

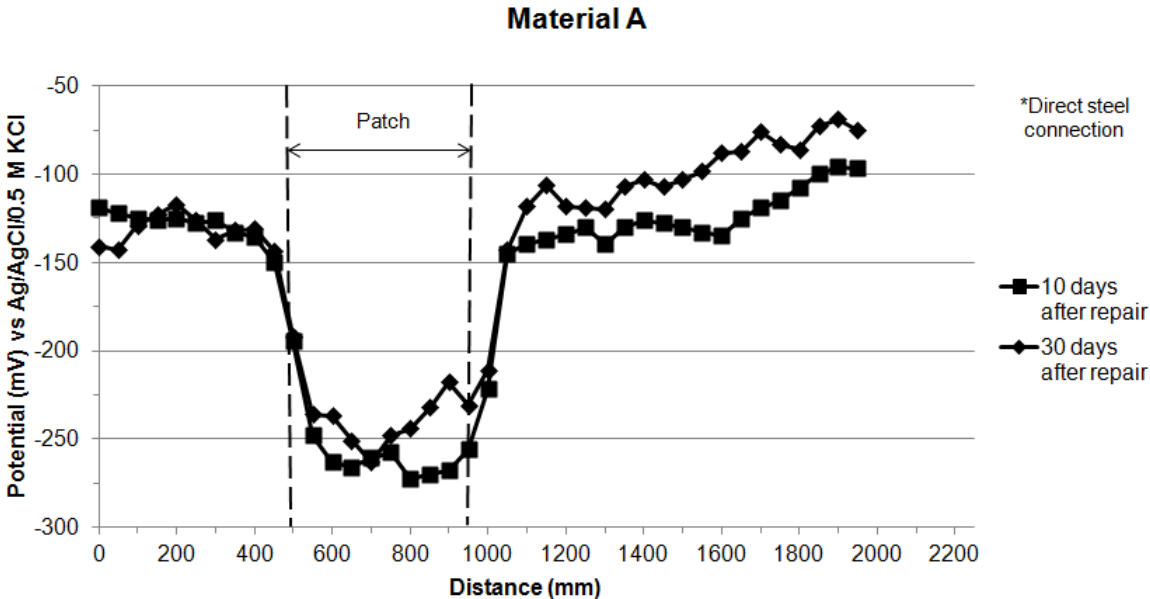
Figure 2: Potential mapping monitoring of material type A on car park deck repair

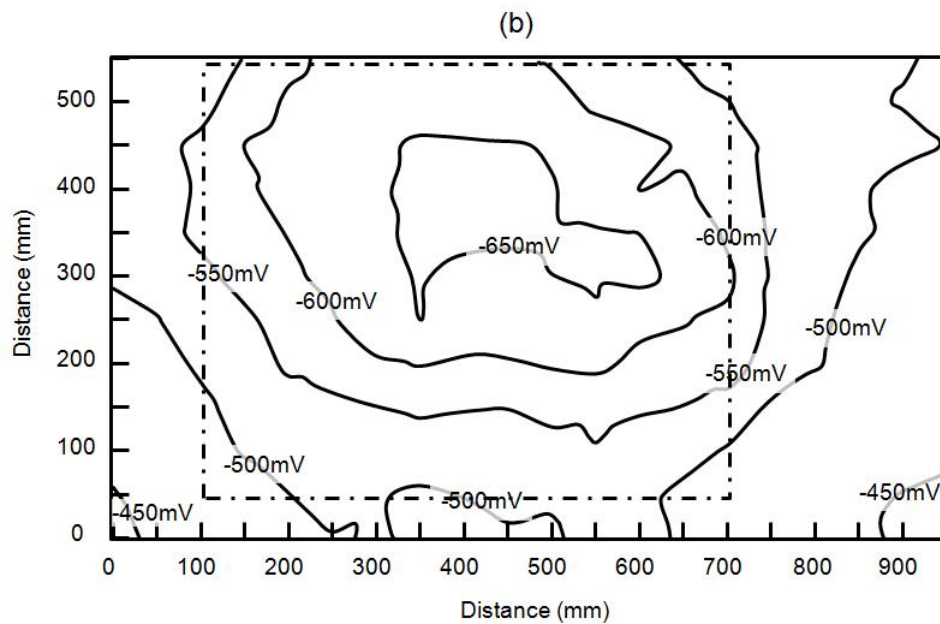
Figure 3: Surface potential mapping on car park repair (a) before and (b) 30 days after repair. Dashed line in (b) illustrates extent of patch repair.

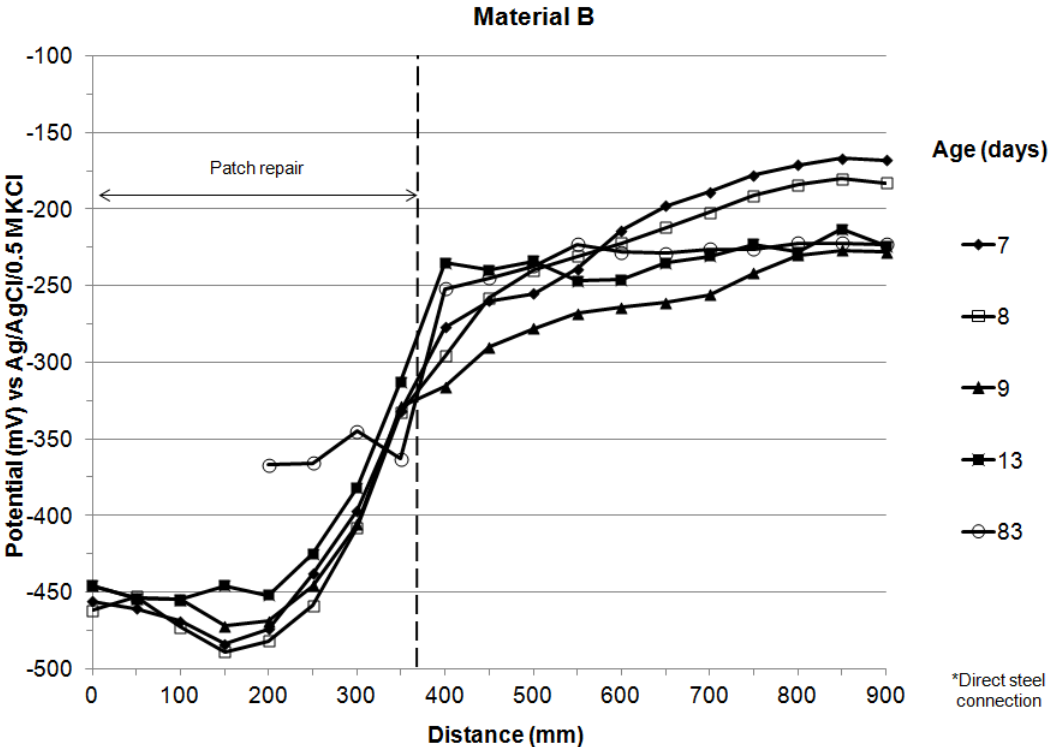
Figure 5: Potential mapping monitoring of material type B on a bridge repair

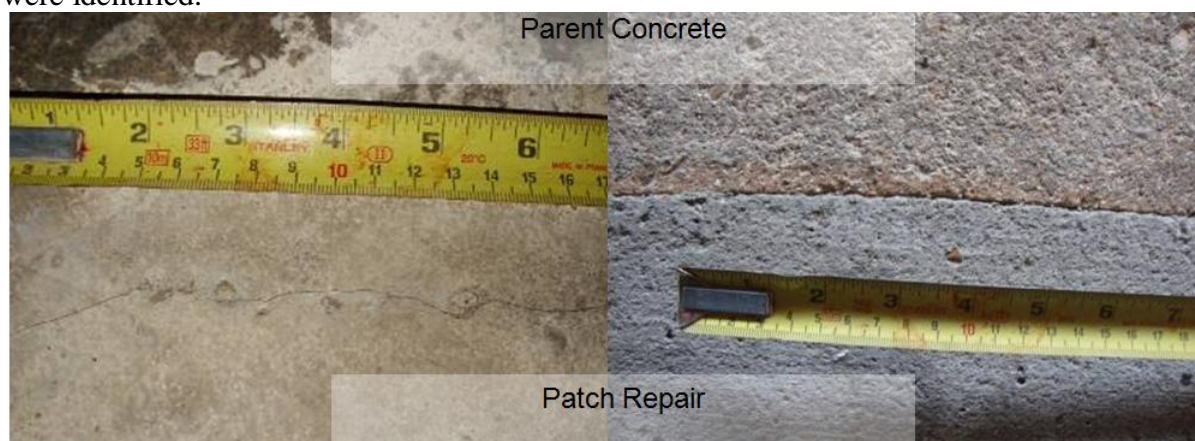
Figure 7: Cracks at the interface of a patch repair in the car park using material A, before and after surface preparation with mechanical shot-blasting

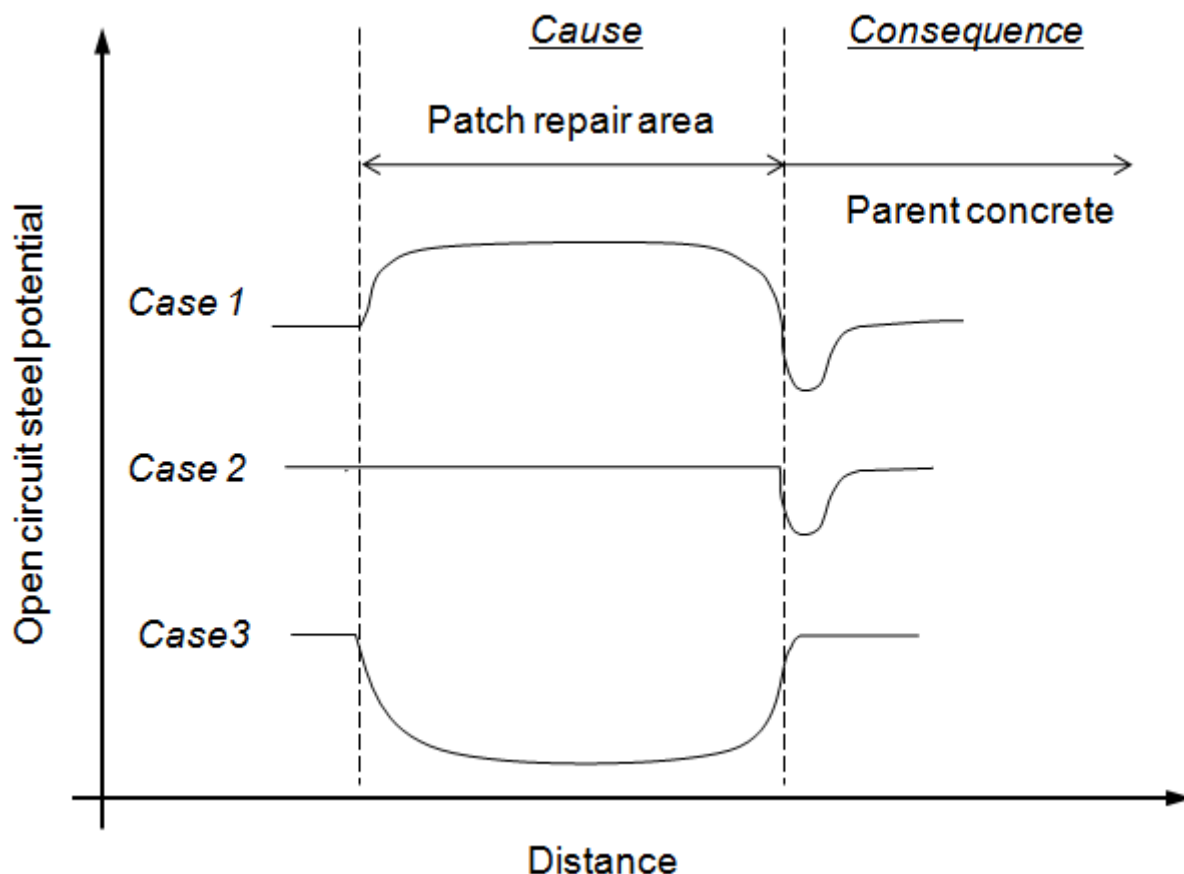
Figure 8: Three cases of potential changes between parent and repair concrete

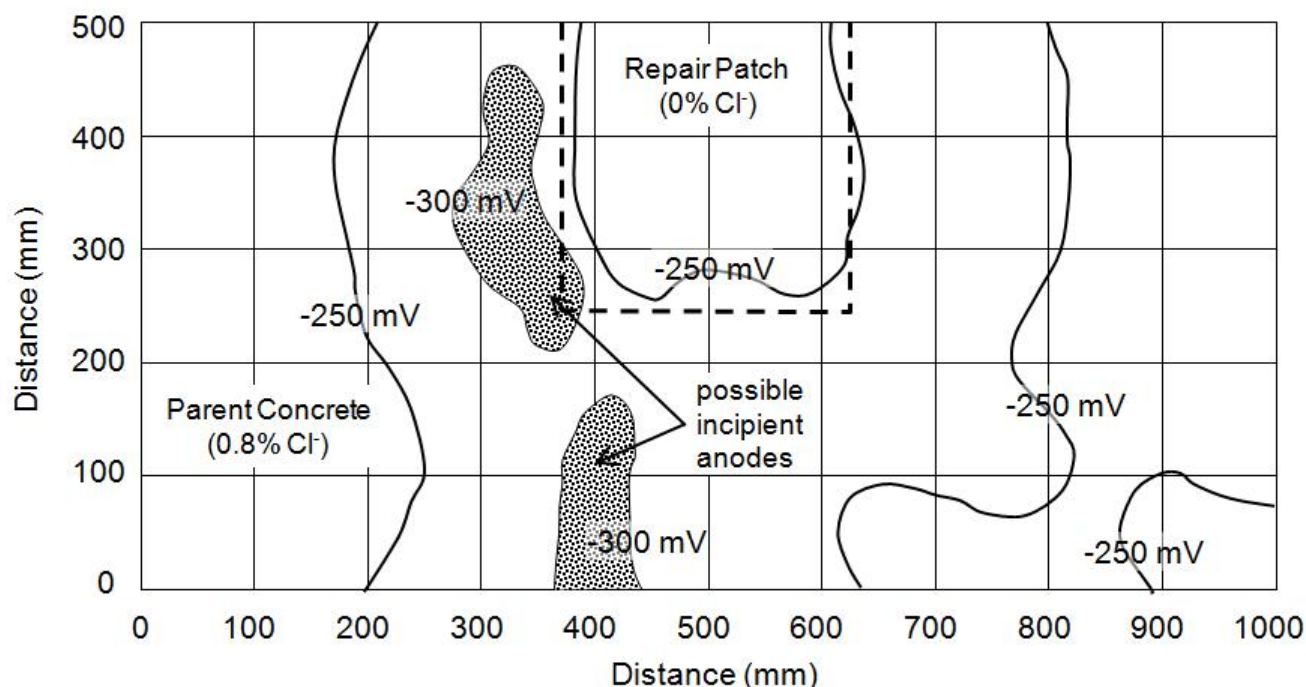
Figure 9: Open circuit steel potentials of a slab following 2 months of conventional patch repair (potential vs Standard Calomel Electrode) [3].

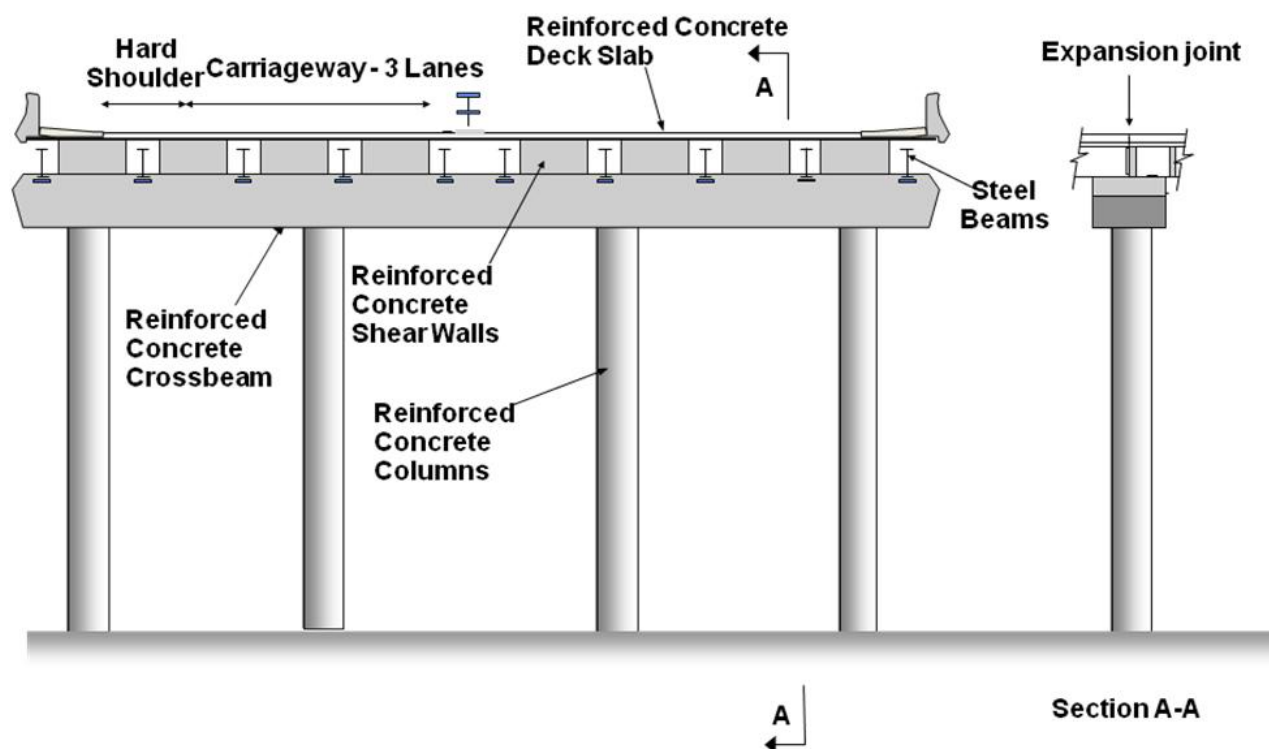
Figure 2: Typical sub-structure arrangement

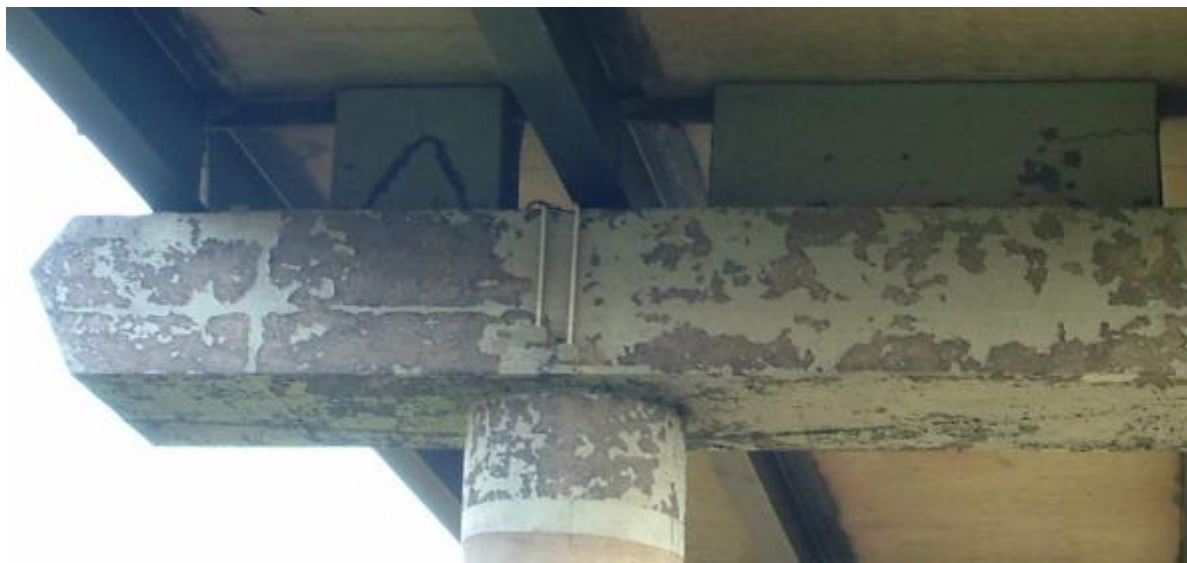
Figure 3: Beam tested for long term effects of ICCP, showing evidence of severe anode deterioration but not signs of corrosion

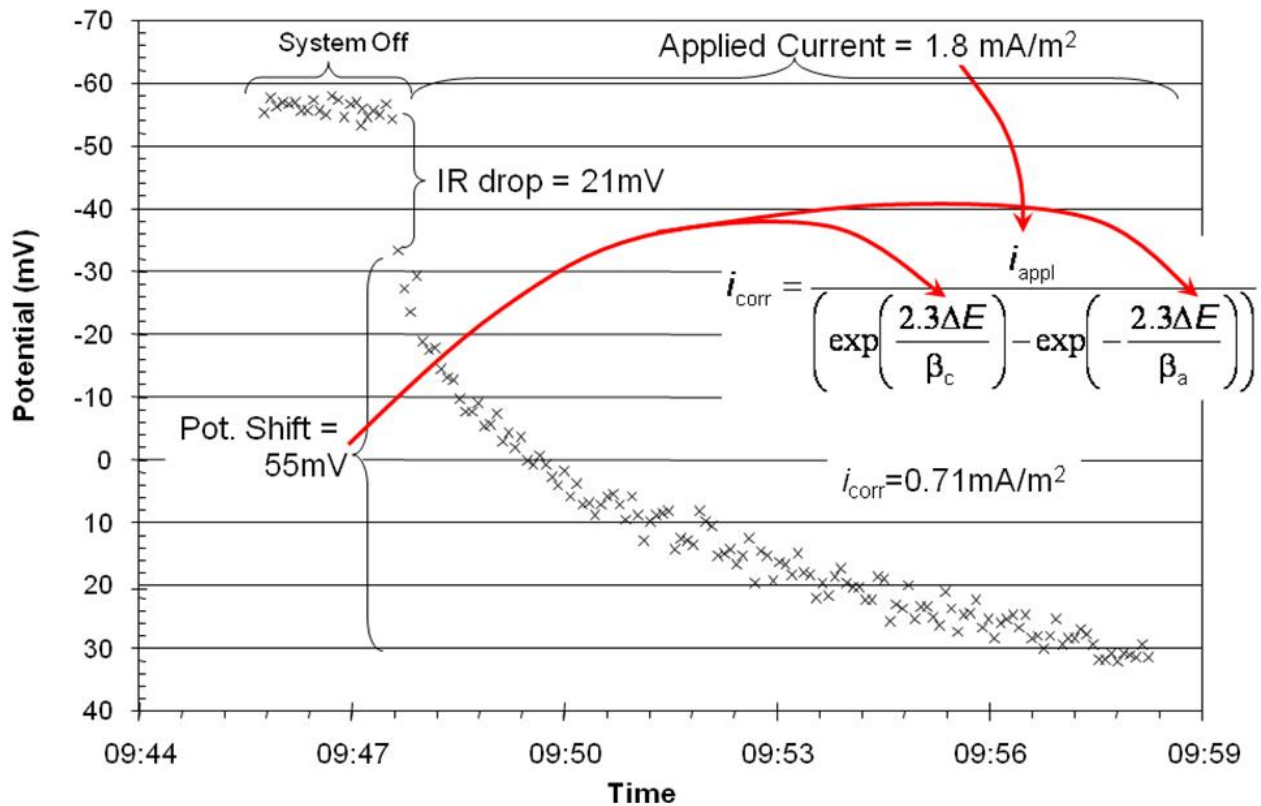
Figure 4: Example of a corrosion rate calculation

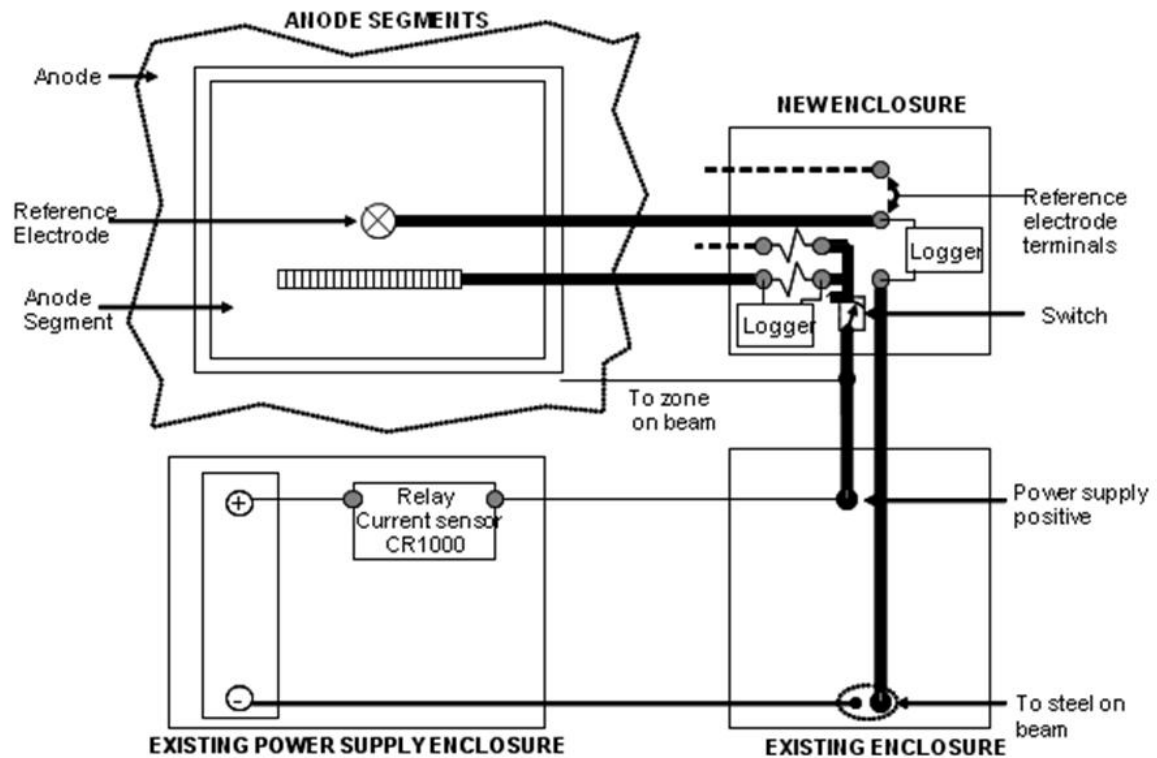
Figure 5: Testing arrangement

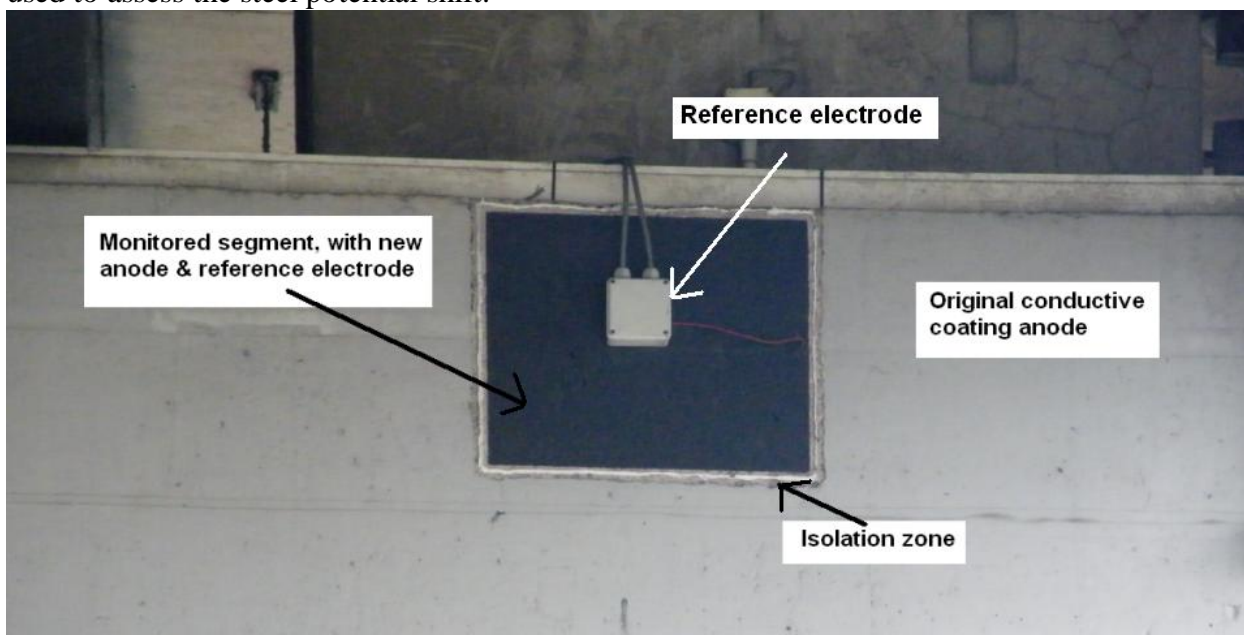
Figure 6: Isolated anode segment and reference electrode location

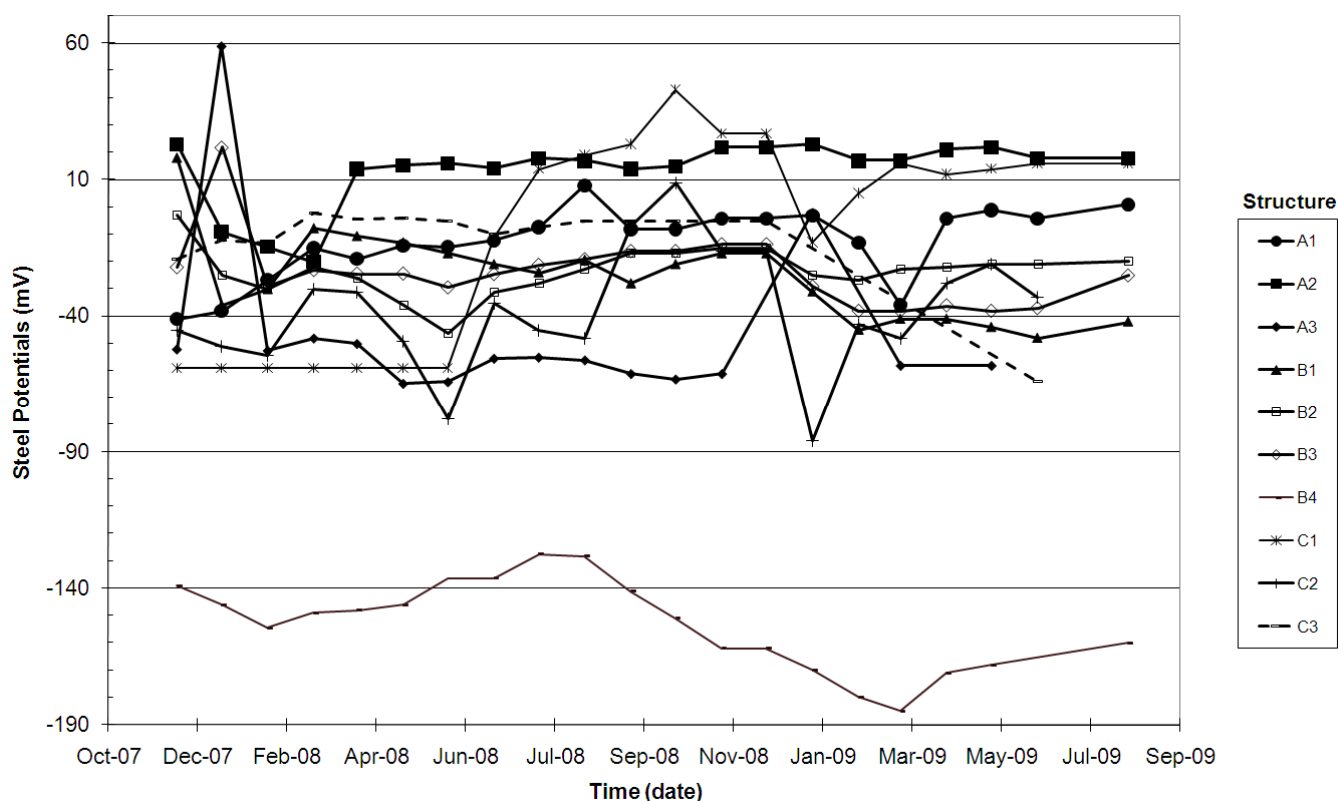
Figure 7: Steel potentials of the 10 structures monitored over a period of 24 months

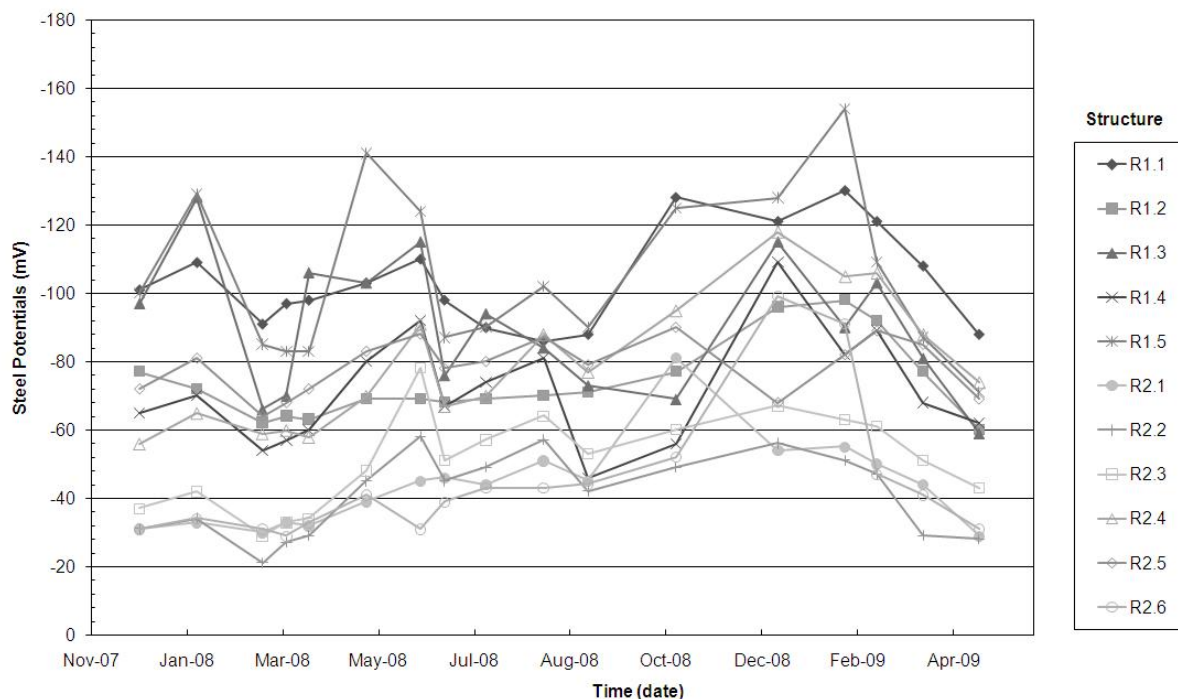
Figure 8: Steel potentials with respect to original reference electrodes for structure C2

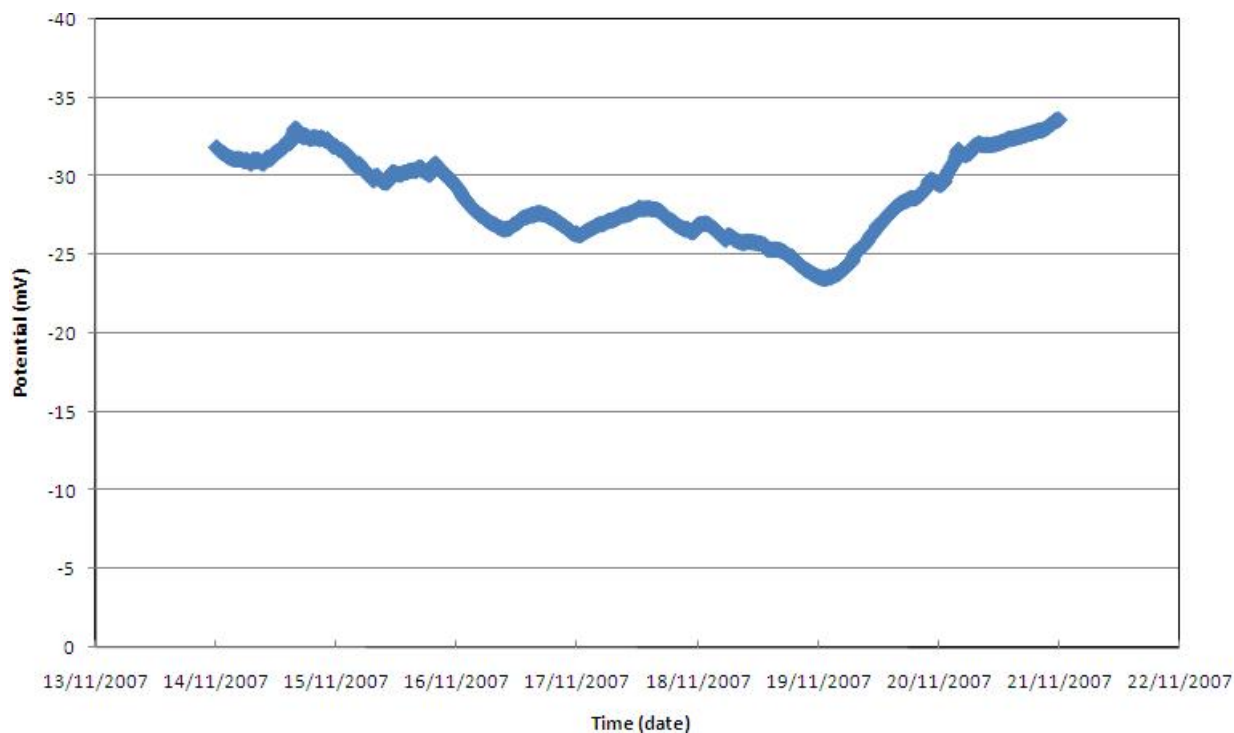
Figure 9: Steel potentials for structure A1 over a 7 day period

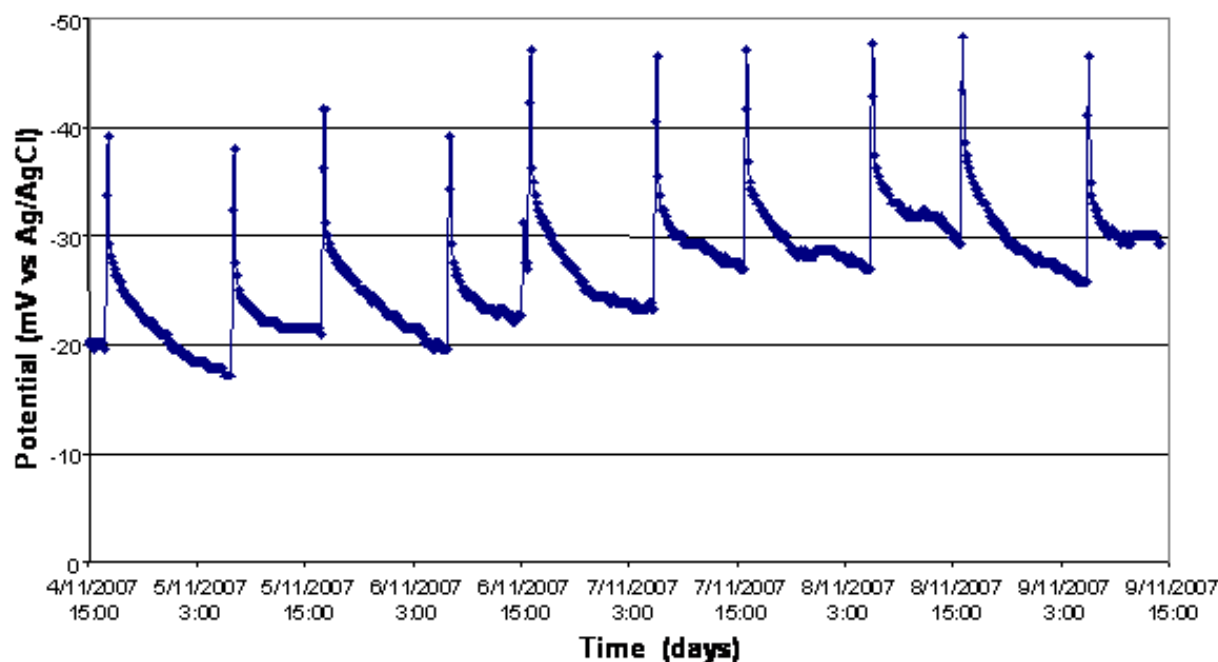
Figure 10: Potential data for structure reference A3, illustrating the long term effects of polarisation induced by a brief and low current density pulse

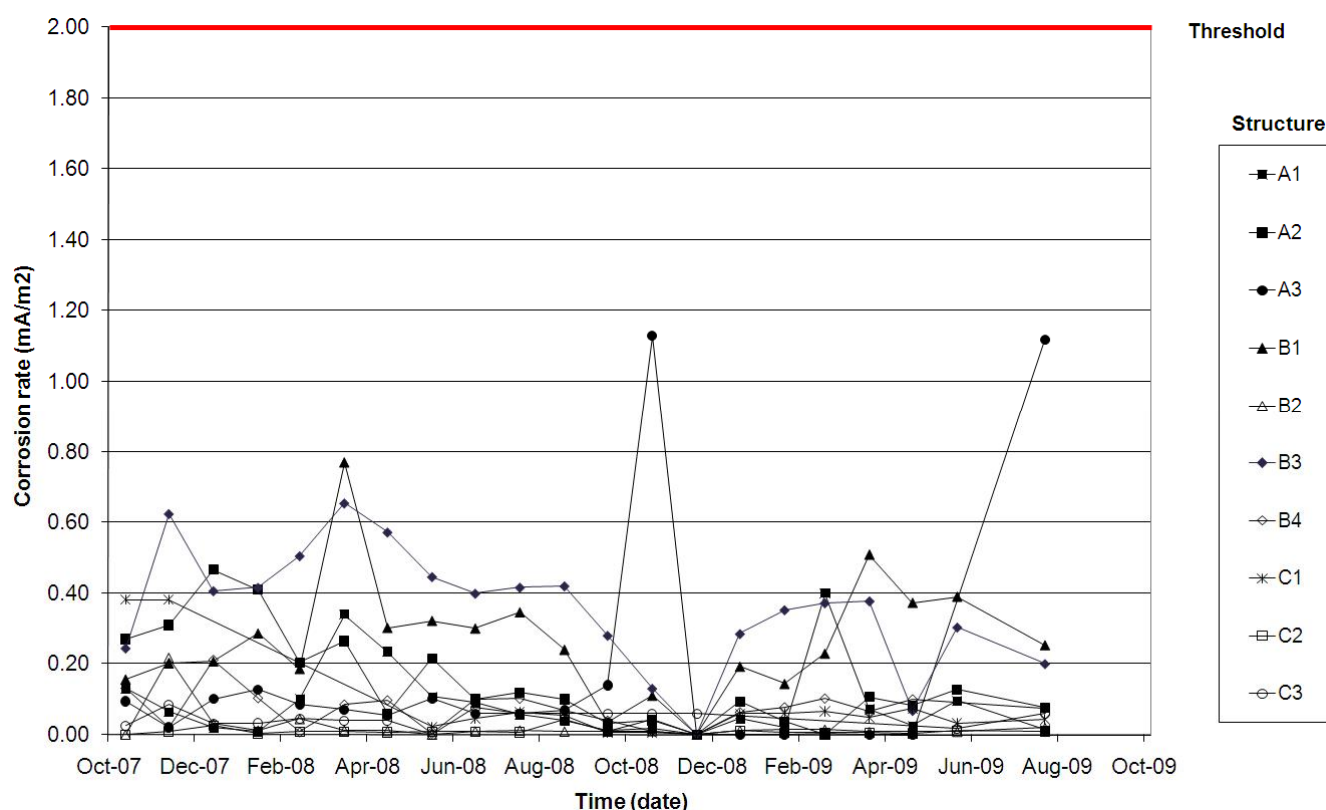
Figure 11: Corrosion rates summary from polarisation resistance testing over a period of 24 months.

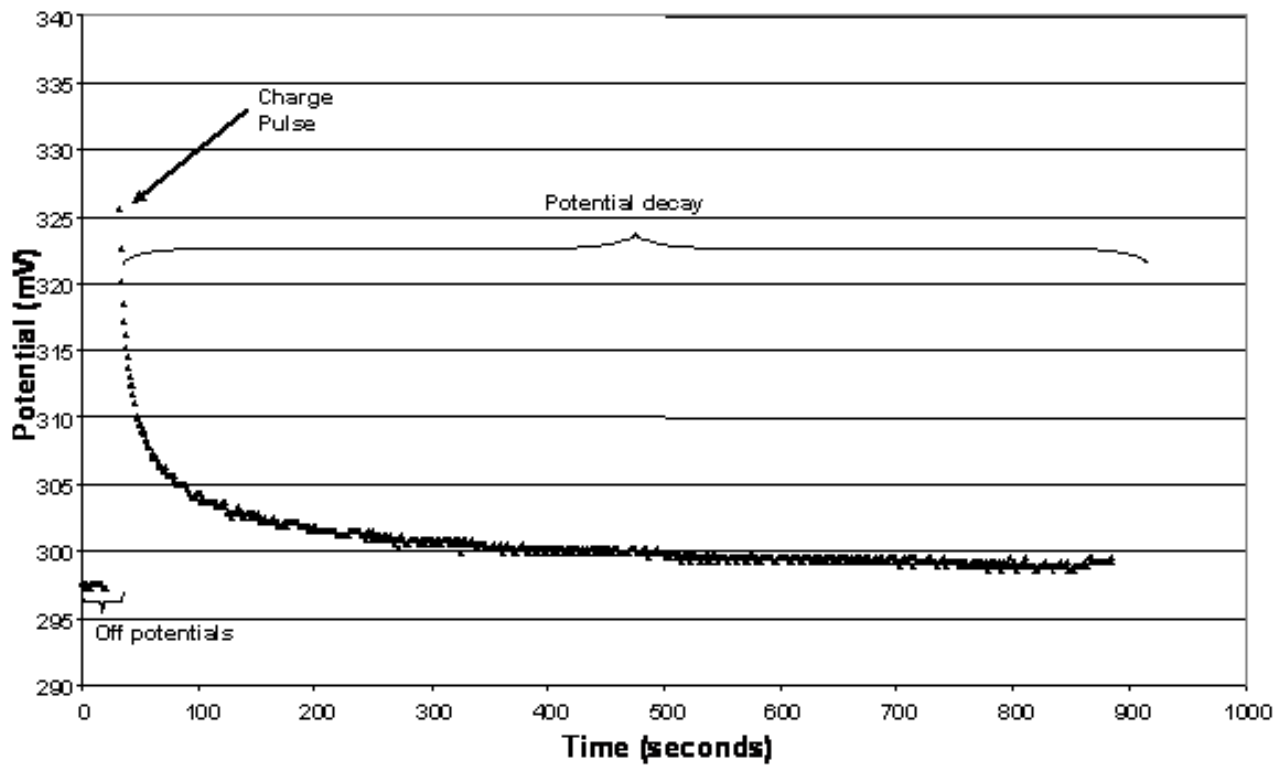
Figure 12: Raw data for impedance analysis for structure C3

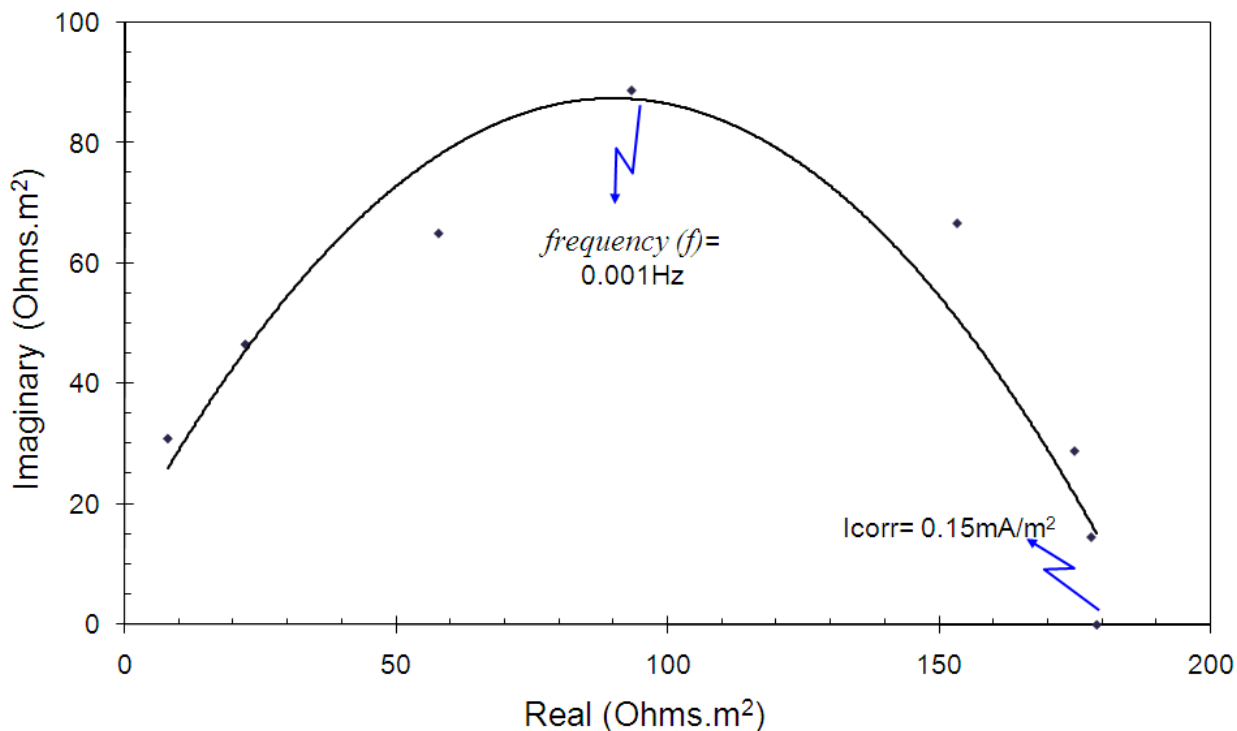
Figure 13: Analysis of raw data to obtain corrosion rate for structure C3

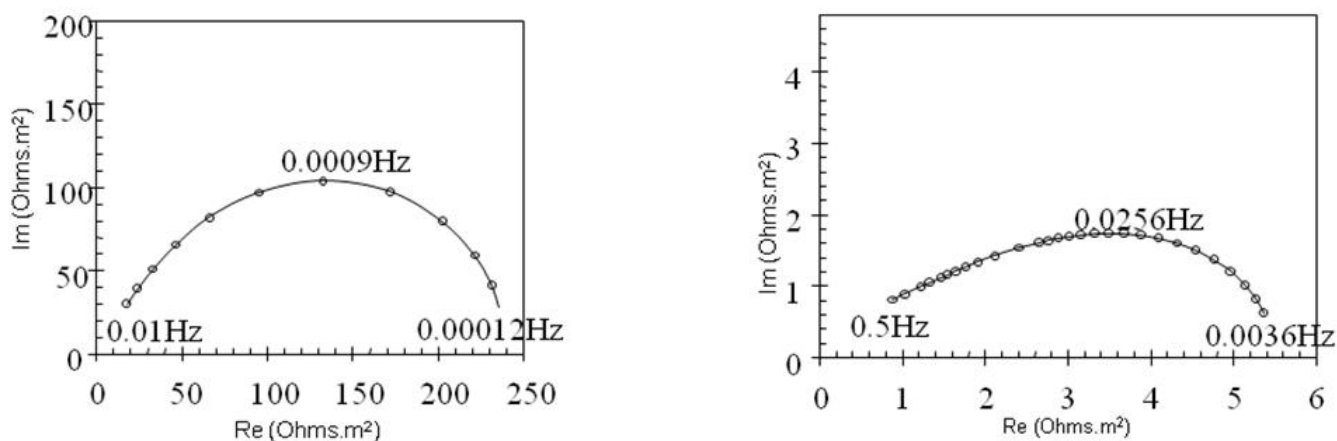
Figure 14: Published impedance data illustrating passive and corroding steel [19]

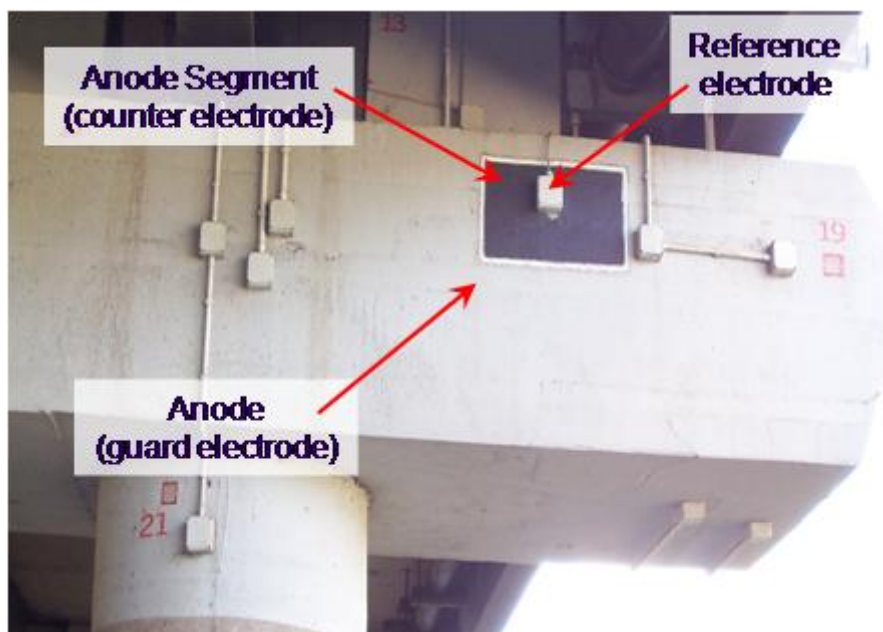
Figure 3: Guard ring arrangement on a reinforced concrete motorway cross beam

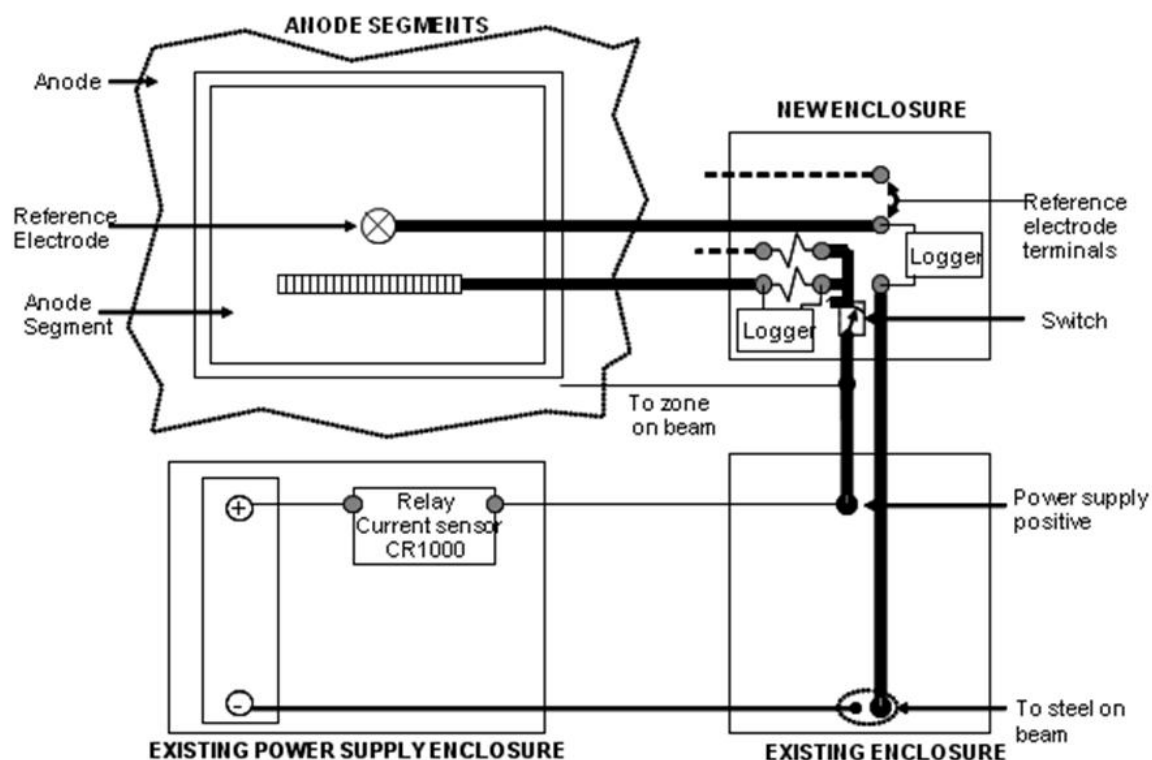
Figure 4: Testing arrangement [1]

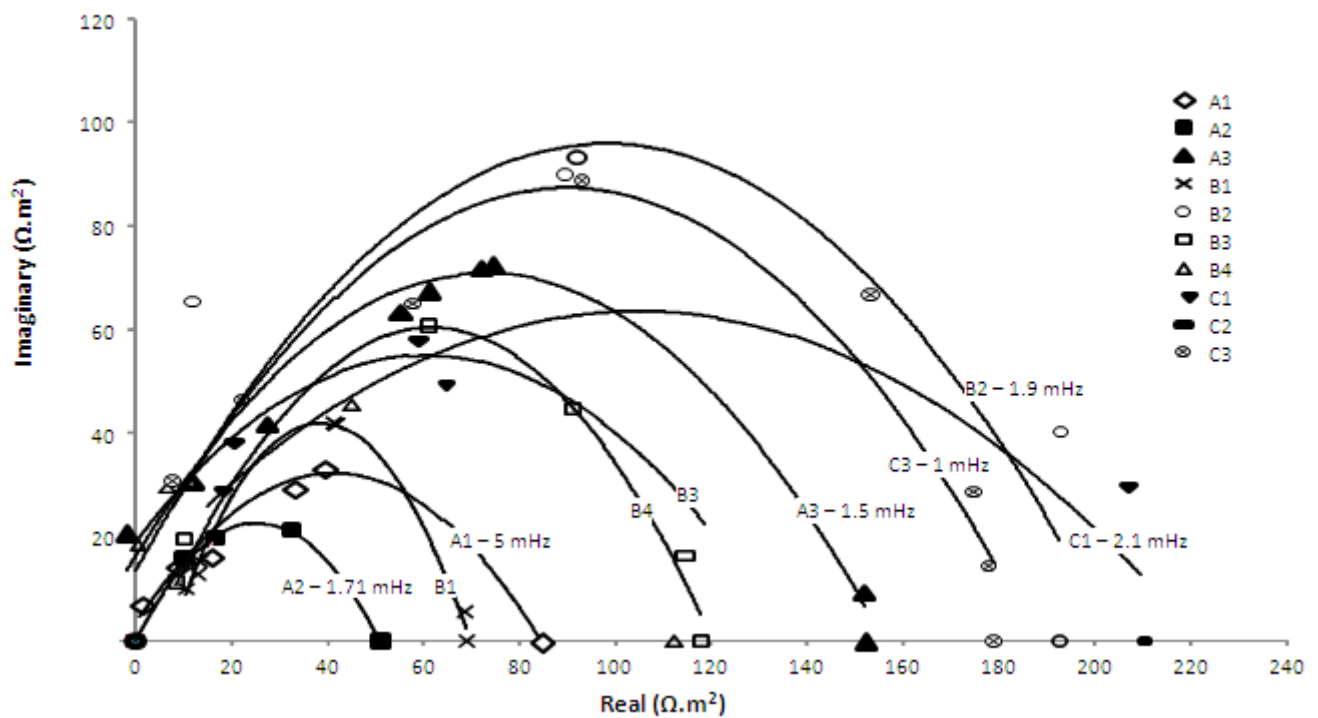
Figure 5: Nyquist plots arising from transient analysis for all ten structures

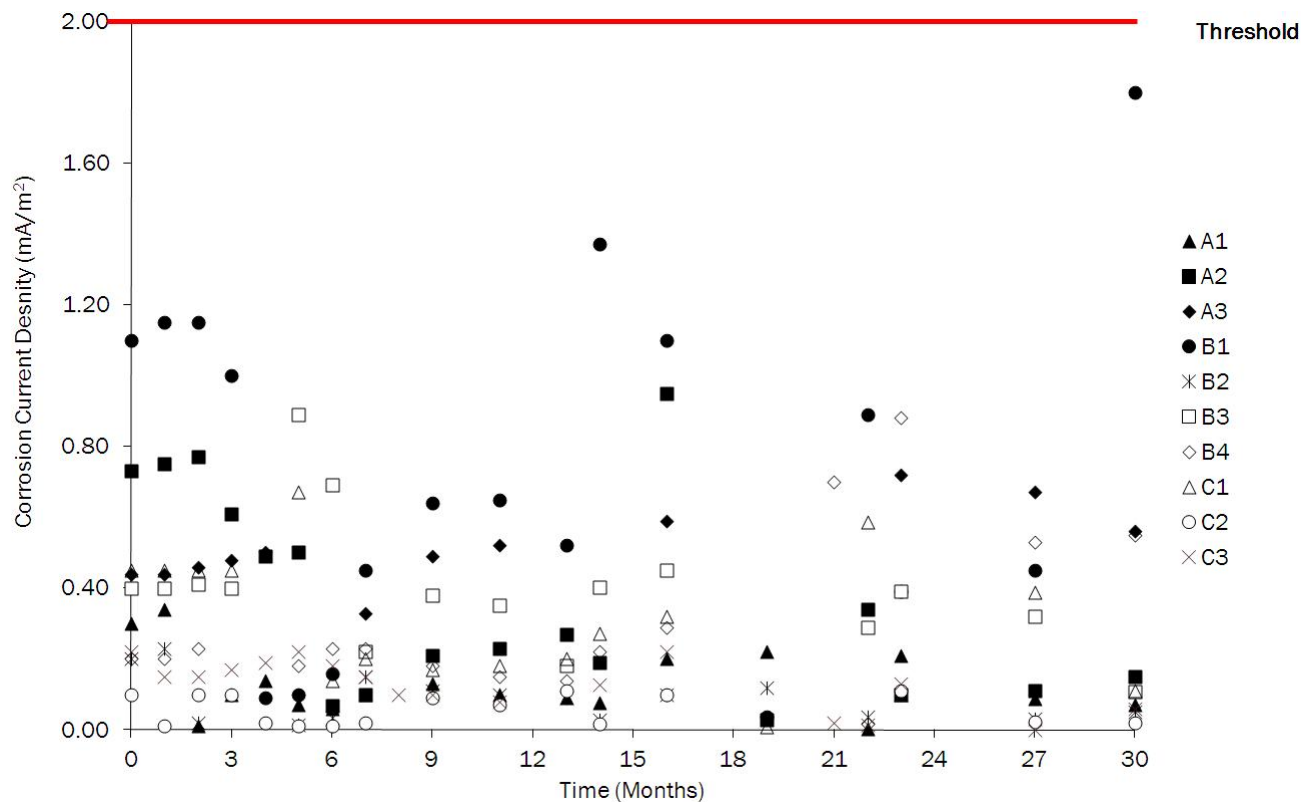
Figure 6: Corrosion current densities from transient response analysis over a period of 30 months
