Repair and Corrosion Management of Reinforced Concrete Structures

REPAIR AND CORROSION MANAGEMENT OF REINFORCED CONCRETE STRUCTURES

A dissertation thesis submitted in partial fulfilment of the requirements for the award of the degree Doctor of Engineering (EngD), at Loughborough University

November 2013

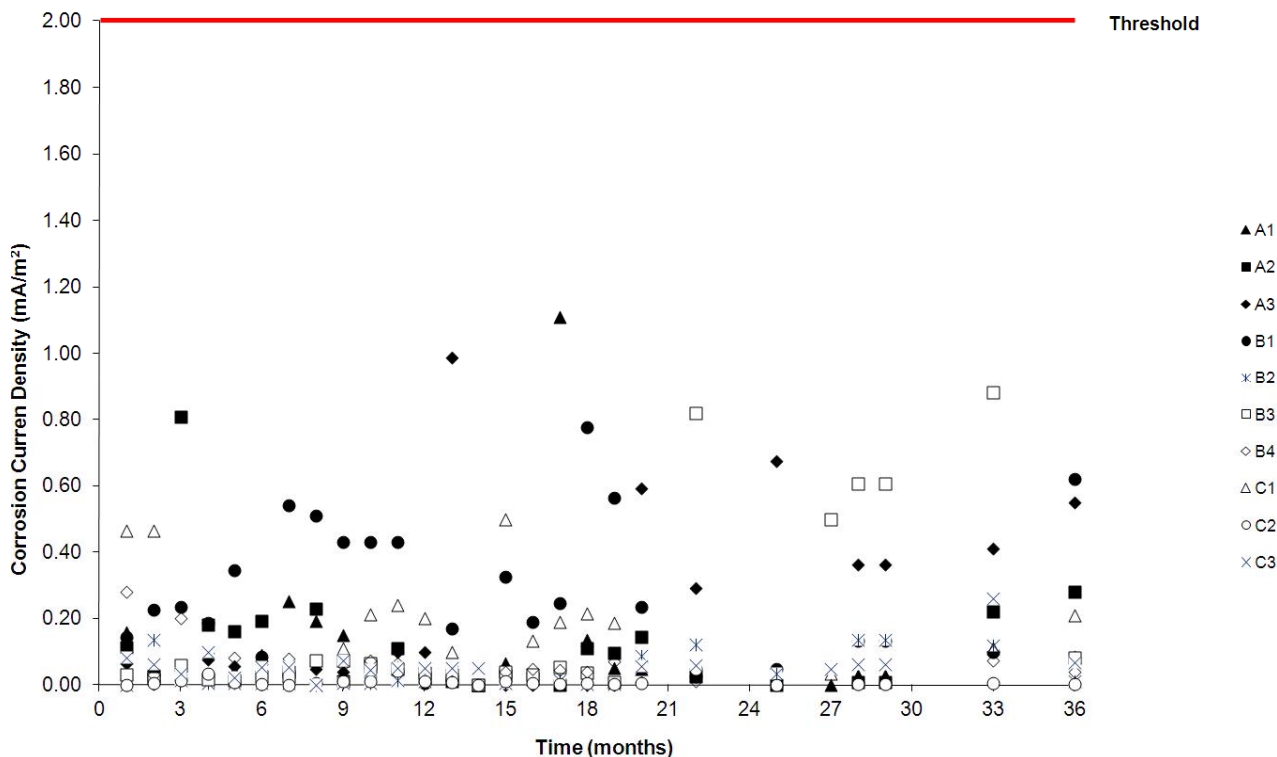
Figure 7: Corrosion current densities from polarisation resistance testing over a period of 36 months [1]

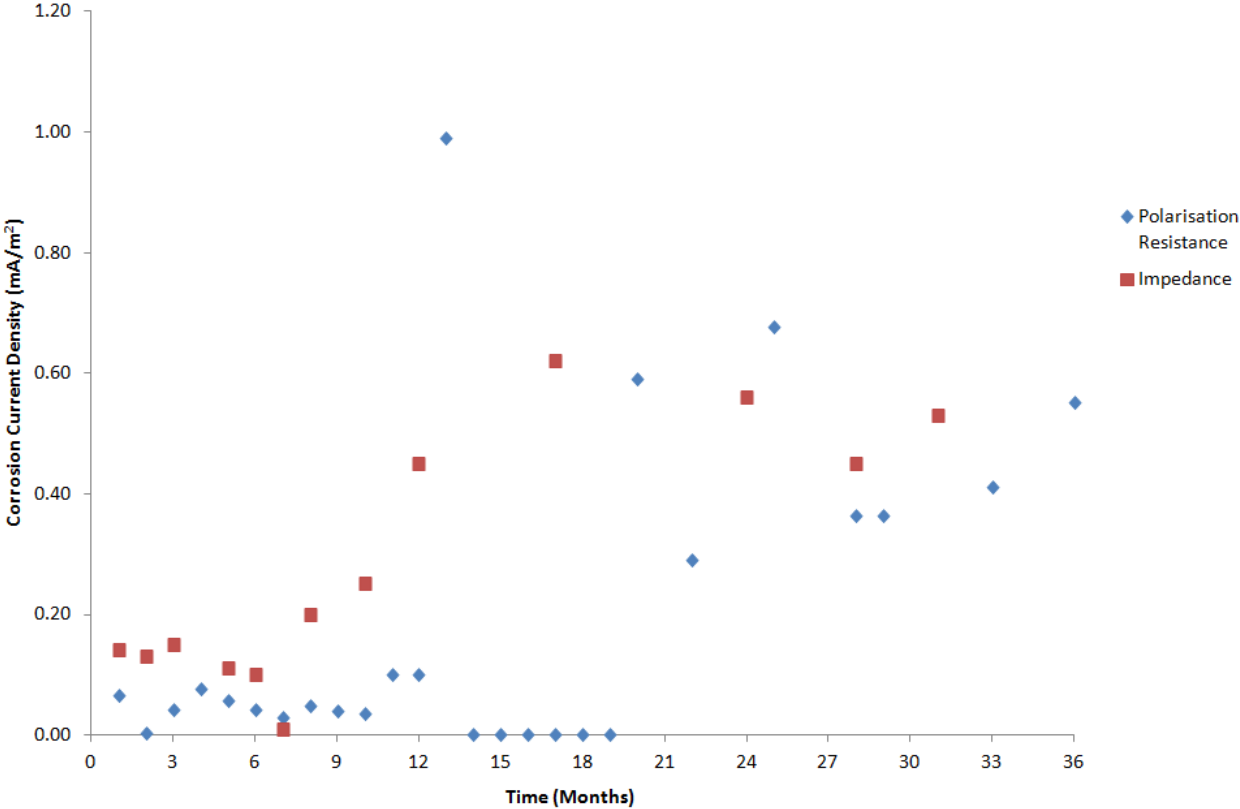
Figure 8: Corrosion current densities for structure A3 obtained from polarisation resistance testing against transient analysis

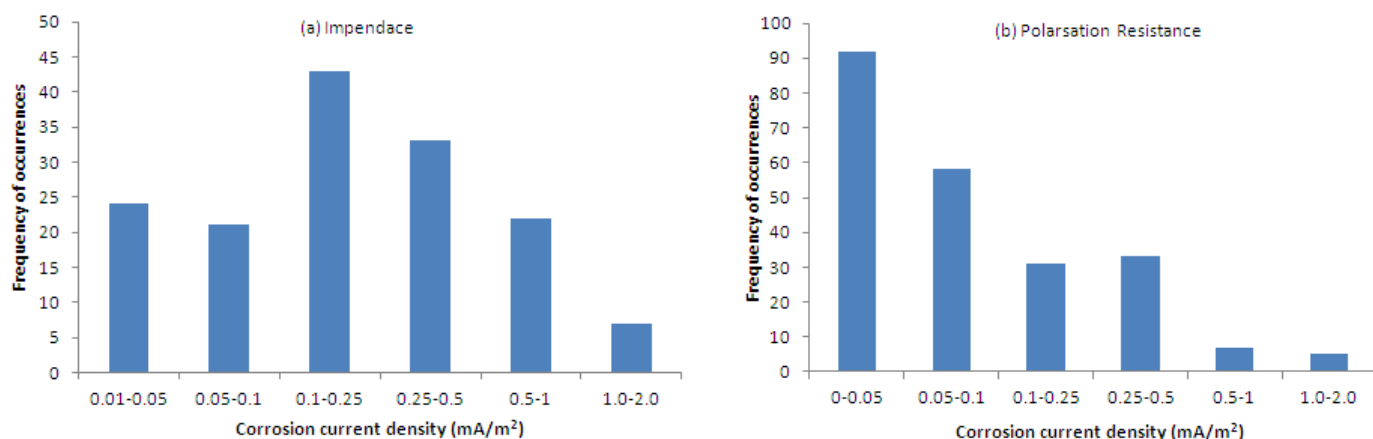
Figure 9: Return of results from transient response and polarisation resistance analysis. (*Note: Frequency is dimensionless and the x-axis does not cover equal-interval or numerically consistent divisions of the x axis. The graph should not be read as a quantitative distribution or histogram.*)

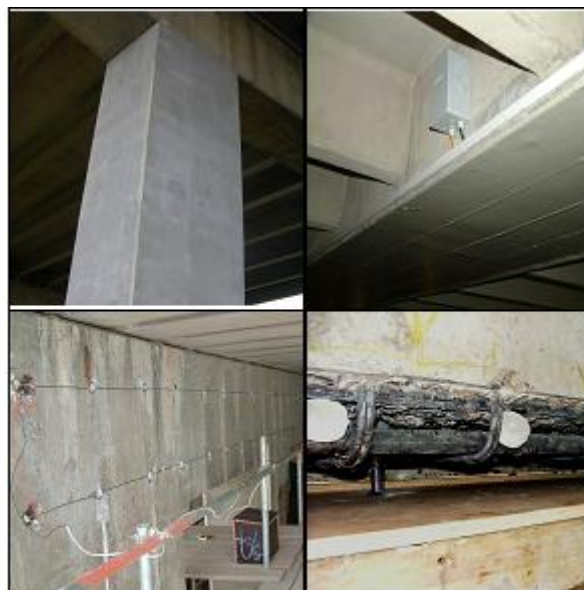
Figure 2: Galvanic anode examples (i) a thermally applied metal coating (top left), (ii) adhesive zinc sheets (top right) [4], discrete anodes in drilled holes (bottom left) [15], discrete anodes installed in patch repair (bottom right).

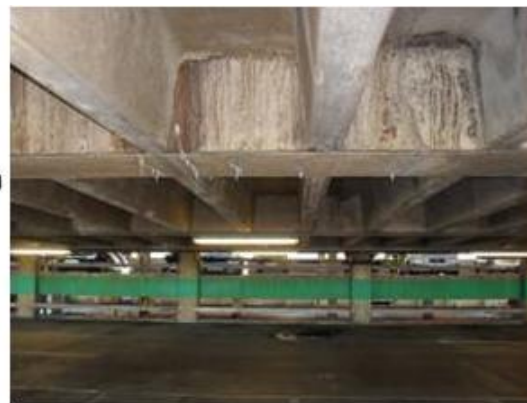
Figure 3: MSCP structural arrangement

The structures comprised a multi-storey car park (MSCP) with 11 stories in the East Midlands, UK and an 18 span bridge approximately 180 m long in Northern Scotland, UK. This MSCP was built in the early 1970s and it has a concrete one-way spanning ribbed type deck arrangement with 80 mm thick slab in-between the ribs (Figure 3). Due to the nature of the structure it was lightly reinforced with steel mesh. The bridge was also built in the early 1970s and comprised prestressed concrete beams supported on RC crossbeams with steel renhex pile supports (Figure 4). Due to the nature of dealing with full-scale structures at an age of at least 40 years, full details of the concrete composition were not available.

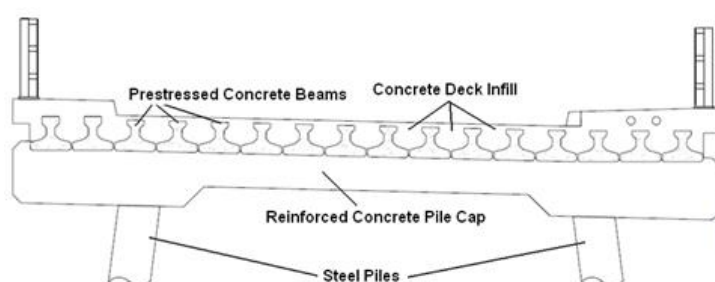
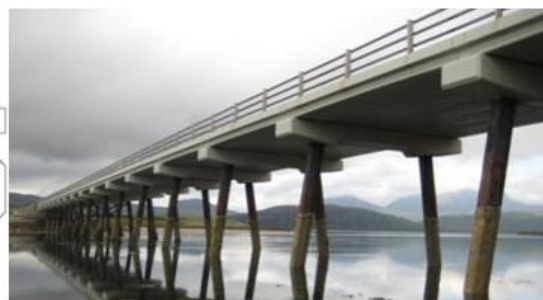
Figure 4: Bridge structural arrangement

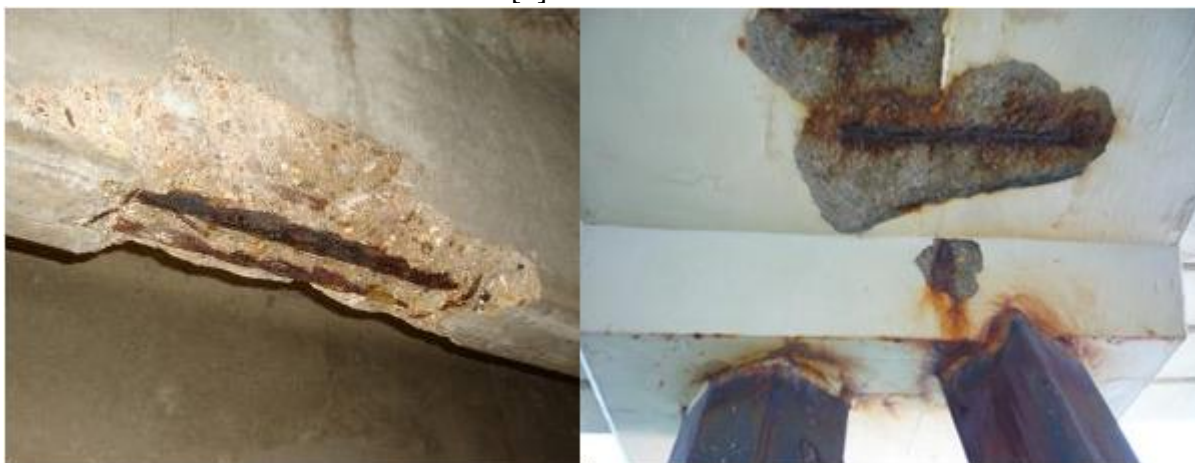
Figure 5: Chloride-induced corrosion and spalling to the MSCP and bridge structures (respectively)

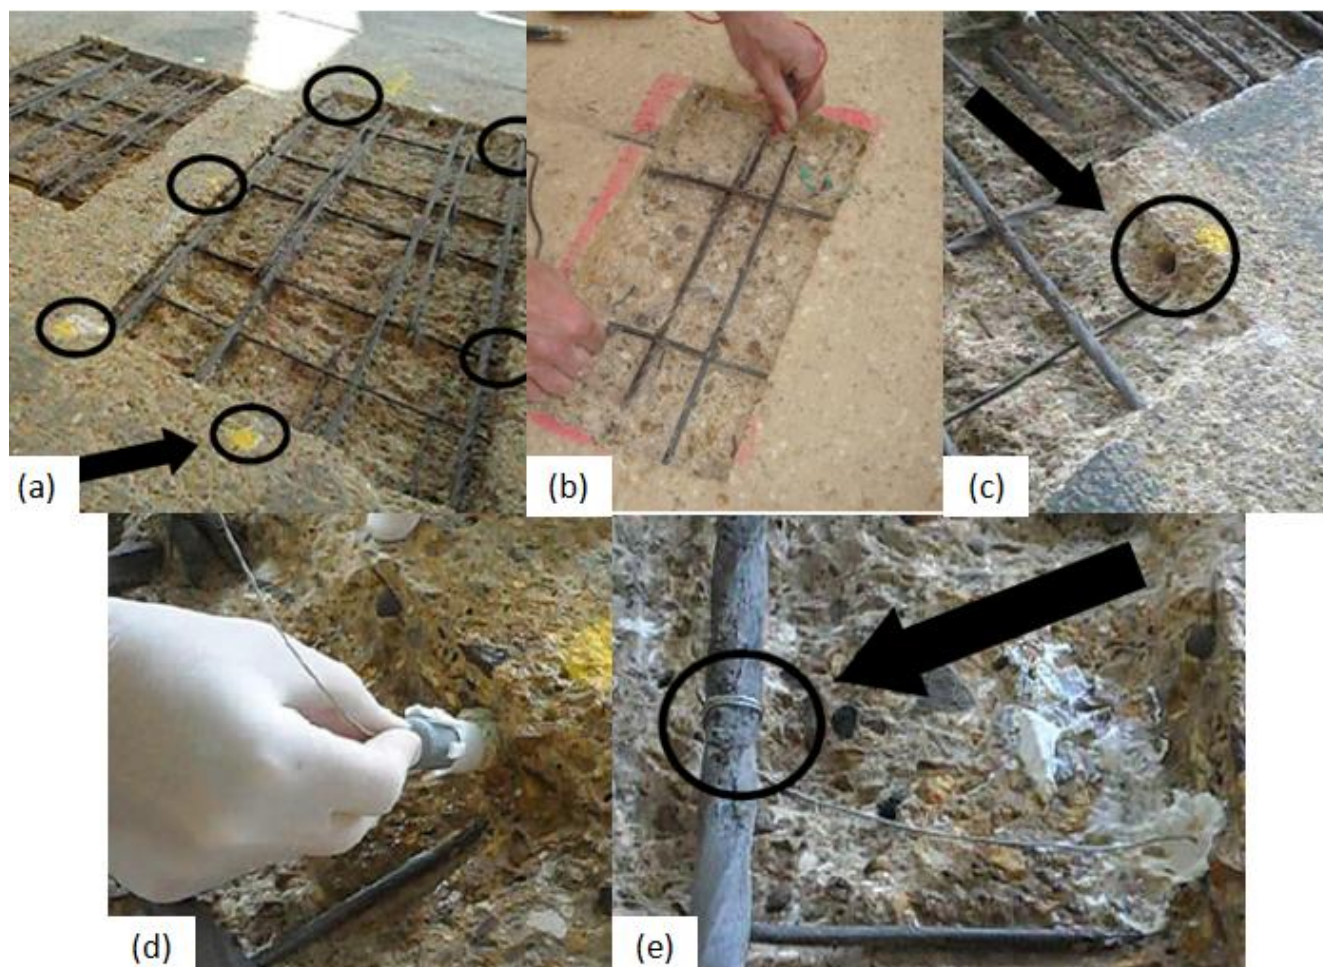
Figure 6: Galvanic anode installation procedure, (a) repair area following breakout and with location of anode installation marked out, (b) testing for reinforcement continuity, (c) pre-drilled holes for anode installation, (d) installation of galvanic anode and (e) connection of galvanic anode to the steel reinforcement and anode hole following filling with the proprietary backfill.

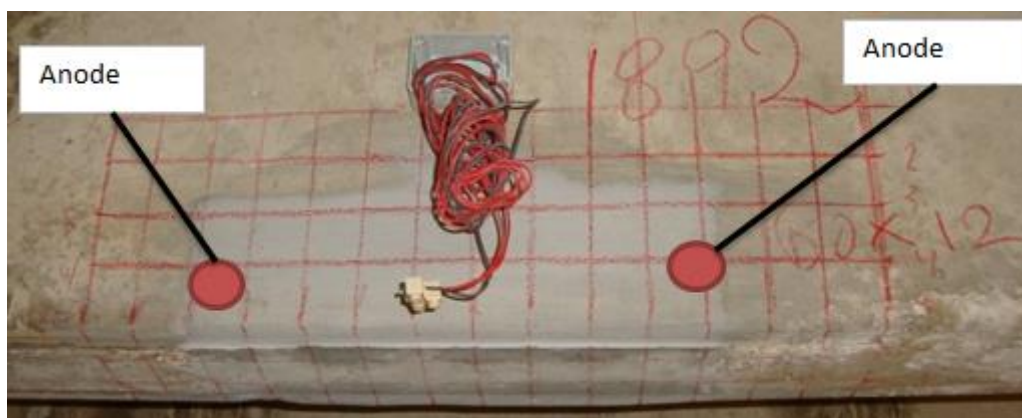
Figure 7: Typical galvanic anode installation at monitoring station to facilitate galvanic current measurements.

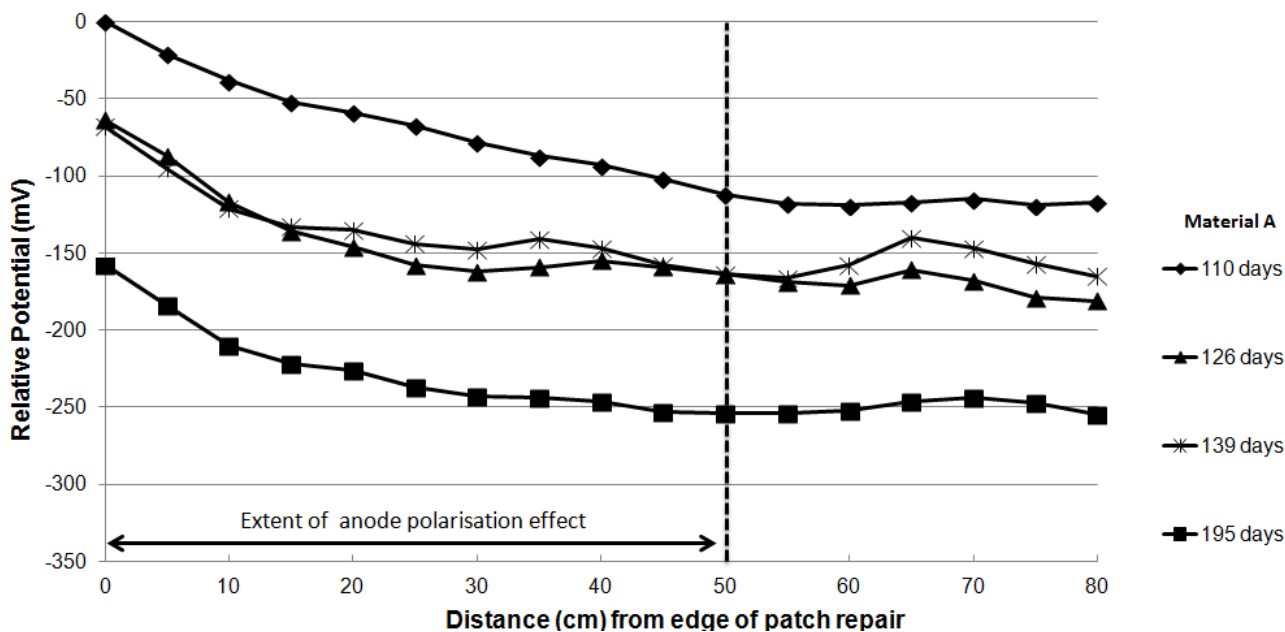
Figure 8: Polarisation effect of the anodes at a distance from the edge of a patch repair in the MSCP with material type A between 110 and 195 days following installation.

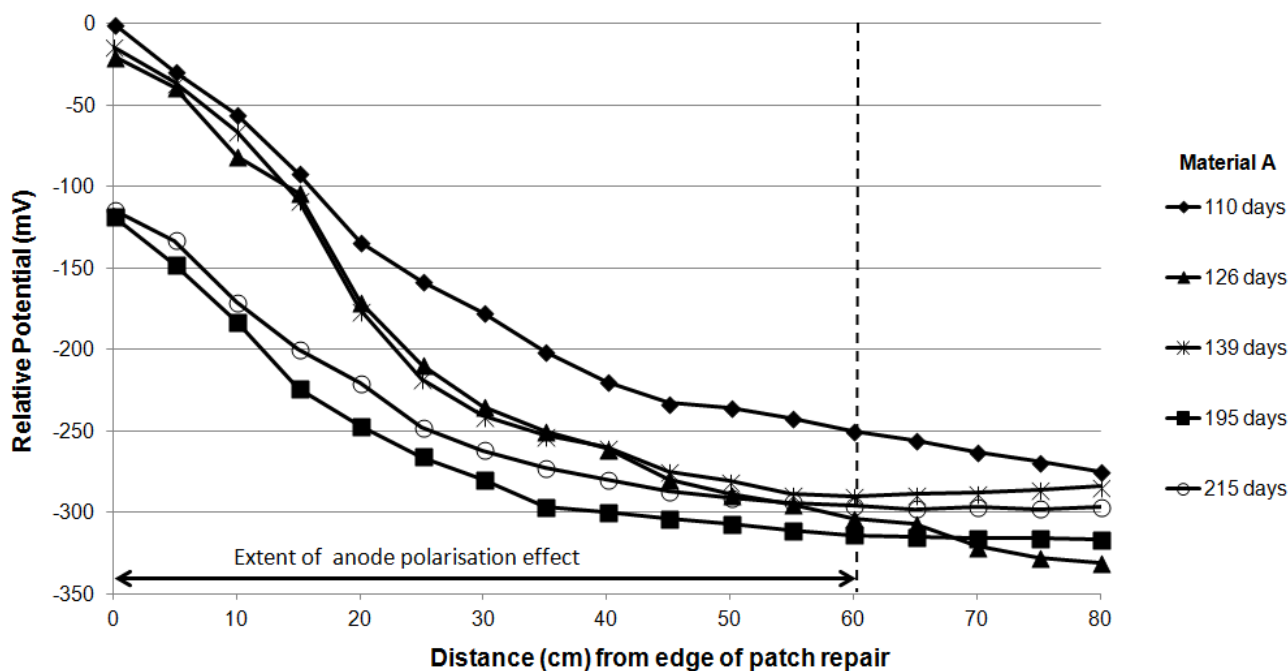
Figure 9: Polarisation effect of the anodes at a distance from the edge of a patch repair in the MSCP with material type A over a period of 215 days.

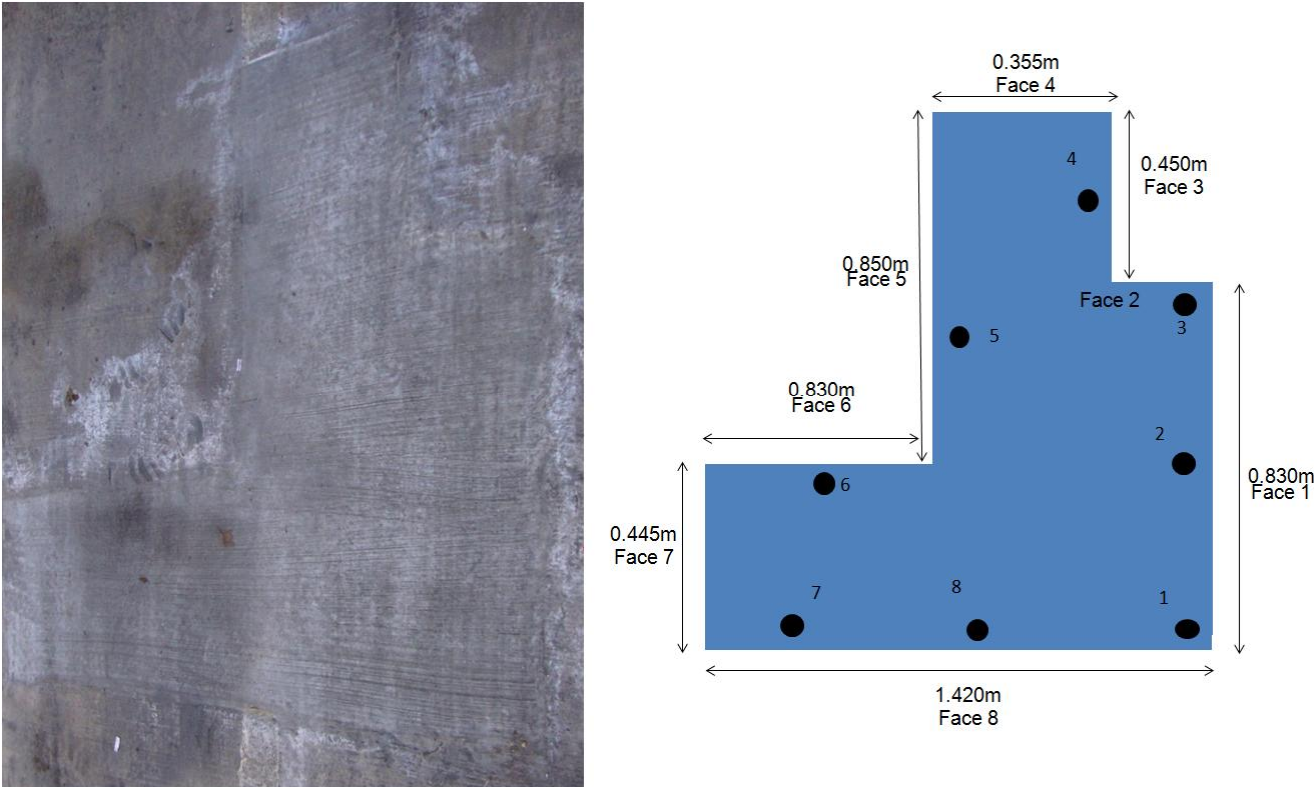
Figure 10: Typical concrete repair (left) and schematic illustration of the location of the galvanic anodes (right).

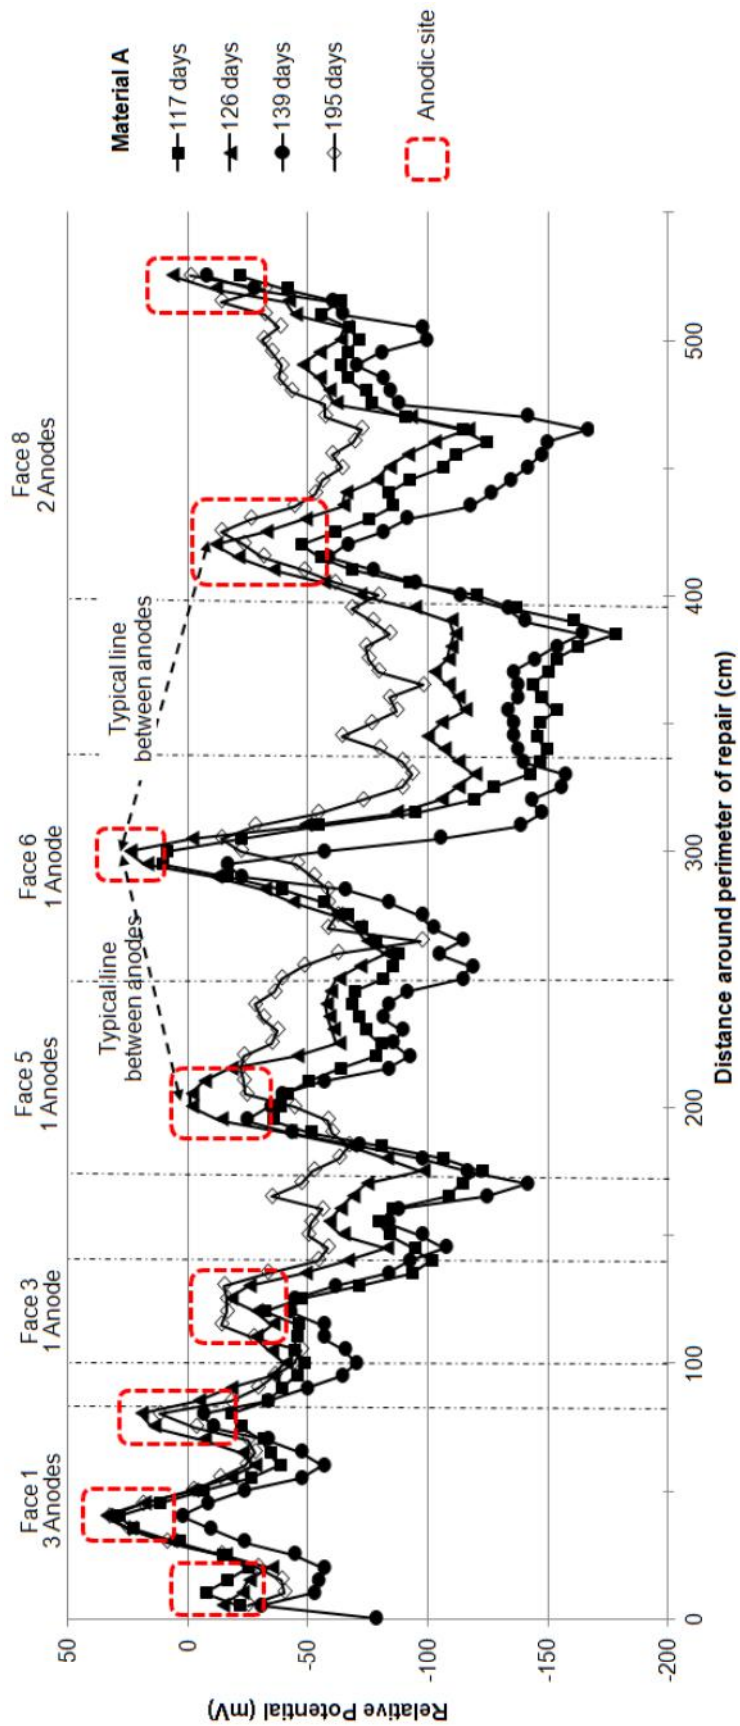
Figure 11: Potential mapping around a repair location with Material A up to 195 days following installation of the galvanic anodes.

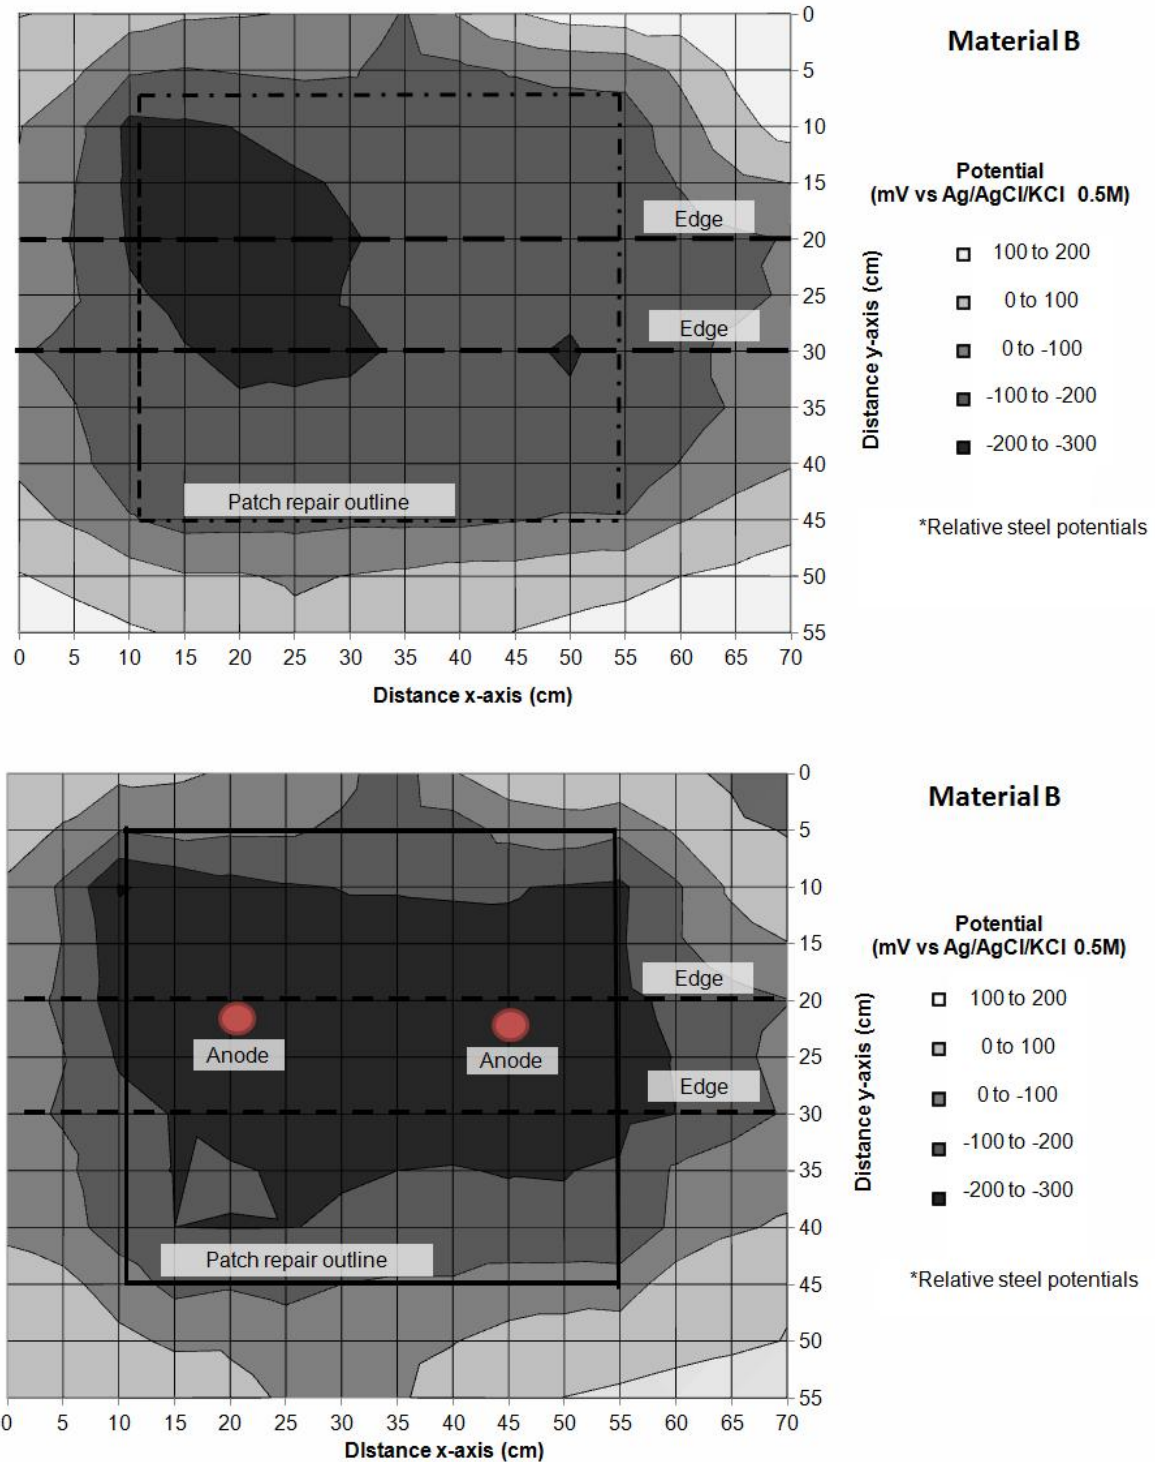
Figure 13: Surface potential mapping on car park repair with Material B (a) following concrete replacement and (b) after connection of the galvanic anodes. Dashed lines illustrate extent of patch repair.

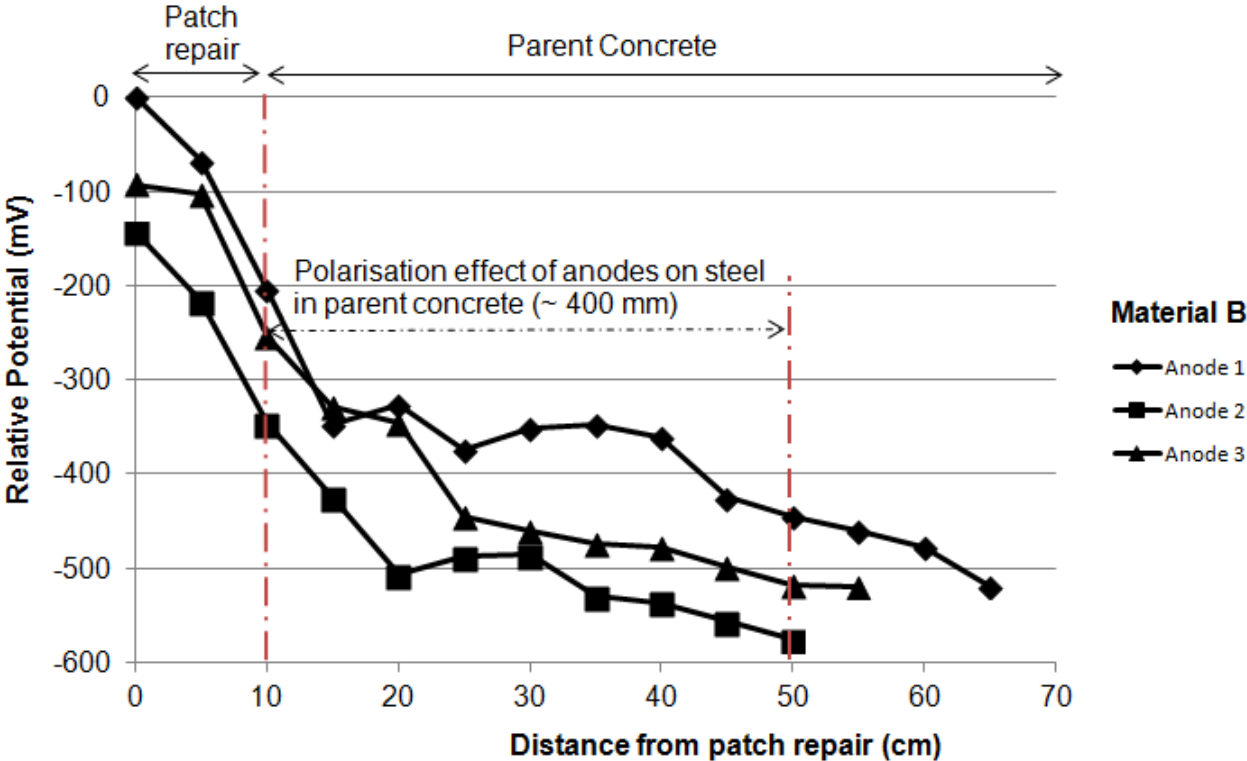
Figure 14: Polarisation effect of anodes at a distance from the edge of a patch repair from the bridge structure, with material type B, 30 days following installation.

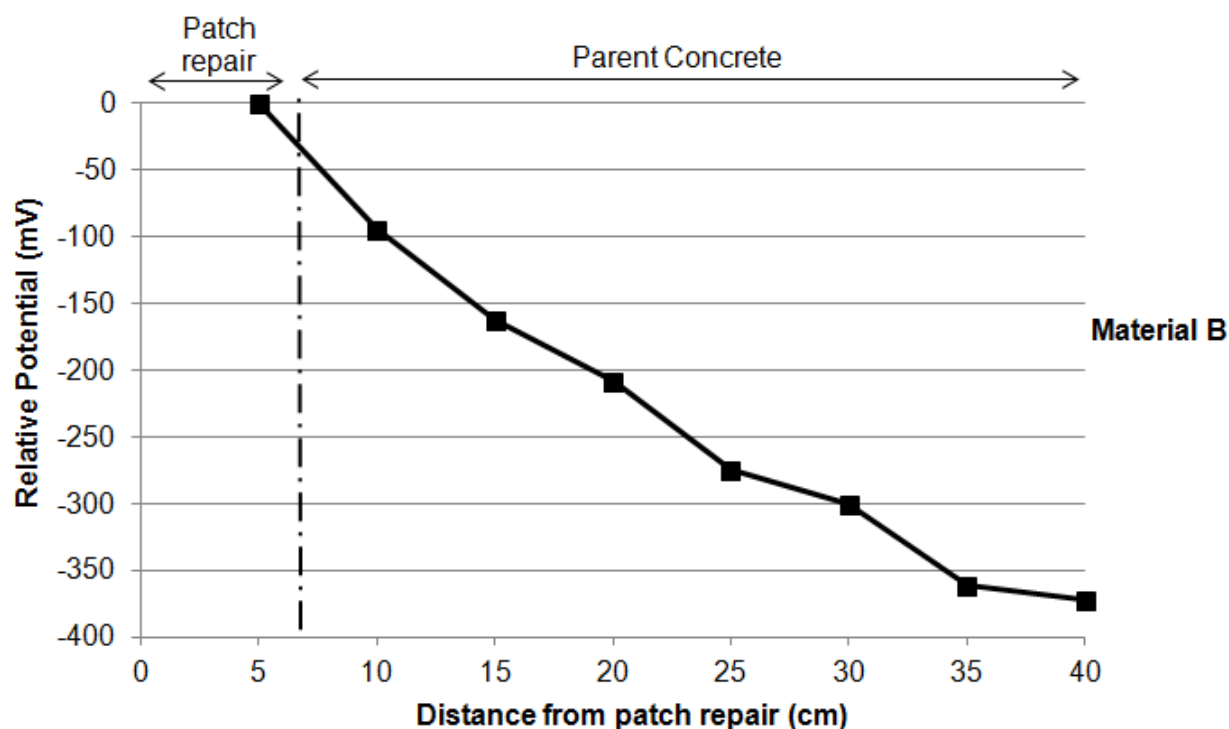
Figure 15: Polarisation effect of anodes at a distance from the edge of a patch repair from the bridge structure, with material type B, 45 days following installation.

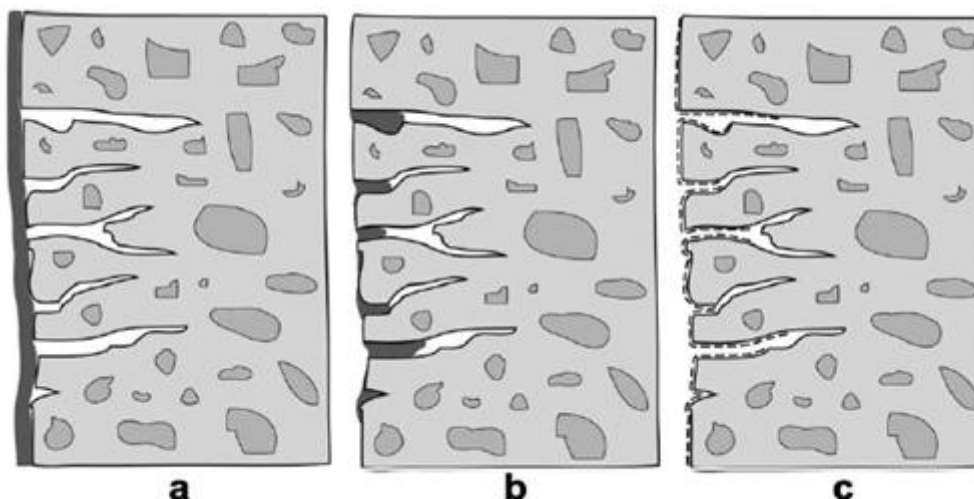
Figure 1: Categories of surface treatments a) coatings, b) pore blockers and c) pore liners [10]

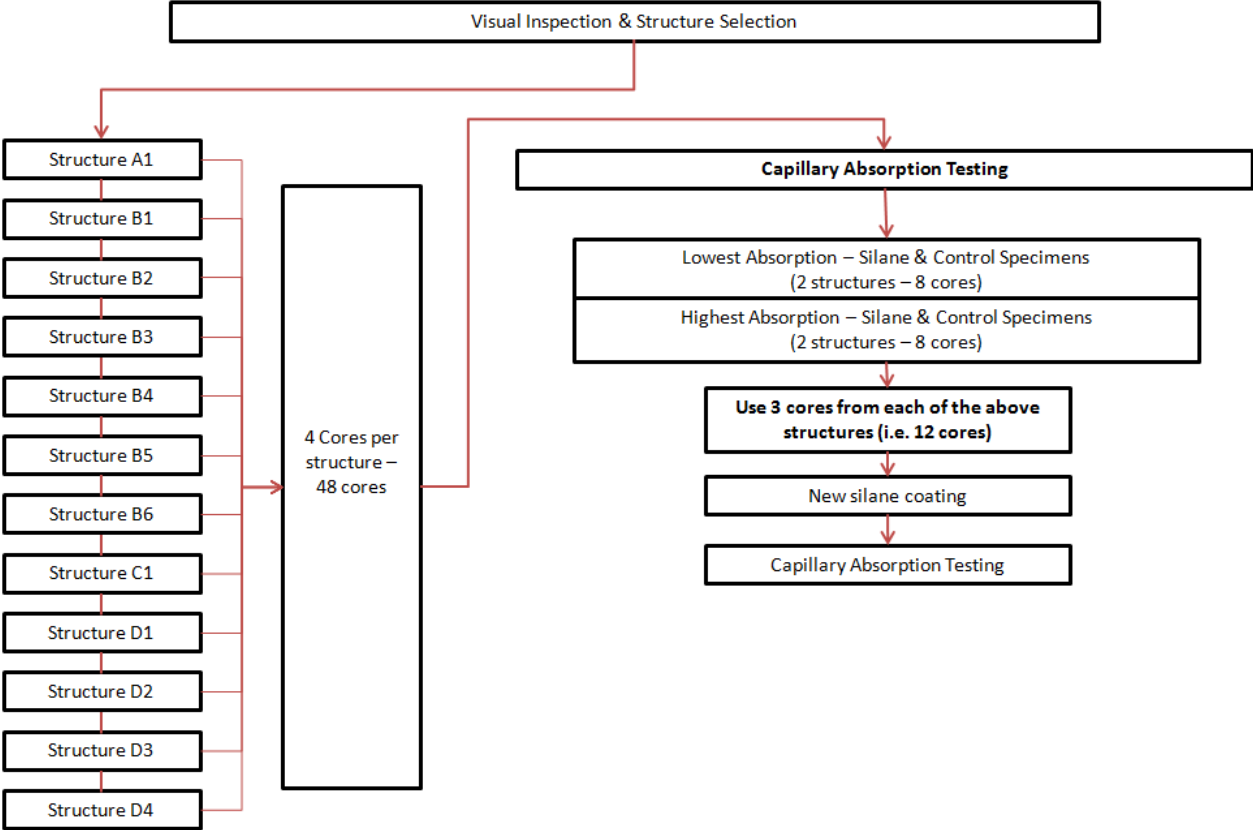
Figure 4: Selection and testing programme for silane treated cross-beams

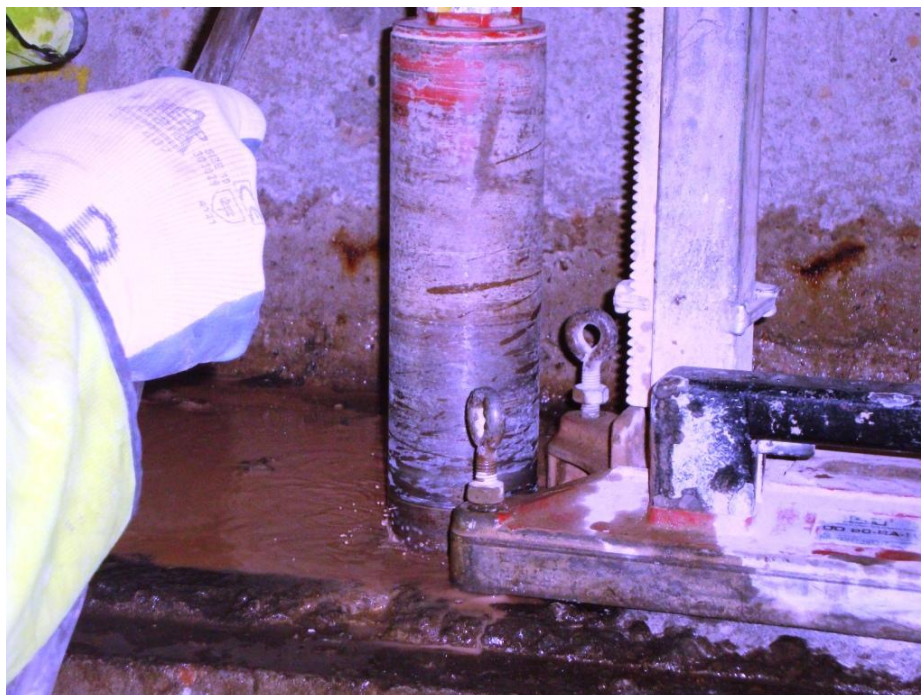
Four cores (diameter and length of 80mm) were extracted from each cross-beam, all from the top surface, which represented the most critical area for water ingress (Figure 5). This residual risk can be attributed to the simply supported articulation arrangement of the bridges with carriageway expansion joints above every cross-beam that were known to be susceptible to water leakage. After coring, each core hole was carefully repaired with a shrink-resistance compensating repair mortar.

Figure 5: Coring on top of a silane-treated RC cross-beam

A correction factor in accordance with BS 1881-122 [27] was applied to normalise the cores into an equivalent of 75mm diameter and to eliminate minor differences in length between the cores as a result of the coring process (Equ.3).

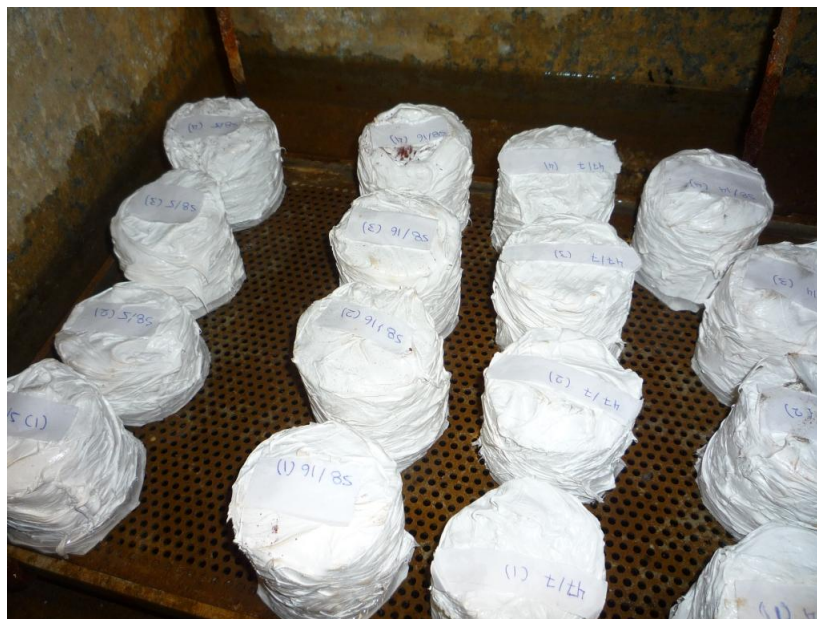
The specimens were placed with their silane treated surface facing down in a layer of water no deeper than 5 mm (Figure 6). Their weights were recorded at 0, 5, 15, 30 minutes and thereafter every 30 minutes over a total period of 4 hours.

Figure 6: Cores sealed with proprietary polysulphide sealant for capillary absorption testing

- v. The immersion depth was approximately 5mm below the water line as proposed by Hall [28] instead of 2 + 1mm. This approach does not alter the results in any way as all of the non-tested surfaces of each core were sealed against water with a proprietary polysulphide sealant.

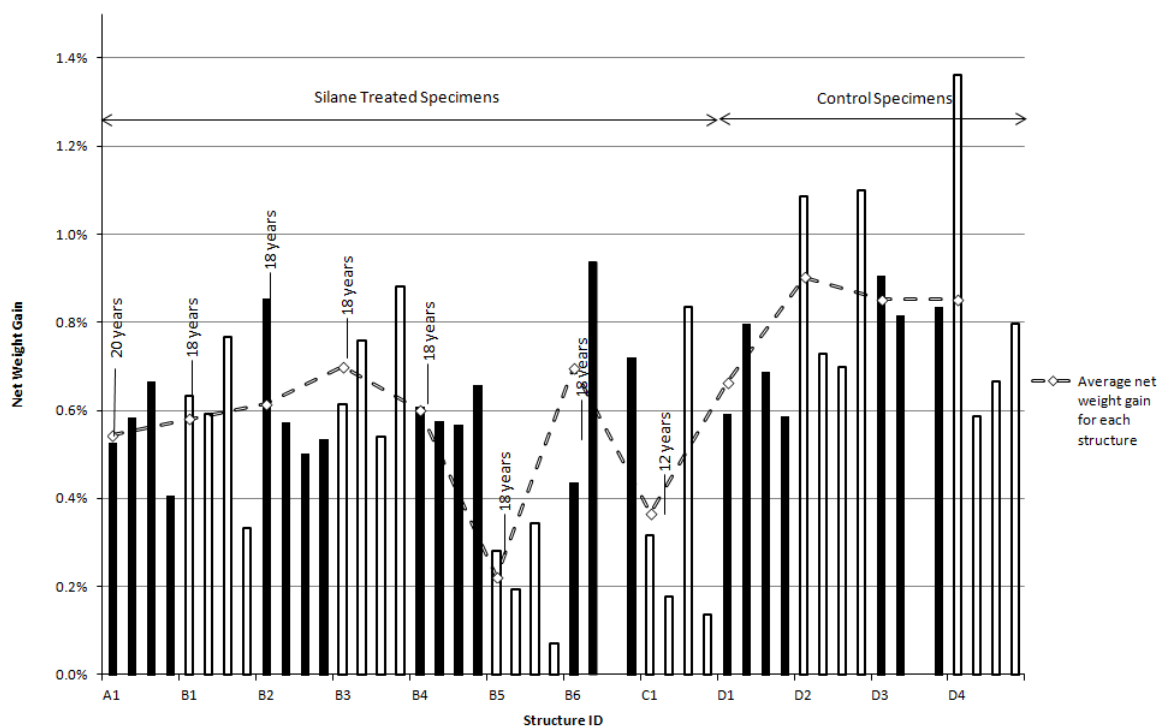
Figure 7: Net weight gain for each specimen and average net weight gain for each cross-beam's group of specimens after 4 hours of capillary absorption testing.

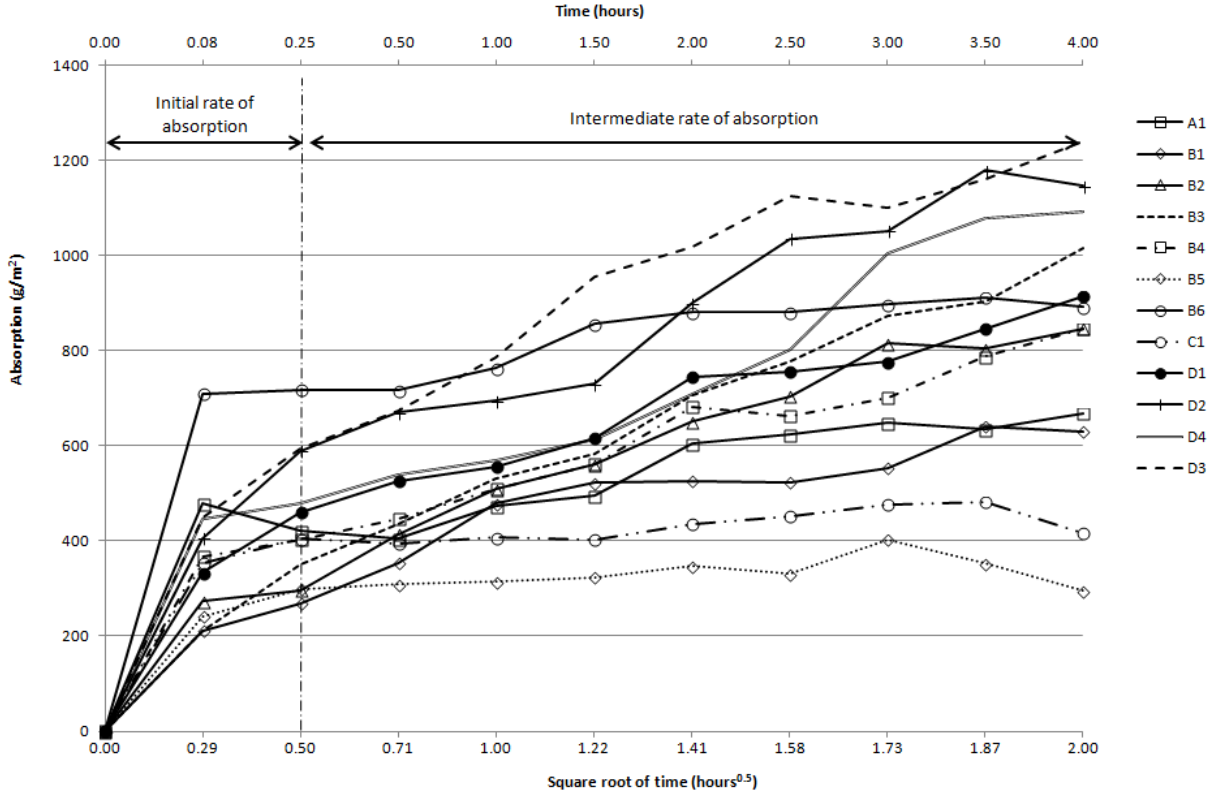
Figure 8: Average cumulative absorption for each cross-beam’s group of specimens over 4 hours of capillary absorption testing.

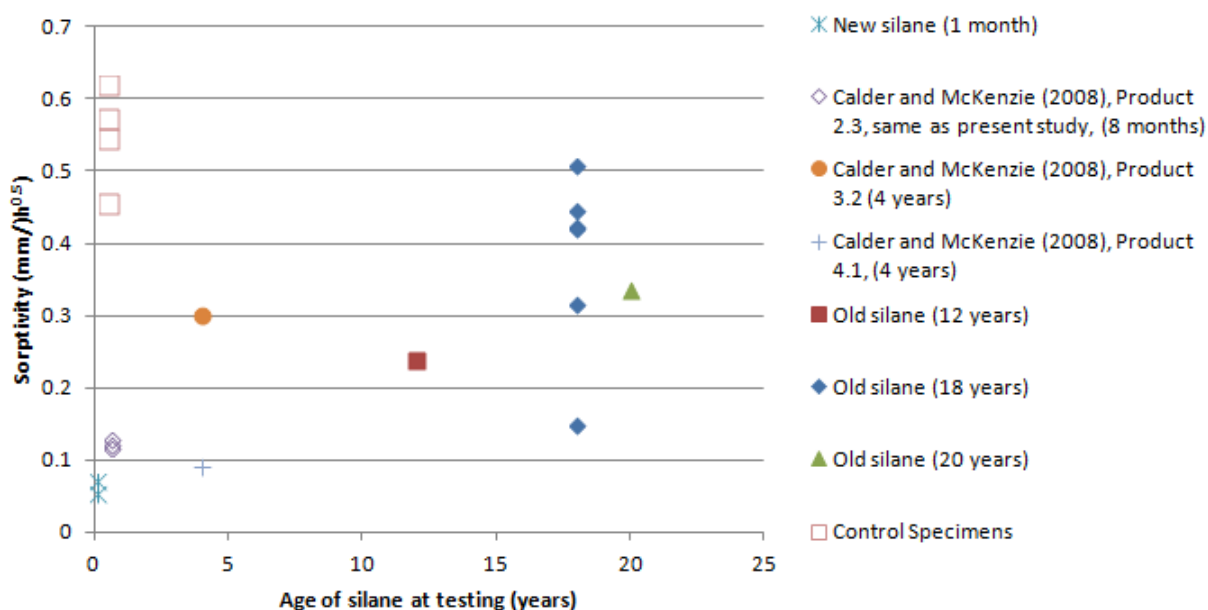
Figure 9: Comparison of the sorptivity of silane treated specimens examined in the study against the sorptivity of specimens from Calder and McKenzie [22].
