Microstructural Evolution in Coated Conventionally Cast Ni-Based Superalloys

Scott David Newman

*Department of Materials
Loughborough University*

*A doctoral thesis submitted in partial fulfilment of the
requirements for the award of Doctor of Philosophy*

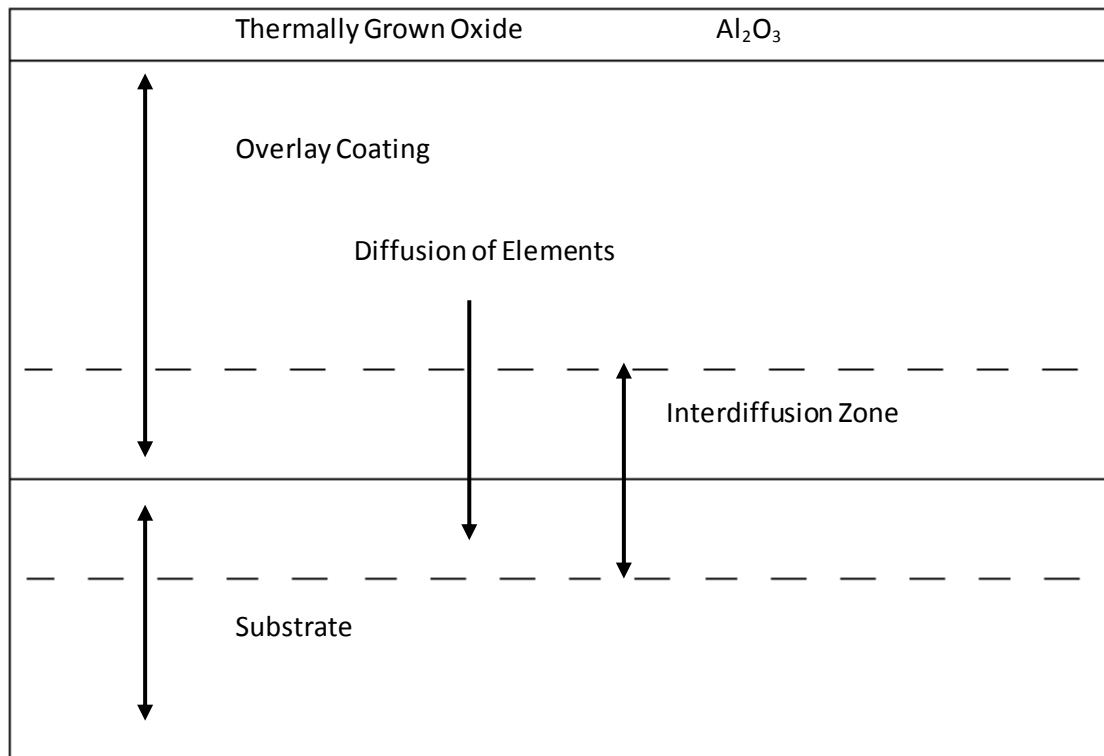
Figure 2.2 A simplified schematic showing an MCrAlY coating highlighting diffusion from within the MCrAlY layer into the substrate across the interdiffusion zone. The location of the thermally grown oxide layer is shown, both the interdiffusion zone and the thermally grown oxide layer are studied in this work.

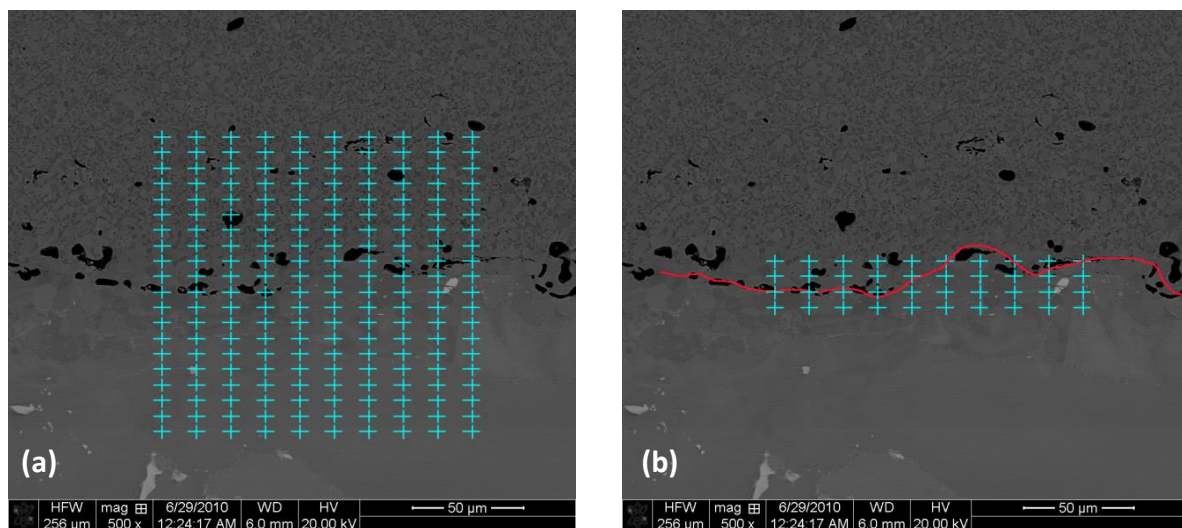
Figure 3.4 A back-scatter image of a sample aged for 3 months at 850°C . EDS chemical analysis was carried out in the region shown in (a). A matrix of 10 x 20 EDS spot analysis points was carried out. Using the chemistry of the substrate and coating the interface was found to be within the region highlighted in (b).

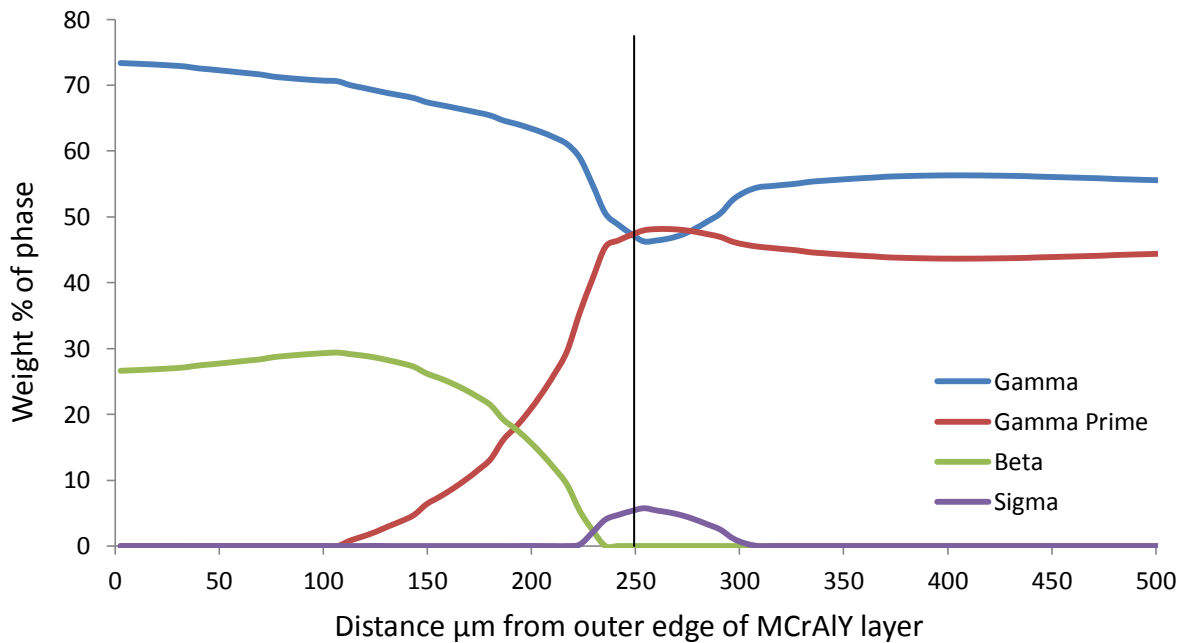
Figure 3.15 A kinetic/thermodynamic model result predicting the phases present within the microstructure of a 250 μm AMDRY995 MCrAlY layer applied to an In738LC substrate after exposure at 900°C for 5004 hours.

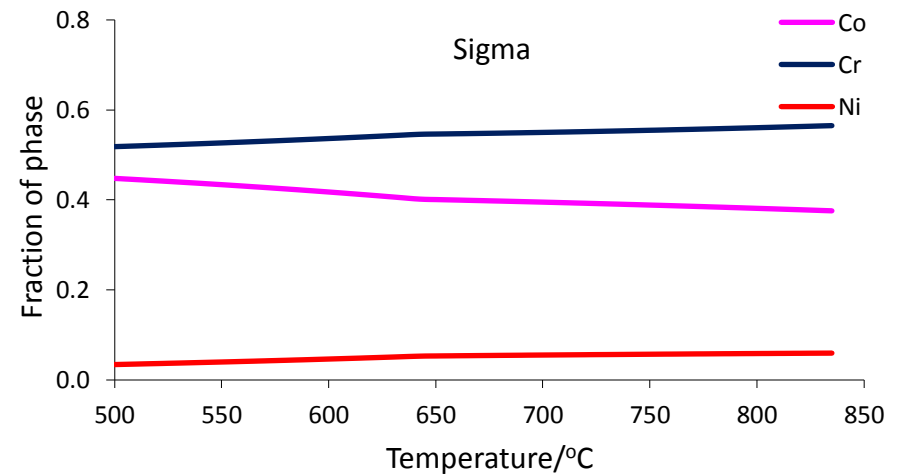
Figure 4.5 Thermodynamic prediction of the composition of the sigma phase in the CoNiCrAlY coating with composition 38.5 Co, 32.5 Ni, 21 Cr, 8 Al Wt.%.

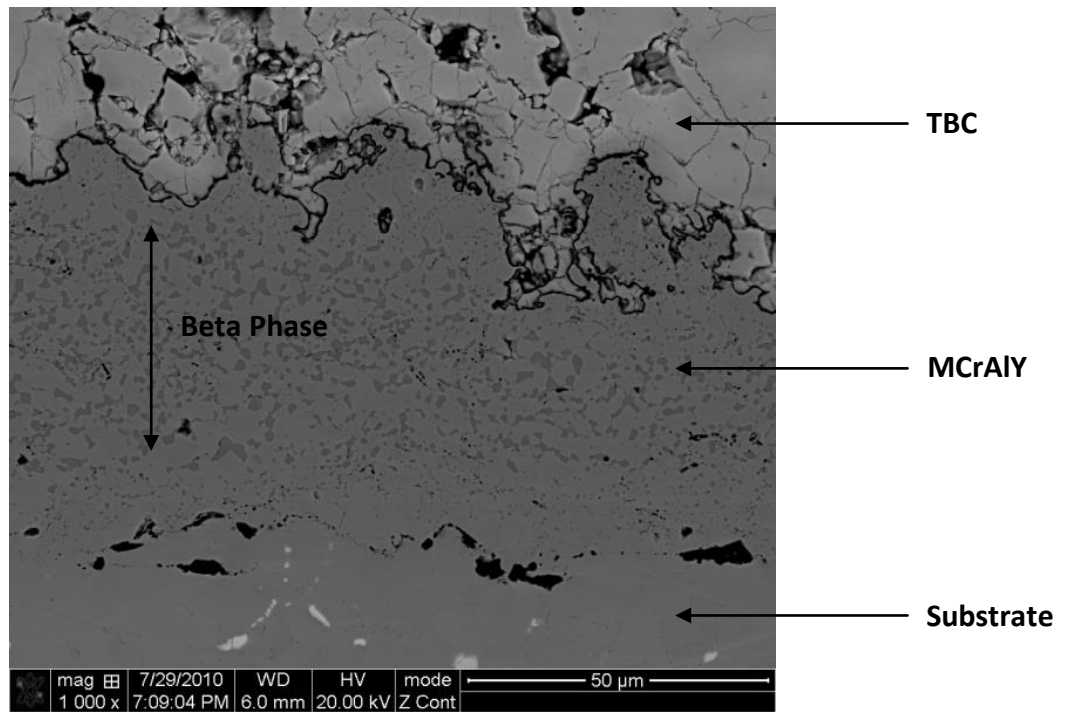
Figure 4.6 A backscatter micrograph showing the coating system components and substrate in the as received condition. Note the beta phase can be observed within the coating in the as received condition.

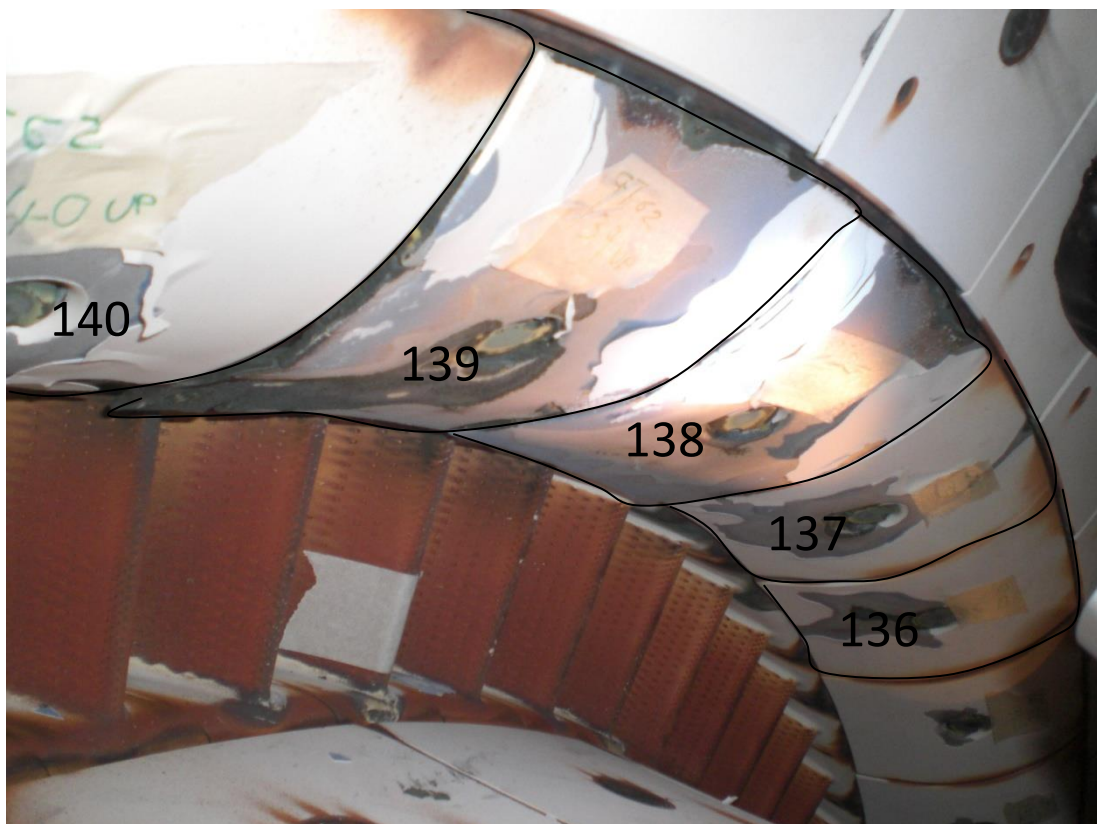
Figure 5.15 A photograph taken from within the engine combustion chamber showing the tiles in their specific locations. The five tiles characterised within this piece of work are highlighted, numbered 136, 137, 138, 139 and 140.

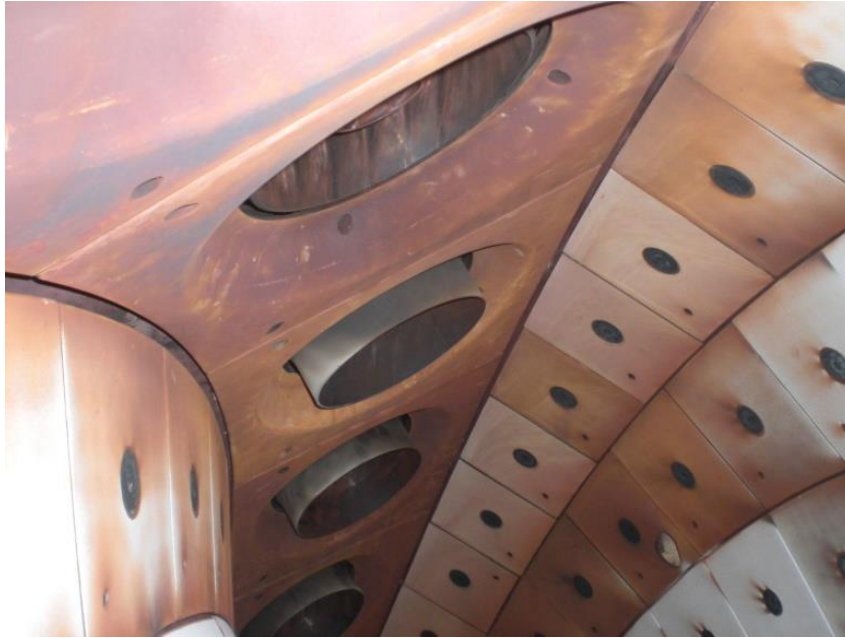
Figure 5.16 A photograph taken from within the engine combustion chamber showing the modified burner rings; this is the location directly opposite the five test tiles.

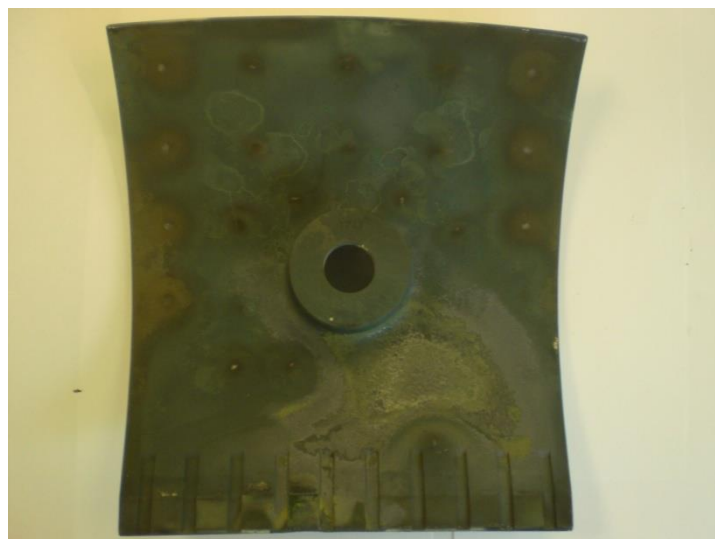
Figure 5.17 A photograph showing the underside of the tile and the updated tile design with additional cooling slots to try and prevent tile overheating.

The engine that the tiles were entered into service within this work has had previous combustion chamber heat shield tile failures. The original tiles that failed were from the row 1 position adjacent to the burners. The investigation suggested one tile failed initially due to overheating. The tiles also showed evidence of thermal distortion, which was attributed to overheating. The tile design was changed to increase the cooling air flow, by manufacturing a series of slots present on the underside of the tiles, and this can be seen within one of the five tiles removed from the engine in Figure 5.17 (47).
