The Development of Improvements to Drivers' Direct and Indirect Vision from Vehicles – Phase 2

For: Department for Transport
DfT TTS Project Ref: S0906 / V8

Prepared by: Loughborough Design
School, Loughborough University
and MIRA Limited

Date: March 2011

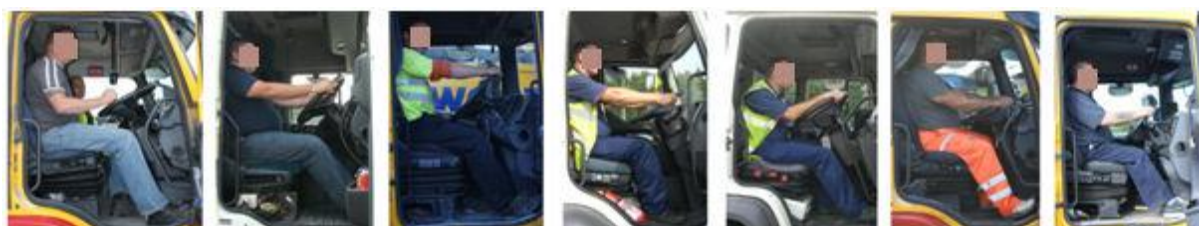
Figure 13. The variety of driver postures exhibited by drivers with a 4thile to 99thile stature range using UK anthropometric data (ADULTDATA 1998)

The driver interviews that were performed at the start of Phase 2 of the project provided an opportunity to capture driver postures and anthropometric data from a range of driver sizes. Figure 13 shows the range of postures that were captured with a 99thile UK male (only 1% of the UK population taller) on the left and a 4thile UK male (Only 4% of the male UK population are shorter) on the right.

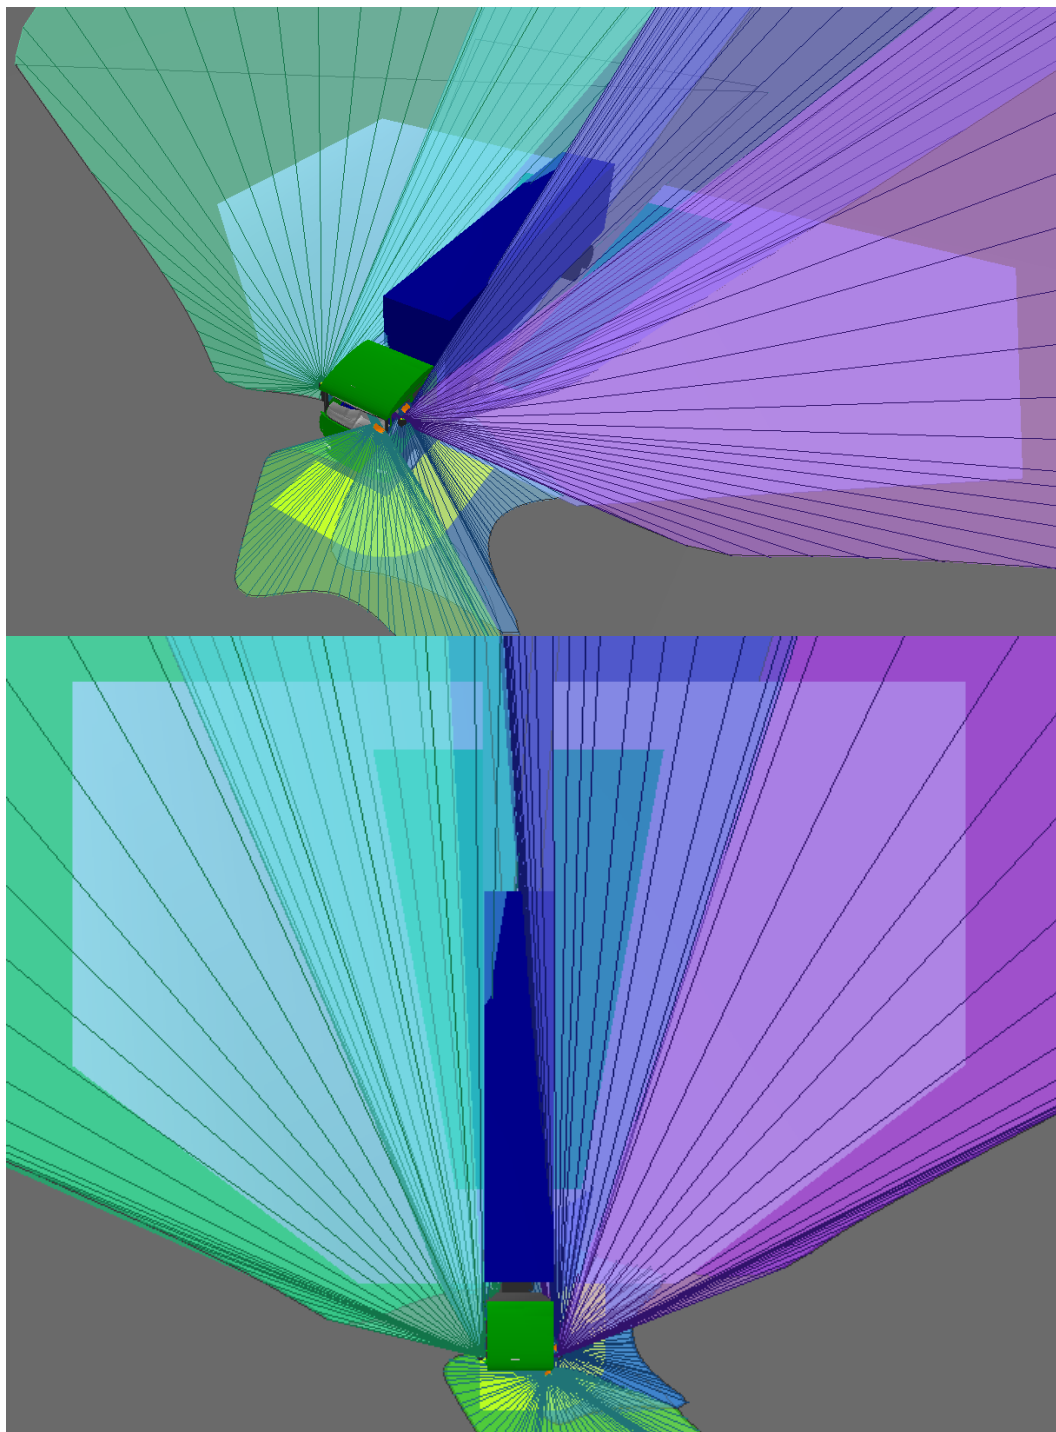
2.5.4.1.1.2 The compliance of the SCANIA R420 category N₃ Right hand drive

Figure 24. The compliance of the SCANIA R420 category N₃ vehicle with the recommended area of visibility at the ground plane

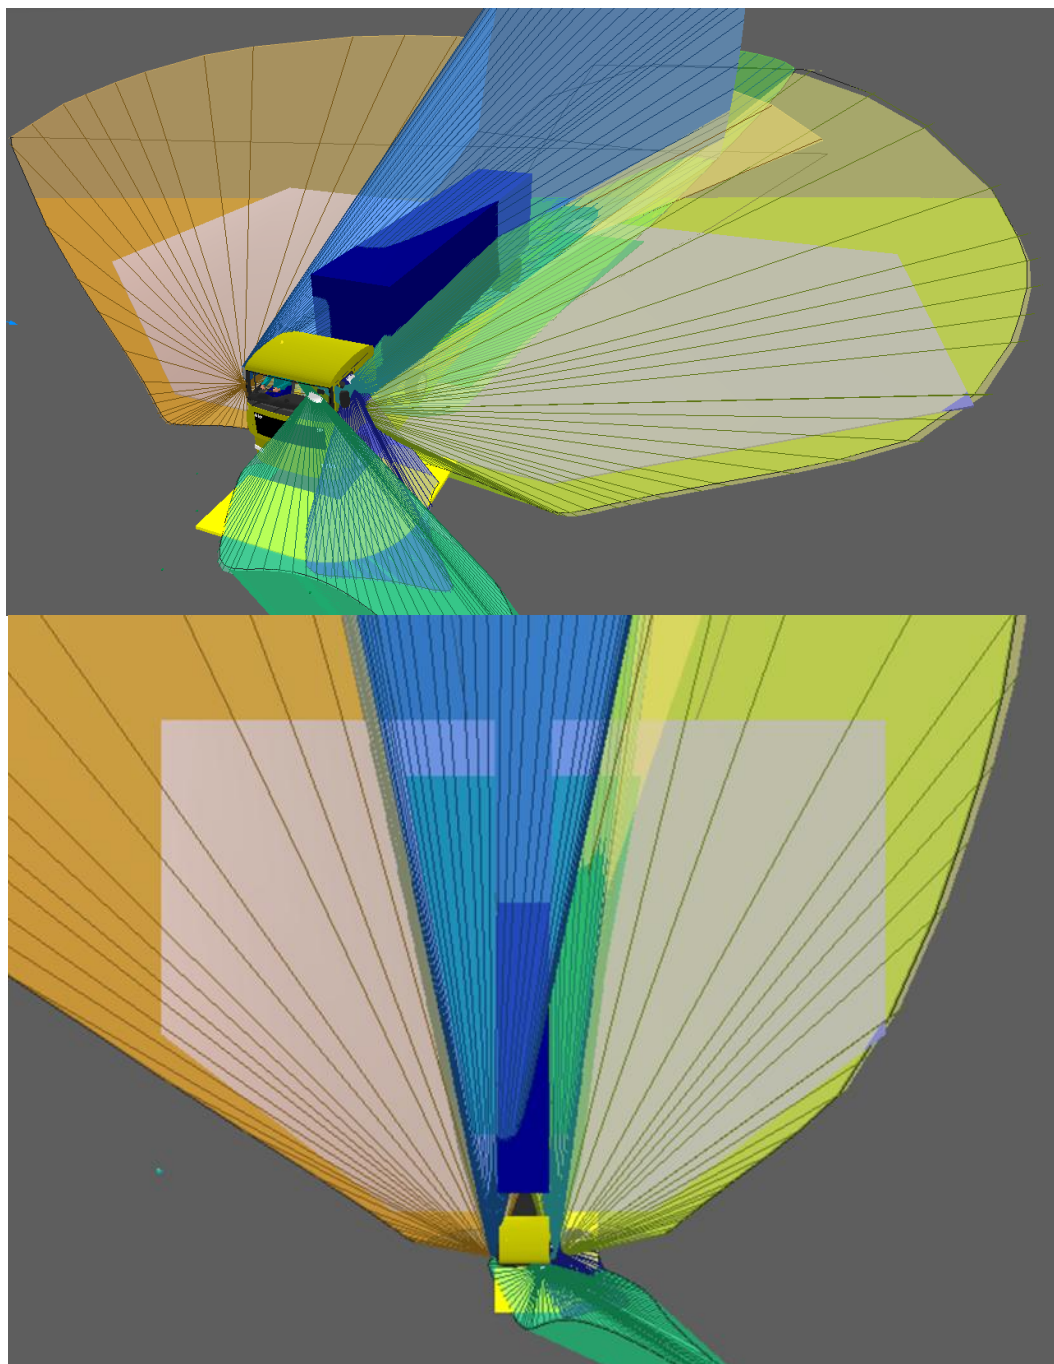
2.5.4.1.1.3 *The compliance of the DAX XF R420 category N₃ Right hand drive*

Figure 25. The compliance of the DAF XF category N₃ vehicle with the recommended area of visibility at the ground plane

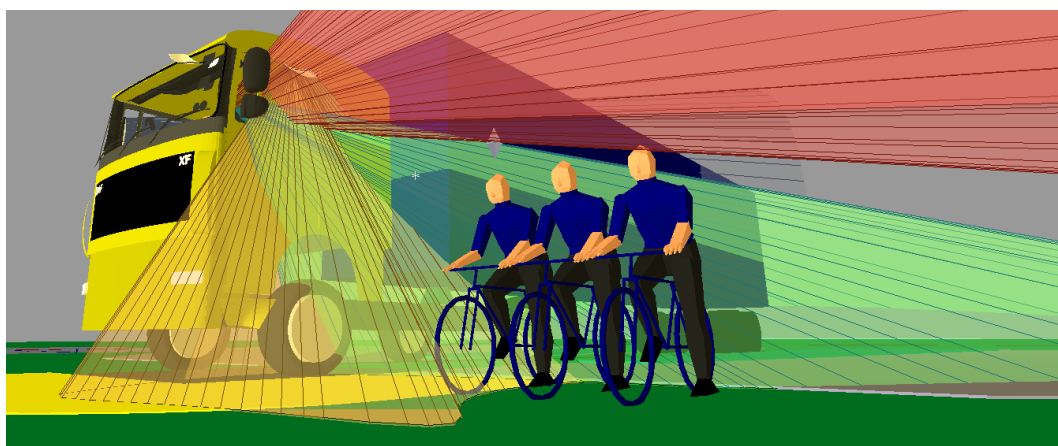
Figure 54. The blind spot between the Class V mirror and the volume that represents the direct vision through the passenger window for 99th%ile driver projections

Figure 51 shows the blind spot between the volume of space visible through the Class V mirror and the volume of space visible through the window aperture for a 4thile UK male driver. This blind spot was able to obscure four cyclists, line abreast with 50thile female stature (UK data). Figure 52 shows that the four cyclists are also not visible within the projected volume for the Class IV mirror. Figure 53 shows that a car can be placed in the identified blind spot with only the offside front wing and wheel being visible in the edge of the Class VI mirror for both 4thile and 99thile driver projections. A six degree rotation of the Class VI mirror in the vertical plane would make the car invisible to the driver of the DAF XF. Figure 54 and Figure 55 illustrate the same result for the 99thile stature driver projected volumes .

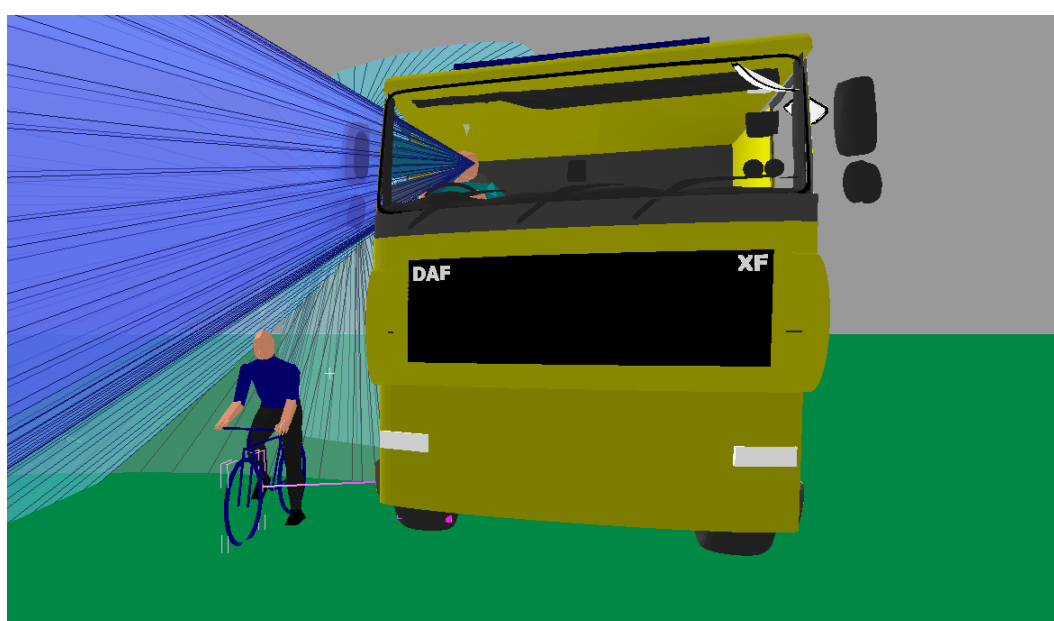
Figure 58. A 50thile UK female cyclist that is 950mm from the driver's side of the vehicle can be obscured from the 4thile stature driver

Figure 58 shows that a 50thile UK female stature cyclist can be located 950mm from the side of the vehicle without being visible to the 4thile stature driver through direct or in-direct vision.

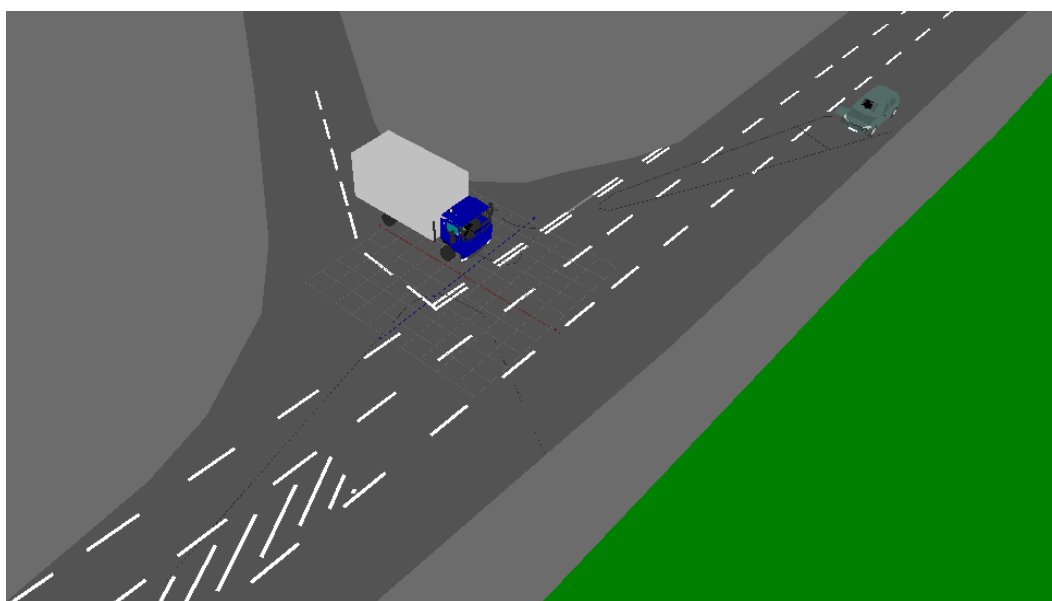
This scenario is based upon a specific OTS case where a category N₂ vehicle pulled out of T-Junction and turned right without seeing a vehicle approaching from the left. A collision then occurred. Figure 115 shows the analysis environment modelled in the DHM system.

Figure 115. The road junction associated with accident scenario 3

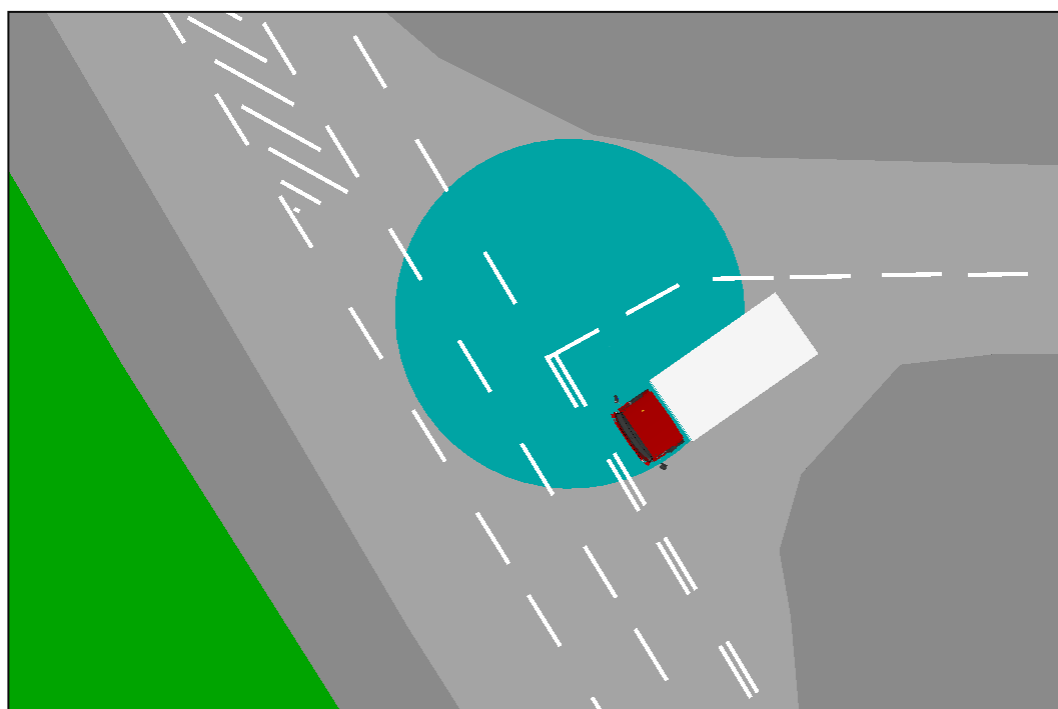
The kerb to kerb turning circle data was gathered for each category N₂ vehicle that is tested in the scenario. The manufacturer's data reports that the Renault Midlum 190 has a kerb to kerb radius of 6.77m, the DAF LF 45 has a radius of 5.52m, and the Iveco Eurocargo has a radius of 6.41m. It was found that the turning circle of the category N₂ vehicles would not hinder the ability to make the turn to the right, allowing all vehicles to be placed perpendicularly to the main carriage way. An example of this can be seen in Figure 117.

Figure 117. Plan view: The selected location for the Renault Midlum 190 with a orientation that is perpendicular to the main carriageway. The blue circle shows the kerb to kerb turning radius of the Renault Midlum

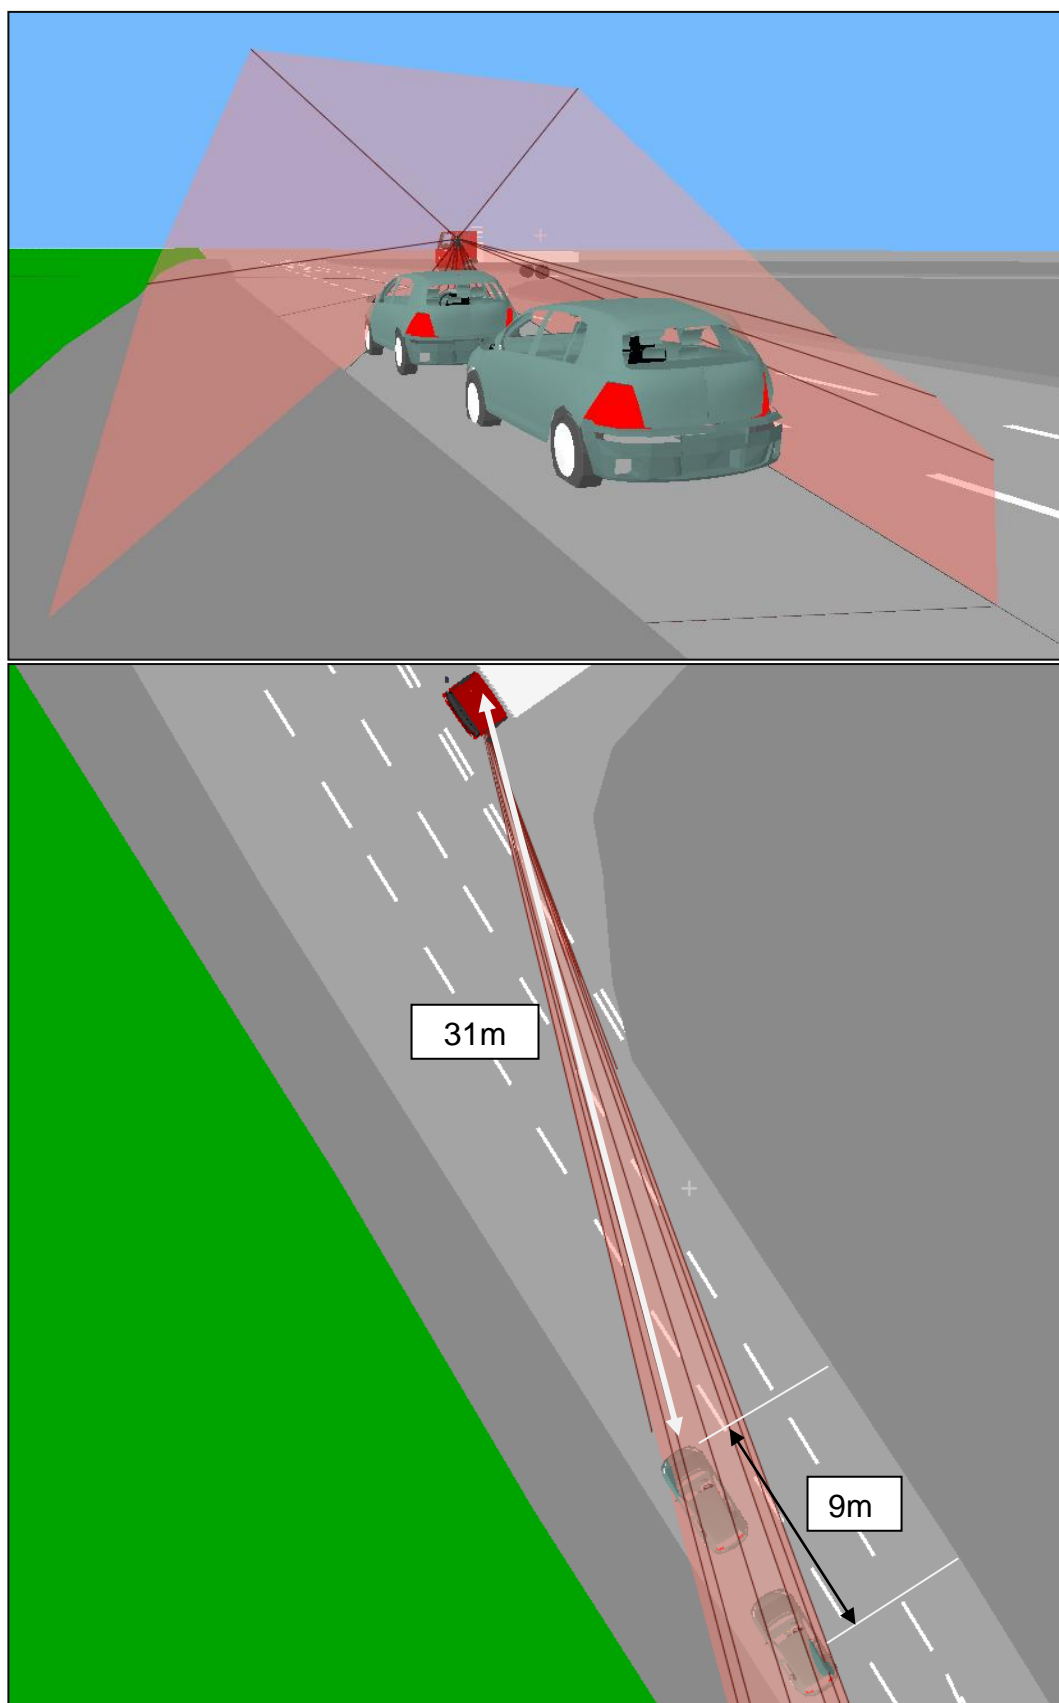
Figure 118. At a distance of 31m from the driver's ocular point the two cars, with a distance of 9m between the front bumper of one, and the rear bumper of the other, can be obscured by the passenger side Class II mirror surround

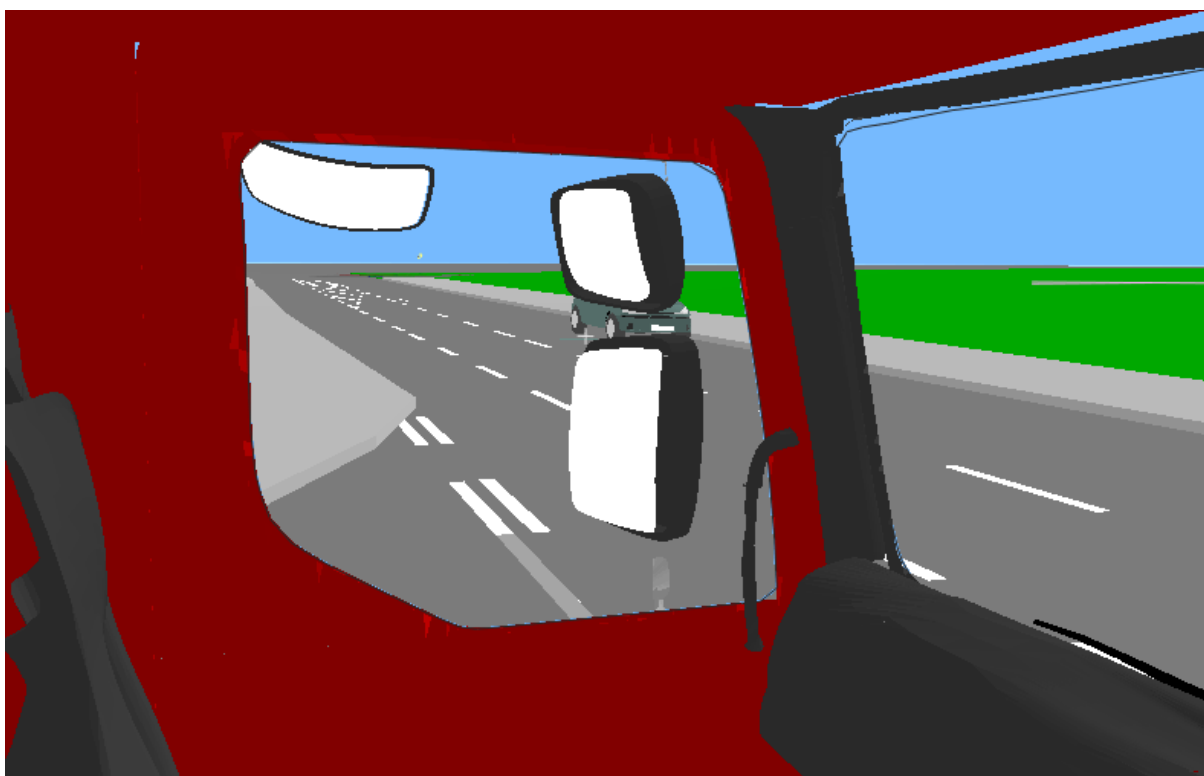
Figure 122. The driver's eye view: The approaching vehicle being partially obscured from the category N₂ Driver's vision due to the Class II and Class IV mirror surrounds

Figure 121, Figure 122 and Figure 123 show that for a driver with 99thile stature the oncoming car is only partially obscured by the mirror housings and the A-pillar.

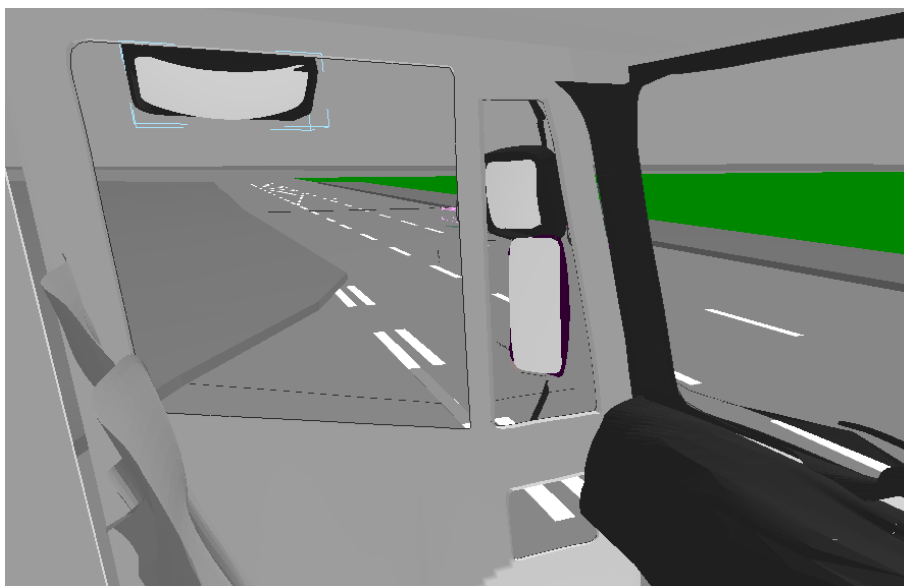
Figure 132. The driver's eye view: The approaching vehicle being partially obscured from the category N₂ Driver's vision due to the Class II and Class IV mirror surrounds

Figure 132, Figure 133 and Figure 134 show that for a driver with 99thile stature the oncoming car is partially obscured by the mirror housings and the A-pillar.

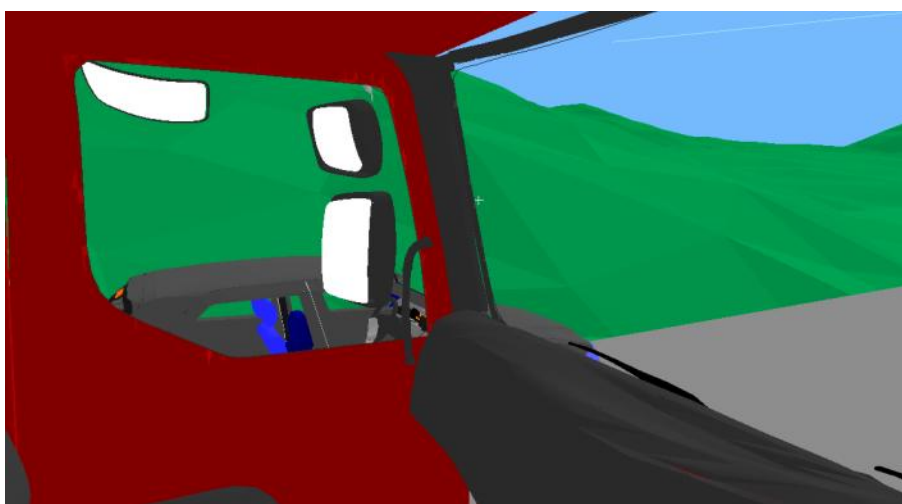
Figure 136. A car to the left of the driver's cab, and forward of the volume of space covered by the Class IV mirror is directly visible to a 4thile stature LGV driver

Figure 135 and Figure 136 show that when a car is positioned to the left of the Renault Midlum in a position that is forwards of the volume of space that is visible through the Class IV mirror the car should be clearly visible with direct vision through the passenger's side window.

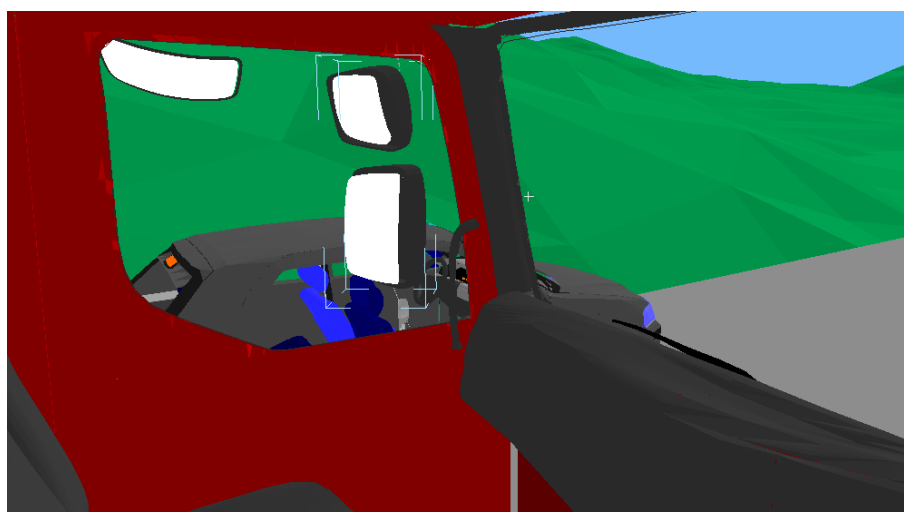
Figure 138. A car to the left of the driver's cab, and forward of the volume of space covered by the Class IV mirror is directly visible to a 99thile stature LGV driver

As with the shorter driver, the Figure 137 and Figure 138 show that when a car is positioned to the left of the Renault Midlum in a position that is forwards of the volume of space that is visible through the Class IV mirror the car should be clearly visible with direct vision through the passenger's side window.

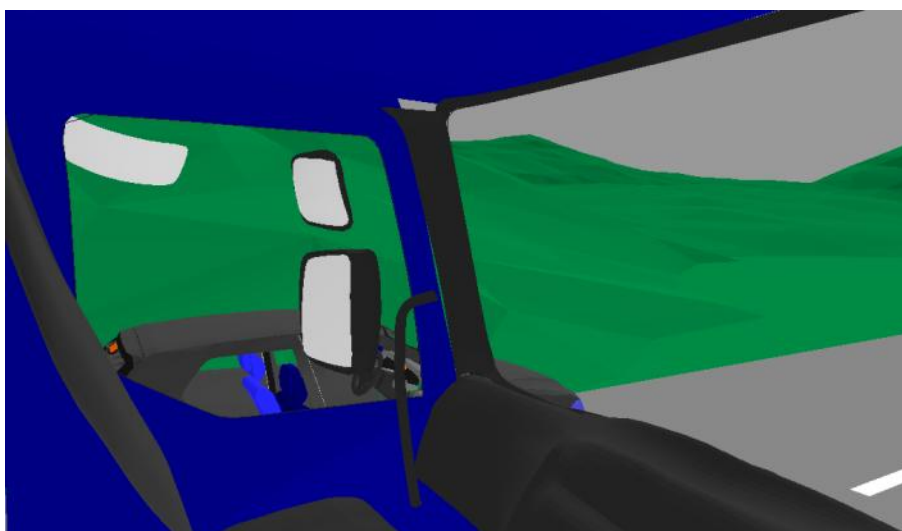
Figure 144. A car to the left of the driver's cab, and forward of the volume of space covered by the Class IV mirror is directly visible to a 4thile stature LGV driver

As observed with the Renault, Figure 143 and Figure 144 show that when a car is positioned to the left of the DAF LF 45 in a position that is forwards of the volume of space that is visible through the Class IV mirror the car should be clearly visible with direct vision through the passenger's side window.

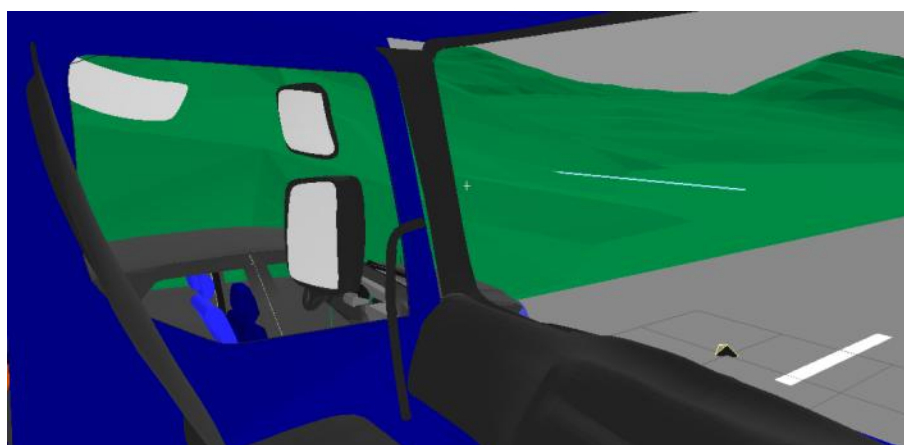
Figure 146. A car to the left of the driver's cab, and forward of the volume of space covered by the Class IV mirror is directly visible to a 99thile stature LGV driver

As with the shorter driver, Figure 145 and Figure 146 show that when a car is positioned to the left of the DAF LF 45 in a position that is forwards of the volume of space that is visible through the Class IV mirror the car should be clearly visible with direct vision through the passenger's side window.

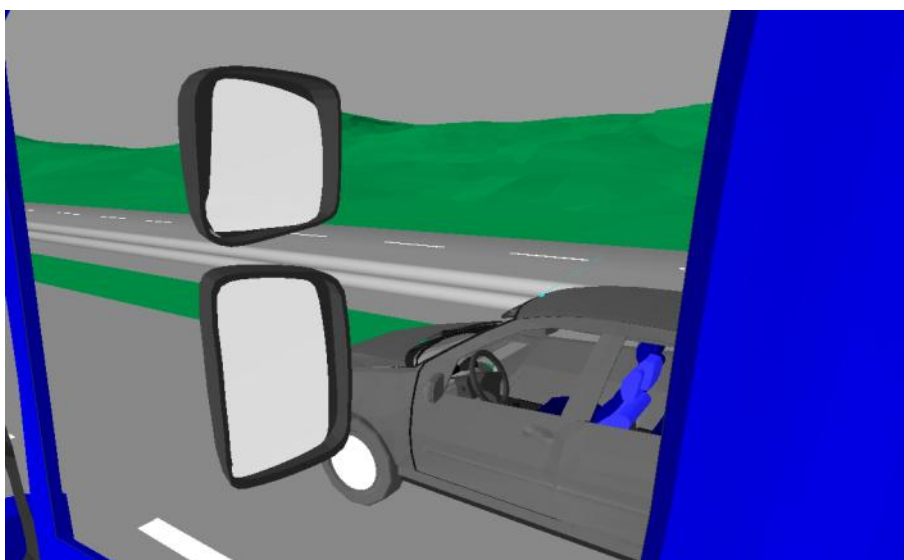
Figure 148. A car to the right of the driver's cab, and forward of the volume of space covered by the Class IV mirror is directly visible to a 4thile stature LGV driver

Again, as observed with the Renault Figure 147 and Figure 148 show that when a car is positioned to the right of the DAF LF 45 in a position that is forwards of the volume of space that is visible through the Class IV mirror the car should be clearly visible with direct vision through the driver's side window.

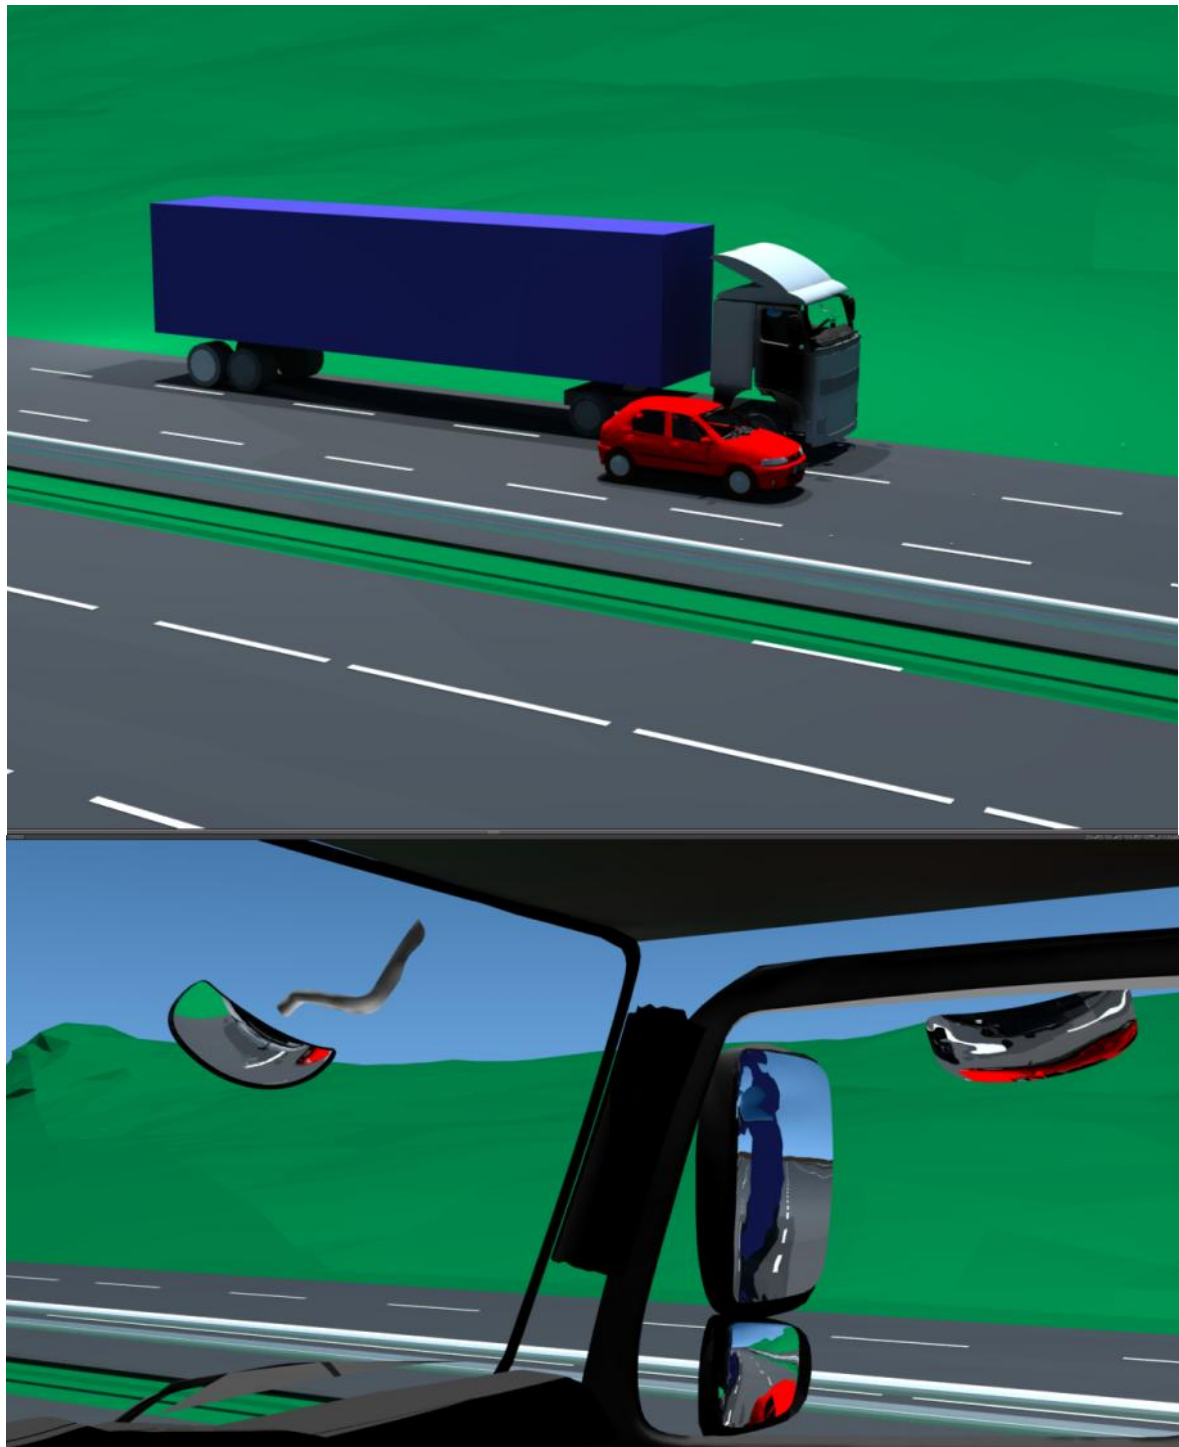
Figure 157. Stage 3: The vehicle is partially visible in the Class IV mirror and partially visible in the Class V mirror and Class VI mirror

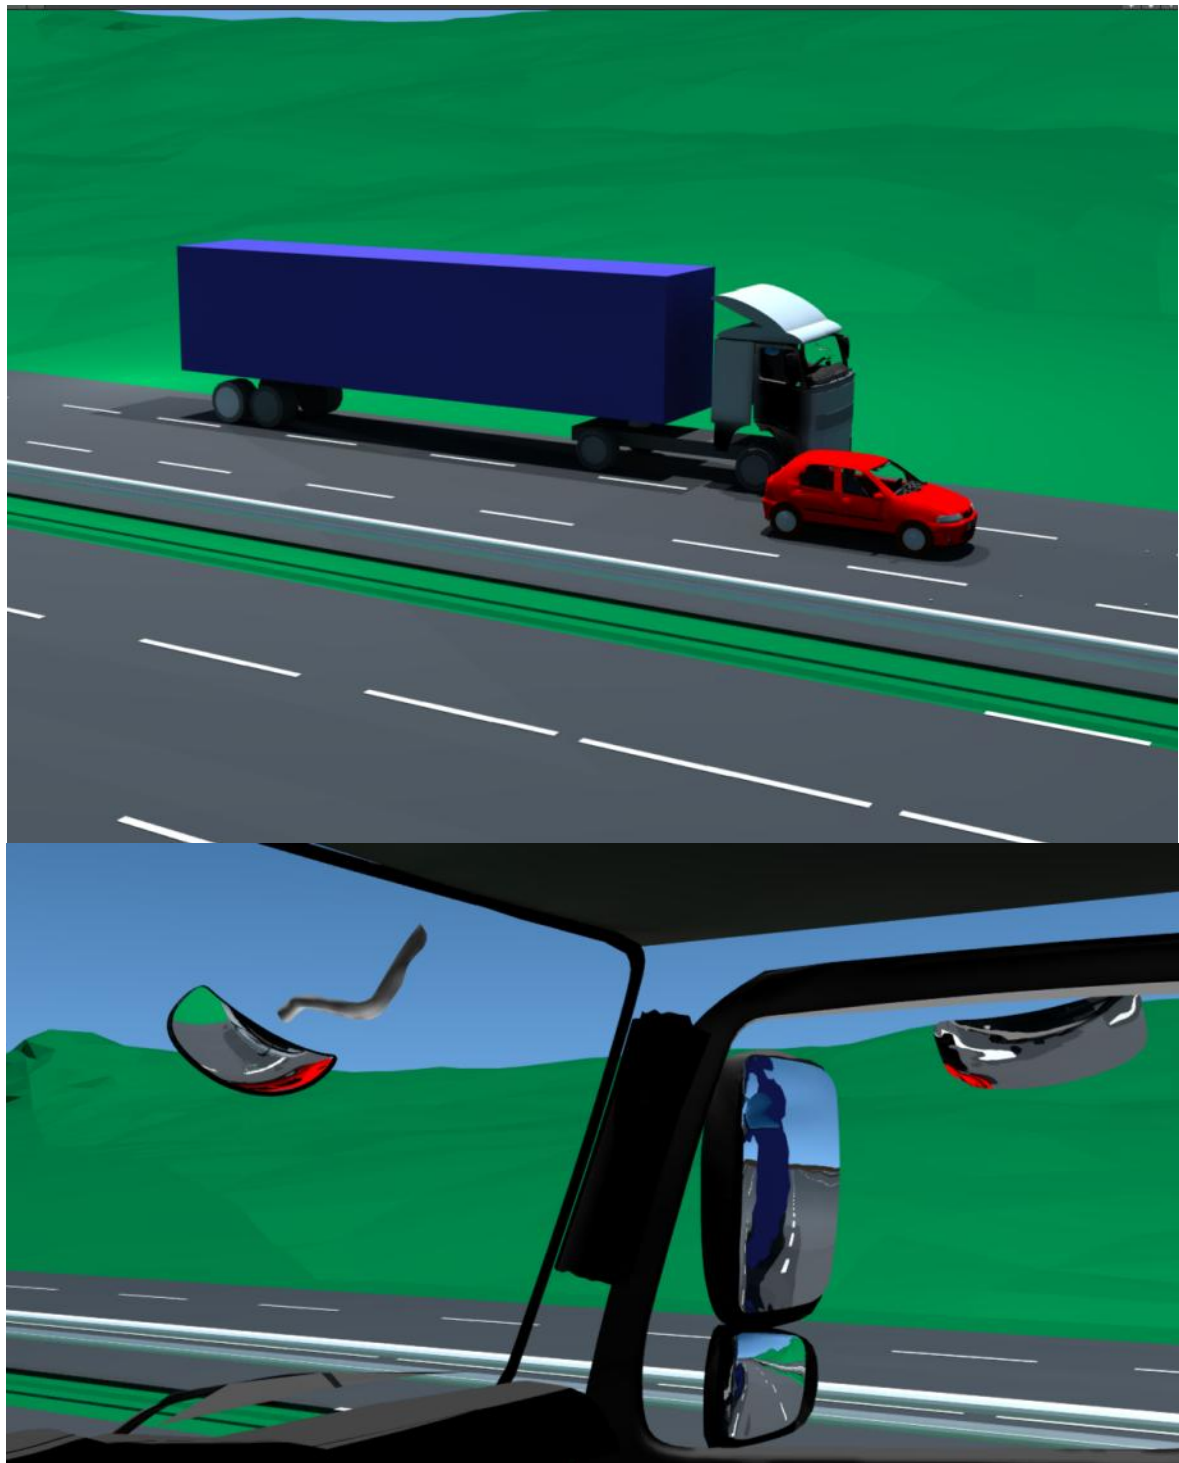
Figure 159. Stage 5: The vehicle is partially visible in the Class V mirror and Class VI mirror

This analysis shows that for Stages four and five, where the M_1 vehicle is adjacent to the cab of the category N_3 vehicle, the M_1 vehicle can only be partially seen in the Class V and Class VI mirrors. Further research would need to be performed to determine if drivers can identify visual targets that are shown at the edge of Class IV, V and VI mirrors. However, the phase 1 report included the discussion of research that demonstrated that drivers only use the Class V and Class VI mirrors for close manoeuvring situations or when stationary at junctions.

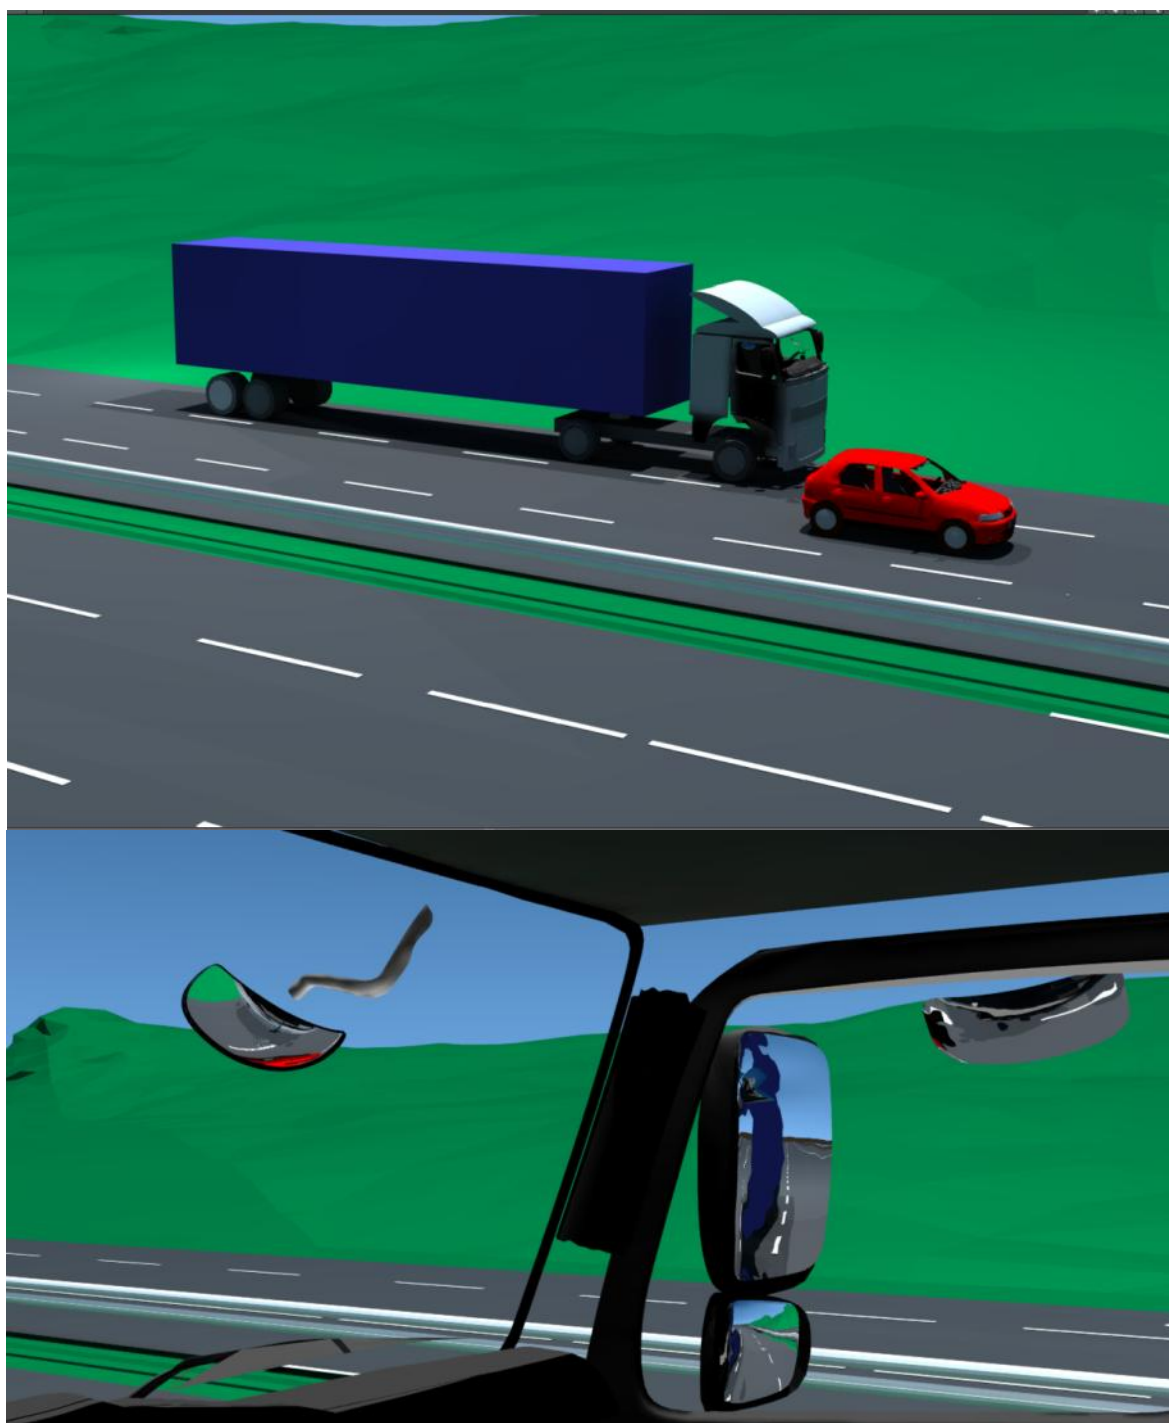
Figure 160. Stage 6: The vehicle is partially visible in the Class VI mirror

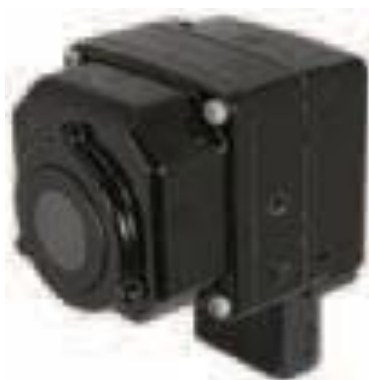
Figure 163. Brigade PathFindIR Thermal Imaging Camera

In a typical passive infra-red system image, "cold" objects are visible by the reflection of ambient near infra-red radiation, but hot objects appear brighter due to their higher temperature. They are therefore capable of highlighting humans and animals against their background.

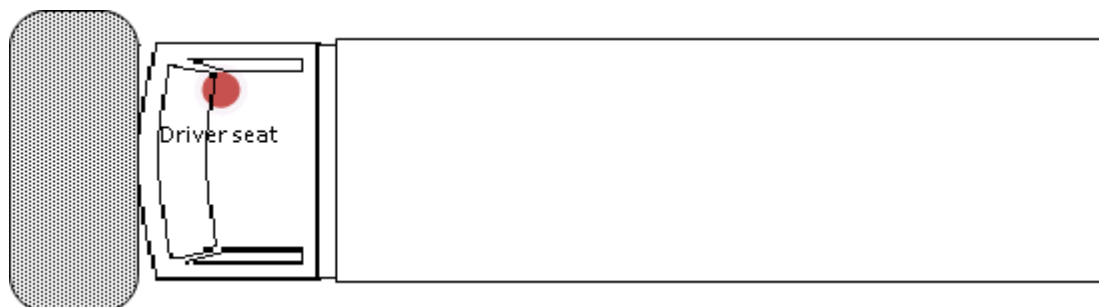
Figure 164. Shaded area indication of the area covered by front sensor systems.

Front sensors provide coverage to the front of the vehicle. Figure 164 presents an outline of a region in which a front sensor system may provide coverage. One potential problem with front systems used to activate a driver alert is that they may generate unnecessary alerts whenever the vehicle is close to another vehicle in a

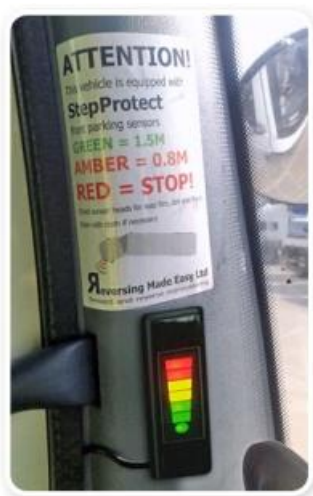
Figure 166. Example of Visual Warning System Mounted on the Nearside A-Pillar

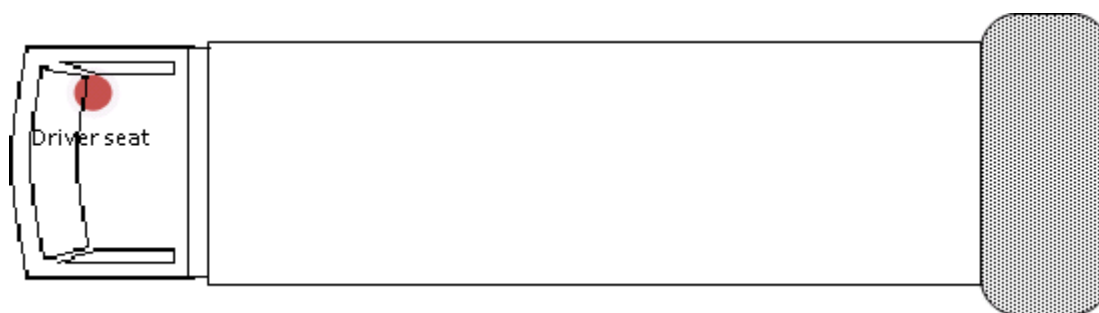
Figure 168. Shaded area indication of the area covered by rear sensor systems.

Rear sensor systems provide coverage to the rear of the vehicle. Figure 168 presents an outline of the typical area covered by a rear sensor system.

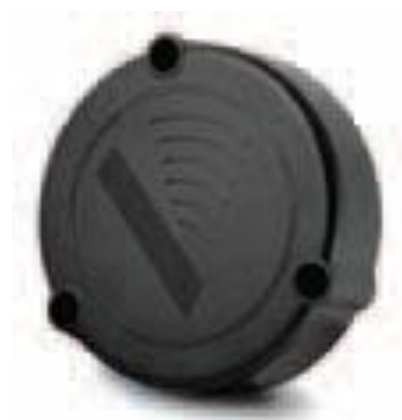
Figure 169: Brigade Backsense Radar Detection Sensor

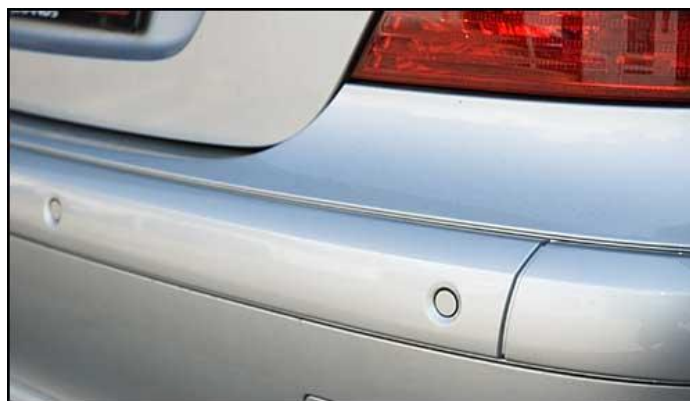
Figure 170. Typical Ultrasonic Reversing Sensor Installation on M₁ Vehicle

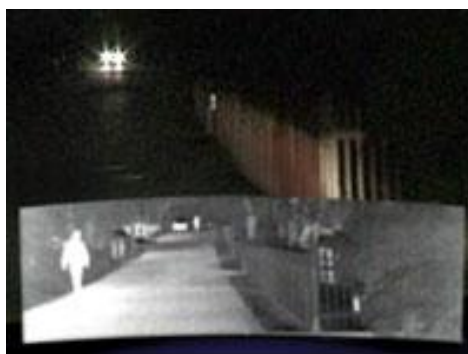
Raytheon Infrareds' Night Vision system is one of the features of the new Volvo XC90 SUV.

Figure 172. Display from Volvo Night Vision System

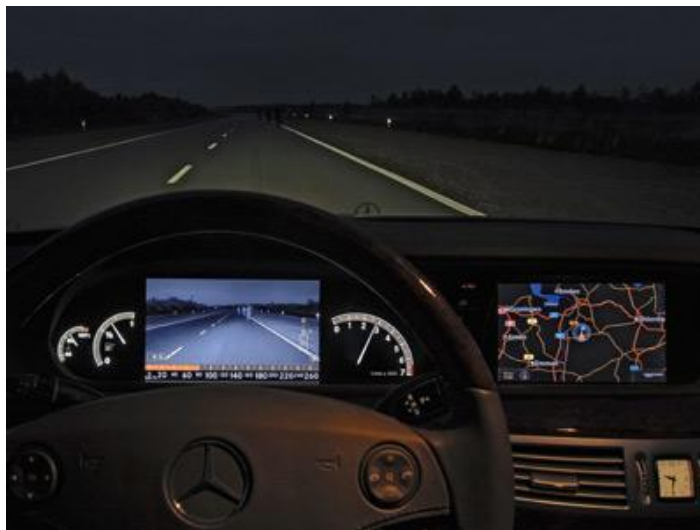
Figure 173. Mercedes Night View Assist Instrument Panel Display

This system is one example of an enhanced vision system using active infra-red, using IR emitters on the front of the vehicle to illuminate the roadway and sensors detecting the reflected IR to form an image. It was first offered on sale on the Mercedes S-class car in 2005. In 2009, Mercedes Benz introduced Night Vision Assist Plus, with image processing alerting the driver to pedestrians. Similar systems are now offered by Toyota.

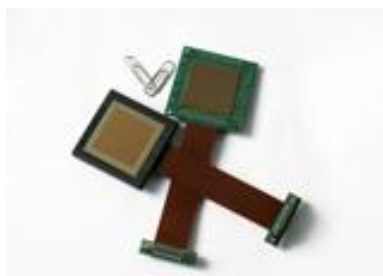
Figure 174. Fraunhofer IRFPA Sensors

The cost of night vision systems is reducing as systems are developed. The current cost as an option on higher end cars is approximately £1500, but this seems likely to reduce, and the systems will no doubt become available on lower-segment vehicles. Some recent developments could herald a dramatic reduction in the cost of night vision sensors. Fraunhofer IMS have recently announced the development of the IFRPA (Infra-Red Focal Plane Array). This is a 256 x 256 pixel array that does not require the cooling technology in current IR detectors, and is claimed to generate a digital output signal directly, without an intermediate converter.

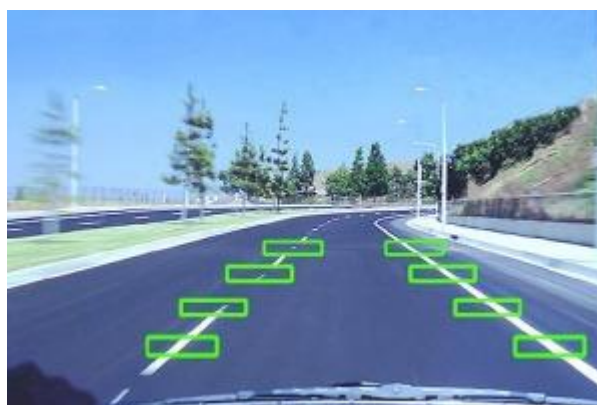
Figure 175. Tracking of Lane Markers by the Iteris Auto Vue LDWS

These systems assist drivers in keeping to their lanes by warning them when their vehicles are in danger of leaving their lane unintentionally (mainly due to lack of driver attention). These work by automatically detecting the white lines at the side of the lane as shown in Figure 175. Current systems use either an audible beep or a “rumble strips” noise, which mimics the sound made when a tyre runs over a lane divider. The first production LDW system was developed by Iteris and offered on the Mercedes Benz Actros in 2000. It is now available on most cars and LGVs on sale in Europe, and the European Commission plans to make its installation compulsory on all new category N₂ and N₃ vehicles as well as category M₂ and M₃ vehicles by 2015.

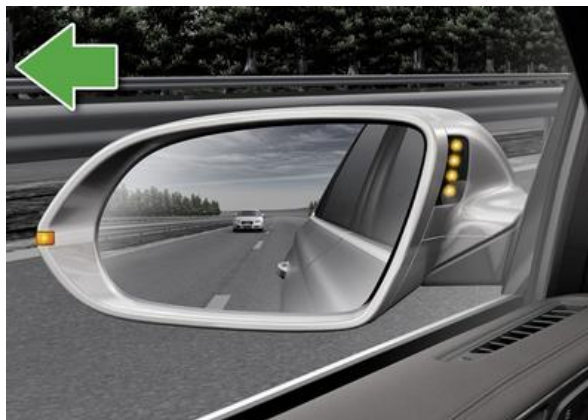
Figure 176. Lane Change Assistant Warning Next to Mirror

These assist drivers intending to change lanes. The LCA monitors the adjacent lanes and warns the driver if another vehicle is likely to come within colliding distance during the lane change. This occurs, for example, if the other vehicle is located in the LCA-equipped vehicle's blind spot (See Figure 176).

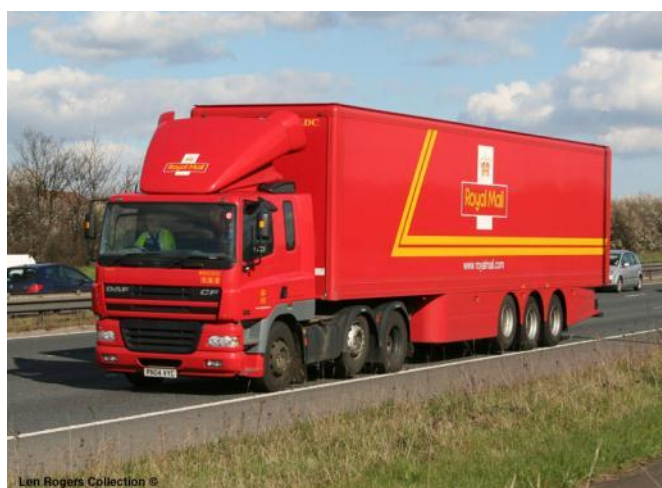
Figure 177. Royal Mail Safety Concept Vehicle

The vehicle is based on a DAF CF85 410, coupled to a Cartwright trailer. As well as a number of features dedicated to the health and safety of the driver in handling the trailer, the combination incorporates a number of key features to help driver awareness and avoid cyclist and pedestrian collisions. These are:

- Reversing sensors on the trailer detect objects to the rear while reversing. These are linked to the braking system and automatically stop the vehicle when there is an object less than 1m behind the trailer.
- While reversing, two loudspeakers generate a “white noise” warning to anyone close to the rear of the trailer. White noise is used in preference to more traditional types of warning, because it is easier for a pedestrian in the danger zone to locate the source of the sound. In addition, it generates less annoyance to people who are not in the immediate vicinity.
