The Development of Improvements to Drivers' Direct and Indirect Vision from Vehicles – Phase 2

For: Department for Transport
DfT TTS Project Ref: S0906 / V8

Prepared by: Loughborough Design
School, Loughborough University
and MIRA Limited

Date: March 2011

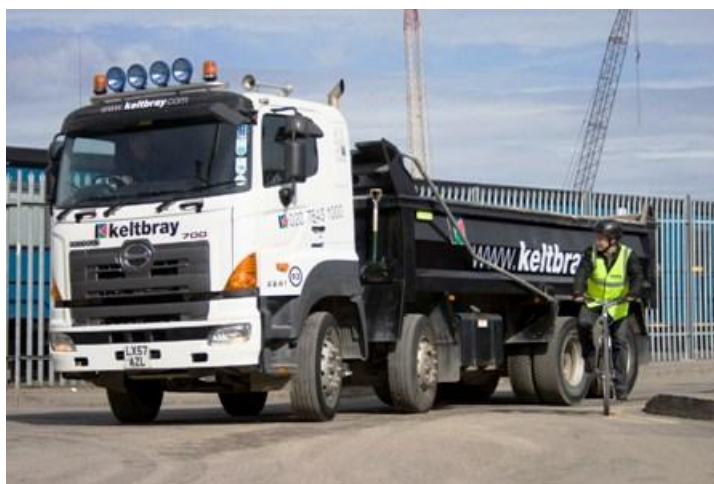
Figure 178. Keltbray Safety Concept Vehicle

Keltbray is a large demolition business which operates a fleet of 38 tipper lorries in the London area. As a safety initiative, they have installed these with a number of safety systems produced by Brigade Electronics, designed to avoid collisions with pedestrians and cyclists. The systems include the following:

- Installation of 4 Brigade “Sidescan” ultrasonic sensors on the nearside of the cab. These detect the presence of pedestrians or cyclists in the nearside blind spot, and alert the driver by an audible warning in the cab. The alert also triggers a visual signal in a small unit mounted at the top of the nearside windscreen pillar. This is positioned close to the blind spot mirror, drawing the driver’s attention to this so that they will identify the cause of the signal in the mirrors. The visual display also displays the distance of the object from the vehicles’s nearside.
- If the system is triggered while the vehicle’s left turn indicator is activated, a loudspeaker on the outside of the cab transmits an audible message, warning the cyclist or pedestrian that the vehicle is about to turn.

- A Brigade reversing camera is installed on the back of the vehicle, and transmits an image to a screen on the header rail, whenever reverse gear is selected.
- While reversing, two loudspeakers on the back of the vehicle transmit a “white noise” to warn any pedestrians in the vicinity. This uses Brigade’s BBS-TEK technology. White noise is used because it allows pedestrians to locate the source of the sound more easily, while the noise is more directional so its distribution is confined to a smaller area, reducing its environmental impact.

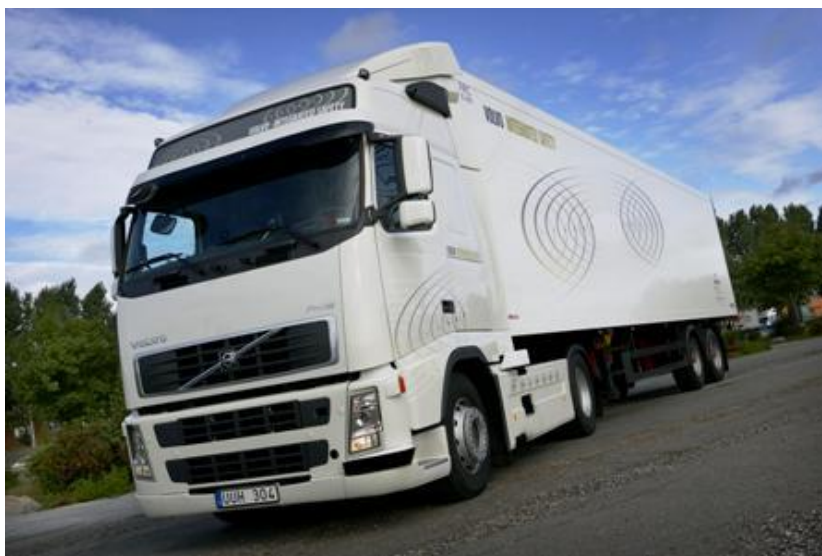
Figure 179. Volvo Integrated Safety Vehicle

The Volvo Integrated Safety Vehicle was presented in 2006 and incorporates many features to increase driver awareness and avoid collisions, developed under the EU-funded Integrated Safety Program. The features include the following:

- The Adaptive Driver-Vehicle Interface helps the driver to focus on safety critical driving tasks. The system uses a GPS map based system and automatic detection of roadside hazards to identify whether maximum attention is required. When this situation is detected, the system delays incoming mobile media messages and calls until the driver is better able to attend to them.
- There are other systems incorporated into the vehicle which, while not directly contributing to driver awareness, help minimise possible distractions.

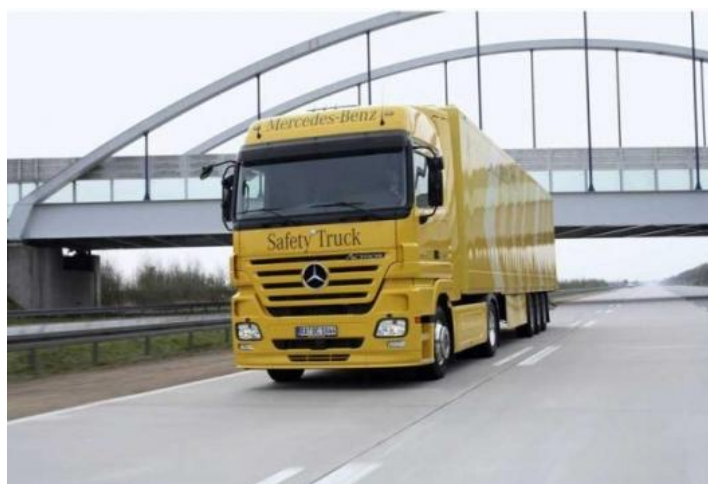
Figure 180. Mercedes Benz Integrated Safety Vehicle

This is equipped with the following features dedicated to improving driver awareness:

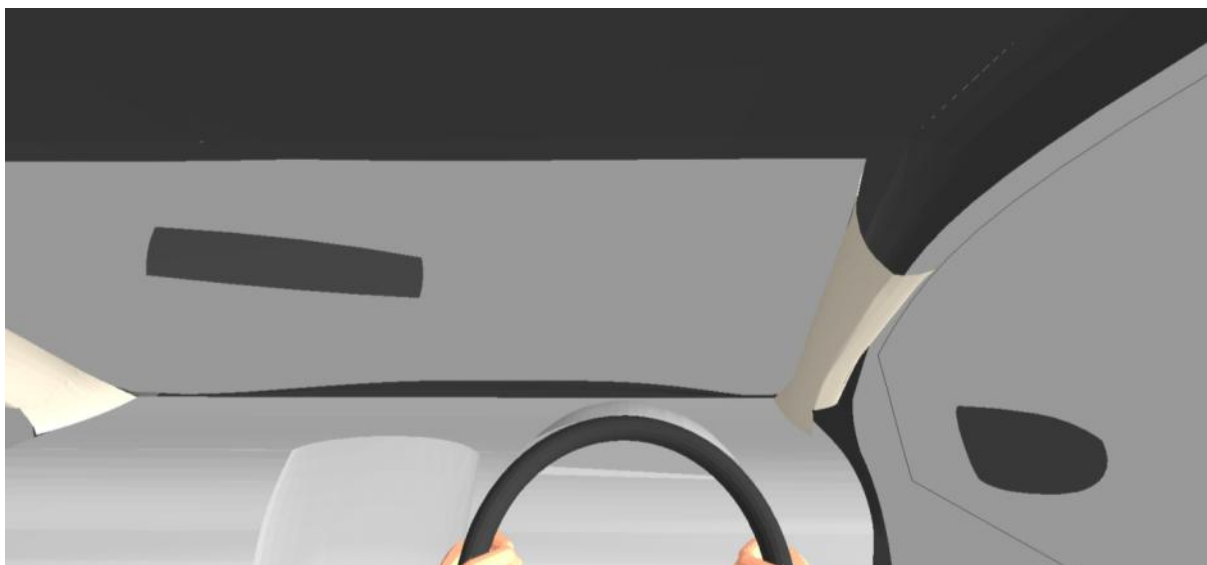
Figure 186. Volkswagen Golf showing the view of the Dutch male

Figure 182, Figure 183, Figure 184, and Figure 185 show the process of matching the position and initial posture of the human model within SAMMIE based on the data captured from the scanning activity. To finalise the posture the driver is reclined to provide a realistic driving posture, relatively reclined for the larger driver, relatively upright for the smaller driver. In addition, the view of the driver and the position of the steering wheel (if it is adjustable), to ensure a clear view of the road and of the instrument binnacle are used to help posture the human (see Figure 186).

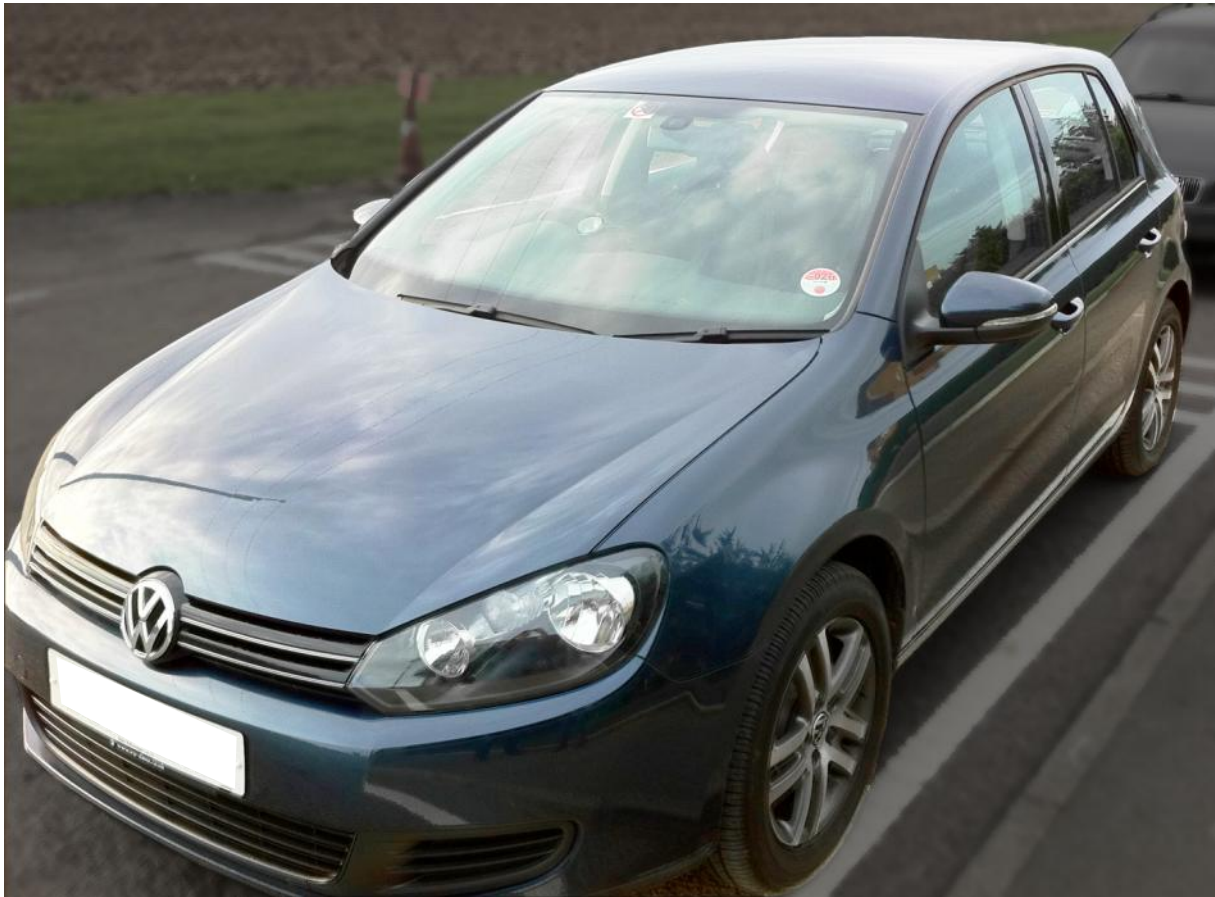
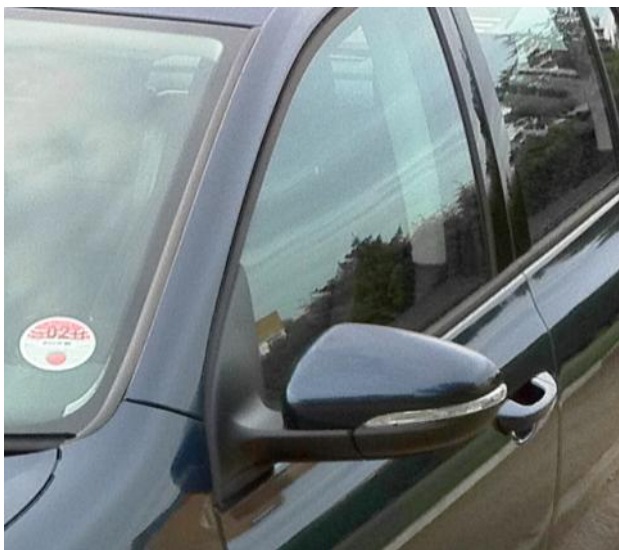
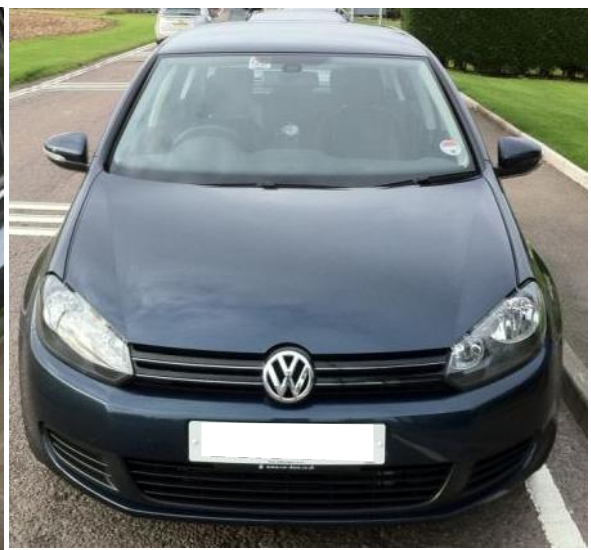
Figure 187A. Volkswagen Golf

- A current (2010 on) model Volkswagen Golf (Golf VI platform) shown in Figure 187 A-C.
- A current (2010 on) model Volkswagen Touran – this MPV style vehicle is based upon the current Golf VI platform and has a split A-pillar configuration, shown in Figure 188 A-C.
- A current (2010 on) model Hyundai i10 shown in Figure 189 A-B.

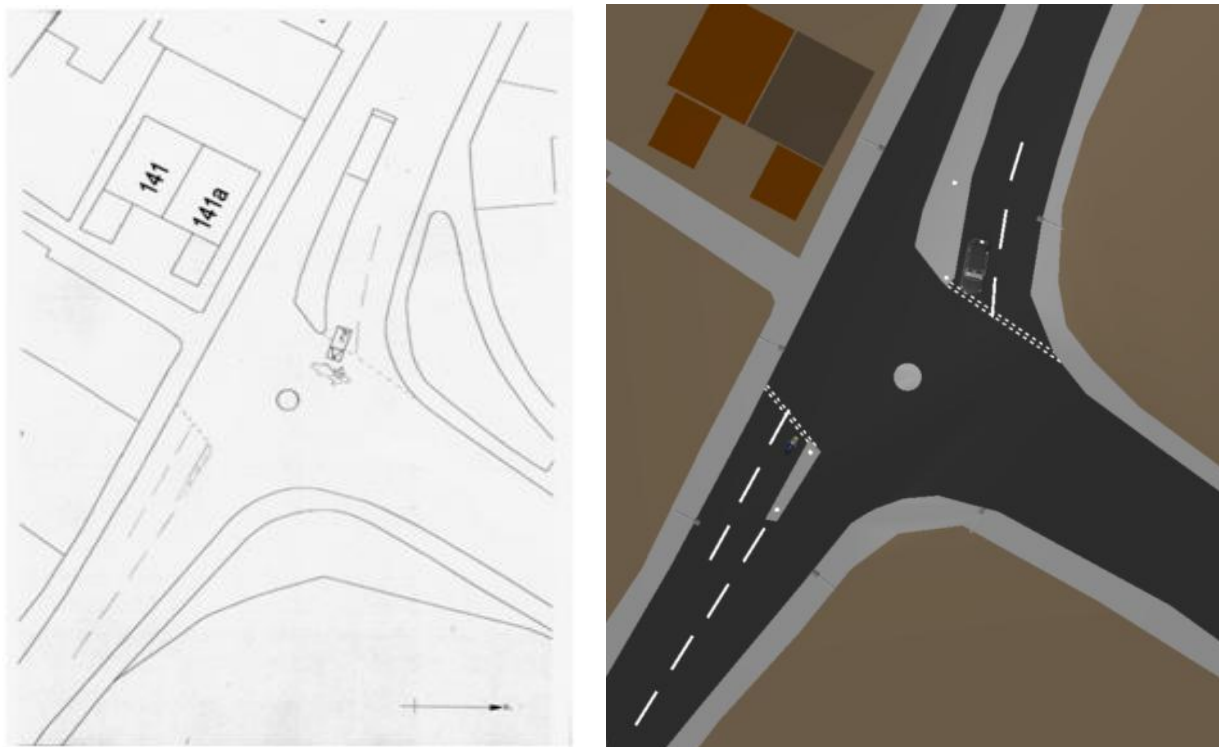
Figure 262. The road layout recreated from the OTS case report

The scenario was modelled using the map data provided in the OTS case report (Figure 262). The angle of the junction to the roundabout has the potential to cause difficulty for the category M_1 driver in terms of positioning for optimum visibility in front and to the right of the vehicle to observe vehicles already on the roundabout. The vehicle CAD model that represents P2V1 (a Yamaha Cygnus x) is positioned initially at the entrance to the roundabout opposite P1V1. As detailed, P1V1 is positioned in lane 2 and oriented in a balance between the need to proceed around the

roundabout heading for exit 2 and to evaluate the possibility for obscuration of the scooter from the offside A-pillar. A third vehicle is included in the scenario using the same exit as that intended for P1V1 to give an indication of the desired path.

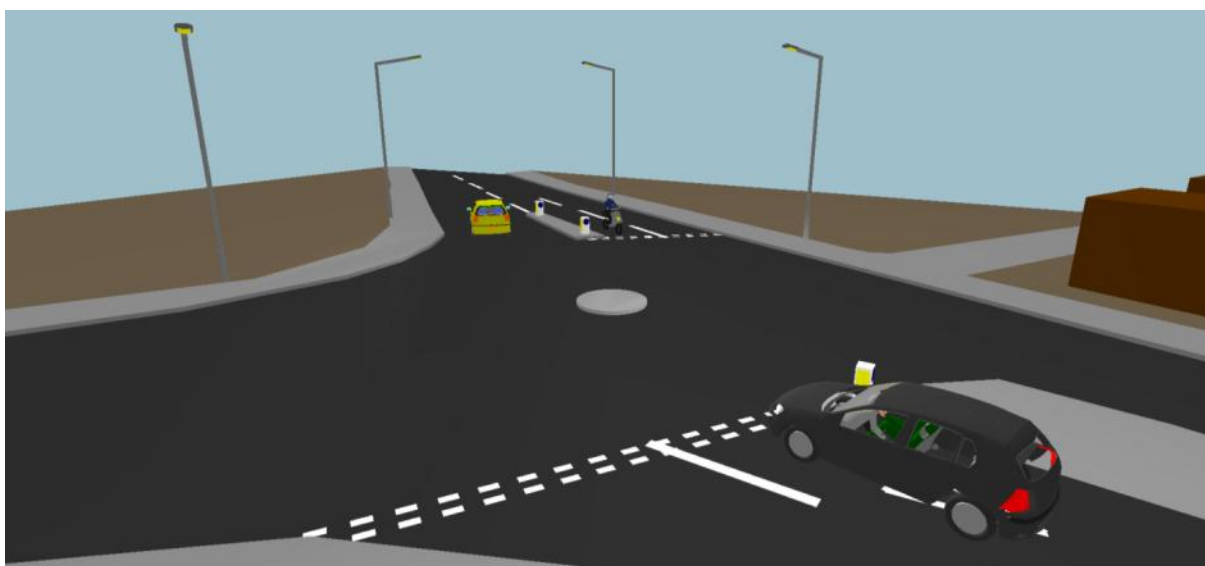
Figure 263. The roundabout layout showing the VW Golf and 99th %ile Dutch male driver

The relative positioning of the vehicles is shown in Figure 263 and Figure 264 below.

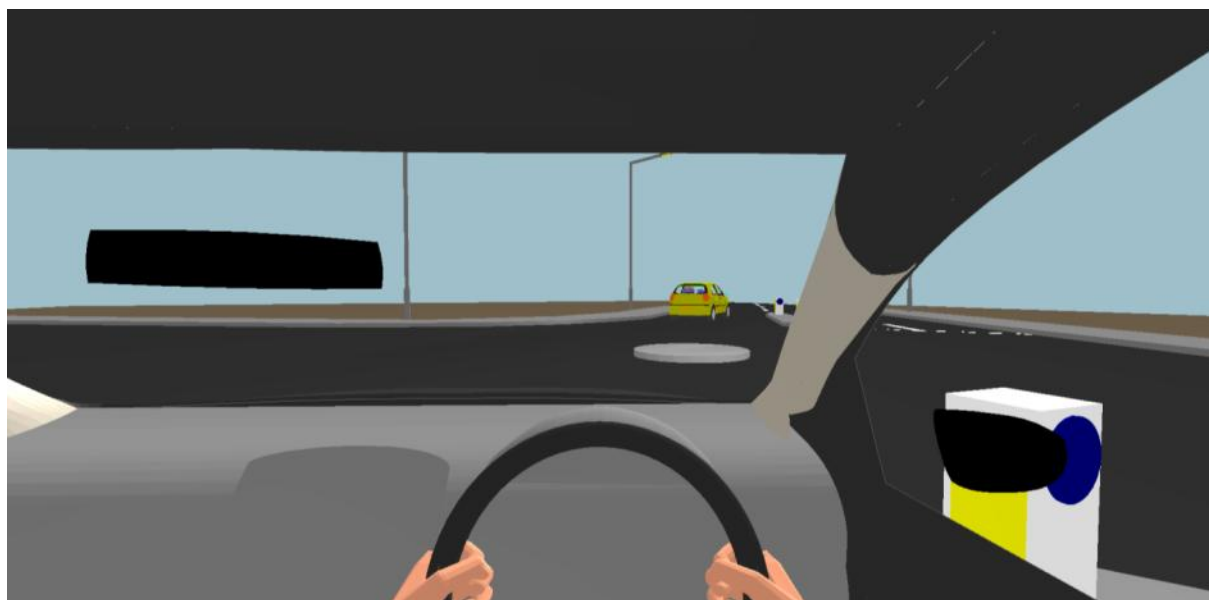
Figure 265. The view of the Dutch male driver

Figure 265 below shows that in this position the scooter and its rider are completely obscured by the A-pillar of the M₁ vehicle. The driver is looking to essentially follow the yellow Fiat Punto off the roundabout.

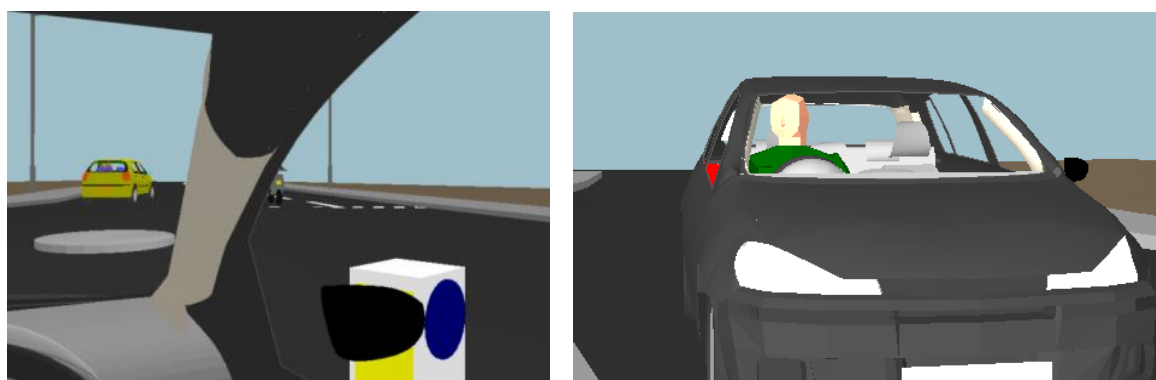
Figure 266. The scooter can be seen if the driver turns their head

Figure 266 above shows that whilst the A-pillar obscuration does mask the scooter and its rider, it is possible for the driver to 'look around' the obscuration if the driver is aware of the blind spot.

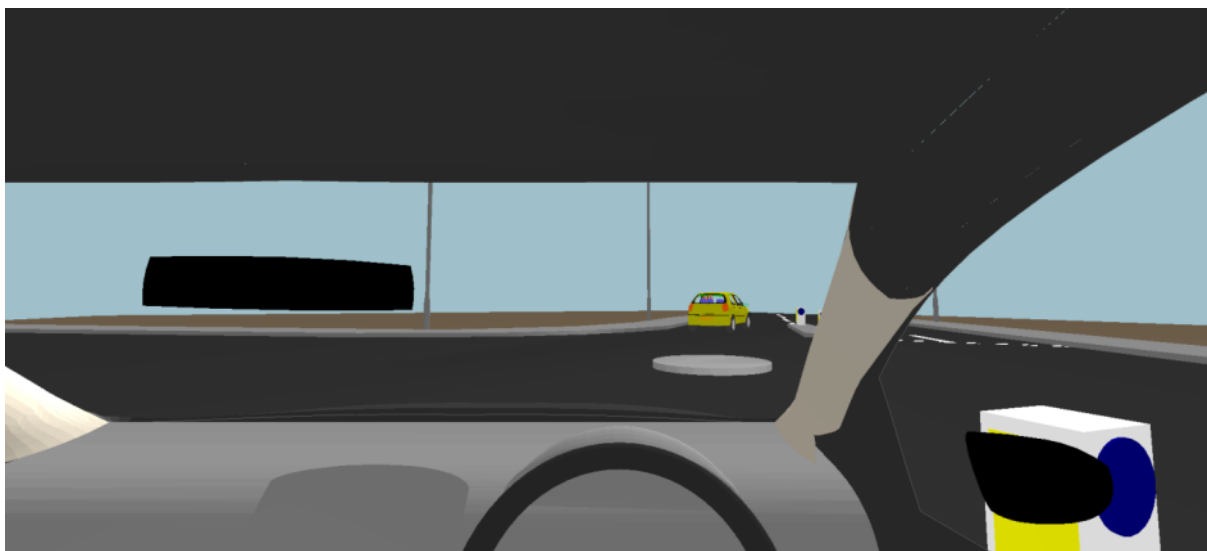
Figure 270. The scooter is still not visible to the M₁ driver

Figure 267, Figure 268 Figure 269, and Figure 270 above show that the scooter could travel down the 'corridor' blind spot caused by the offside (right) a-pillar and thus remain obscured whilst the driver of the M₁ vehicle performs their observations prior to setting off.

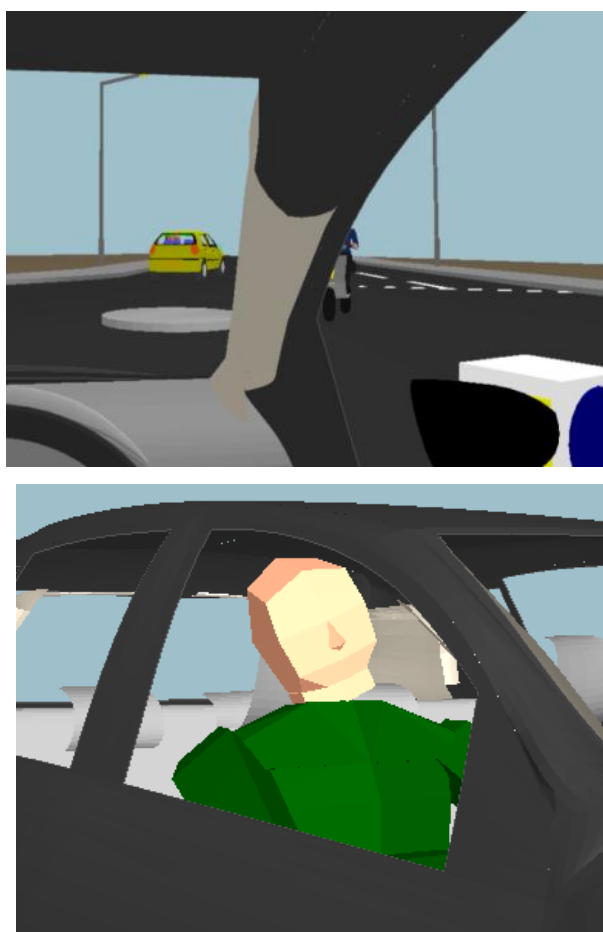
Figure 271. The scooter can be seen if the driver leans their head

Whilst the scooter is obscured by the A-pillar, if the driver is aware of the blind spot it is still possible to 'look around' the obstacle by tilting the head to the side (Figure 271).

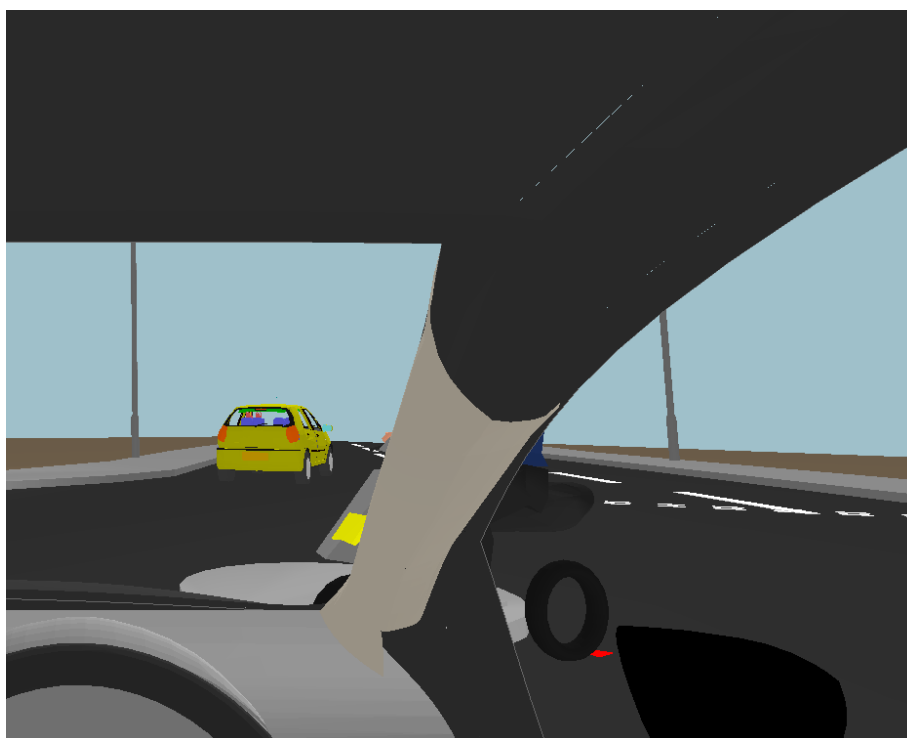
Figure 273. The scooter can effectively travel the whole distance until the point of impact obscured by the M₁ A-pillar – driver's view at point of impact

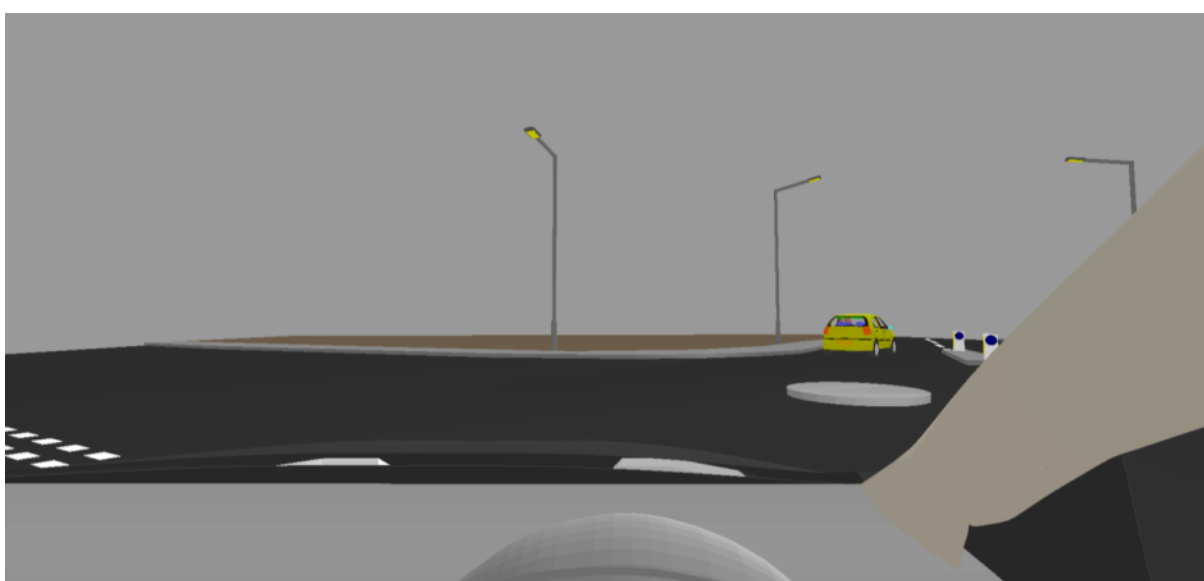
Figure 275. The view of the UK female driver

Figure 275 and Figure 276 show that in this position the scooter and its rider are completely obscured by the A-pillar of the M_1 vehicle. The UK female driver's eye point is much closer to the A-pillar than for the Dutch Male and so the pillar appears larger and more to the right, relatively, within the forward field of view. To provide the obscuration the car has to be positioned pointed more to its left, relative to the position for the Dutch male driver, to provide the obscuration (Figure 274).

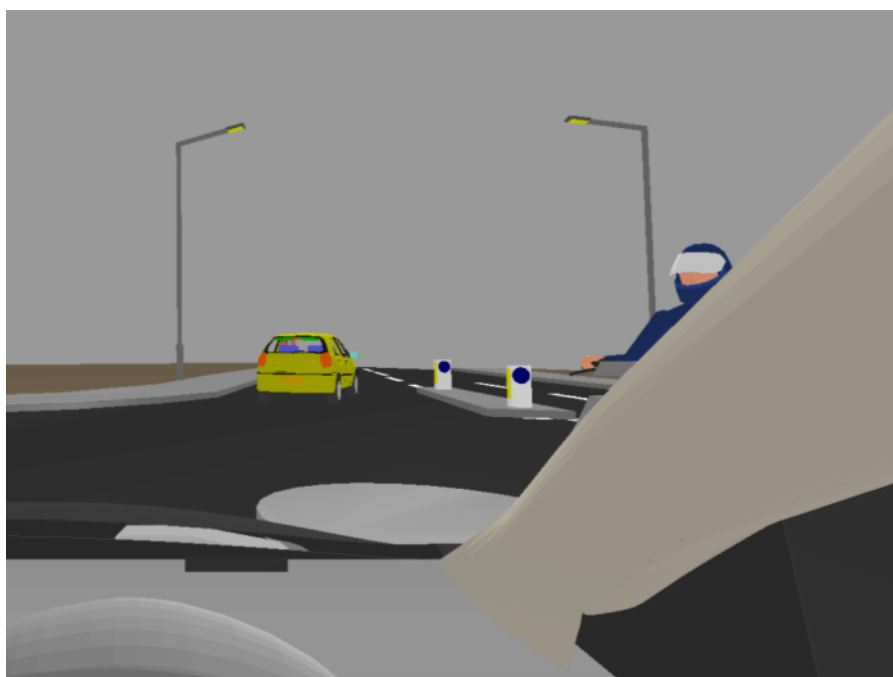
Figure 279. The scooter can effectively travel the whole distance until the point of impact obscured by the M₁ A-pillar – driver's view at point of impact

As with the Dutch Male driver if the M₁ driver fails to take account of the blind spot by changing the position of the head, it is possible for the scooter and M₁ vehicle to travel to the point of impact without the M₁ driver being able to see the scooter (see Figure 278 and Figure 279).

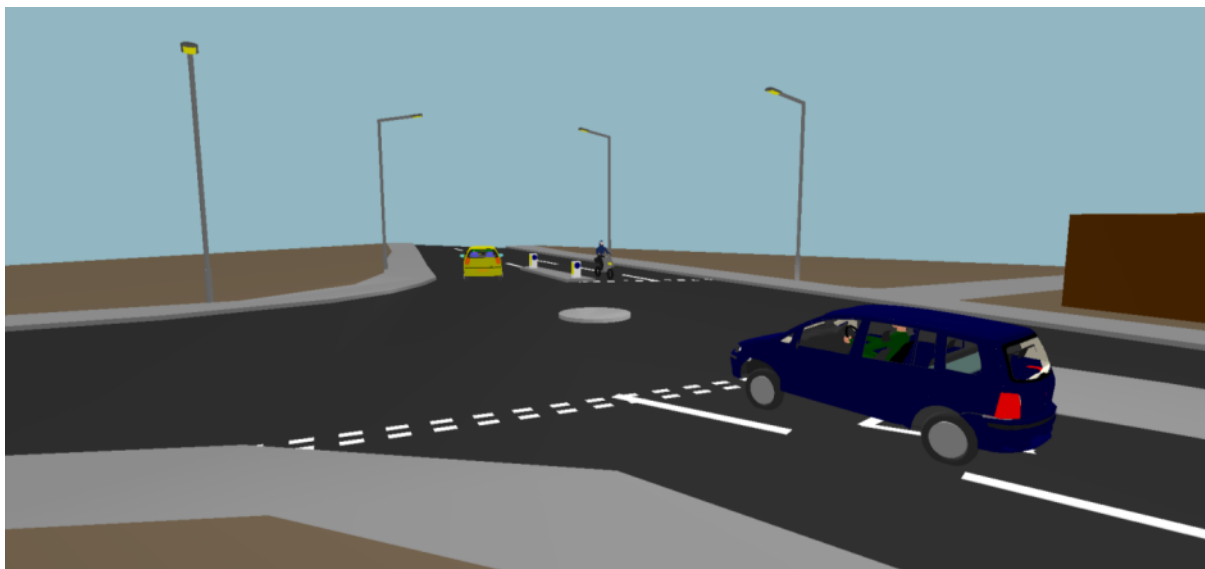
Figure 280. The roundabout layout showing the VW Touran and 99thile Dutch male driver

The relative positioning of the vehicles is shown in Figure 280 and Figure 281 below.

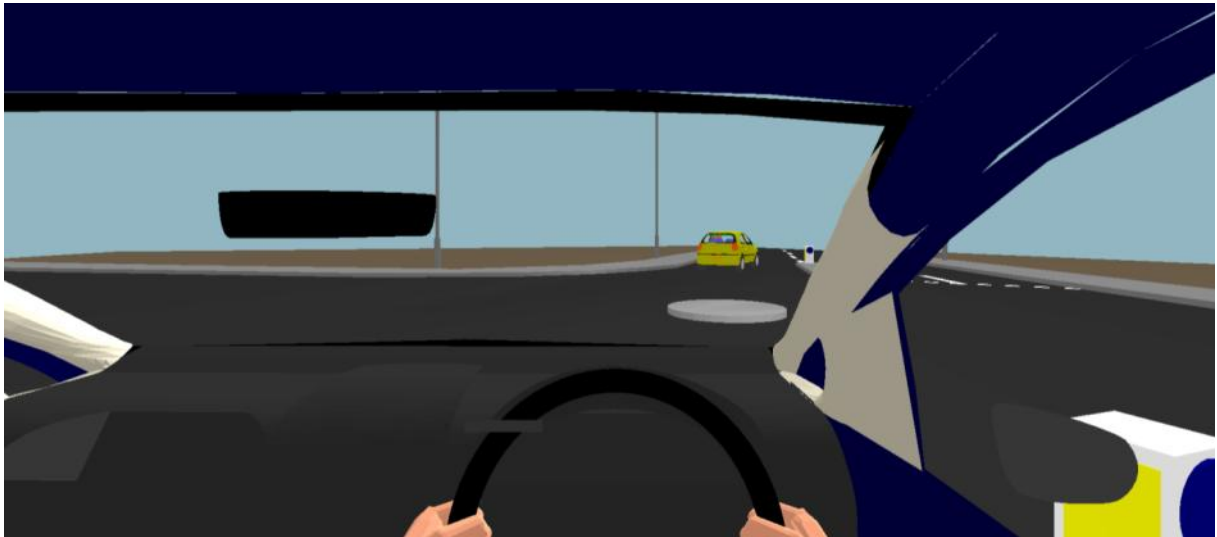
Figure 282. The view of the Dutch male driver

Figure 282, shows that in this position the scooter and its rider are completely obscured by the A-pillar of the M₁ vehicle. The driver is looking to essentially follow the yellow Fiat Punto off the roundabout. The A-pillar is physically larger than that of the Golf, though the colour of the interior trim does make the visual effect greater.

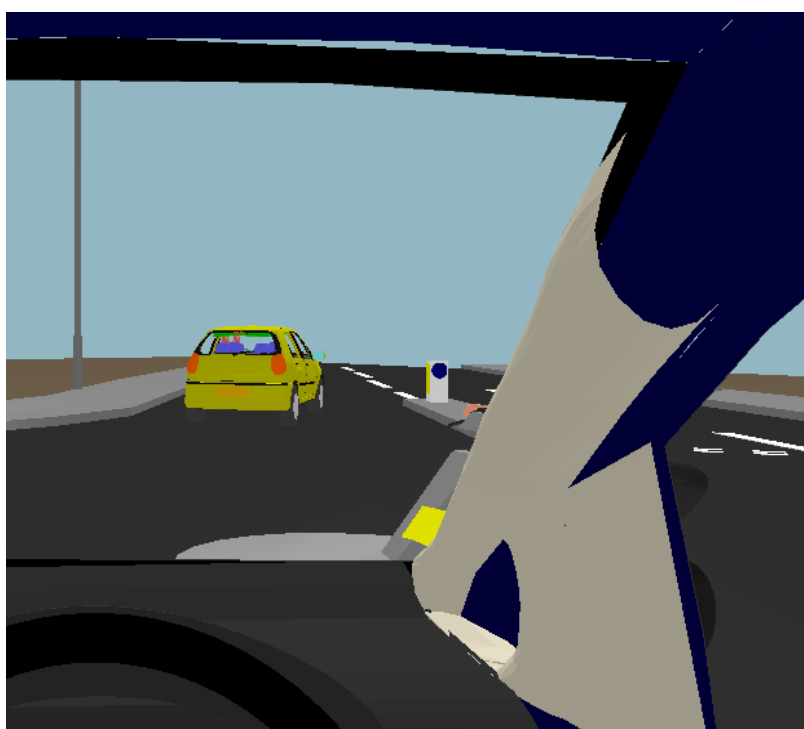
Figure 286. The scooter can effectively travel the whole distance until the point of impact obscured by the M₁ A-pillar – driver's view at point of impact

Figure 284, Figure 285 and Figure 286 show that the scooter could travel down the 'corridor' blind spot caused by the offside (right) A-pillar and thus remain obscured whilst the driver of the M₁ vehicle performs their observations prior to setting off. The size of the blind spot is comparable with the Golf for the same size of driver.

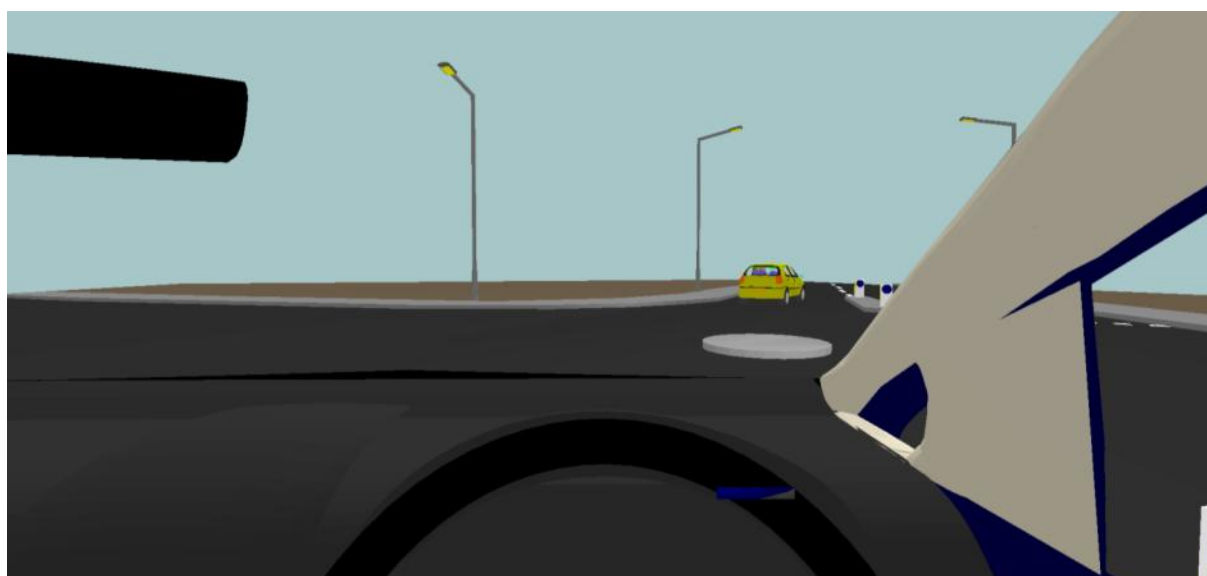
Figure 288. The view of the UK female driver

Again with the correct positioning of the M₁ vehicle at the entrance to the roundabout (Figure 287) the scooter and its rider can be completely obscured by the A-pillar of the M₁ vehicle. Here the proximity of the driver's eye point to the A-pillar, and its greater size, makes it a significant obscuration within the driver's field of view (Figure 288). To provide the obscuration the car has to be positioned pointed more to its left, relative to the position for the Dutch male driver, to provide the obscuration. However, it is still possible for the driver to 'look around' the obscuration (Figure 289).

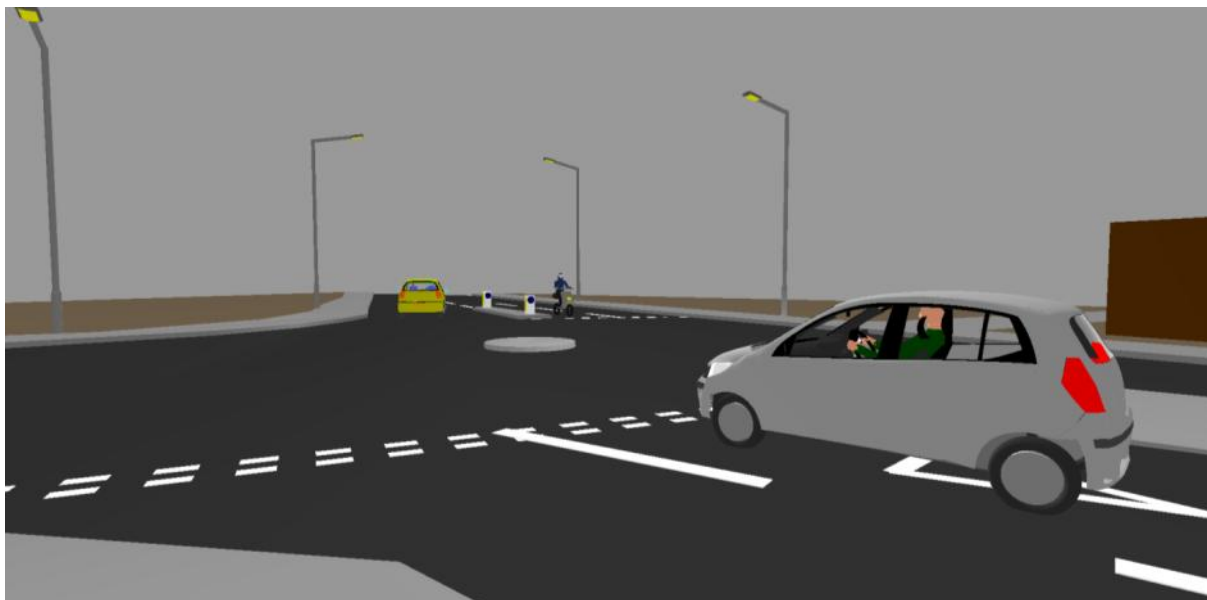
Figure 294. The roundabout layout showing the Hyundai i10 and 99%ile Dutch male driver

The relative positioning of the vehicles is shown in Figure 294 and Figure 295 below.

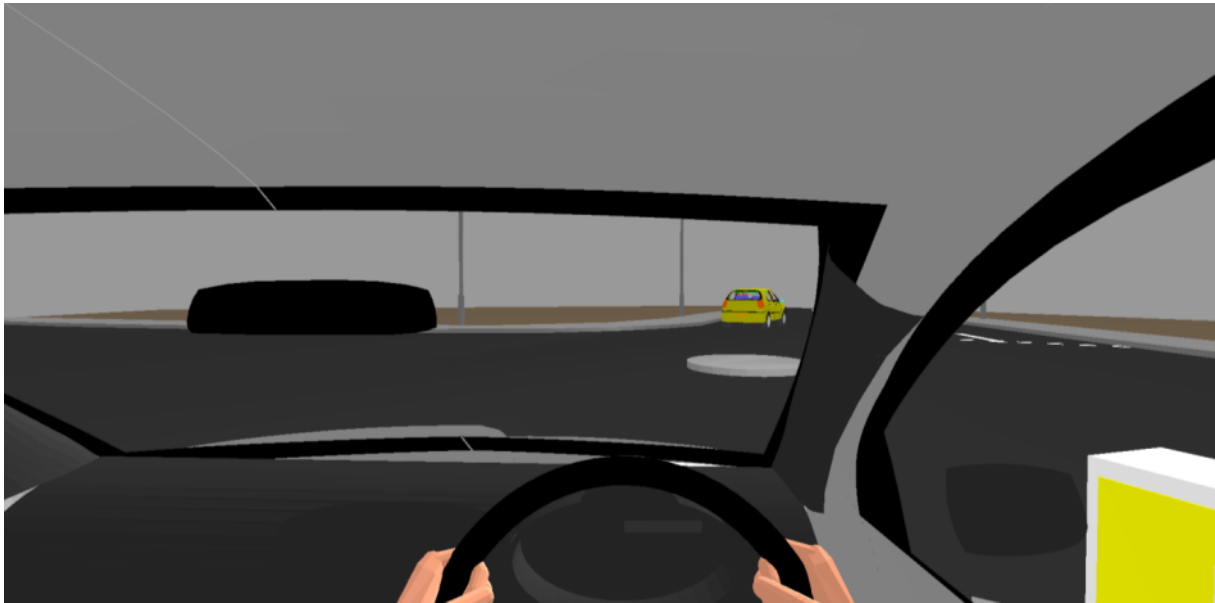
Figure 296. The view of the Dutch male driver

Figure 296 shows that in this position the scooter and its rider are completely obscured by the A-pillar of the M₁ vehicle. However, it is still possible for the driver to 'look around' the obscuration (Figure 297).

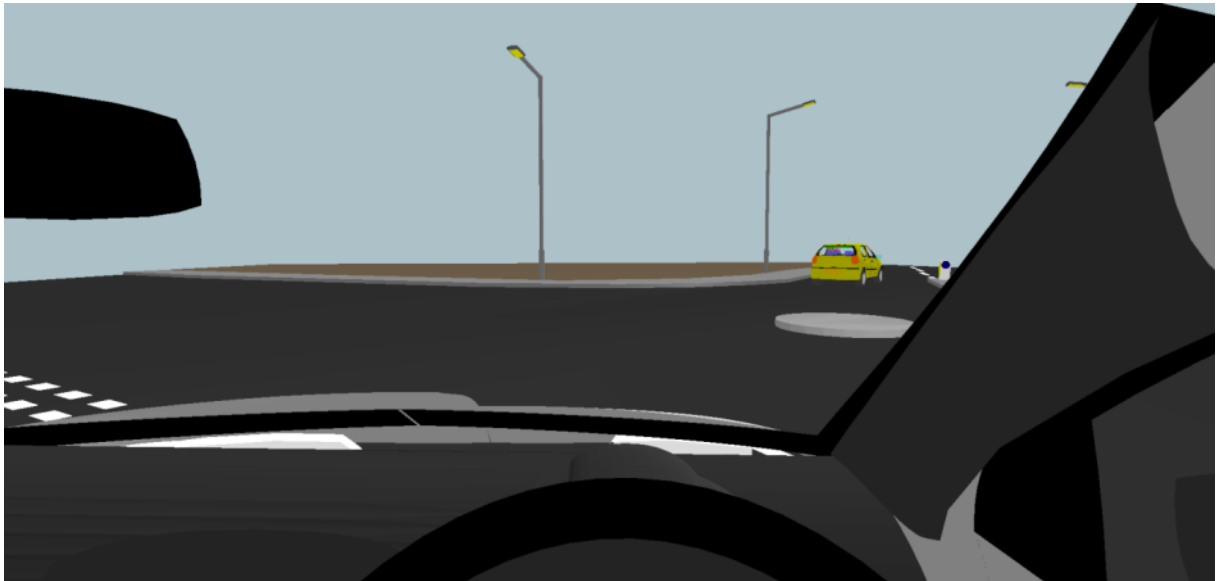
Figure 302. The view of the UK female driver

With the correct positioning of the M₁ vehicle at the entrance to the roundabout (Figure 301) the scooter and its rider can be completely obscured by the A-pillar of the M₁ vehicle (Figure 302). Here the proximity of the driver's eye point to the A-pillar and its greater size makes it a significant obscuration within the driver's field of view. As with the other M₁ vehicles the car has to be positioned pointed more to its left, relative to the position for the Dutch male driver, to provide the obscuration.

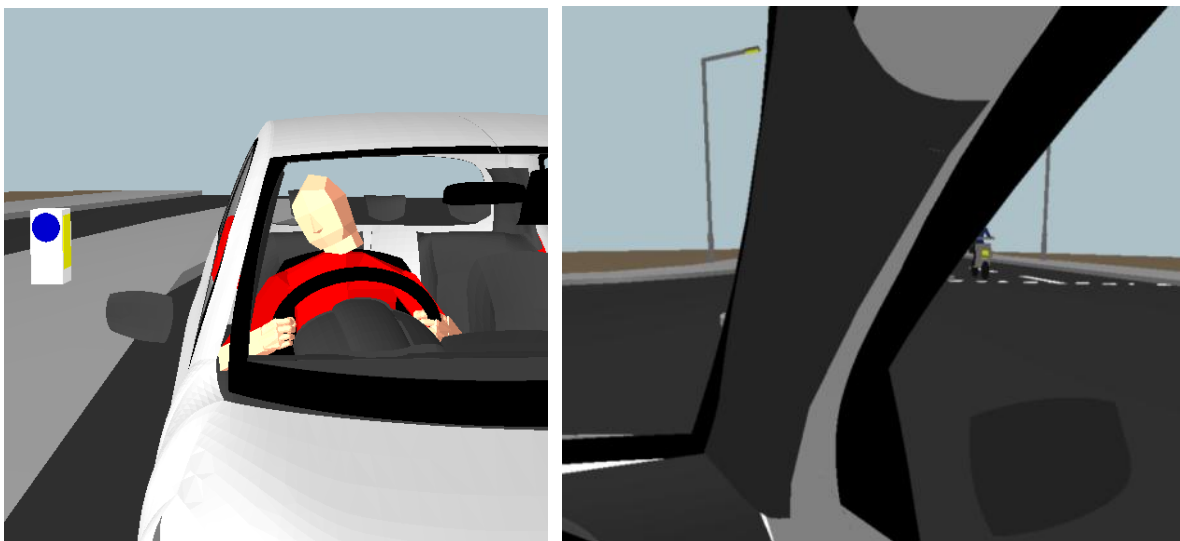
Figure 304. The scooter can be seen if the driver leans their head (to the right)

As with all vehicles in this scenario, if the driver is aware of the blind spot it is possible to 'look around' the obstacle by tilting the head to the side. However due to the significance of the obscuration the posture to 'look around' the A-pillar is not a simple glance to the side but requires a very deliberate lean of the head or lean forward of the torso to either side (Figure 303 and Figure 304).

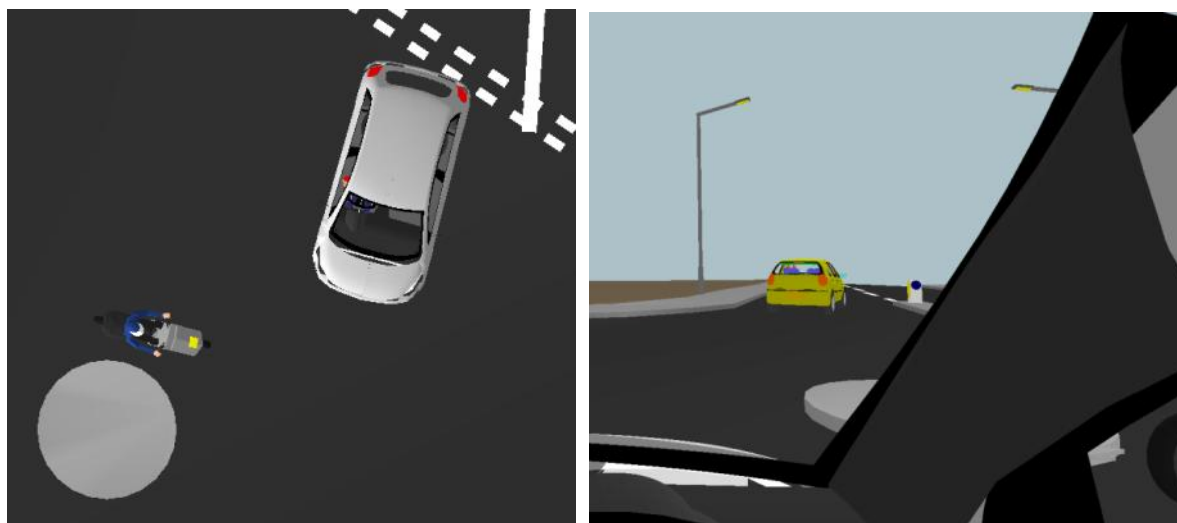
Figure 307. The scooter can effectively travel the whole distance until the point of impact obscured by the M_1 A-pillar

Figure 305 and Figure 306 show that the scooter, and indeed the whole opposite entrance to the roundabout, could be obscured by the A-pillar. The size of the blind spot is the largest seen in these evaluations. The result of this blind spot is that the scooter could get all the way to the impact point without being seen by the driver of the M_1 vehicle (Figure 307).

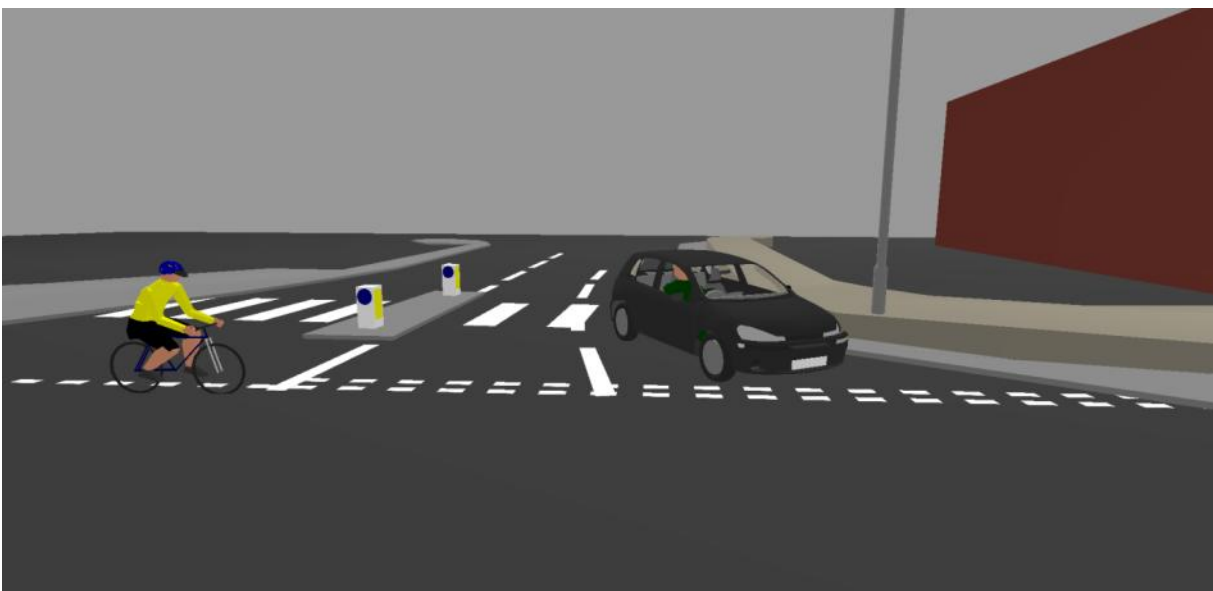
Figure 315. The T-Junction layout showing the VW Golf and 99%ile Dutch male driver

The relative positioning of the vehicles is shown in Figure 315 and Figure 316 below.

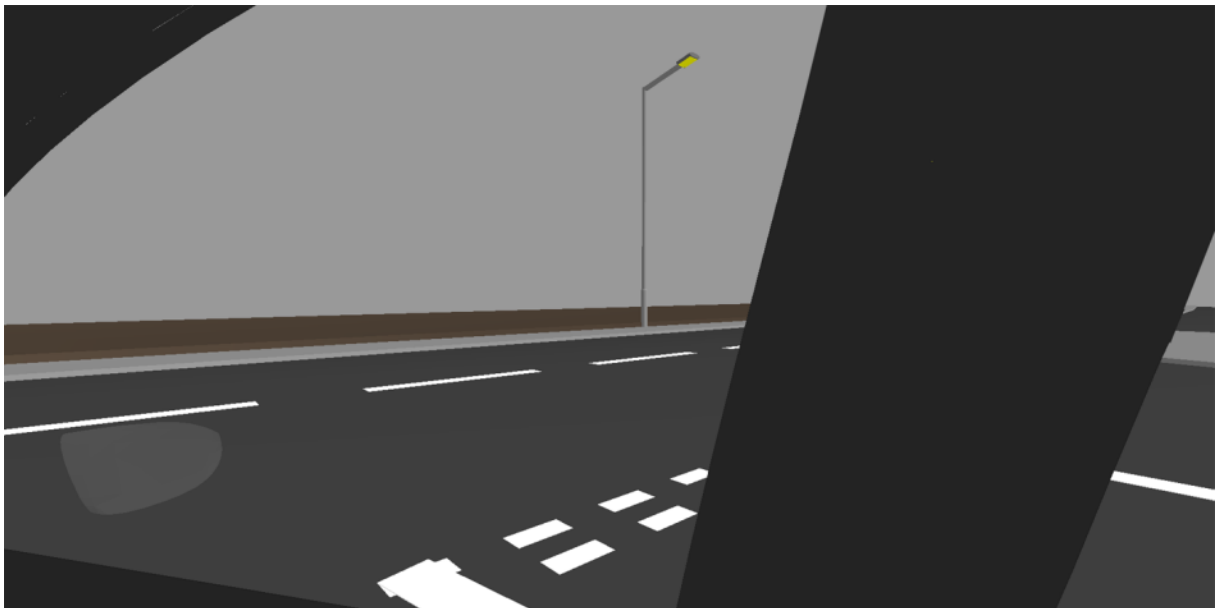
Figure 317. The view of the Dutch male driver

Figure 317 shows that in this position the cyclist is completely obscured by the B-pillar of the M₁ vehicle. The driver is looking to the right to check the coast is clear prior to pulling off.

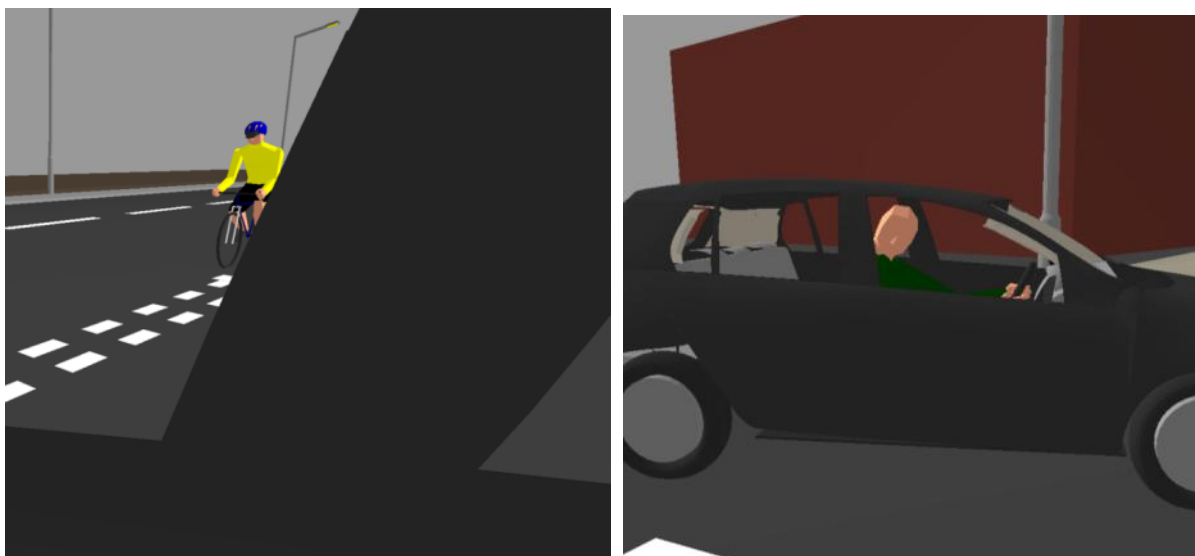
Figure 318. The cyclist can be seen if the driver leans their head

Figure 318 above shows that whilst the B-pillar obscuration does mask the cyclist, it is possible for the driver to 'look around' the obscuration if the driver is aware of the blind spot.

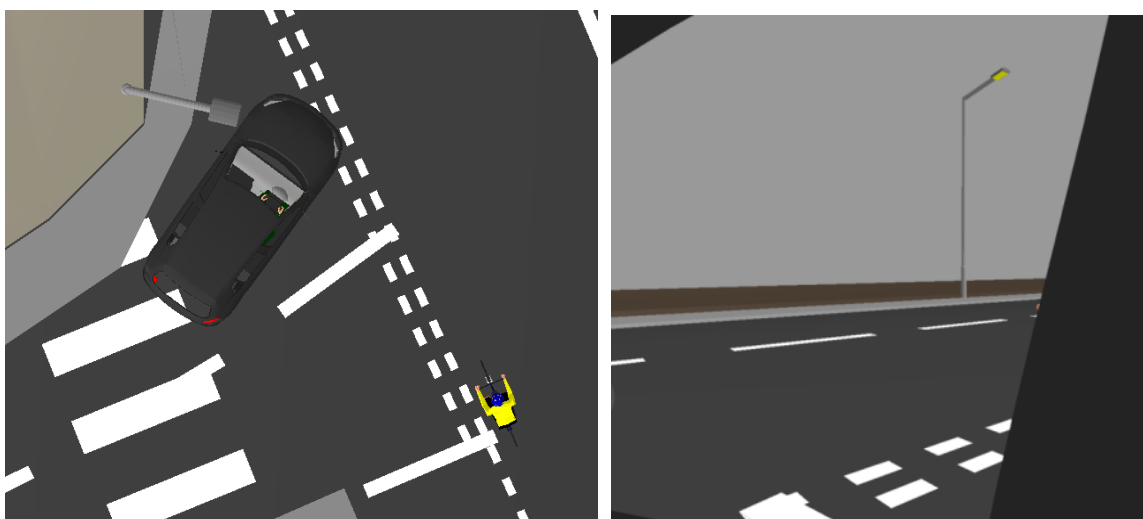
Figure 320. The cyclist can get within 4.5m of the M₁ whilst obscured by the B-pillar

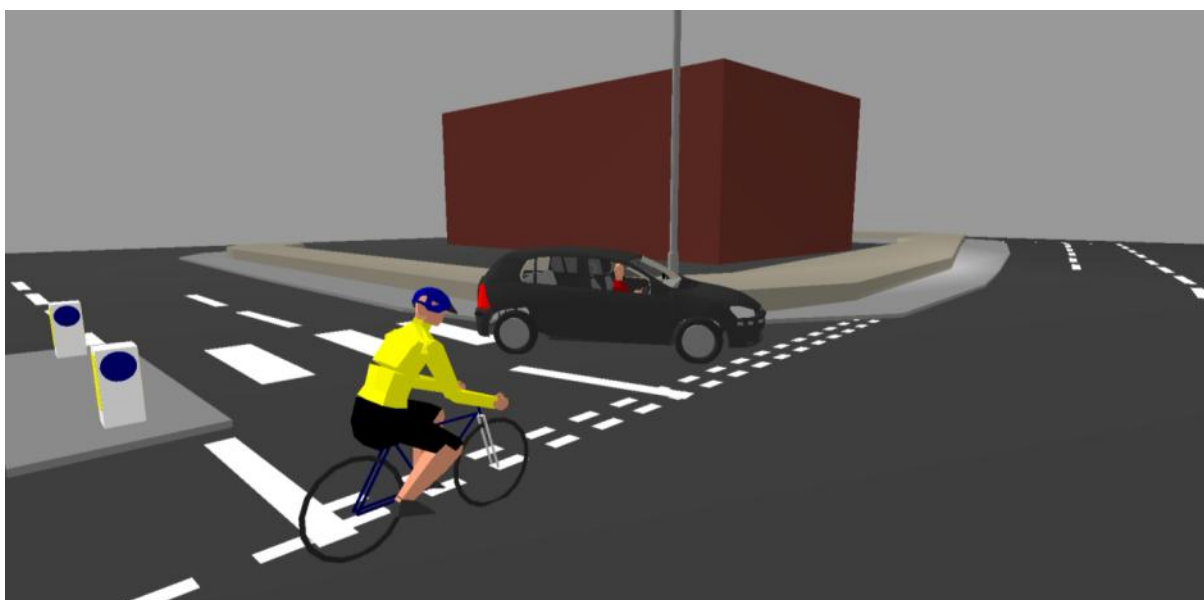
Figure 321. The T-Junction layout showing the VW Golf and 5%ile UK female driver

The relative positioning of the vehicles is shown in Figure 321 and Figure 322 below.
