The Development of Improvements to Drivers' Direct and Indirect Vision from Vehicles – Phase 2

For: Department for Transport
DfT TTS Project Ref: S0906 / V8

Prepared by: Loughborough Design
School, Loughborough University
and MIRA Limited

Date: March 2011

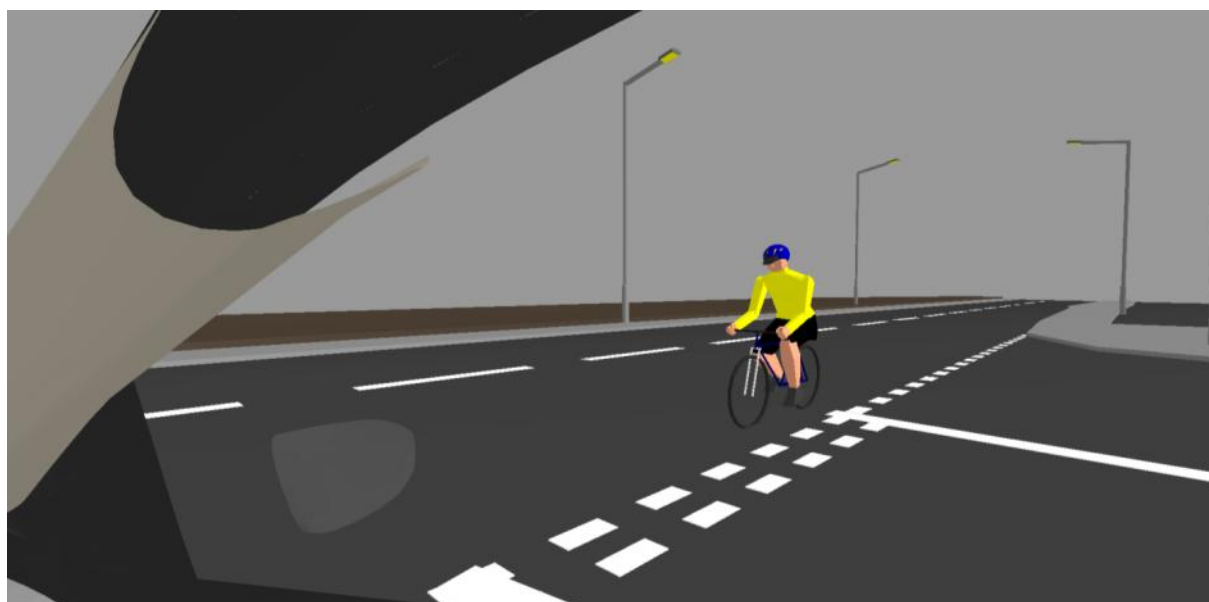
Figure 323. The view of the UK female driver

Figure 323 and Figure 324 show that in this position the cyclist is completely visible through the offside (right) front window. Due to the driver's eye point being further forwards in the vehicle in comparison to the Dutch male, the B-pillar is relatively rearward of the eye point and thus its obscuration does not affect this scenario setup. There is a clear view of the road for a considerable distance.

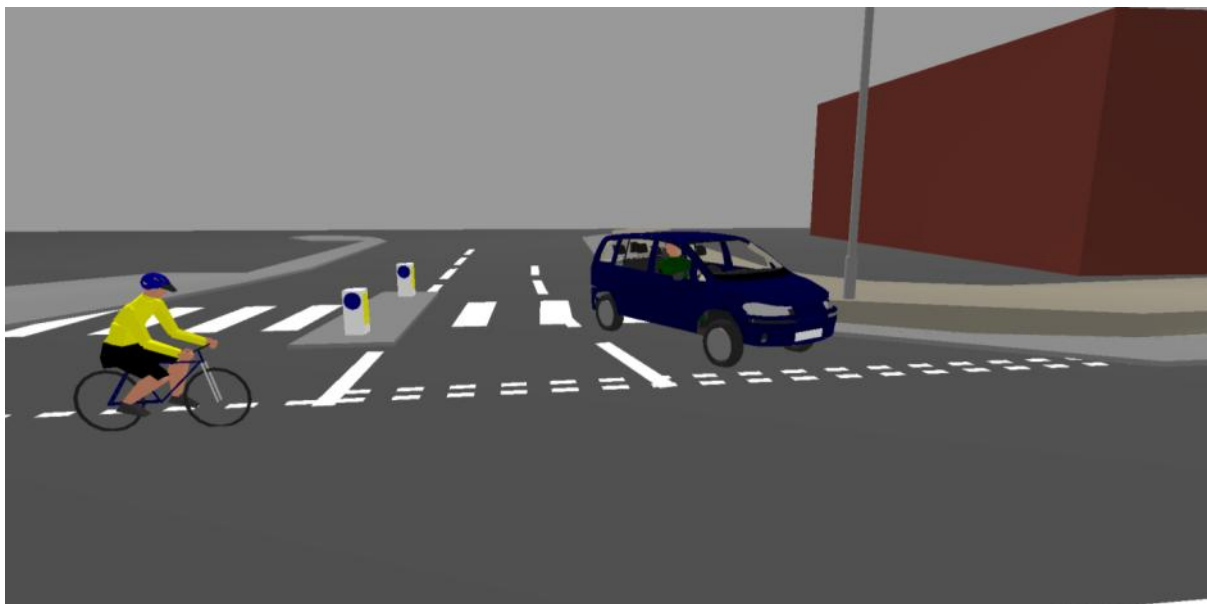
Figure 326. The T-Junction layout showing the VW Touran and 99thile Dutch male driver

The relative positioning of the vehicles is shown in Figure 326 and Figure 327 below.

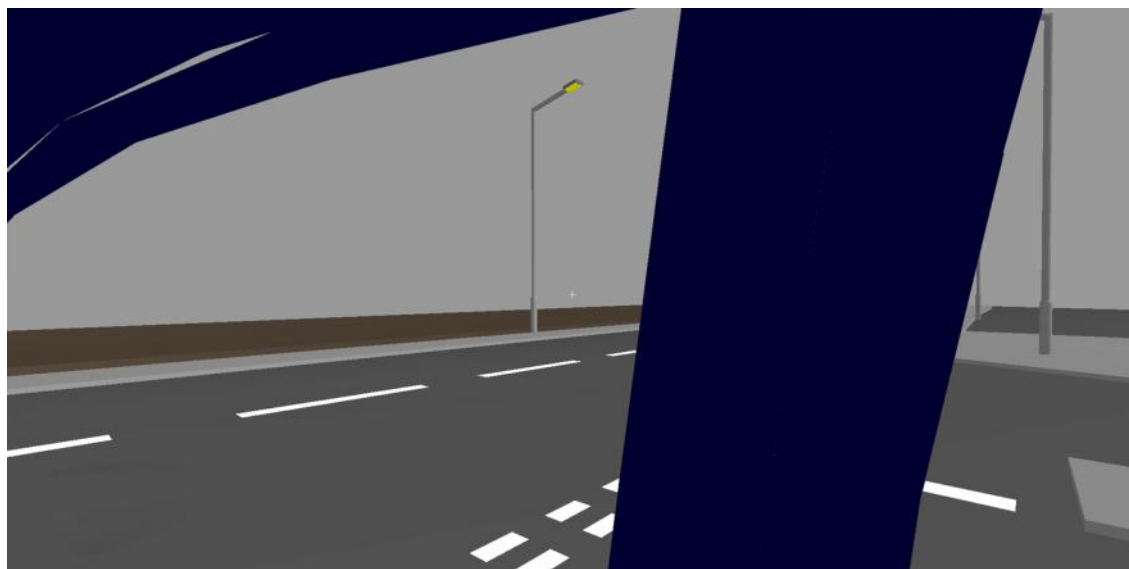
Figure 328. The view of the Dutch male driver

Figure 328 shows that in this position the cyclist is again completely obscured by the B-pillar of the M₁ vehicle.

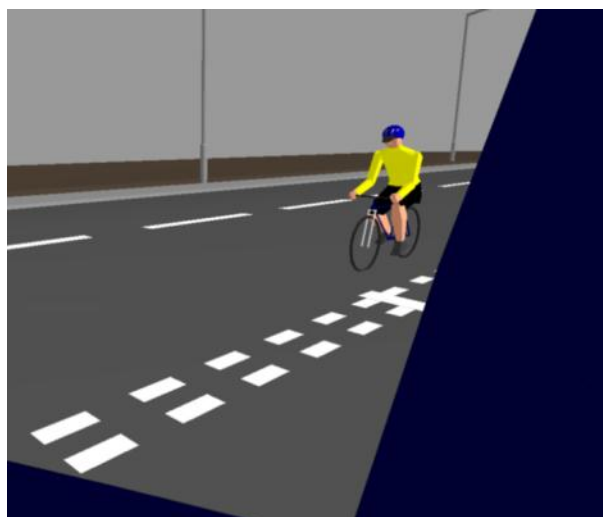
Figure 329. The cyclist can be seen if the driver leans their head

If the driver fails to look around the obscuration (Figure 329), it is possible for the cyclist to get to within 4.5m of the M₁ vehicle whilst still being within the blind spot caused by the B-pillar (Figure 330 and Figure 331). At 4.5m from the front of the M₁ vehicle (the same as for the Golf) and travelling at a relatively modest 14mph they could cover this distance in 0.719s. It is clear the driver could look and not see the cyclist and then pull out in front of the oncoming cyclist.

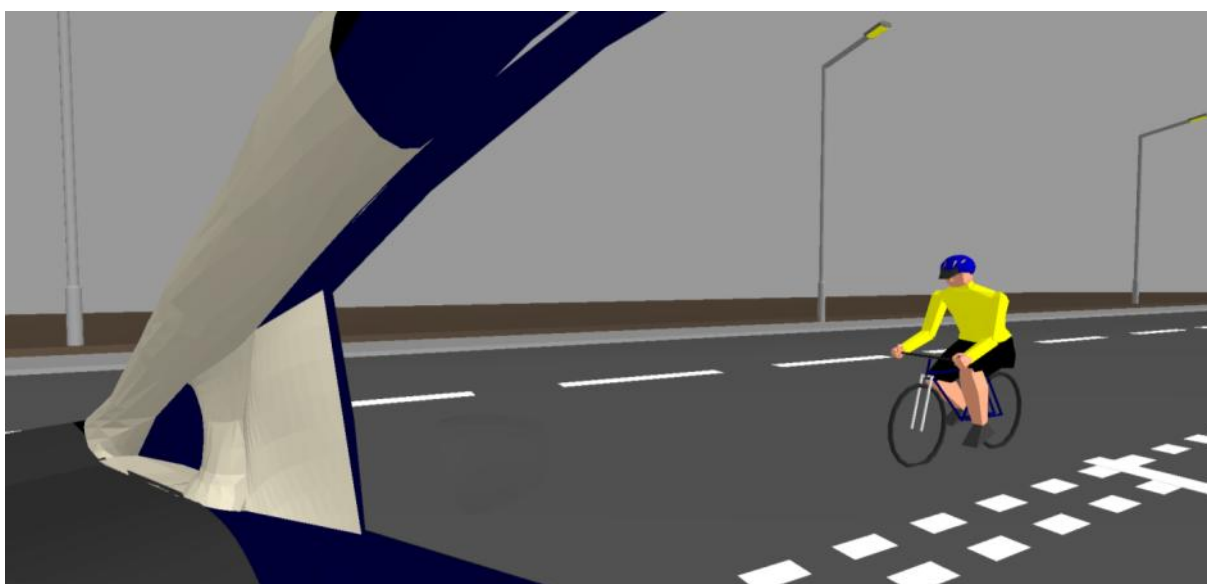
Figure 334. The view of the UK female driver

Figure 334 and Figure 335 show that in this position the cyclist is completely visible through the offside (right) front window. Due to the driver's eye point being further forwards in the vehicle in comparison to the Dutch male, the B-pillar is relatively rearward of the eye point and thus its obscuration does not affect this scenario setup.

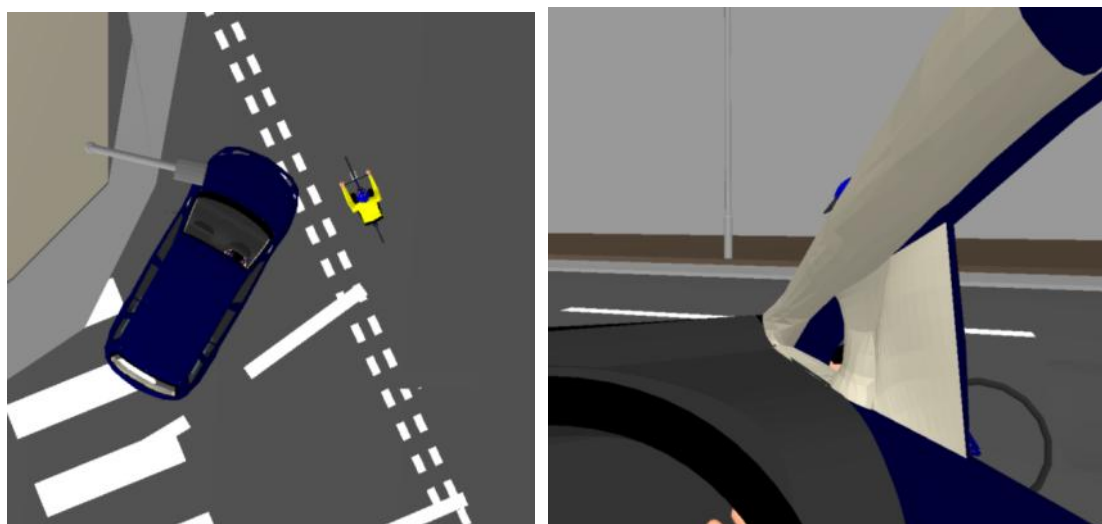
Figure 336. Evaluating the possibility of A-pillar obscuration for this scenario

Figure 336 evaluates whether the A-pillar could pose a sufficient obscuration for the UK female driver in this scenario. The A-pillar does pose a more significant obscuration in comparison to the Golf but is still very unlikely to be the reason for the driver to have failed to see the cyclist.

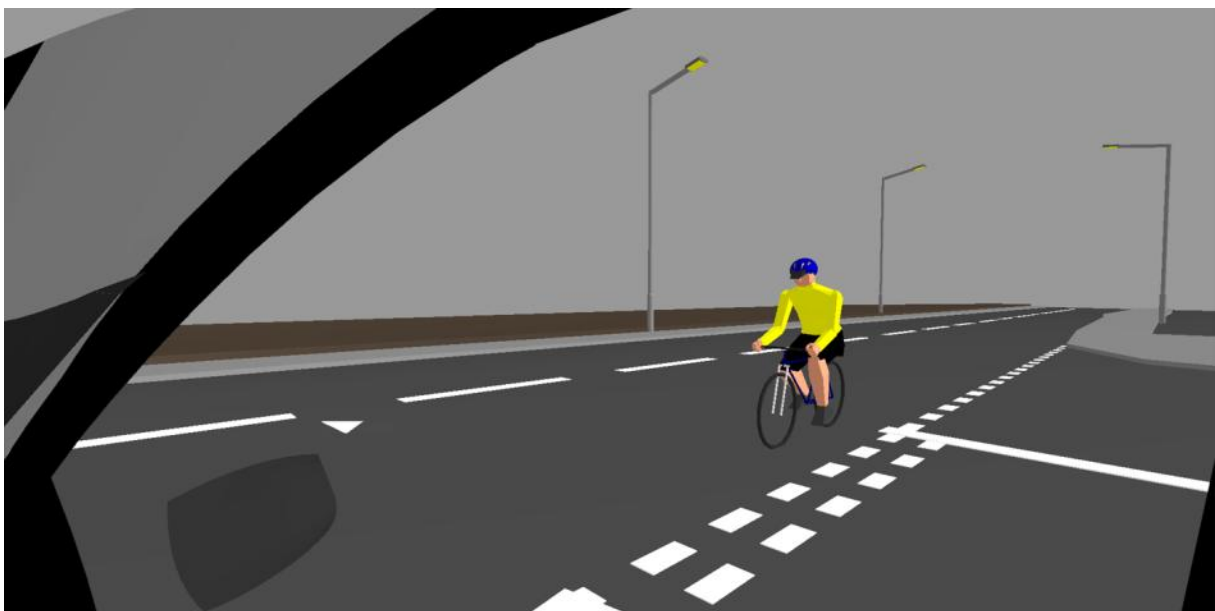
Figure 345. The view of the UK female driver

Figure 345 and Figure 346 show that in this position the cyclist is completely visible through the offside (right) front window.

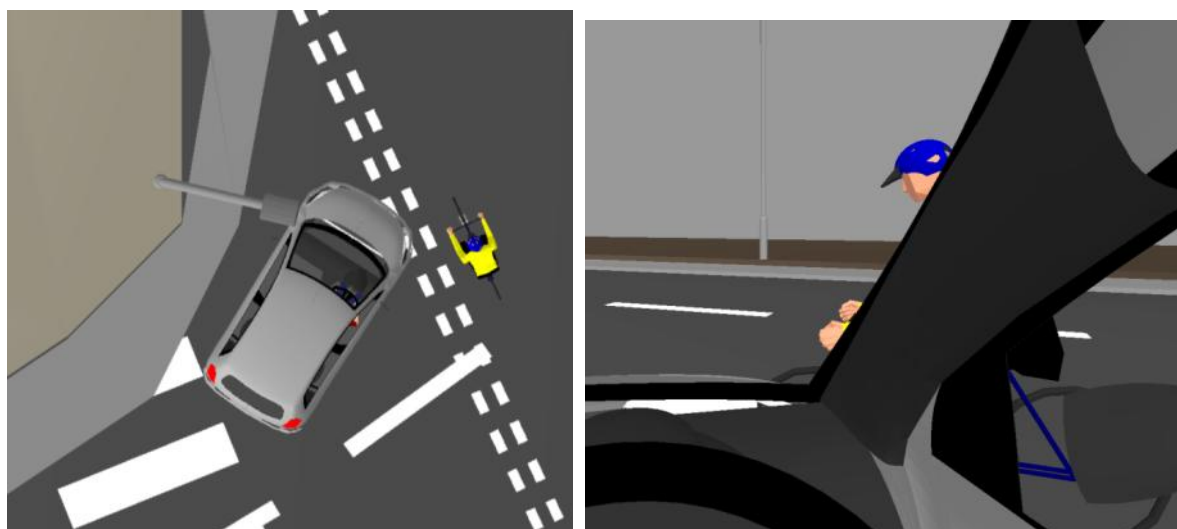
Figure 347. Evaluating the possibility of A-pillar obscuration for this scenario

As with the other M₁ vehicles it appears that the A-pillar is very unlikely to be the reason for the driver to have failed to see the cyclist (Figure 347).

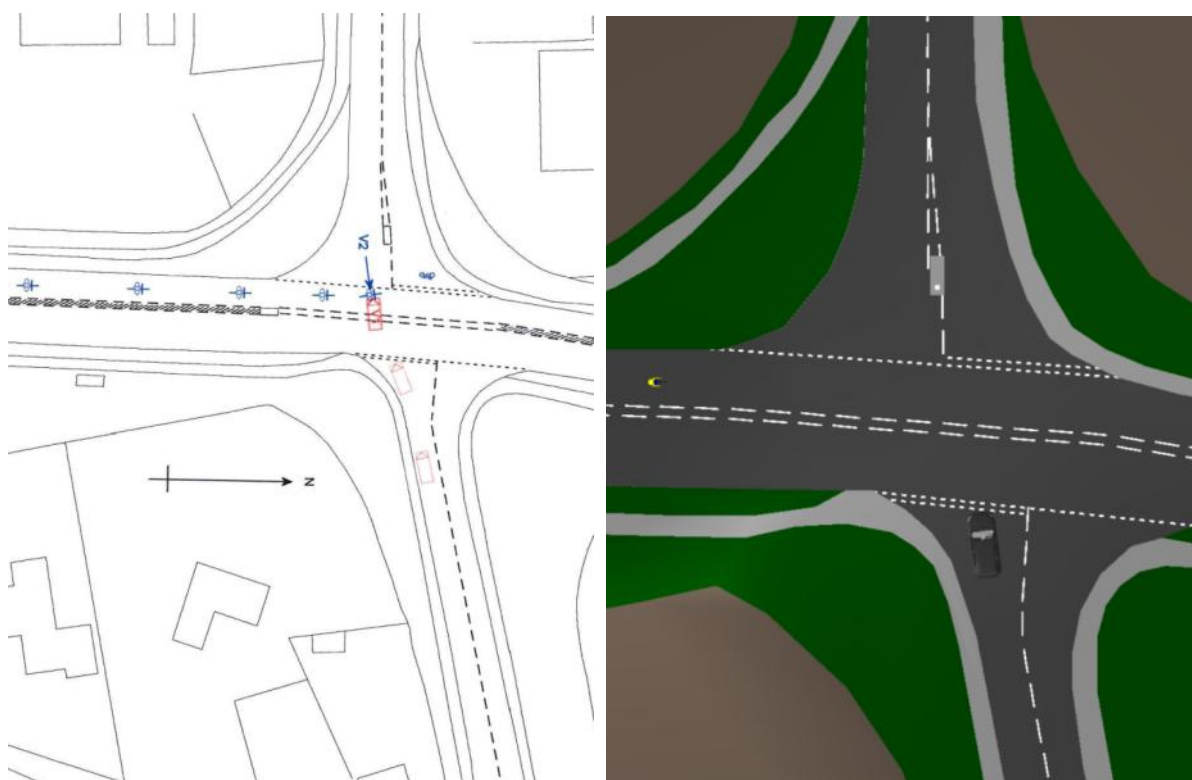
Figure 352. The road layout recreated from the OTS case report

The scenario was modelled using the map data provided in the OTS case report (Figure 352). The angle of the junction from the car park to the main road has the potential to cause difficulty for the category M_1 driver in terms of positioning for optimum visibility to the left of the vehicle to observe vehicles already on the main road travelling from left to right. The vehicle CAD model that represents P2V1 (a Pinarello Angliru pedal cycle) is positioned travelling along the main road from left to right across the path of the M_1 vehicle. P1V1 is positioned to travel across the crossroads bearing slightly left as the junction is offset.

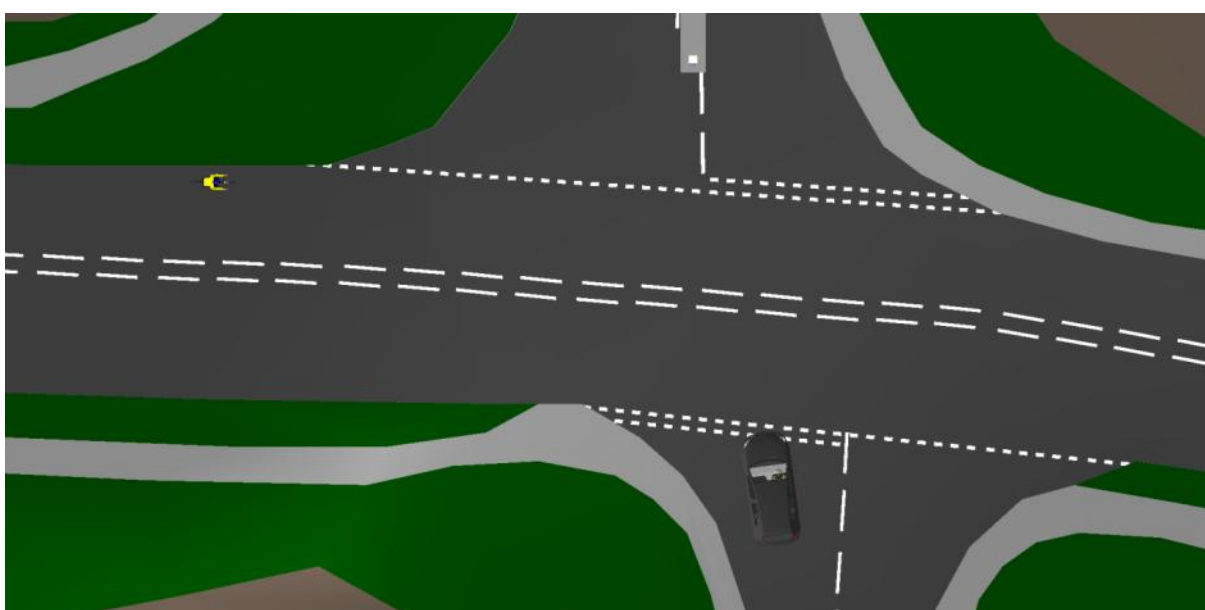
Figure 354. The vehicle positioning at the junction

The relative positioning of the vehicles is shown in Figure 353 and Figure 354 below.

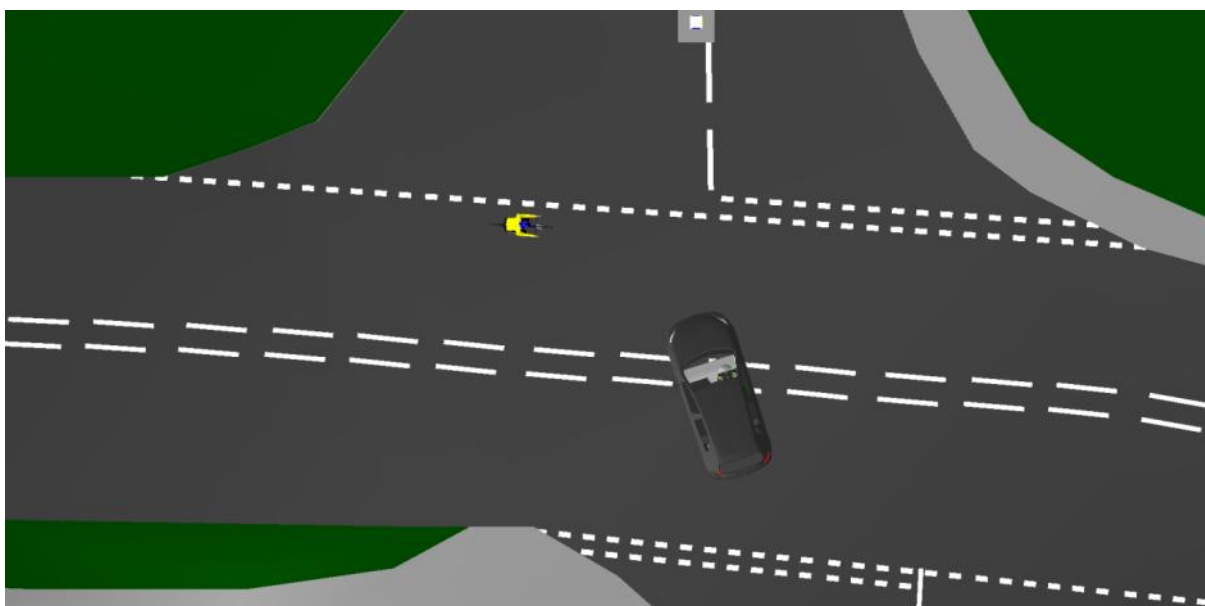
Figure 359. The advanced vehicle positioning at the junction

Figure 358, Figure 359 and Figure 360 show the unfolding of the scenario. As the blind spot is a relatively long way to the left of the M_1 vehicle the driver would be able to look and not see the cyclist, potentially look again to the right to check for traffic on the nearest carriageway, and then set off. However, in this time the cyclist will have moved forward down the carriageway and into the field of view of the M_1 driver. In addition, the cyclist will be able to see the M_1 vehicle set off and potentially be able to take avoiding action. If the M_1 vehicle set off at the point in which the cyclist was obscured by the blind spot the collision could occur if the cyclist could not stop in time.

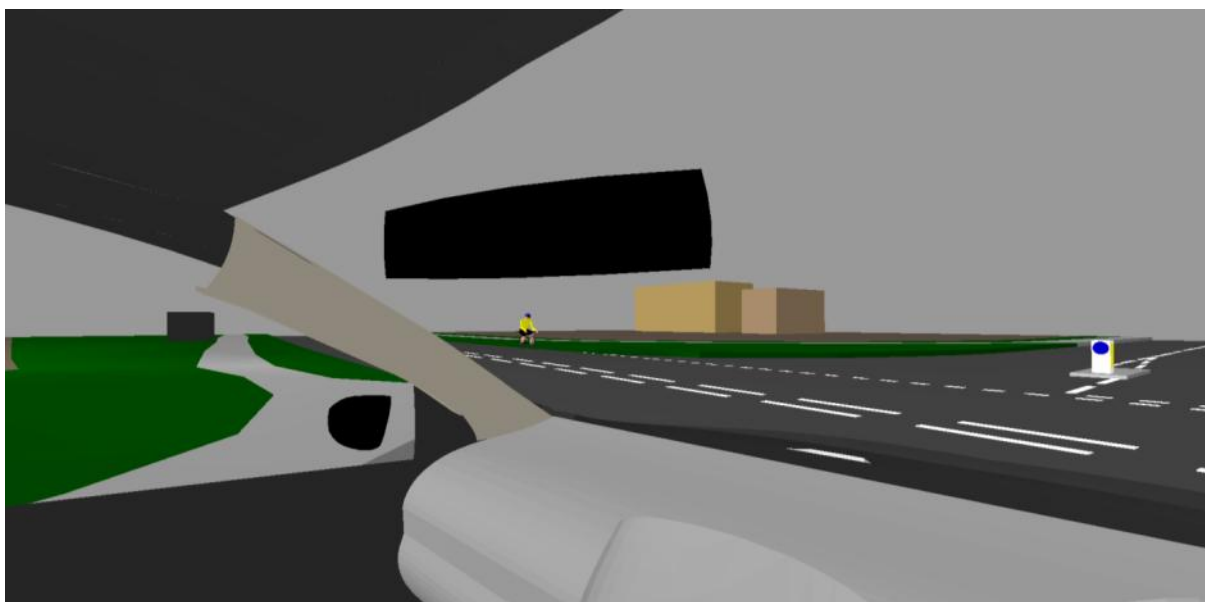
Figure 363. The view of the UK female driver

The relative positioning of the vehicles is shown in Figure 362 and Figure 363 below.

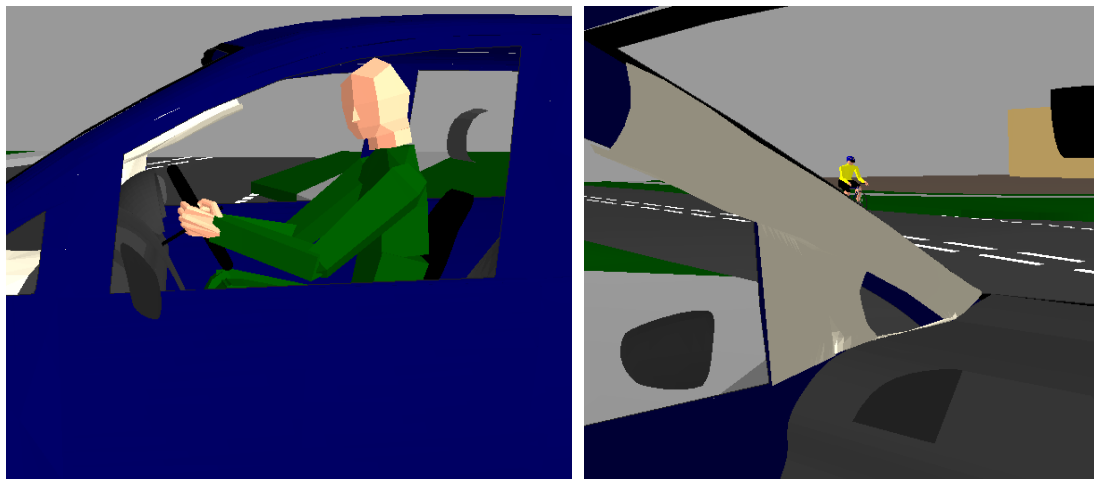
Figure 371. The cyclist can be seen if the driver leans their head forward

Figure 370 shows that in this position the cyclist is completely obscured by the nearside (left) A-pillar of the M₁ vehicle and that it is possible to look around the obscuration with a deliberate lean forwards (Figure 371).

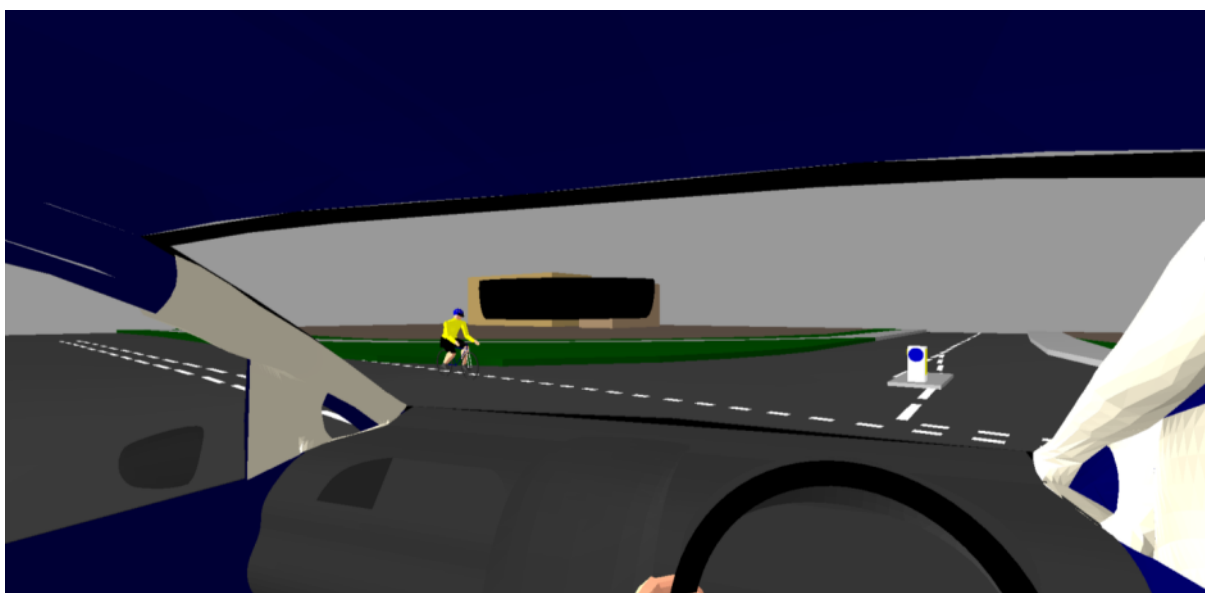
Figure 374. The cyclist needs to be a relatively long way to the left of the M₁ vehicle to stay hidden behind the A-pillar

The distances, positioning and relative fields of view are very similar to those observed for the Golf (Figure 373 and Figure 374). Thus from these evaluations it is possible that the collision could occur but unlikely that A-pillar obscuration could be the only factor in this accident.

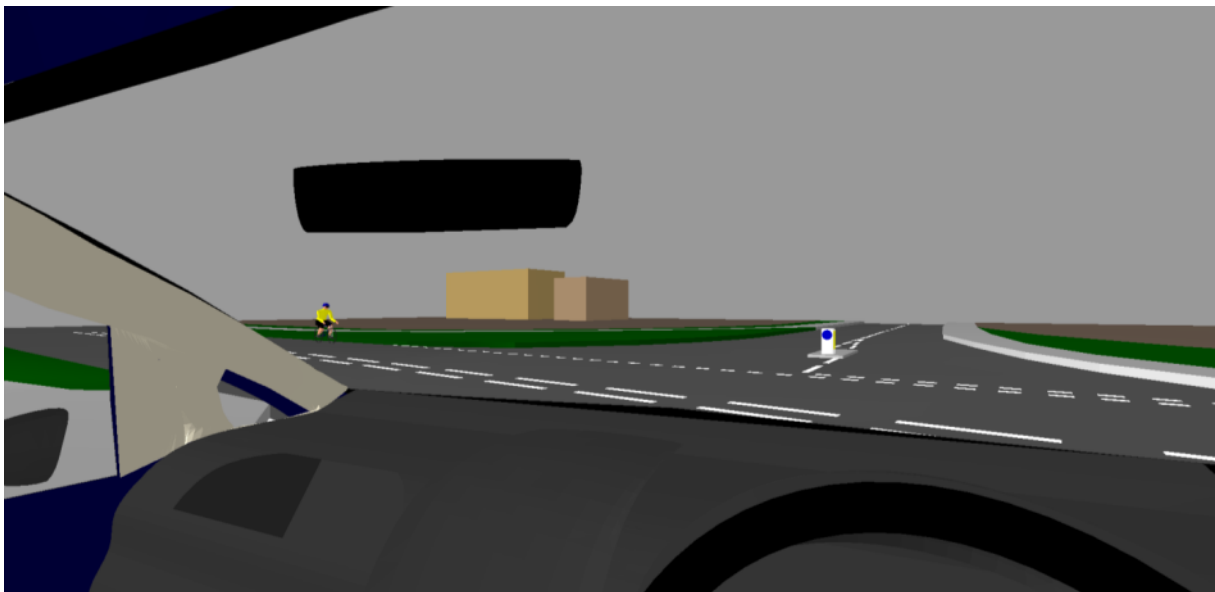
Figure 376. The view of the UK female driver

The relative positioning of the vehicles is shown in Figure 375 and Figure 376 below.

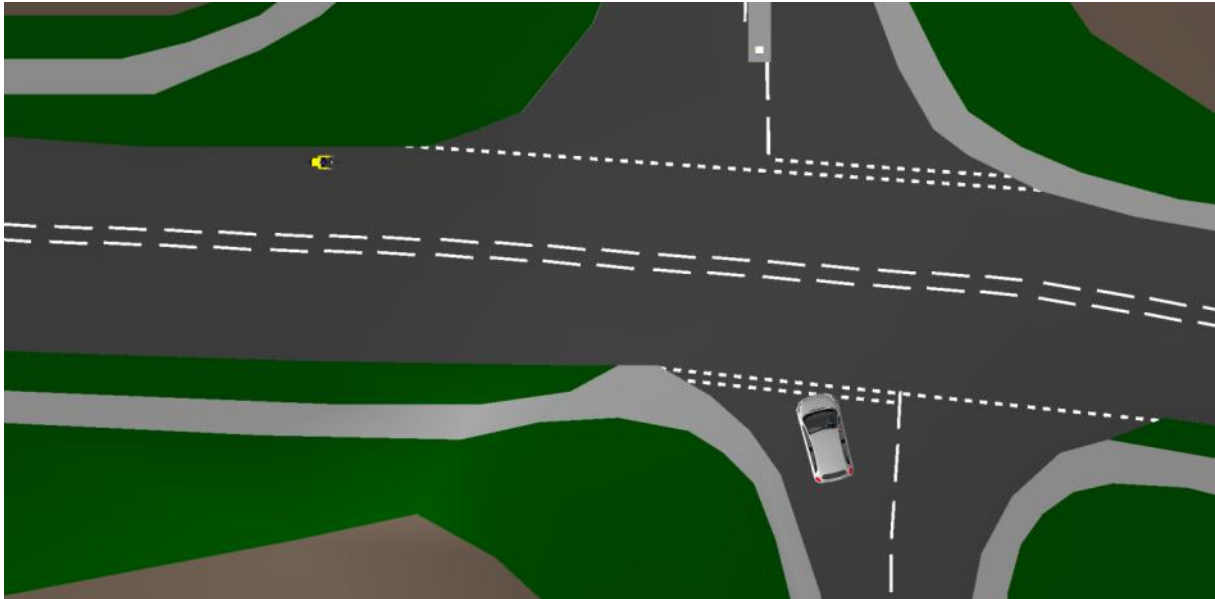
Figure 385. The vehicle positioning at the junction

The relative positioning of the vehicles is shown in Figure 385 and Figure 386 below.

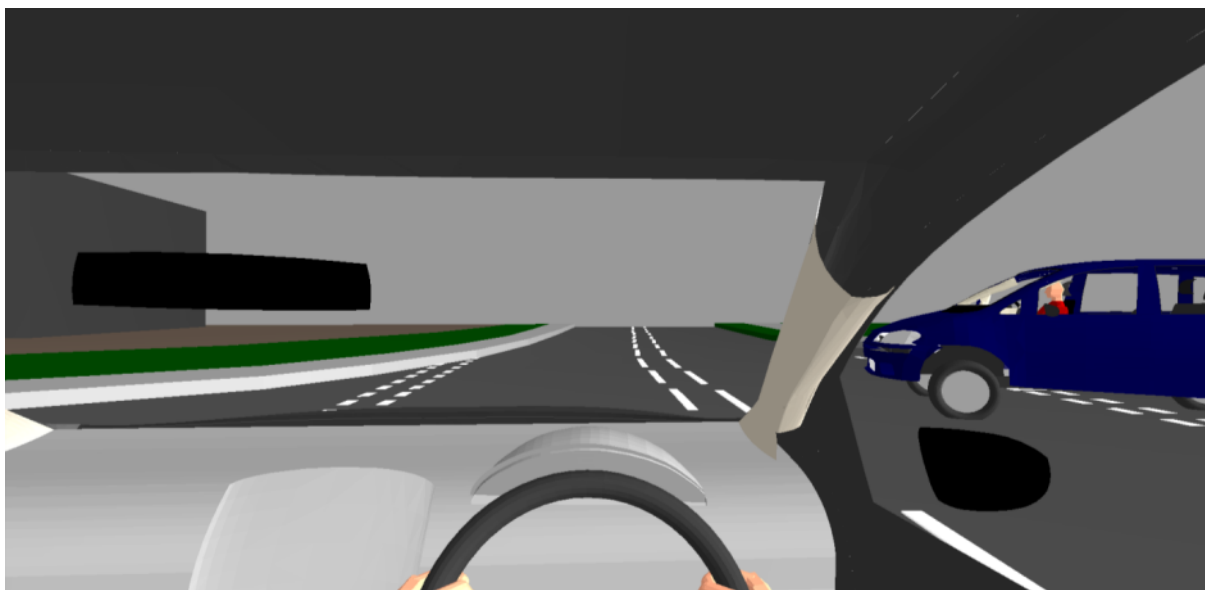
Figure 396. The field of view of the driver of the second vehicle clearly shows the M₁ vehicle pulling out but at speed they might have insufficient time to react and avoid an accident

The driver of the second M₁ vehicle would be able to see the first M₁ vehicle pull out but at national speed limits would find it difficult to stop in time to avoid the accident (Figure 396). The blind spot obscures the second M₁ vehicle from the first M₁ at a distance of 15m from the potential point of impact at 30mph this would be covered in 1.11s, at 40 in 0.83s, and at 60 in 0.55s, leaving very little reaction time for the driver.

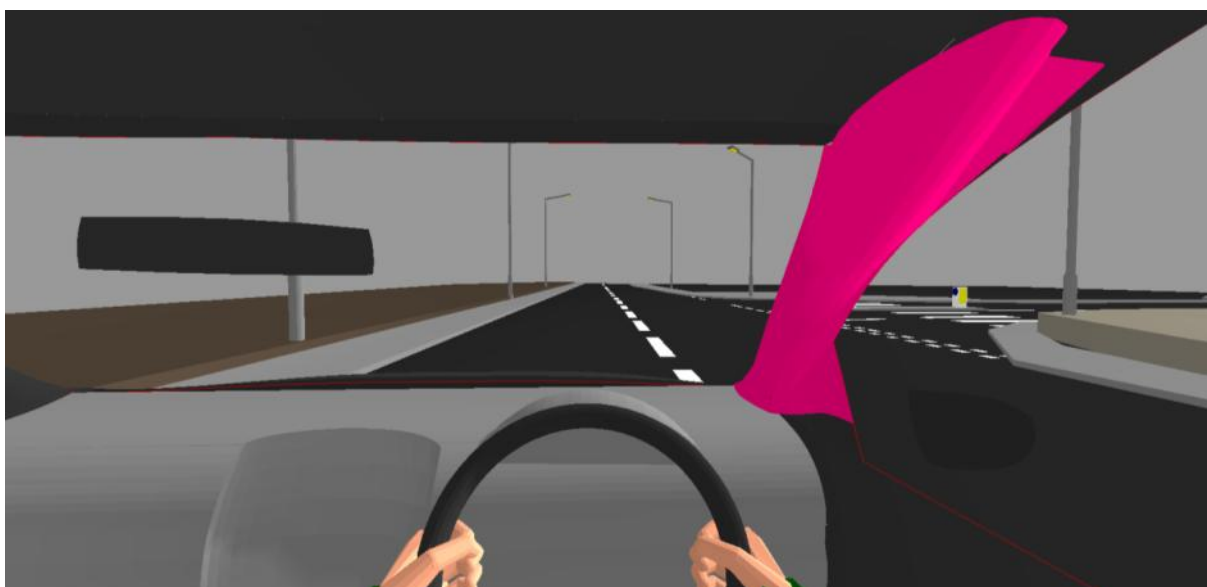
Figure 398. The monocular view of the Dutch Male driver

Figure 397 shows the evaluative setup of a 99th %ile Dutch male driver in the Volkswagen Golf M₁ vehicle positioned relative to a cyclist approaching from the opposite direction. At this point the cyclist is completely obscured from the driver when using monocular vision from the 'mean' eye point (Figure 398 and Figure 399).

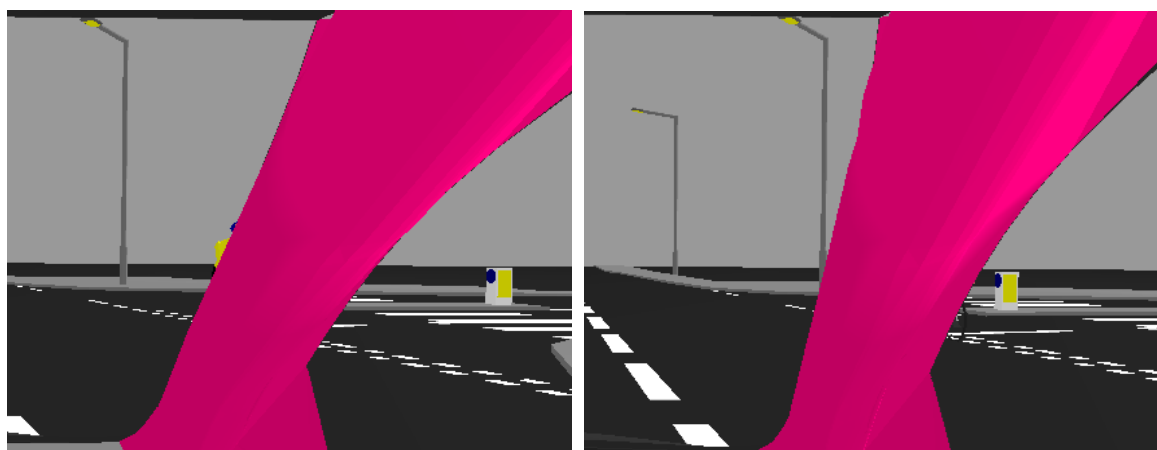
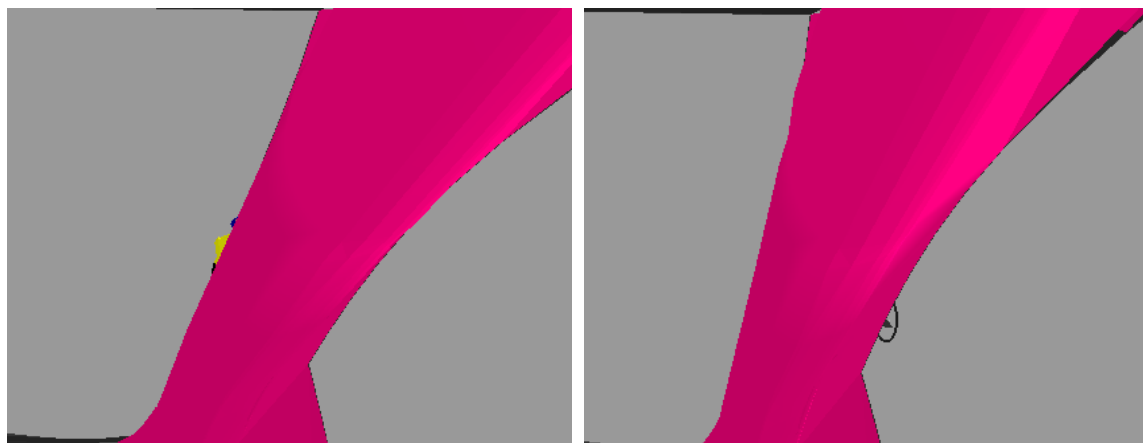
Figure 400. Left and Right eye views respectively

Figure 401. Left and Right eye views respectively

The monocular vision from the left and right eyes respectively (Figure 400 and Figure 401) can then be combined to form the binocular image shown in Figure 402 and Figure 403. The images show that the cyclist, completely obscured in monocular vision for the Dutch male driver, becomes slightly visible in binocular vision, with the effective width of the A-pillar reduced substantially.

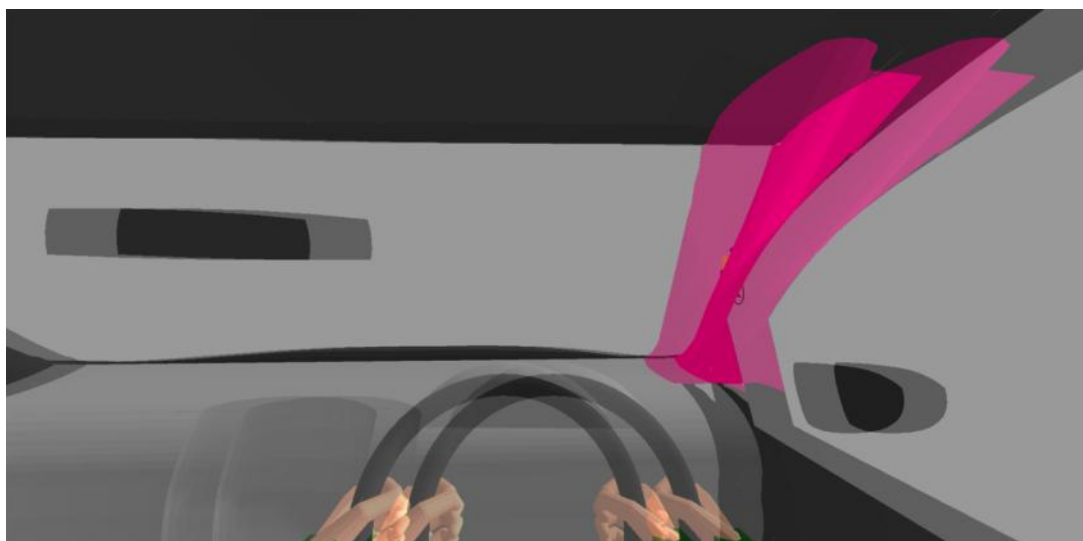
Figure 402. The binocular view of the Dutch Male driver

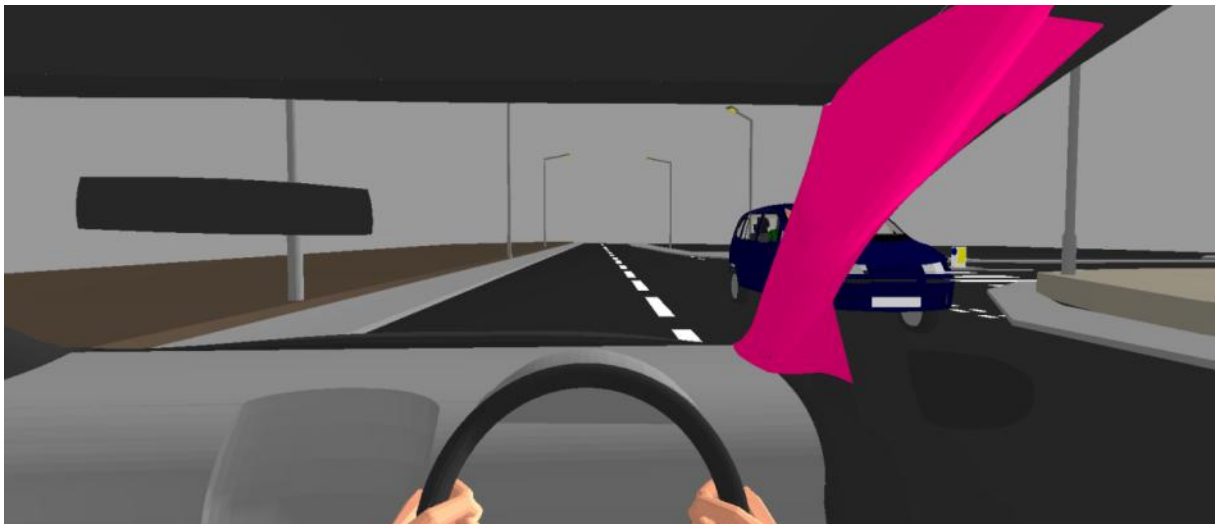
Figure 405. The monocular view of the Dutch Male driver

If the cycle is replaced with a larger target, in this case a second M_1 vehicle, shown in the scenario below (Figure 404, Figure 405 and Figure 406). It can be seen that the significant obscuration is reduced but binocular vision is insufficient to completely reveal the vehicle.

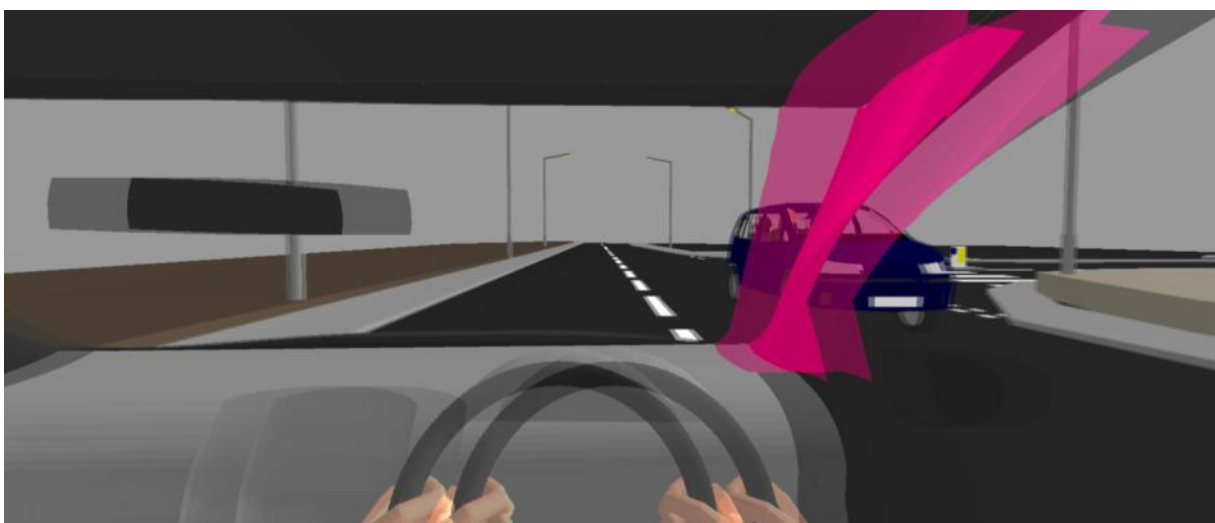
Figure 406. The binocular view of the Dutch Male driver

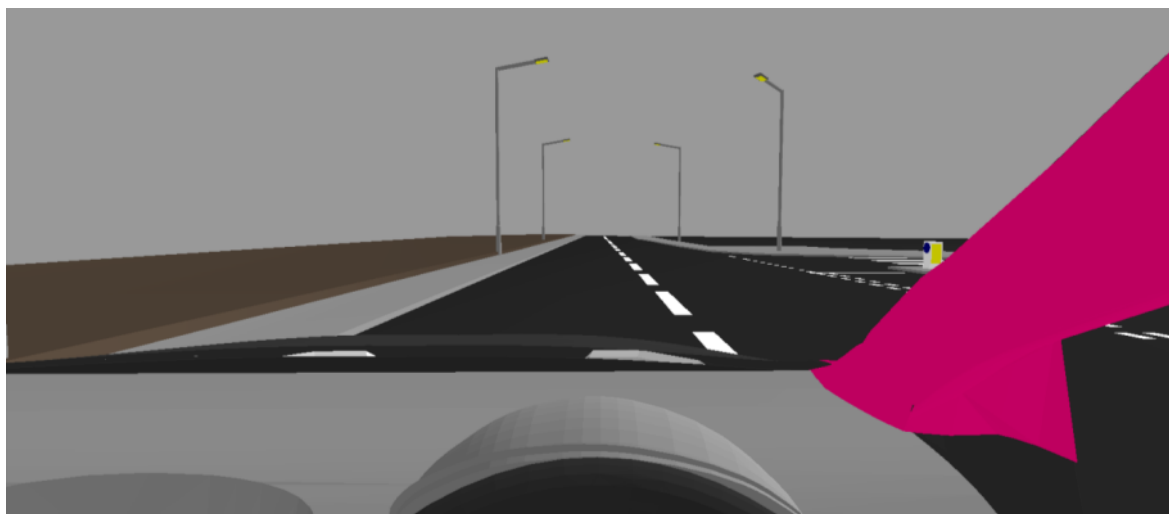
Figure 407. The monocular view of the UK female driver

Repeating the exercise with the UK female driver the effect is still evident but much reduced. Figure 407 and Figure 409 below show how the effective pillar size is reduced and the obscured cyclist becomes very slightly visible.

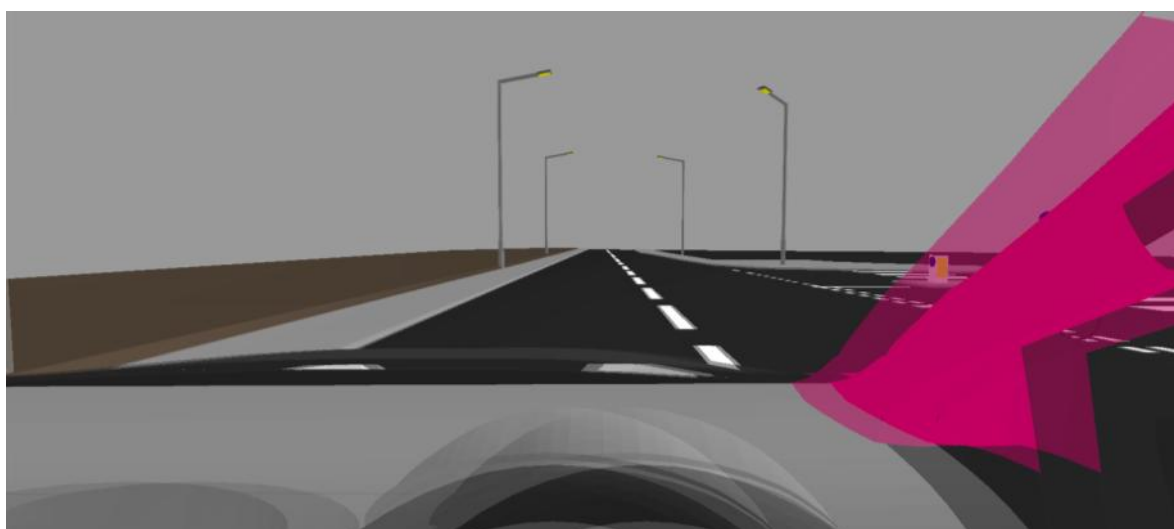
Figure 408. The binocular view of the UK female driver

Figure 397 to Figure 409, above show that a small visual target completely obscured by the A-pillar in monocular vision becomes partially visible with binocular vision. A larger target partially obscured becomes significantly less obscured with binocular vision. However, the pillar never fully disappears and the effect is markedly greater for eye points further from the A-pillar such as that for the 99%ile Dutch male. For smaller drivers, the A-pillar is a greater obscuration to vision and the effect of binocular vision is much reduced.

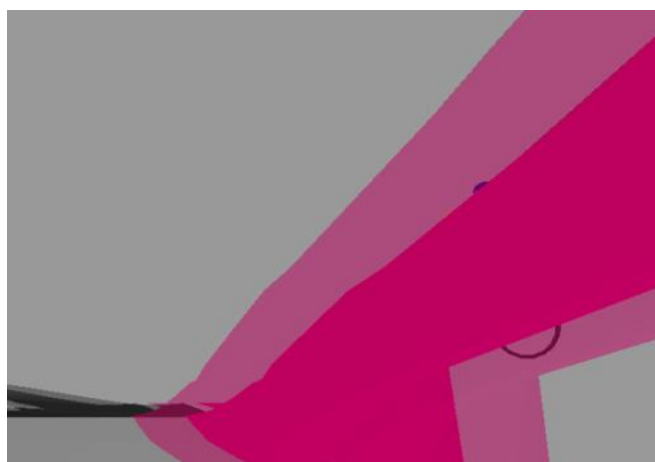
Figure 409. The binocular view of the UK female driver

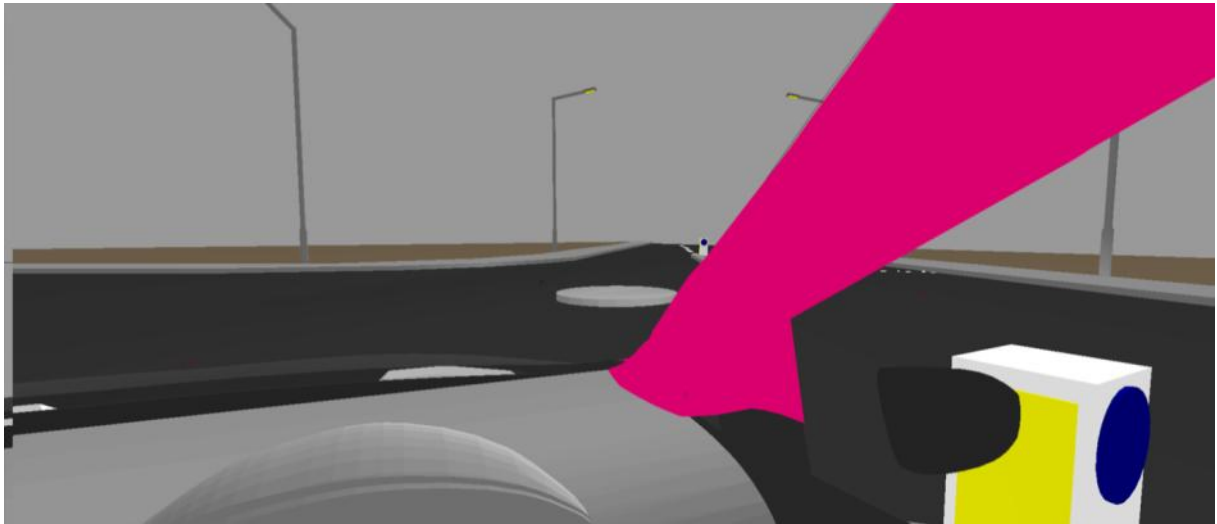
Figure 415. The view from the Golf with its original A-pillar size

Figure 415, Figure 416 and Figure 417 shown above show a visual comparison of reducing the A-pillar of the Volkswagen Golf from its current configuration to a size reduced in both longitudinal and transverse directions by 50mm. In reality this would be a major structural change to the vehicle and require substantial re-engineering of the crash structure. If it were feasible to achieve this reduction the increase in view is illustrated above. The increase in view is still relatively modest even with this degree of A-pillar reduction. The A-pillar is still a clear obstruction to view. Part of this effect is due to the geometrical alignment of the A-pillar and the relative position of the eye point. As the eye point is inboard of the A-pillar the axes of the A-pillar alignment are not aligned with the direction of view. As such, reductions in size are not the equivalent of reducing the width of the a-pillar horizontally in a plane perpendicular to the direction of view. The impact of this effect is that the size of the A-pillar has to be substantially reduced to have a noticeable effect on A-pillar size in the direction of view, as shown in the images. A further consequence of this effect is that it would be possible to increase the depth, parallel to the direction of view, of the A-pillar structure without increasing the observed a-pillar size. Theoretically this would allow the A-pillar to maintain a critical size for structural reasons but be reduced to improve visibility. The limitation to this approach is that there is no consistent eye point for the driving population, such that the direction of view is different between the largest and smallest drivers. Furthermore increasing the dimension of the A-pillar in the direction of view increases its profile from the front of the vehicle and this would affect aerodynamic performance and fuel economy.

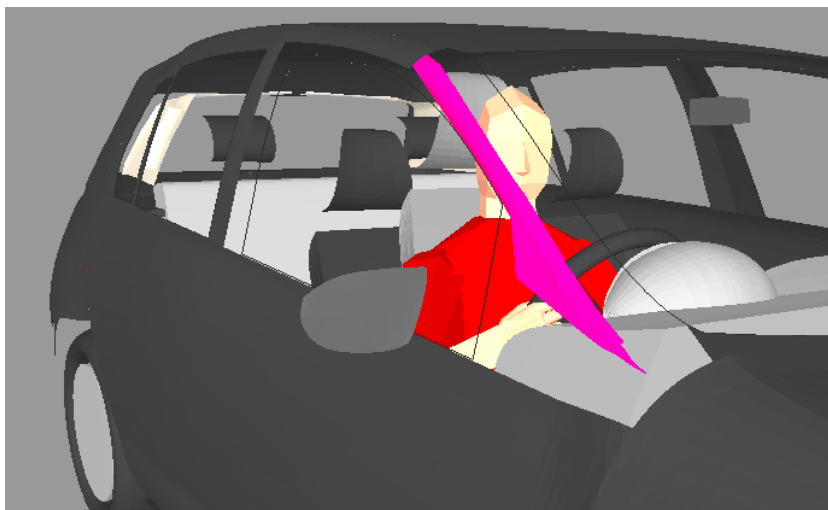
Figure 420. The size of A-pillar required to accommodate the 5%ile UK female in an inter-ocular solution

With all efforts to change the A-pillar to accommodate a particular eye point any solution is always going to be dedicated to a single eye point. To accommodate an inter-ocular distance for the smaller driver the pillar has to be very slim (Figure 420). Thus it is not feasible to produce a generic inter-ocular A-pillar solution that would be able to accommodate all drivers.

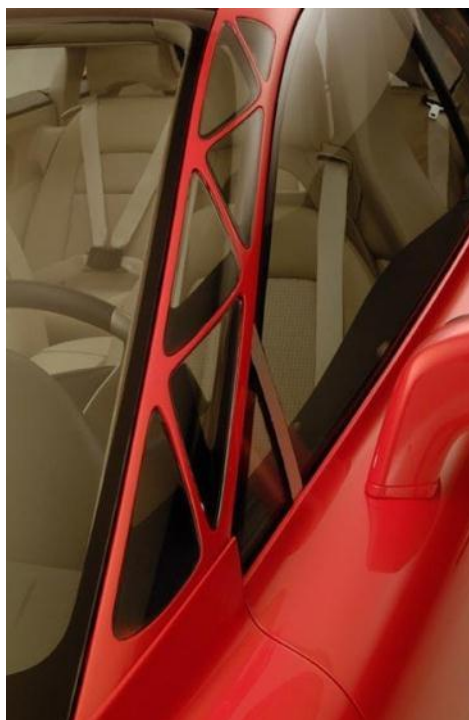
Figure 422. The webbed A-pillar of the Volvo SCC (courtesy of volvocars.com)

Solutions are limited to this particular issue. Ideally pillars would be designed to be non-existent, transparent, or as slim as possible such as those proposed in the Volvo Safety Concept Car (Figure 422 and Figure 423).

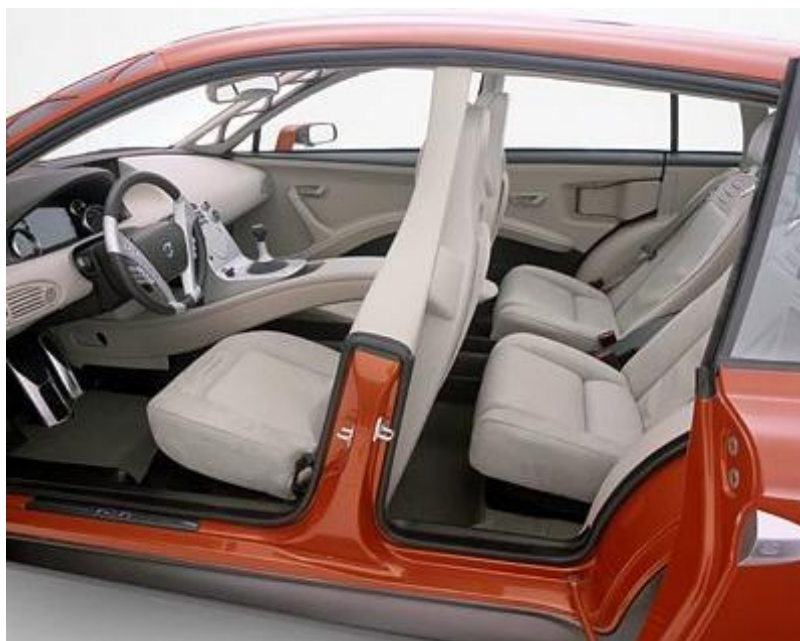
Figure 423. The curved interior B-pillar of the Volvo SCC (courtesy of volvocars.com)
