The Development of Improvements to Drivers' Direct and Indirect Vision from Vehicles – Phase 2

For: Department for Transport
DfT TTS Project Ref: S0906 / V8

Prepared by: Loughborough Design
School, Loughborough University
and MIRA Limited

Date: March 2011

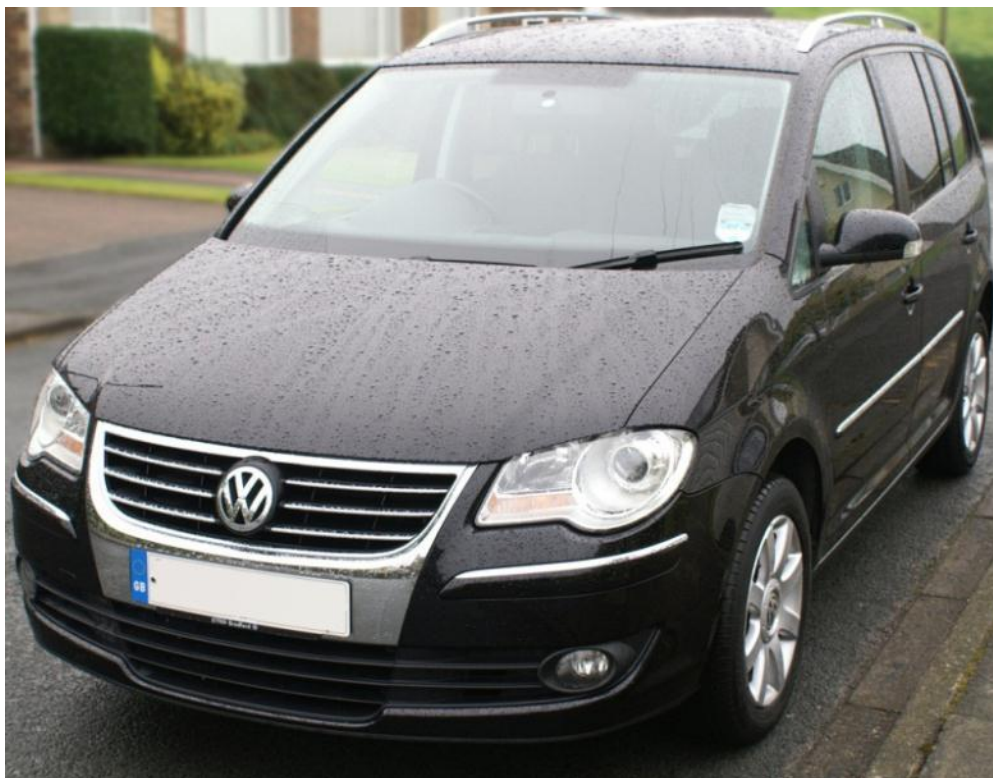
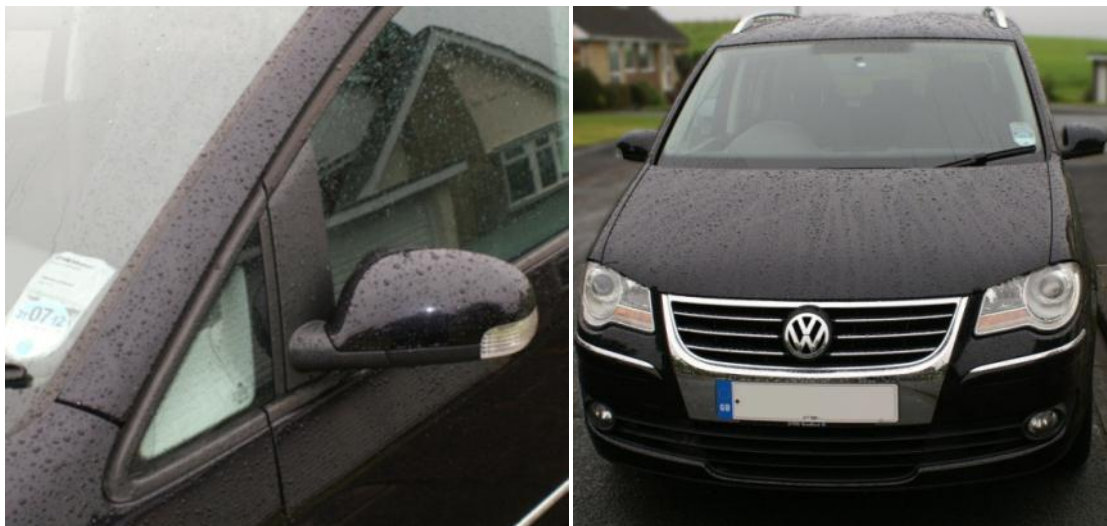
Figure 424A. Volkswagen Touran MPV

- M₁: a current (2010 on) model Volkswagen Touran – this MPV style vehicle is based upon the current Golf VI platform, shown in Figure 424 A-C.
- M₂: a current (2006 on) model Ford Transit in long wheelbase mini-bus configuration, shown in Figure 425 A-C.

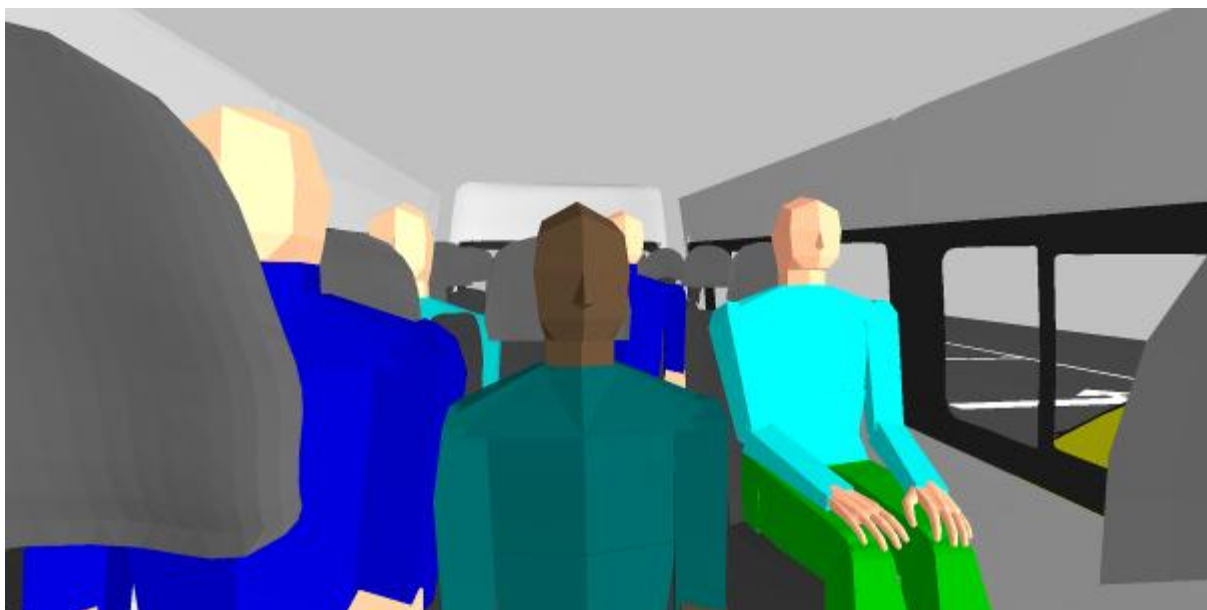
Figure 432. 1m Rearwards visibility with occupants (head restraints at highest setting)

Figure 432 shows the direct rearwards view, for an occupied vehicle with the head restraints all set to their highest, is almost completely obscured. A small amount of the nearside is visible through the side windows. Target A and B are both fully obscured.

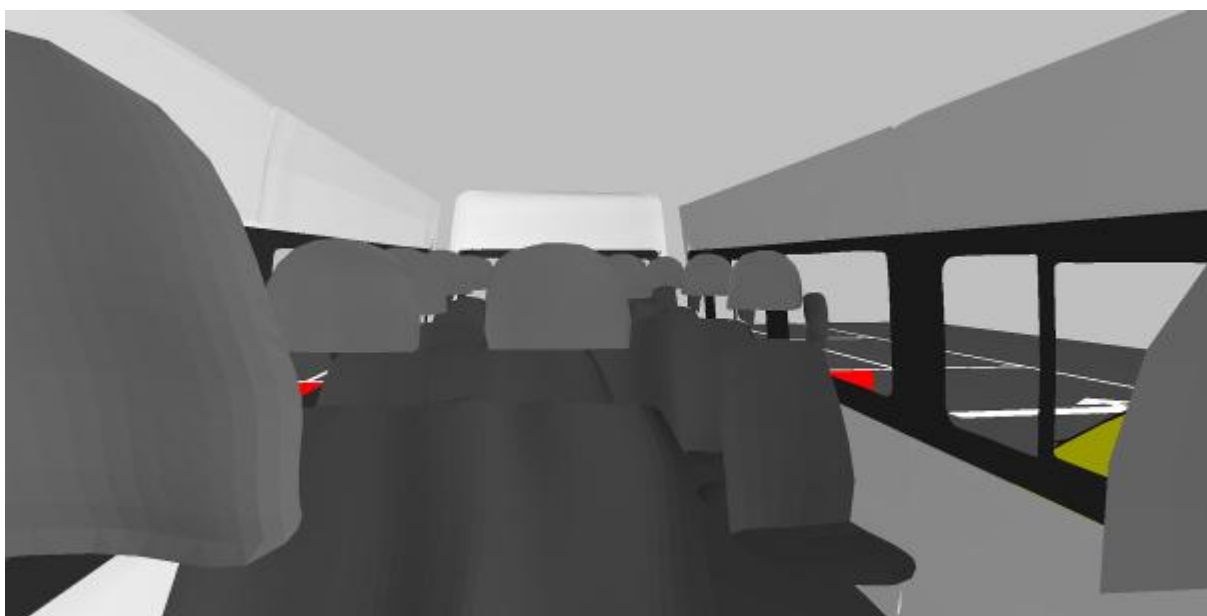
Figure 433. 1m Target Rearwards visibility unoccupied (head restraints at highest setting)

Figure 433 shows the direct rearwards view, for an unoccupied vehicle with the head restraints all set to their highest, is also almost completely obscured. An increased area of the nearside is visible through the side windows. None of target A is visible.

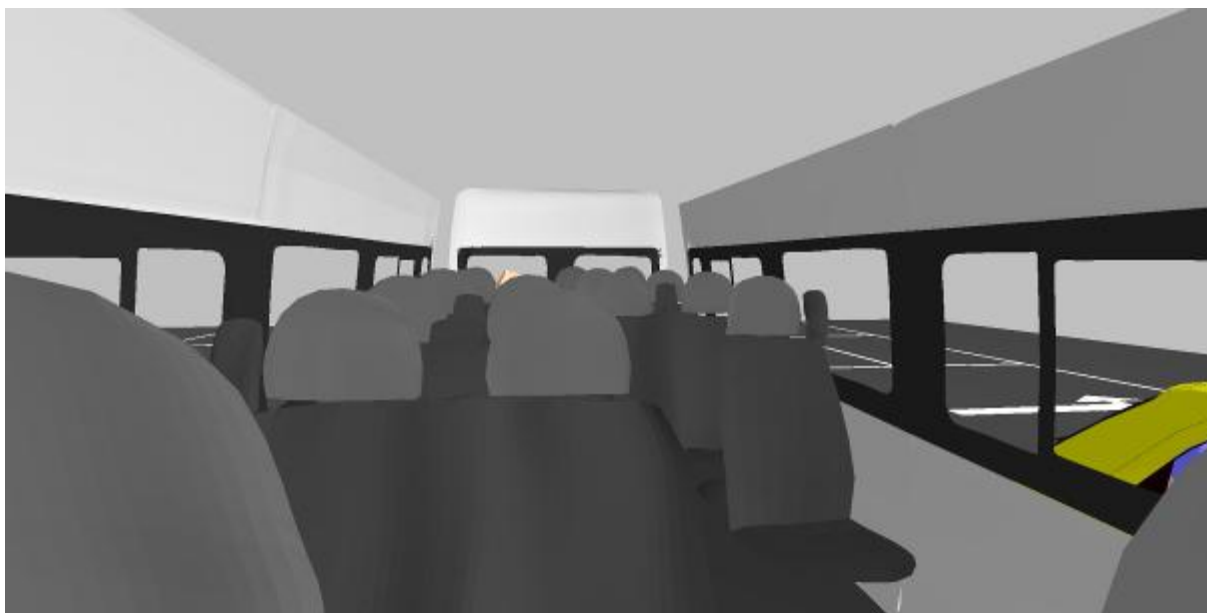
Figure 438. 1.8m Stature person (74%ile UK Male) rearwards of the vehicle

In a practical test, a human with a stature of 1800mm (74%ile UK male) is barely visible out of the rear of the vehicle (Figure 438).

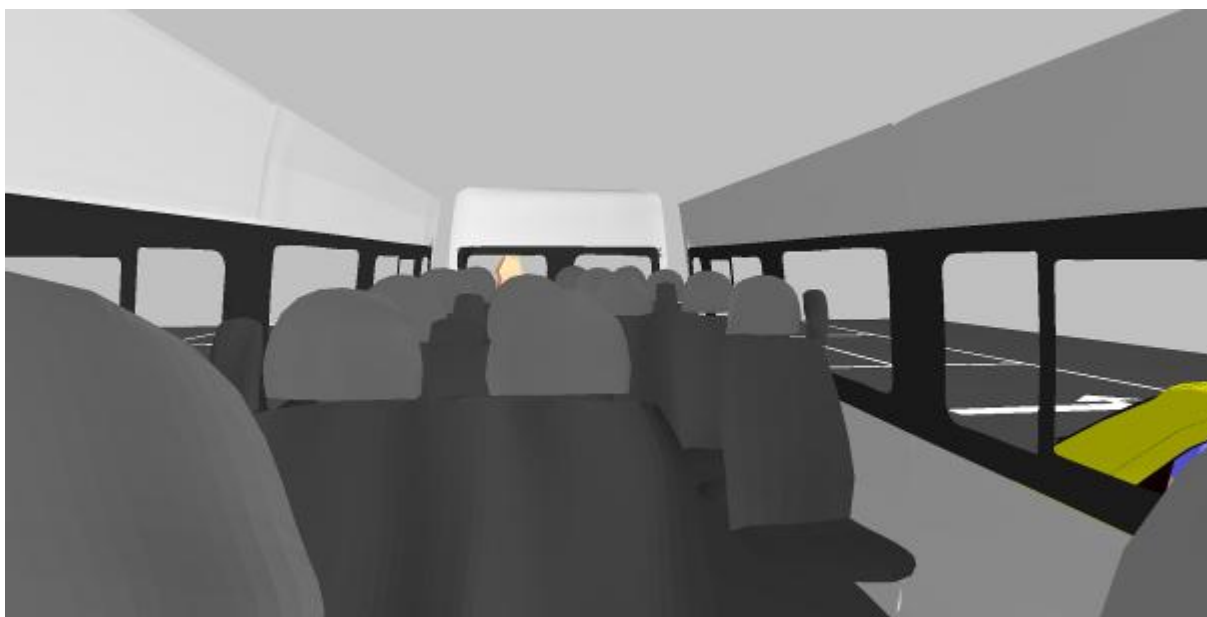
Figure 439. 1.912m Stature person (99%ile UK Male) rearwards of the vehicle

Figure 439 shows a 99%ile UK male (1912mm stature) visible in the rear windows. This gives an indication of maximum visibility possible in this configuration.

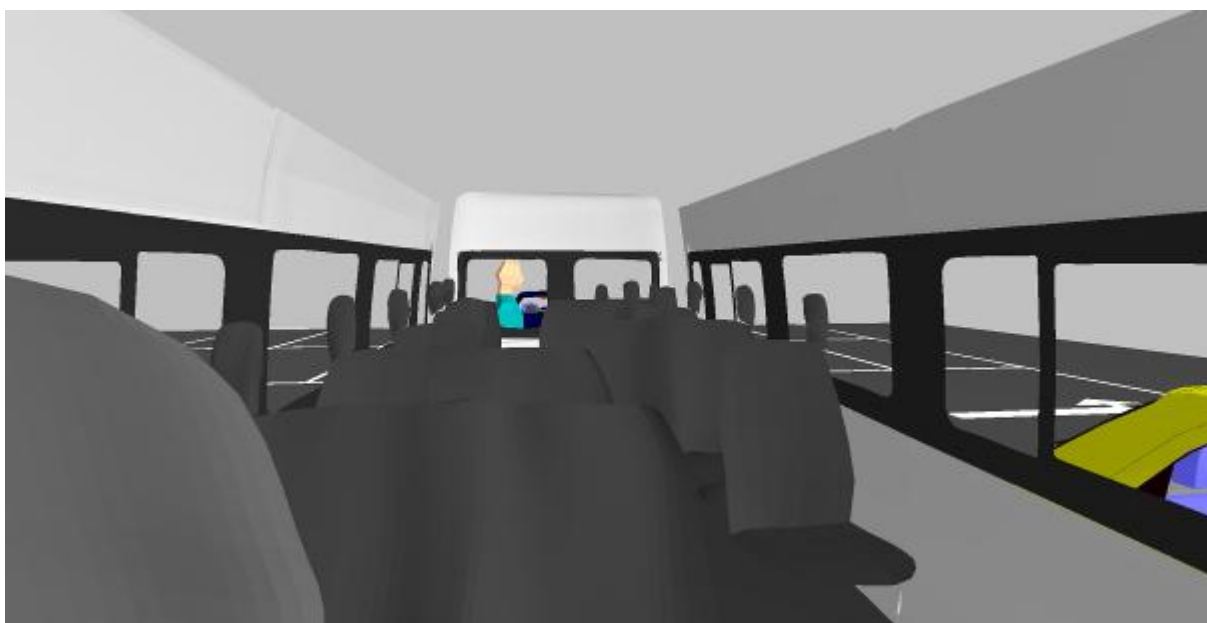
Figure 441. Rearwards view of human with head restraints removed

Whilst the head restraints are an important safety feature it is interesting to evaluate their impact on the rearwards visibility. Removal of the head restraints increases rearwards visibility significantly. However, full visibility from the rear windows is still not possible. In one area on the offside rear window, visibility is possible from 1400mm vertically upwards (Figure 440). Even in this configuration both targets A and B are not visible directly to the rear (Figure 441).

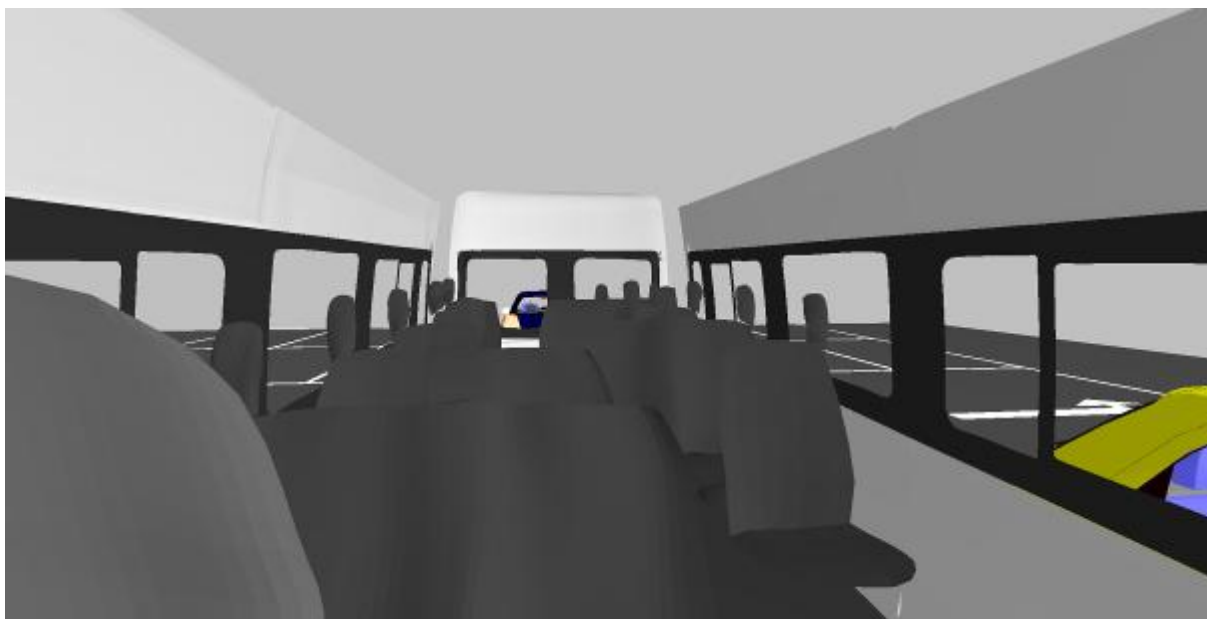
Figure 442. 1.47m Stature person (1%ile UK Female) rearwards of the vehicle (head restraints removed)

Figure 442 shows that it is possible to see a 1%ile UK female from the rear of the vehicle in this configuration. This is also equivalent to a 5%ile 14 year old UK female (1480mm).

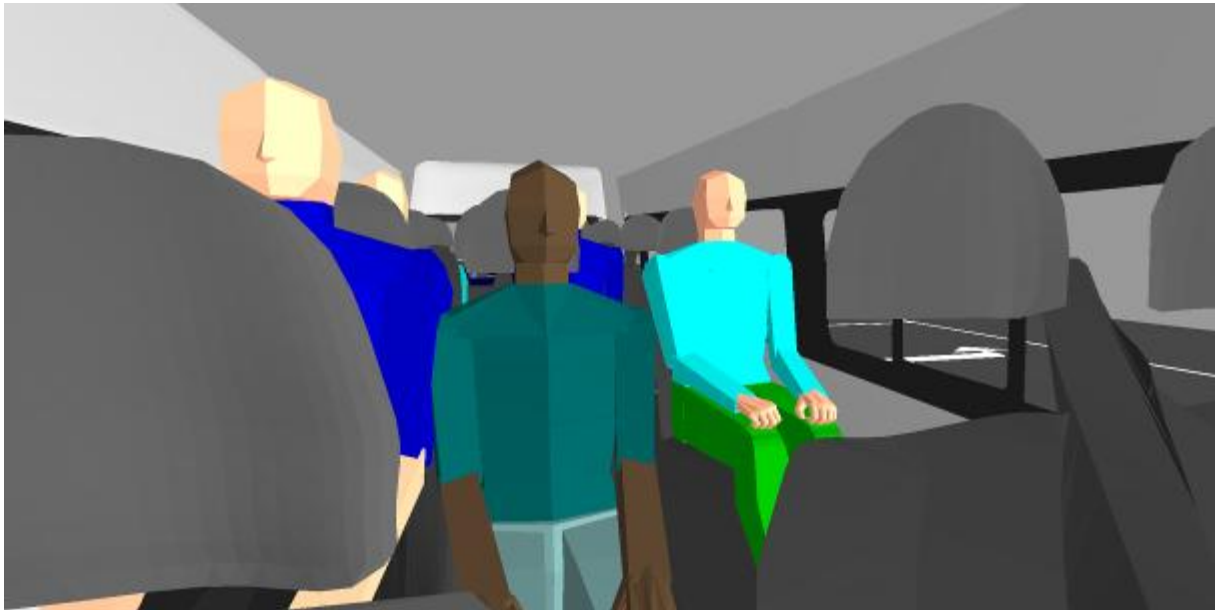
Figure 463. 1m Rearwards visibility with occupants (head restraints at highest setting)

Again, target A is completely obscured (Figure 463, Figure 464, Figure 465 and Figure 466). Target B is barely visible to the nearside. Target B needs to be increased to 1800mm to be just visible through the rear windows (Figure 466 and Figure 467).

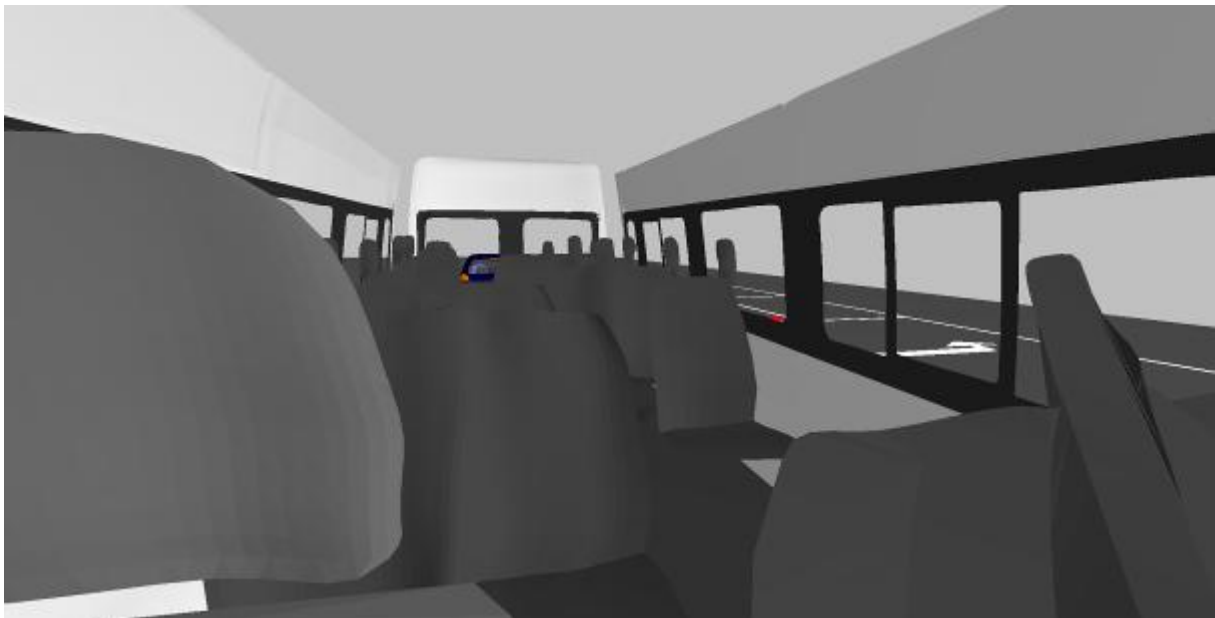
Figure 468. Rearwards view of targets with head restraints removed

Removal of the head restraints again increases rearwards visibility significantly (Figure 468 and Figure 469). However, full visibility from the rear windows is still not possible. In one area on the offside rear window, visibility is possible from 1400mm vertically upwards. Even in this configuration both targets A and B are not visible directly to the rear.

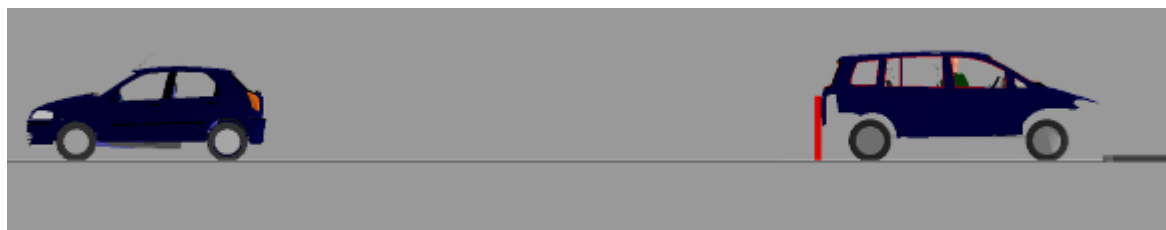
Figure 489. Rearwards visibility test B for 1000mm rearwards target (side view)

- A: 4 raised target markers 1100mm high and spaced 400mm inboard of either outside edge of the vehicle, in two rows, 600mm and 1600mm rearwards of the vehicle according to ISO/TR 12155, see Figure 486, Figure 487, and Figure 490.
- B: 1 wall-like target directly behind the vehicle. The target is 5m wide and is centred to be equidistant either side of the mid plane. Its initial height is 1000mm and will be increased to determine minimum requirements, see Figure 488, Figure 489 and Figure 490.

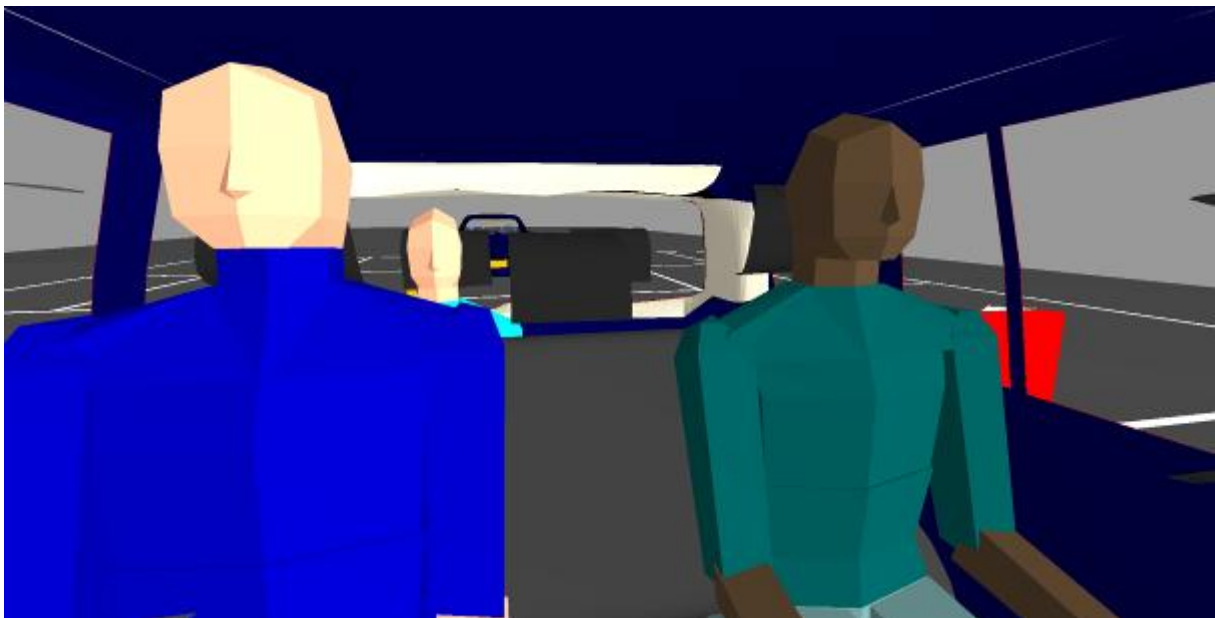
Figure 491. 1m Rearwards visibility with occupants (head restraints at highest setting)

The direct rearwards view, for an occupied vehicle with the head restraints all set to their highest, is highly obscured, particularly if all seats are occupied (Figure 491). A portion of the nearside and offside is visible through the side windows. None of targets A or B is visible through the rear window.

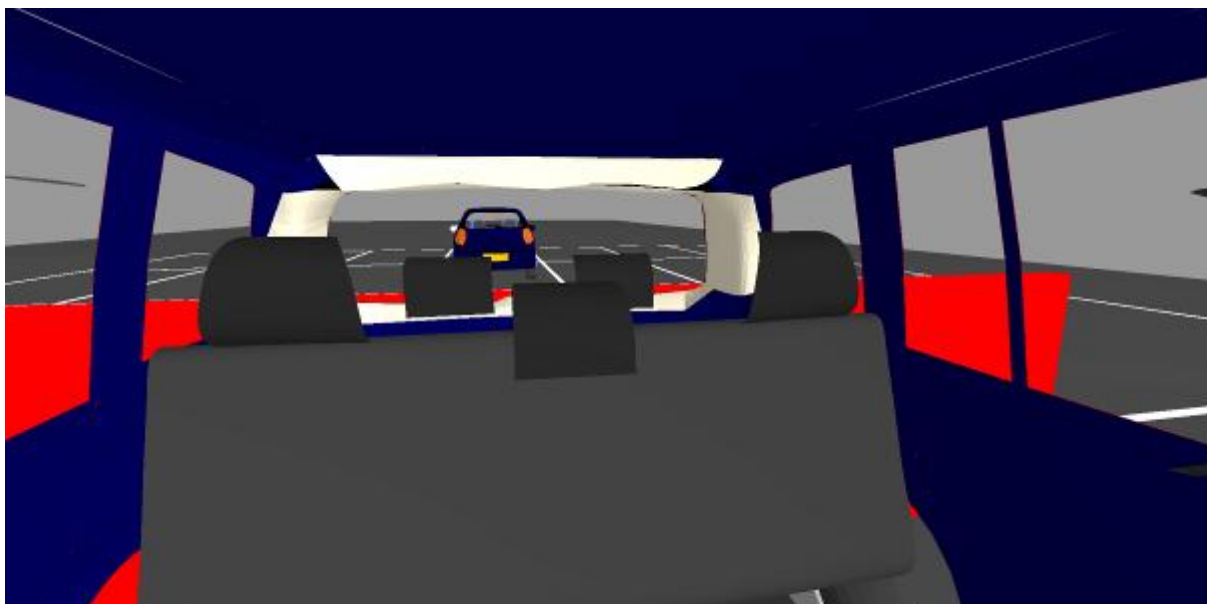
Figure 494. 1.15m Target Rearwards visibility unoccupied (head restraints at lowest setting)

Figure 494 above shows the height of target B required to be viewed directly out of the rear windows. This requires a target of 1150mm in height, equivalent to a 5%ile 7 year old UK male (1140mm). However, the amount of visible area of the target is negligible and it is unlikely that anything would actually be recognisable from this level of view.

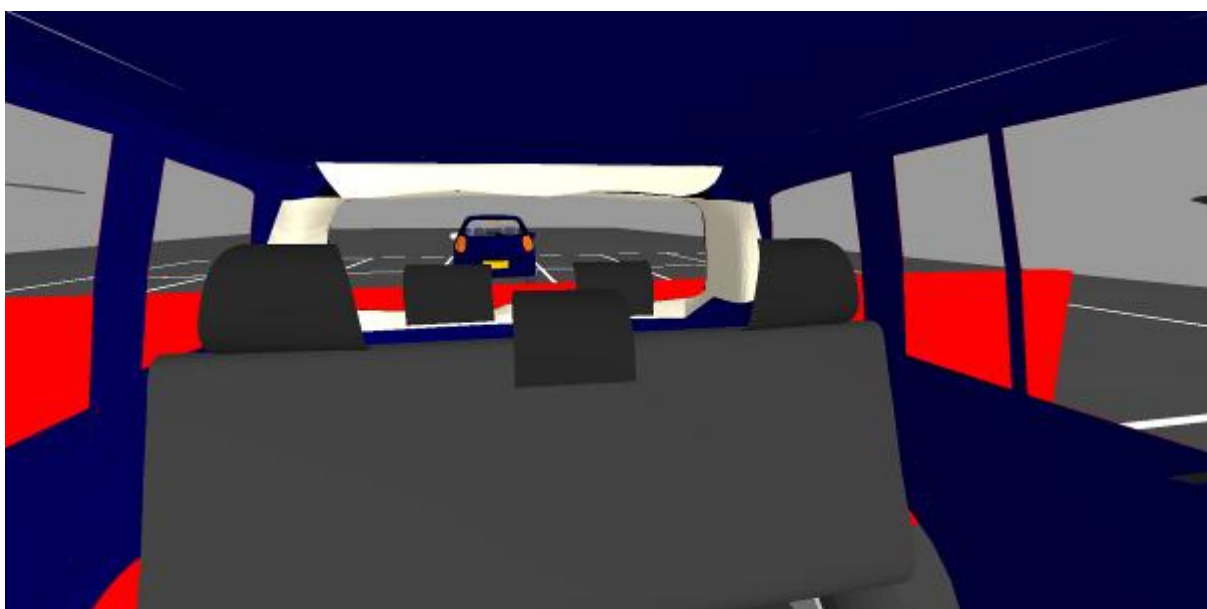
Figure 495. 1.2m Target Rearwards visibility unoccupied (head restraints at lowest setting)

Increasing the target height to 1200mm, equivalent to a 5%ile 9 year old UK male (1220mm), begins to provide a view in which a target may be recognisable out of the rear windows (Figure 495).

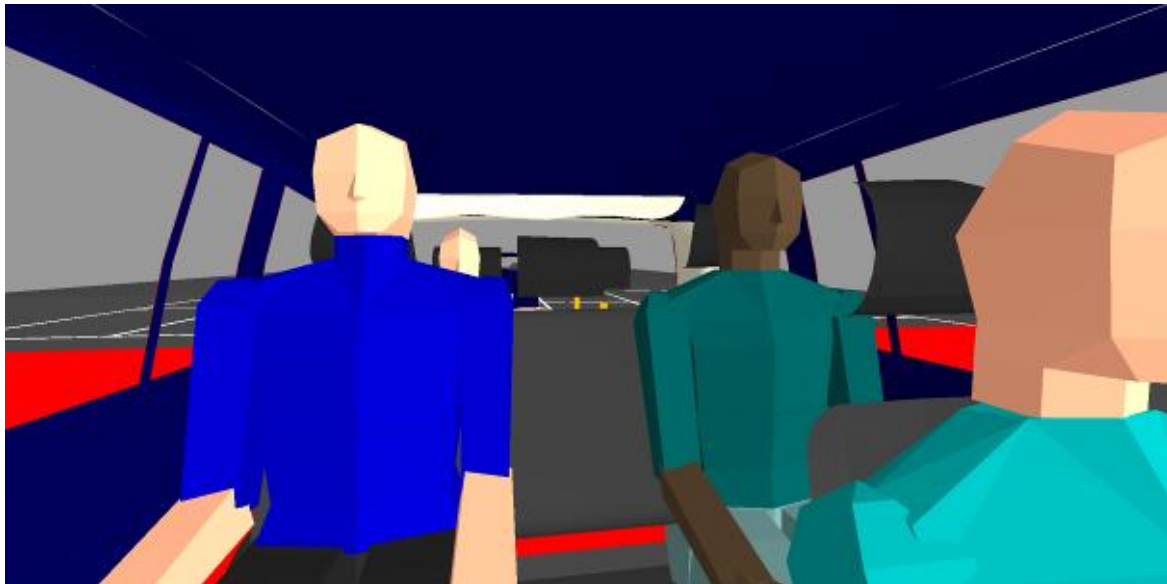
Figure 521. 1m Rearwards visibility with occupants (head restraints at highest setting)

Again, target A is almost completely obscured (Figure 521 and Figure 523) apart from with the head restraints in their highest position (Figure 522) where a small amount may be visible under the headrest. Target B is visible to the offside and marginally to the nearside.

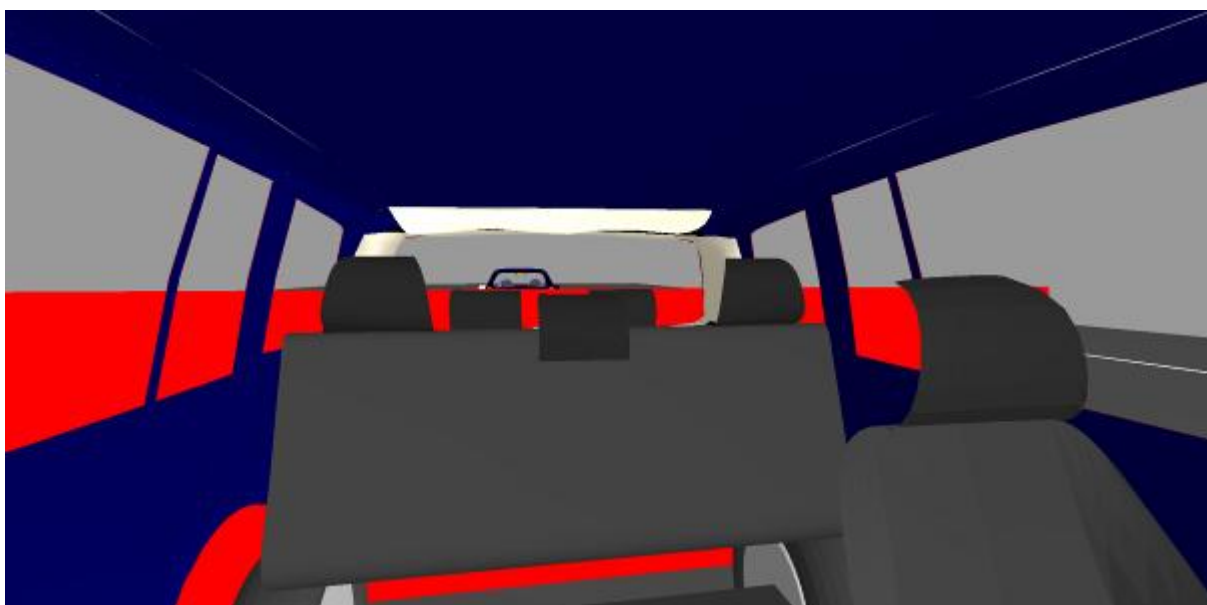
Figure 524. 1.3m Target Rearwards visibility unoccupied (head restraints at lowest setting)

Target B needs to be increased to 1300mm to be clear the rear head restraints through the rear windows (Figure 524).

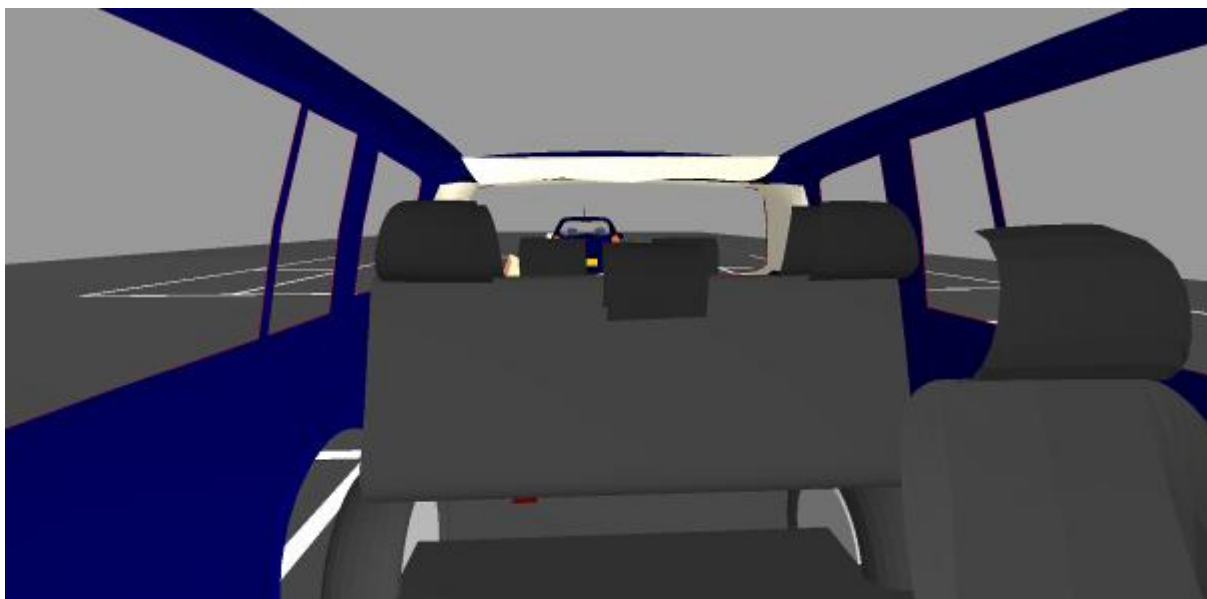
Figure 525. 1.22m Stature person (5%ile 9yr old UK Male) rearwards of the vehicle

Figure 525 and Figure 526 show a 5%ile 9yr old (1220mm stature) and a 13yr old UK male (1400mm stature) visible in the rear windows. This gives an indication of the height necessary to clear the rear head restraints in their lowest position and be visible. The lower eye point of the 35%ile UK female has reduced the visibility.

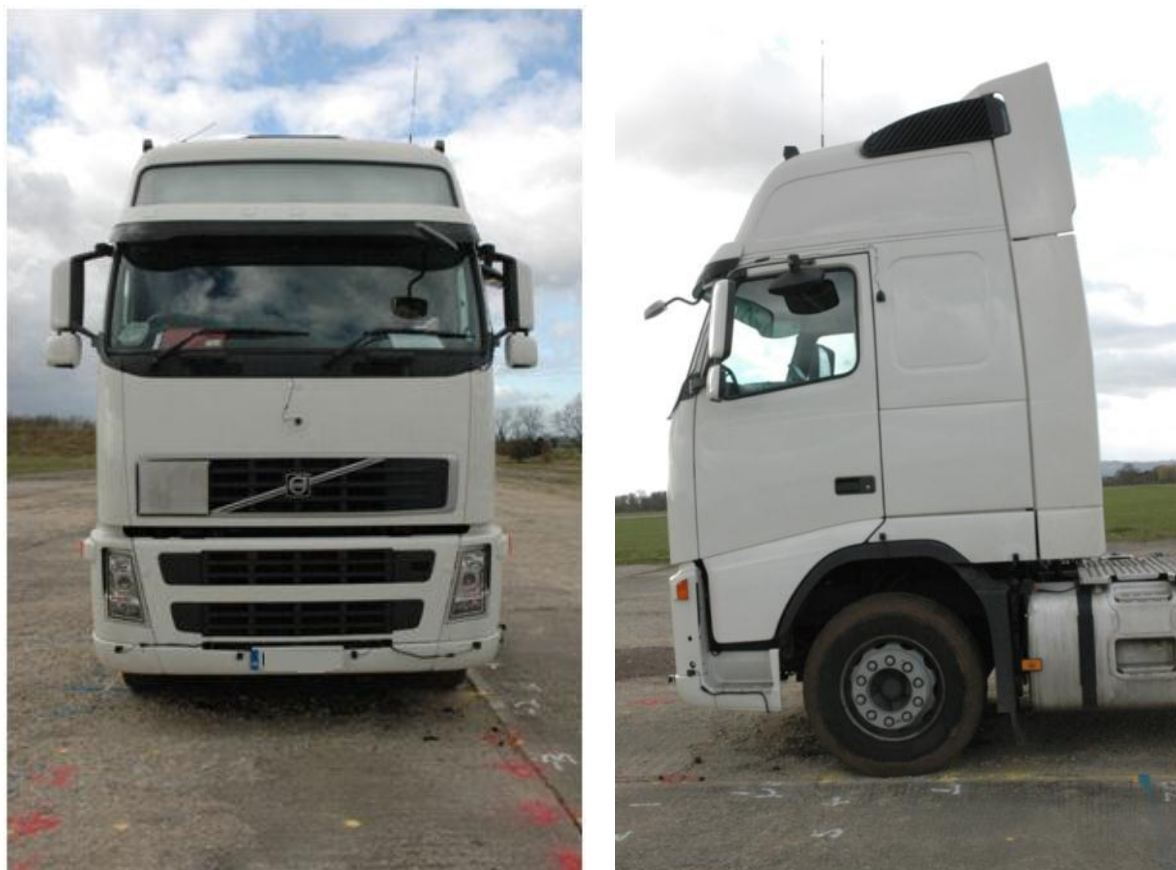
Figure 541. Volvo FH tractor unit used in trials

A number of vehicles were used in the pilot testing and it was recognised that vehicle selection would be a material factor in the results achieved. The vehicle finally selected was a Volvo FH tractor unit, an N₃ category vehicle first registered in 2007 and fitted with mirrors compliant with Regulation ECE46-02 and Directive 71/127/EEC, as amended by 2003/97/EC (see Figure 541). It is acknowledged that different results may have been obtained if a different LGV /mirror combination had been employed but as the mirrors were regulation compliant the results achieved are representative within the variation accepted by the standard.

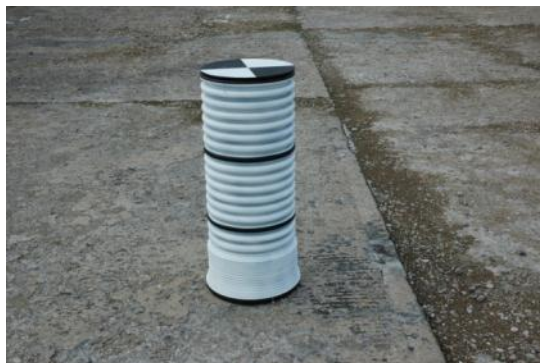
Figure 542. Test target used to validate prescribed field of view

The test target comprised a cylinder (900mm high & 300mm diameter), see Figure 542. The cylinder was painted black and white and had a top plate marked with black

and white quadrants and can be seen as consistent with the dimensions of a child pedestrian.

The test procedure involved presenting the test target at each grid point in turn and asking a driver to make a glance observation in the appropriate mirror. The driver was asked to report the presence / absence of the test target and the degree of distortion/visibility if perceived. This procedure enabled the production of detection plots indicating areas of the field of view that were likely to be more prone to detection failure or image distortion. It was established that the view afforded by Class IV mirrors was generally adequate and undistorted, poor vision was only reported for test locations at the maximum tested distance.

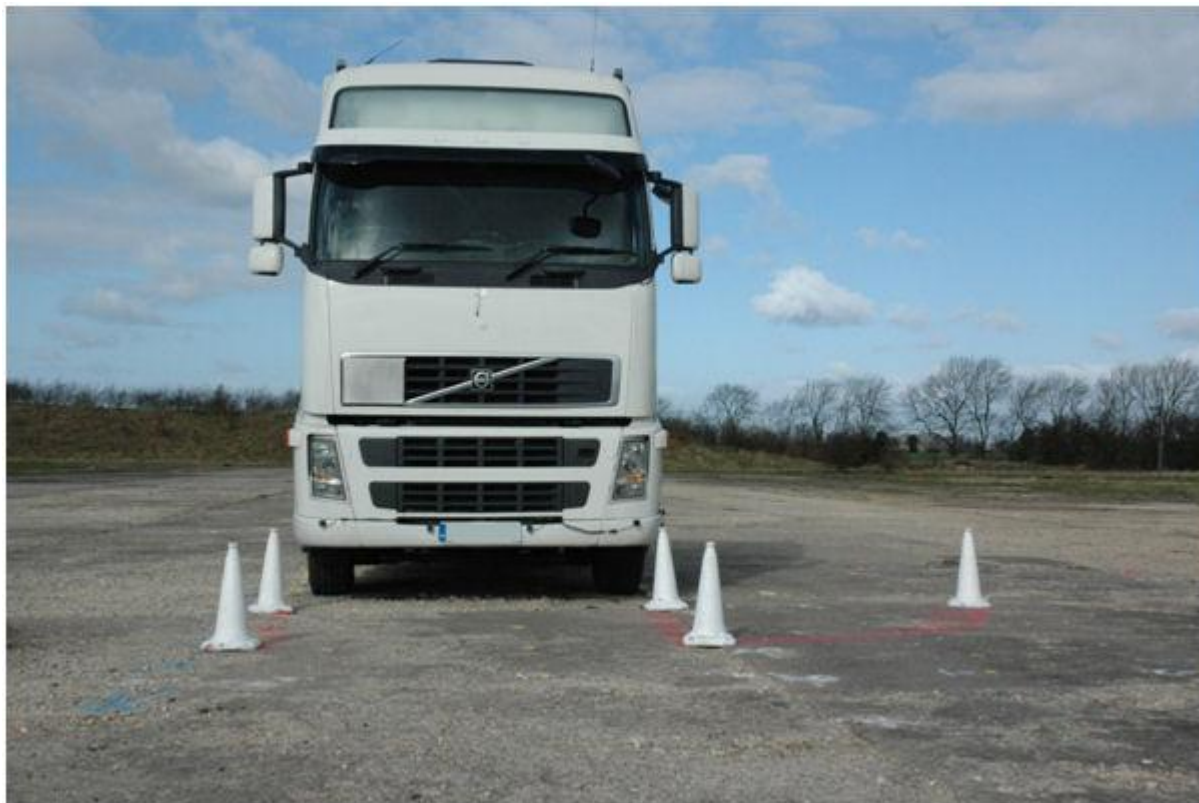
Figure 547. Class VI mirror adjustment procedure

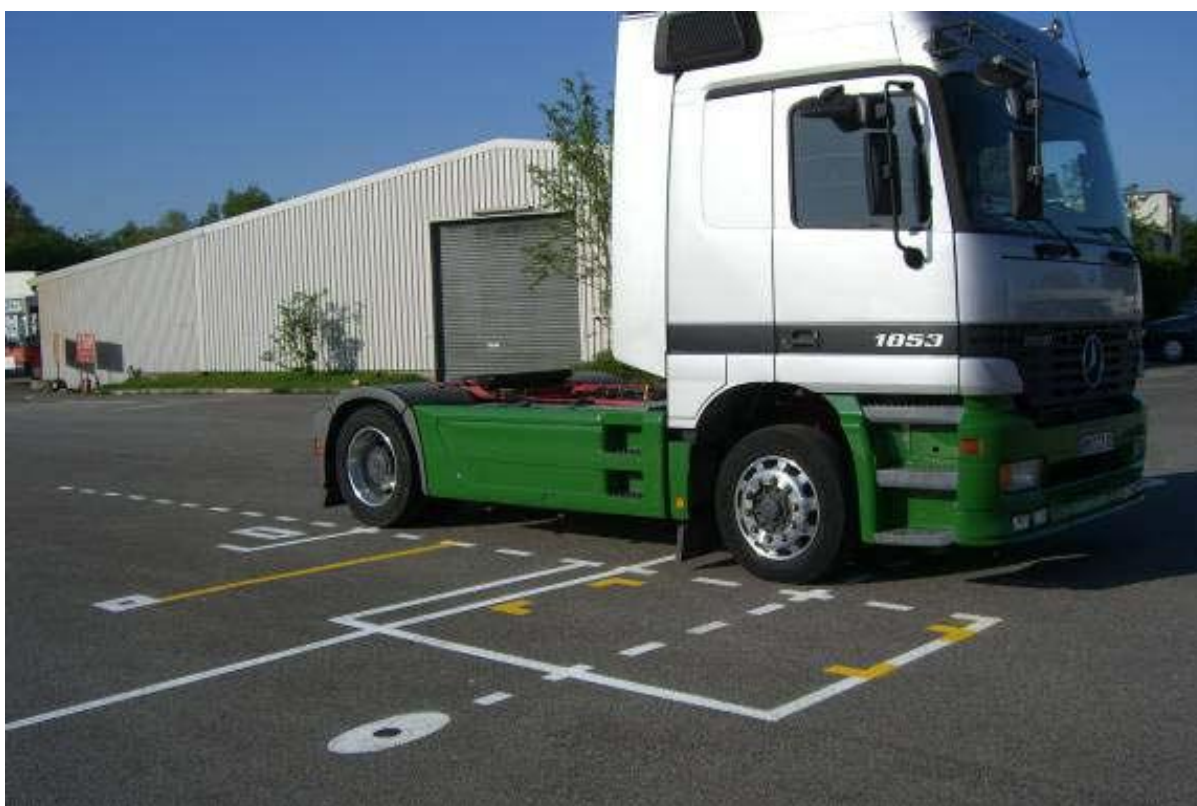
Figure 548. Mirror adjustment guidance (from Niewoehner, 2005)

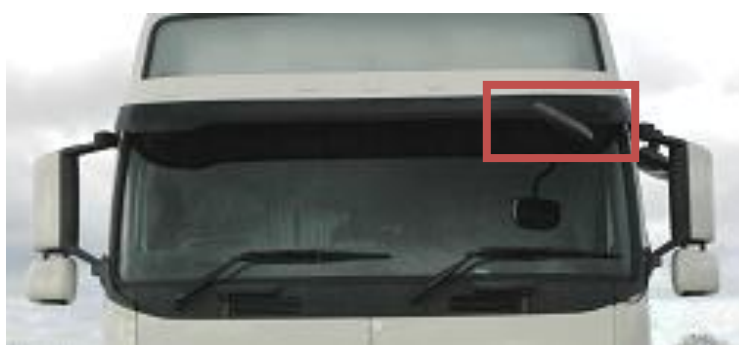
Figure 549. Class VI mounted in lateral position (Mirror within red box)

Class VI mirrors can be mounted either centrally, in the middle above the front windscreen or laterally, to the nearside. For the purposes of the trials the mirror was positioned in the lateral position, as this is preferred by some drivers since it is possible to access it via the near side door rather than needing to use a ladder for cleaning and adjustment (Figure 549).

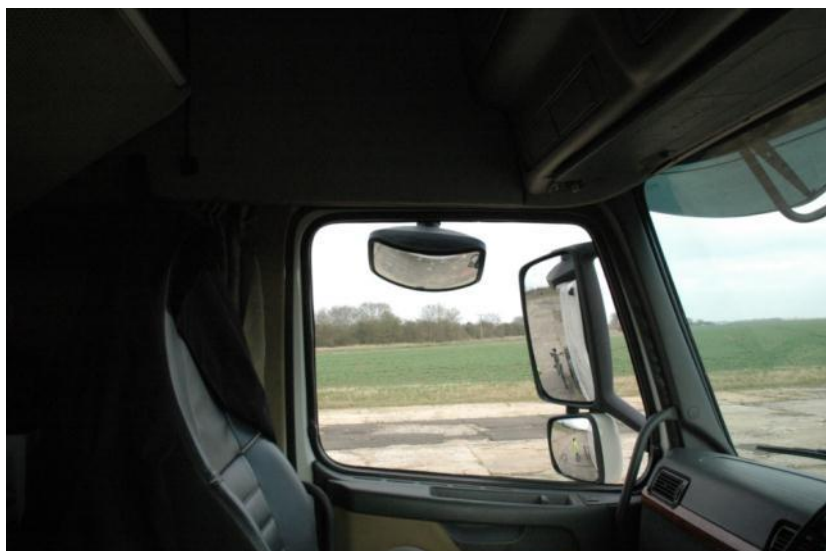
Figure 550. Spafax mirror mounted in Class V mirror position

The extended view Class V mirror, which incorporates a glass of 300mm radius of curvature (which is common across Class V mirrors) but has a greater height and so covers a larger area to the side of the vehicle if adjusted properly, was mounted in the same position as the Class V mirror (Figure 550).

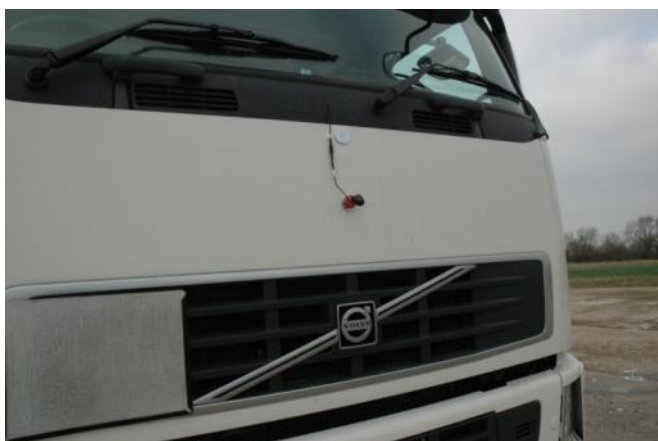
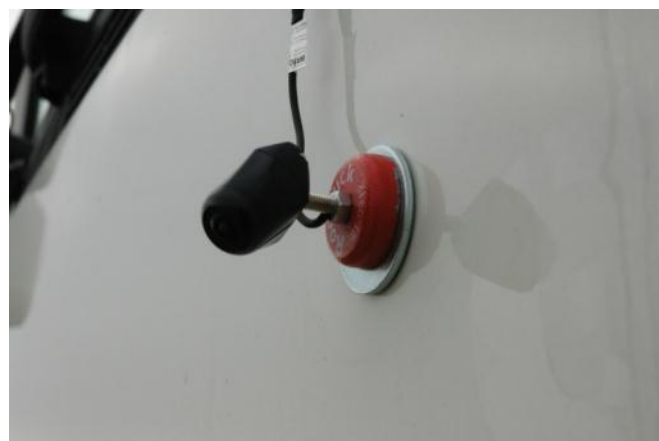
Figure 551. Camera fitted to the front of the vehicle

The camera was mounted by the manufacturer to provide Class VI coverage. The camera was mounted 1800mm above the ground in the middle of the front of the vehicle. Due to the temporary nature of the fitting, the camera protrudes the front body work by approximately 50mm (Figure 551). In a permanent fitting a small hole would be made and the camera would be mounted flush with the bodywork of the front panel. For the purposes of this assessment this difference would have minimal effect.

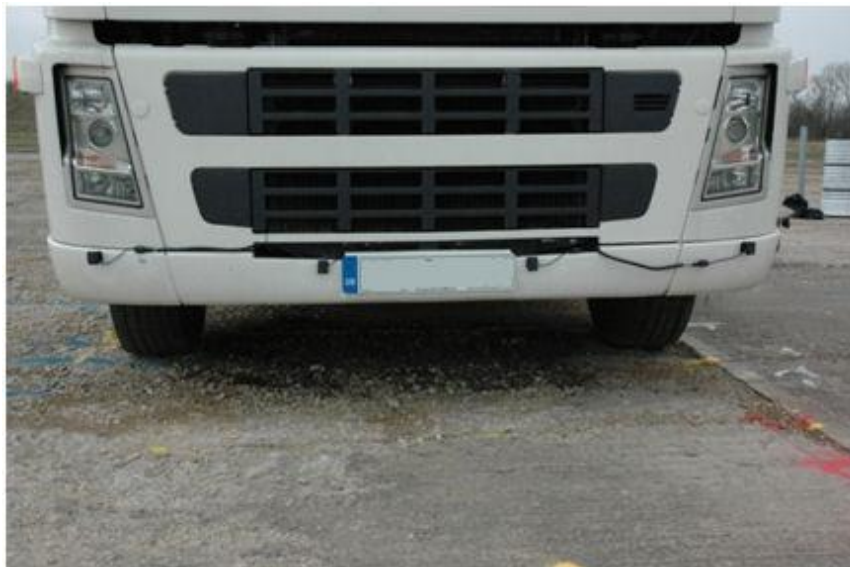
Figure 552. Sensors fitted to the front of the vehicle.

A series of four front sensors were mounted onto the front lower portion of the cab (Figure 552). These were mounted by the manufacturer to provide Class VI coverage.

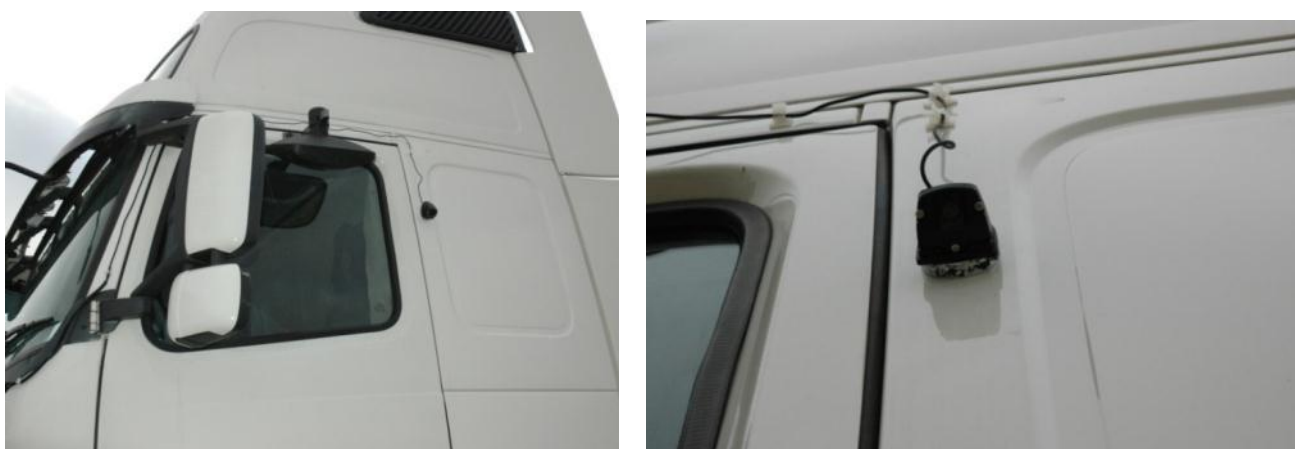
Figure 553. Camera fitted to the side of the vehicle

The camera was mounted by the manufacturer to provide Class V coverage. The camera was mounted 2650mm above the ground. Due to the temporary nature of the fitting the camera protruded slightly, by approximately 30mm (Figure 553). In a permanent fitting a small hole would be made and the camera would be mounted flush with the bodywork. For the purposes of this assessment this difference would again have minimal effect.

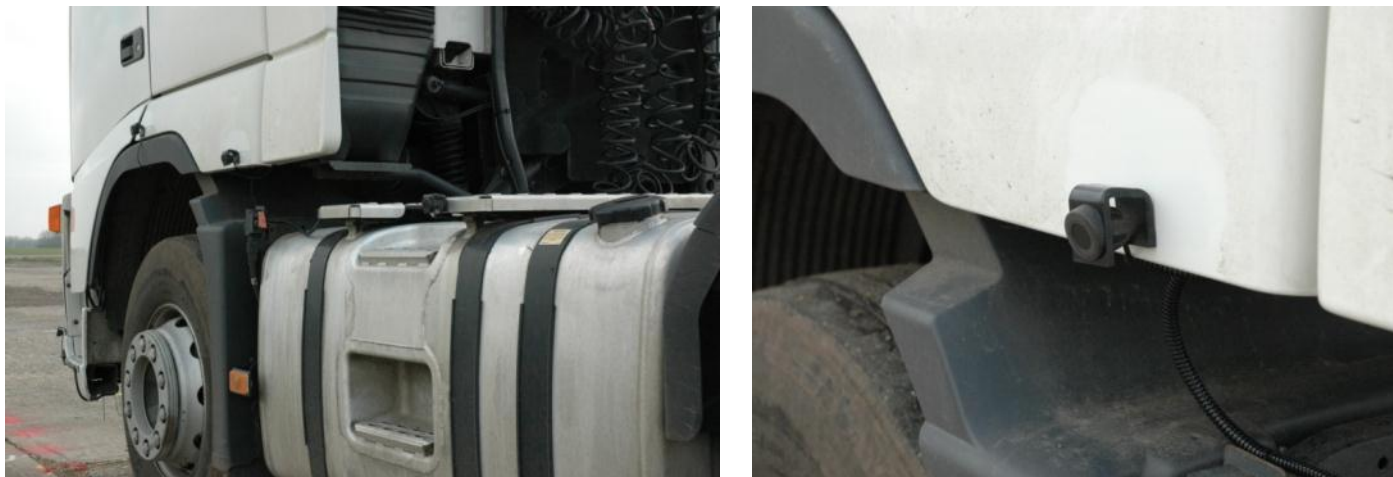
Figure 554. Sensors fitted to the side of the vehicle

A series of four sensors were mounted along the side lower portion of the cab (Figure 554) and just beyond. These were mounted by the manufacturer to provide Class V coverage.

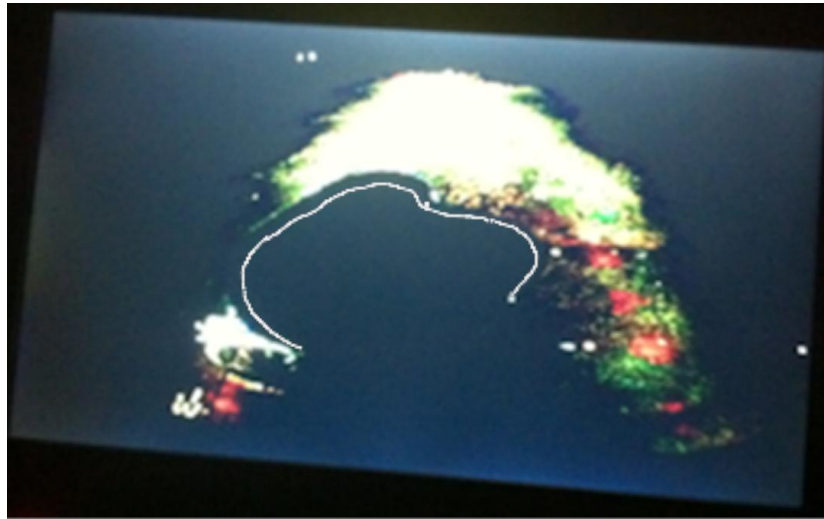
Figure 567. Cyclist target in non-illuminated area to front of vehicle

When the child pedestrian was positioned close to the cab front in the non-illuminated area between the headlamps, this target could not be seen. When the cyclist was positioned in this area, the greater size of the cyclist target and its closer proximity to the camera resulted in a large image which could be detected as a shadow against the illuminated road surface. Refer to Figure 567.

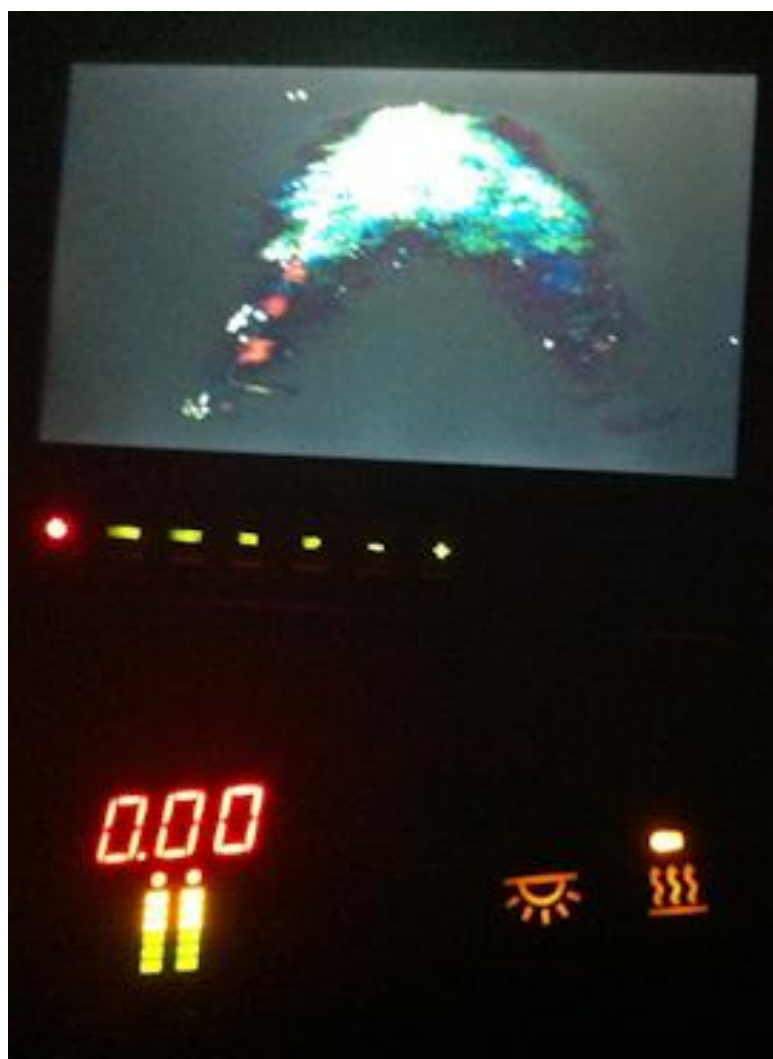
Figure 570. Class VI area sensor detecting target not visible on screen

Targets in close proximity to the sensors were detected to the front of the vehicle cab and the alerting display activated. Refer to Figure 570.
