The Development of Improvements to Drivers' Direct and Indirect Vision from Vehicles – Phase 2

For: Department for Transport
DfT TTS Project Ref: S0906 / V8

Prepared by: Loughborough Design
School, Loughborough University
and MIRA Limited

Date: March 2011

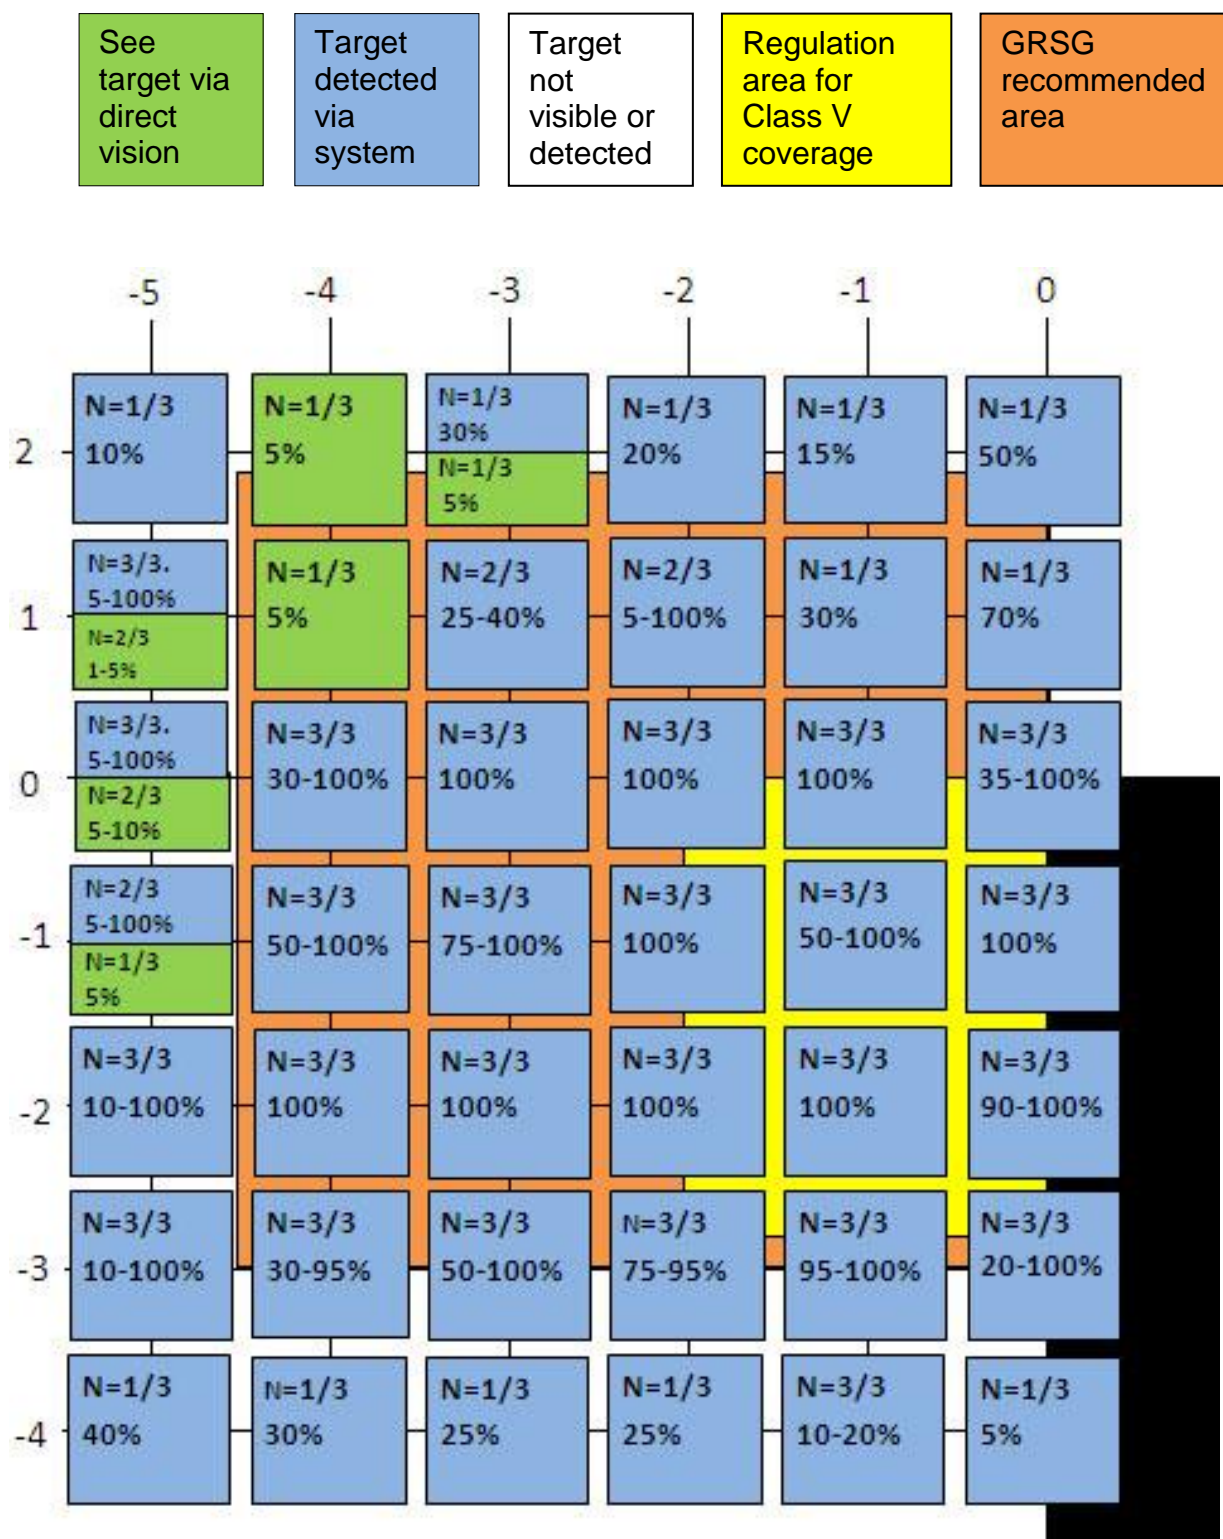
Figure 572. Spafax detection map

Figure 572 depicts the detection map of the Spafax mirror. The map shows that the area of coverage provided by the Spafax mirror far exceeded the region specified in 2003/97/EC Directive (Approximately marked out in yellow), extending three metres

further to the left of the prescribed area and a further one to two metres to the fore and aft of the prescribed area. In comparison to the GRSG recommended area (Approximately marked out in orange) the Spafax mirror nearly covers the whole area, only failing to provide coverage of very top left nodes (Column -4, Row 2 and Column -4, Row 1).

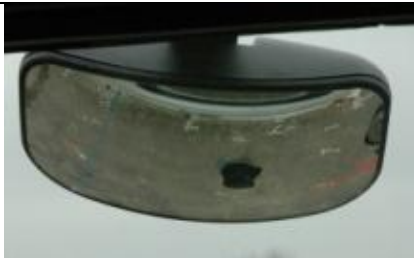
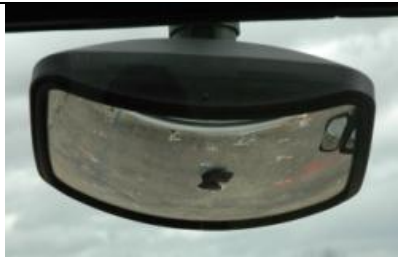
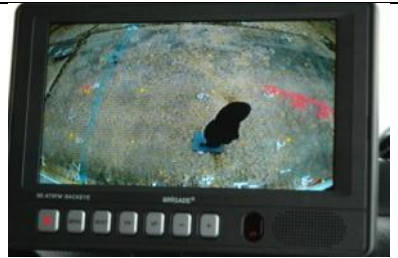
Figure 575. Example of images and the type of orientation and recognition scores for each of the visual systems

Location Column -1, Row -1 Example of mean recognition score 2.7. Orientation reported by assessors was 180 (upside down)	Location Column -1, Row -1 Example of mean recognition score 3.3. Orientation reported by assessors was 180 (upside down)	Location Column -1, Row -1 Example of mean recognition score 4. Orientation reported by assessors was +45
Class V mirror	Spafax mirror	Side camera

recognition scores within the Directive 2003/97/EC prescribed area, whereas the camera system gained highest scores in the Directive 2003/97/EC prescribed area and just beyond, spreading out into the orange, GRSG proposed area. Figure 575 shows an image from all three visual systems for the same presentation location of the target. It illustrates the differences in recognition scores and orientation across the three types of system.

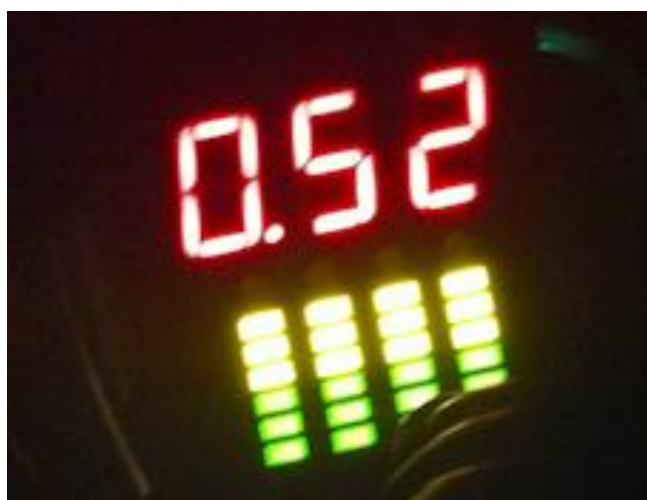
Figure 584. Class V area sensor detecting passing car

Targets in close proximity to the sensors were detected to the side of the vehicle cab and the alerting display activated. Refer to Figure 584.

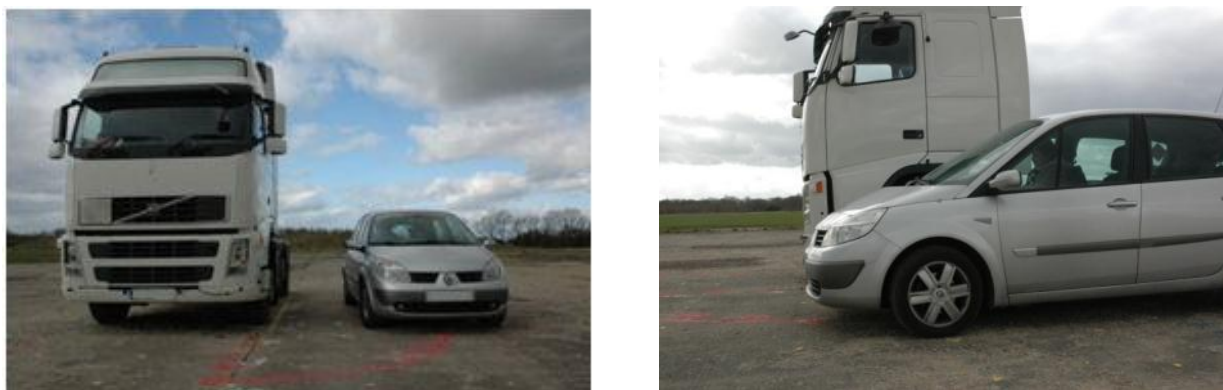
Figure 585. Target car at 2 metre off-set from LGV

assessments. The target was positioned with the middle of the car two metres out from the side of the LGV and with the front of the car in line with the front of the LGV cab, as depicted in Figure 585. Photographs of the images of the car in this positioned as presented in the Class V mirror and the Spafax were then taken.

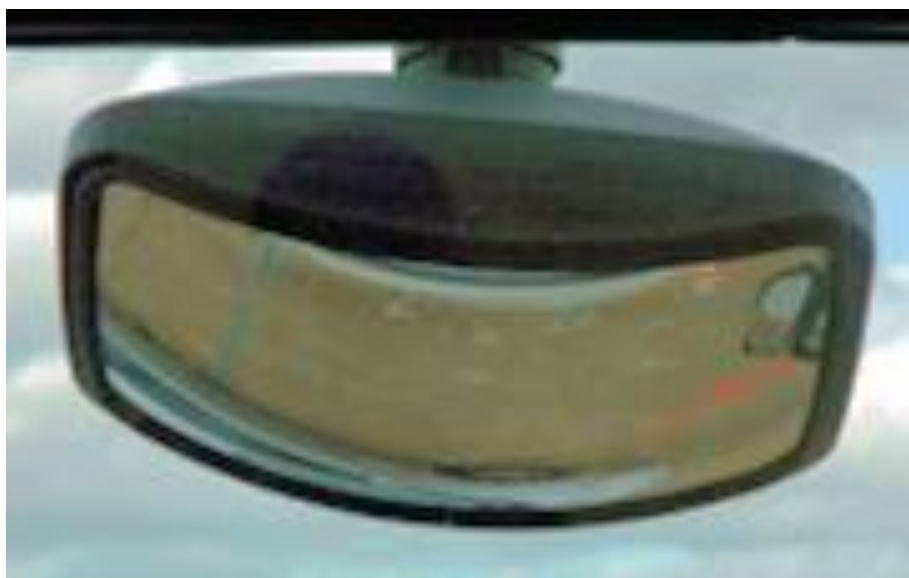
Figure 587. Image of car at the edge of the GRSG proposal areas

Compared to the view gained when the car was positioned at the two metre boundary of the Class V area, Figure 587 shows that the level of distortion is more pronounced in the Spafax mirror due to its greater curvature (The target was not detectable in the Class V mirror).

The target was then re-positioned such that it was on the boundary of the GRSG proposal with its nearside wheels at 4.5 metres from the side of the LGV. It was positioned in row 0, with the front of the car in line with the front of the LGV cab. The target whilst distorted is visible in the Spafax mirror as shown; however it was not visible in the Class V mirror.

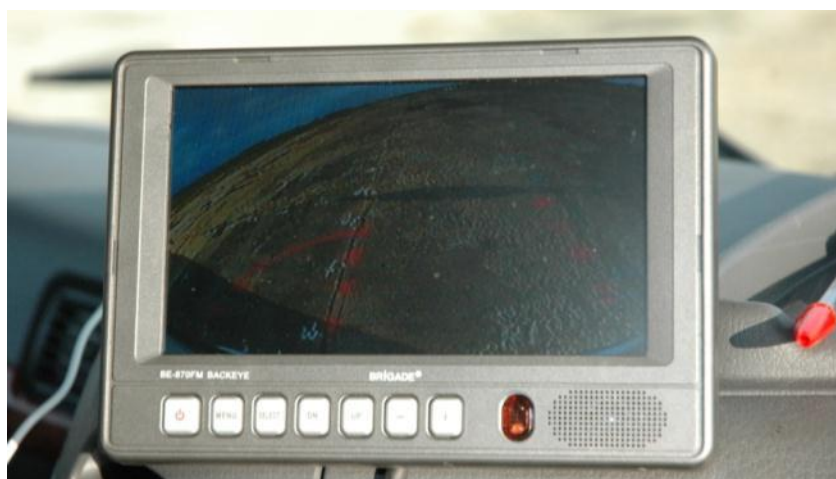
Figure 589. Internal screen of the camera system with the sun light shining onto the screen

- Mirrors are affected by rain and dirt more so than camera systems. The mirror surface and windscreen are both vulnerable whilst the camera lens may enjoy considerable protection from being mounted vertically and having a hood
- However, the image from camera systems is reliant on the quality of the camera lens and the internal viewing screen. Viewing of the screen can also be compromised by the effects of glare and sudden changes in contrast, Figure 589.

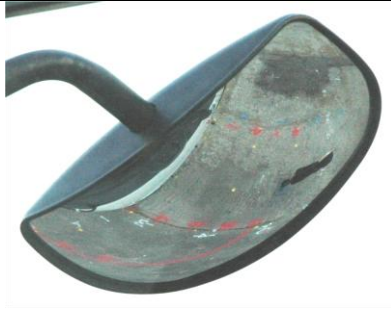
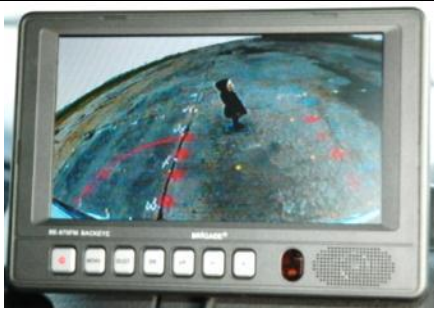
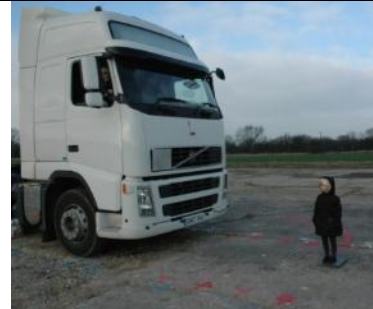
Figure 590. Example 1

<p>Class VI Mirror</p>	<p>Camera system</p>	<p>External view</p>
<p>Location Column +1, Row 2</p>		
<p>The camera system is more intuitive in terms of the location of the target in relation to the LGV. The position of the target on the screen better reflects the real location outside, whereas the mirror is less clear. On the mirror the child target appears further away and more offset than it actually is.</p> <p>Notice the child appears to be facing left in mirror. Whereas the child appears to be facing right in camera view, which reflects its real position.</p>

- The camera system, being subject to fewer changes in orientation and distortion, provided the most intuitive system in that the image provided on the screen provided a truer reflection of what was happening externally. This is best illustrated through example. Below are two examples illustrating the effect of orientation and predicting what that target will do (Figure 590 and Figure 591).

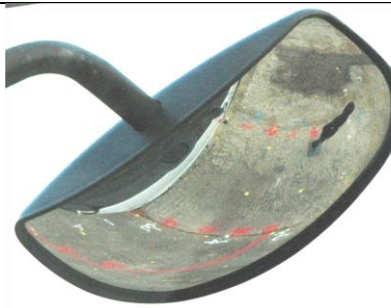
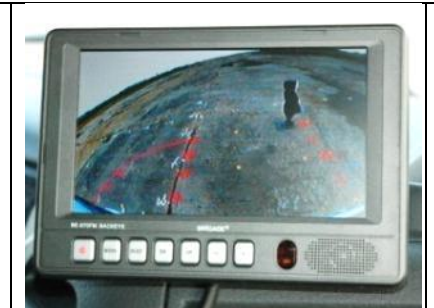
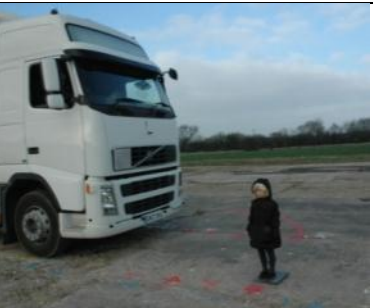
Figure 591. Example 2

<p>Class VI Mirror</p>	<p>Camera system</p>	<p>External view</p>
<p>Location Column +2, Row +2</p>		
<p>Note: On the camera system the child is facing right whereas on the mirror the child is facing left. The mirror gives a greater view to the right of the driver but the orientation of the target impairs prediction of the child's likely movement.</p>
