The Determination of Accessible Taxi Requirements

PPAD 9/72/87 (UG539)

Mobility and Inclusion Unit, Department for Transport

June 2004

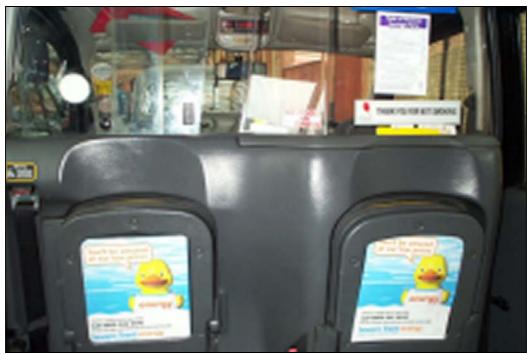
Figure 15: Visual clutter in a taxi

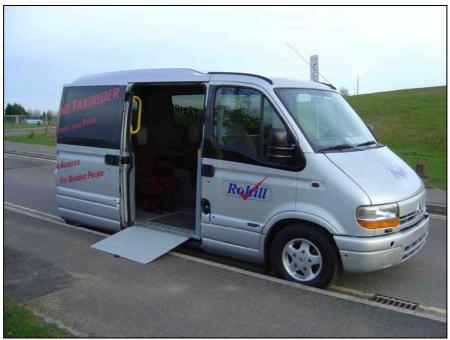
Figure 16: Rohill TaxiRider

- Kneeling mechanism to give very low floor height
- Sliding door
- High door and roof
- Flexible seating arrangement

Participants were invited to inspect and try getting in and out this vehicle, and report on how easy it was to use. They were also asked if they preferred it over the more familiar purpose built taxis.
