Landslide hazard evaluation by means of several monitoring techniques, including an acoustic emission sensor

N. Dixon & M.P. Spriggs

ABSTRACT: At Passo della Morte in the Italian Eastern Alps a geomorphological survey has identified potential instability of the valley side slope that could result in a debris/rock avalanche, which would threaten the Tagliamento River. A nationally important road passes through a tunnel 130 m long behind the potentially unstable slope. The stratum comprises a sequence of Limestone layers, dipping in the slope direction towards the river. Although currently there is no clear evidence of movement, the geological setting indicates a predisposition to instability that could involve a large landslide and extremely fast deformations can be foreseen. To appraise the physical characteristics of the rock mass and to provide an early warning of instability, monitoring instrumentation has been installed and monitored since late 2010. Extensometers, MEMS, TDR cables, a vertical inclinometer, a seismic station to monitor Limestone rock mass deformation generated micro-tremors and an acoustic emission (AE) monitoring system have been installed. The instruments a

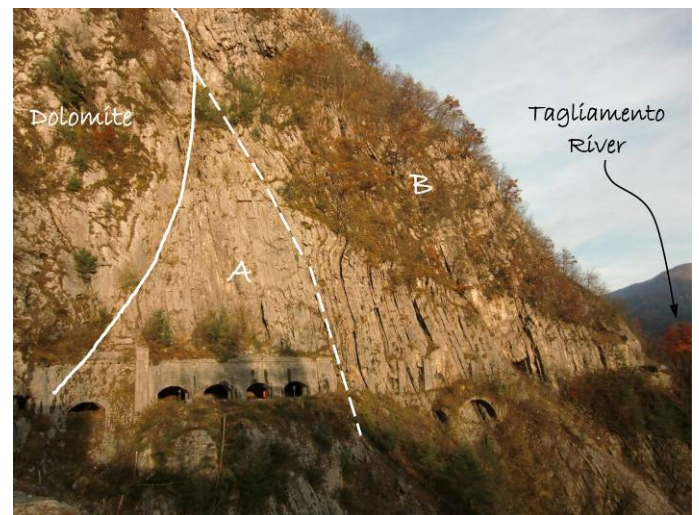
Figure 2. Limestone rock mass, Zone A is described as a compact rock mass while Zone B is characterized by open bedding discontinuities. The dashed line marks the boundary between Zones A and B and coincides with a poor Rock Quality Design (RQD <25%) band, two metres wide.

From the structural point of view it is possible to identify in the Limestone rock mass two distinct zones. These are shown in Figure 2 where they are divided by the dashed line.

- Zone A has planar and slightly irregular layers, the bedding planes are substantially closed or rarely open a few millimeters and fill material is absent.
- Zone B is characterized by open bedding planes, or partially open, that are planar to undulating and have marl in-filling. In the upper part of the zone, associated with small folds, the Limestone layers have a shallower slope angle.

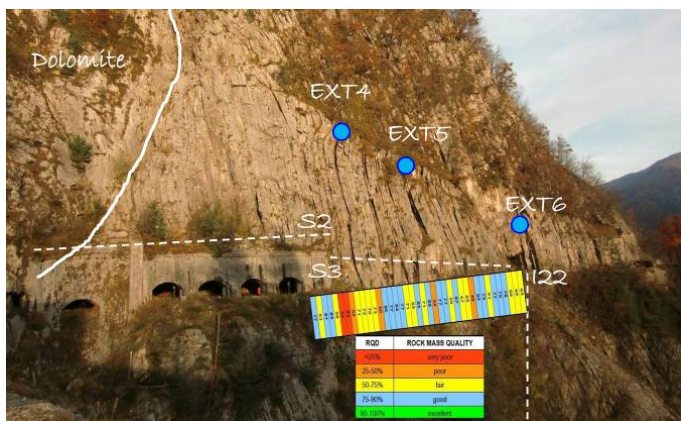
Figure 4. Projected RQD analysis from the S1 core on the west rock mass face, location of external extensometers and indicative location of inclinometer casing, waveguides and TDR cables.

RDQ analysis was performed on the core retrieved from borehole S1 and this information was used to locate the anchor point for extensometer EXT1 within competent intact rock and to ensure monitoring takes place of the “poor” rock mass band within the Limestone. Three extensometers were installed in borehole S1 in order to understand which zones of the rock mass are involved in the landslide mechanism and hence to locate the primary shear plane that controls stability. Two MEMS type accelerometers were also installed in borehole 1 to provide additional information to the extensometer data trend. Core analysis also provided an opportunity to observe the type of fracturing affecting the rock mass, joint surface morphology and their condition. For example, interlayer marls when stresses reveal evidence of movement through the formation of graphite. Projection of the borehole S1 core analysis in the west rock mass face (Figure 4) supported the geomechanical survey and selection of the optimum type and location of sensors. High precision (± 0.01 mm) wire extensometers (EXT4, EXT5 and EXT6)

were installed across open bedding planes in areas of poor rock quality (Figure 4).

During the monitoring period to date only EXT4 has measured deformations. This extensometer is located on the slope surface across a bedding plane
