# Field trial of an acoustic emission early warning system for slope instability

N. Dixon & M.P. Spriggs

*School of Civil and Building Engineering, Loughborough University, Leicestershire, UK*

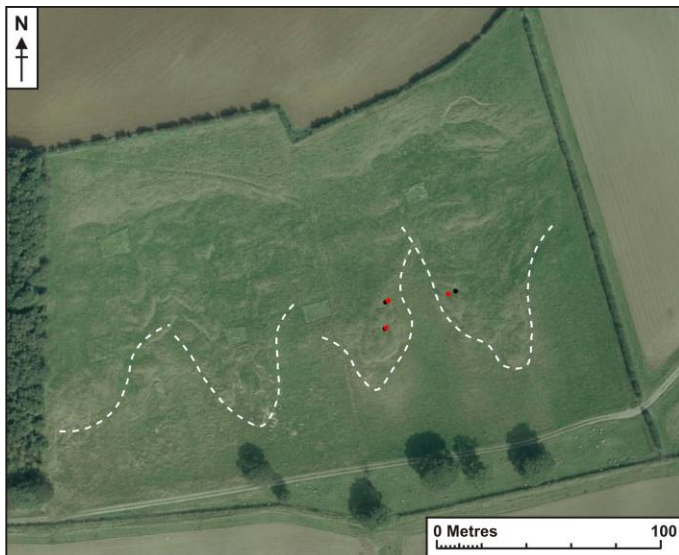
Figure 2. Aerial photograph of the Hollin Hill research site with the extent of the landslide lobes defined and the waveguides/inclinometer instrument locations marked (© UKP/Getmapping Licence No. UKP2008/01)

Three pairs of active waveguides and inclinometer casings have been installed through two of the lobes (Figures 2 and 3). The waveguides were installed in 130mm diameter holes to depths of 5.7 m below ground level. The waveguides comprise two 3.0 metre lengths of 50 mm diameter 3mm thick steel tubing connected with screw threaded couplings. The annulus around the steel tubing, which is located in the centre of the borehole, is backfilled with angular 5 to 10 mm gravel. This is placed in nominally 0.25 metre high lifts, each compacted before addition of the next lift. The top 0.3 metres of the borehole is backfilled with a bentonite grout plug to seal against the ingress of surface water. The steel tube extends 0.3 metres above ground level and is encased in a secure protective chamber (Figure 3). Inclinometer casings were installed approximately 1.0 metre from the waveguides with keyways orientated along the slope dip and strike directions. The inclinometer casings penetrate to a depth of 6 metres below ground level and the annulus around the casing is grouted using medium stiffness cement bentonite

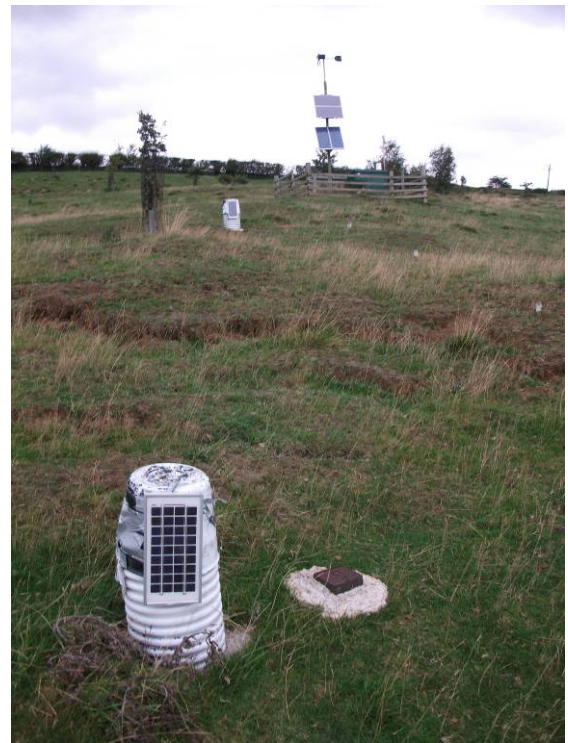
Figure 3. A view looking up the slope of the middle lobe with Cluster 1 acoustic waveguide protective cover and adjacent inclinometer casing in the foreground and Cluster 2 next to the small tree. BGS resistivity instrumentation compound and solar

power array is at the top of the photograph.

which is re-charged by a solar panel (Figure 3). Monitoring is continuous.

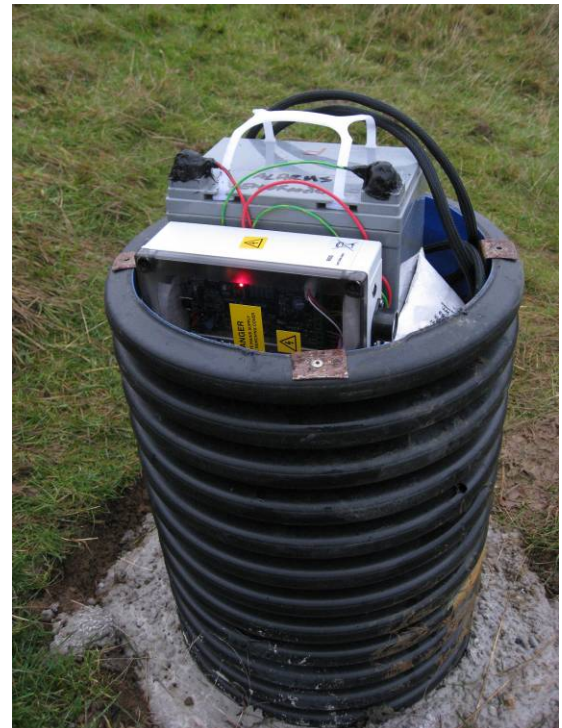
Figure 4. Acoustic emission sensor and battery

A unitary AE sensor is located inside the protective cover (Figure 4). A piezoelectric transducer is attached to the waveguide and linked to the sensor via a cable. The AE sensor is powered by a battery,

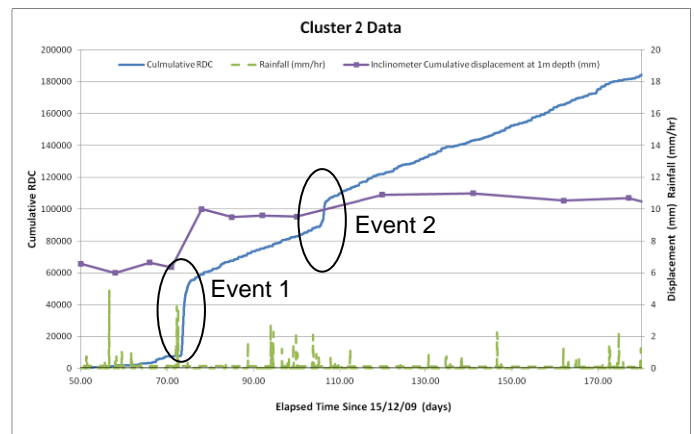
Figure 5 shows cumulative AE for Cluster 2, rainfall per hour and the cumulative inclinometer displacements at a depth of 1 metre. Of note are the steep rises in AE, labeled Events 1 and 2, which follow intensive periods of rainfall. These increased rates of generated AE are located in periods of slope deformation indicated by the inclinometer measurements. It is concluded that these increased rates of AE events, and other similar events recorded at the three clusters, are generated by slope deformations, and

Figure 5. Cumulative AE and cumulative displacements for Cluster 2 and hourly rainfall

hence that AE can be used as a measure of the timing and rate of slope displacement. As continuous measurements of deformation were not available, it is an assumption at this time that the steps in cumulative AE give the timing of the slope movements. However, the existence and timing of these events adds weight to the assumption. For example, measurements at Clusters 1 and 2 give AE events at exactly the same time, which is expected as they are located on the same lobe of the landslide. This hypothesis is being tested at other sites where continuous slope deformations are being measured using in-place inclinometers (Section 4).

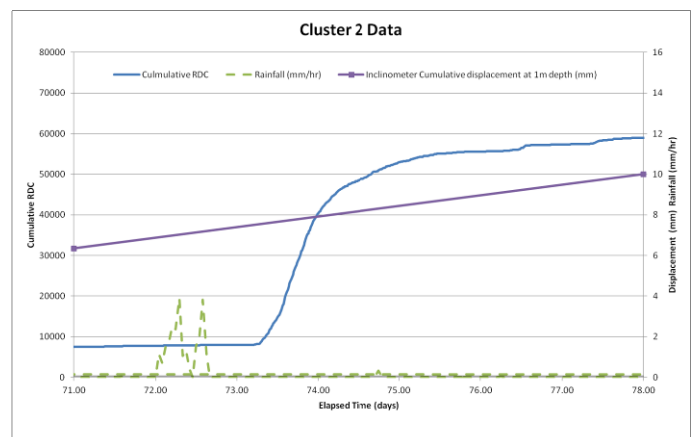
Figure 6 shows Event 1 at a larger scale. It can be seen that the start of AE generation is about 30 hours after the preceding rainfall event commenced. The AE rate rapidly increases, denoted by the slope of the cumulative AE vs. time relationship, and then slowly decreases, giving an 'S' shaped curve. This shape is produced by all of the AE events that are believed to be generated by slope deformations.

Figure 6. Cumulative AE for event 1, Cluster 2

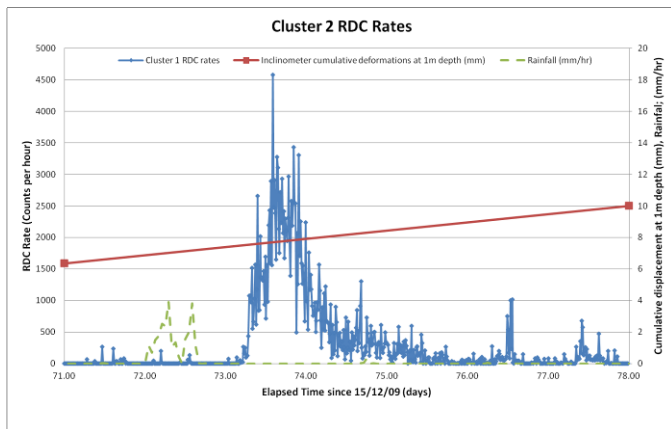
The AE ring down count rate per hour for Event 1 is shown in Figure 7. The bell shaped relationship is produced by the 'S' shaped cumulative AE measurements and is typical of the events monitored. For

this event the RDC relationship is log normal but in some of the other events it is closer to a normal distribution.

Figure 7. AE ring down count rate for event 1, Cluster 2
