# Stress Corrosion Cracking of Low Pressure Steam Turbine Blade and Rotor Materials

Claire Louise Verona

A doctoral thesis submitted in partial fulfilment of the requirements  
for the award of Doctor of Philosophy

September 2010

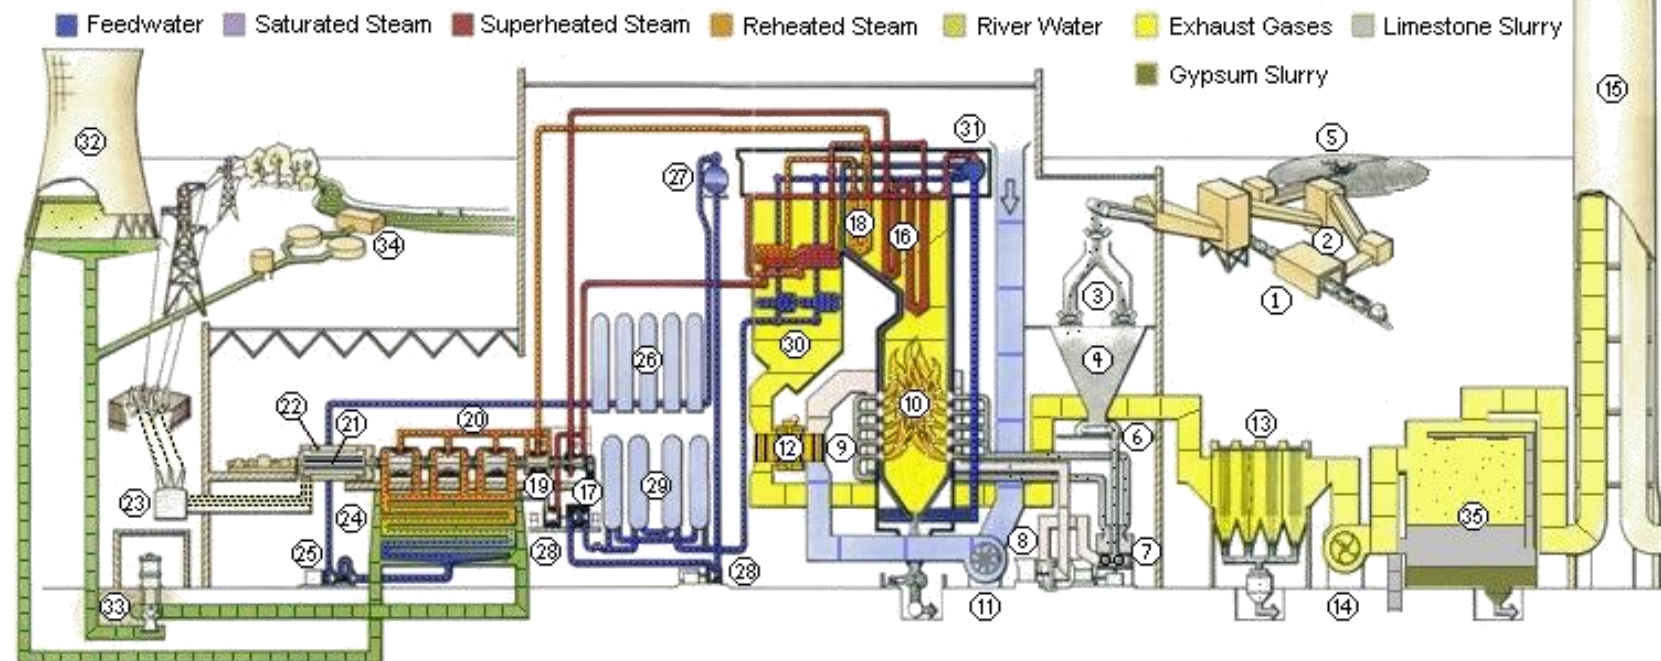
Figure 2.1: Schematic of Drax power station showing the successive stages of power generation (<http://www.draxpower.com>, viewed 20/04/2007).

1. Rail Unloading House	2. Junction House	3. Coal Conveyor	4. Boiler Coal Bunker	5. Bucket Wheel Machine
6. Coal Feeder	7. Pulverising Mill	8. Primary Air Fan	9. Boiler Burners	10. Boiler
11. Forced Draught Fan	12. Air Heater	13. Electrostatic Precipitator	14. Induced Draught Fan	15. Main Chimney
16. Superheater	17. High Pressure Turbine	18. Boiler Reheater	19. Intermediate Pressure Turbine	20. Low Pressure Turbine
21. Rotor	22. Stator	23. Generator Transformer	24. Condenser	25. Condensate Extraction Pump
26. Low Pressure Feed Heaters	27. Deaerator	28. Boiler Feed Pump	29. High Pressure Feed Heaters	30. Economiser
31. Steam Drum	32. Cooling Tower	33. Circulating Water Pumps	34. Circulating Water Make-Up	35. FGD Absorber Tower

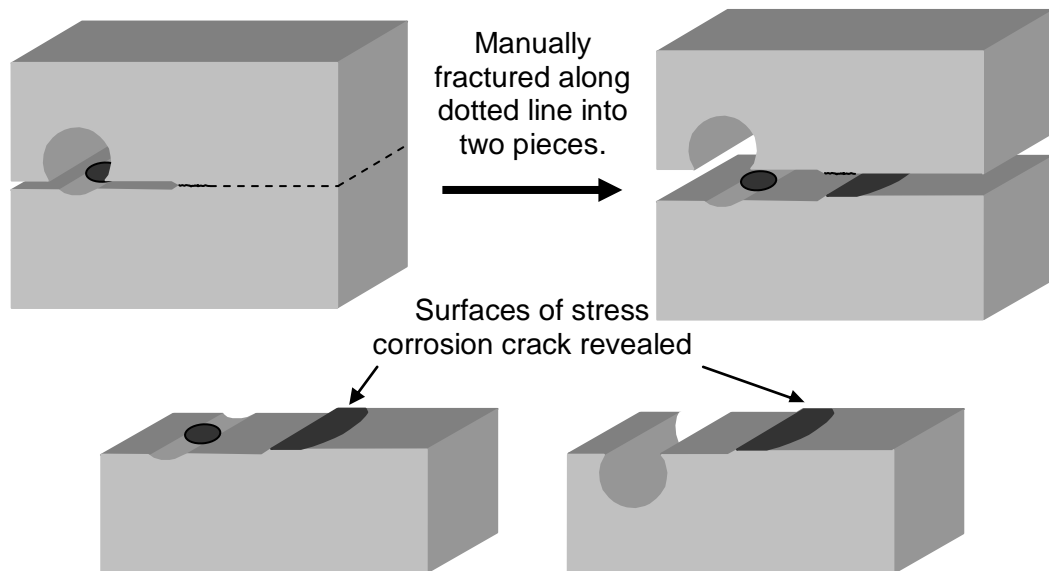
**Figure 3.2: Schematic showing how the WOL specimens were fractured into two pieces to facilitate examination of the stress corrosion crack surface.**

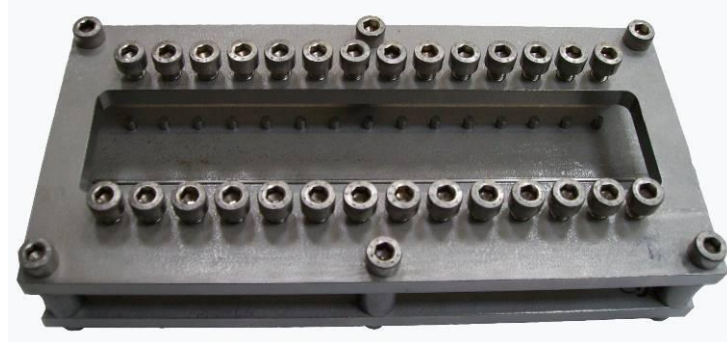
**Figure 3.8: Three point bending jig used to stress SENB specimens whilst exposed to condensing steam at 95°C.**

Preliminary tests were carried out on one SENB specimen to confirm the conditions required for the remaining specimens. The optimum conditions were determined to be 40,000 cycles at 5 Hz with a calculated load of 15 kN to achieve an initial  $K$  of  $30 \text{ MPam}^{1/2}$ . Specimens were stressed in a custom made three-point bend jig (Figure 3.8) and placed in a oven maintained with condensing steam at  $95^\circ\text{C}$  for times of 730, 1460, 2920, 4380, 5840, 7300 and 8760 h, which equate to 1, 2, 4, 6, 8, 10 and 12 months.

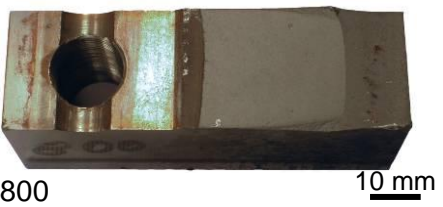
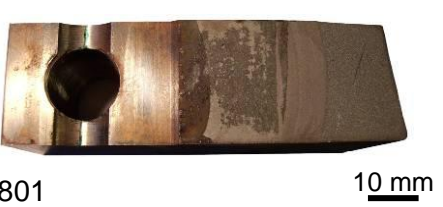
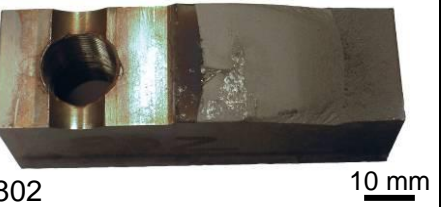
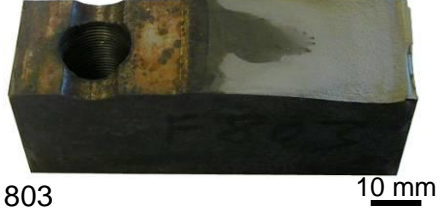
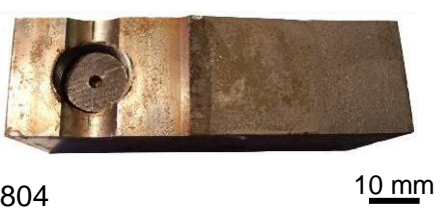
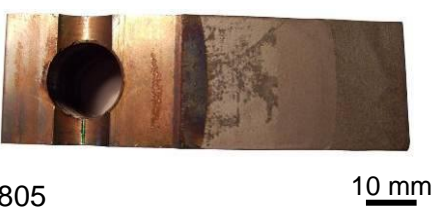
**Figure 4.1: Half WOL specimens in the as-received condition after exposure to condensing steam at 95°C and subsequent fracture into two pieces (The exposure time and proof strengths are labelled).**

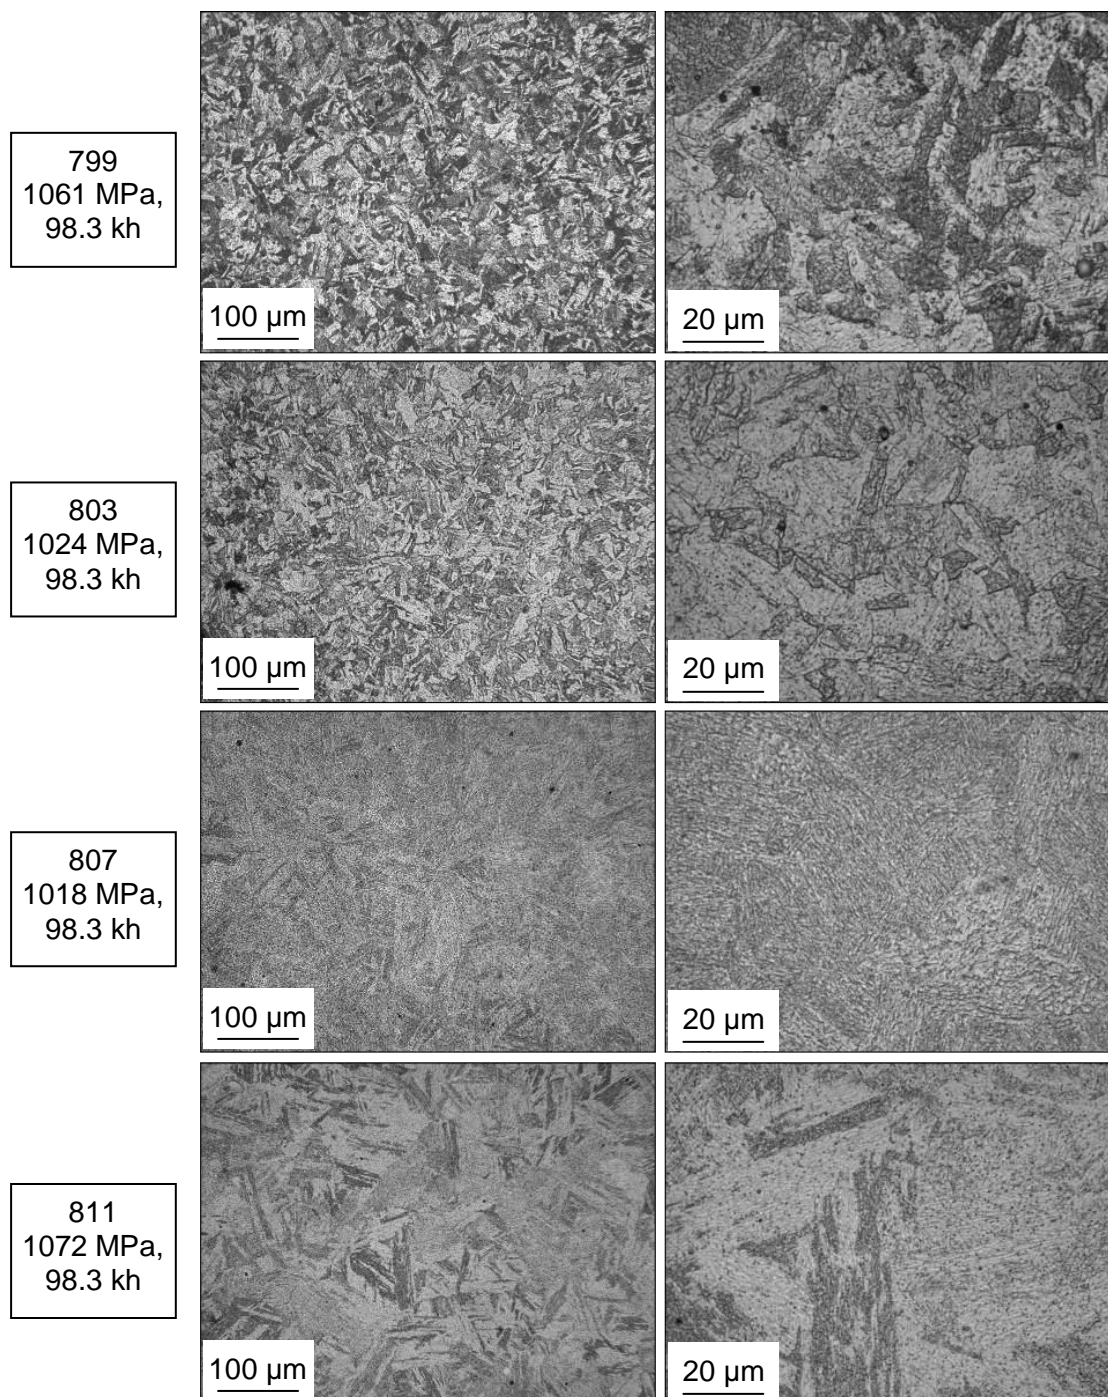
**Figure 4.2: Optical micrographs showing the substrate microstructure at two magnifications for one specimen of each proof strength: 799 (1061 MPa, 98.3 kh), 803 (1024 MPa, 98.3 kh), 807 (1018 MPa, 98.3 kh) and 811 (1072 MPa, 98.3 kh).**

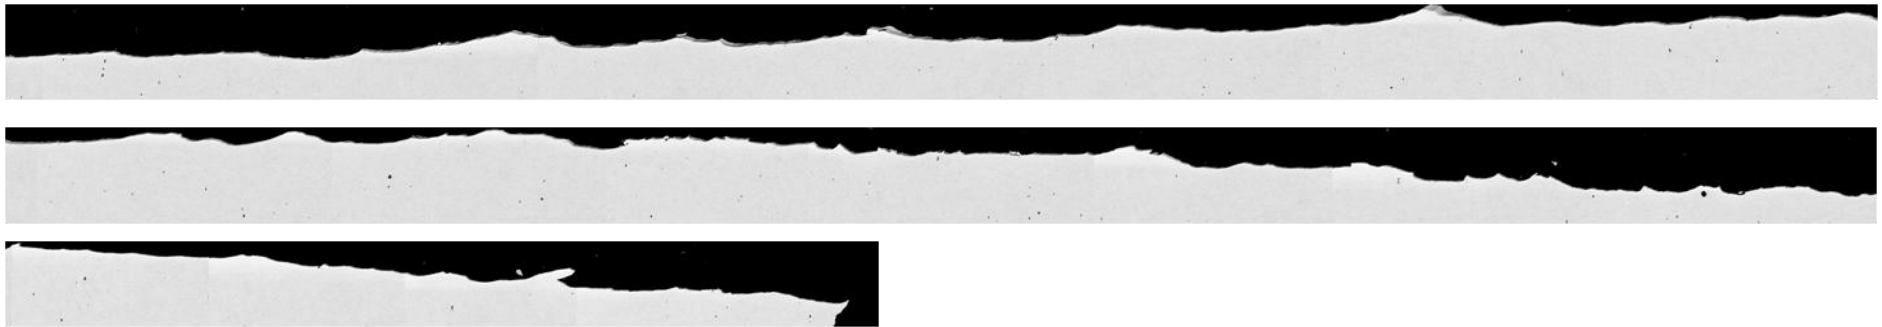
**Figure 4.3: Composite of backscattered electron micrographs showing the full length of the stress corrosion crack through specimen 799 (1061 MPa, 98.3 kh)**

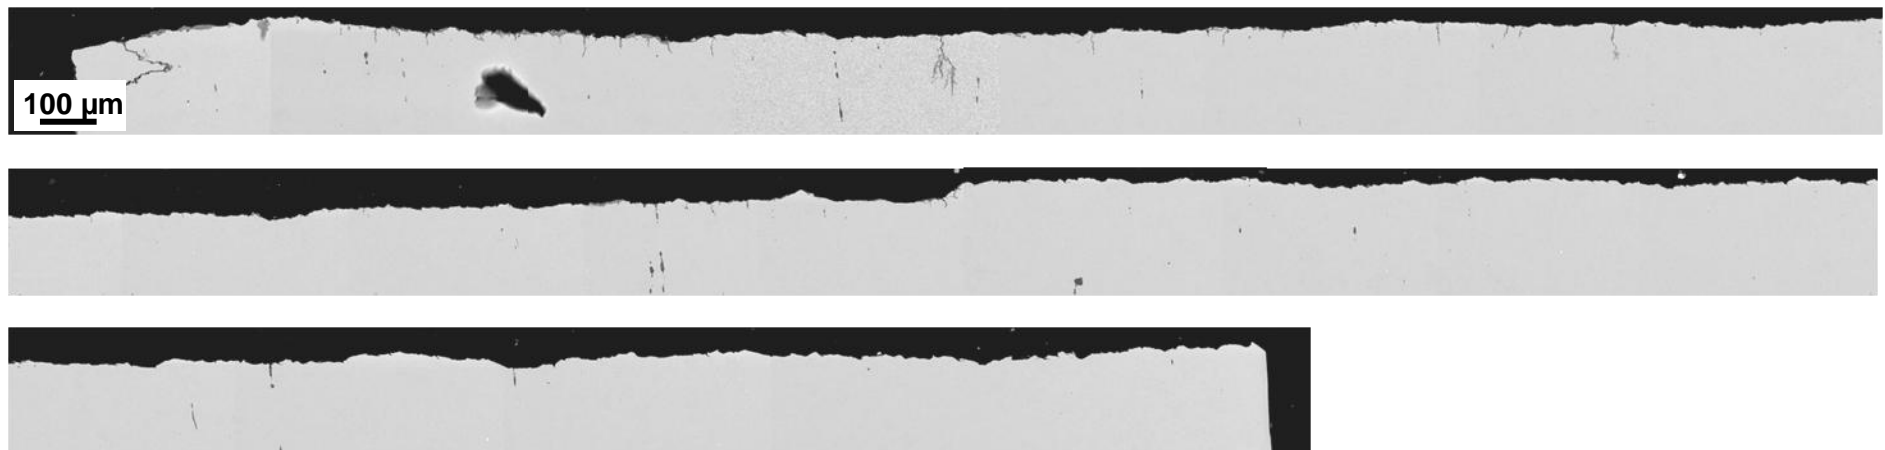
**Figure 4.4: Composite of backscattered electron micrographs showing the full length of the stress corrosion crack through specimen 803 (1024 MPa, 98.3 kh)**

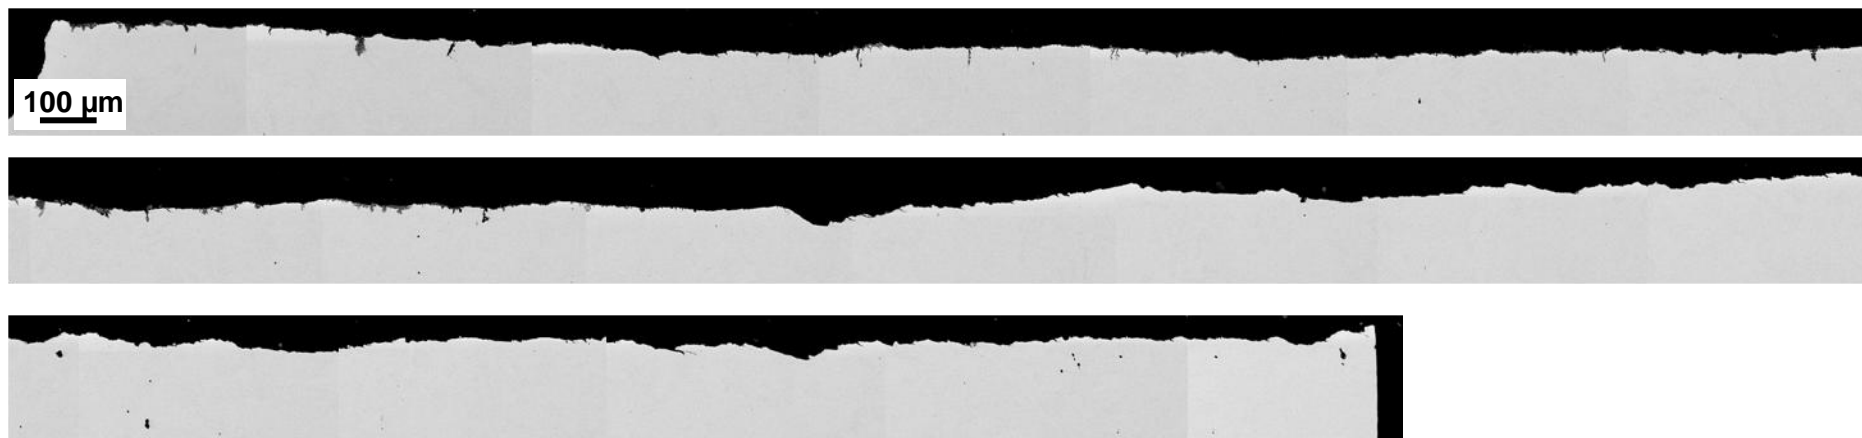
**Figure 4.5: Composite of backscattered electron micrographs showing the full length of the stress corrosion crack through specimen 807 (1018 MPa, 98.3 kh)**

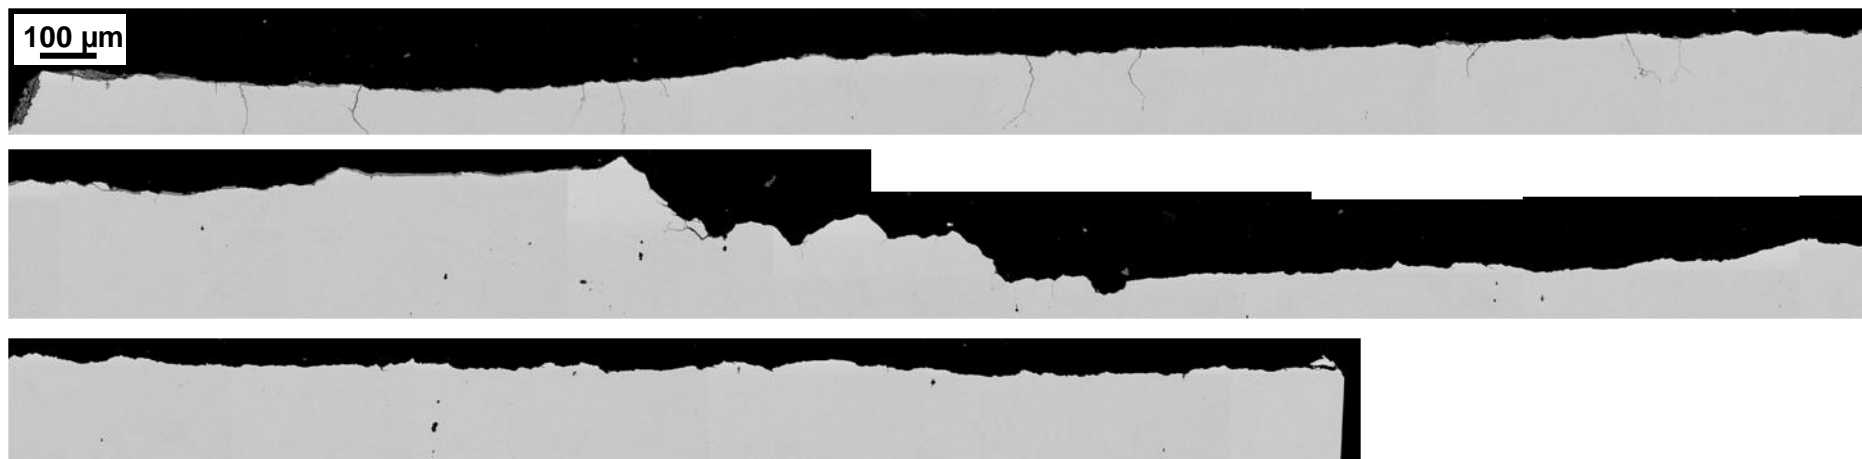
**Figure 4.6: Composite of backscattered electron micrographs showing the full length of the stress corrosion crack through specimen 811 (1072 MPa, 98.3 kh)**

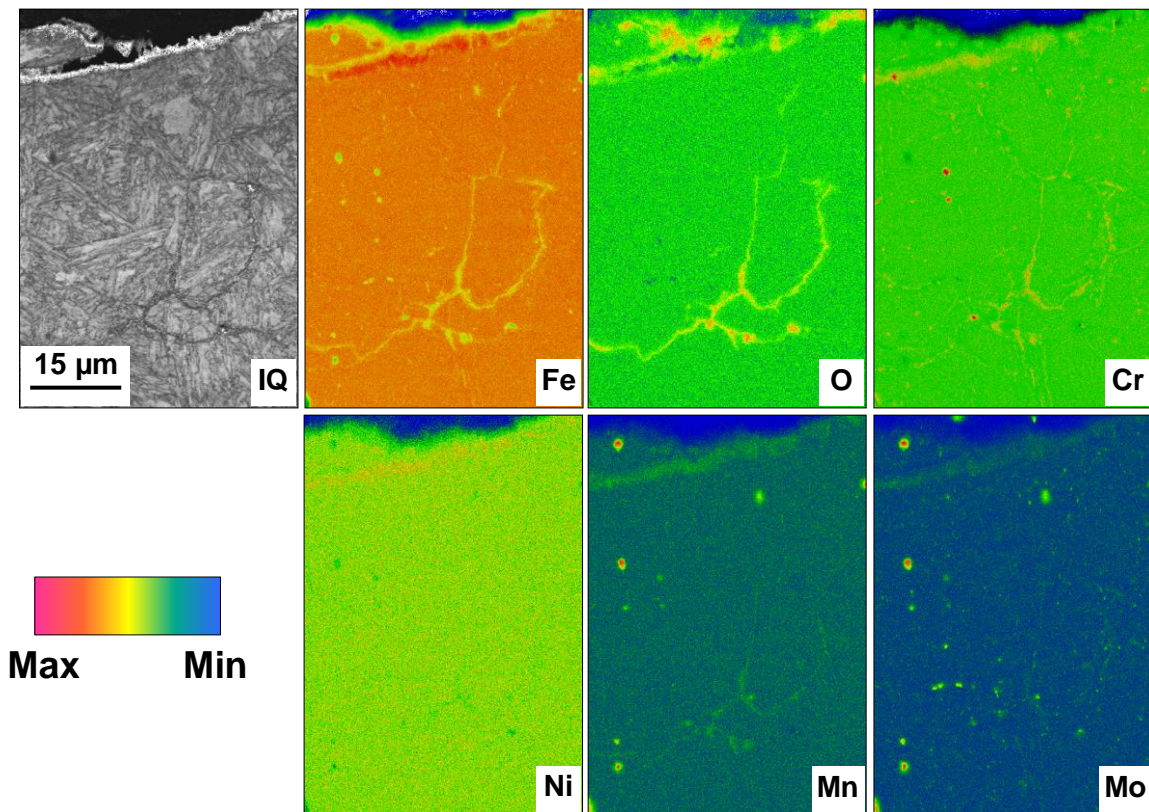
**Figure 4.10: Image Quality map with accompanying rainbow EDS maps showing the chemical distribution within substrate crack branching in specimen 799 (1061 MPa, 98.3 kh).**

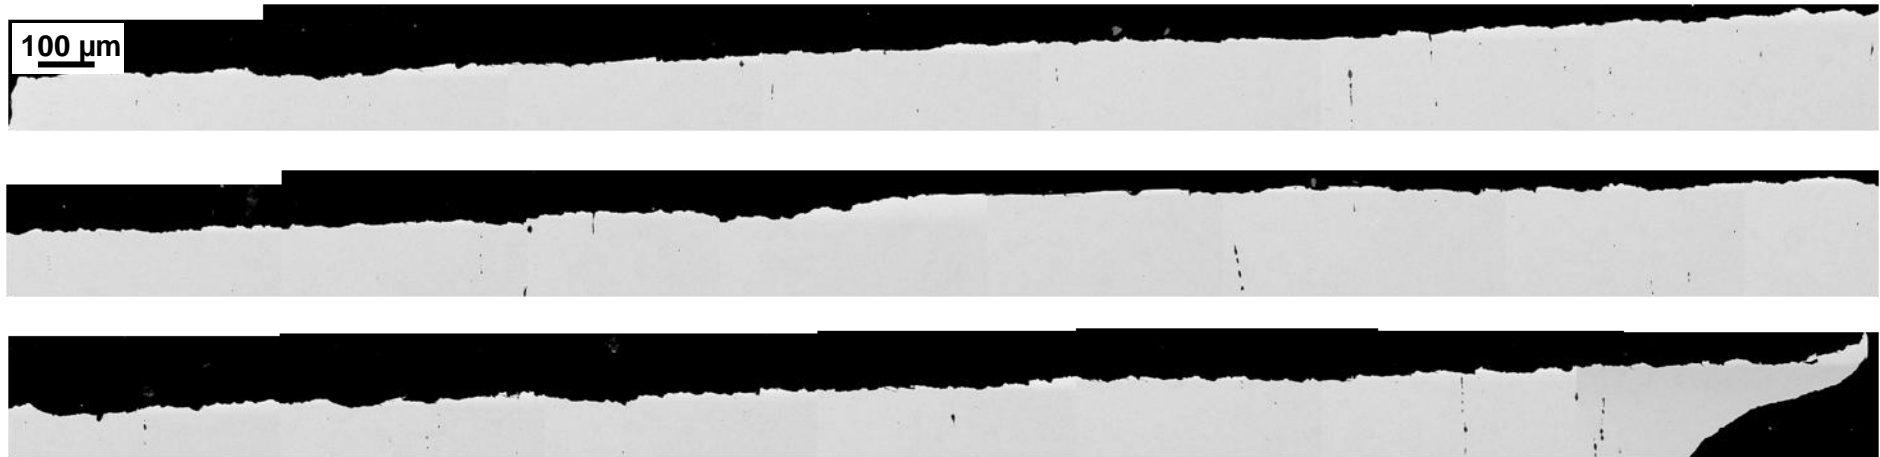
*Figure 4.11: Composite of backscattered electron micrographs showing the full length of the stress corrosion crack through specimen 800 (1061 MPa, 13.0 kh)*

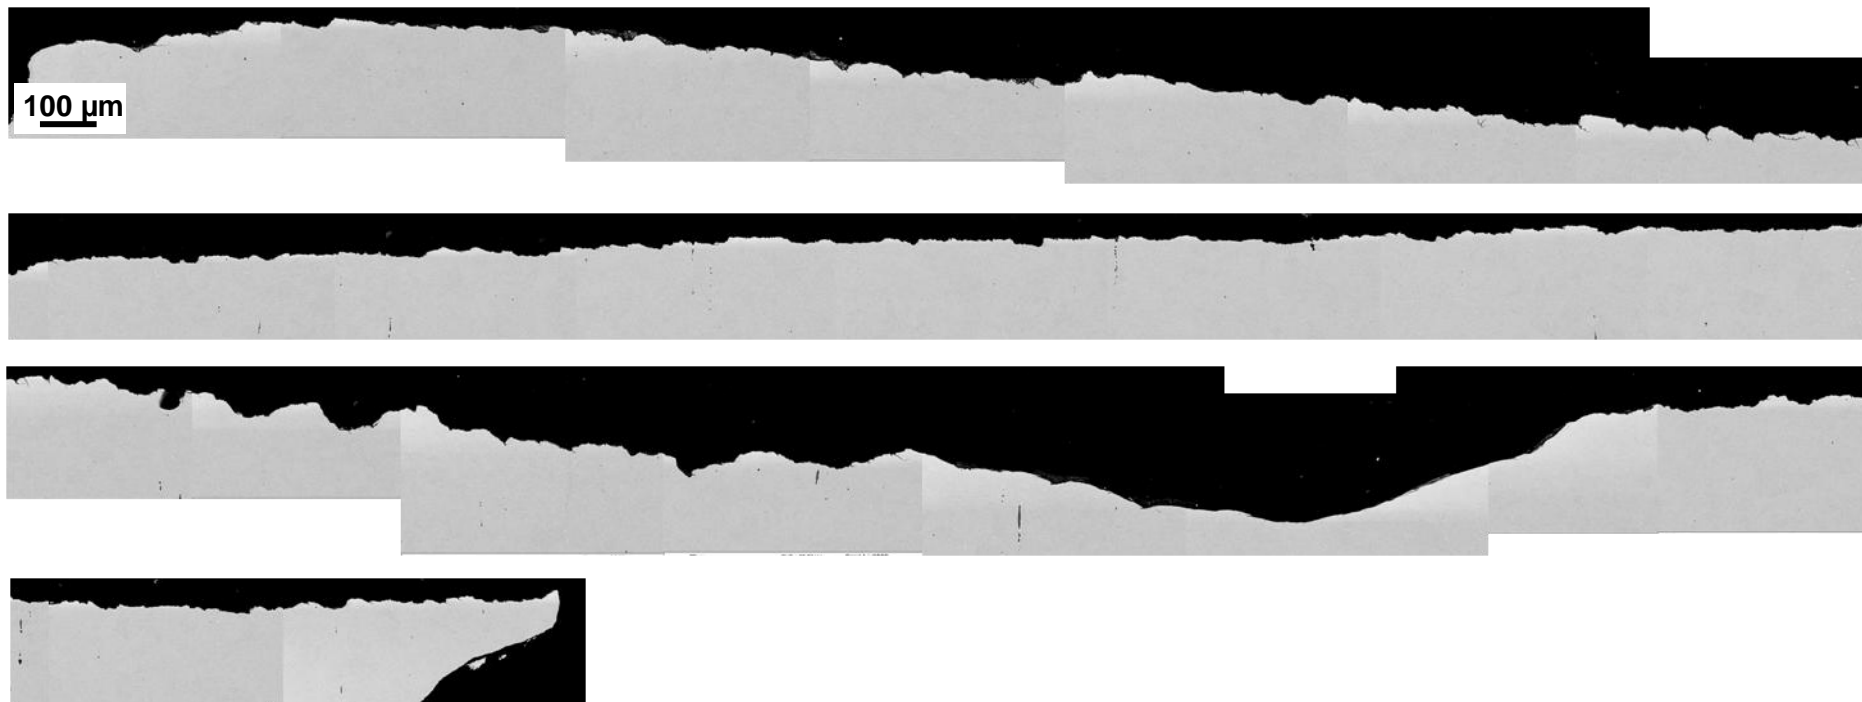
**Figure 4.13: Composite of backscattered electron micrographs showing the full length of the stress corrosion crack through specimen 802 (1061 MPa, 7.5 kh)**

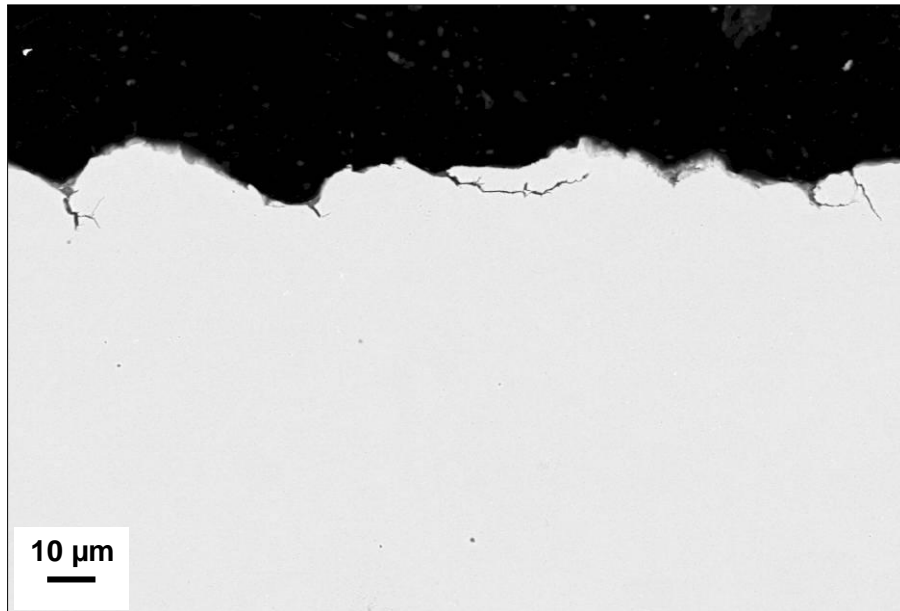
**Figure 4.14: Backscattered electron micrograph showing substrate cracks along a stress corrosion crack through a sample exposed to condensing steam at 95°C for 7.5 kh.**

A typical region of the cross section through the 7.5 kh sample is shown in Figure 4.14. In this micrograph there is little oxide visible along the crack surface, however, there are numerous cracks penetrating the substrate some of which are branched, with lengths that vary between 5 μm and 25 μm. The general direction of the cracks from initiation to tip is diagonally down and to the right, which is consistent with the growth direction of the main crack.

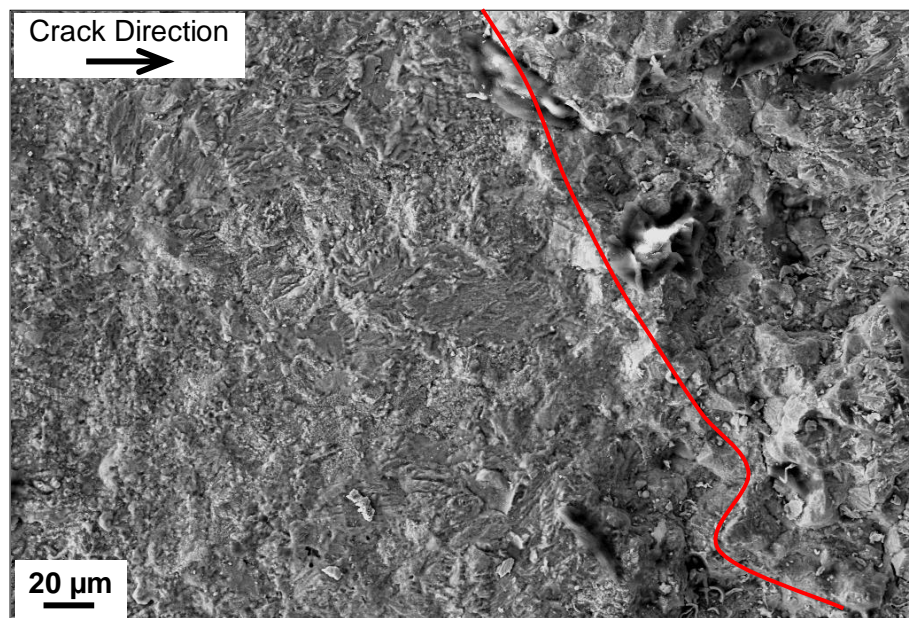
**Figure 4.17: Secondary electron micrograph showing the surface of the stress corrosion crack in specimen 803 (1024 MPa, 98.3 kh) leading up to the fatigue pre-crack tip, which is highlighted by the solid red line.**

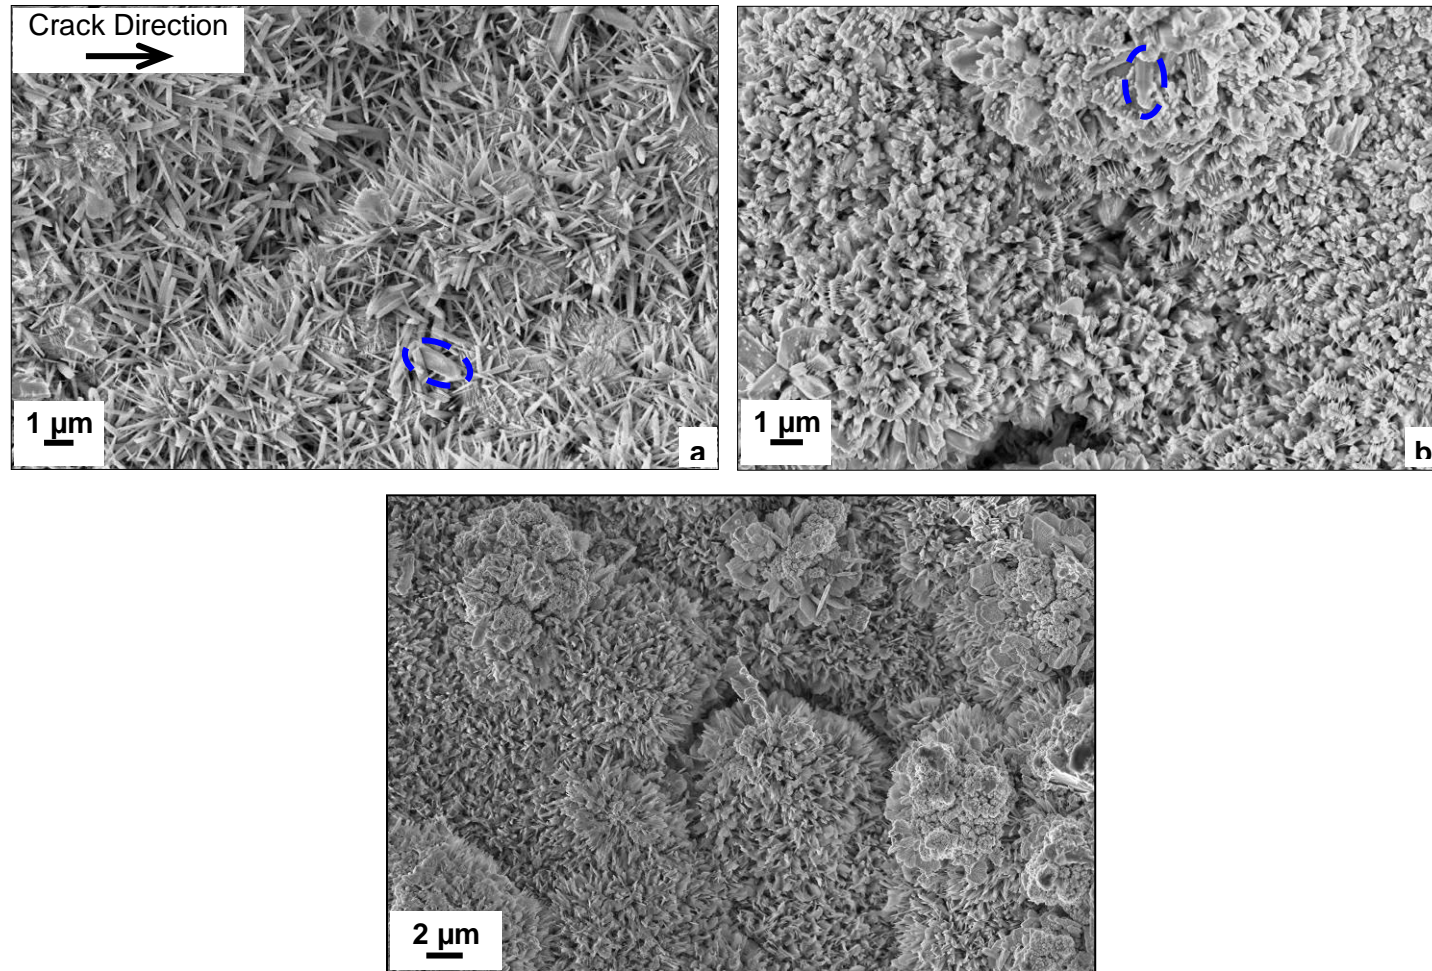
**Figure 4.20:** Secondary electron micrographs showing the surface of specimen 799 with (a and b) randomly orientated needle-like oxide morphologies and (c) clusters of needle-like oxide morphologies radiating from central points.

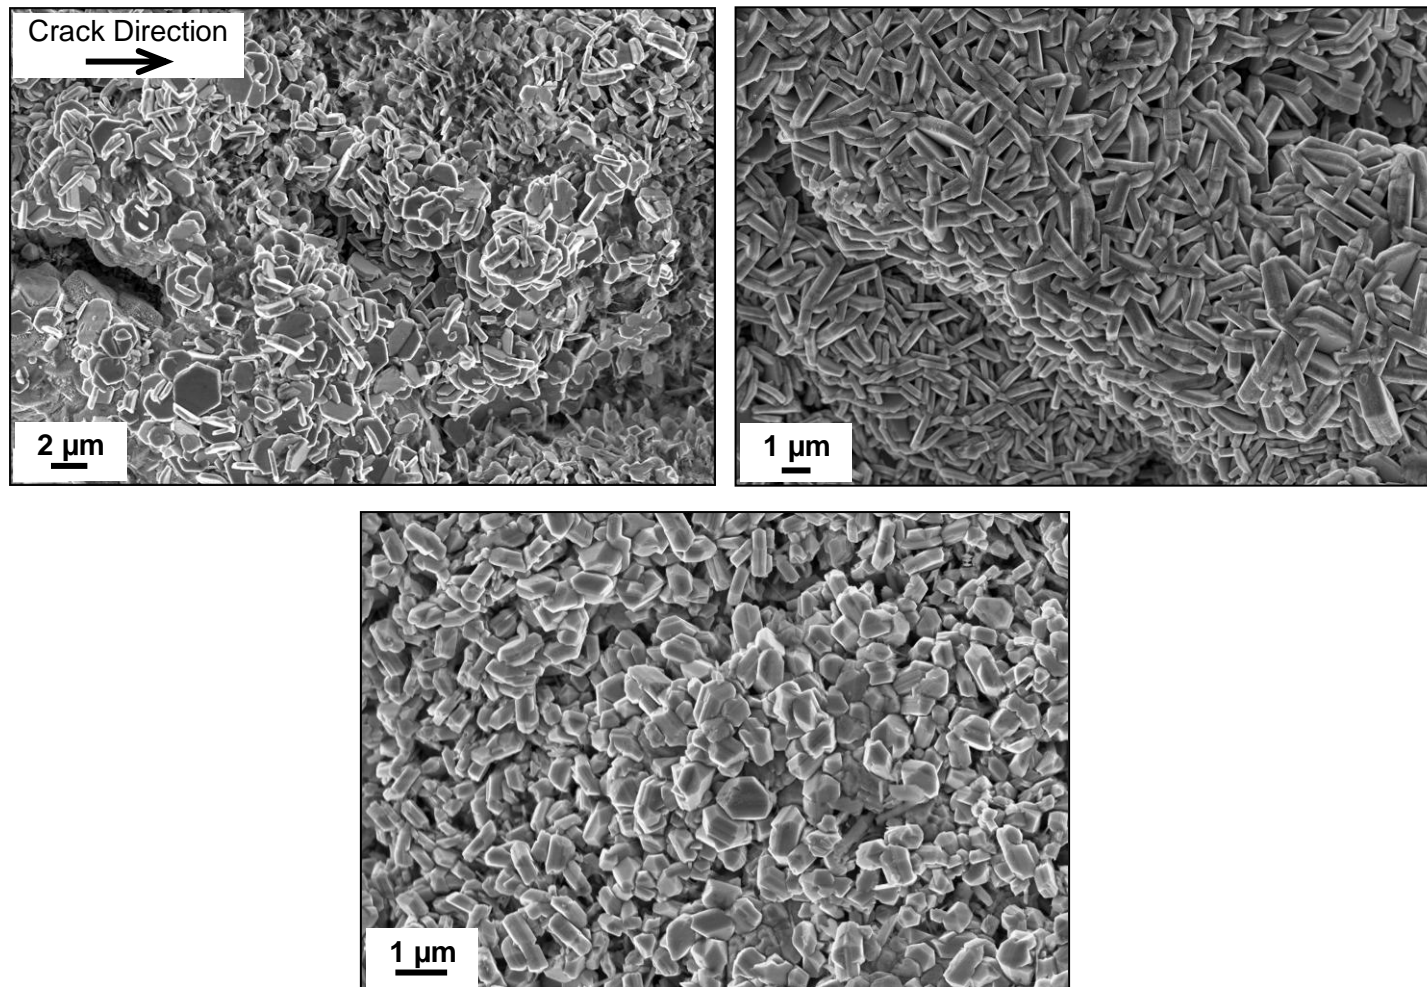
**Figure 4.21: Secondary electron micrographs showing (a) faces, (b) edges and (c) misshapen hexagonal platelet oxide morphologies on the surface of specimen 799.**

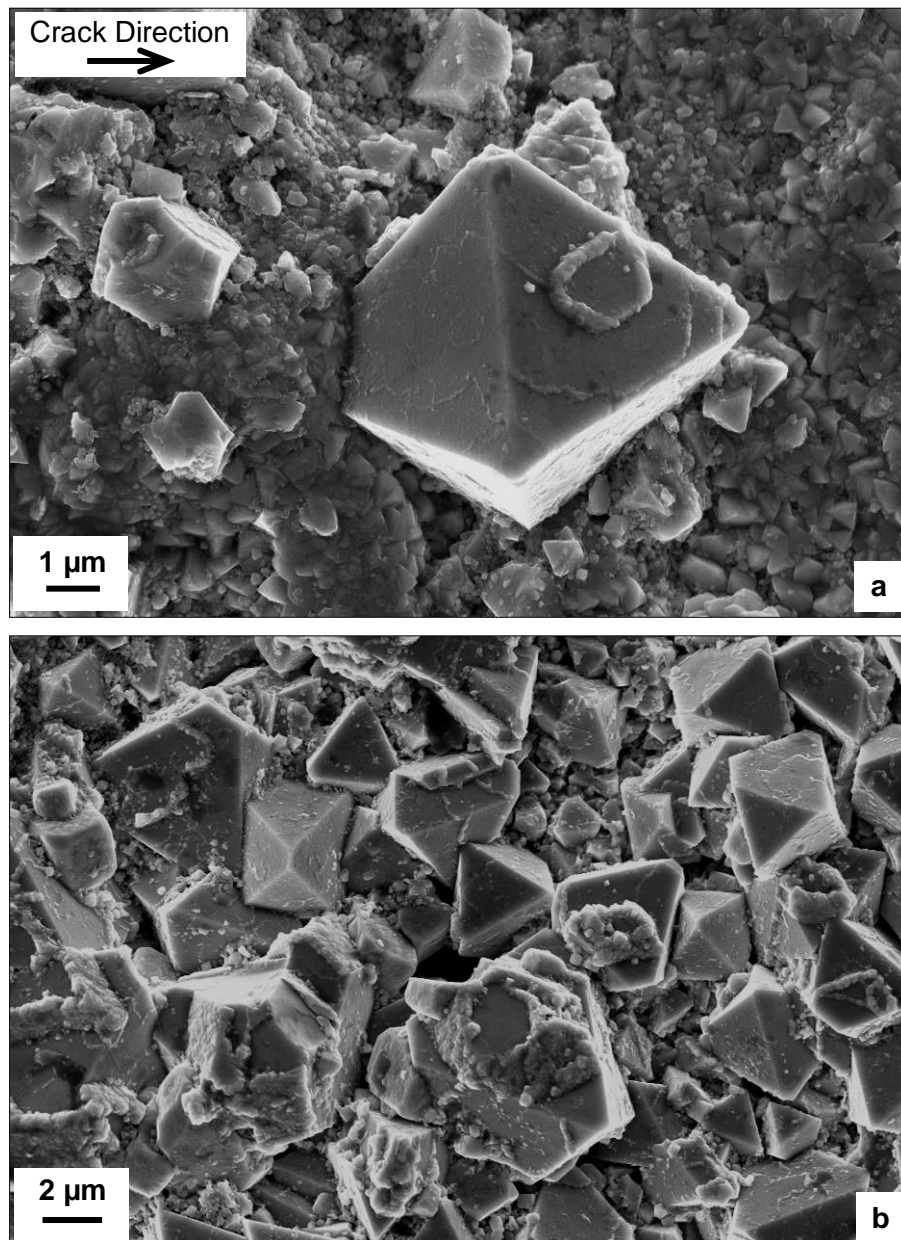
**Figure 4.22: Secondary electron micrographs showing (a) an individual octahedron oxide crystal and (b) octahedral oxide crystals over a region of the crack surface of specimen 799 (1061 MPa, 98.3 kh).**

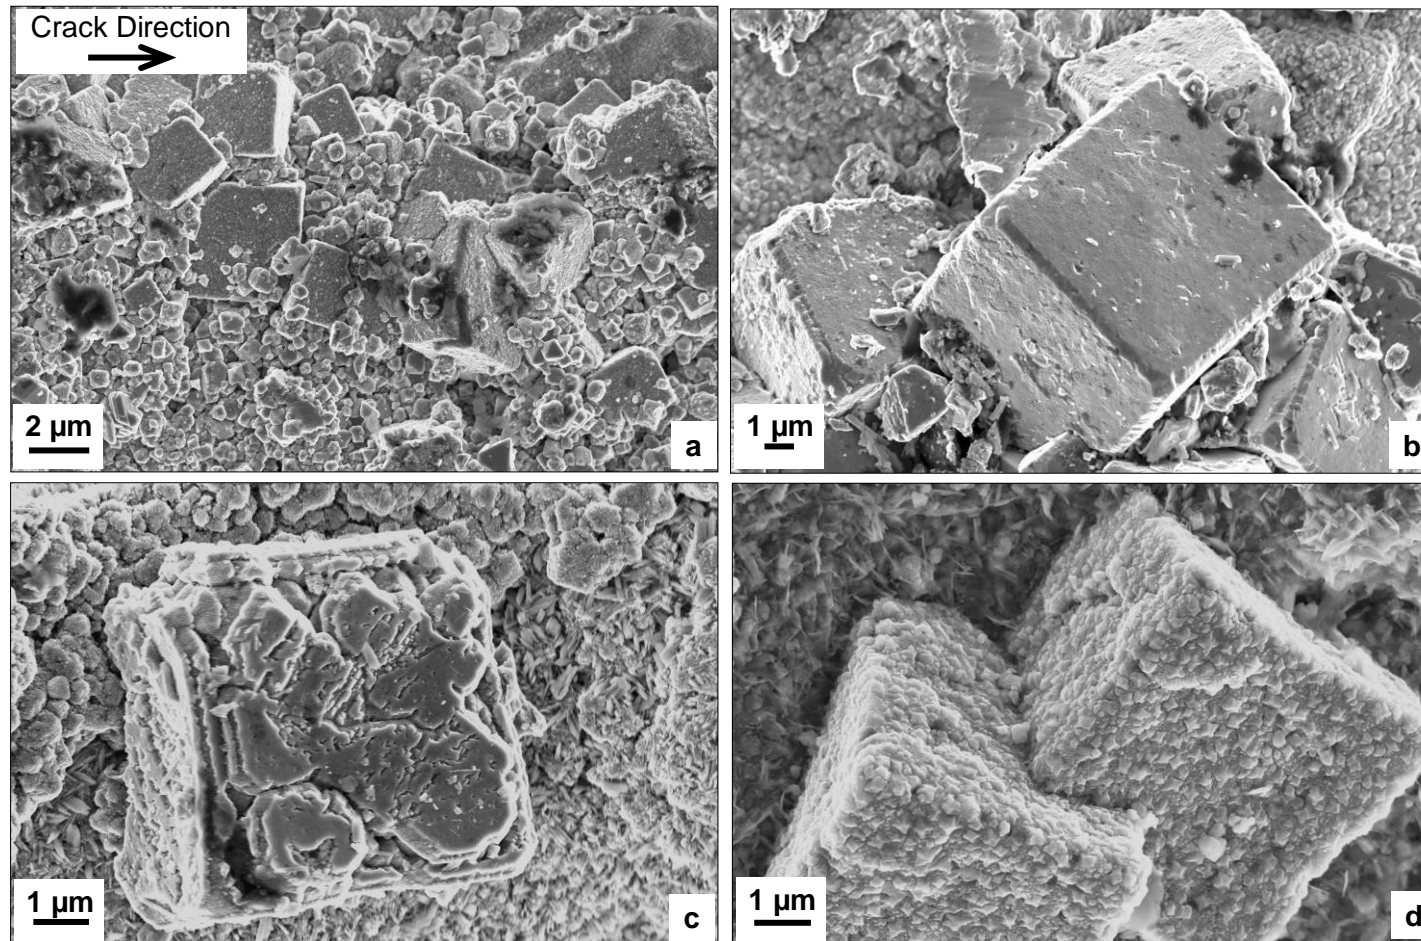
**Figure 4.23: Secondary electron micrographs showing cubic oxide crystals on the crack surface of specimens exposed to condensing steam at 95°C for 98.3 kh; (a) densely packed region of cubic oxide grains, (b) oxide crystals with relatively smooth faces, (c) oxide crystal within complete surfaces and (d) oxide crystals with raised surfaces.**

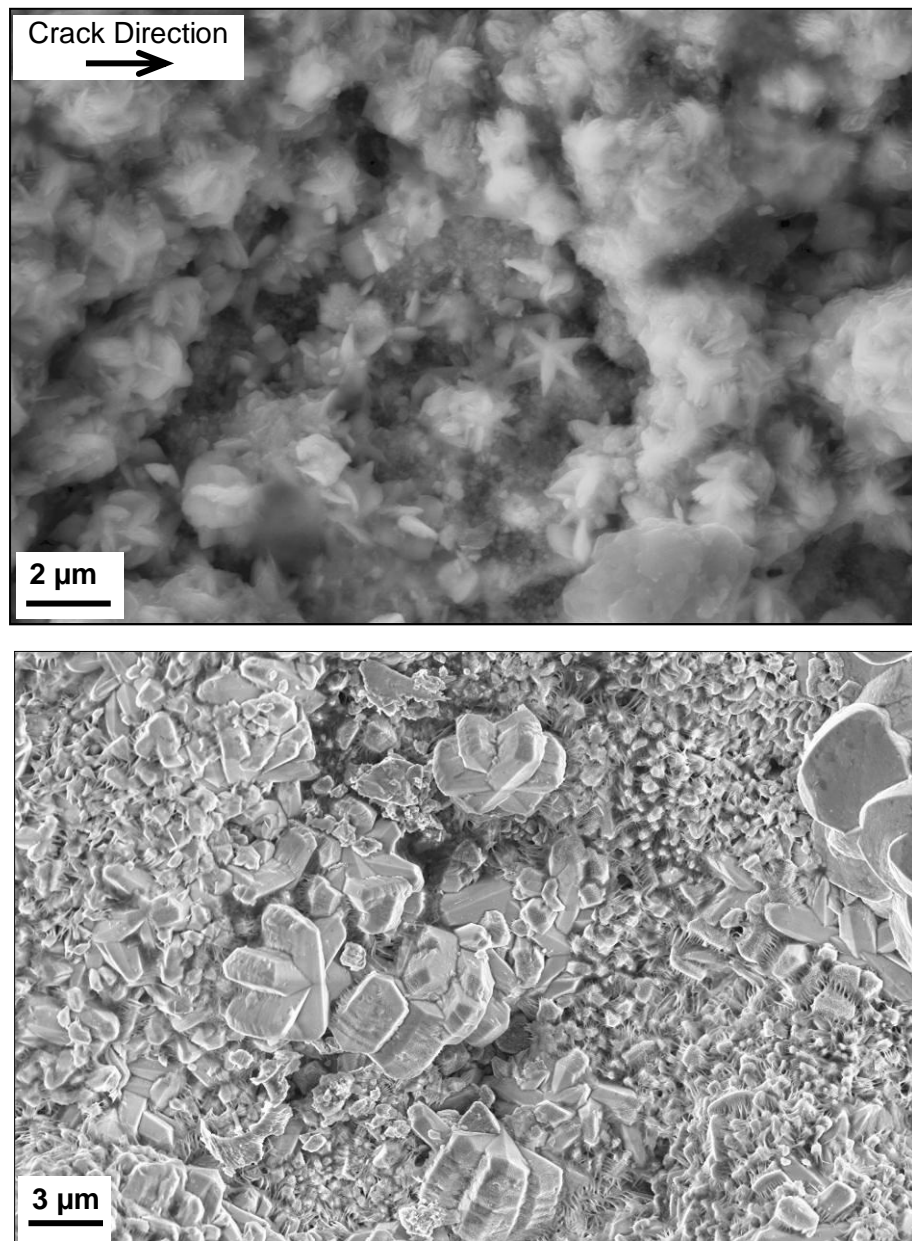
**Figure 4.25: Secondary electron micrograph of asterisk oxide morphology on the crack surface of (a) specimen 803 (1024 MPa) and (b) specimen 799 (1061 MPa).**

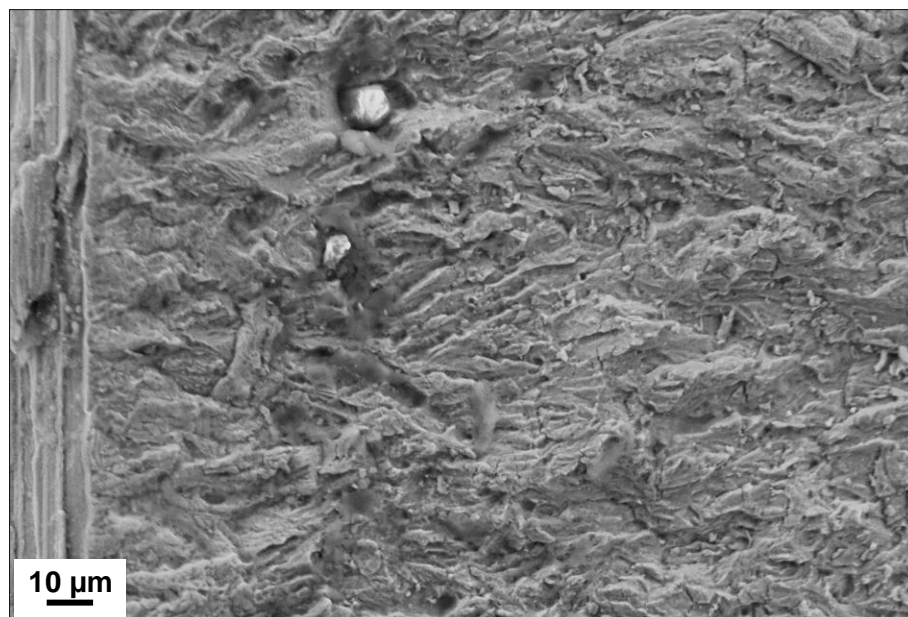
**Figure 4.26: Secondary electron micrograph showing the crack initiation region of specimen 804.**

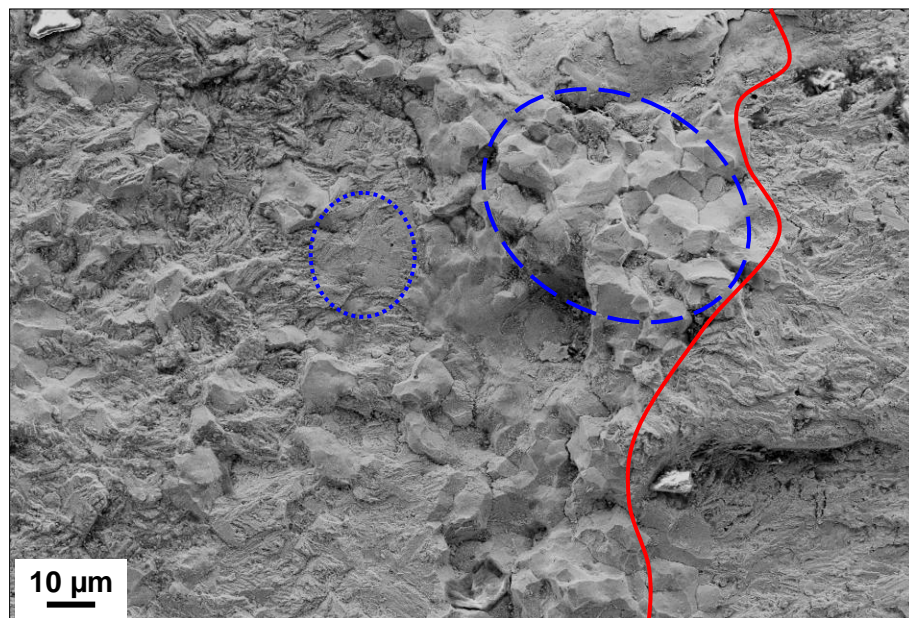
**Figure 4.28: Secondary electron micrograph showing the crack tip region of specimen 800 (1061 MPa, 13.0 kh).**

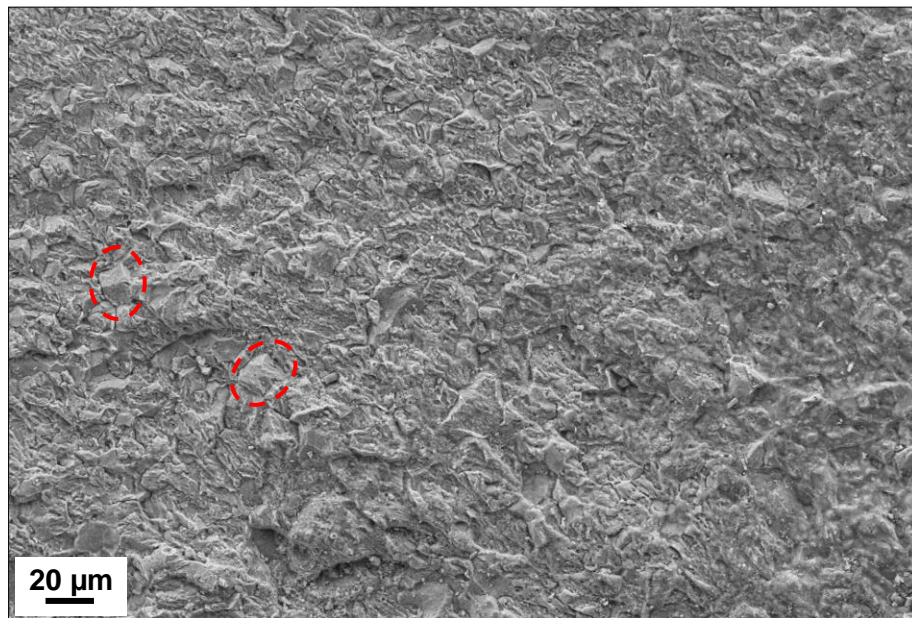
**Figure 4.29: Secondary electron micrograph showing a typical region of the crack surface of specimen 801 (1061 MPa, 9.8 kh).**

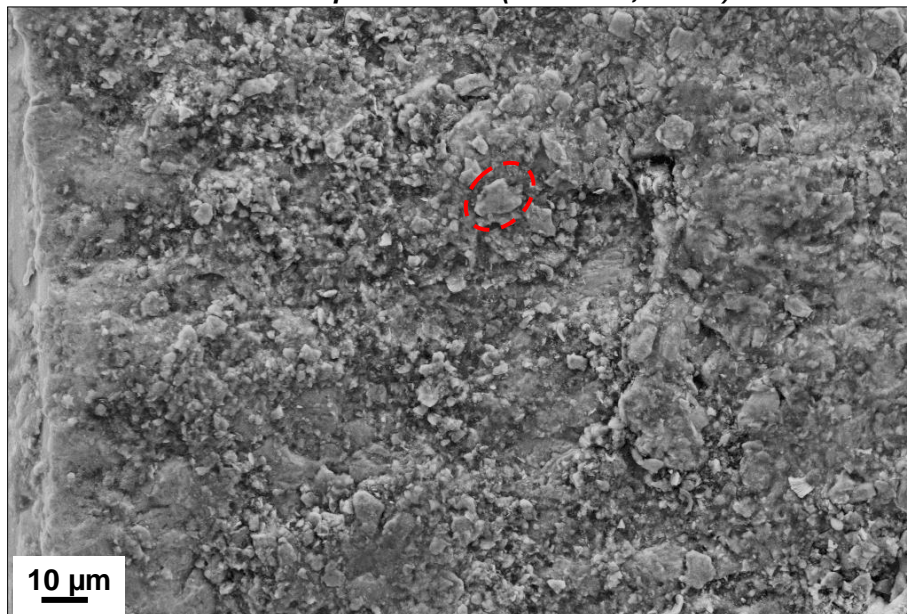
**Figure 4.30: Secondary electron micrograph showing the oxide at the crack initiation of specimen 801 (1061 MPa, 9.8 kh).**

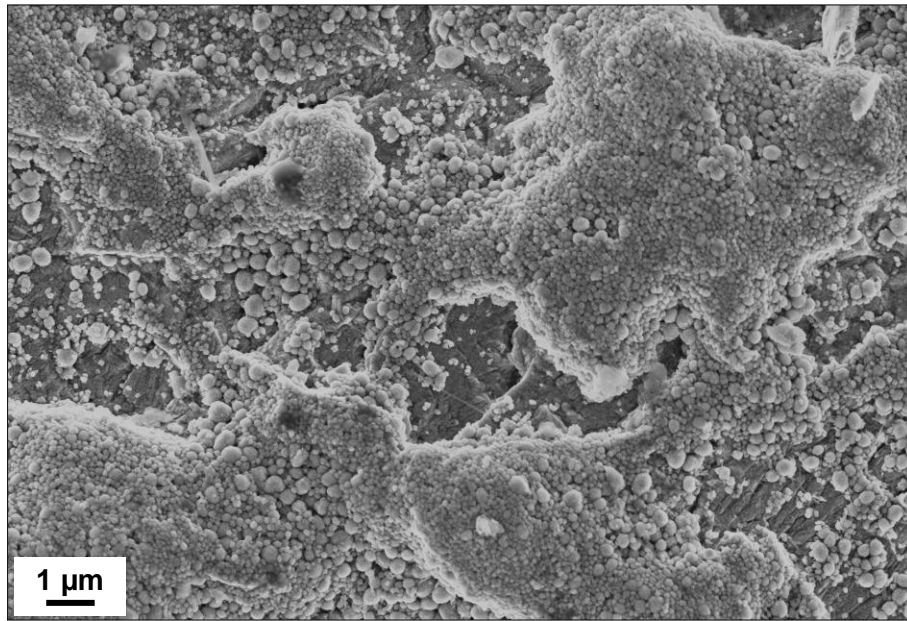
**Figure 4.31: Secondary electron micrograph showing balls of oxide on the crack surface of specimen 801 (1061 MPa, 9.8 kh).**
