# Stress Corrosion Cracking of Low Pressure Steam Turbine Blade and Rotor Materials

Claire Louise Verona

A doctoral thesis submitted in partial fulfilment of the requirements  
for the award of Doctor of Philosophy

September 2010

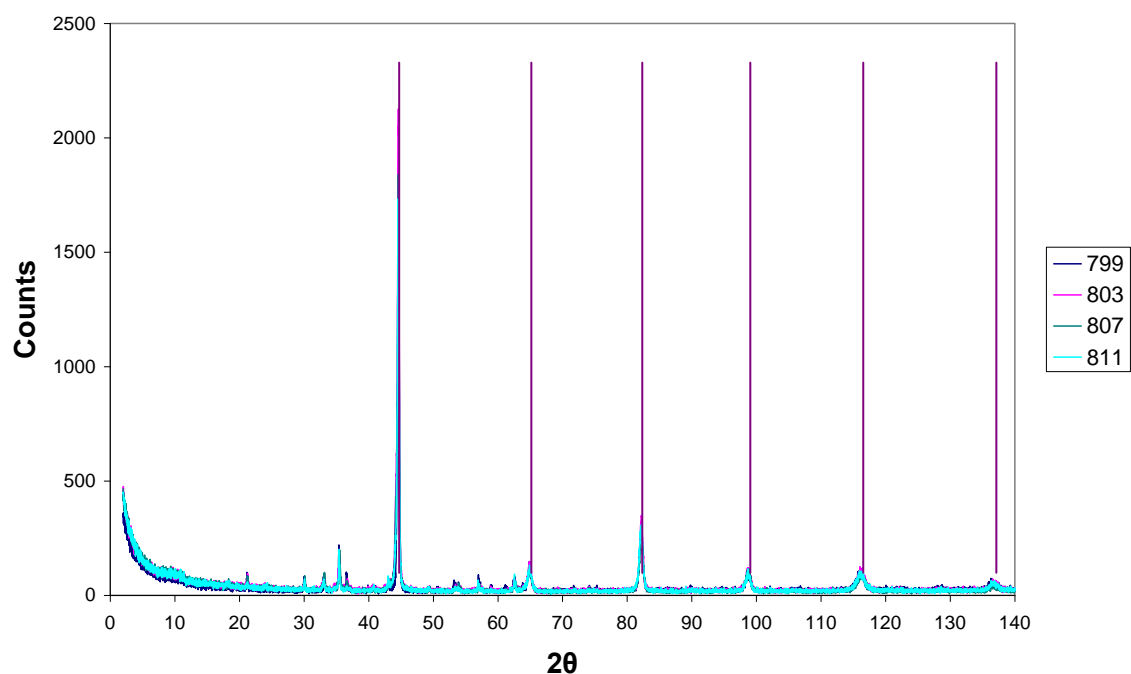
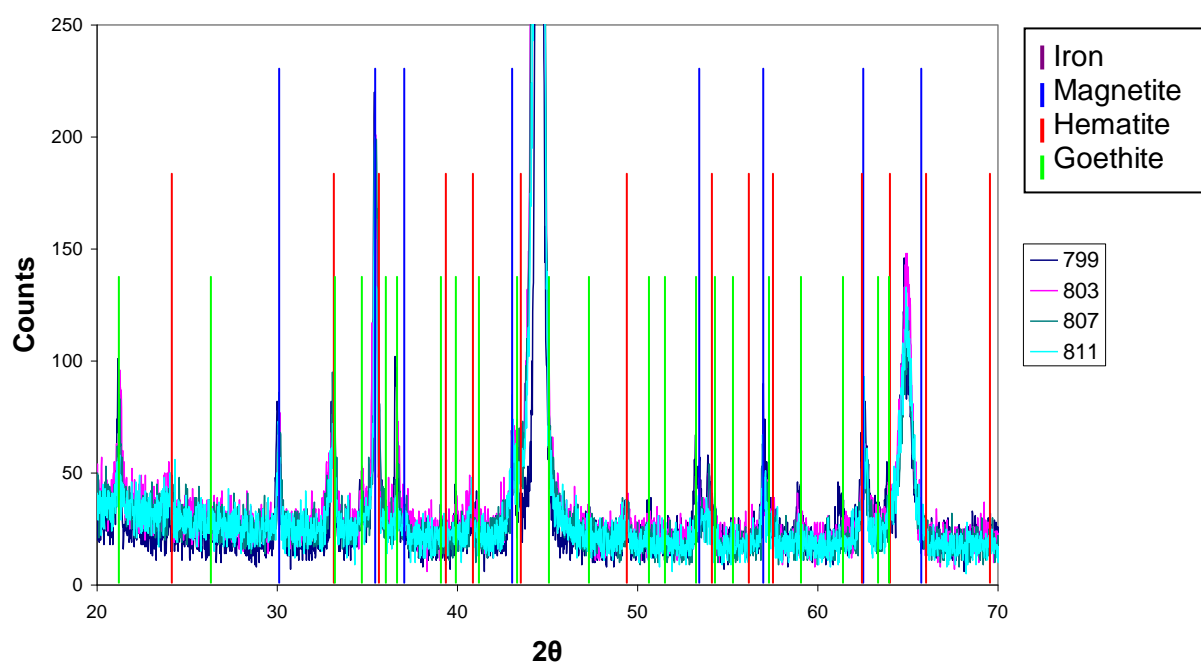
**Figure 4.34: XRD data for samples 799, 803, 807 and 811 exposed to condensing steam at 95°C for 98.3 kh showing (a) all the peaks between 2 and 140° and (b) 20-70° focusing on the peaks not accounted for by the substrate.**

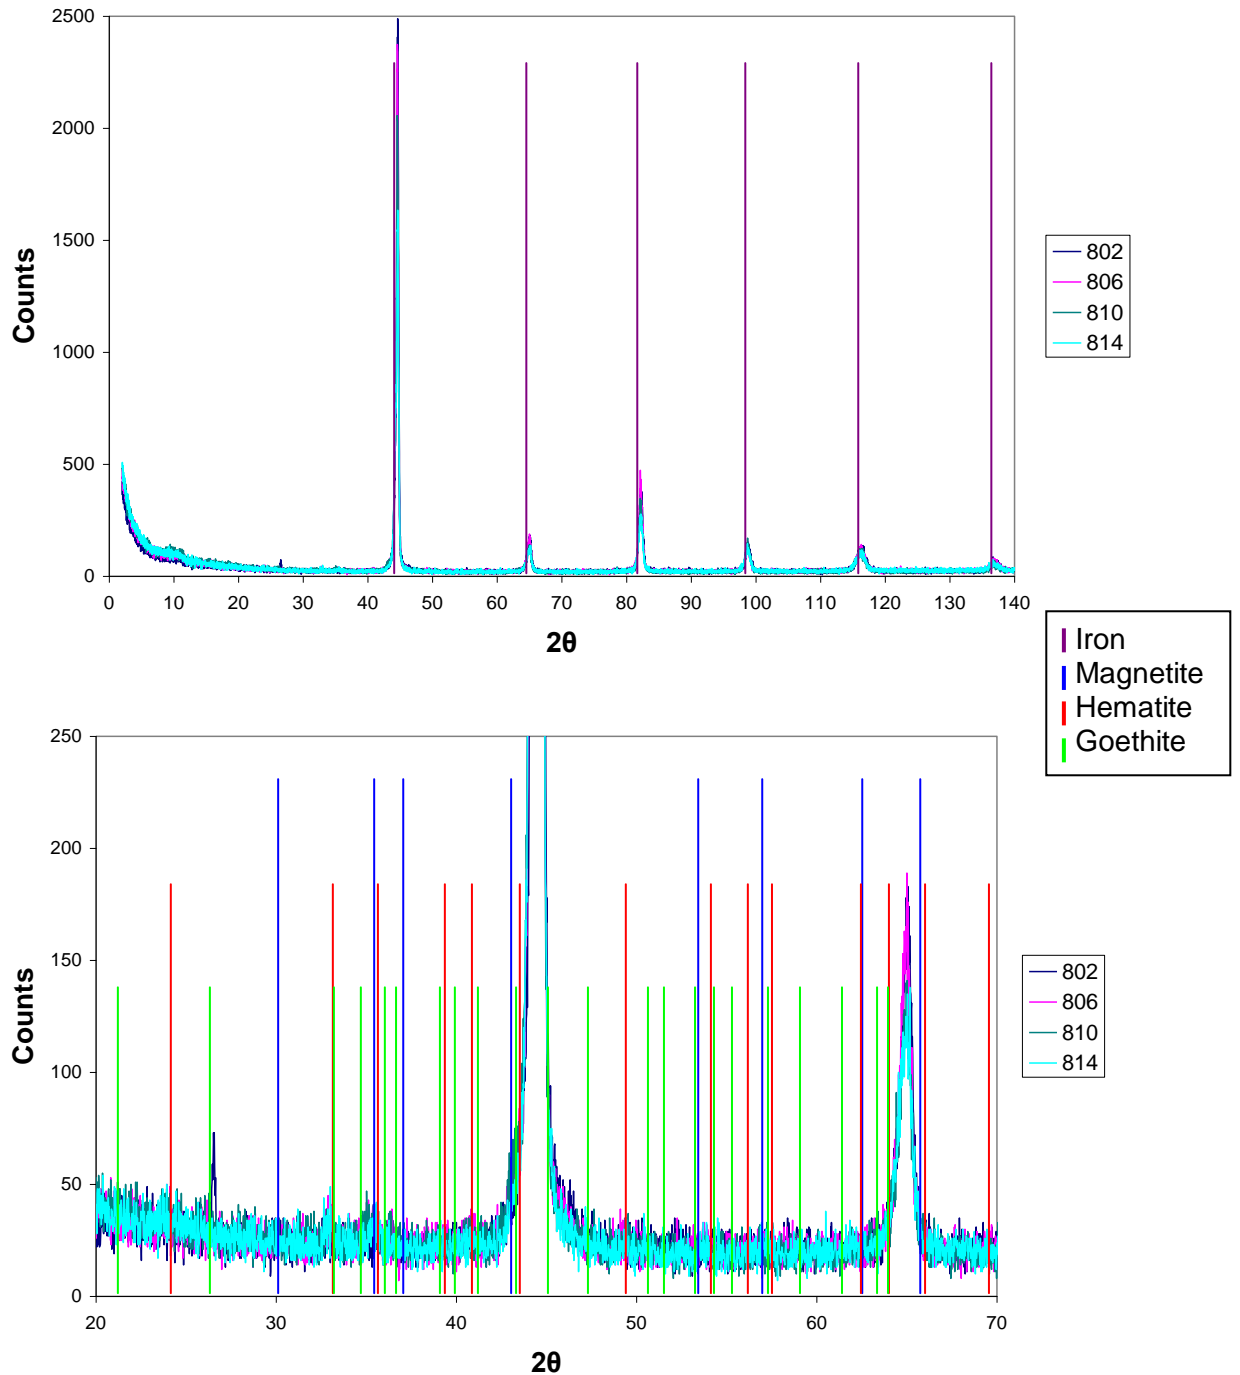
**Figure 4.37: XRD data for samples 802, 806, 810 and 814 exposed to condensing steam at 95°C for 7.5 kh showing (a) all the peaks between 2 and 140° and (b) 20-70° focusing on the peaks not accounted for by the substrate.**

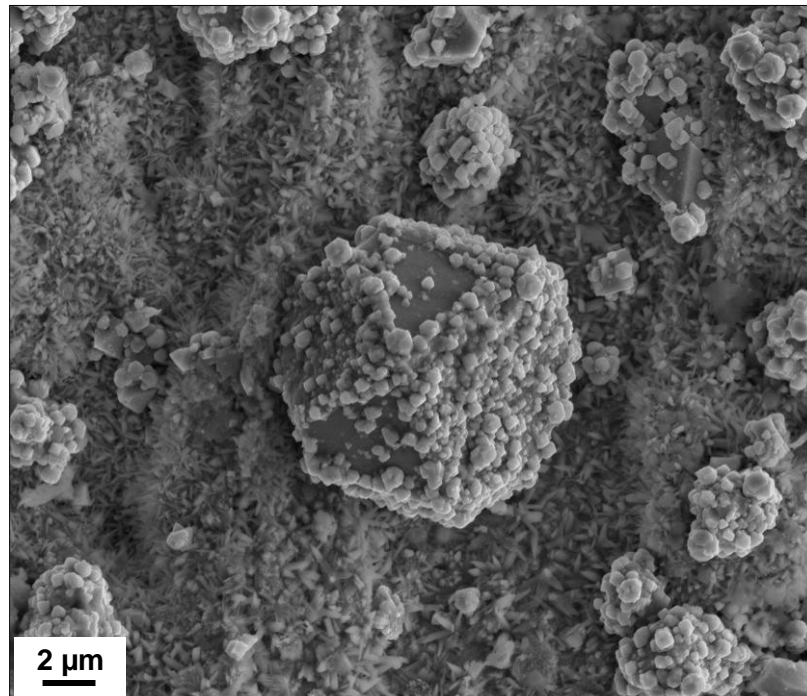
**Figure 4.38: Secondary electron micrograph of a cuboctahedron on the crack surface of specimen 799 (1061 MPa, 98.3 kh)**

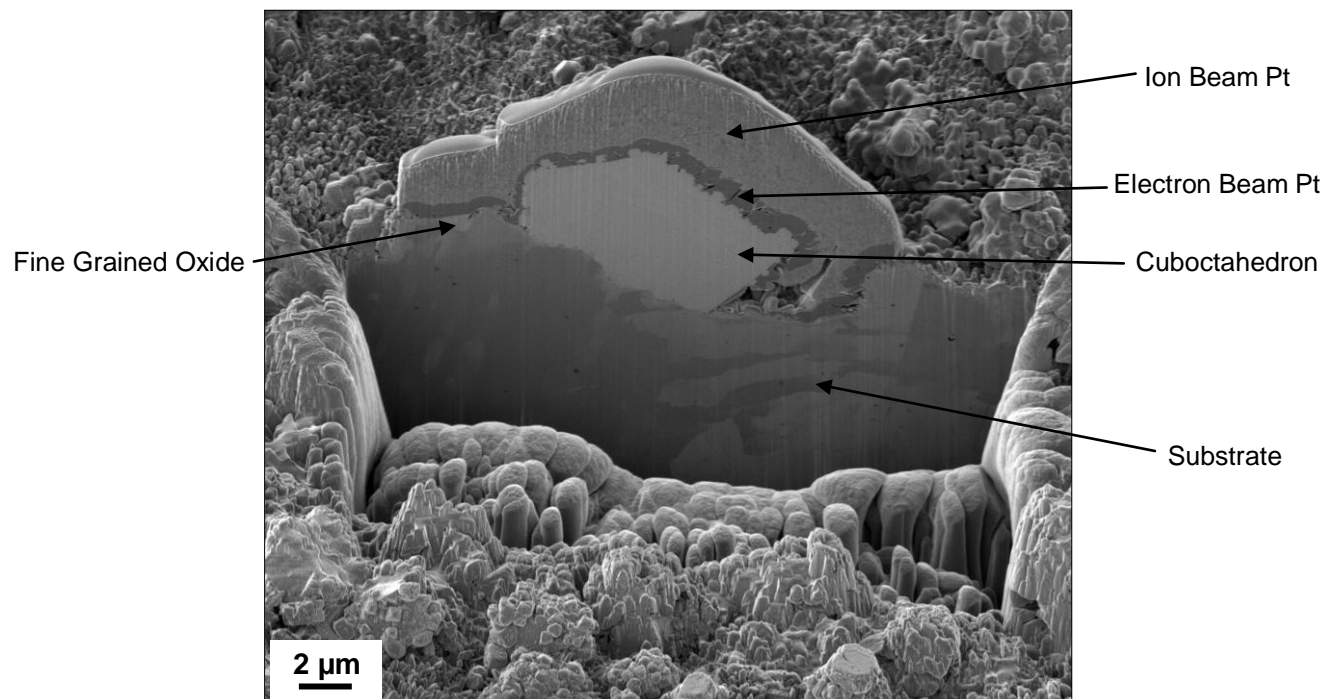
**Figure 4.39: Ion induced secondary electron micrograph showing the cross-section of the cuboctahedron from Figure 4.38.**

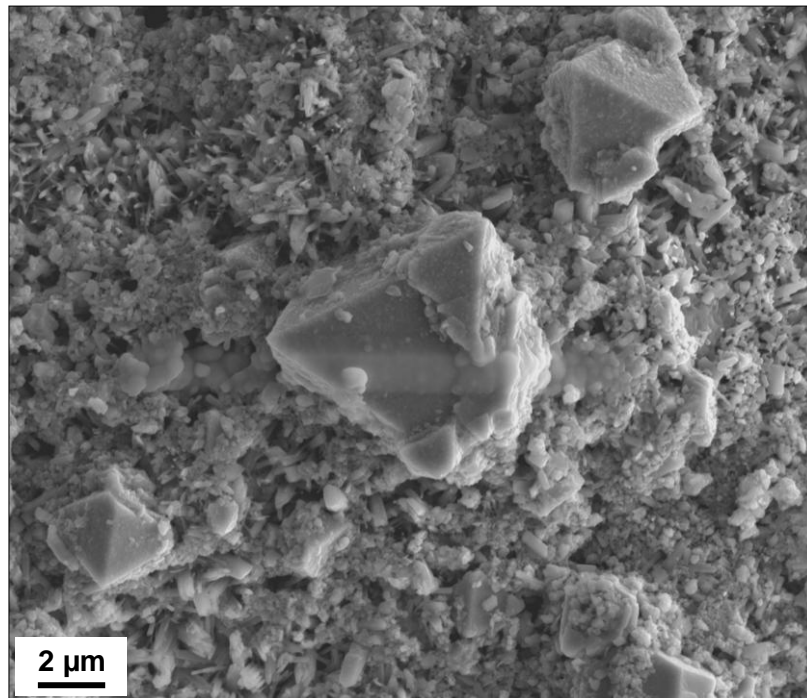
**Figure 4.47: Secondary electron micrograph showing an octahedron on the crack surface of specimen 799 (1061 MPa, 98.3 kh)**

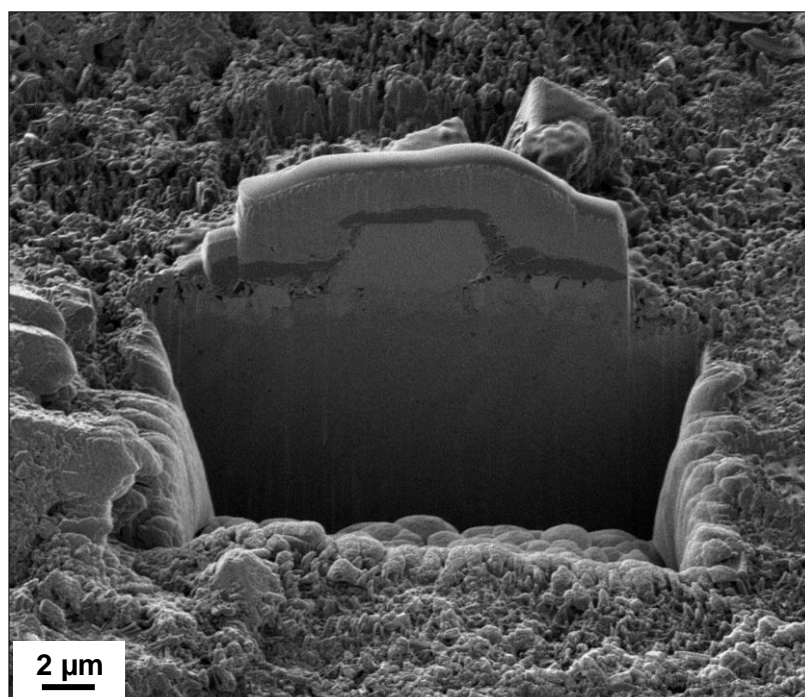
**Figure 4.48: Ion induced secondary electron micrograph showing the cross-section of the octahedron in Figure 4.47.**

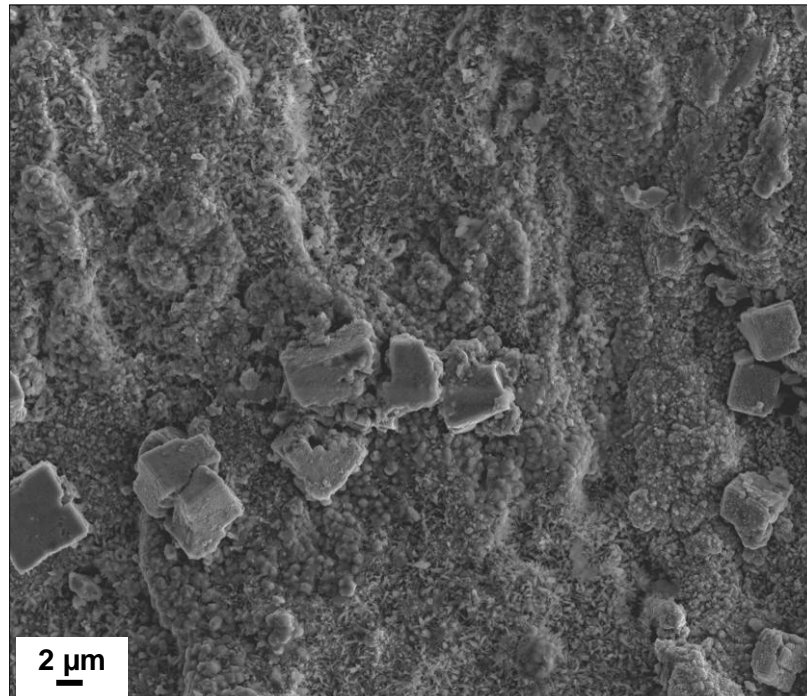
**Figure 4.51: Secondary electron micrograph showing three intertwined imperfect cubes on the crack surface of specimen 799 (1061 MPa, 98.3 kh).**

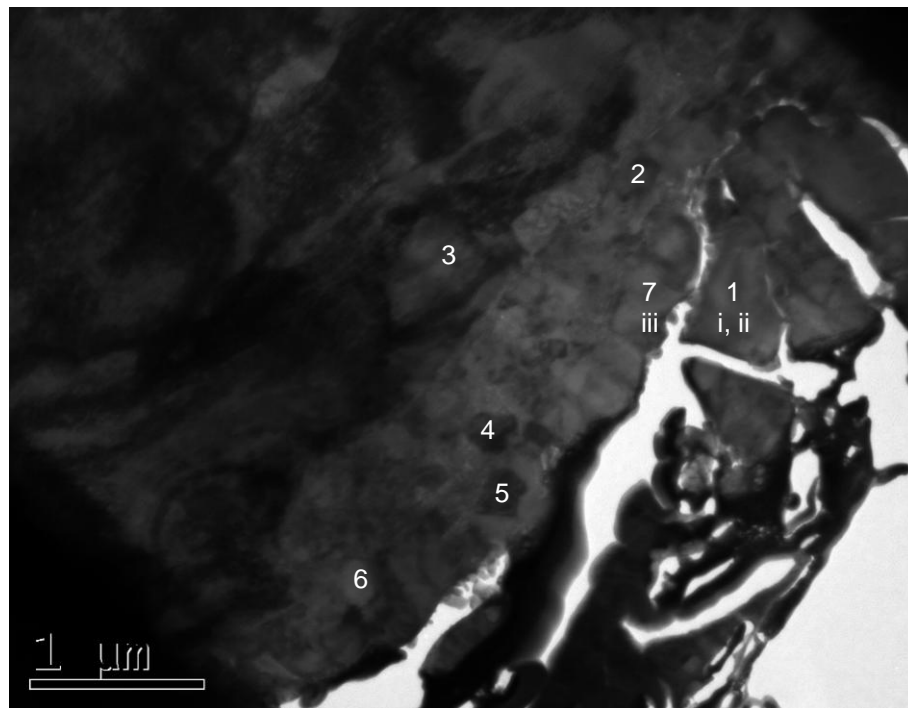
**Figure 4.52: Transmission electron micrograph showing a cross-section through the three cubes on the crack surface of specimen 799 (1061 MPa, 98.3 kh) shown in Figure 4.51. The letters i-iii correspond to the selected area diffraction patterns Figure 4.53 - Figure 4.55 and the numbers 1-6 refer to the EDS data in Table 4.5.**

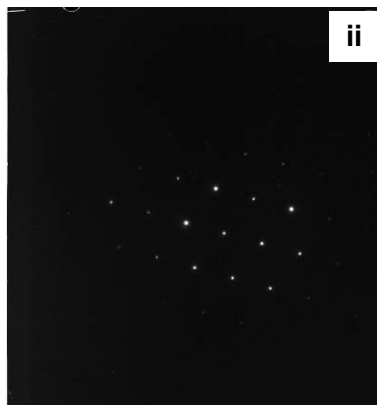
**Figure 4.54: Selected area diffraction pattern collected from point ii on Figure 4.52.**

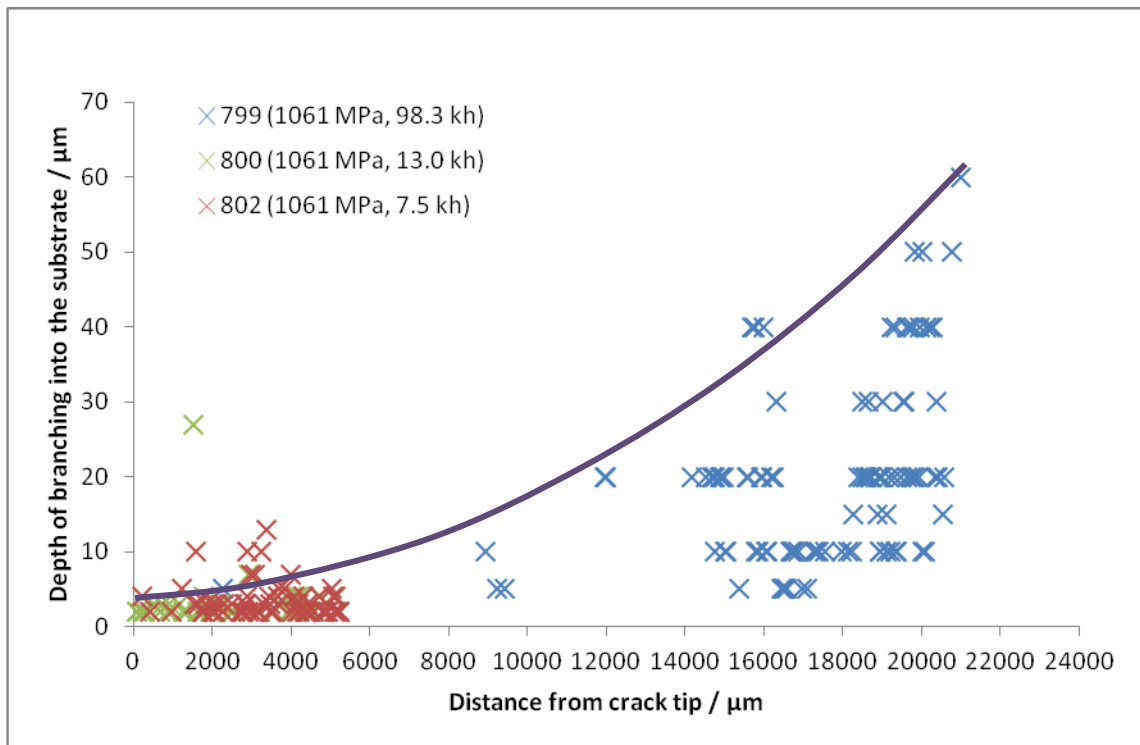
**Figure 4.64: Penetration depth of crack branching into the substrate versus the distance along the main crack from the crack tip for specimens 799 (1061 MPa, 98.3 kh), 800 (1061 MPa, 13.0 kh) and 802 (1061 MPa, 7.5 kh)**

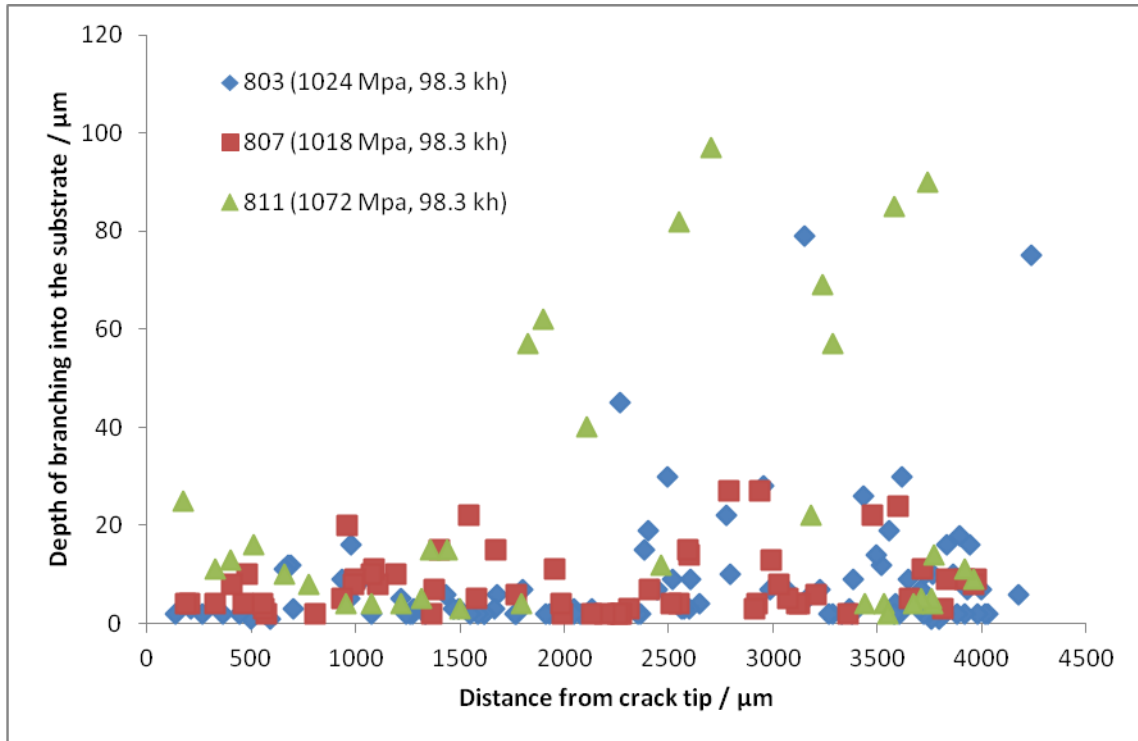
**Figure 4.65: Penetration depth of crack branching into the substrate versus distance along the main crack from the crack tip for specimens 803 (1024 MPa, 98.3 kh), 807 (1018 MPa, 98.3 kh) and 811 (1072 MPa, 98.3 kh).**

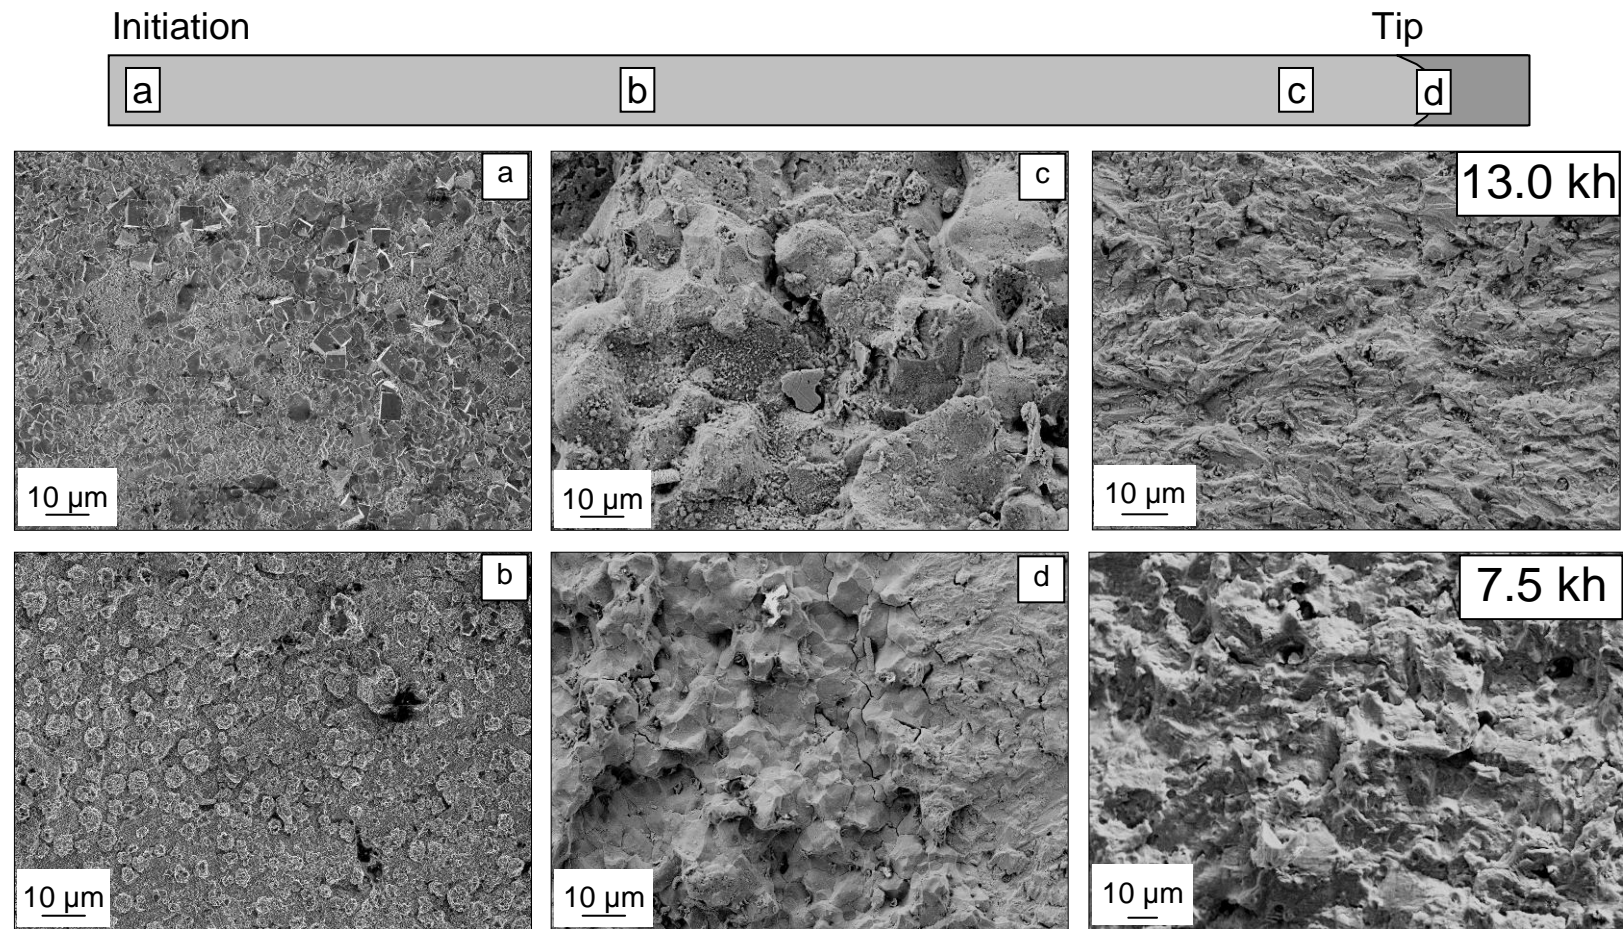
**Figure 4.66: Series of secondary electron micrographs (a-d) showing oxide development with time based on linear crack growth of specimen 799 (1061 MPa, 98.3 kh). The surface and oxide morphology of positions c and d correspond to surface micrographs of specimens exposed for 13.0 kh and 7.5 kh respectively.**

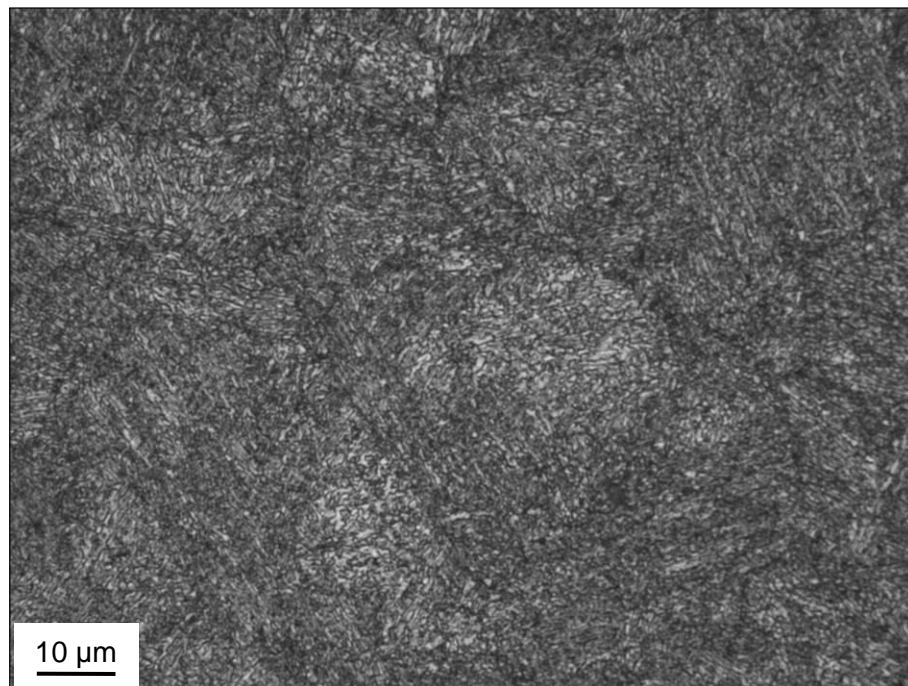
**Figure 5.2: Optical micrograph showing the microstructure of the hot rolled slab of FV520B from which the SENB specimens were made.**

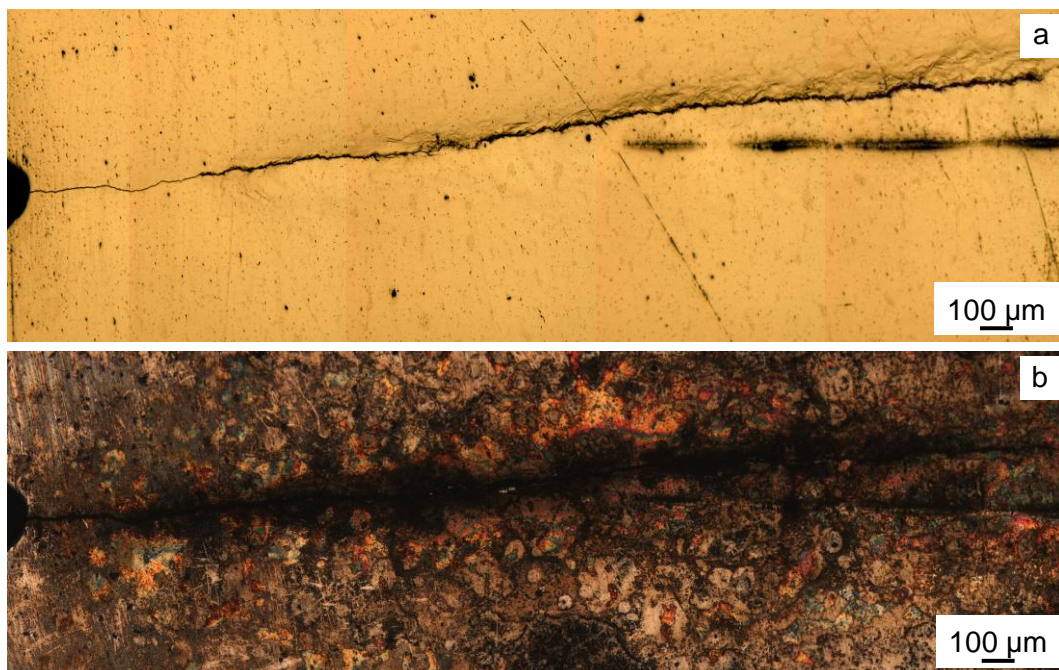
**Figure 5.3: Optical micrographs showing the same specimen (a) with a fatigue pre-crack and (b) after exposure to condensing steam at 95°C for 8.8 kh.**

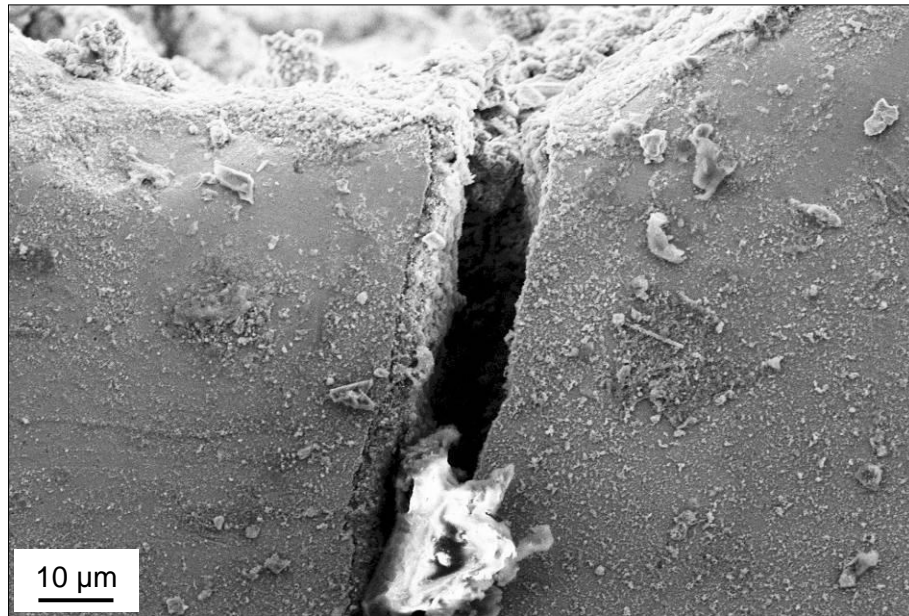
**Figure 5.4: Secondary electron micrograph showing the crack initiation of a SENB specimen exposed to condensing steam at 95°C for 8.8 kh.**

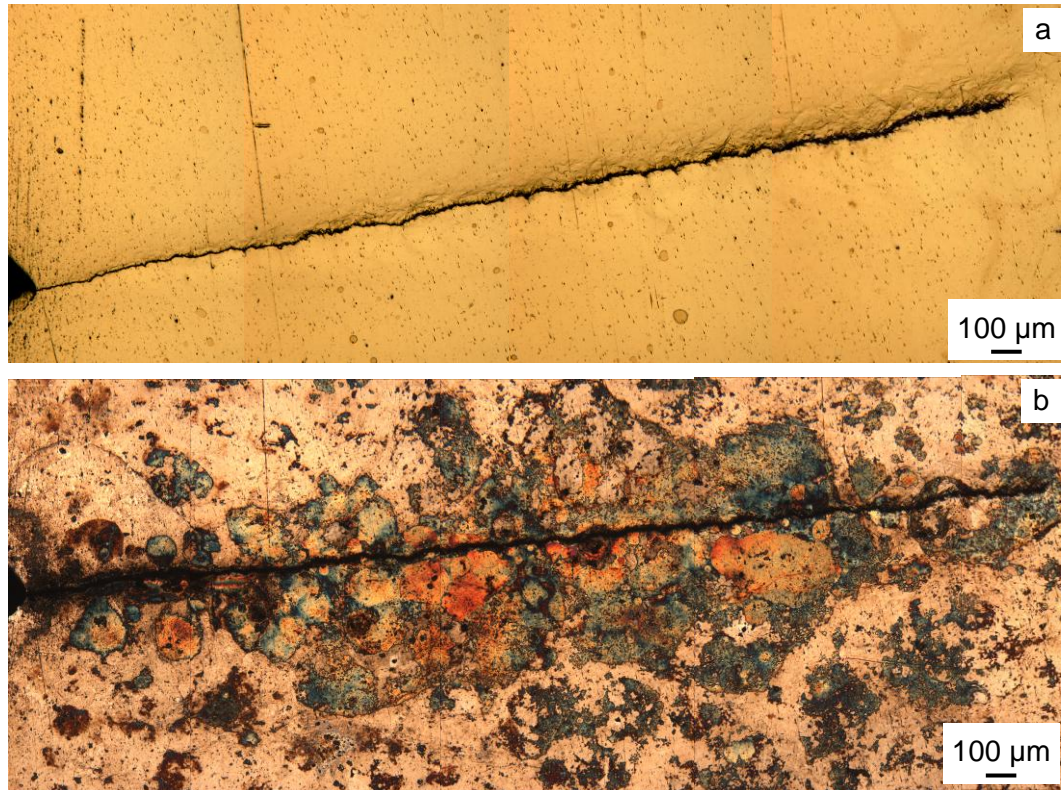
**Figure 5.7:** Optical micrographs showing the same specimen (a) with a fatigue pre-crack and (b) after exposure to condensing steam at 95°C for 7.3 kh.

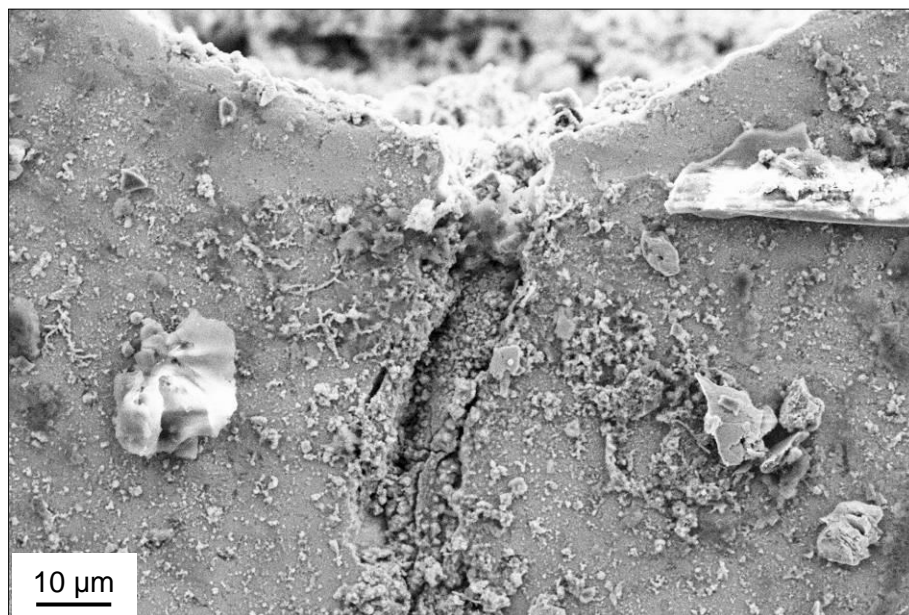
**Figure 5.8:** Secondary electron micrograph showing the crack initiation of a SENB specimen exposed to condensing steam at 95°C for 7.3 kh.

Figure 5.8 shows a secondary electron micrograph of the crack initiation region of a SENB specimen exposed to condensing steam at 95°C for 7.3 kh. In this SENB specimen the fatigue pre-crack initiated almost centrally to the notch tip. The fatigue crack is filled with oxide and the original fatigue crack surfaces are difficult to identify due to the level of corrosion. There is a crack running through the oxide in the same direction as the original pre-crack, which would provide a path for steam to travel down and for corrosion to occur further along the crack.

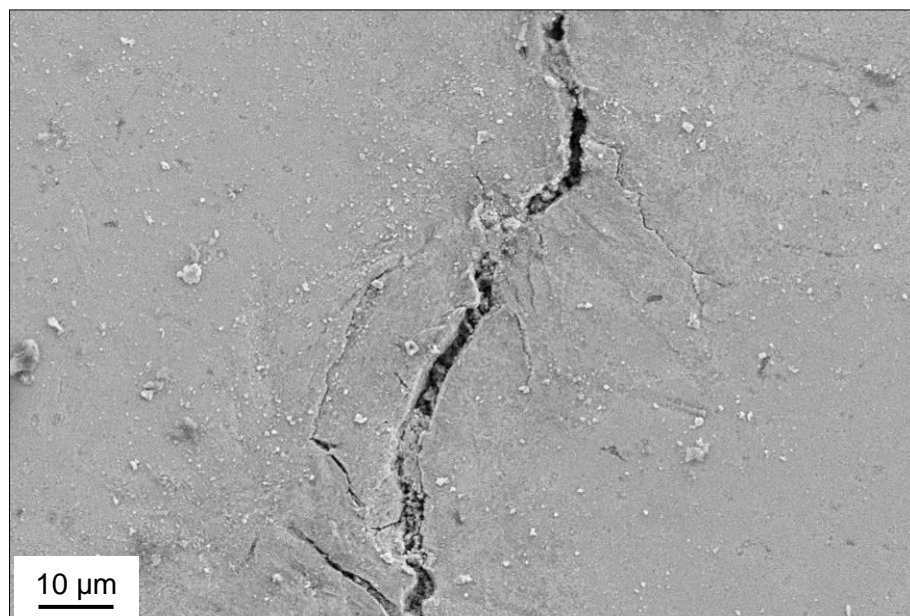
**Figure 5.10: Secondary electron micrograph of crack branching in a SENB specimen exposed to condensing steam at 95°C for 7.3 kh.**

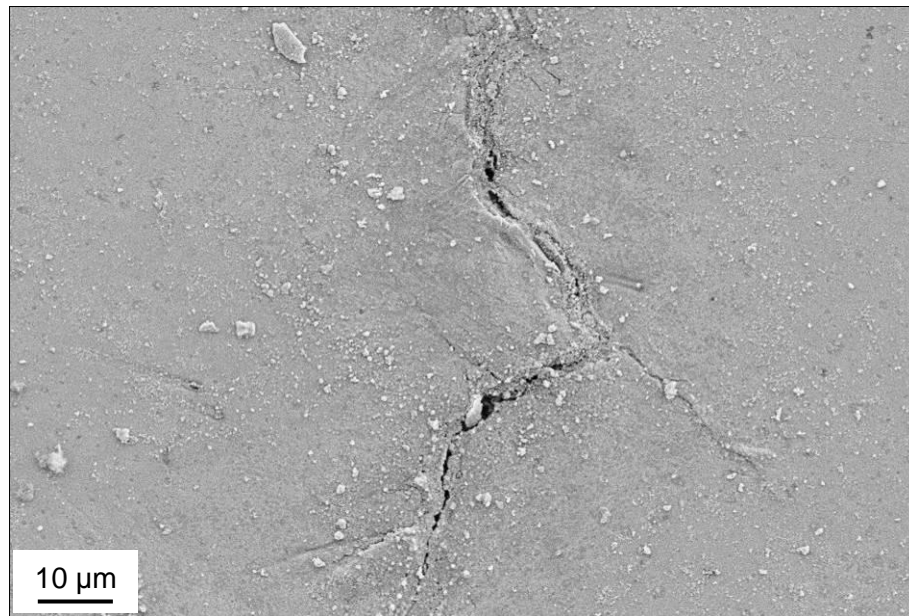
***Figure 5.11: Secondary electron micrograph of crack branching in a SENB specimen exposed to condensing steam at 95°C for 7.3 kh.***

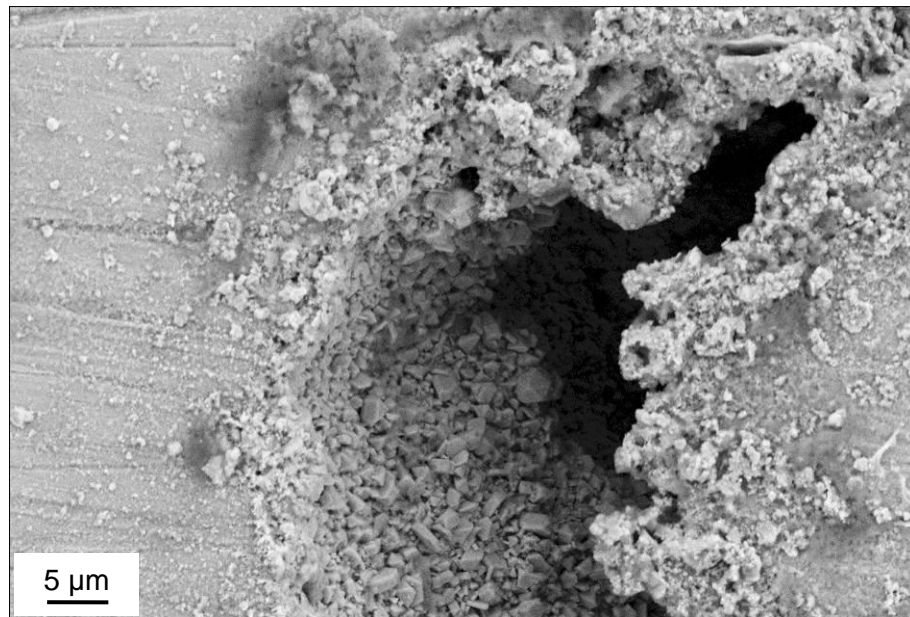
**Figure 5.14: Secondary electron micrograph of the crack through a SENB specimen exposed to condensing steam at 95°C for 5.8 kh.**

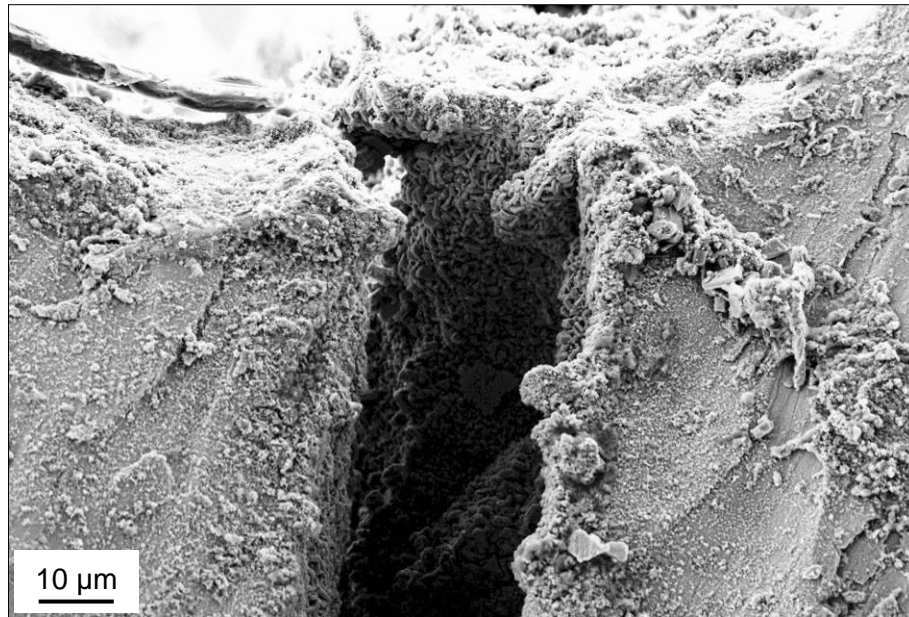
**Figure 5.16: Secondary electron micrograph of a SENB specimen exposed to condensing steam at 95°C for 4.4 kh.**

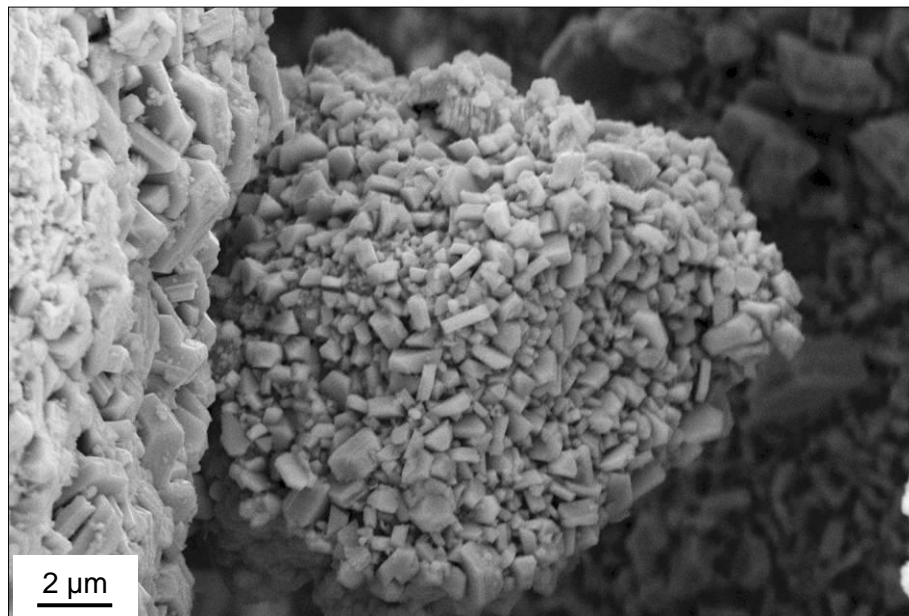
**Figure 5.17: Secondary electron micrograph of an agglomeration of oxide particles within the crack of a SENB specimen exposed to condensing steam at 95°C for 4.4 kh.**

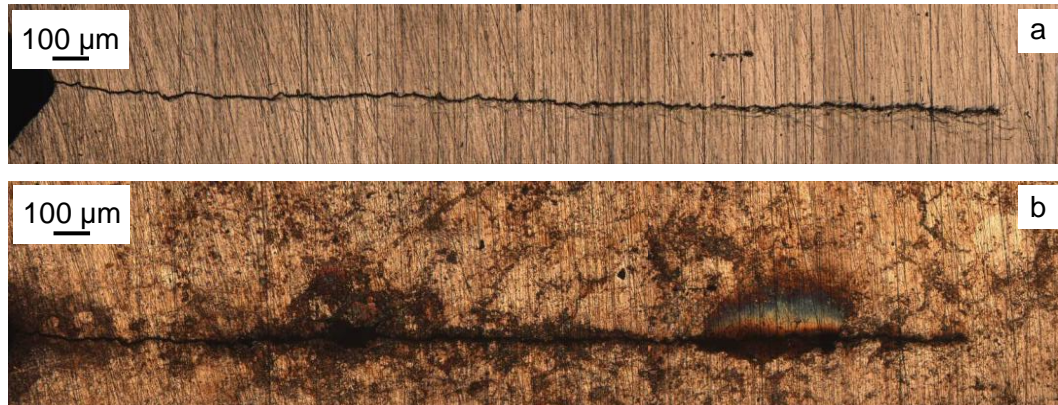
**Figure 5.18: Optical micrographs showing the same specimen (a) with a fatigue pre-crack and (b) after exposure to condensing steam at 95°C for 2.9 kh.**

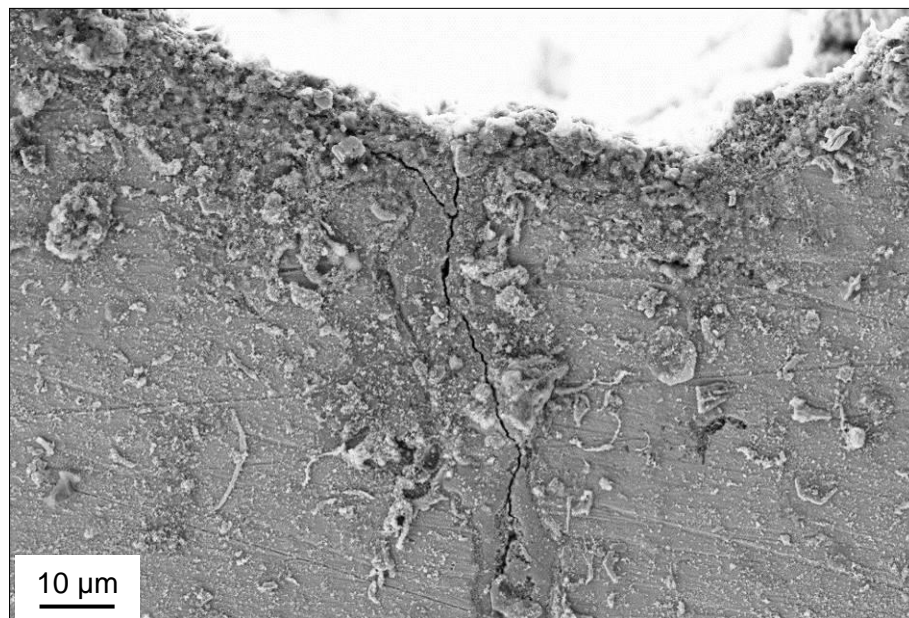
**Figure 5.19: Secondary electron micrograph of a SENB specimen exposed to condensing steam at 95°C for 2.9 kh.**

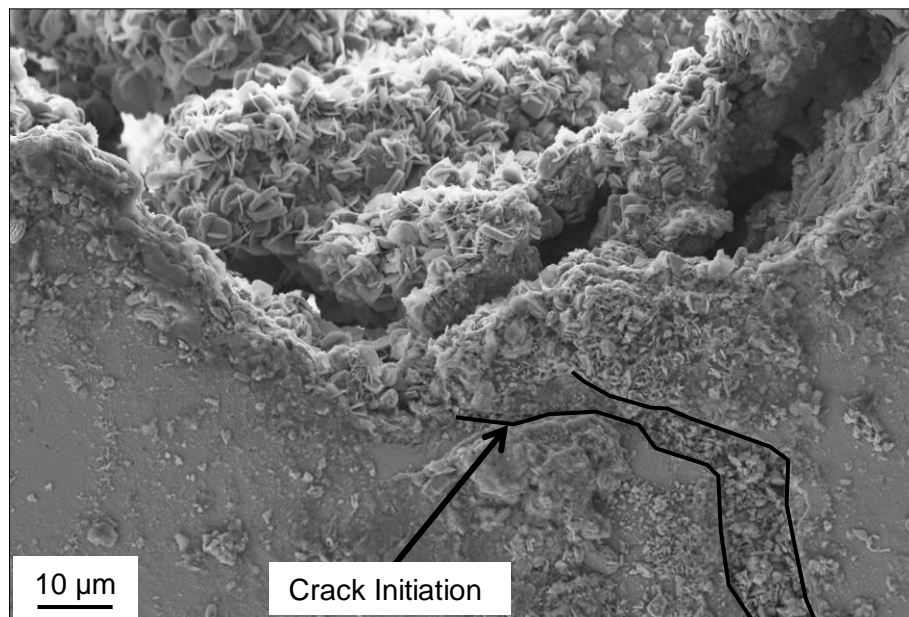
**Figure 5.21: Secondary electron micrograph of the crack initiation region of a SENB specimen exposed to condensing steam at 95°C for 1.5 kh.**

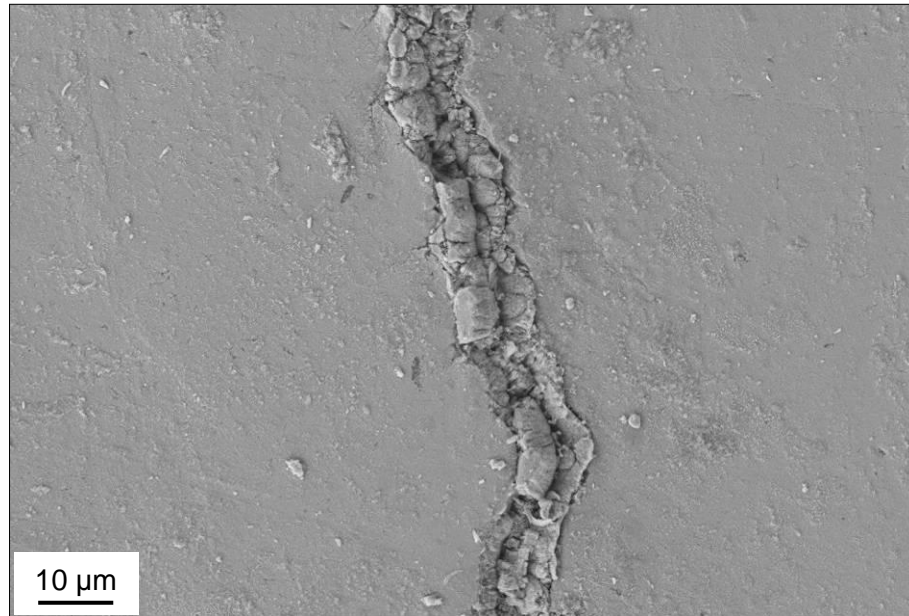
**Figure 5.22: Secondary electron micrograph of a SENB specimen exposed to condensing steam at 95°C for 1.5 kh.**

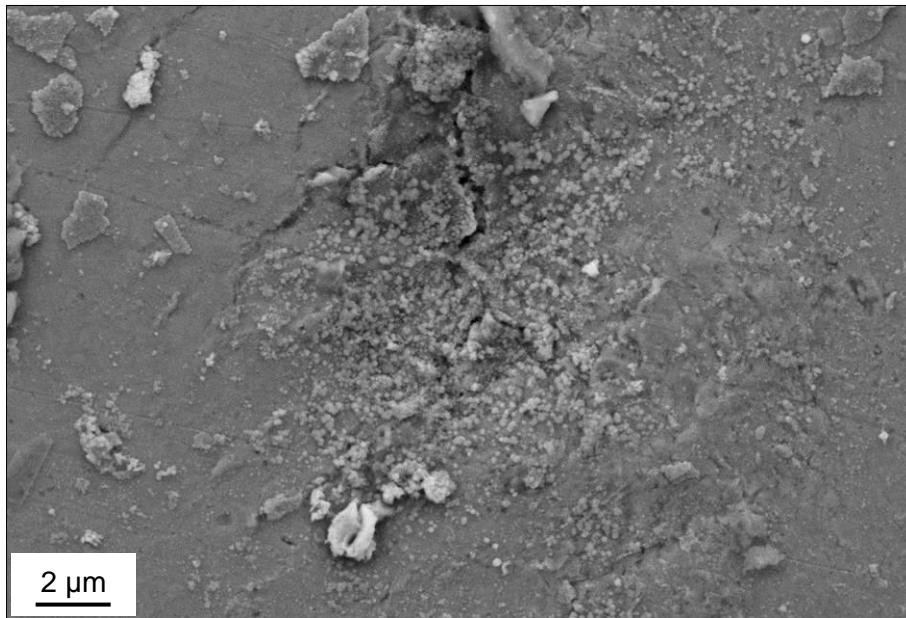
**Figure 5.24: Secondary electron micrograph of a SENB specimen exposed to condensing steam at 95°C for 0.7 kh.**

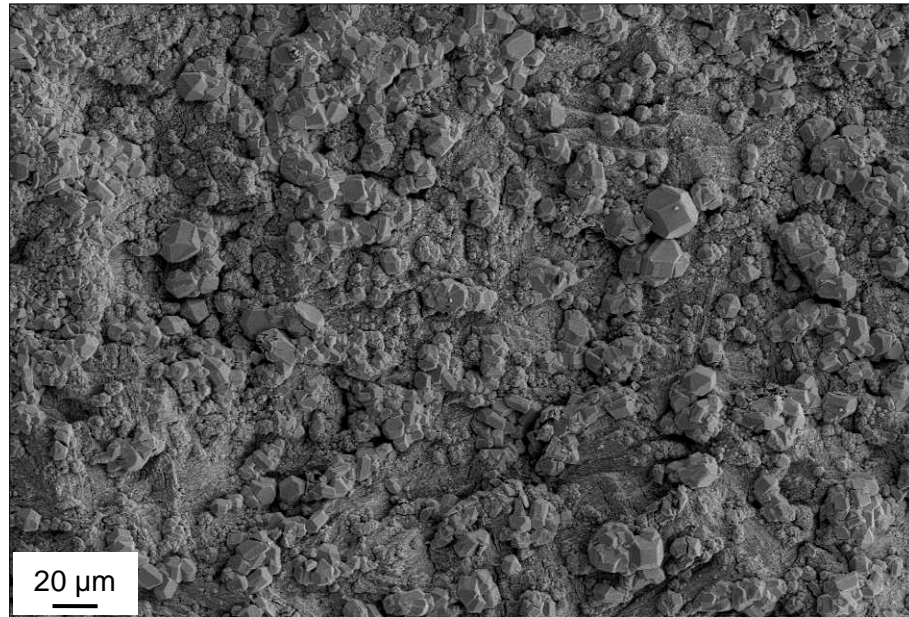
***Figure 5.27: Secondary electron micrograph showing cuboctahedron and other geometric shaped oxide structures on the crack surface of the SENB exposed to condensing steam at 95°C for 8.8 kh.***

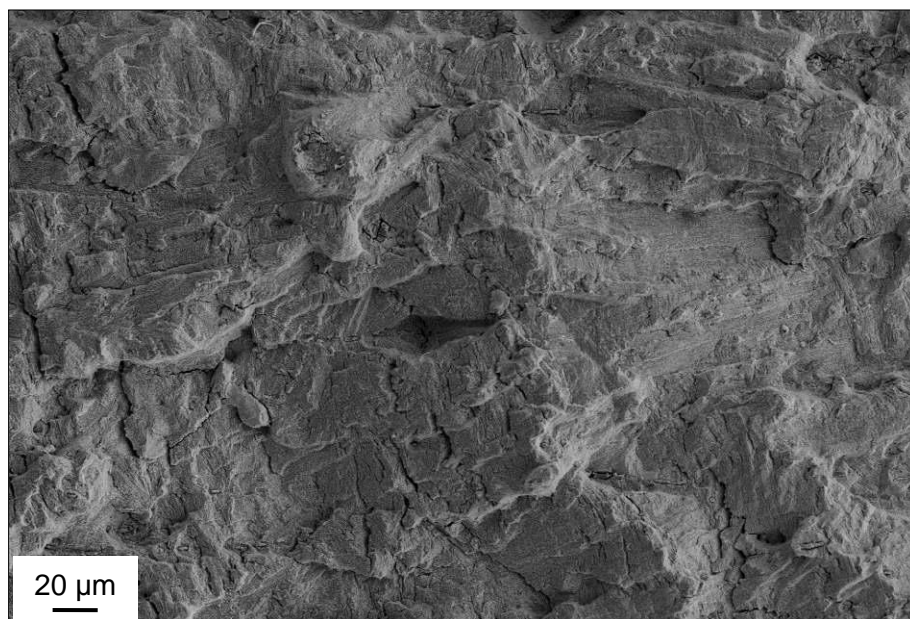
**Figure 5.35: Secondary electron micrograph showing the crack surface of a SENB specimen exposed to condensing steam at 95°C for 2.9 kh.**

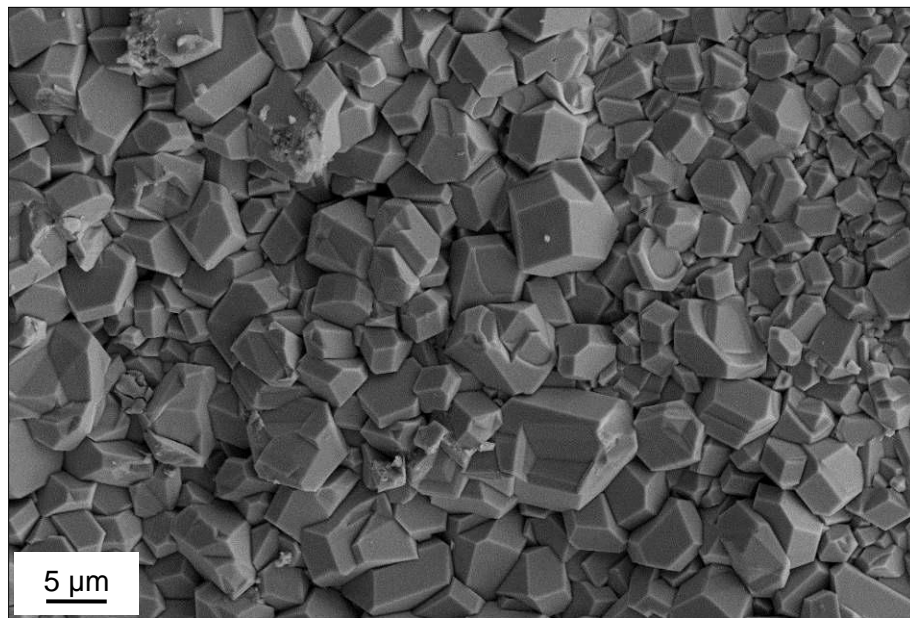
***Figure 5.36: Secondary electron micrograph showing mixed geometric oxide morphologies on the crack surface of a SENB specimen exposed to condensing steam at 95°C for 2.9 kh.***

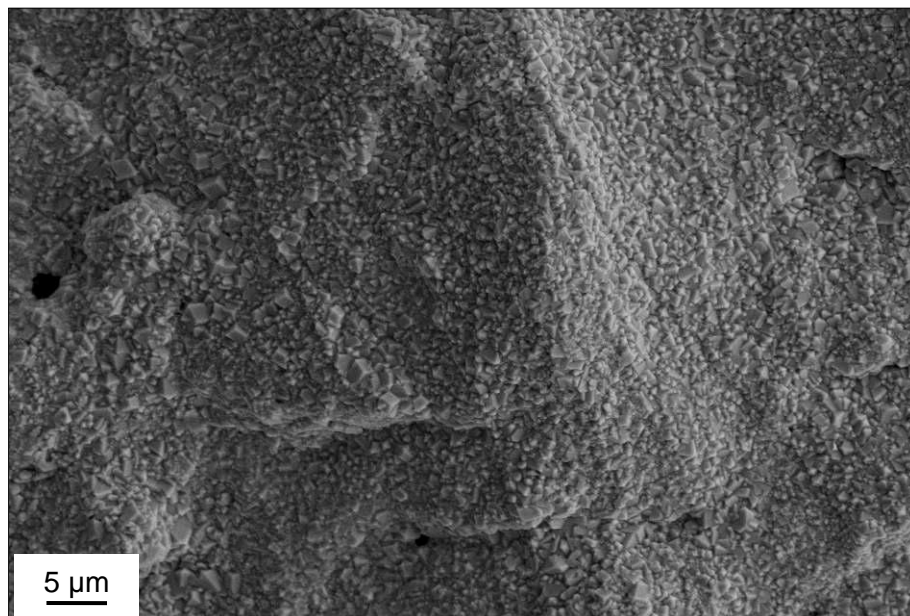
**Figure 5.38:** Secondary electron micrograph showing mixed geometric oxide morphologies on the crack surface of a SENB specimen exposed to condensing steam at 95°C for 1.5 kh.
