# Stress Corrosion Cracking of Low Pressure Steam Turbine Blade and Rotor Materials

Claire Louise Verona

A doctoral thesis submitted in partial fulfilment of the requirements  
for the award of Doctor of Philosophy

September 2010

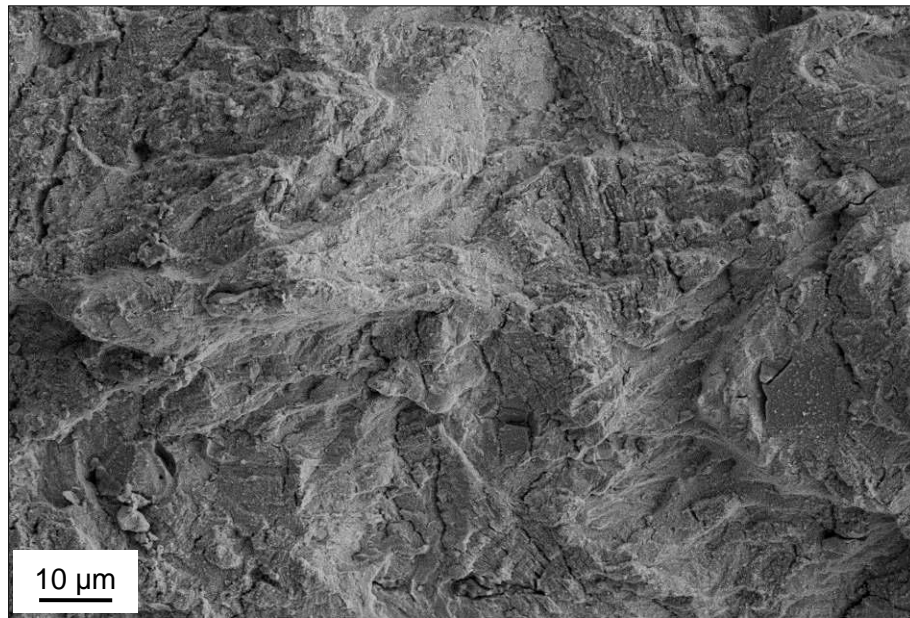
**Figure 5.39: Secondary electron micrograph showing the crack surface of a SENB specimen exposed to condensing steam at 95°C for 0.7 kh.**

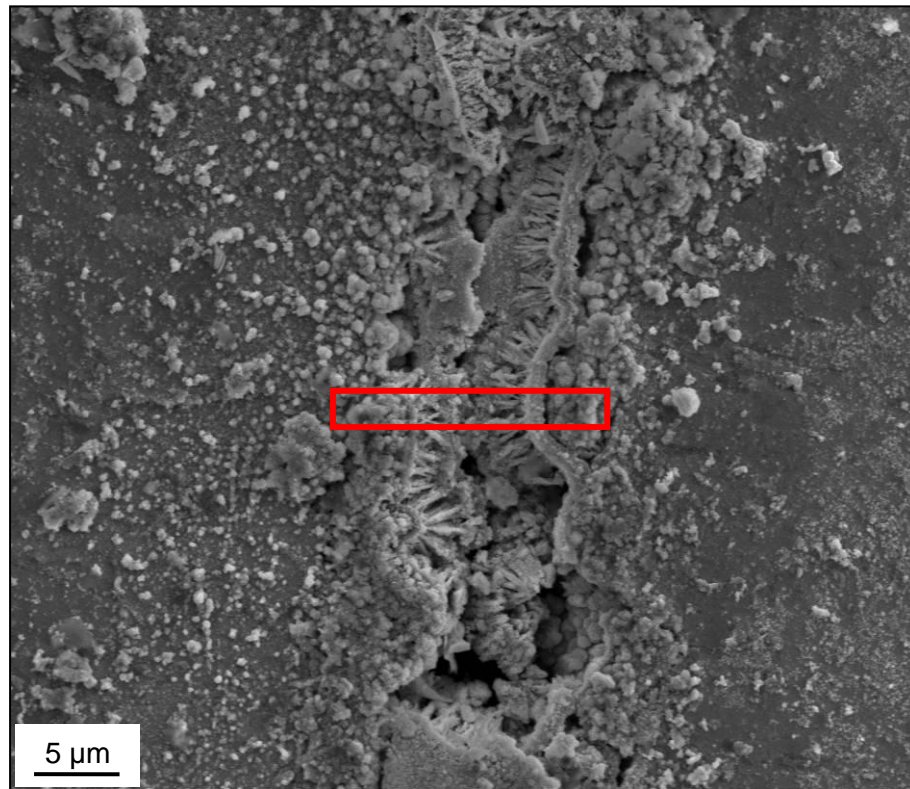
**Figure 5.40: Secondary electron micrograph showing the crack through the SENB specimen exposed to condensing steam at 95°C for 7.3 kh.**

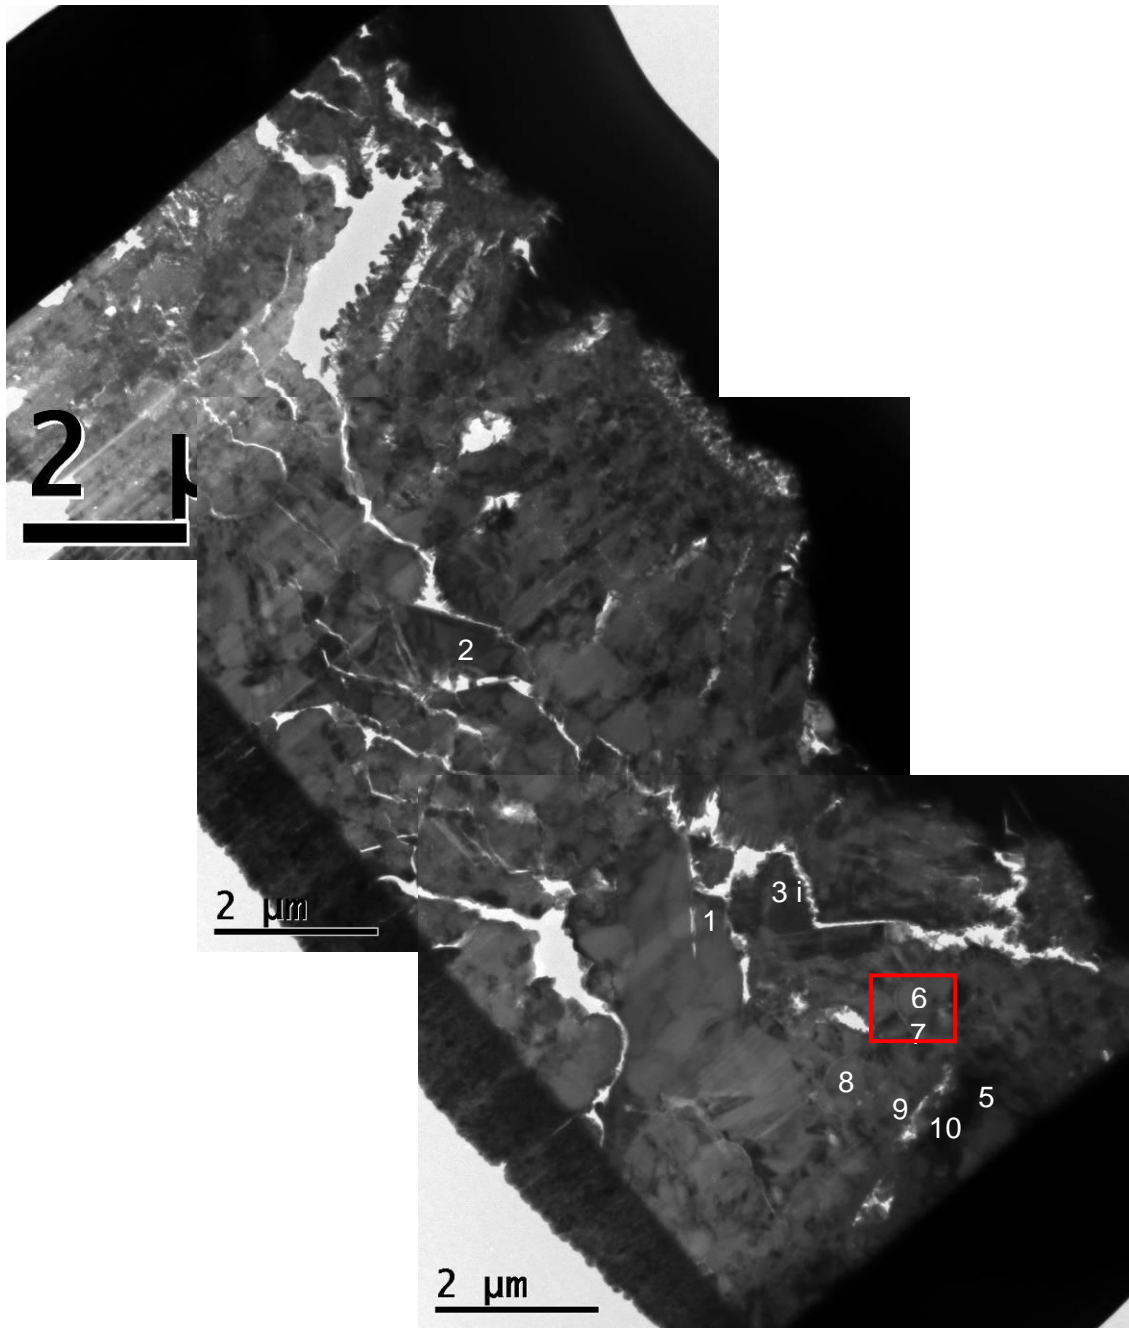
**Figure 5.41: Composite image of transmission electron micrographs showing a site-specific cross-section through the crack of the SENB specimen exposed to condensing steam at 95°C for 7.3 kh at the location shown in Figure 5.40. The letter i corresponds to a selected area diffraction pattern shown in Figure 5.43 and the numbers 1 – 10 refer to EDS point spectra detailed in Table 5.1.**

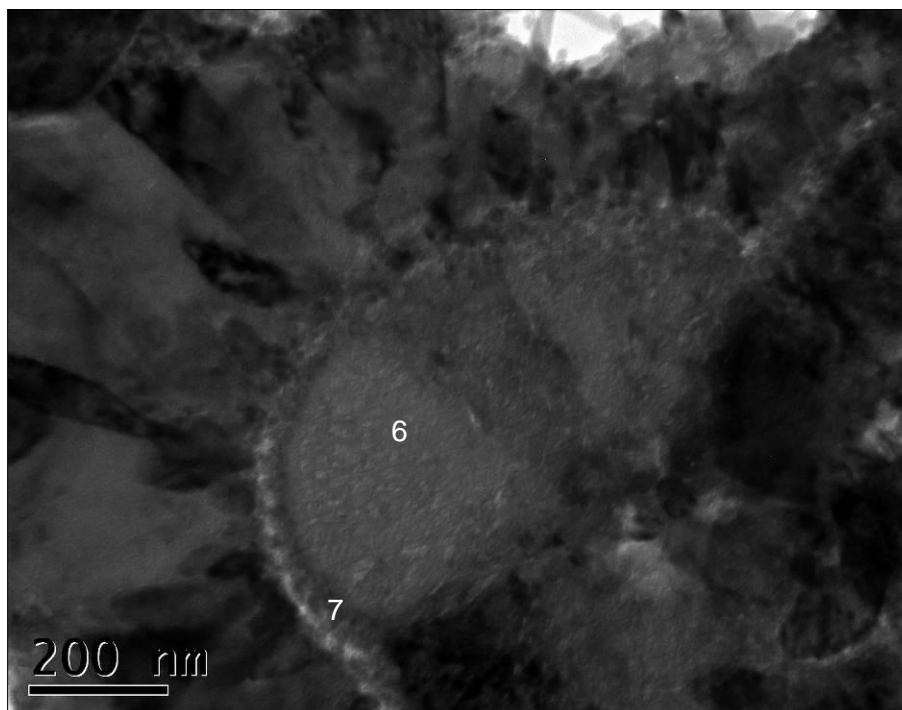
**Figure 5.42: Transmission electron micrograph of the red boxed area highlighted in Figure 5.41**

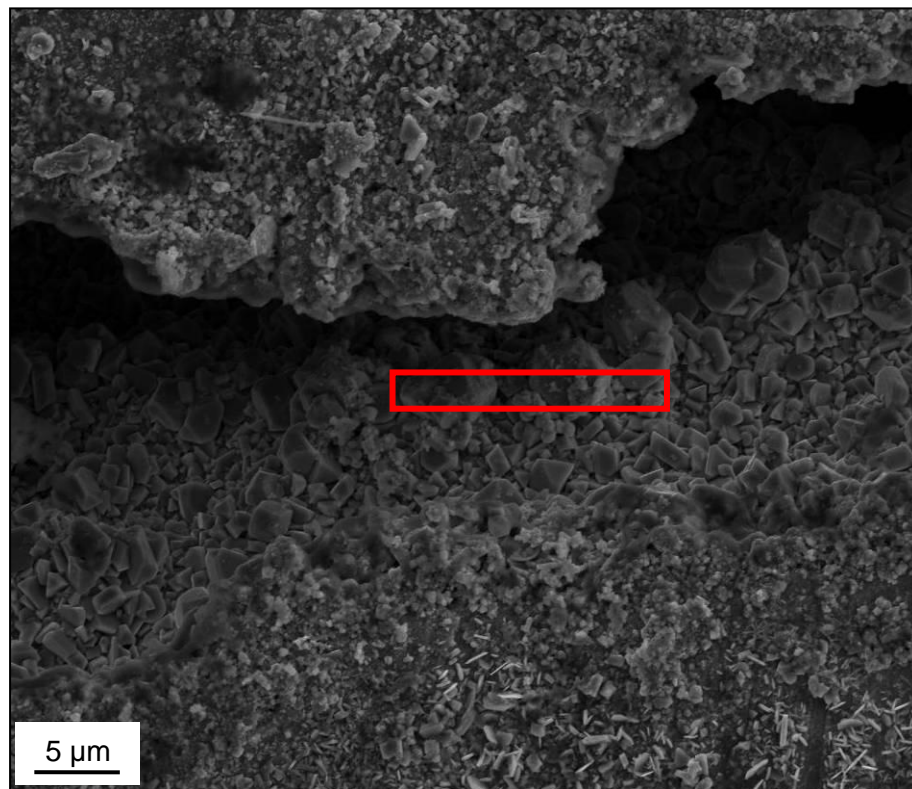
**Figure 5.44: Secondary electron micrograph showing the crack through the SENB specimen exposed to condensing steam at  $95^\circ\text{C}$  for 5.8 kh.**

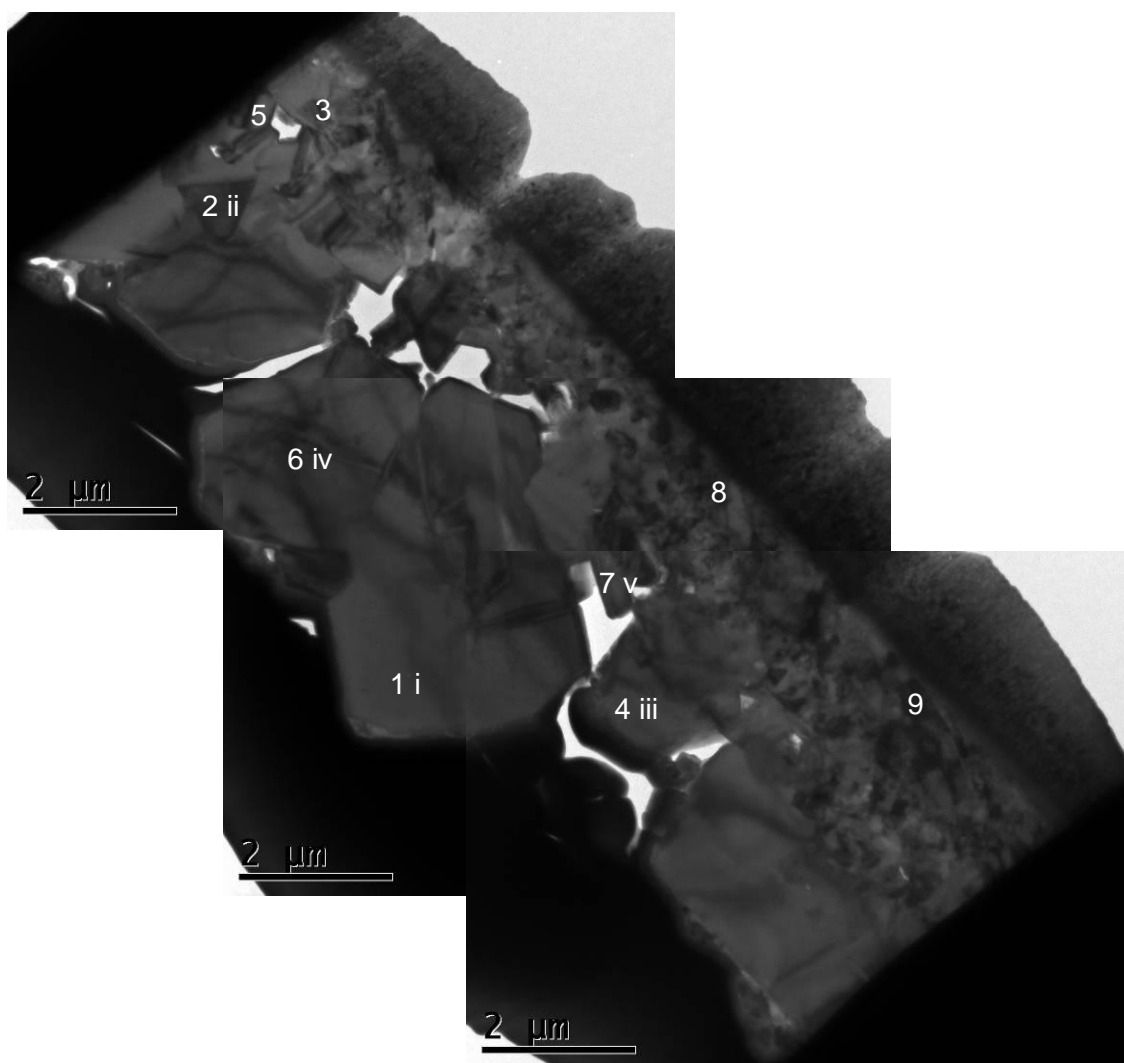
**Figure 5.45: Composite image of transmission electron micrographs showing a site-specific sample removed from the crack through the SENB specimen exposed to condensing steam at 95°C for 5.8 kh. The letters i-iv correspond to the selected area diffraction patterns shown in Figure 5.46 - Figure 5.50 and the numbers 1-9 correspond to the EDS spectra displayed in Table 5.2.**

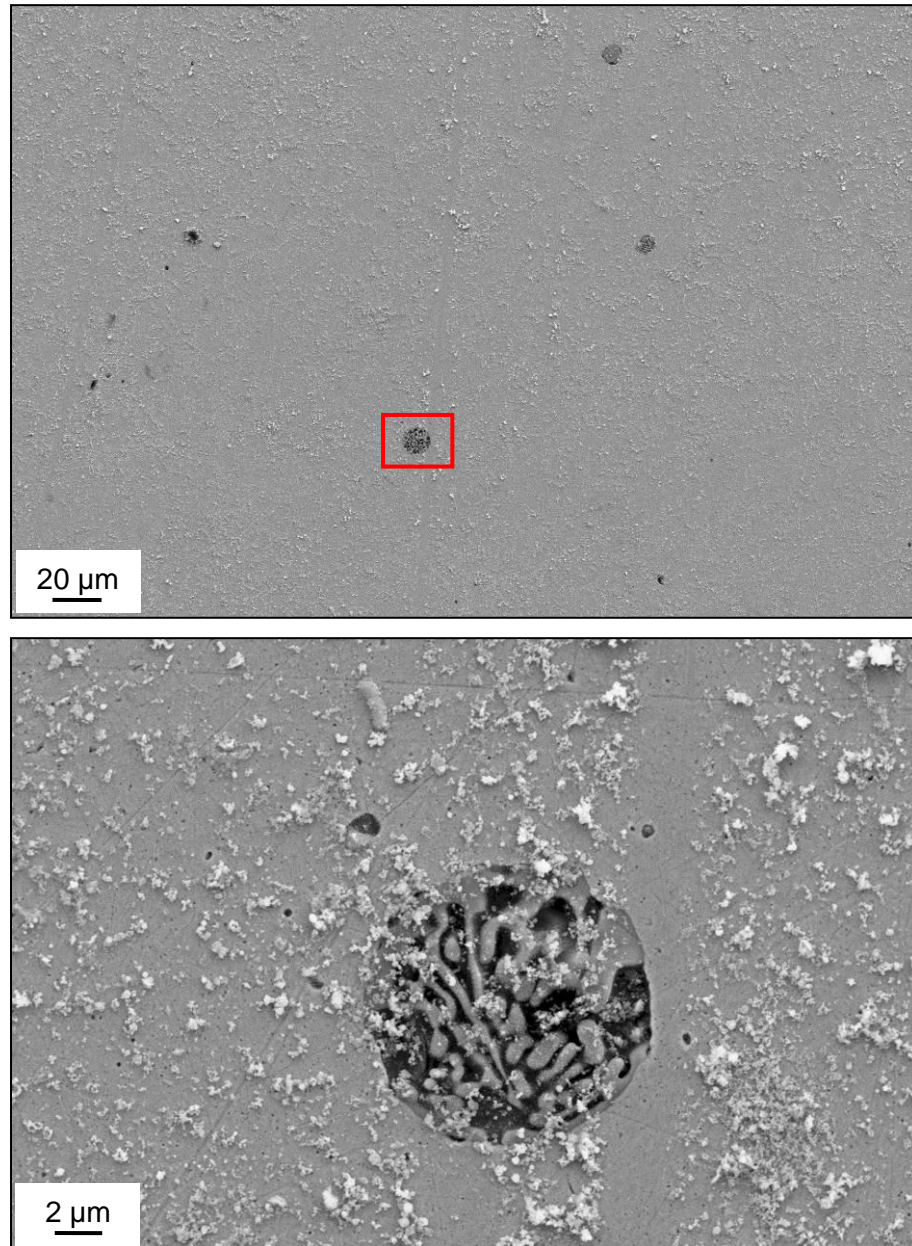
**Figure 6.1: Secondary electron micrograph showing (a) the pitting and general oxidation on the free surface specimen prepared to 1  $\mu\text{m}$  and exposed to condensing steam at 95°C for 10.2 kh and (b) a higher magnification micrograph of a pit highlighted by the red rectangle.**

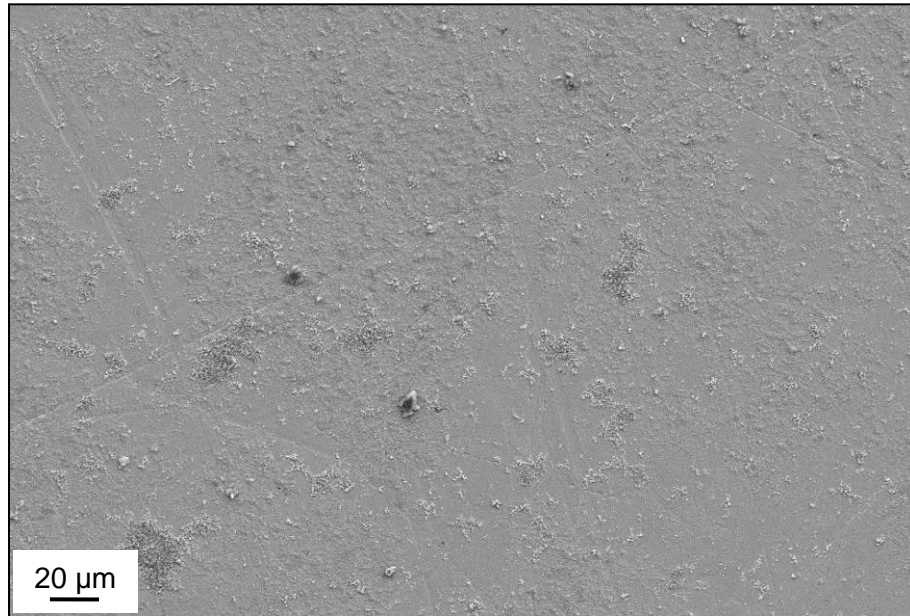
Figure 6.2 shows a secondary electron micrograph of the free surface specimen prepared to 220 grit and exposed to condensing steam at 95°C for 10.2 kh. This micrograph is at the same magnification as Figure 6.1 so they are comparable with each other. The appearance of the oxide in Figure 6.2 is very similar to that in Figure 6.1, but the surface of the specimen prepared to 220 grit has corroded more than the specimen prepared to 1  $\mu\text{m}$  grit for the same exposure time.

**Figure 6.2: Secondary electron micrograph showing the free surface specimen prepared to 220 grit and exposed to condensing steam at 95°C for 10.2 kh.**

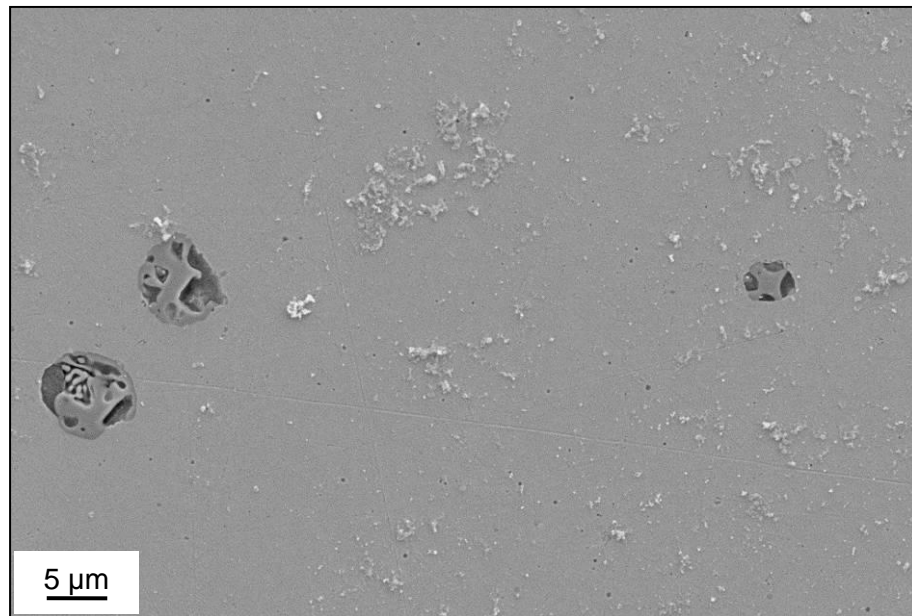
**Figure 6.3: Secondary electron micrograph showing pitting and general corrosion on the free surface specimen prepared to 1 μm and exposed to condensing steam at 95°C for 8.8 kh.**

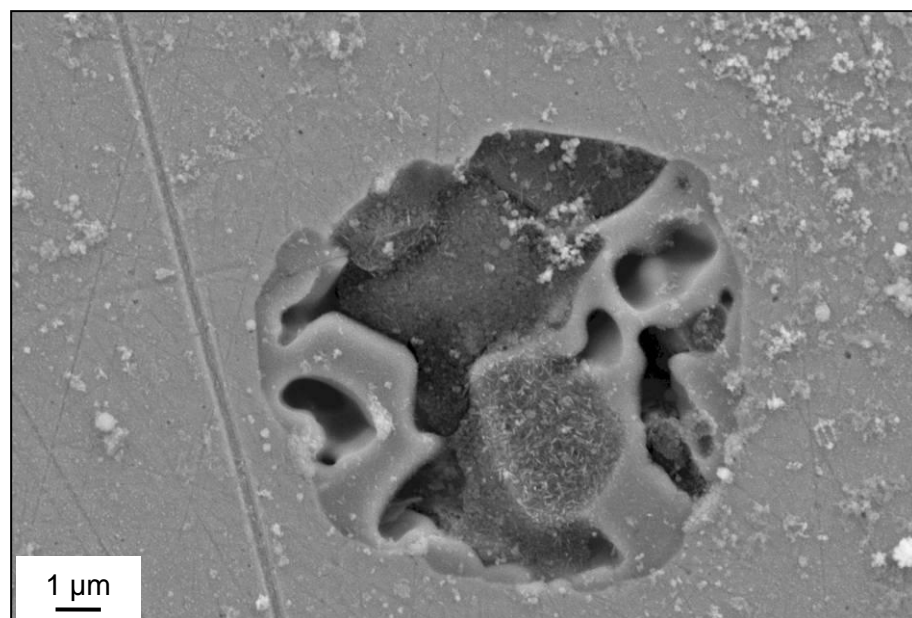
**Figure 6.4: Secondary electron micrograph showing a pit on the free surface specimen prepared to 1 μm and exposed to condensing steam at 95°C for 8.8 kh.**

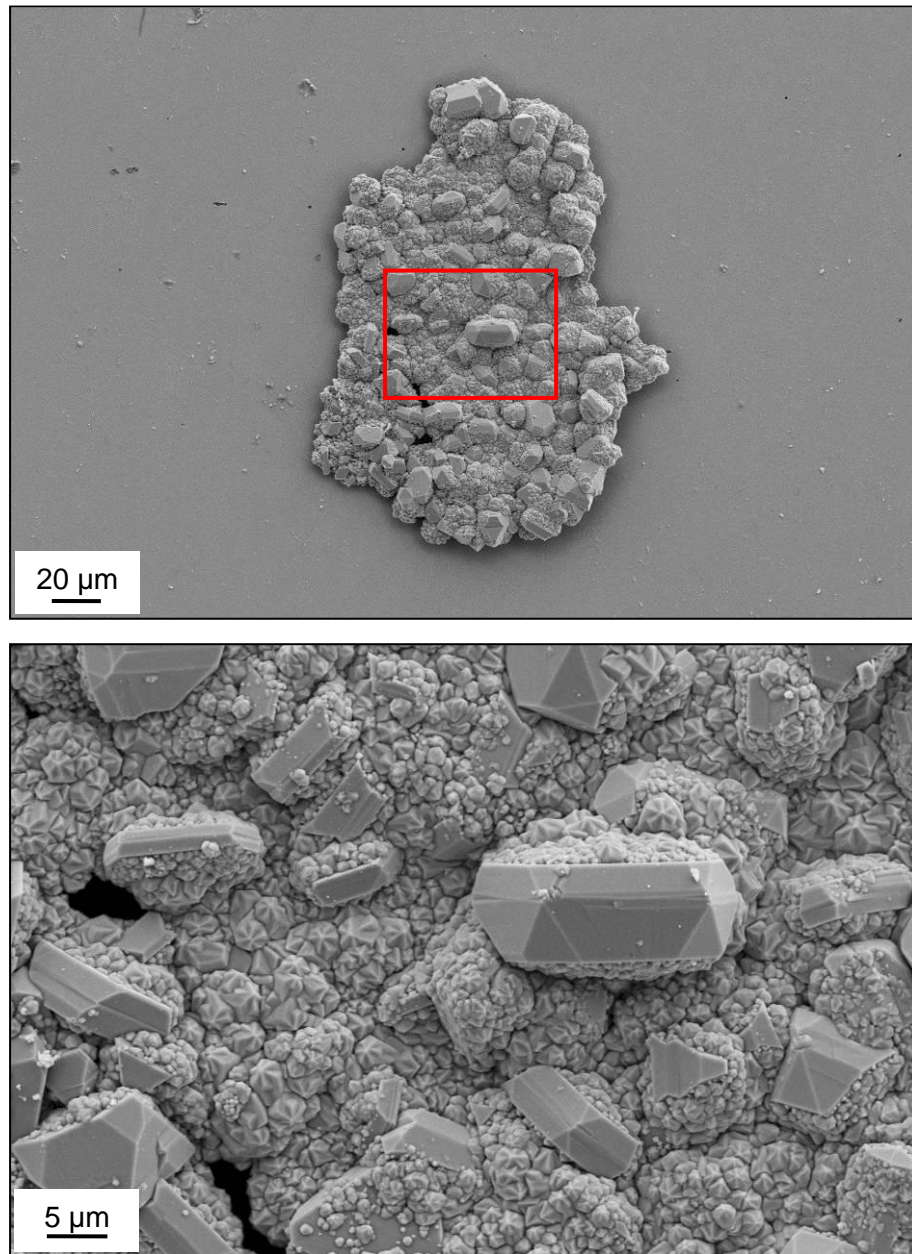
**Figure 6.6: Secondary electron micrograph showing (a) an agglomeration of oxide on the free surface prepared to 1  $\mu\text{m}$  and exposed to condensing steam for 7.3 kh and (b) a higher magnification micrograph of a section of the oxide highlighted by the red rectangle.**

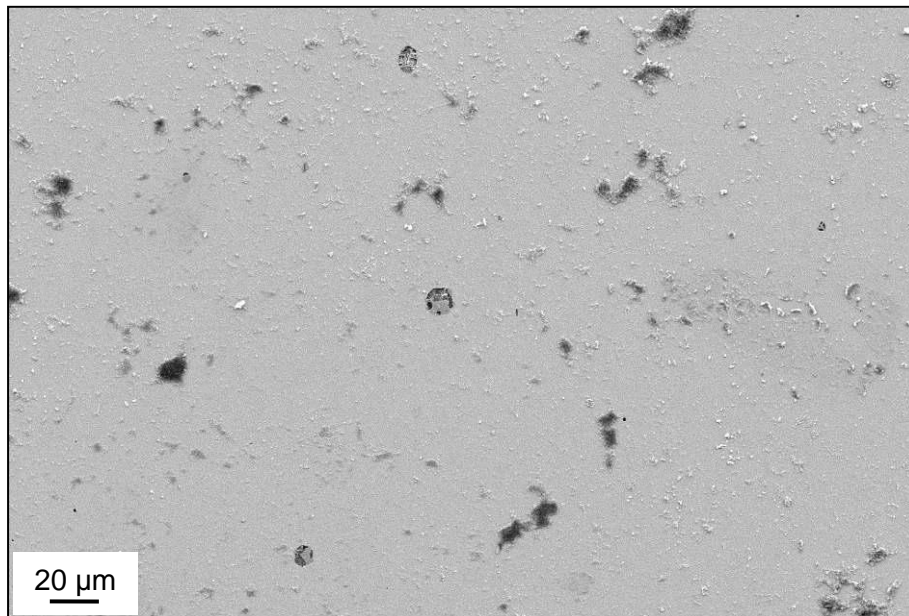
**Figure 6.8: Secondary electron micrograph showing oxidation and pitting on the free surface specimen prepared to 1  $\mu\text{m}$  and exposed to condensing steam at 95°C for 5.8 kh.**

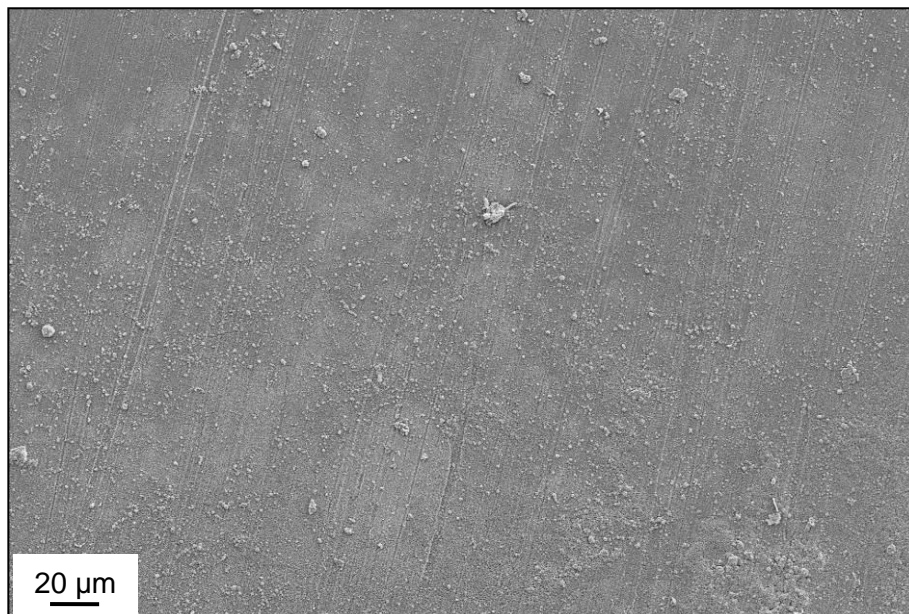
Figure 6.9 shows a secondary electron micrograph of the specimen prepared to 220grit and exposed to condensing steam at 95°C for 5.8 kh. Similarly to the other specimens, there is oxide scattered over the surface and the amount is greater than the specimen prepared to 1 μm prior to exposure to the experimental conditions.

**Figure 6.9: Secondary electron micrograph showing the free surface specimen prepared to 220 grit and exposed to condensing steam at 95°C for 5.8 kh.**

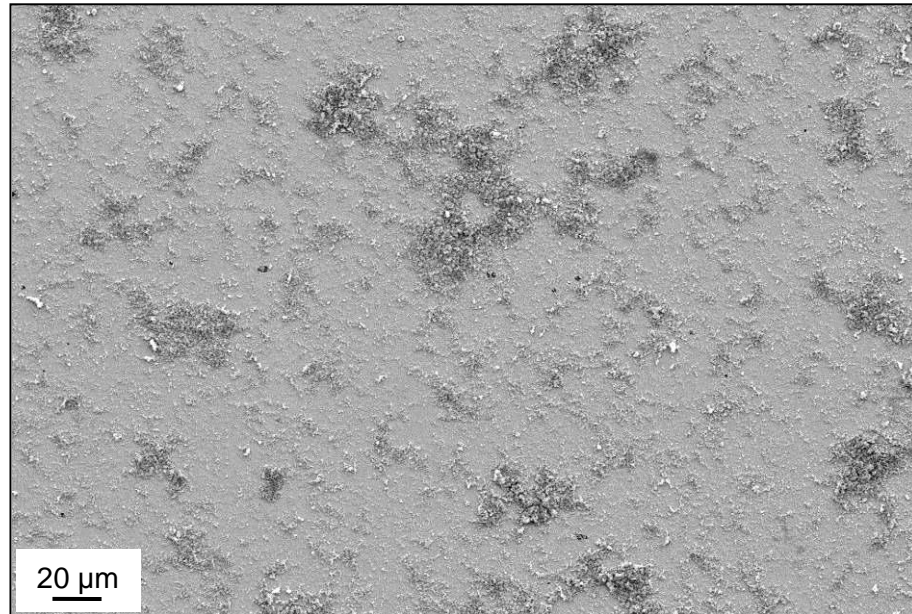
**Figure 6.12: Secondary electron micrograph showing the free surface specimen prepared to 1  $\mu\text{m}$  and exposed to condensing steam at 95°C for 2.9 kh.**
